**FULHAM PALACE,
BISHOPS AVENUE, FULHAM,
LONDON SW6 6EA**

**BUILT HERITAGE RECORDING AND
ARCHAEOLOGICAL WATCHING
BRIEF OF TWO GATEWAYS WITHIN
THE GARDEN**

PCA REPORT NO: R12493

JUNE 2016

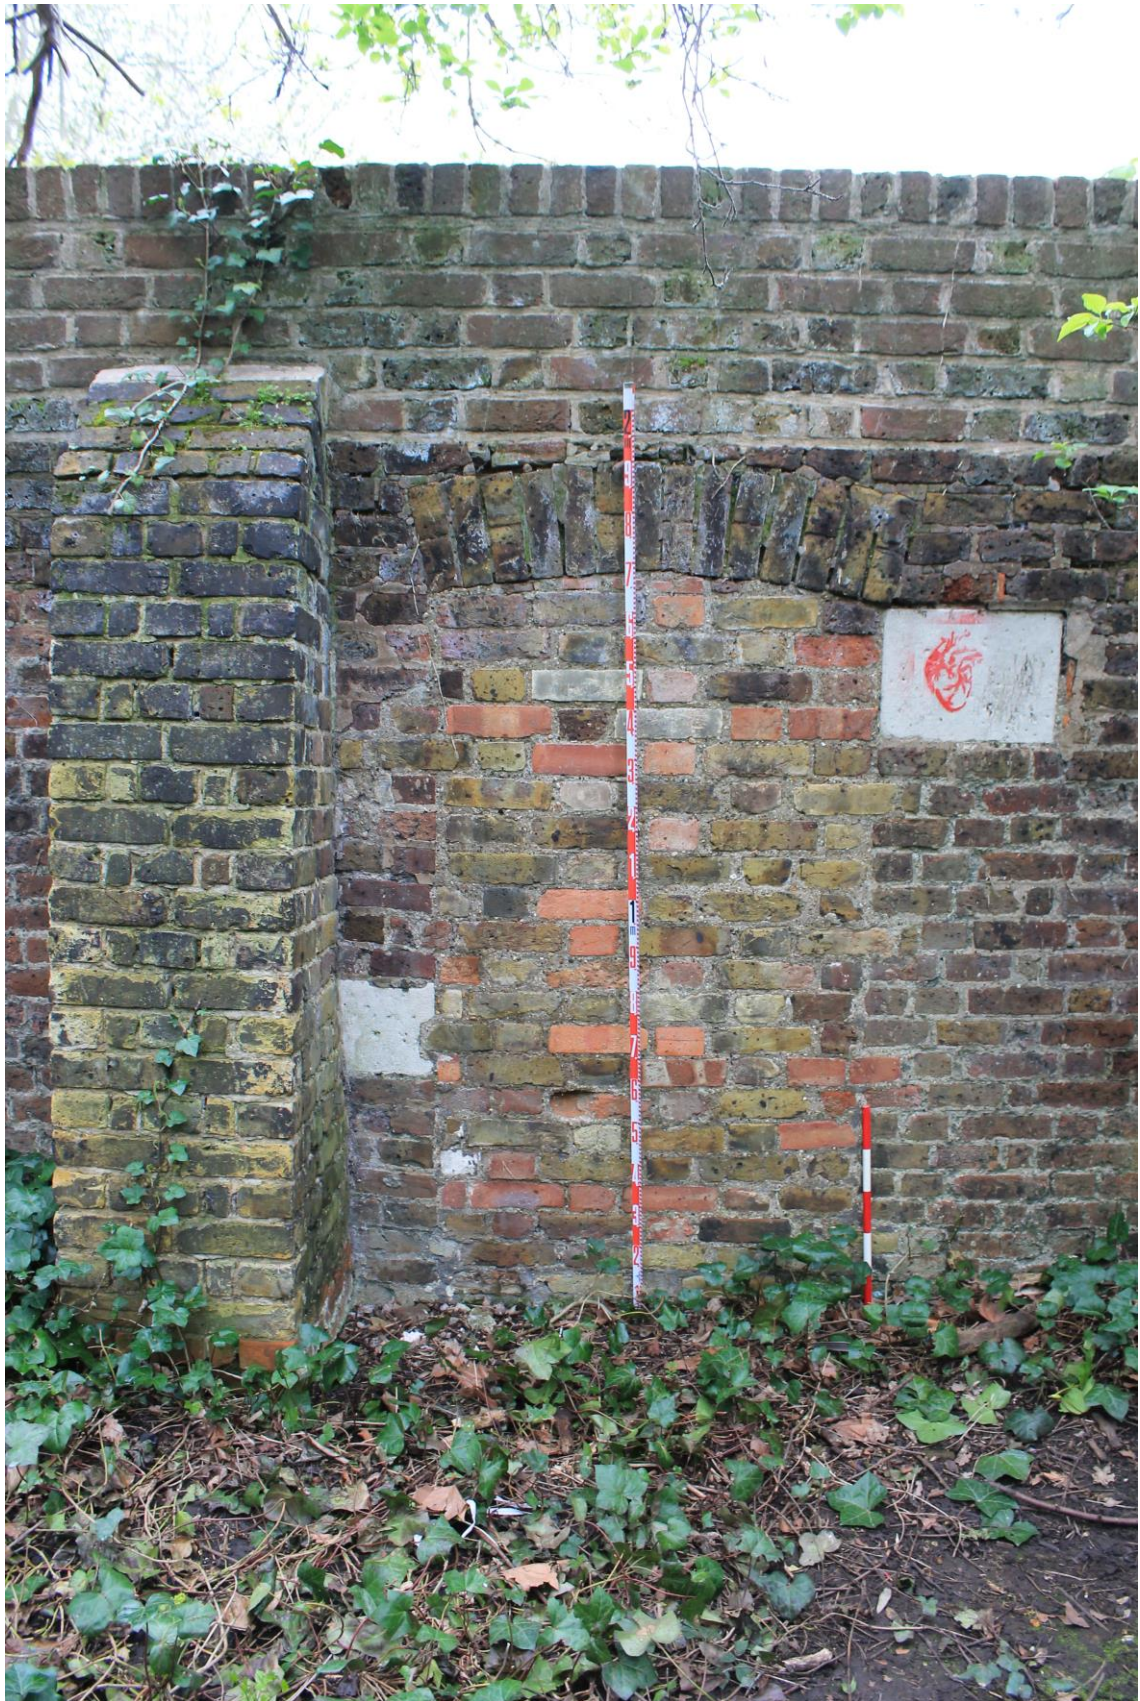
Plate 1 Blocked door opening in Southern Garden Wall (south side)

- 6.1.1 The blocked opening was located roughly centrally along the south wall of the walled garden and biased towards the east, some 38.8m to the west of the south-eastern corner (**Figure 2**). It was situated immediately to the east of a brick buttress, a later addition which respected its location and which formed one of five similar buttresses built within the eastern half of the southern wall (**Figure 2; Plate 1**).

- 6.1.2 The blocked opening measured (south side) 0.94m wide and 1.66m in height from the present ground level. It was built with a segmental brick arch of stock brick with alternating cross-cuts. There is no evidence for the use of queen closers to the opening and the brickwork around both jambs is messy and irregular, suggesting the opening is a later insertion.

- 6.1.3 The brickwork in this area showed four main phases of construction (A-D). The earliest brickwork (A) comprising the lower 25 courses of the wall built using post-Great Fire London stock brick laid in Flemish Bond. The bricks, coloured yellow, pink and red with distinct pockets of clinker material, typically measured 220x60-65x95-100mm, consistent with a mid to late 18th century date and conforming to the sizes required by the brick regulation tax introduced around 1770. This brickwork was laid in a beige/cream coloured lime mortar, which showed some evidence of penny struck pointing. Two squared and faced blocks of Portland stone flanked the opening along its eastern and western jambs. The larger, eastern masonry block was situated at the springing point of the arch, while the western masonry block was situated mid-height and was partly overbuilt by the adjacent buttress. Although their function is unclear, remains of small iron fixings (like nails) were present on the south face.

- 6.1.4 The opening was blocked by brickwork (B). This was formed using a mixture of bricks comprising re-used clinker rich yellow stocks, smooth faced red bricks, Suffolk white type bricks and bricks with distinct kiss mark reminiscent of Fletton bricks. They were laid in Flemish bond and within a very firm mortar tempered with common small inclusions.

- 6.1.5 A brick-built tabled and battered buttress was located to the west of the blocked doorway. Measuring 0.48m wide (two stretcher lengths) and c.2.04m in height, it was constructed using larger yellow stock bricks (230x60x100mm) of a late 19th or early 20th century date (brickwork C). It was built in Flemish Bond laid in a firm cement mortar and incorporates queen closers. It overbuilt both a Portland stone in the jamb of the blocked door and a later rebuilding of the upper wall brickwork (D)

- 6.1.6 The uppermost 6 courses of brickwork represented a rebuilding of the top of the wall present along the entire length of the south wall. Very similar brickwork, and a much more considerable reconstruction/repair, was also present in the east garden wall. This brickwork, built in Flemish bond with a simple brick on-edge coping, comprised a mixture of re-used stock bricks and hard red brick (210x60x100mm). They were laid in an off-white very hard mortar using wide mortar joints.
-

- 7.3 Whilst these lower courses represent the original 18th century brickwork, the southern wall to the walled garden had clearly been altered and repaired, showing evidence of a later re-building to the uppermost courses of the wall and addition of buttresses during the late 19th century. Possibly the most relevant to this project is that the blocked door opening into the garden from the south was not an original feature but a later insertion. This was suggested by the absence of queen closers to the opening and irregular 'untidy' brickwork and pointing to both the jambs. This conclusion was supported by the absence of a foundation lintel within the lower level of the wall as seen in Trench 400.

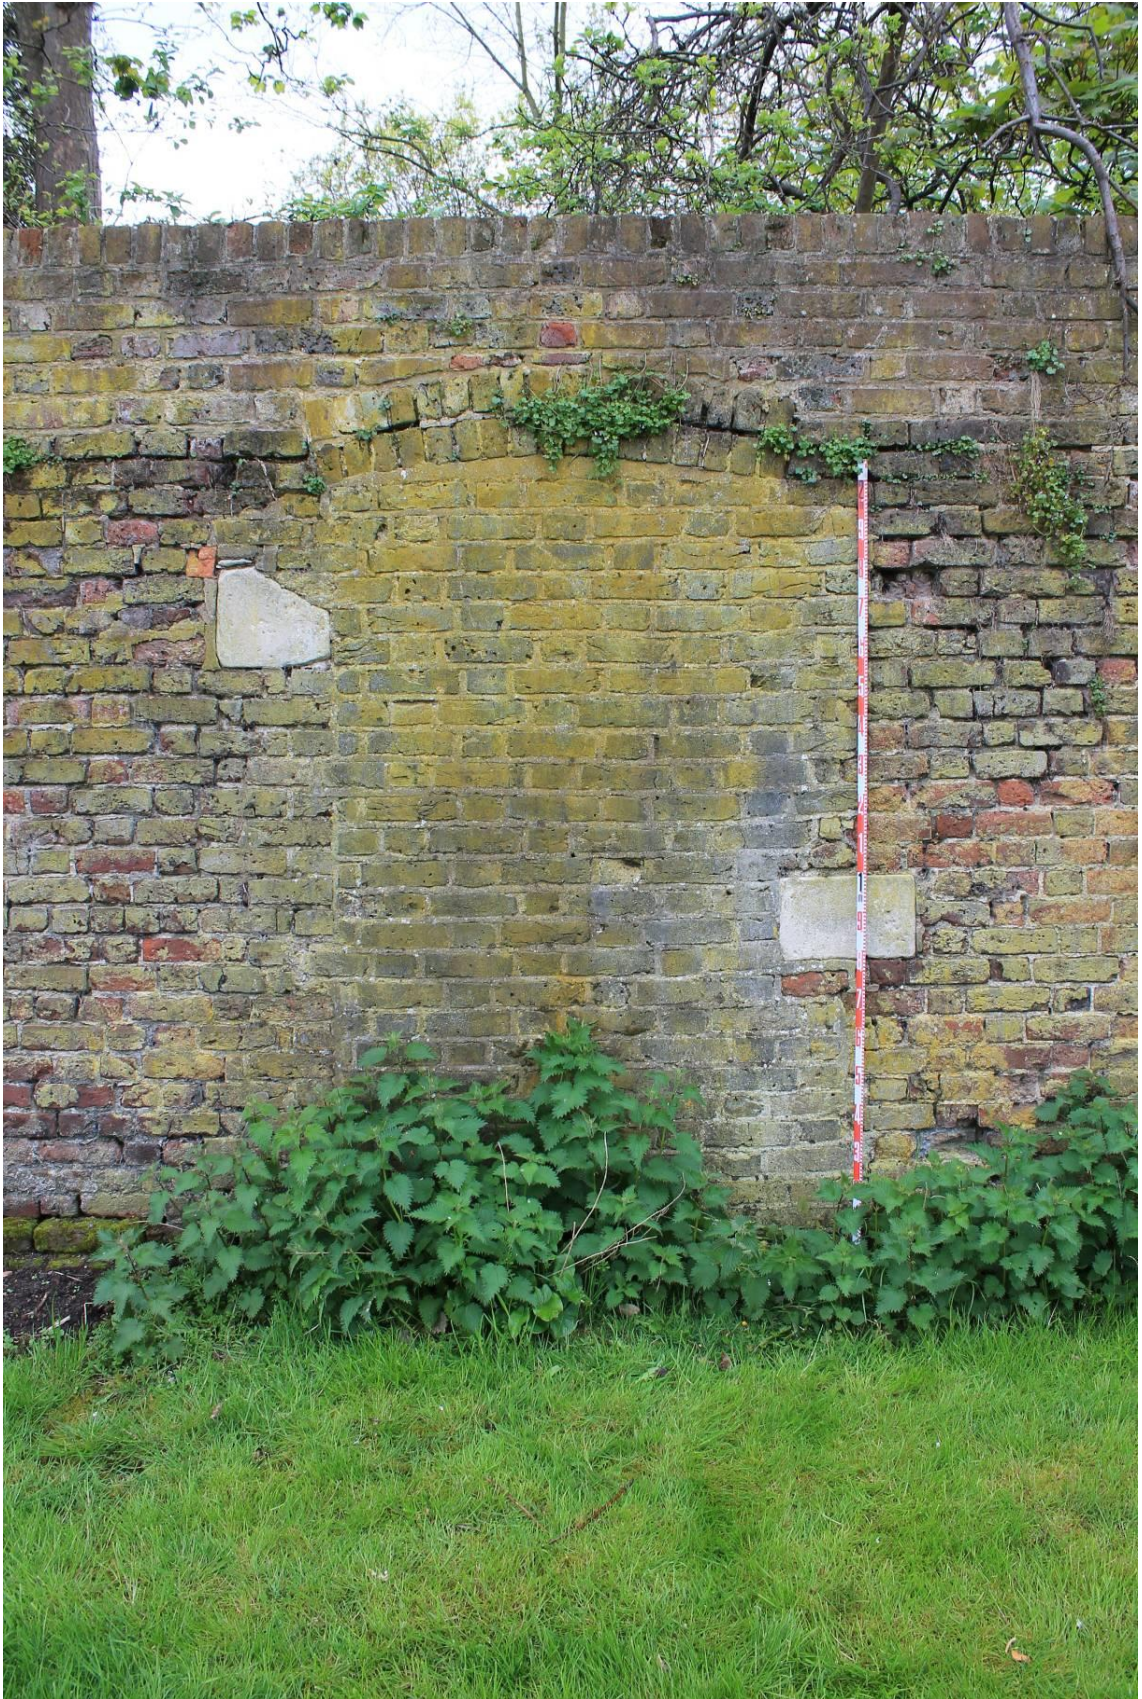
Plate 2 Blocked door opening in Southern Garden Wall (north side)

- 6.1.7 The same blocked opening on the north (garden) side of the south wall was slightly different in both its dimension and form. It was slightly wider at 1.04m wide and had a simpler arch of two brick on-edge courses (**Plate 2**). The same Portland masonry blocks appeared in its jambs with that to the west set slightly below the springing for the arch. The blocking brickwork (B) appeared to be the same as that on the other side. The upper 6 courses of brickwork at the top of the wall (D) had been rebuilt and have a brick on-edge coping as on the other side.

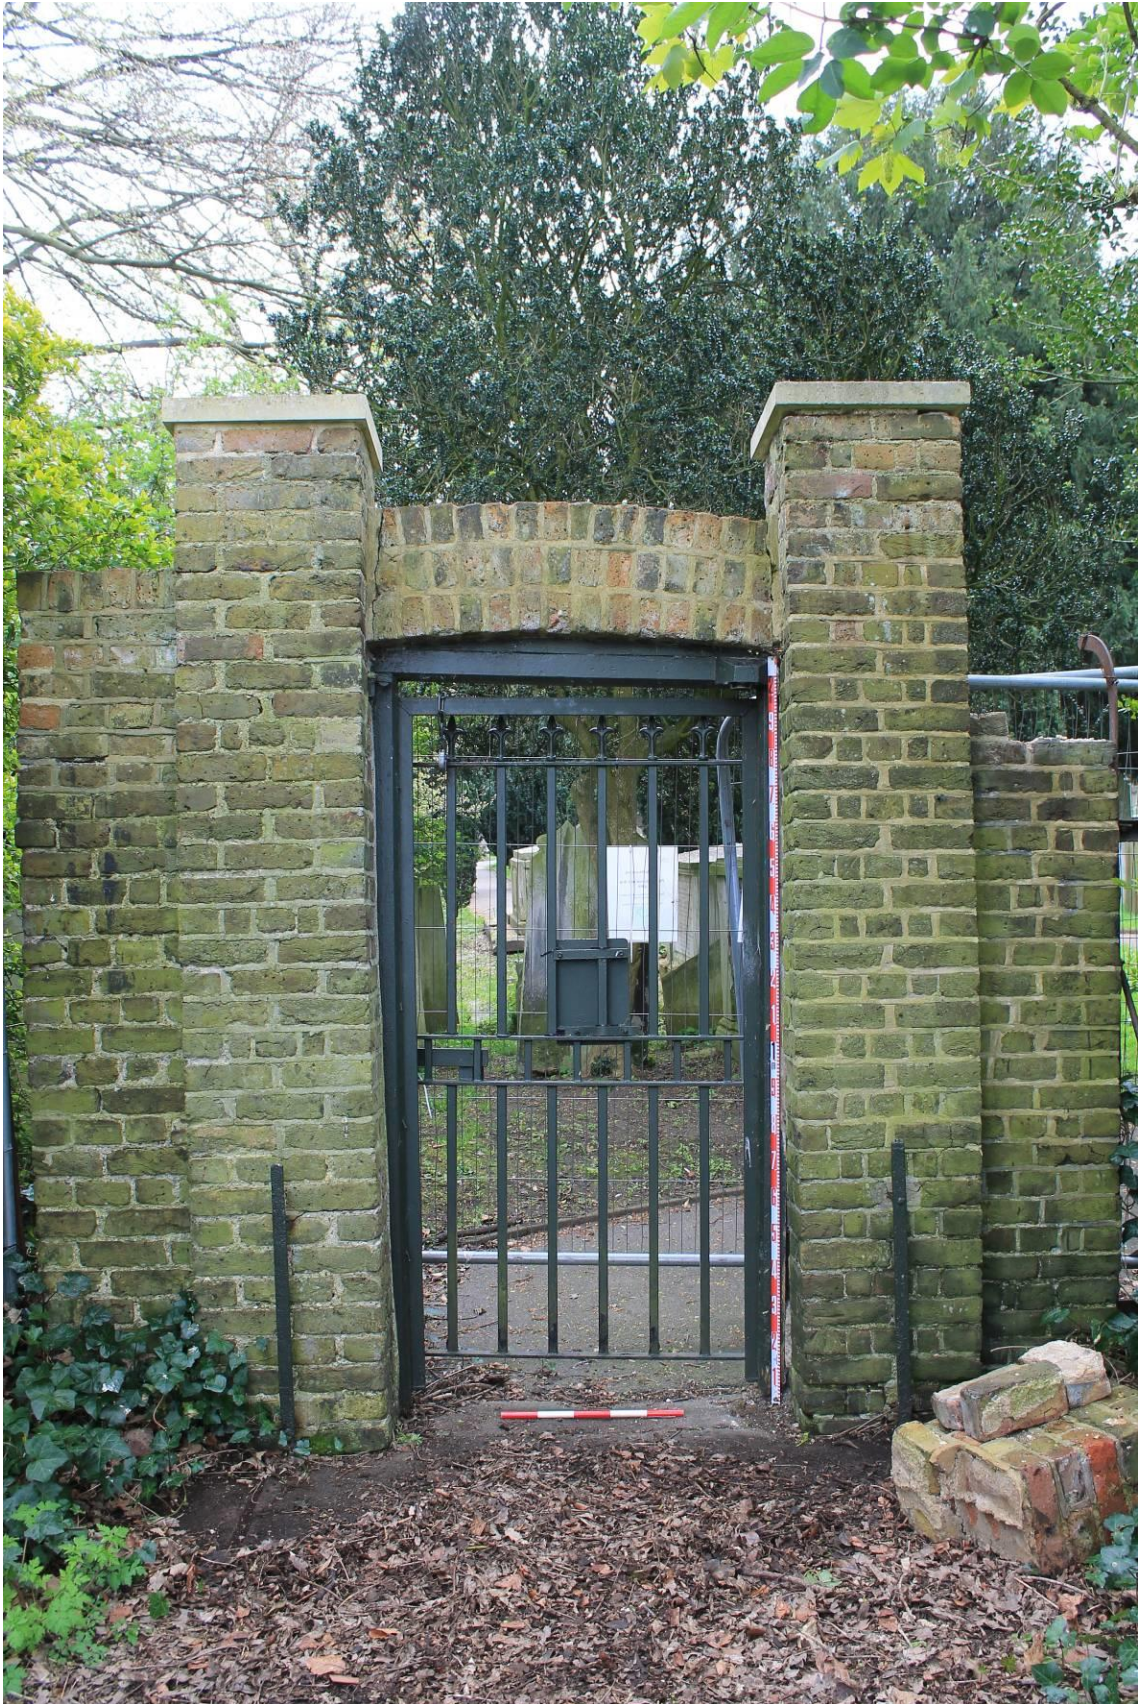
Plate 3 Gateway from Fulham Palace to the churchyard looking east

- 6.2.1 The gateway was formed using a pair of tall brick piers, flanked on each side by short stubs of perimeter wall. It was bridged above the door frame by a brick segmental arch (**Plates 3 and 4**). The door frame held a modern 'wrought iron' gate. The gateway appeared to be out of true and distorted on the north side.

- 6.2.2 The two brick piers and most of the adjoining stub walls used the same brickwork (E) comprising large clinker rich London Stock bricks (220-230x65-70x100-105mm). The bricks had creased faces and horizontal pressure marks and were set in a hard lime mortar, later re-pointed using a sand cement mortar. Queen closers were used, more extensively in the south pier and stub wall, possibly suggesting they were not built at the same time. The piers were capped by a pair of simple concrete coping slabs, the northern of which was set onto a single course of later brickwork (F).

- 6.2.3 The same brickwork (F) was also used for the construction of the brick segmental arch, which was built of three on-edge courses. The arch was not structurally built into the brickwork of the two piers and was clearly a later addition butting up to the inside of the piers. It was built using a hard beige coloured sandy cement mortar and crudely built with wide joints. A brickwork repair using similar brickwork was also present along the top of the stub wall to the north.

- 7.5 The gateway to the churchyard was built using London stock bricks with a late 19th to early 20th century date range, and had clearly been altered in recent years with the addition of a new brick arch, new copings, localised rebuilding and re-pointing. Despite these repairs the gateway had subsided and the adjoining walls showed evidence of collapse. The stepped foundation course to the norther pier of the arch was recorded at 0.70m below ground level

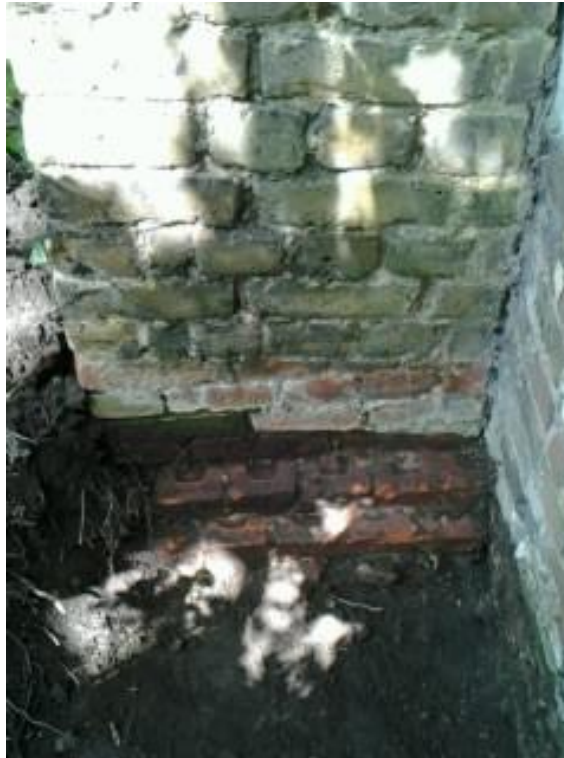
Plate 5: Footing [402] to later buttress [403] external to the Walled Garden

- 6.1.8 Trench 400 was excavated at the base of the doorway on the external side of the wall. The base of the bricked up doorway [401] was seen at 0.35m beneath the ground surface. This had been built without any foundation lintel, whereas the rest of the garden wall had been constructed on rectangular foundation bricks. There was no evidence of any construction cut for the wall.

- 6.1.9 At the base of the trench was the brick foundation [402] of a buttress [403] which supported the outside of the garden wall (Plate 5). This consisted of frogged red bricks which measured 106mm in width by 60mm in height and were bonded by a light brown mortar. Both this foundation and the buttress were clearly later additions to the garden wall.

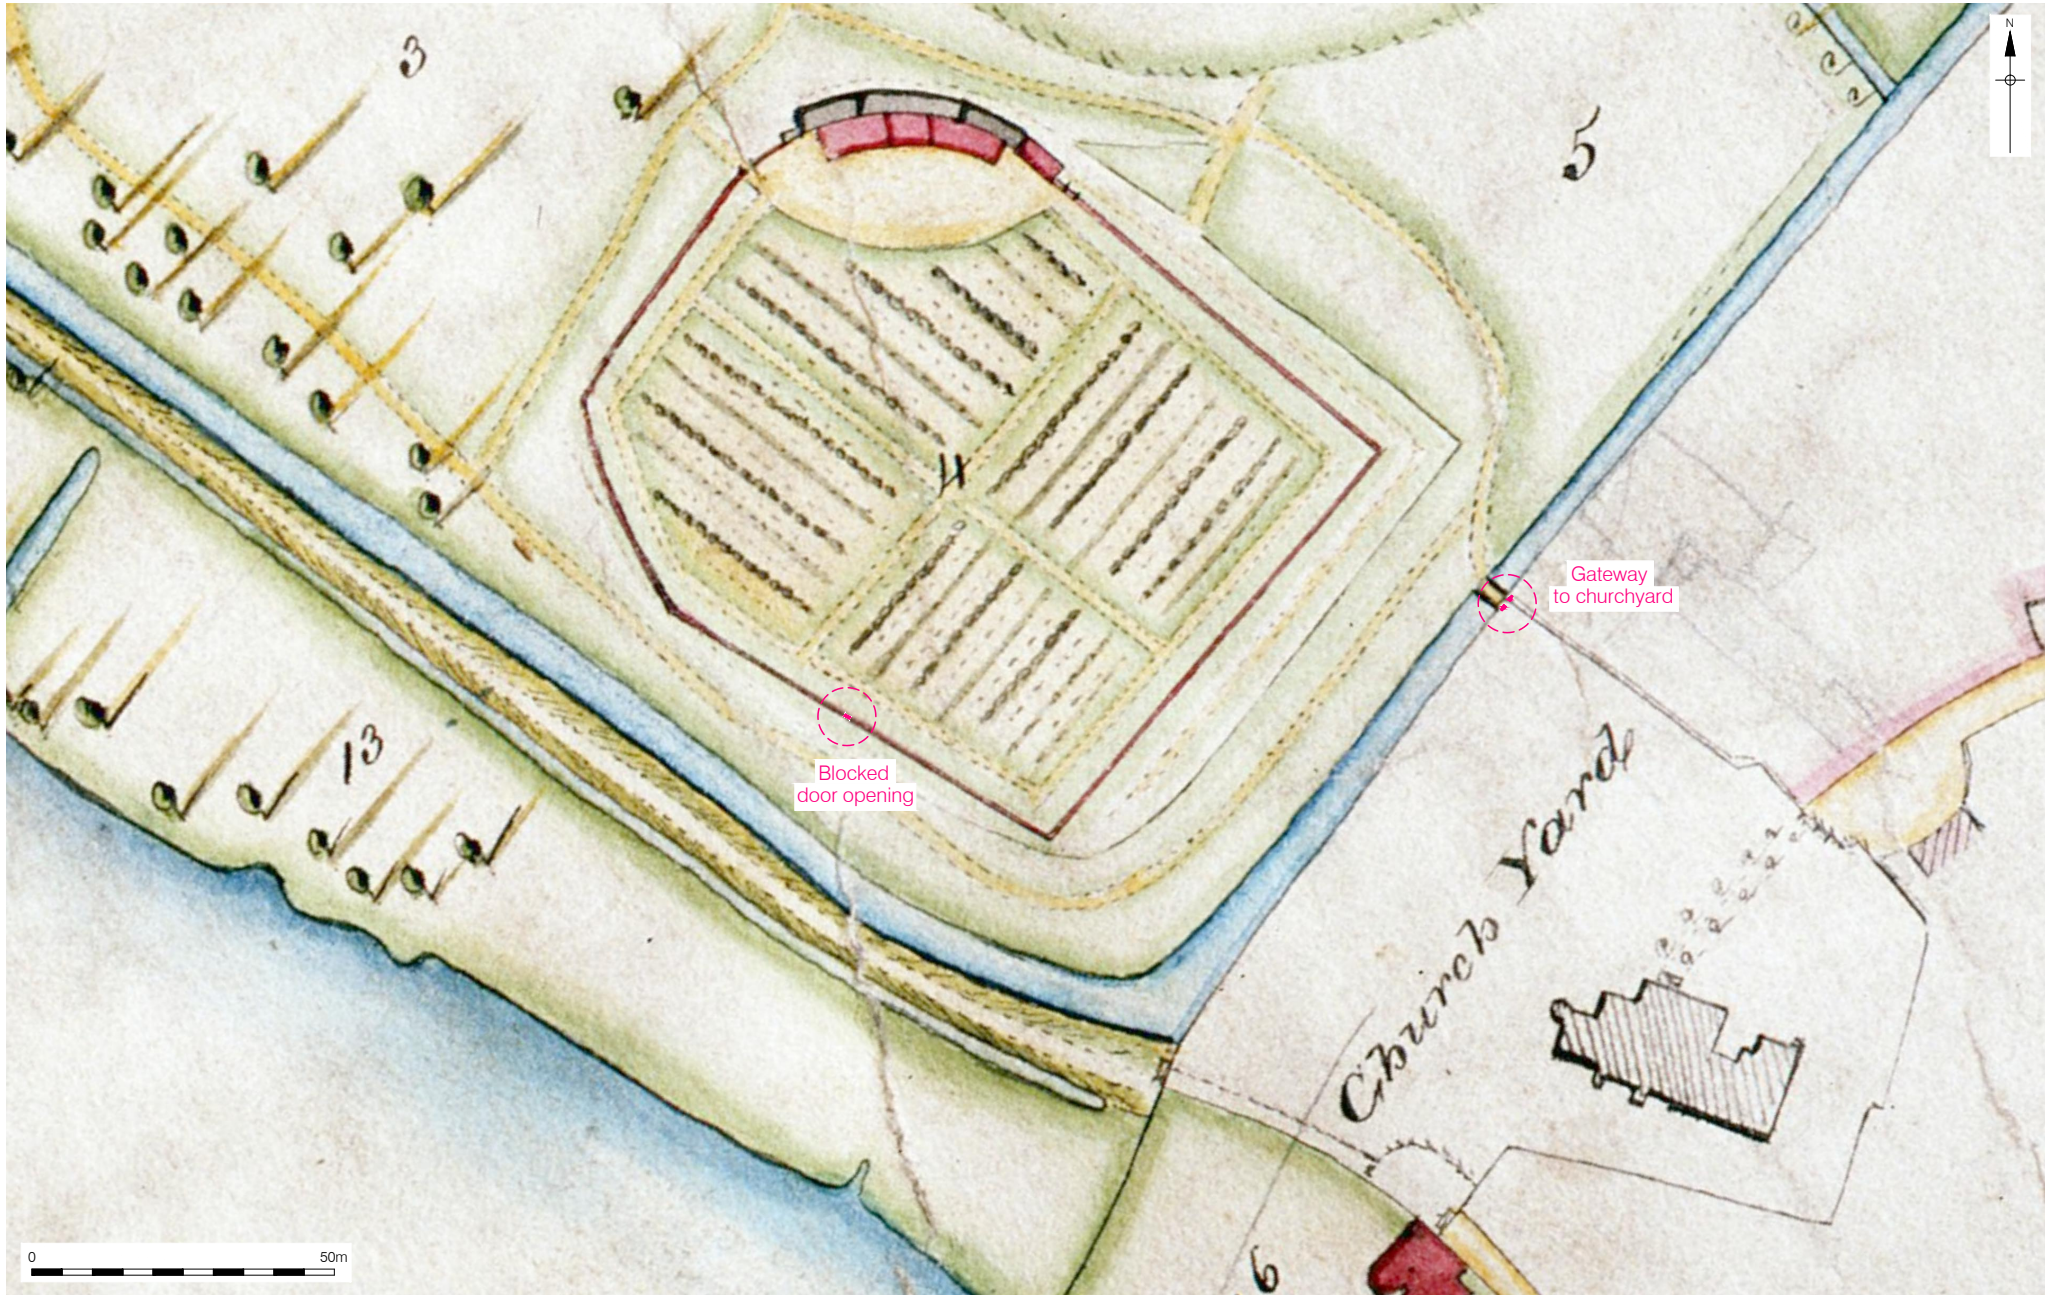
Figure 3
Estate Map of 1831
1:1,250 at A4

- 5.9 The Walled Garden is depicted in a series of 19th century maps dating to 1831, c.1860 and 1869 (**Figures 3 to 5**). They depict the walled garden with a traditional layout, built with a perimeter path and cross walks converging at the centre of the garden, planting beds and trees. The Estate Map of 1831 (**Figure 3**) shows the walled garden (4) laid out to the same footprint as at present, incorporating the glasshouse range (built by 1828), bothy and sheds on each side of the curving north-west corner and a canted return to the south-west. It is divided by a cruciform path into four main compartments. It is noticeable that the cross path to the south wall does not align with the blocked opening in the south wall, nor does an external path from the south approach it. The gateway to the churchyard and a path, approaching it from the west and crossing the moat, is however shown on the estate map, although clearly the churchyard had latterly been enlarged to the north side. James Wyld's map of Fulham c.1860 (**Figure 4**) shows little change to the internal layout of the garden apart from the formal layout of a parterre next to the glasshouses. The compartments are bordered with trees (fruit) while openings are shown in the north, east and west walls but not the south. The walled garden lies within a naturalistic landscaped parkland.

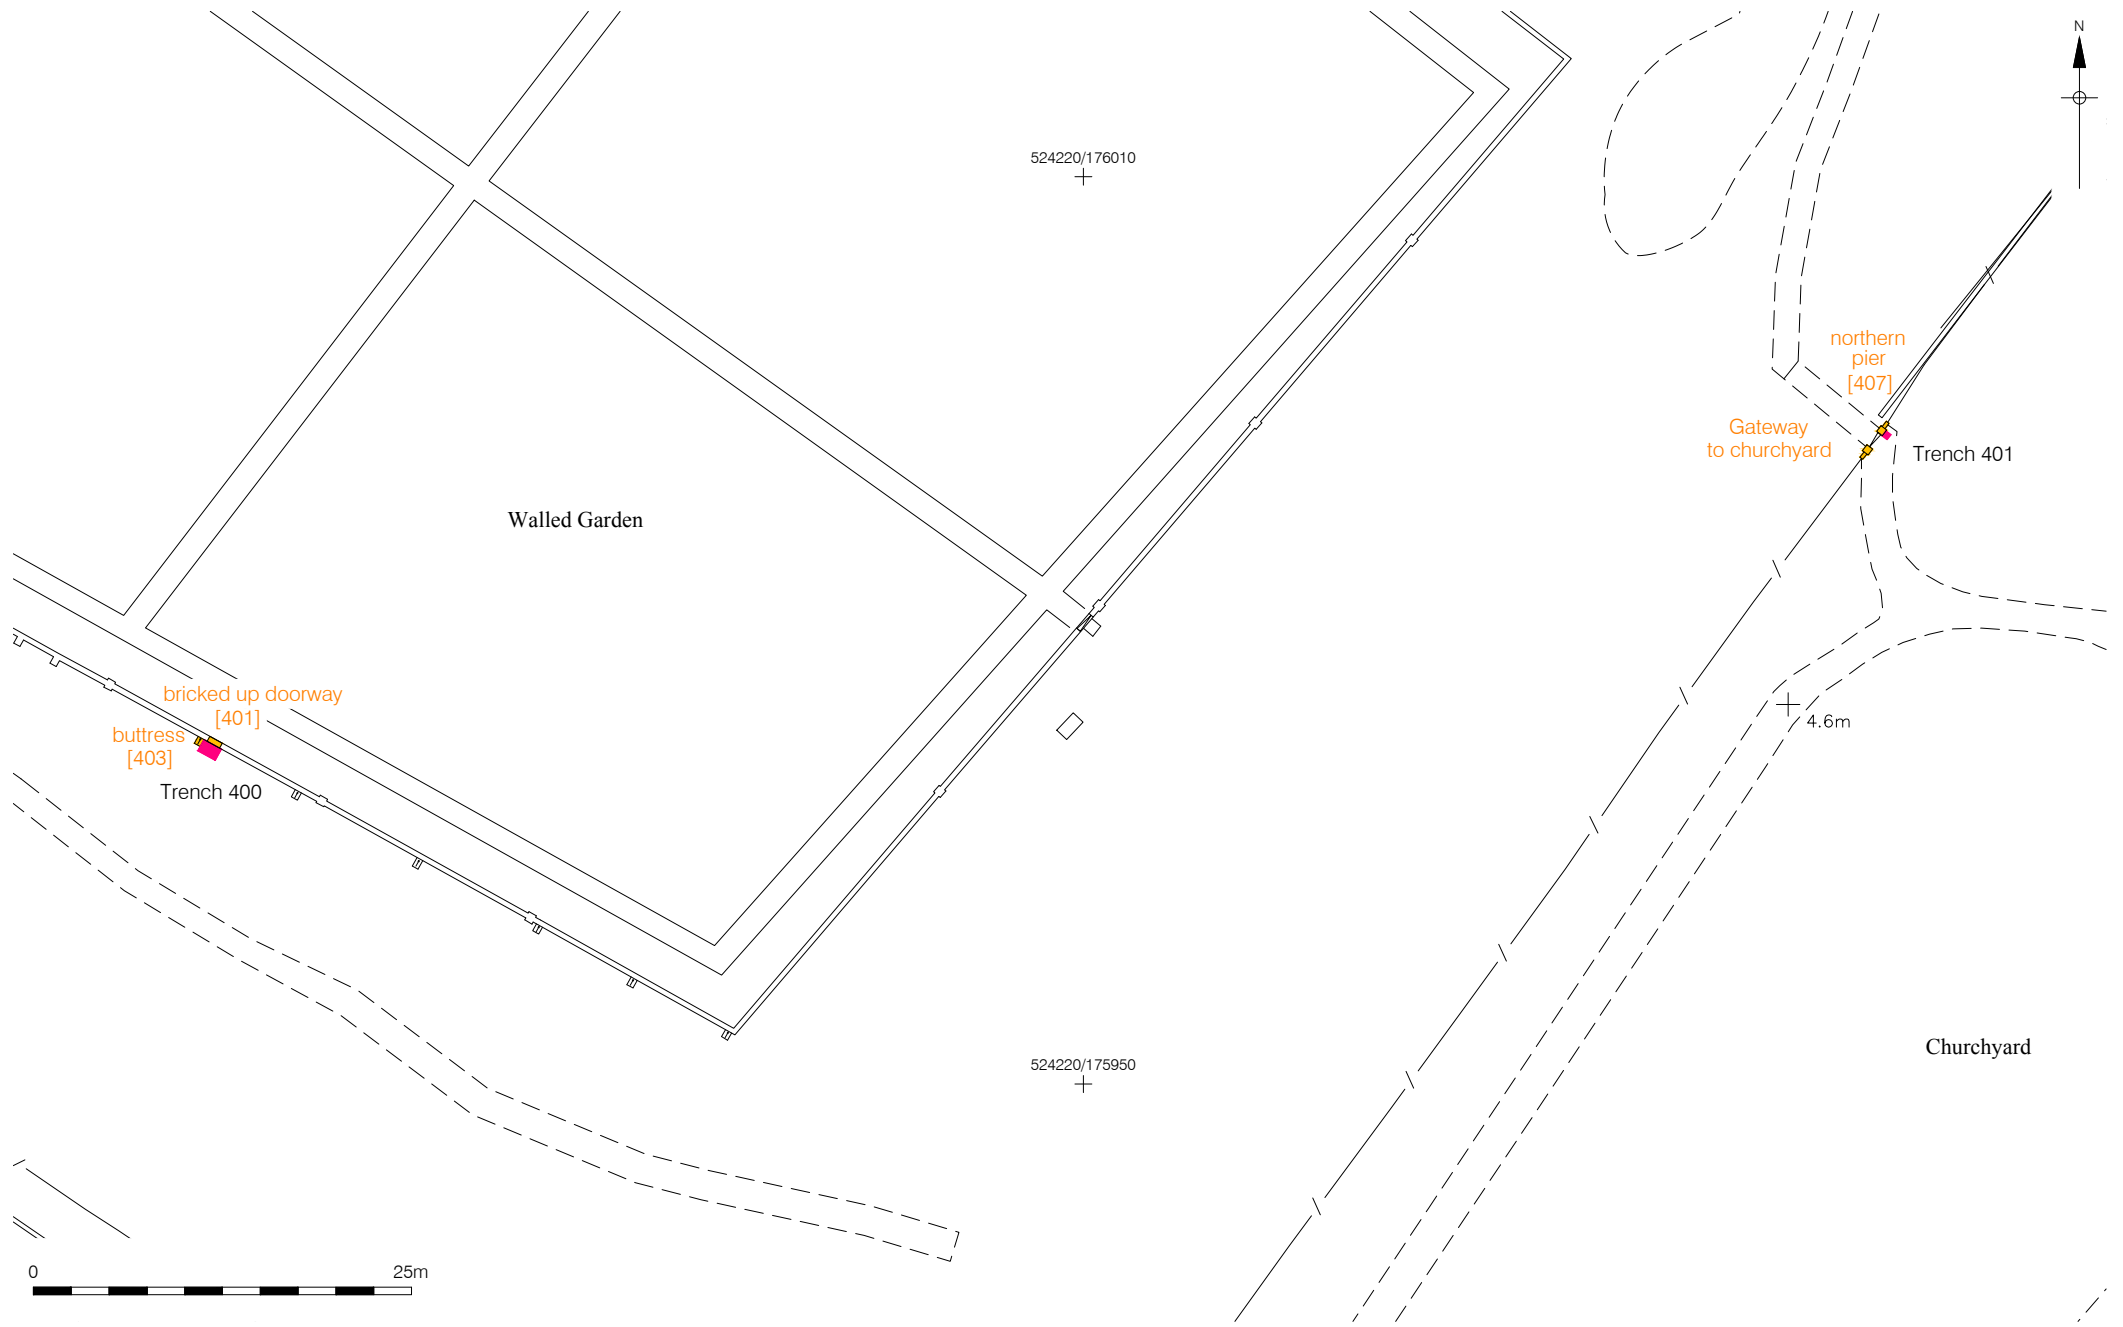
Figure 6
 Location of Watching Brief Trenches 400 & 401
 1:500 at A4

4.3.2 The pit located by the former gate into the Walled Garden was designated Trench 400. It

measured 1.30m NW-SE by 0.84m NE-SW and was excavated on the external side of the Walled Garden in the corner between the wall and a later supporting buttress. The pit was excavated to a depth of approximately 0.35m to determine the depth of the foundation to the wall.

- 4.3.3 The pit located by the brick archway which leads between the grounds of Fulham Palace and the churchyard of All Saints Church was designated Trench 401. This excavation against the northern pier of the gate was to determine the foundation level of the pier prior to works to restore the gateway. The intervention measured 0.40m by 0.40m and was dug to a depth of 0.70m beneath the current ground surface.
