**GILLS HILL FARM, GILLS HILL,  
BOURN, CAMBRIDGESHIRE:  
ARCHAEOLOGICAL TRIAL  
TRENCH EVALUATION**

AN ARCHAEOLOGICAL TRIAL TRENCH  
EVALUATION

Pre-Construct Archaeology Ltd	
Project Number	K4519
Report Number	R12520

**Local Planning Authority:** Cambridge City Council

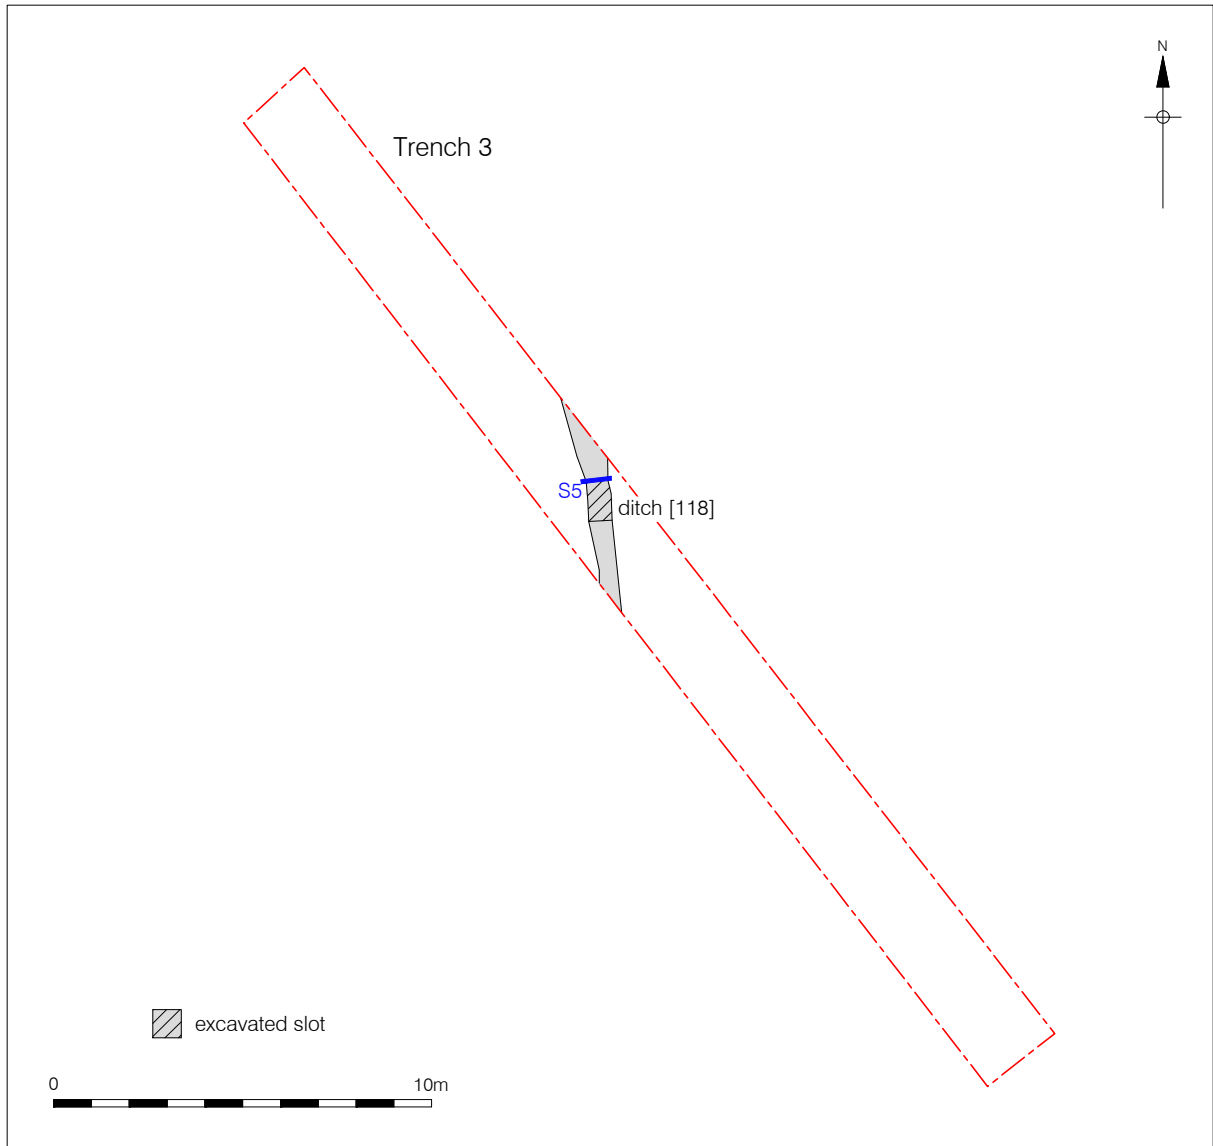
5.4.2 Ditch [118] (Plate 7 Figure 4, Section 5) was 0.65m wide and over 0.30m deep, with a v-shaped profile and a single backfill of mid blueish grey silty clay (119) which contained no finds. The ditch was unable to be fully excavated due to a rapidly rising water level.

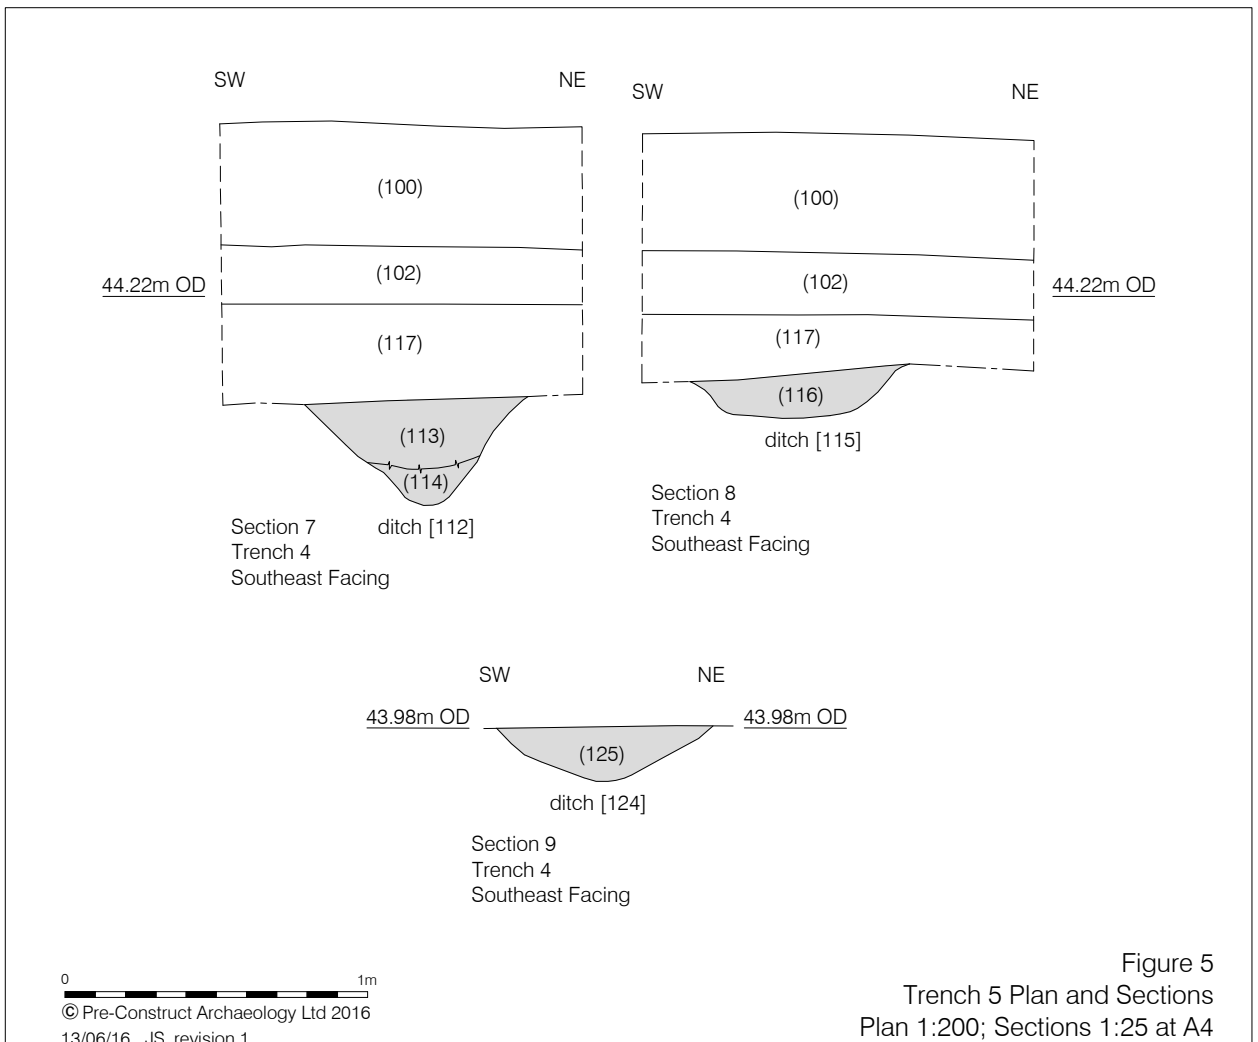
Figure 5  
Trench 5 Plan and Sections  
Plan 1:200; Sections 1:25 at A4

5.6.2 Ditch [115] (Figure 5, Section 8) extended across the central part of trench 5. It was 0.74m wide and 0.19m deep with a moderately sloping side and a flat base. It contained a single fill of sterile mid brown clay (116).

5.6.3 Ditch [112] (Plate 10; Figure 5, Section 7) lay immediately to the southwest of [115] and was on the same alignment. It was 0.73m wide and a depth of 0.36m, with a v-shaped profile. Its basal fill was light yellowish brown clay (114) which was overlain by a fill of mid brown clay (113). Neither fills contained any finds.

5.6.4 Ditch [124] (Plate 11; Figure 5, Section 9) was located at the south-western end of the trench and was 0.70m wide and 0.18m deep with moderately sloping sides and a concave base. It contained a single fill of sterile mid

5.6.5 A deposit of mid greyish brown clay (117) was recorded along the length of the trench, sealing the ditches. It was of a slightly different colour to the subsoil and natural and very sterile, suggesting it was naturally formed. Trench 5 was located down slope from the rest of the site, which strongly suggests the deposit was colluvial.

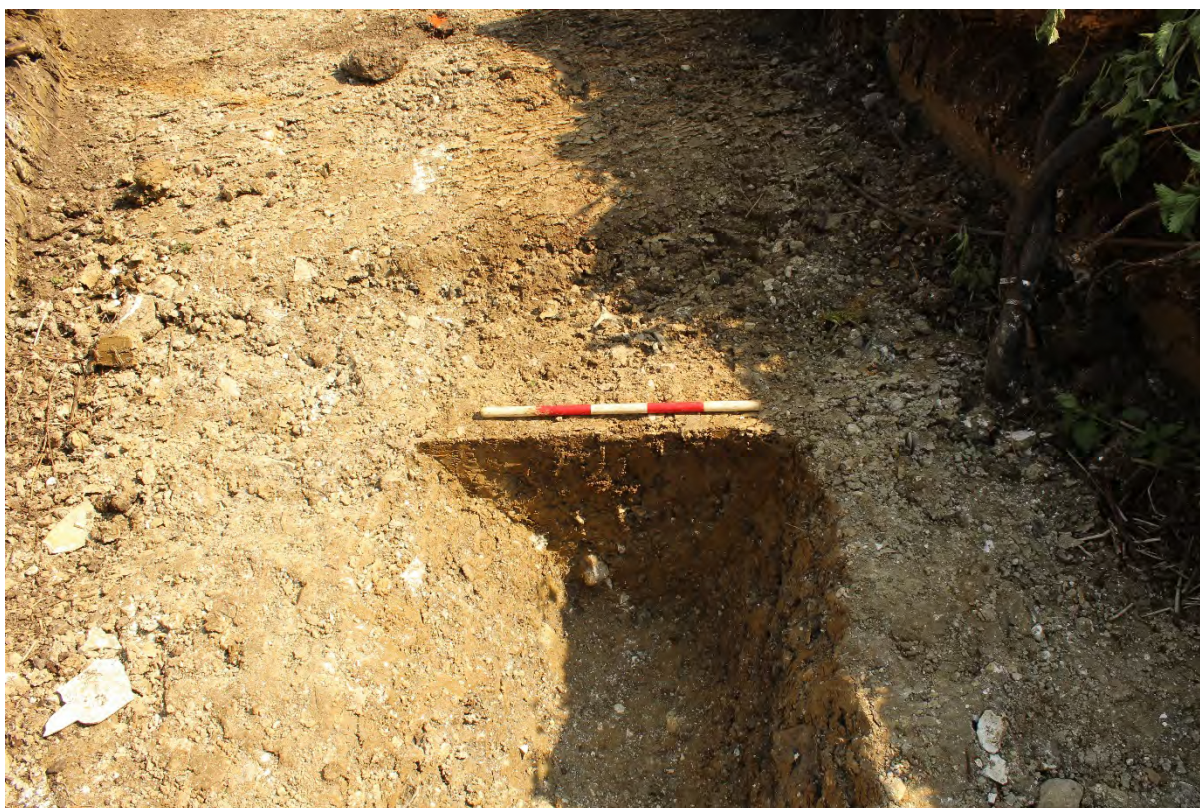
Plate 2: Ditch [104], view south

5.2.2 Ditch [104] (Plate 2; Figure 3, Section 1) was located at the north-western end of the trench and extended beyond the north and south limits of excavation. It was 0.70m wide and 0.28m deep with a v-shaped profile. It had a single fill (105) of light to mid brown silty clay which contained no finds.

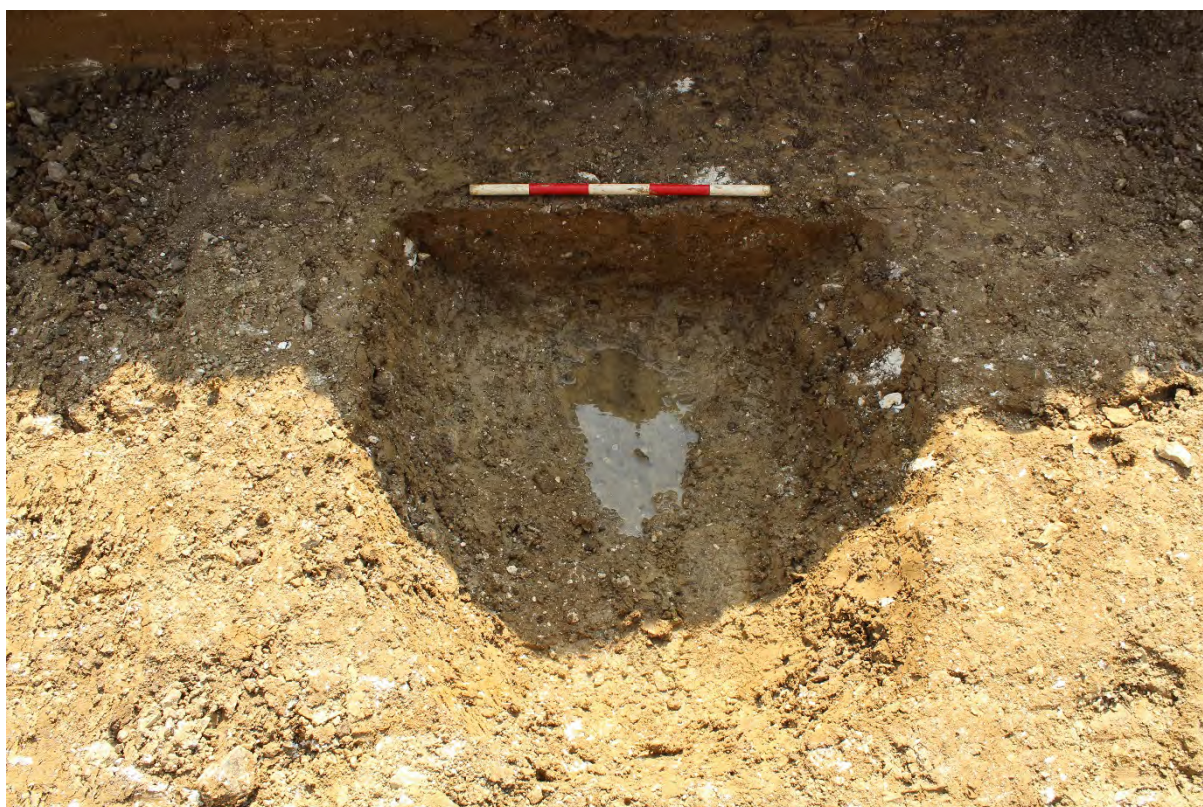
Plate 3: Ditch terminus [106], view southwest

5.2.3 Pit [106] (Plate 3; Figure 3, Section 2) was located south of [104]. It was 0.6m wide and 0.20m deep with moderate concave sides and a concave base. It had a single fill of mid greenish-grey silty clay (107), which contained no finds.

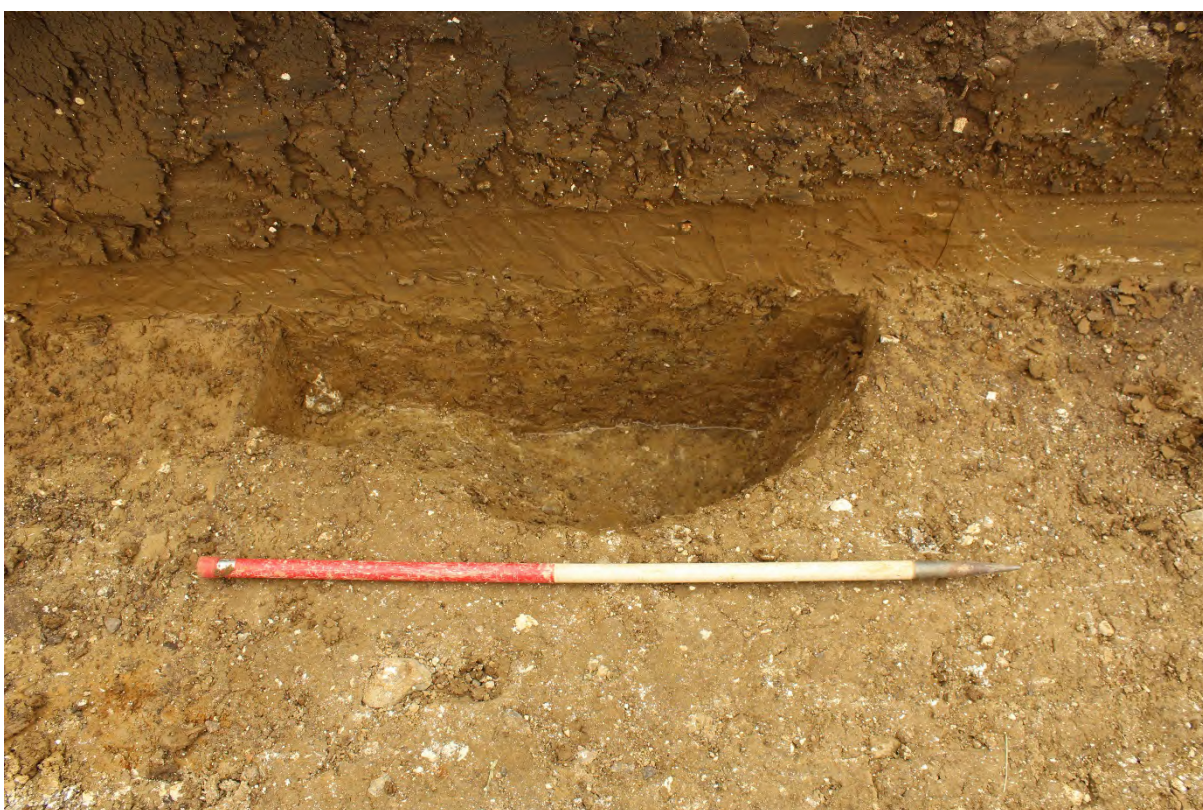
Plate 4: Pit [110] truncated by feature [121], view southwest

5.2.5 Pit [110] (Plate 4; Figure 3, Section 4) was located at the southern end of Trench 1. It was 0.38m wide and 0.20m deep, with a u-shaped profile. It

5.2.6 Pit [110] was truncated by an undetermined feature [120] (Plate 4; Figure 3, Section 4) which only just extended out from the south-western side of the trench and was seen mainly in section. The feature contained a single fill of mid yellowish brown silty clay (121) and contained no finds.

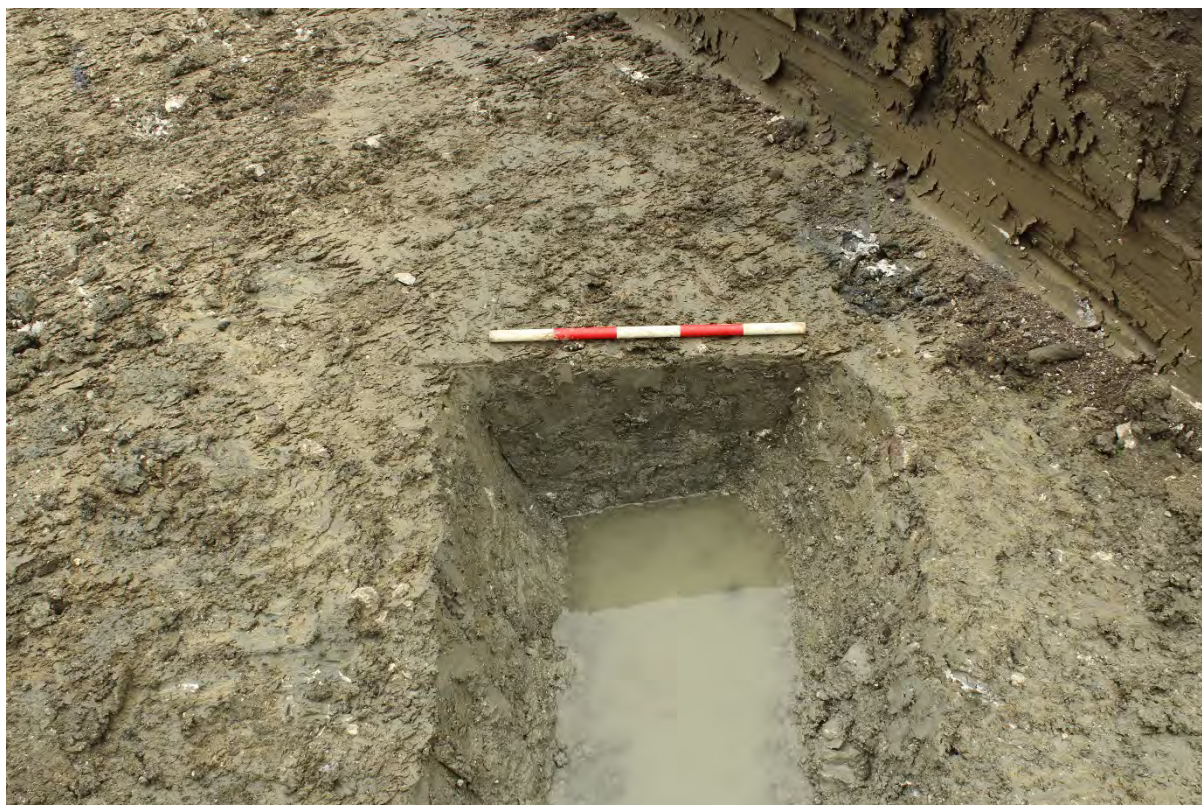
Plate 7: Ditch [118], view south

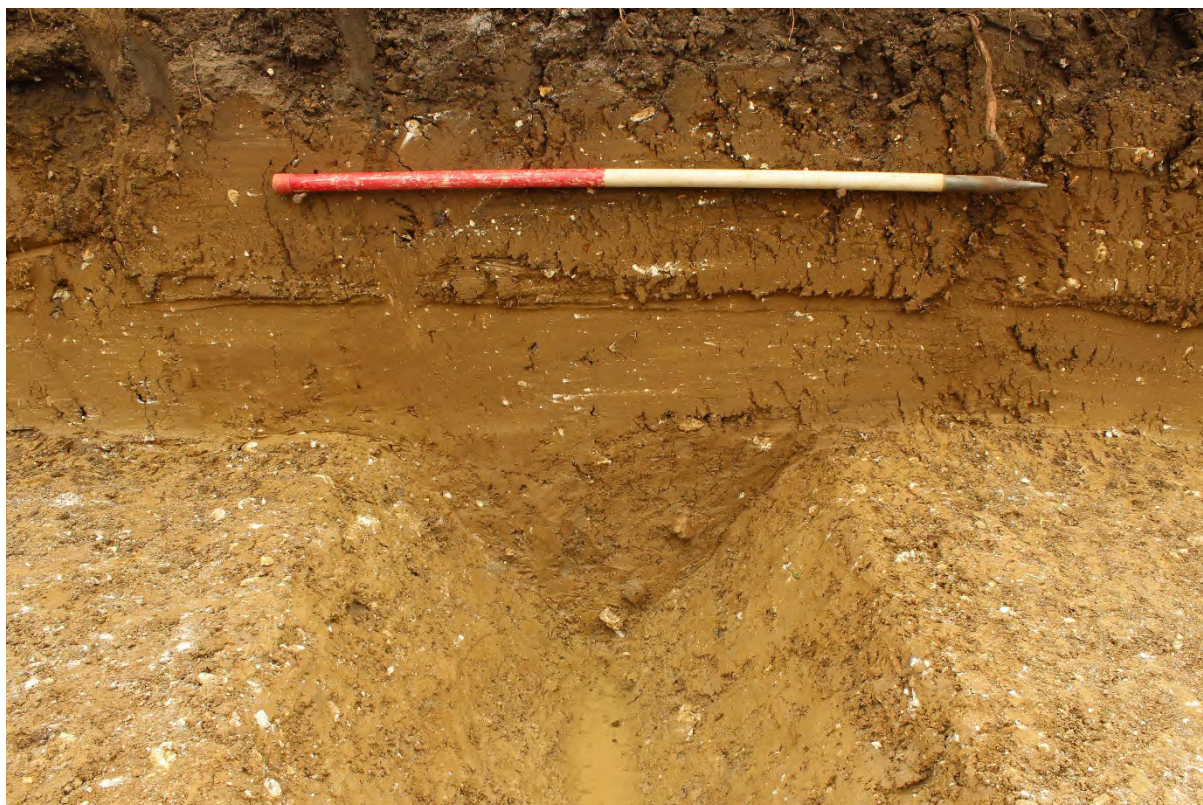
Plate 10: Ditch [112], view northwest

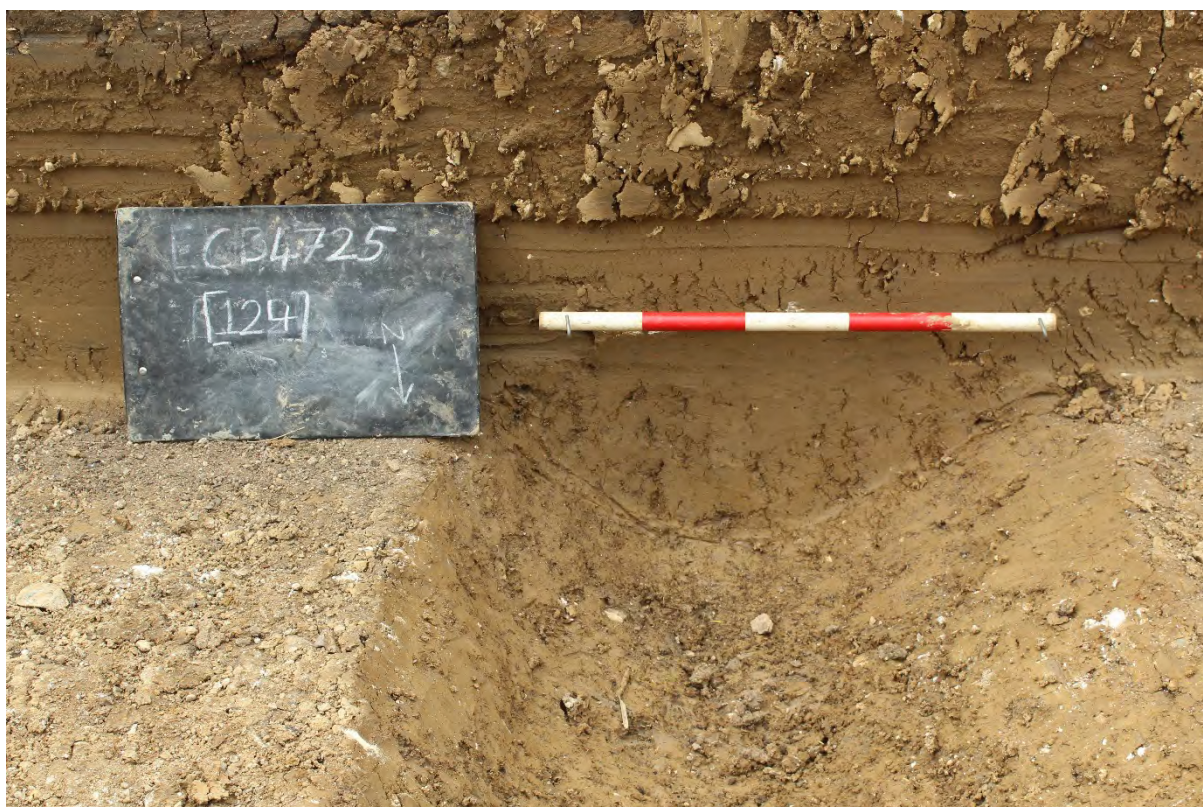
Plate 11: Ditch [124], view northwest

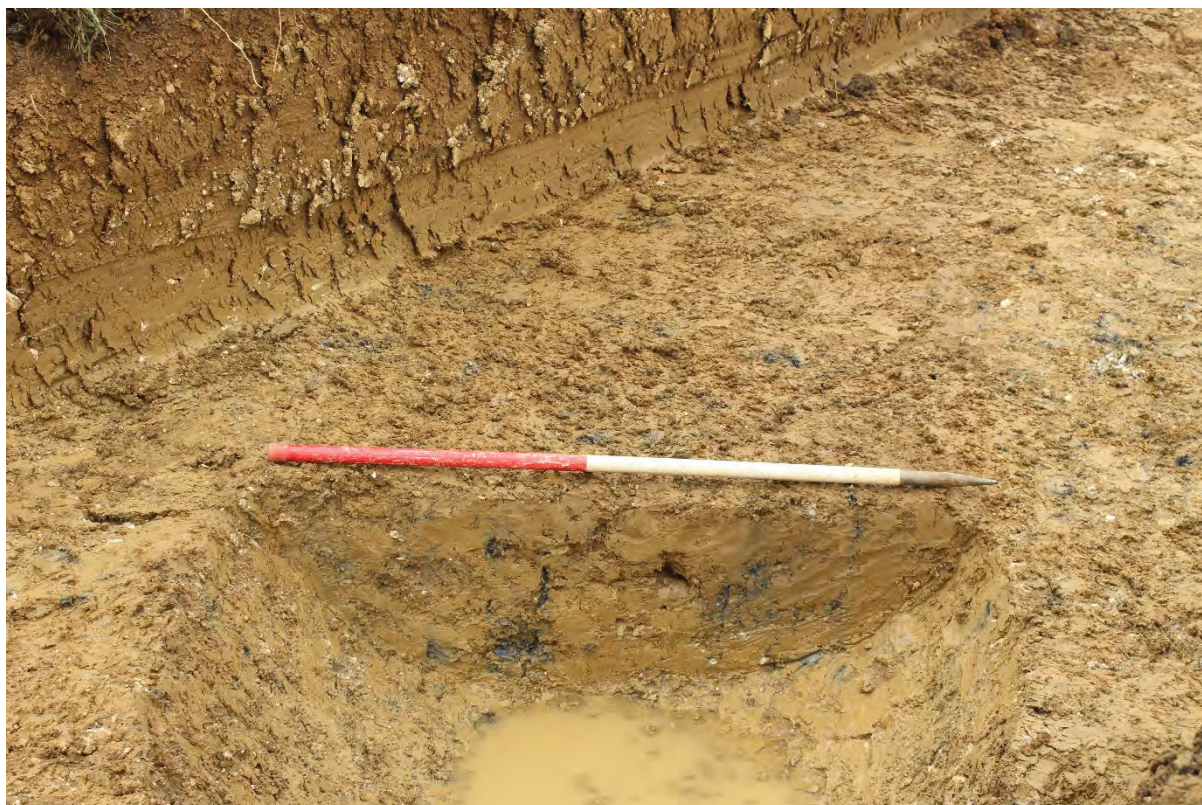
Plate 14: Ditch [126], view southwest

5.8.3 Ditch [126] (Plate 14; Figure 6, Section 10) lay to the northwest of ditch [122]. It was 1.10m wide, with a depth of 0.4m and had moderately sloping sides and a concave base. The ditch contained a fill of light greyish brown silty clay (127), which contained no finds.
