**CLARENCE HOUSE,
ST JAMES'S PALACE,
LONDON SW1 1BA**

**AN ARCHAEOLOGICAL
WATCHING BRIEF**

PCA REPORT NO. R12505

JUNE 2016

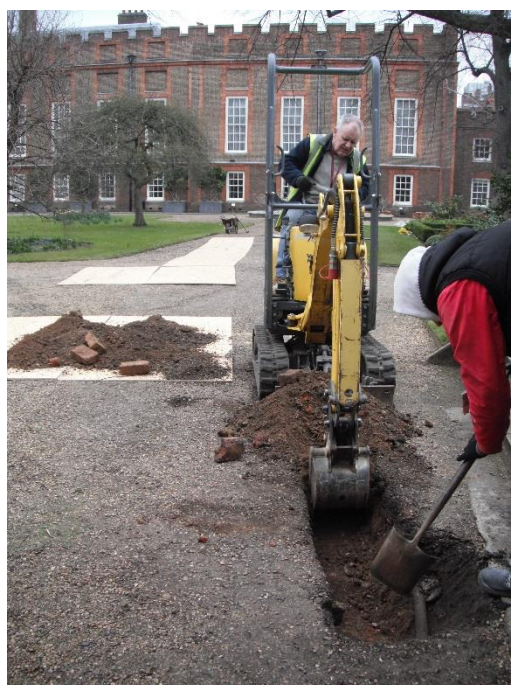
Plate 1: Excavation in progress, view north

- 5.3 The trench was, for the most part, excavated by machine using a 300mm-wide flat-bladed bucket; however where this was not possible (around existing services and masonry) deposits were excavated by hand. All excavation was monitored by the attendant archaeologist under watching brief conditions.

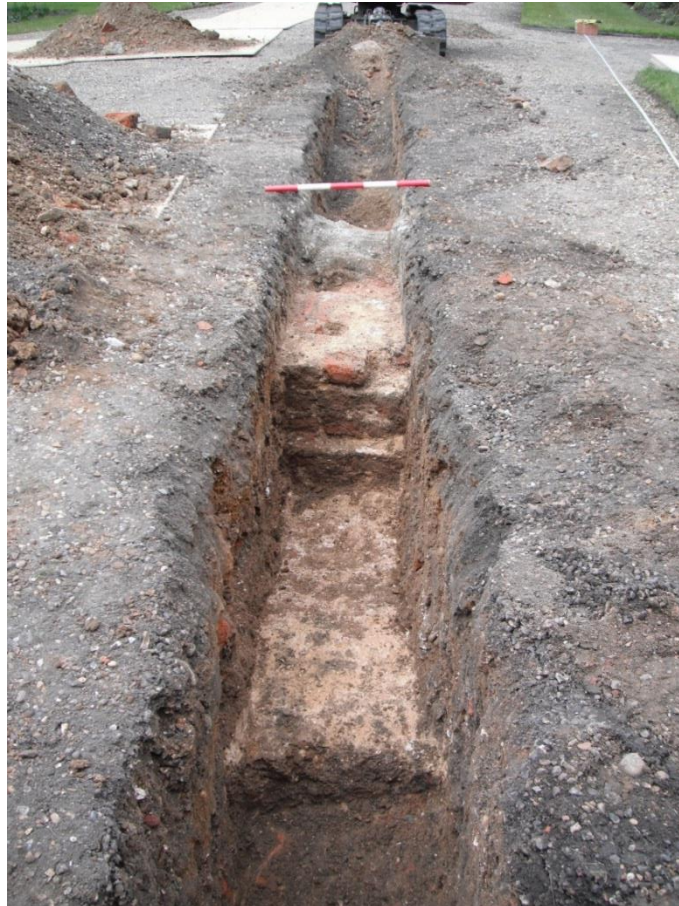
Plate 2: Looking north, east-west wall [4] and mortar layer [5]

- 6.1.6 A section of east-west orientated masonry [4], (Plate 2, Section 1, Figure 3 – Inset D) was uncovered at distance of 6.5m from the southern perimeter wall of the garden. It was constructed
-

of 17/18th century whole bricks bonded with compact hard yellow white mortar, and is considered to represent part of a retaining wall for the raised walkway built along the southern extent of the garden during the late 17th century. It was contained within a substantial construction cut [6] with backfills [56], [5] and [2]. Within the garden Clarence House the raised walkway now only exists in part and has been modified as raised planting beds, however it still exists in its entirety within the neighbouring garden of Marlborough House (Plate 5) and can be seen in the bird's-eye view illustration of St James's Palace by Johannes Kip in 1705. The excavated trench was not sufficient to establish the full depth of the wall.

- 6.3.3 A phase of garden modification was evident towards the southern portion of the trench where the east-west wall [4] and brick steps [9] had been substantially reduced in height and covered over with gravel path layers, [10] and [11], at approximately 7.16m OD, respectively.

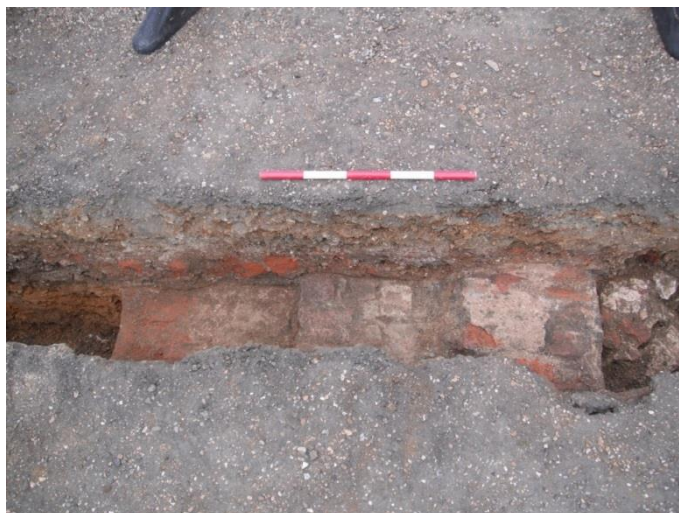
Plate 3: Looking east, brick steps [9]

6.2.1 To the north of retaining wall [4] was a section of east-west orientated masonry [9] (Plate 3) with a rubble core [7] between it and the earlier retaining wall [4]. Structure [9] was constructed of complete and part-bricks bonded with pink and yellow mortar. The structure stepped down from south to north, and it is likely that this fragment represented part of a stairway to the raised walkway. The masonry was within a substantial construction cut [15], backfilled with [12]. It can be seen in contemporary illustrations (Plate 4) that these steps were introduced at or by the time that the raised walkway was extended along the east and western perimeter of the site (Cookson & Tickner 2014).

6.2.2 The construction cut [15] for the stairs was observed cutting through Phase 1 gravel layer [13] (see para 6.1.5 above). This suggests that the level of that layer, approximately 6.85m OD, reflects the contemporary ground level when the stairs were built.

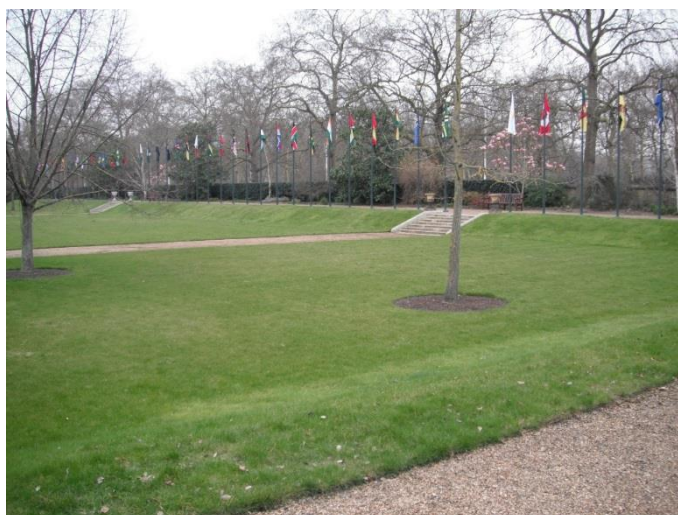
Plate 5: Looking south east, Raised walkway still in use within Marlborough House Garden

- 7.4 At the southern extent of the trench an east-west wall was uncovered which is interpreted as the retaining wall for the raised walkway which, in the late 17th century, ran the full length of the southern limit of the garden. The raised walkway has been altered over time as seen in a number of 17th through to 19th century illustrations. In modern times it has been heavily landscaped and converted into raised planting areas, but in the neighbouring gardens of Marlborough House it can still be seen in much the same style as it was originally (Plate 5).

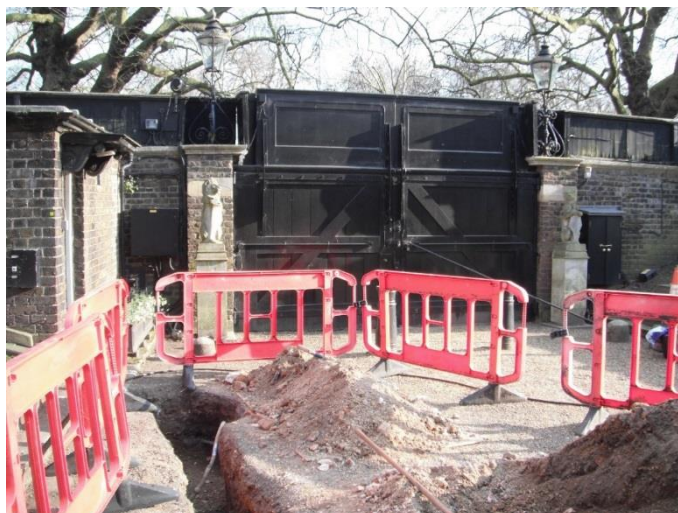
Plate 6: Looking south, southern gates to Clarence House garden still in place today

- 7.7 During the early 19th century the raised walkway was partly removed, as demonstrated by the brick steps and retaining wall having been significantly reduced in height and now surviving approximately 0.25m below the modern ground surface. This reduction was undertaken to allow the extension of the central pathway to the south and the installation of a gateway into the southern perimeter wall (Plate 6).
-

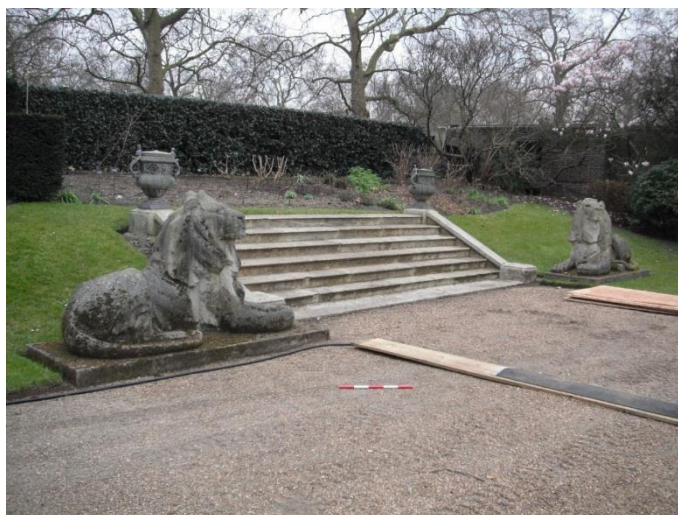
Plate 7: Looking south west, steps leading to raised walkway

- 7.8 In the late 19th century several ground raising layers were encountered at the northern end of the pathway, which sealed the earlier garden features and east-west intrusive features and probably marks the installation of the carriage turning circle. At about this date the eastern extent of the garden was lost to the construction of Marlborough Road, the Gate Keepers Lodge at the southern limit of the garden was built and stepped access to the raised walkway was reinstated at the eastern and western ends of the garden. The western set of steps were moved once more before the production of the 1895 Ordnance Survey map, to the location where they still remain (Plate 7).

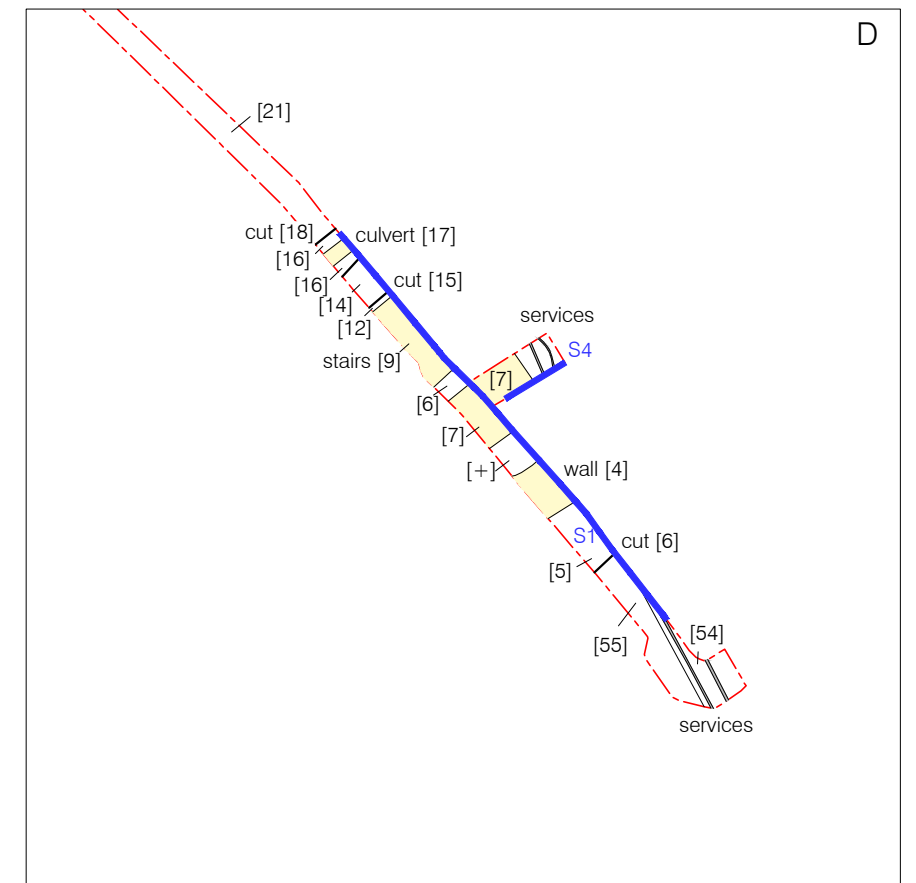
Figure 3
Trench Plan
1:500 and 1:100 at A3

- 6.1.4 Within the area of the coach turning circle, further garden features were encountered (see Figure 3 - inset A & Section 2). These were for the most part composed of mid grey brown sandy-silts [35], [52], [62], [63], [64] filling linear features (Figure 3). The pattern of these features appears consistent with the garden layout seen in illustrations of St James's palace dating from the late 17th century until the late 19th century (Cookson & Tinckner 2014). Due to the small size of the trench it was not possible to establish the exact nature of these features, but they may simply be planting beds. Interestingly, within garden feature [35] a sherd of Kraak Chinese porcelain dated to 1630-1650 was recovered – a prestigious find but unsurprising given the site.
