LAND AT SCHOOL LANE,  
BROUGHTON, HAMPSHIRE

AN ARCHAEOLOGICAL  
EVALUATION

REPORT NO: R12506

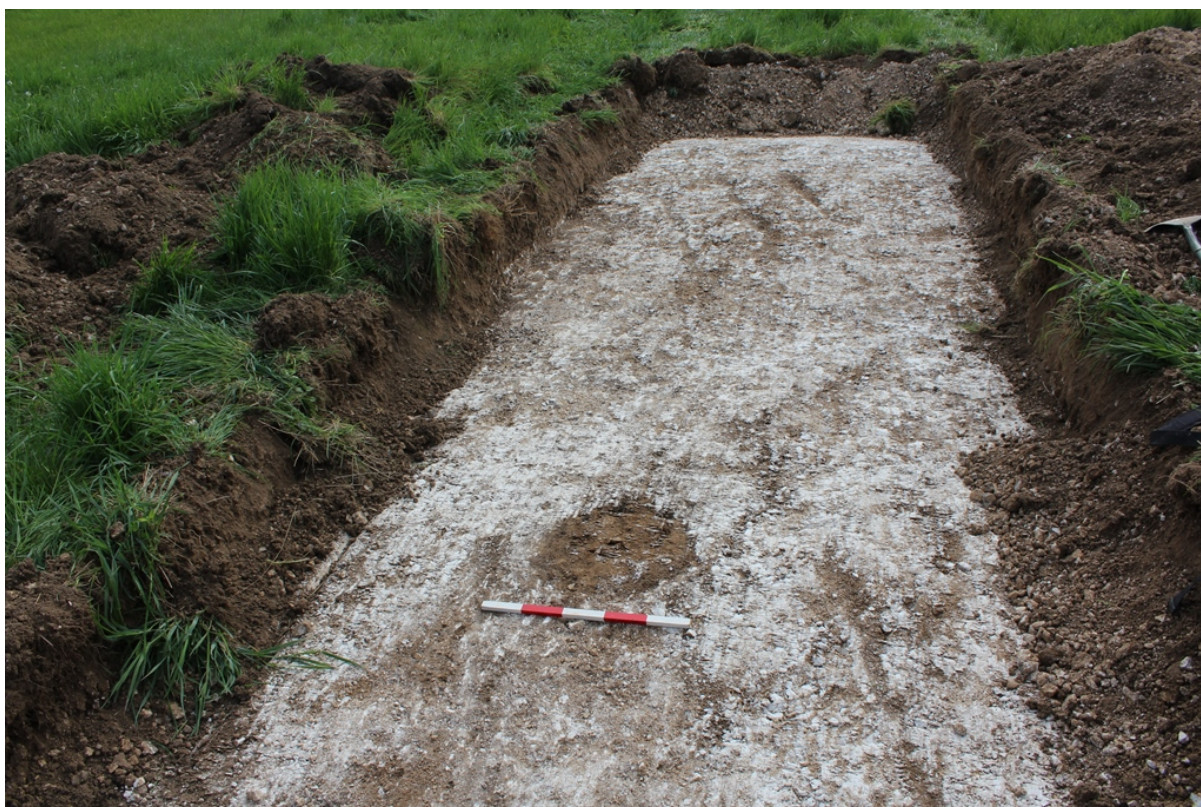
4.4.1 The remains of an *in situ* urned cremation burial, ([804]) were identified in Trench 8 (**Figure 3 and Plate 2**); this was not excavated as a part of the evaluation. The vessel had an approximate diameter of 0.35m and is likely to be of a later prehistoric date, however not enough of the fabric was exposed to accurately date the urn.

Plate 2: Trench 8, showing circular urned cremation burial. View to east. 0.5m scale.

4.5.2 Both the cremation in Trench 8 and the group of pits in Trench 13 represent moderately significant archaeological resources and require further investigation, in mitigation of the impact of the proposed development of the Site.

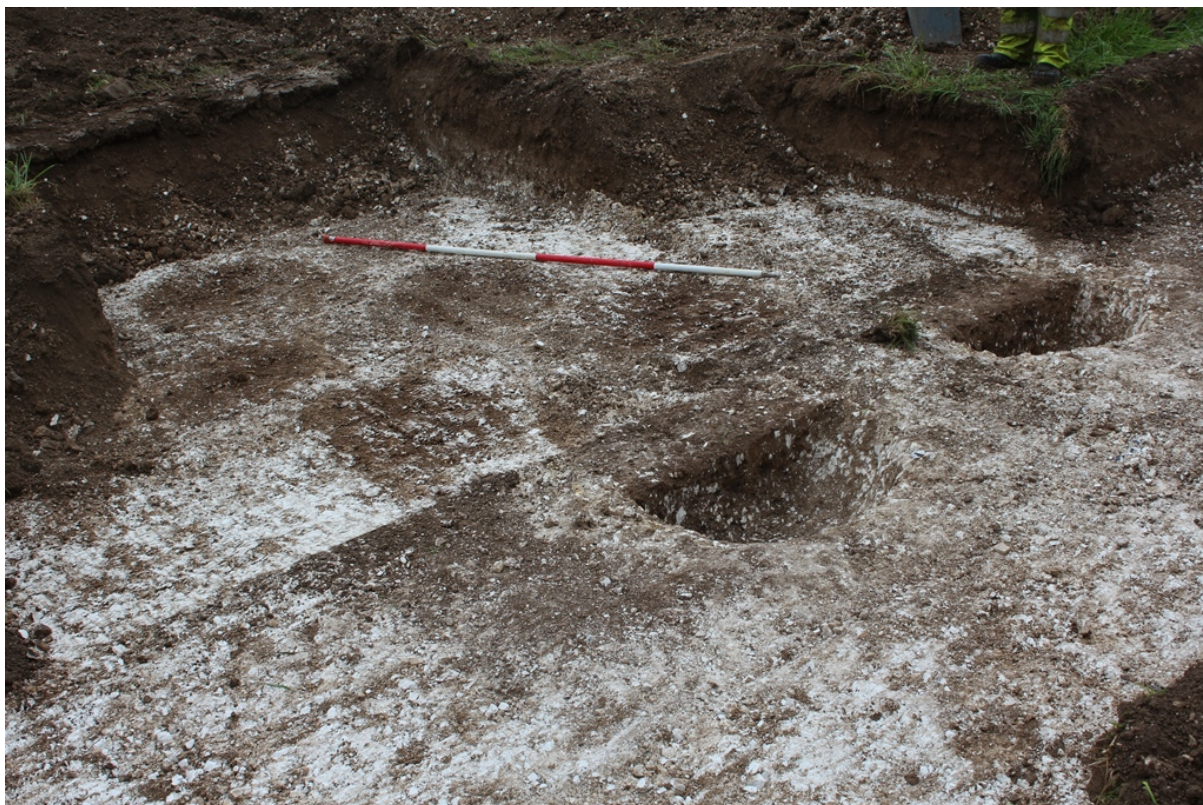
4.4.2 A group of seven pits ([1305], [1307], [1309], [1311], [1313], [1315] and [1317]) was identified in Trench 13 (**Figure 4 & Plate 3**). Two pits were visible inside the eastern baulk of the trench, which was then widened to expose a further five pits. The pits appeared to run in two rows and were all of a relatively consistent size and shape in plan. Three of the pits were sample excavated as a part of the evaluation, but no dating evidence was retrieved. All of the excavated pits were of a largely consistent form, with an average depth of 0.24m.

Plate 3: Trench 13, showing group of pits, [1305] et al. View south-east. 2m scale.

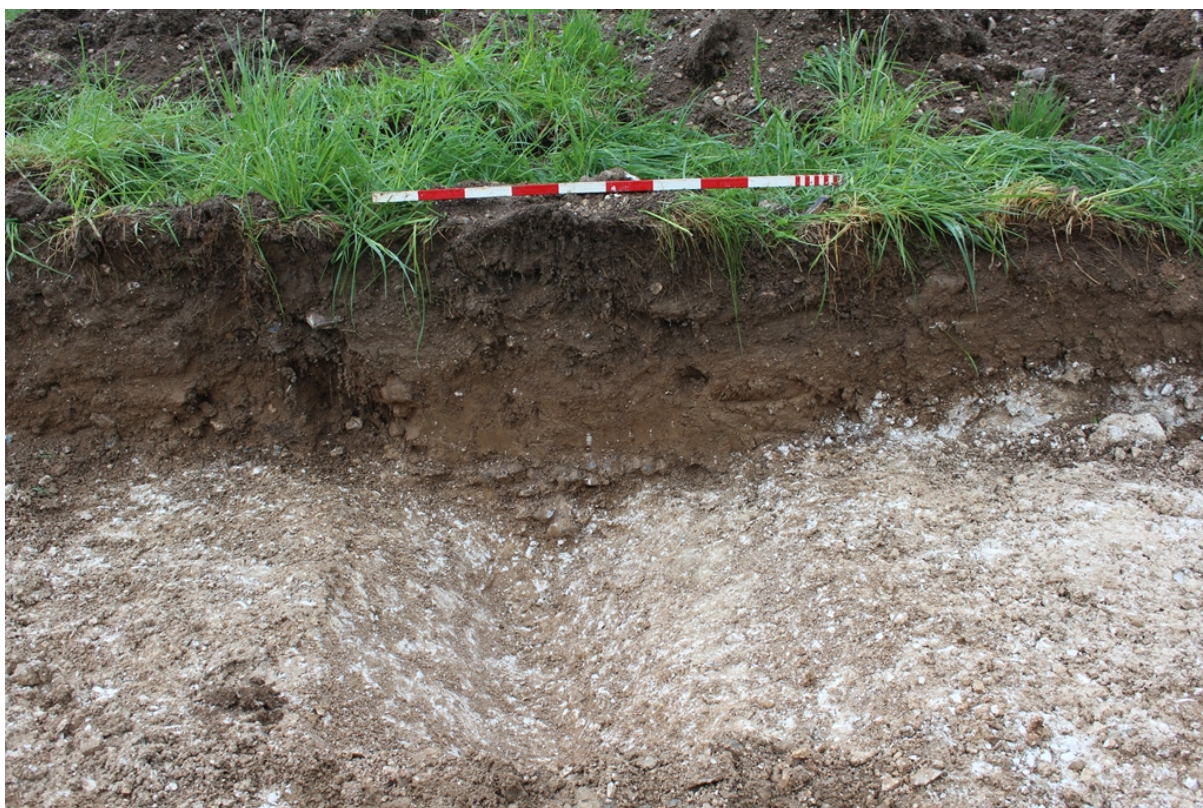
4.4.3 A linear feature was identified in both Trench 17 and 18 ([1707] and [1805]); in both cases appearing at a high level, cutting through the subsoil (**Figure 5 and Plate 4**). A layer of flints was present towards the base of the feature in both excavated slots. Both exposed section of linear feature appeared to be on the same alignment and are likely to relate to a modern drainage ditch, excavated through the field.

Plate 4: Trench 17, section and profile of ditch [1707]. View north. 1m scale.

4.5.3 The linear feature seen in Trench 17 and 18 appears to represent a modern drainage ditch, of low archaeological significance, and does not require any further investigation.
