**BUILDINGS 4-7,  
FOUNDATION PARK,  
ROXBOROUGH WAY, MAIDENHEAD,  
BERKSHIRE SL6 3PR**

**AN ARCHAEOLOGICAL WATCHING  
BRIEF DURING GEOTECHNICAL  
INVESTIGATIONS**

Pre-Construct Archaeology Ltd	
Project Number	K4561
Report Number	R12510

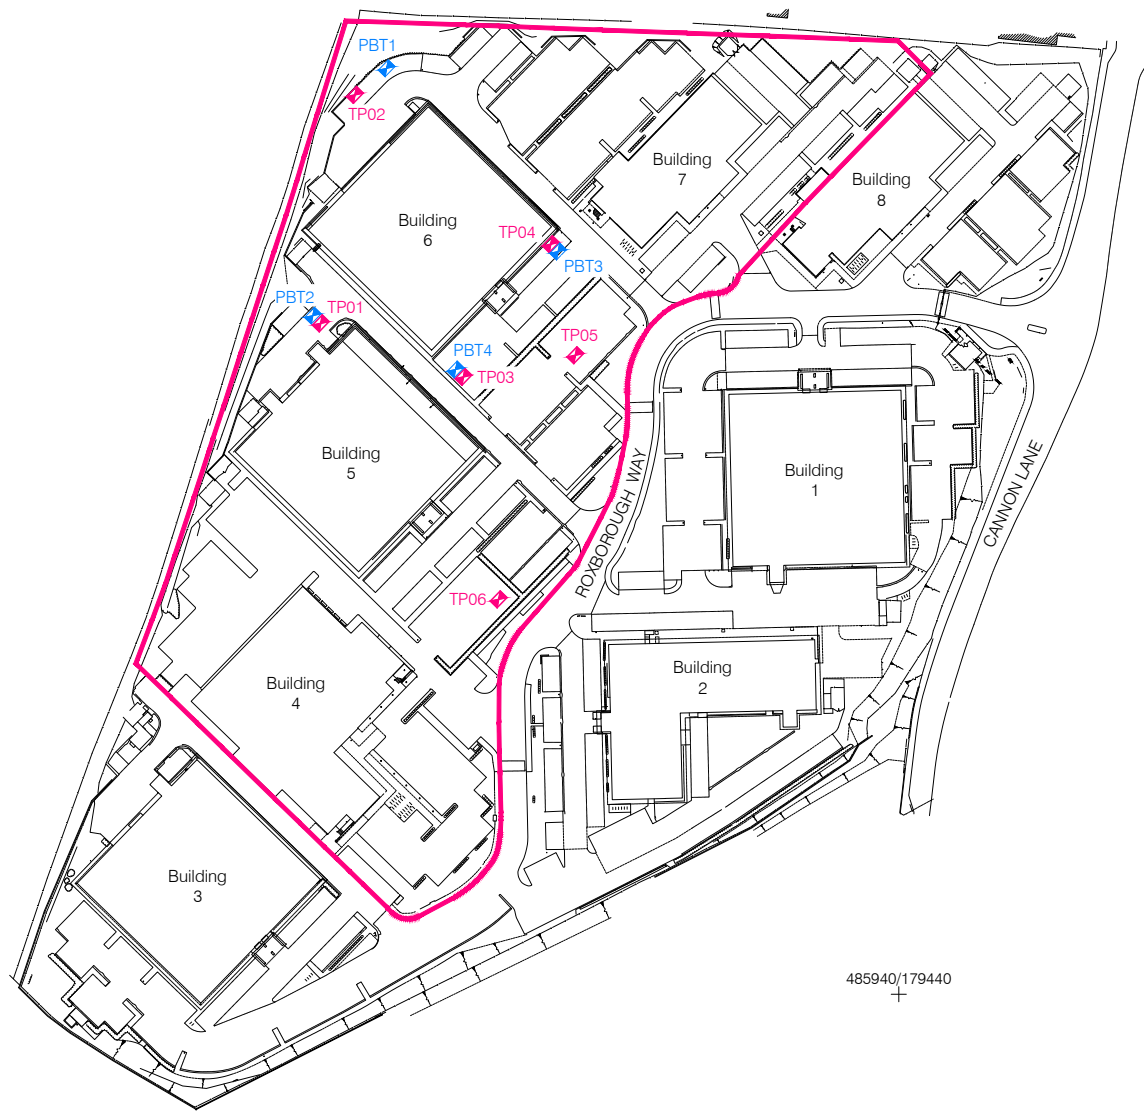
Figure 2  
Location of Monitored Interventions  
1:2,000 at A4

TP01 Machine Excavated Trial Pit

PBT1 Plate Bearing Test

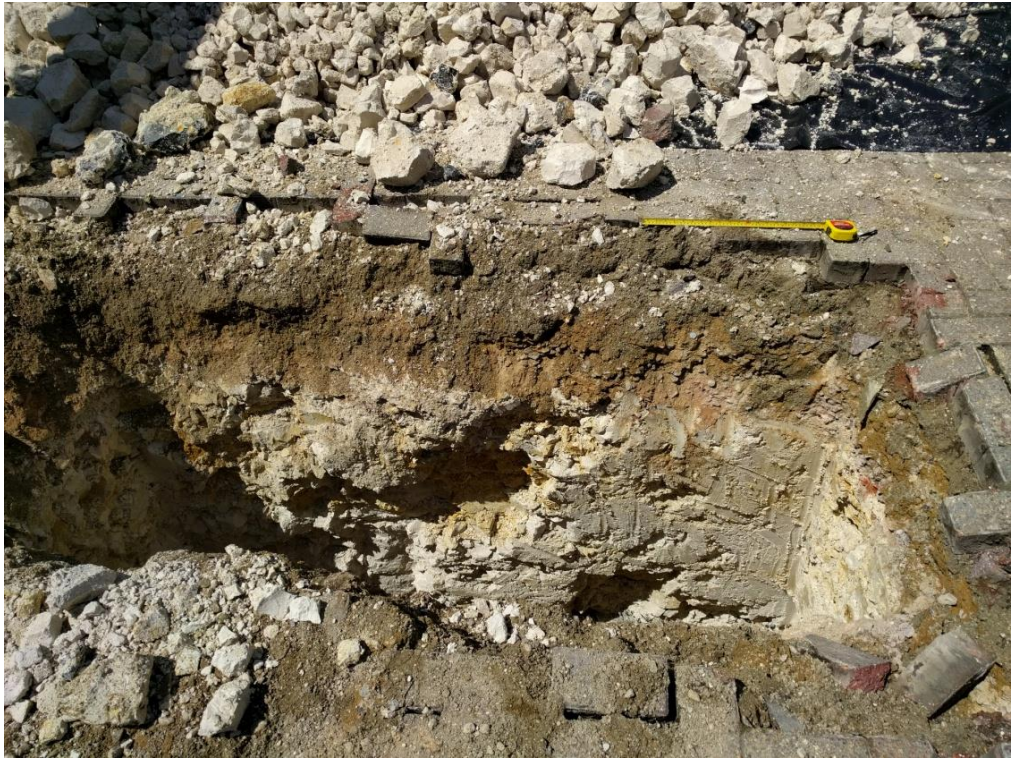
*Plate 1 Southeast facing section of Test Pit 1; showing modern surface bricks [5] made ground [2] and chalk [3].*

Intervention	TP01	ground level (m OD):	37.27	
Description	Context	Thickness (m)	height (m OD)	comments
brick surface	05	0.08	37.27	modern surface
made ground	02	0.32	37.19	modern levelling material
natural chalk	03	>2.9	36.87	natural bedrock

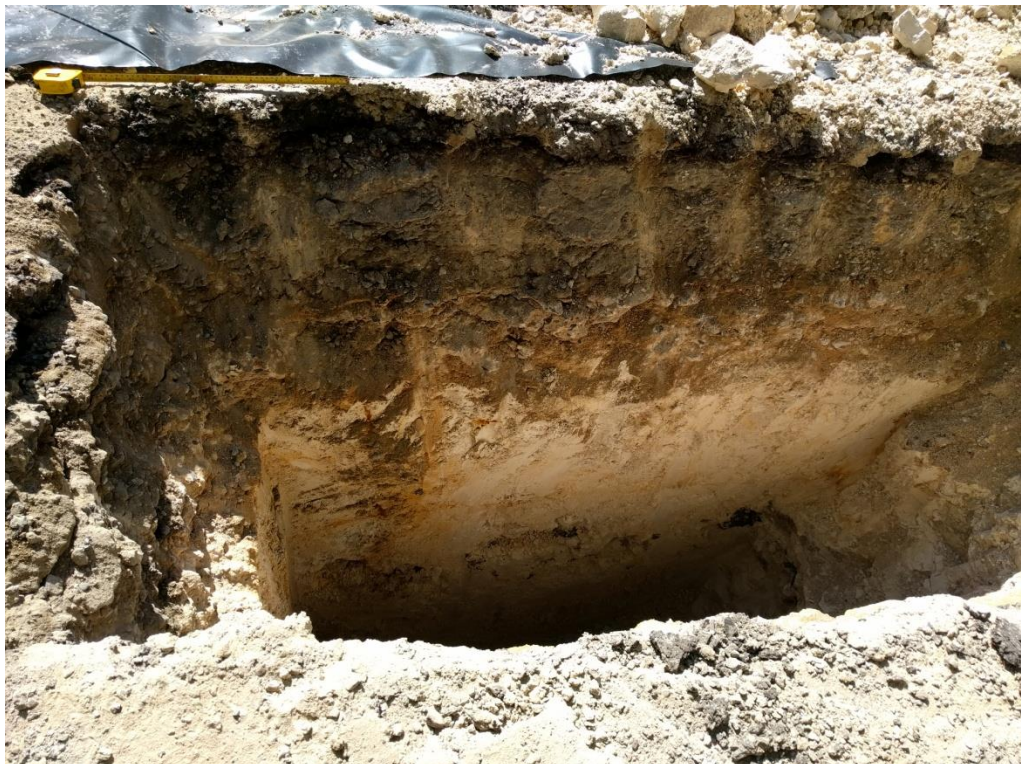
*Plate 2 Southeast facing view of Test Pit 2; showing the top of chalk [3] overlain by concrete [8] and sealed by tarmac [1].*

Intervention	TP02	ground level (m OD):	37.59	
Description	Context	Thickness (m)	height (m OD)	comments
asphalt	01	0.10	37.59	modern surface
concrete	08	0.70	37.49	modern levelling material
natural chalk	03	>2.3	36.79	natural bedrock

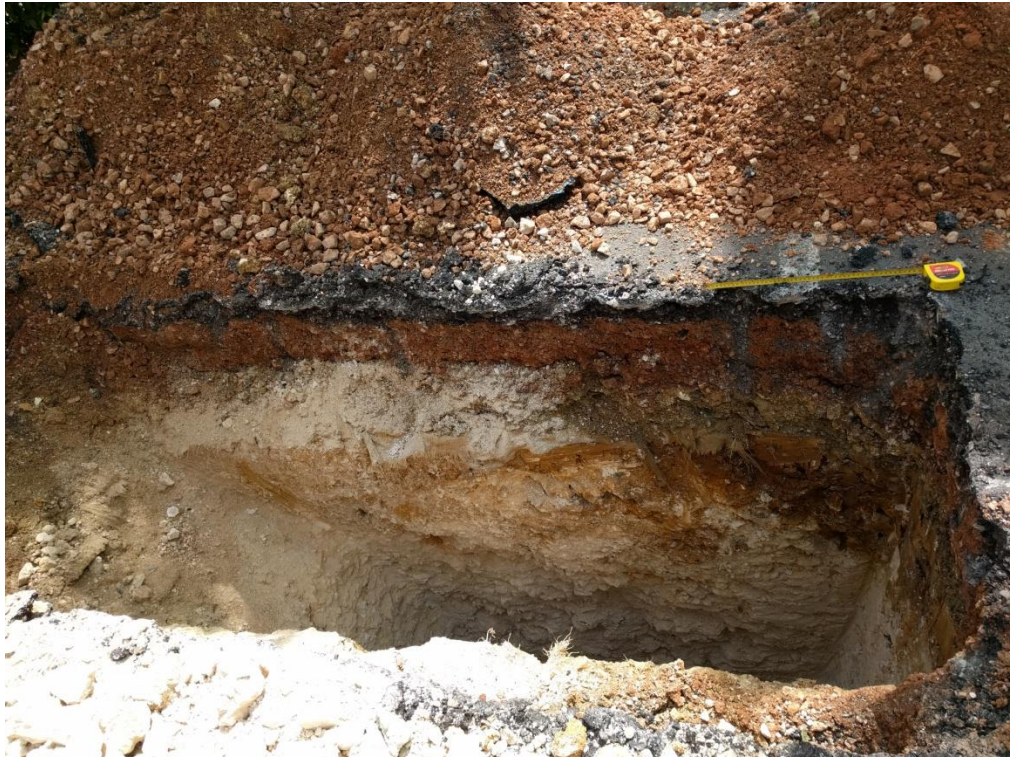
*Plate 3 Northwest facing view of Test Pit 6; showing chalk [3] cut by [7] with a reddish clay fill [6], overlain by made ground [9] and sealed by tarmac [1].*

Intervention	TP06	ground level (m OD):	37.36	
Description	Context	Thickness (m)	height (m OD)	comments
asphalt	01	0.14	37.36	modern surface
modern hoggin	09	0.56	37.22	modern levelling material, above terram
clay fill	06	1.00	36.66	modern levelling material above horizontal cut [07]
landscaping cut	07	n/a	36.66	modern landscaping cut, filled by [06]

natural chalk	03	>2.8	35.66	natural bedrock
---------------	----	------	-------	-----------------

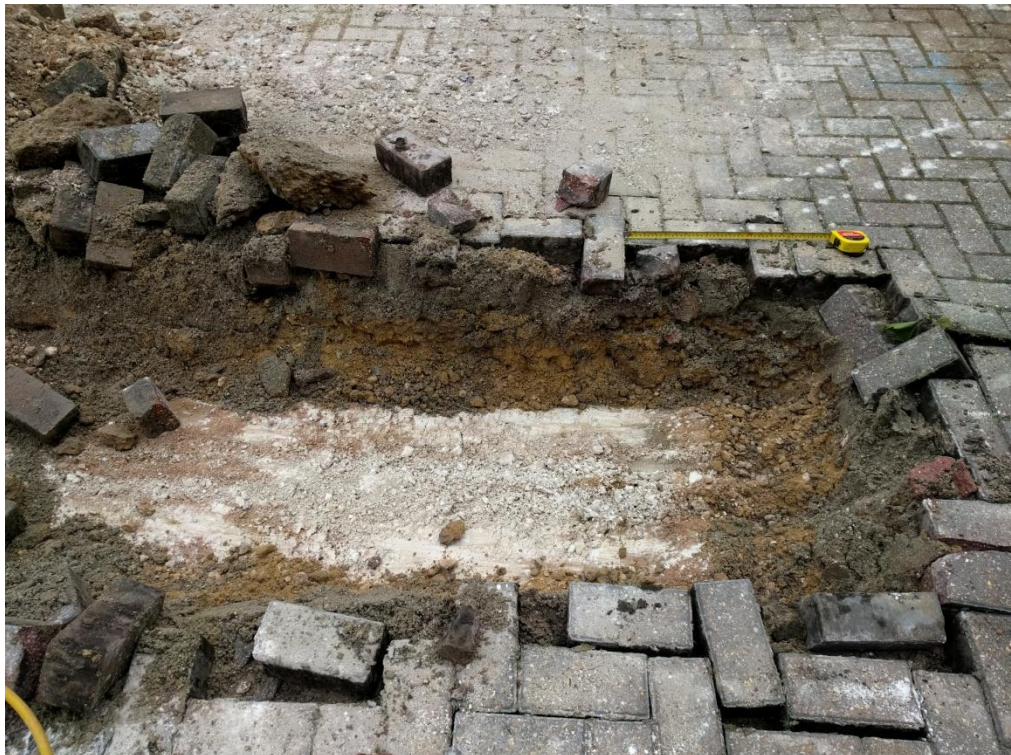
*Plate 4 Northwest facing view of PBT02; showing the natural chalk [3] and made ground [2] overlain by modern bricks for the car park [5].*

Intervention	PBT02	ground level (m OD):		37.27	
Description	Context	Thickness (m)	height (m OD)	comments	
brick surface	05	0.08	37.27	modern surface	
concrete	08	0.32	37.19	modern levelling material	
natural chalk	03	unknown	36.87	natural bedrock
