**SOUTHALL LANE, WASTE
DEPOT , LONDON
BOROUGH OF HOUNSLOW:
AN ARCHAEOLOGICAL
EVALUATION**

**SITE CODE: SLL 16
REPORT NO: R12562**

AUGUST 2016

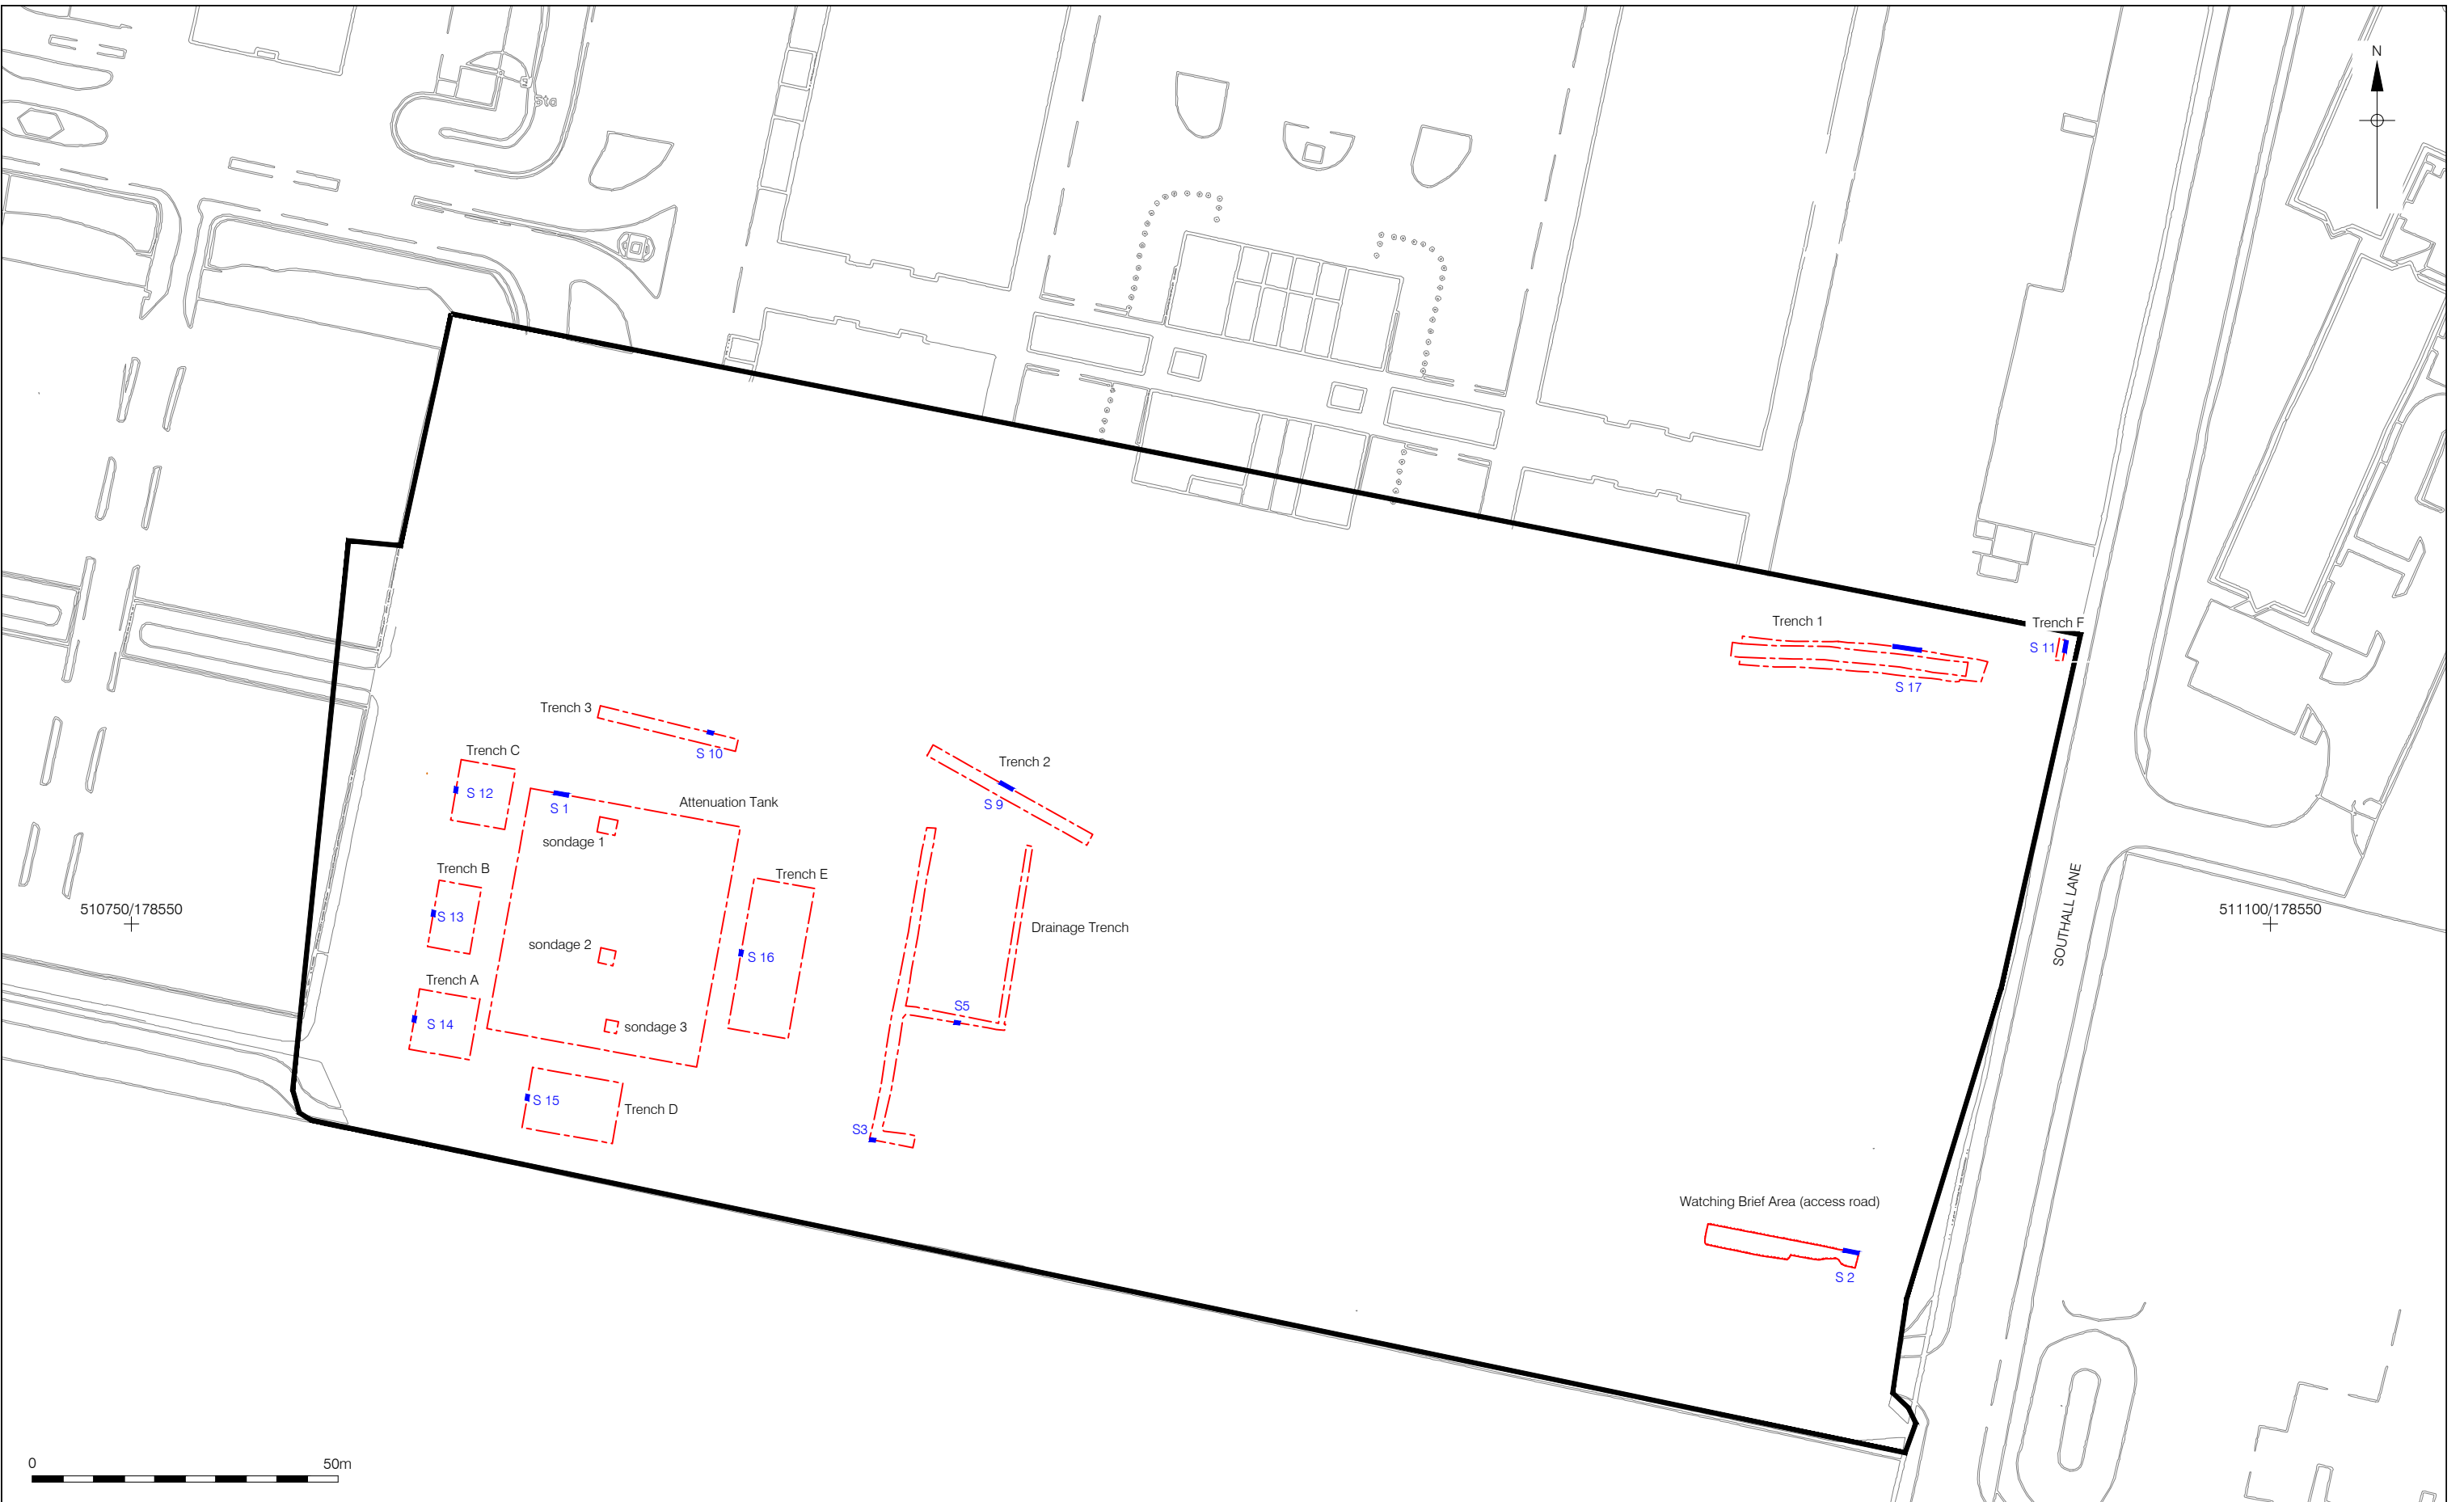
- 6.9.1 The access road drainage trenches were excavated over several days over an area measuring 60m north to south by 22m east to west (Figure 2). This excavation (Plate 3) varied in depth between 28.94m OD and 29.18m OD (0.90m BGL and 0.58m BGL).

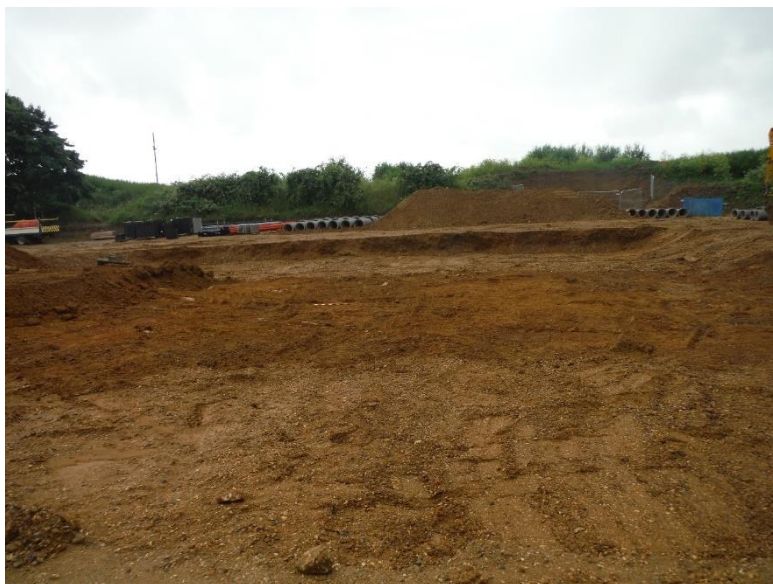
Plate 1: Looking south, Attenuation Tank

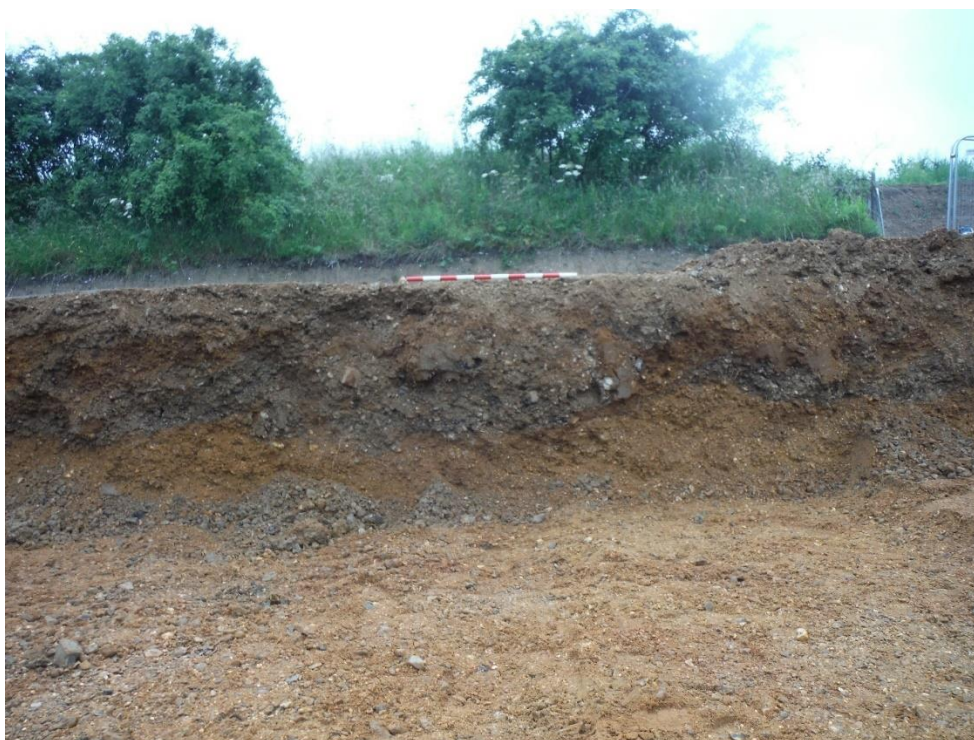
- 7.3.1 The footprint of the previous modern building had heavily truncated the natural gravel and removed all of the subsoil within both the Attenuation Tank ([4] and [5] (Plate 2)), Service Trenches A to E ([26], [27], [28], [29], [30], [31], [32], [33], [34] and [35]) and Trench 3 ([18] and [19]) (Plate 5). The material relating to the previous building was very mixed, and contained moderate amounts of concrete, plastic pipe and metal fragments.

Plate 2: Looking south, Attenuation Tank north facing section [4] and [5]

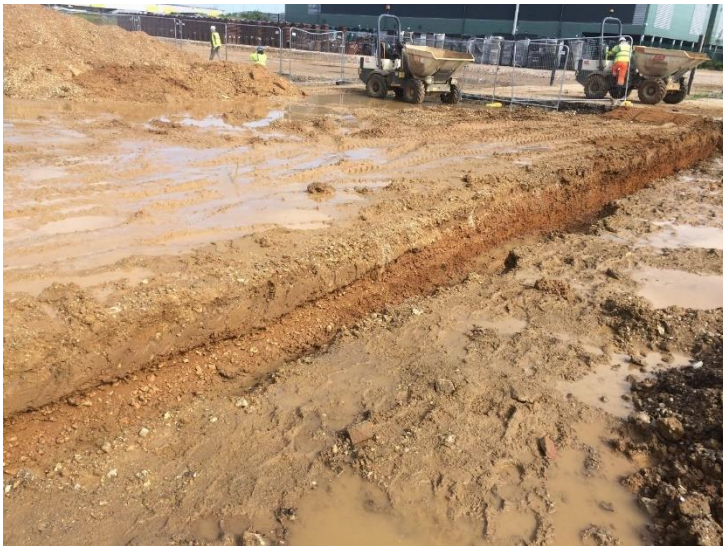
- 7.2.1 There were only two locations where a mid orange brown subsoil was encountered. These were both within the access road drainage trenches, layer [7] to the south-eastern area of the site, located at a height of 29.96m OD, and layer [10] (Plate 3) in the centre of the southern half of the site at a height of 29.60m OD. This layer of subsoil was between 0.30 and 0.45m thick, potentially surviving to a greater depth to the east where it was not fully excavated.
- 7.2.2 It appears that the reason for the subsoil's survival was a lack of modern truncation in this area. The areas where it was encountered were far outside any previous building footprint.

Plate 3: Looking north west, Access road drainage including subsoil [10]

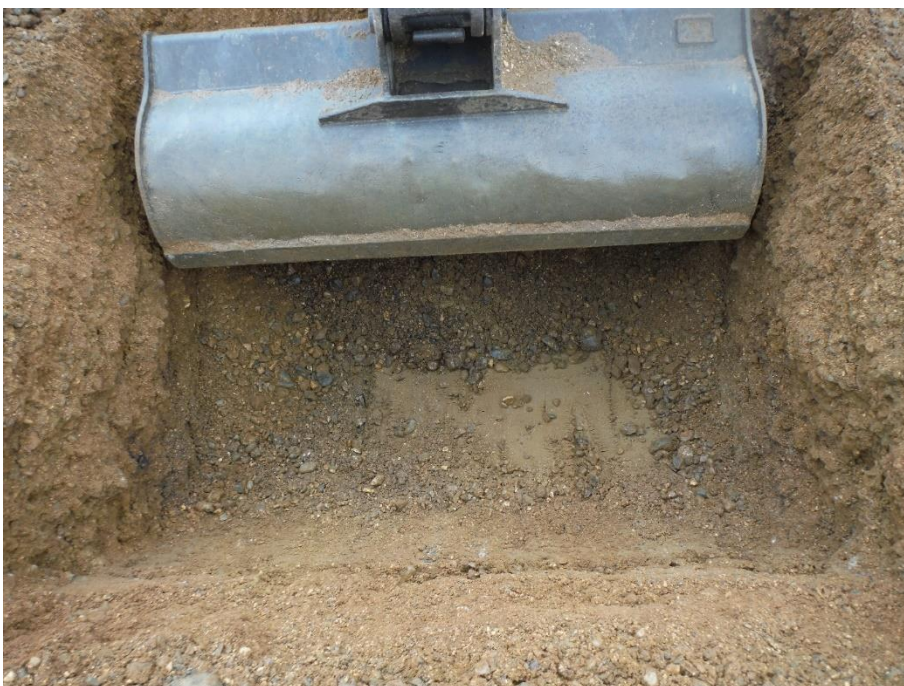
- 7.1.1 Sondages measuring c. 2m by 2m, within the base of the Attenuation Tank, showed natural sand [1], [2], [3] and [17] (Plate 4) at a height of between 26.97m OD and 28.82m OD. Similarly, the access road drainage trenches uncovered mid orange sand and gravel [11] at 29.30m OD. In the eastern part of the access road a layer of natural mid orange clay and gravel [8] was encountered at 28.96m OD. The layer had a thickness of 0.1m although this was not fully excavated and so its full thickness is not known. Within Trench 1 natural gravel was discovered in three locations along the trench [36], [37] and [41], heavily truncated by modern material, and at this height separated by modern intrusions. The natural gravel was, where visible, surviving to a height of 29.35m OD, 29.42m OD and 28.60m OD respectively. In Trench 2 (Plate 6) natural gravel [23] was also truncated by modern material, seen at a height of 29.54m OD. In Trench 3, modern truncation meant that the natural gravel [20] was only visible in a sondage, having been reduced to a height of 27.35m OD.

Plate 4: Looking east, natural sand [17] southern sondage in Attenuation Tank

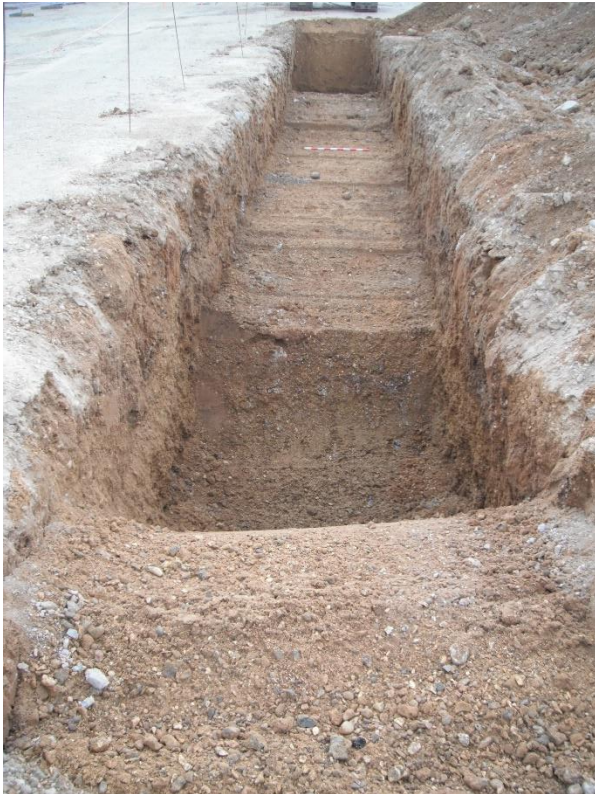
Plate 5: Looking west, Trench 3

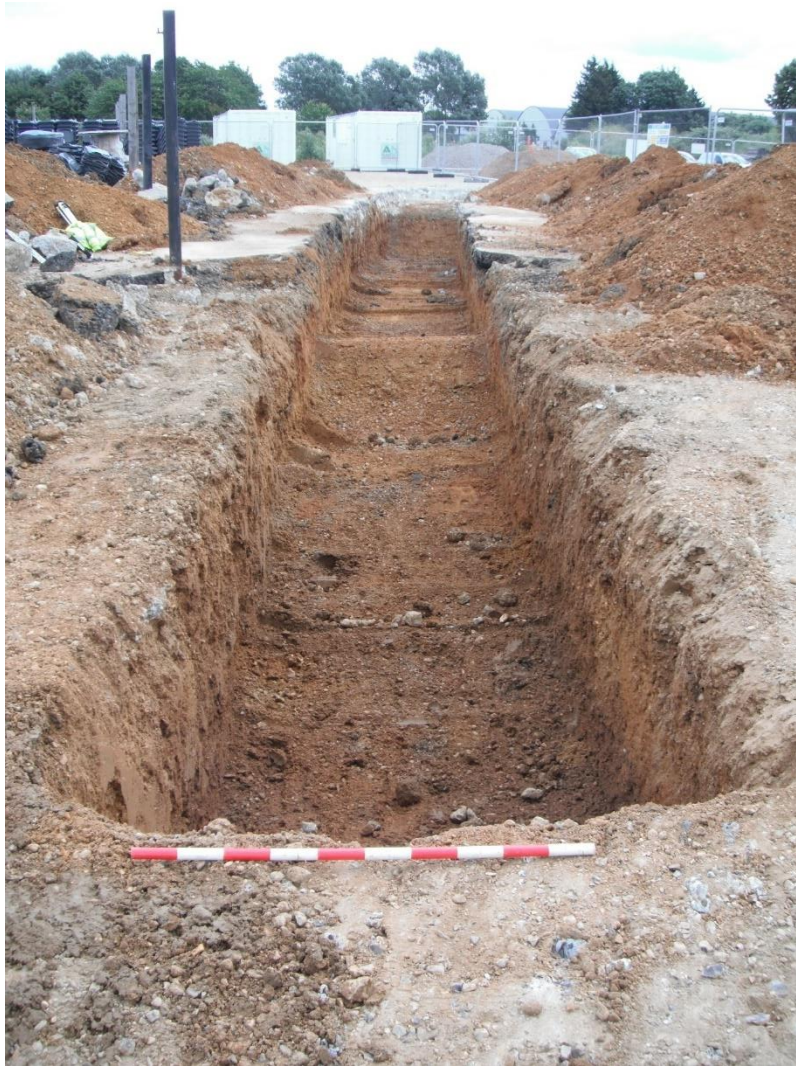
- 7.3.2 Within Trench 2 the modern layers were made ground [21] (29.81m OD) associated with the installation of reinforced concrete hard standing and made ground [22] (29.68m OD) levelling for the tarmac road associated with the previous use of the site. Both layers contained concrete pieces.

Plate 6: Looking south-east, Trench 2

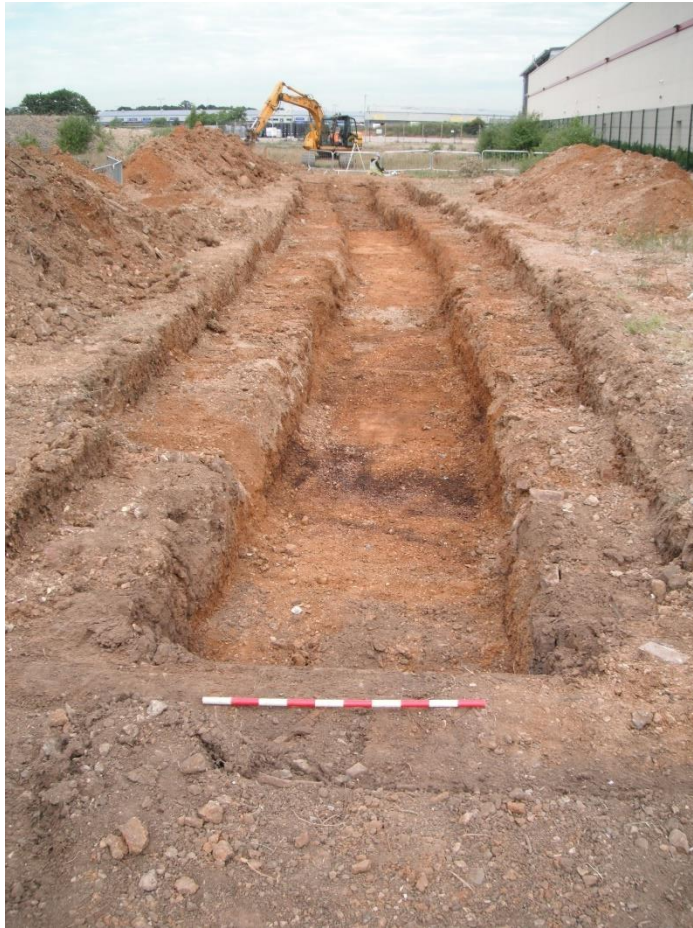
6.10.1 Trench 1 (Plate 7) was excavated in the northeast corner of the site, in an east to west direction, and was stepped in order to conform with onsite health and safety regulations. Trench 2 was partly located over an old area of reinforced concrete hard standing and the remnants of a tarmac road surface which had to be broken out, it was also placed in a north-west to south-east direction. Trench 3 (Plate 5) was the westernmost of the three trenches, running east to west, in its base a sondage was excavated at both ends in order to reach the natural sand and gravels.

- 7.3.3 Trench 1 had several layers of modern material present, the layers appear to be related to ground levelling using a 0.45m thick layer of redeposited natural [38], a 0.07m thick layer of purple sand [39] and a 0.06m thick layer of shingle [40]. Whilst these layers of modern material were sterile of artefacts, the presence of shingle of the same type as seen around pipes onsite suggests a modern date. The two recorded layers from Service Trench F were also modern, and consisted of dark silty clay [24] containing brick rubble, and metal and mid orange brown silty clay [25].

Plate 7: Looking west, Trench 1
