**HISTORIC BUILDING
RECORDING OF
THE STABLEYARD,
16A BALHAM HILL,
LONDON BOROUGH OF
WANDSWORTH,
SW12 9EB**

REPORT NO: R12583

AUGUST 2016

Site Code: BAM16

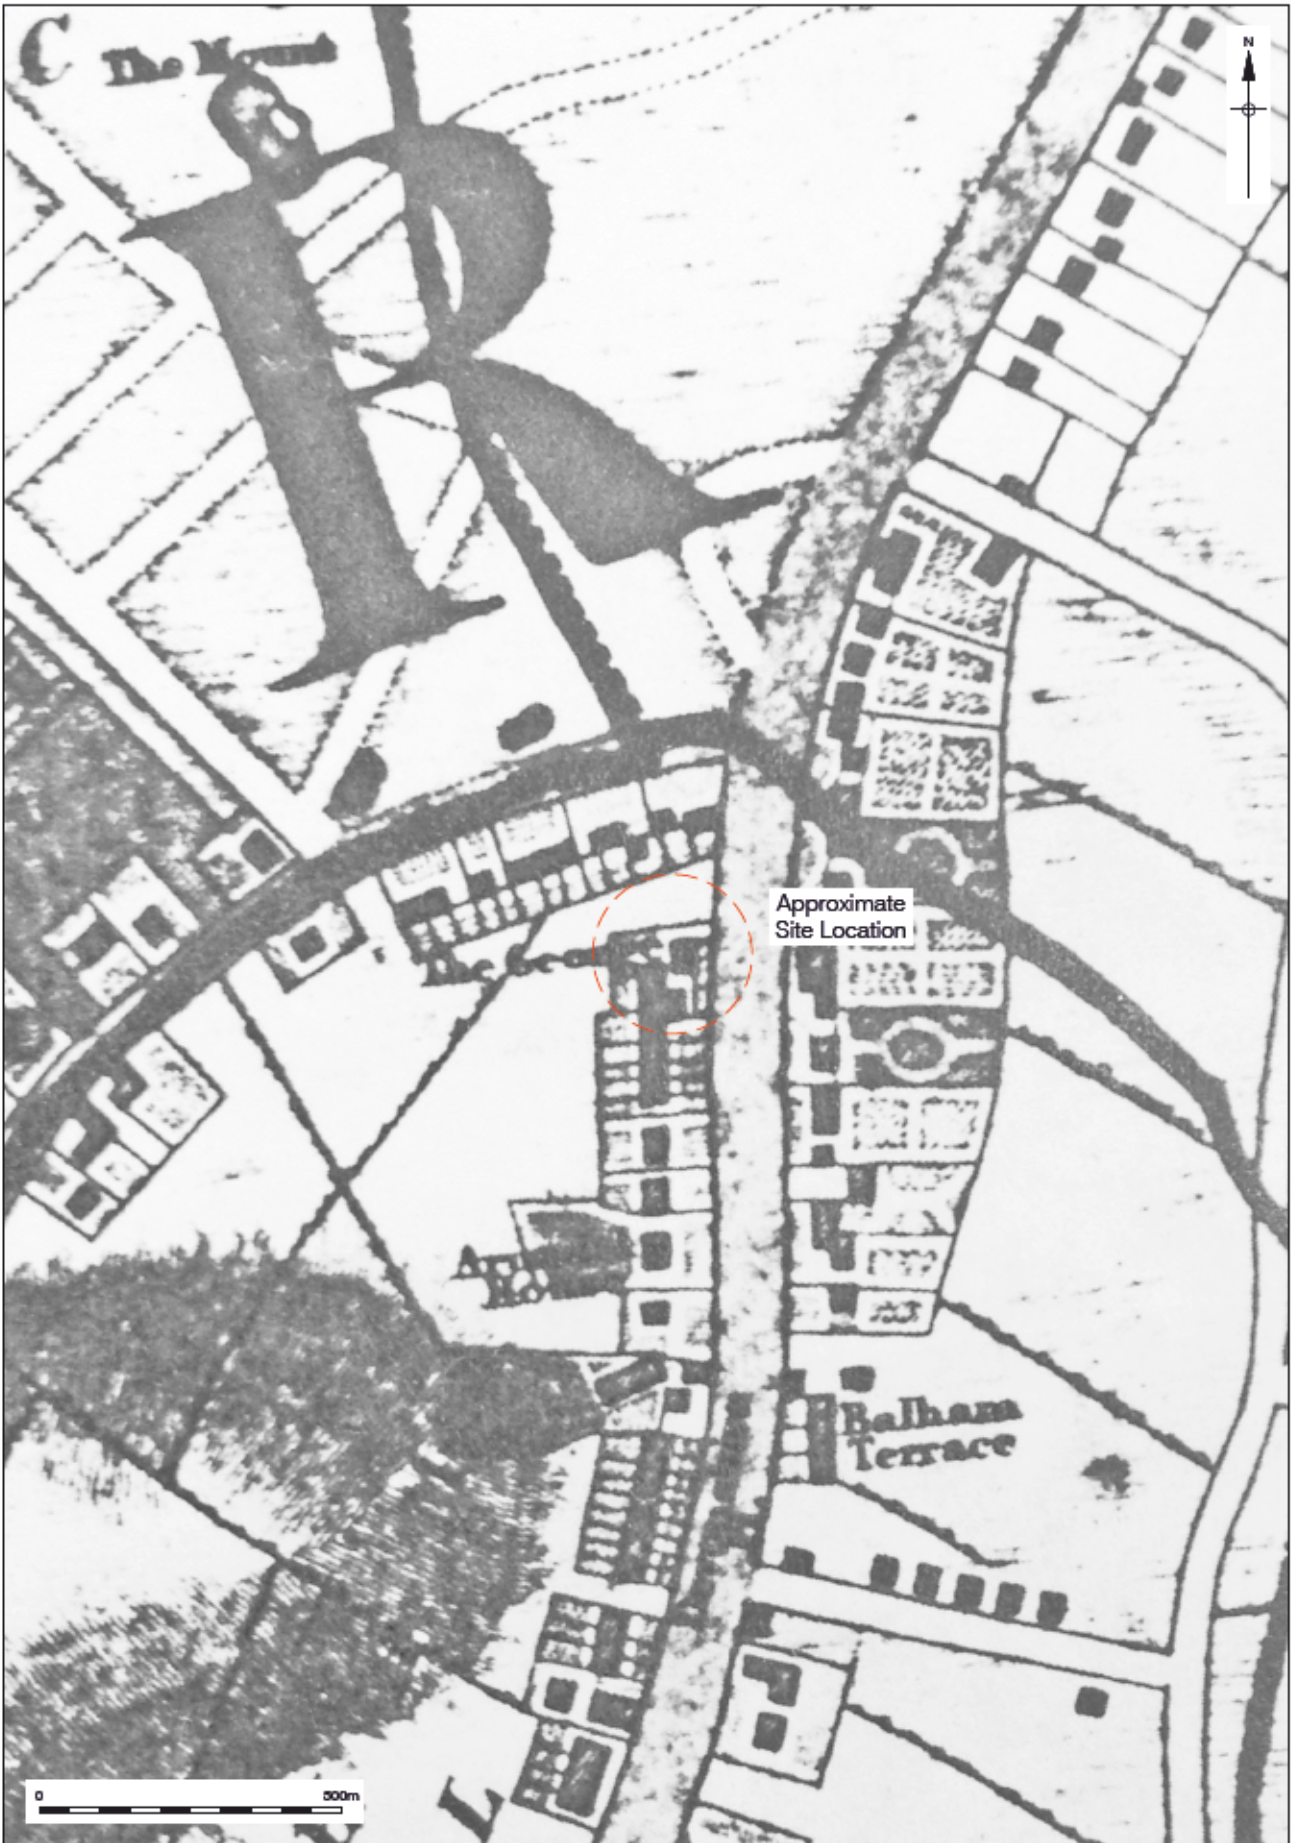
Figure 4
Crutchley's map, 1829
Approx. 1:12,500 at A4

- 5.1.3 Crutchley's Map of 1829 (**Figure 4**) depicts considerable development along the frontages to Balham Hill. 'Desirable Villas' (Hibbert & Weinreb 2008), many with large ornamental gardens are shown along the eastern side of the road, whilst smaller properties, in the area of the site, are located to the western road frontage. 'The George Inn' (now the Avalon) is clearly labelled and shown to the immediate north of the site. The inn had a complex of small out-buildings, most likely stabling and associated buildings. The coaching inn provided for travellers visiting the capital, situated on Balham Hill, one of the principal routes into and out of the capital from the south.

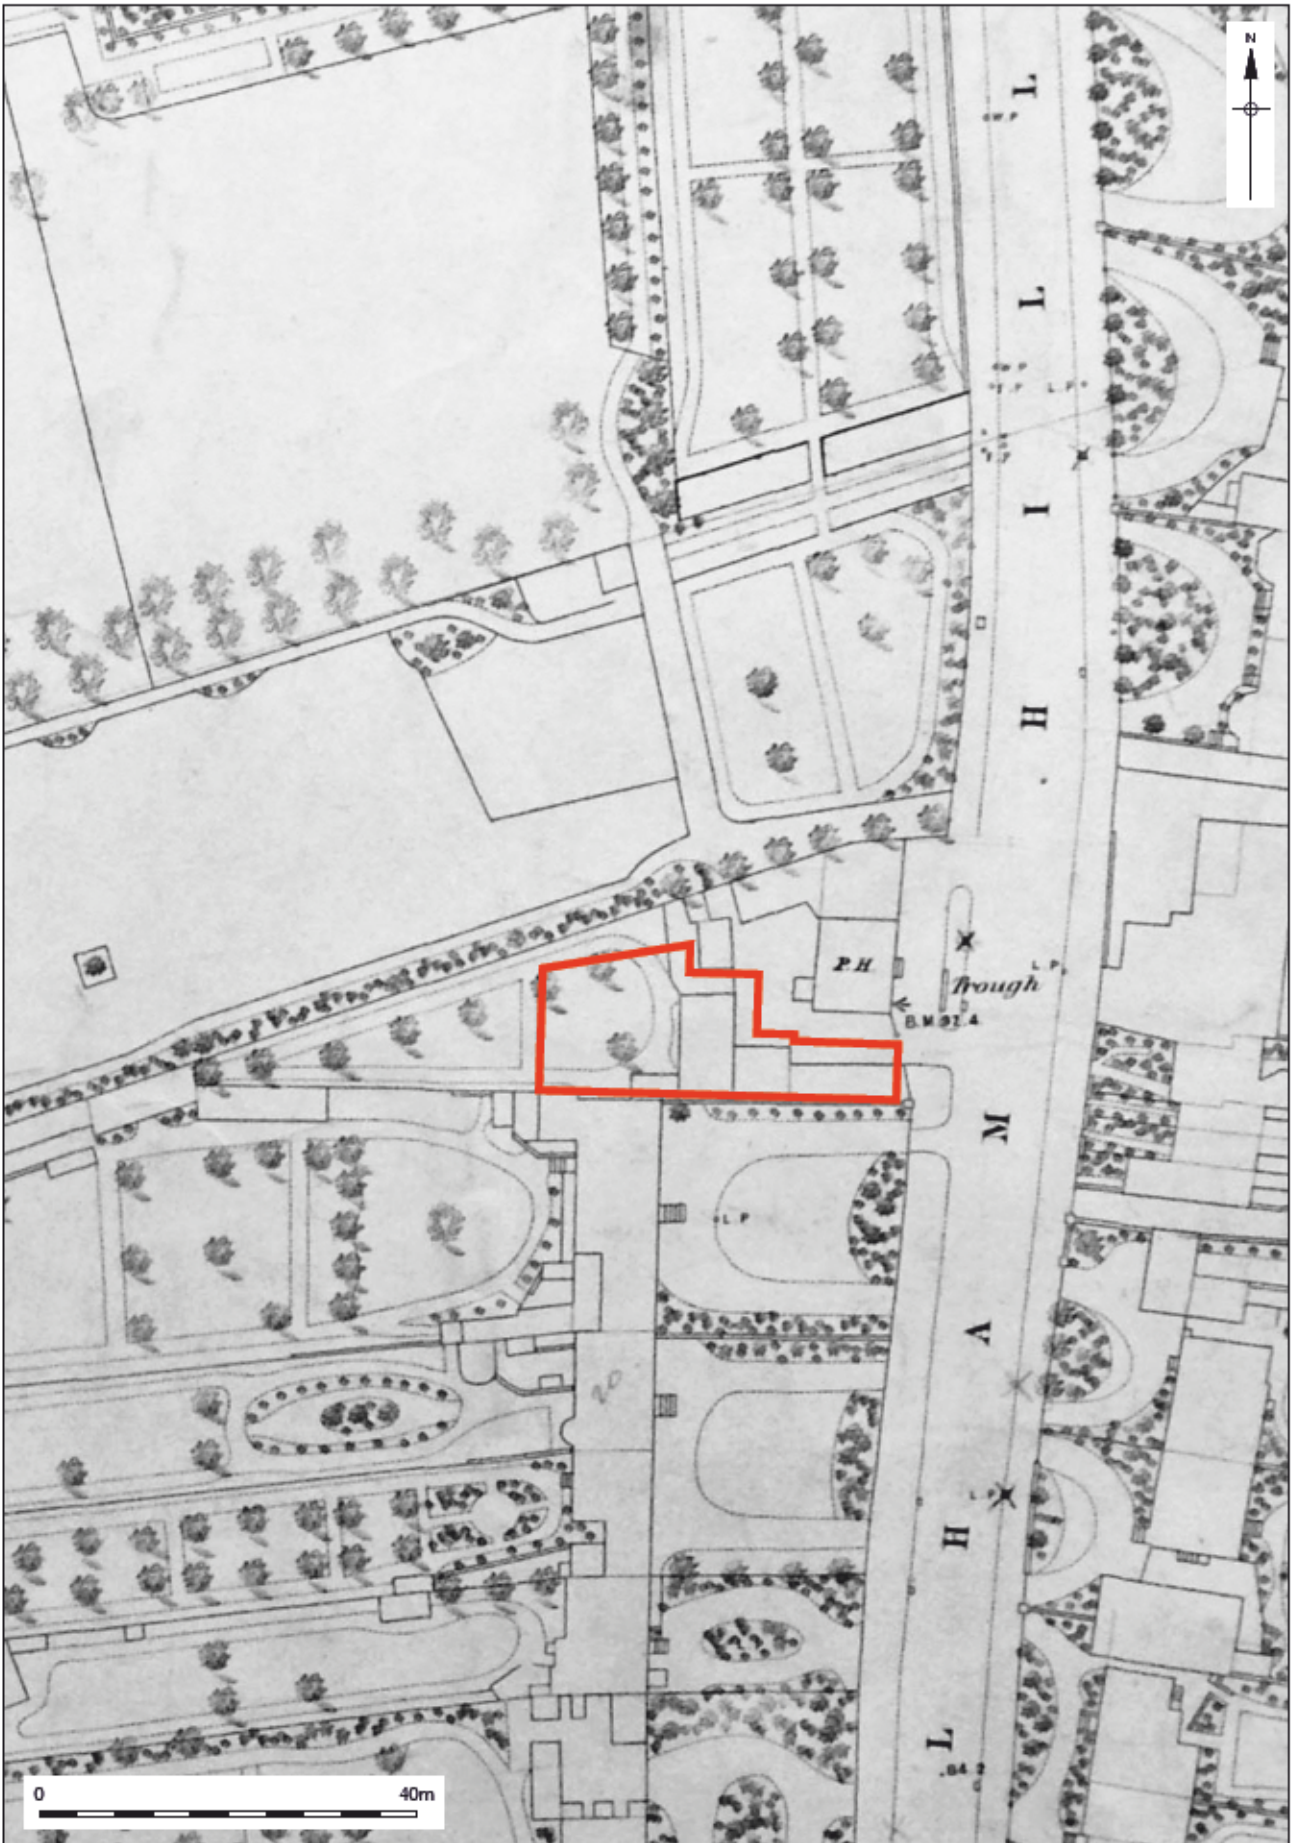
Figure 6
Ordnance Survey map, 1869
1:800 at A4

- 5.1.5 The historic map evidence shows that between 1869 (**Figure 6**) and 1894-96 (**Figure 7**) the present stable buildings and the apartment over the carriage entrance were constructed. It also appears that the George Inn was remodelled and considerably enlarged in this period. This late 19th century rebuilding coincides with a complete transition of Balham from a 'country village' to part of the urban sprawl of London (Hibbert & Weinreb 2008). The earliest available documentary reference to the licensee of the George Inn dates to 1870 and concerns the death and estate of the former landlord David Dixon and his succession by Charles William Dixon, reported in the *Era Newspaper*.

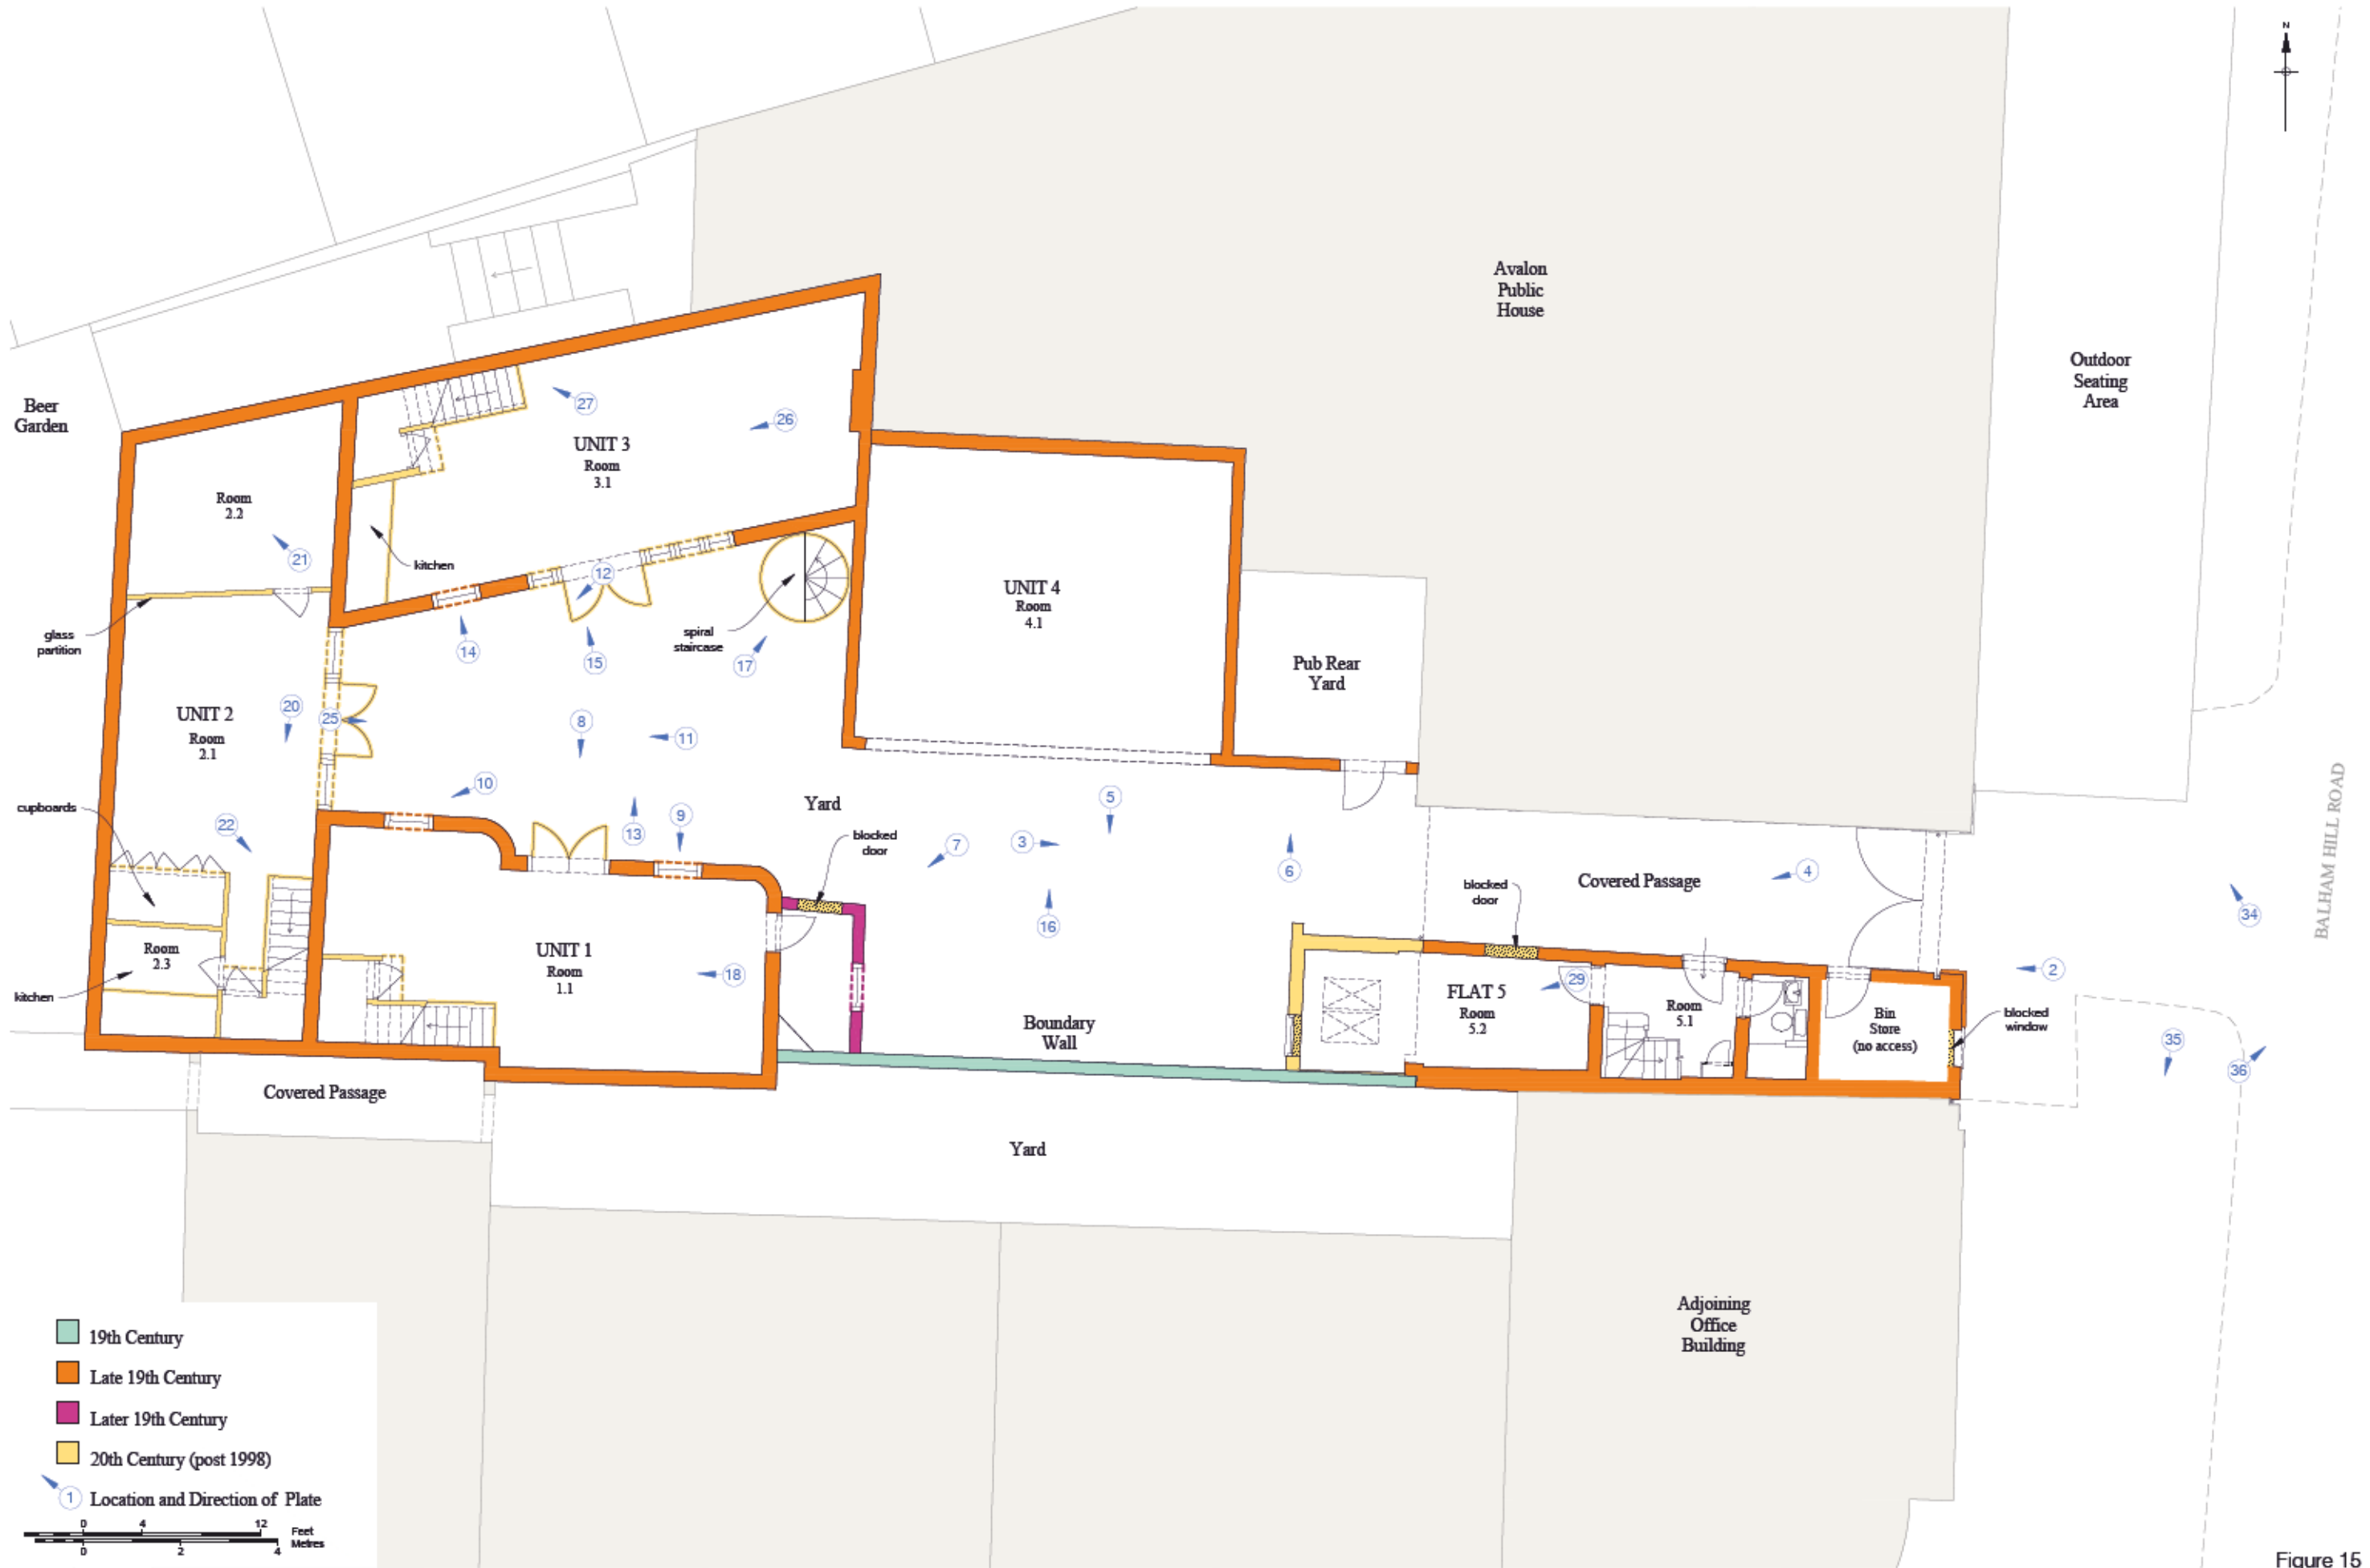
Figure 15
Ground Floor Phase Plan of Units 1-4 & Flat 5
1:125 at A3

boundaries (**Figure 15**). It presents its principal and longest elevation to the north and is built over one and a half storeys, with an attic floor built into the in-line pitched roof space (**Plates 7 and 8**). A small flat roofed former office building projects from its eastern end, while a slightly forward set single storey bay with a rounded-off corner and pent roof, projects northwards to the west and towards Unit 2 (**Plate 7**). The rounding-off of the corner is also present to the east and plausibly may be a design feature incorporated to help prevent damage to both building and animal. A centrally located double-door opening (with modern doors) provides the main access into the stable (**Plate 8**). It is flanked on each side by a pair of window openings, built with gauged brick heads and plain stone sills which retain their original casement windows, the latter split horizontally, with a bottom hung, pivoting upper casement and a fixed lower casement (**Plates 9 and 10**). A smaller casement of similar design is present in the end wall of the flat-roofed office range (**Plate 7**). A tethering ring survives to the east of the western window and within the rendered lower wall (**Plate 10**), while a decorative terracotta through-wall ventilation brick lies directly above (**Plate 8**).

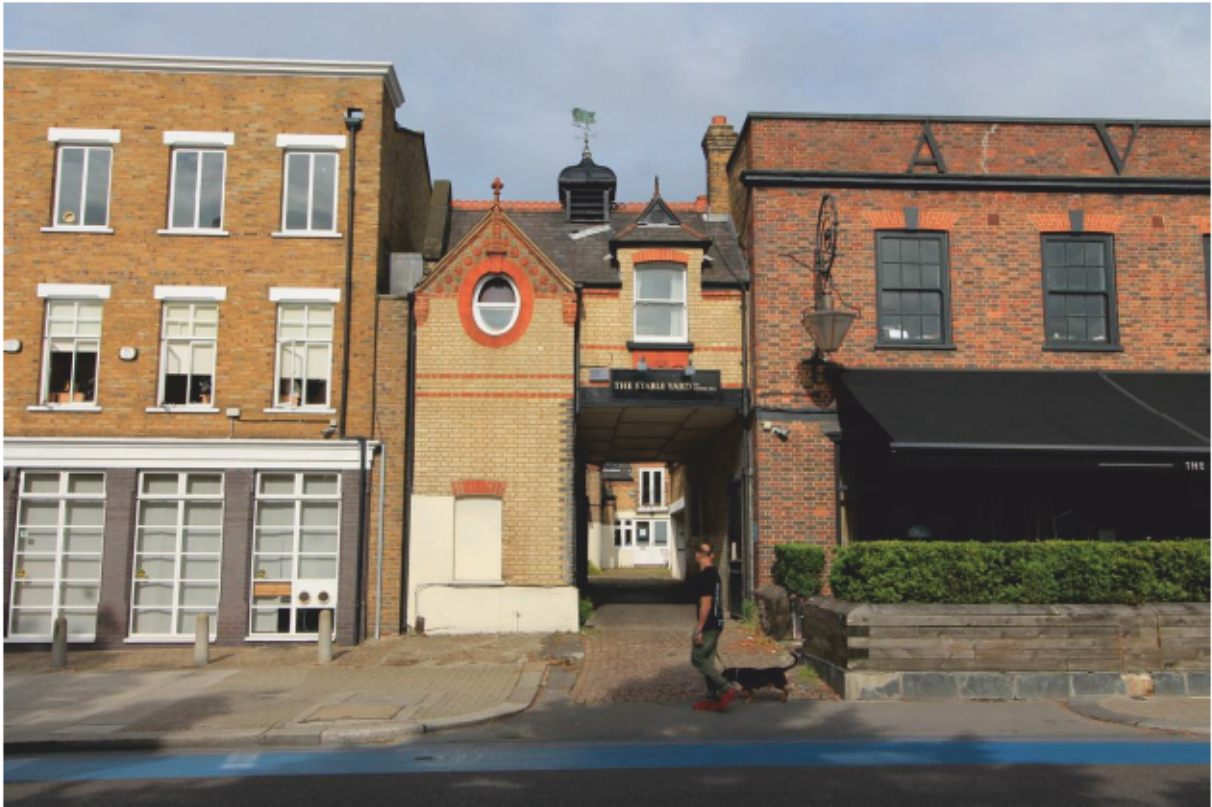
Plate 1 No. 16a Balham Hill showing adjoining public house (the former George Hotel) to the north looking west

6.2.2 The carriageway facade is typically later Victorian, built with eclectic Gothic motifs, with pitched roofs, decorative finials and ridge-line bonnets (**Plate 2**). The brickwork, laid in Flemish bond is poly-chromatic, with contrasting red brick string courses at carriage, sill and eaves levels, gauged red brickwork to window openings, contrasting red brick kneelers, a red brick apron and blue bull-nosed brickwork to the southern corner of the carriage entrance (**Plate 1**).

6.2.6 The in-line roof over the carriage entrance is pitched, covered in non-local Welsh slate and ornamented with simple red clay bonnets (**Plate 1**). It abuts the higher end wall of the adjoining public house to the north and incorporates a gable parapet to the south.

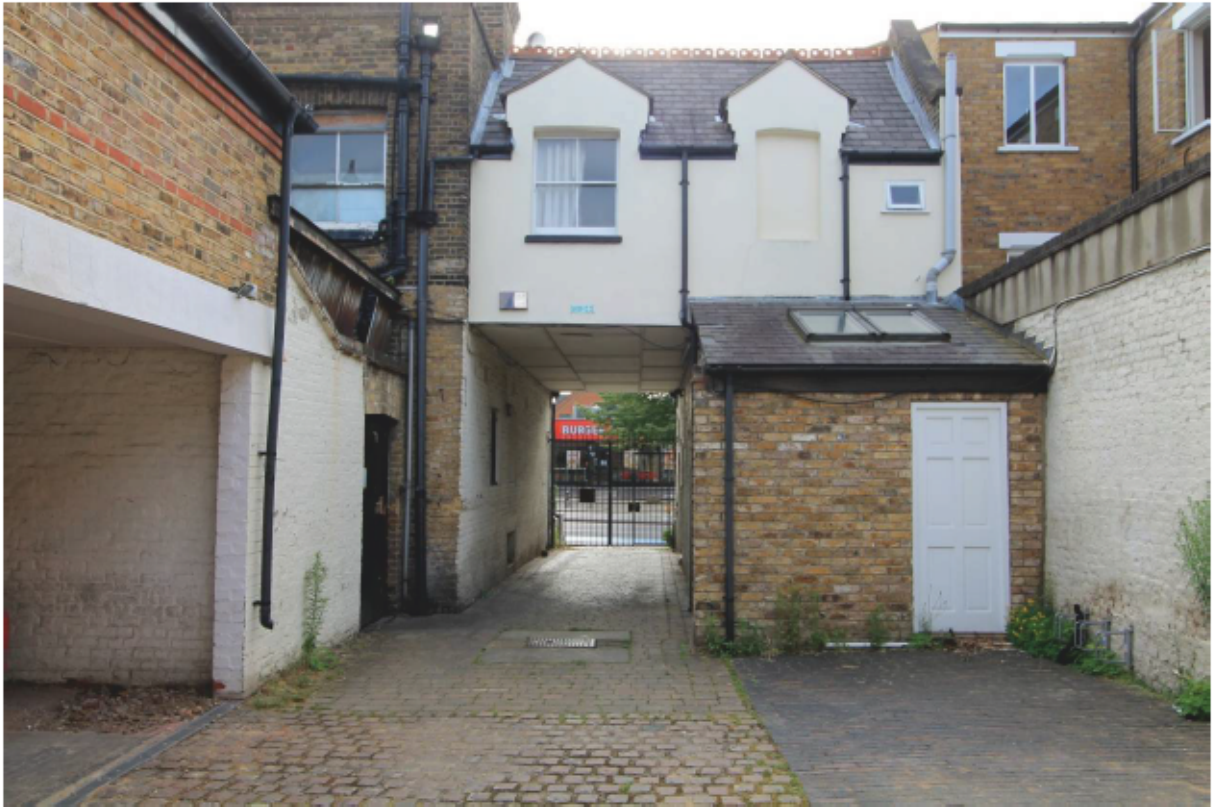
Plate 3 Rear elevation to carriage entrance and lean-to extension, looking east to Balham Hill

6.2.1 The carriage entrance range when viewed from the thoroughfare is built using good quality yellow stock bricks, which contrast with the brindled red brick facade of the adjoining Avalon public house (**Plates 1 and 2**). This contrast is not so apparent to the rear as the carriageway brickwork is painted, the rear elevation is rendered and the rear elevations to the public house are built using cheaper yellow London stock bricks (**Plate 3**).

6.2.7 The rear elevation to the flat over the carriageway is plainly rendered and incorporates a pair of eaves-line, dormers with gable parapets (**Plate 3**). The southern of the two window openings has been blocked while the northern retained an original two over two horned sash window. A small modern toilet window has been inserted to the south.

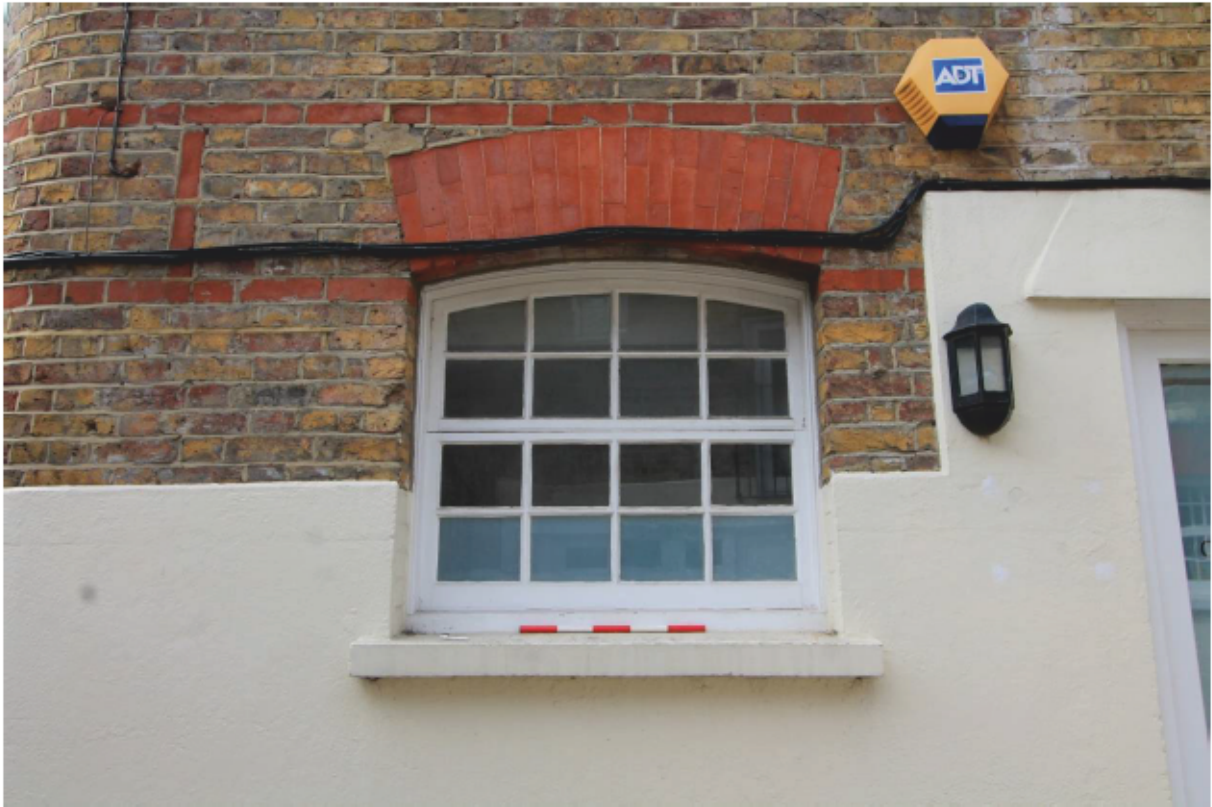
Plate 9 Original casement window with brick segmental arched head looking south

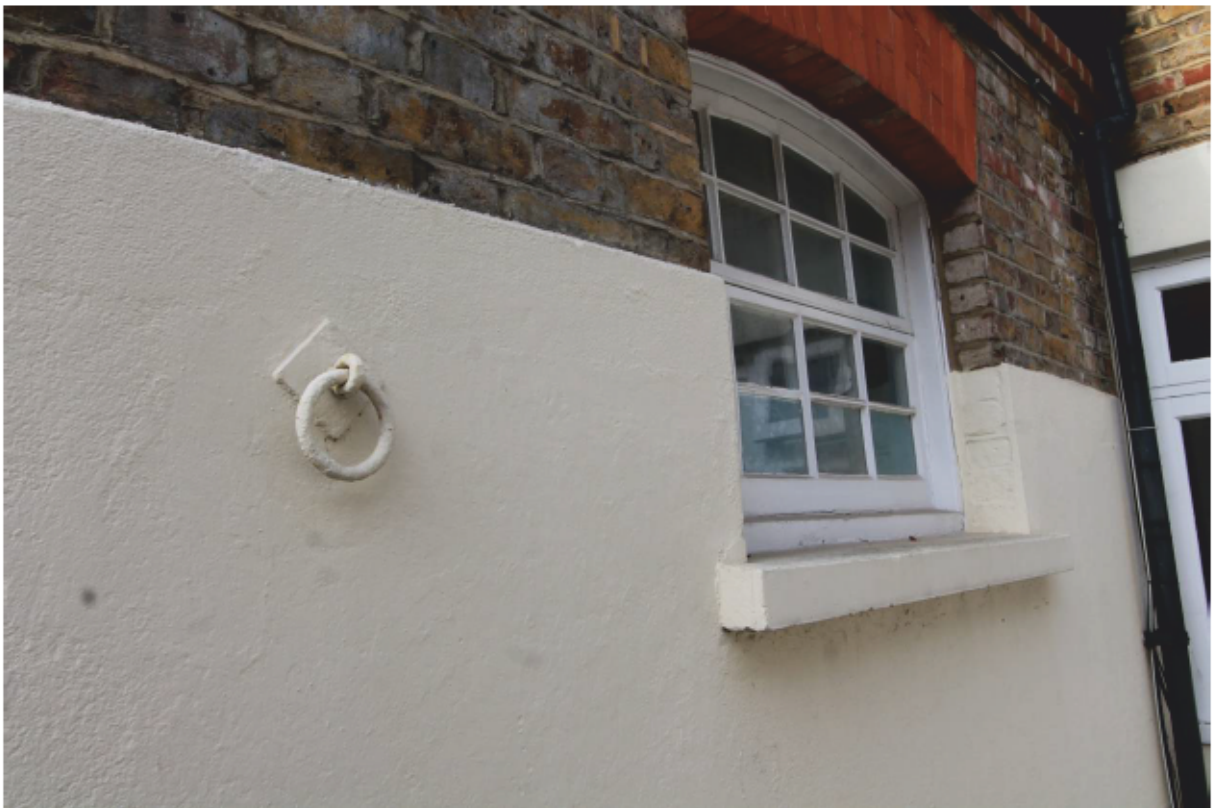
Plate 10 Extant tethering ring, Unit 1 looking south-west

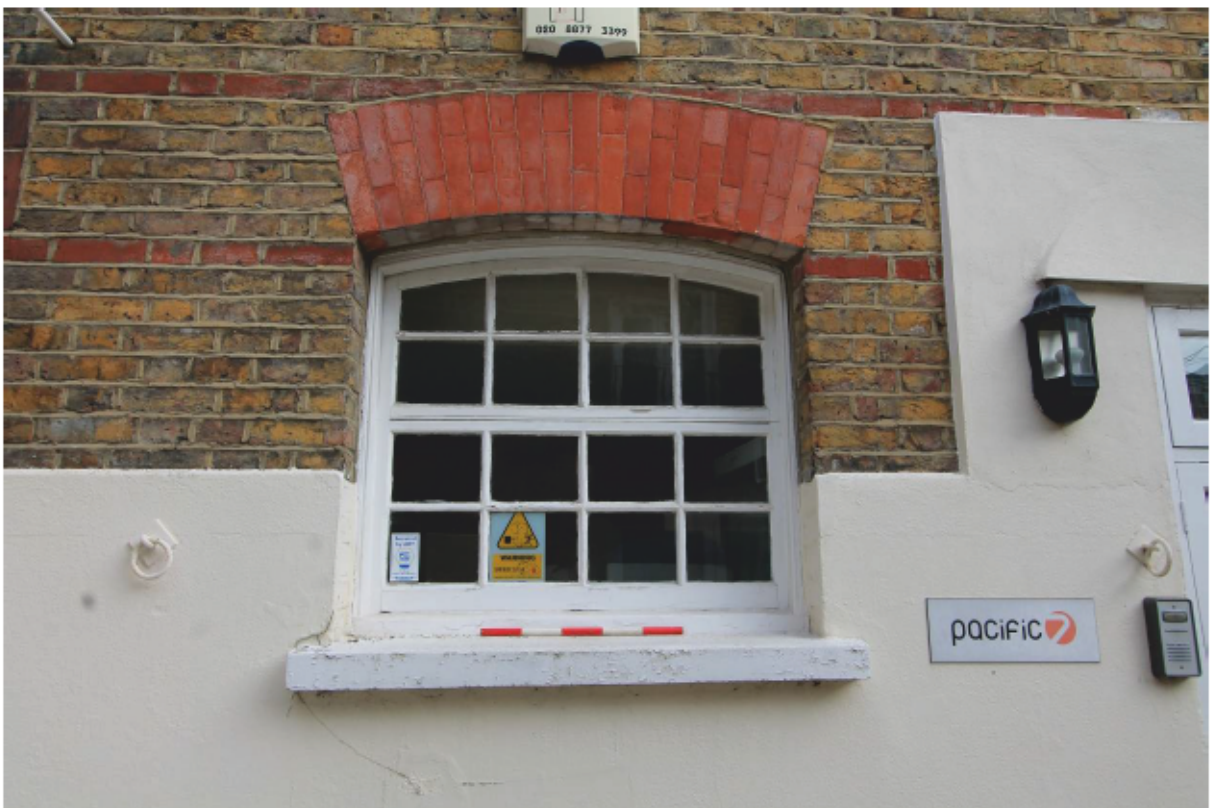
Plate 14 Unit 3, original casement window and tethering ring looking north

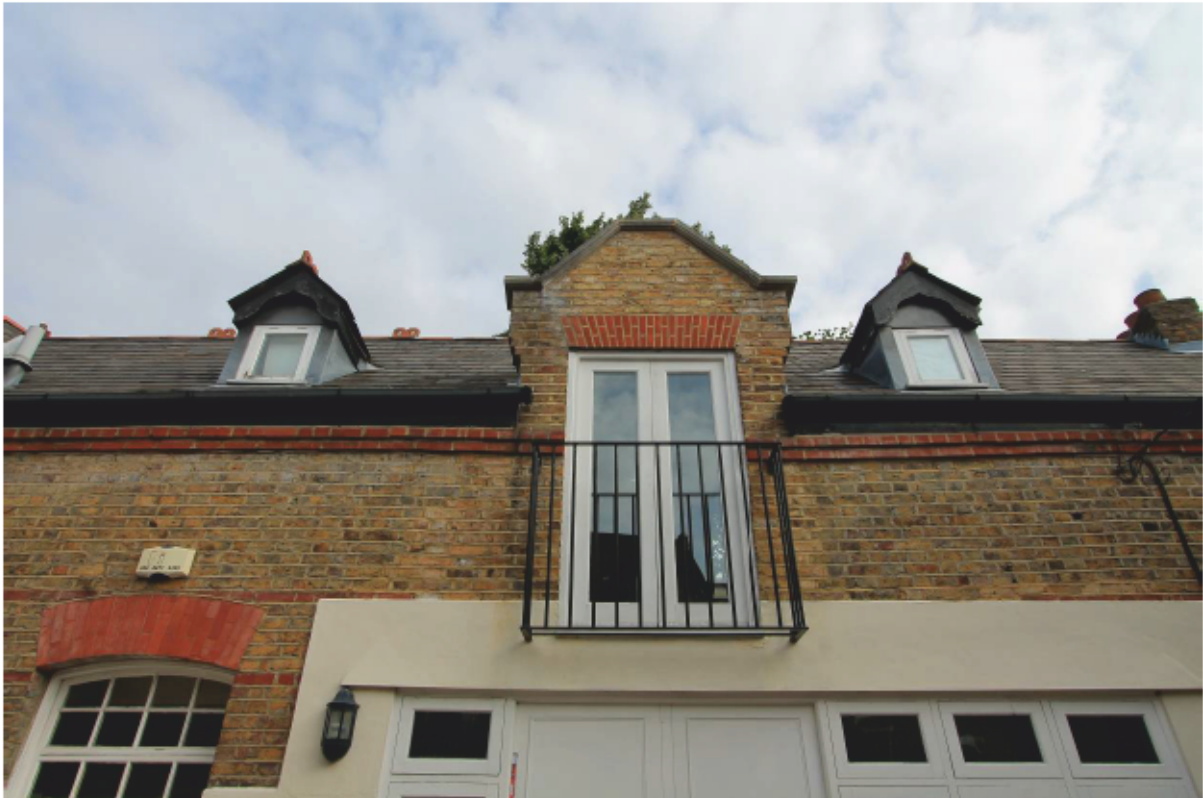
Plate 15 Converted 'taking in' door in the north elevation of Unit 3 looking south

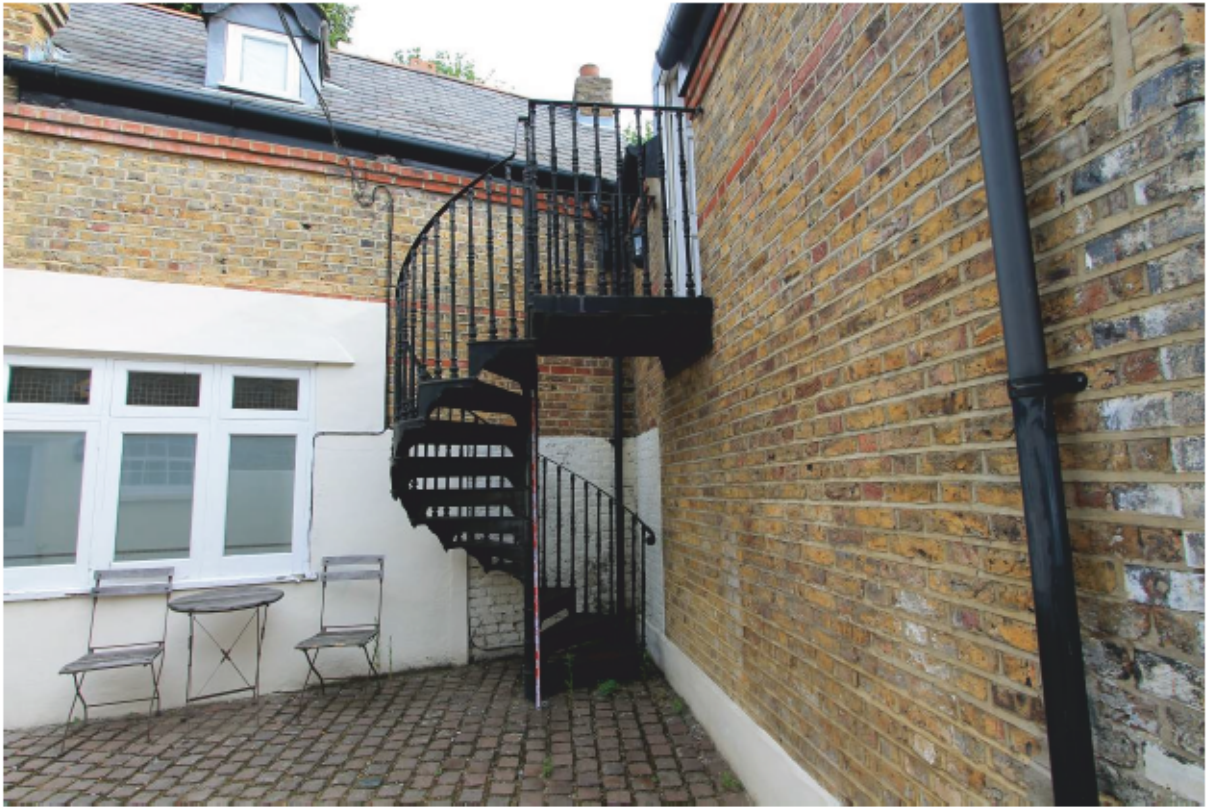
Plate 17 Modern spiral staircase, Unit 4 looking north

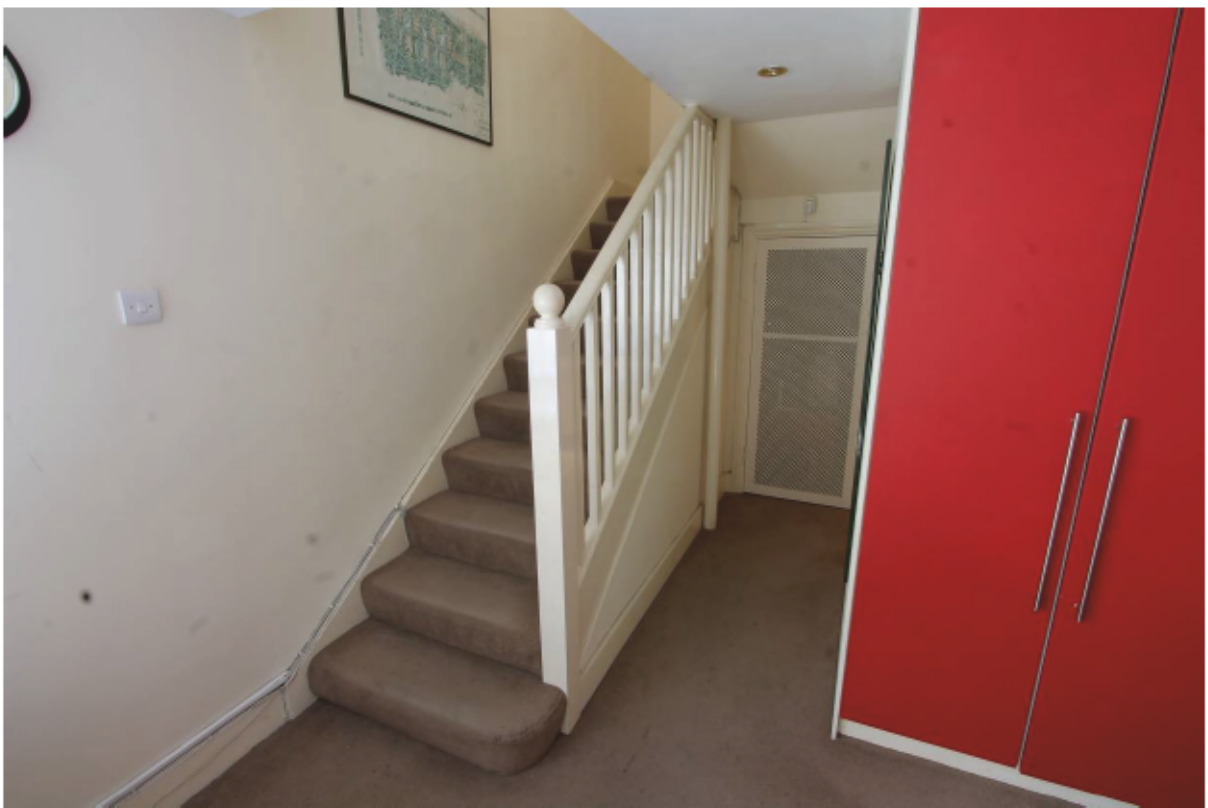
Plate 22 Inserted staircase in Ground Floor Office 2.1 of Unit 2, looking south-east

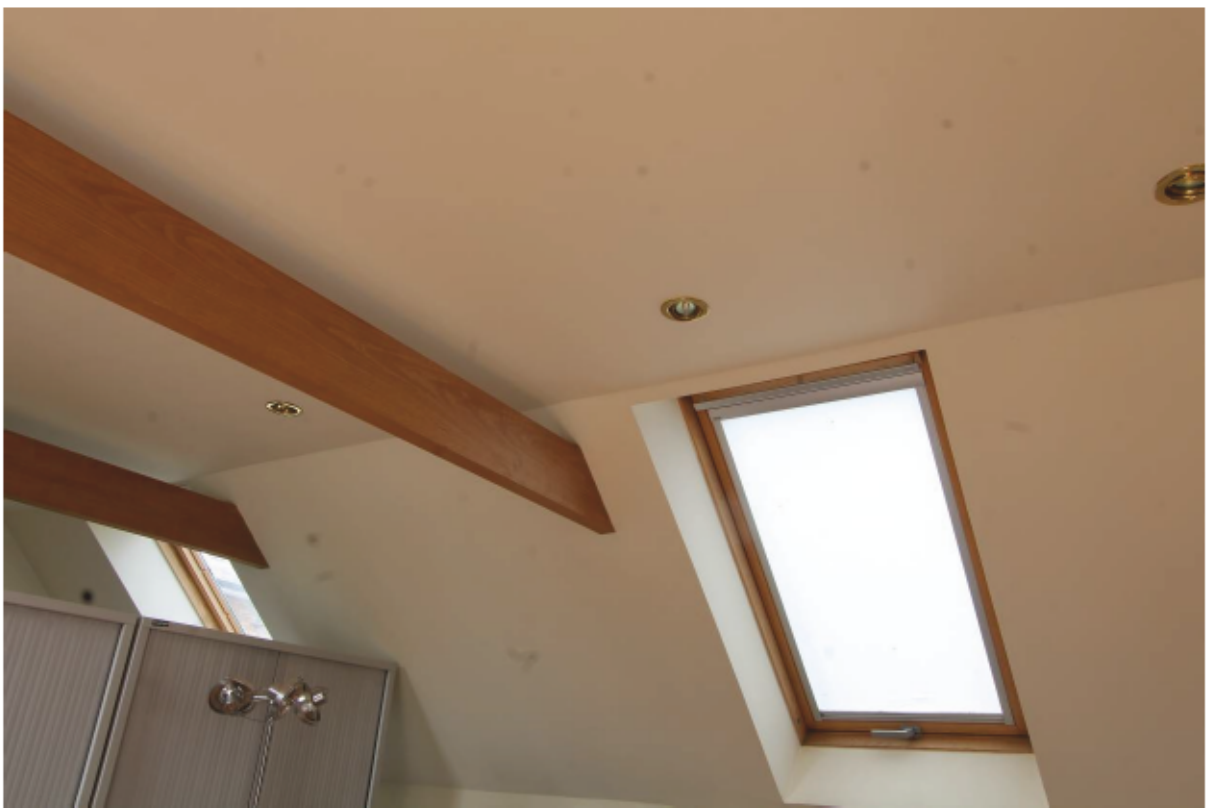
Plate 24 Inserted Velux windows and oak collars in first floor room 2.4 in Unit 2 looking south-west

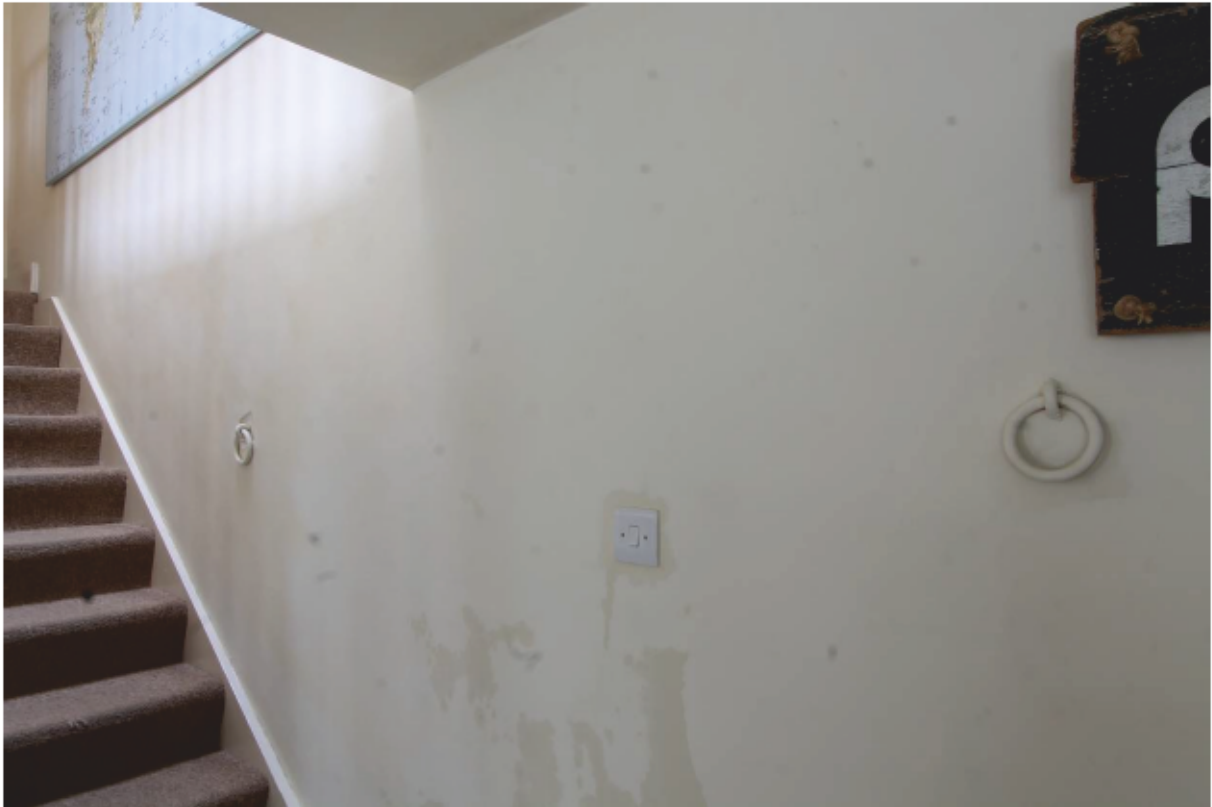
Plate 27 Extant Tethering Rings on North Wall of Ground Floor Room 3.1 in Unit 3 looking north-west

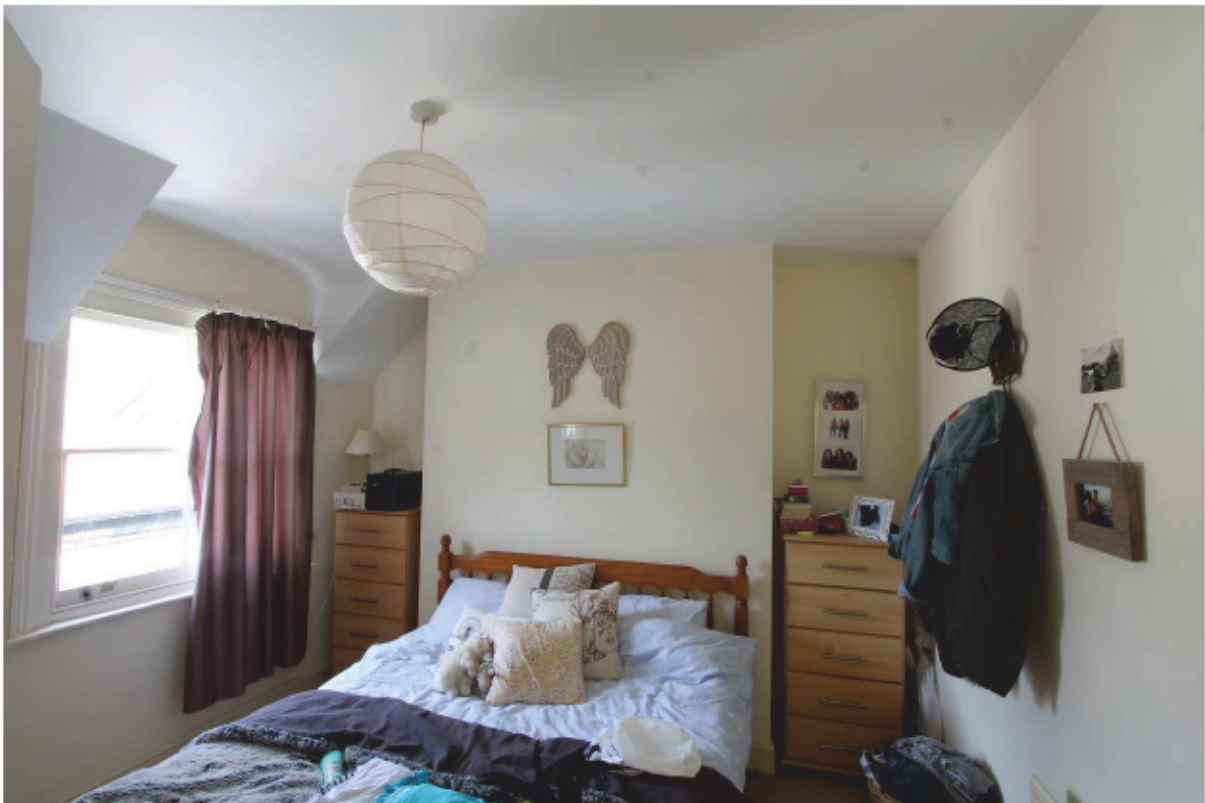
Plate 33 Rear Bedroom 5.7 in Flat (5) looking north

- 6.2.13 The larger bedroom to the rear (5.7) similarly retained its original, but repaired, two over two sash horned window, but no other contemporary fixtures and fittings. A blocked fireplace lay central to the north wall (**Plate 33**). Its position, and those of the fireplaces in the kitchen and sitting room suggest that the present layout to these three rooms were as built (**Figure 16**).
