**ST MARY'S VICARAGE, 18 NEASDEN  
LANE, WILLESSEN, LONDON  
BOROUGH OF BRENT, NW10 2TS**

**ARCHAEOLOGICAL EVALUATION**

**PCA REPORT NO: R12608**

**SEPTEMBER 2016**

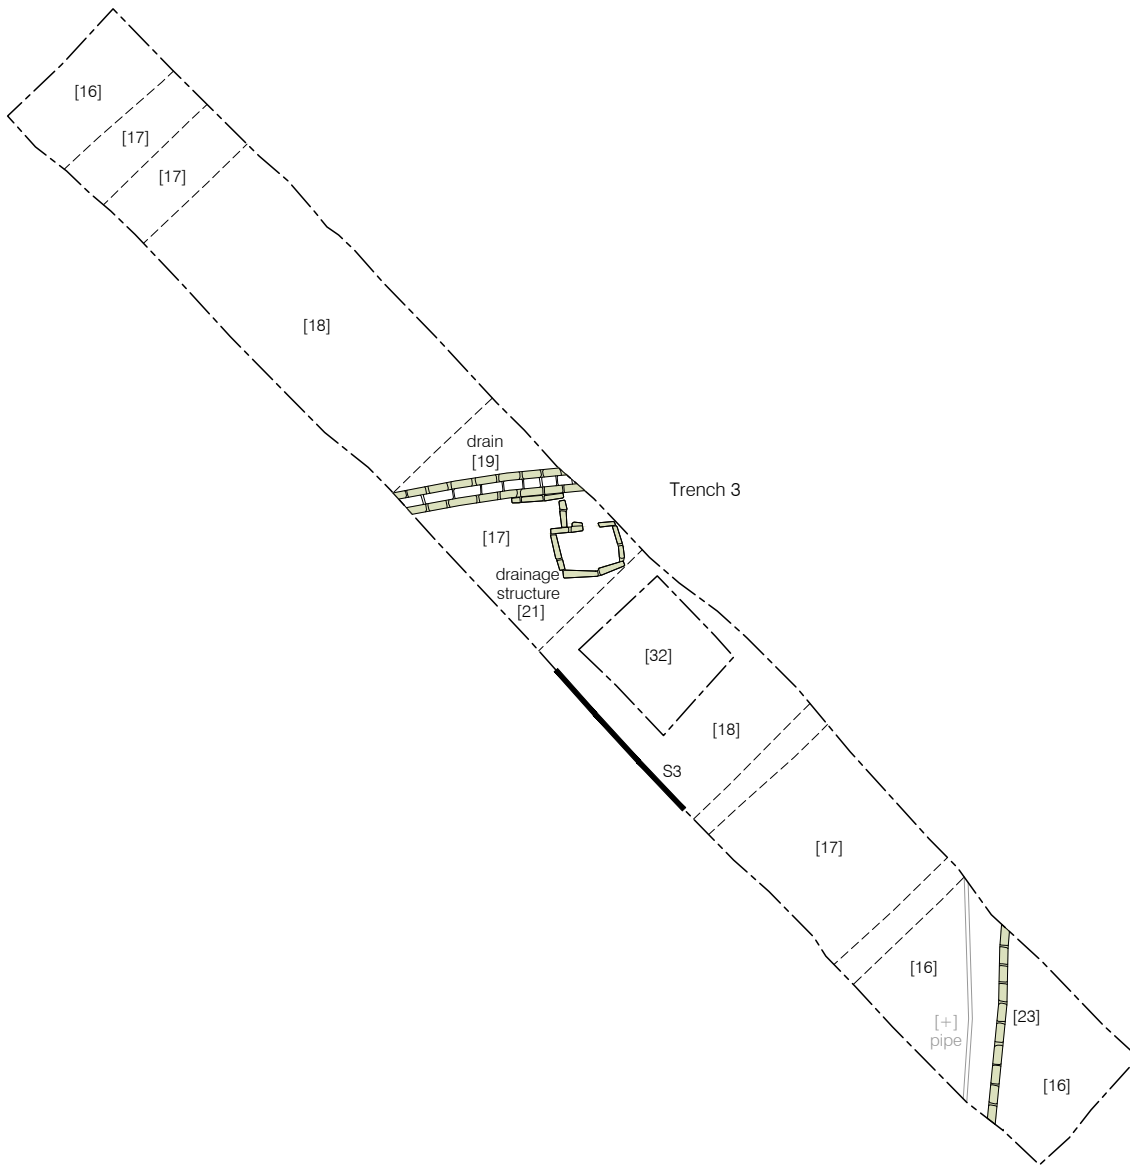
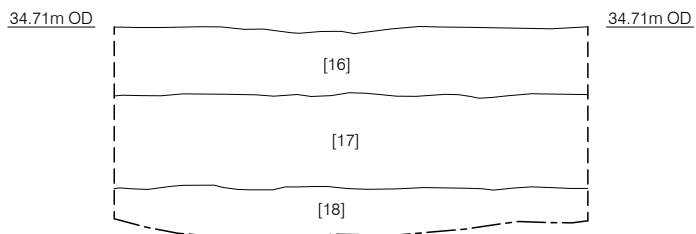
Figure 5  
Plan of Trench 3 & Section 3  
1:100 & 1:40 at A4

Section 3  
North East facing  
Trench 3

### **7.3 Trench 3 (Figure 5 & Images 3 and 5)**

- 7.3.1 Phase 1: Natural
- 7.3.2 The earliest deposit found in Trench 3 was naturally deposited very firm mid-light greyish brown clay [32]. It was found within a sondage in the central part of the trench at a height of 33.38m AOD.

- 7.3.7 Drain [19], within construction cut [20], was constructed of post-medieval paver brick and fairly loose light-mid yellowish grey sandy mortar with a base built of unglazed peg tiles dating to AD 1700-1900. It ran east-west for 2.15m, was 0.32m wide and 0.22m deep and was encountered at a maximum height of 34.22m AOD.

- 7.3.8 Manhole/drainage structure [21] was on the same orientation and immediately to the south of drain [19]. It lay within construction cut [22] and measured 0.70m long by 0.70m wide and was seen at a maximum height of 33.98m AOD. The manhole/drainage structure [21] was constructed of type 3032 bricks and fairly loose yellowish grey sandy mortar and dated to AD 1750-1900.

- 7.3.11 An east-west orientated line of type 3032 brick was found at a height of 34.37m AOD in the southern part of the trench [23]. It was considered that this single course of unmortared bricks probably represented the buried edge of a defunct planter bed.

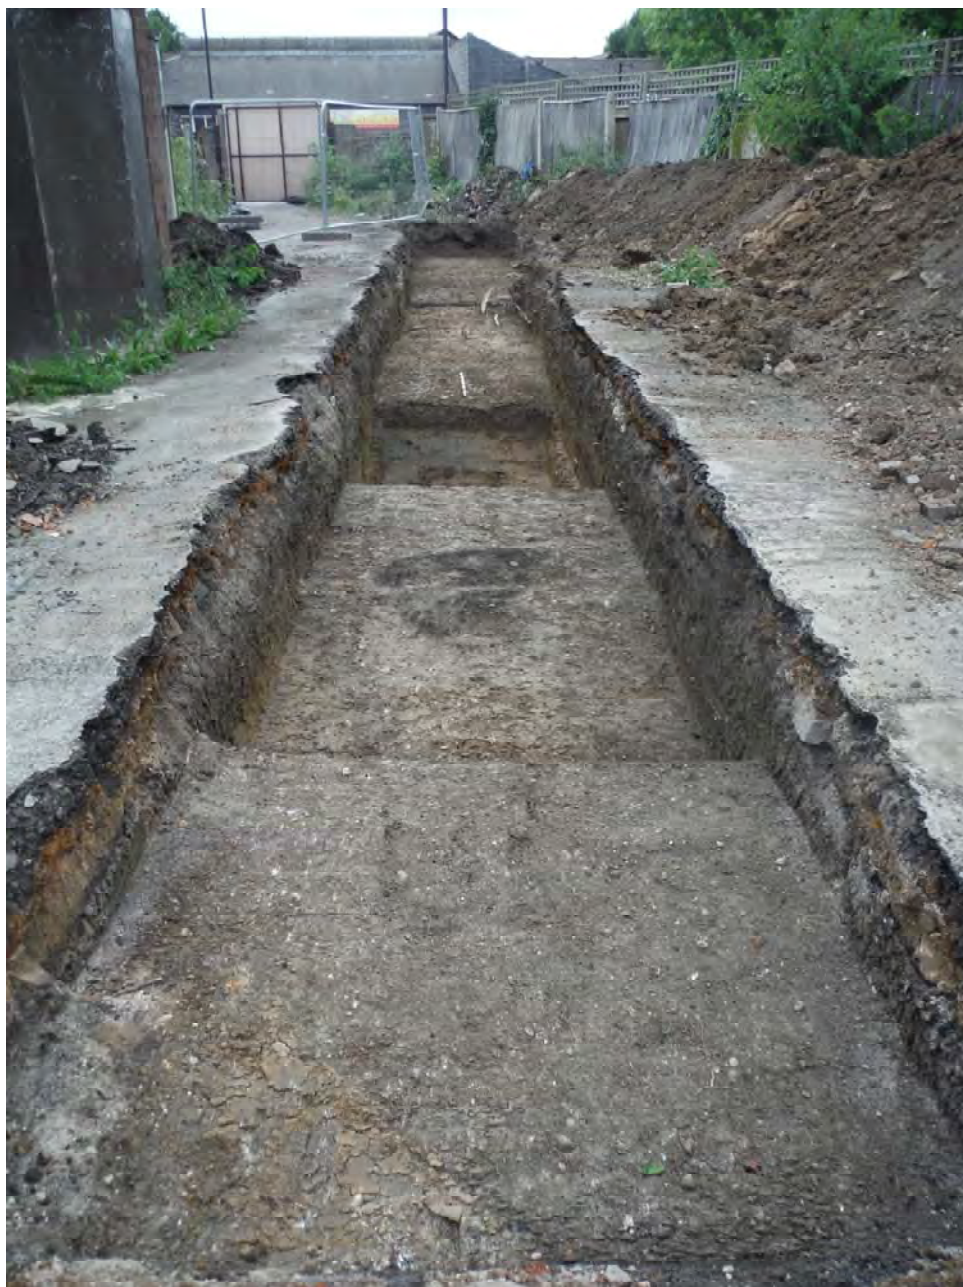
**Image 1: West facing view of Trench 1 (1m scale)**

### 7.1 Trench 1 (Figure 3 & Images 1 and 4)

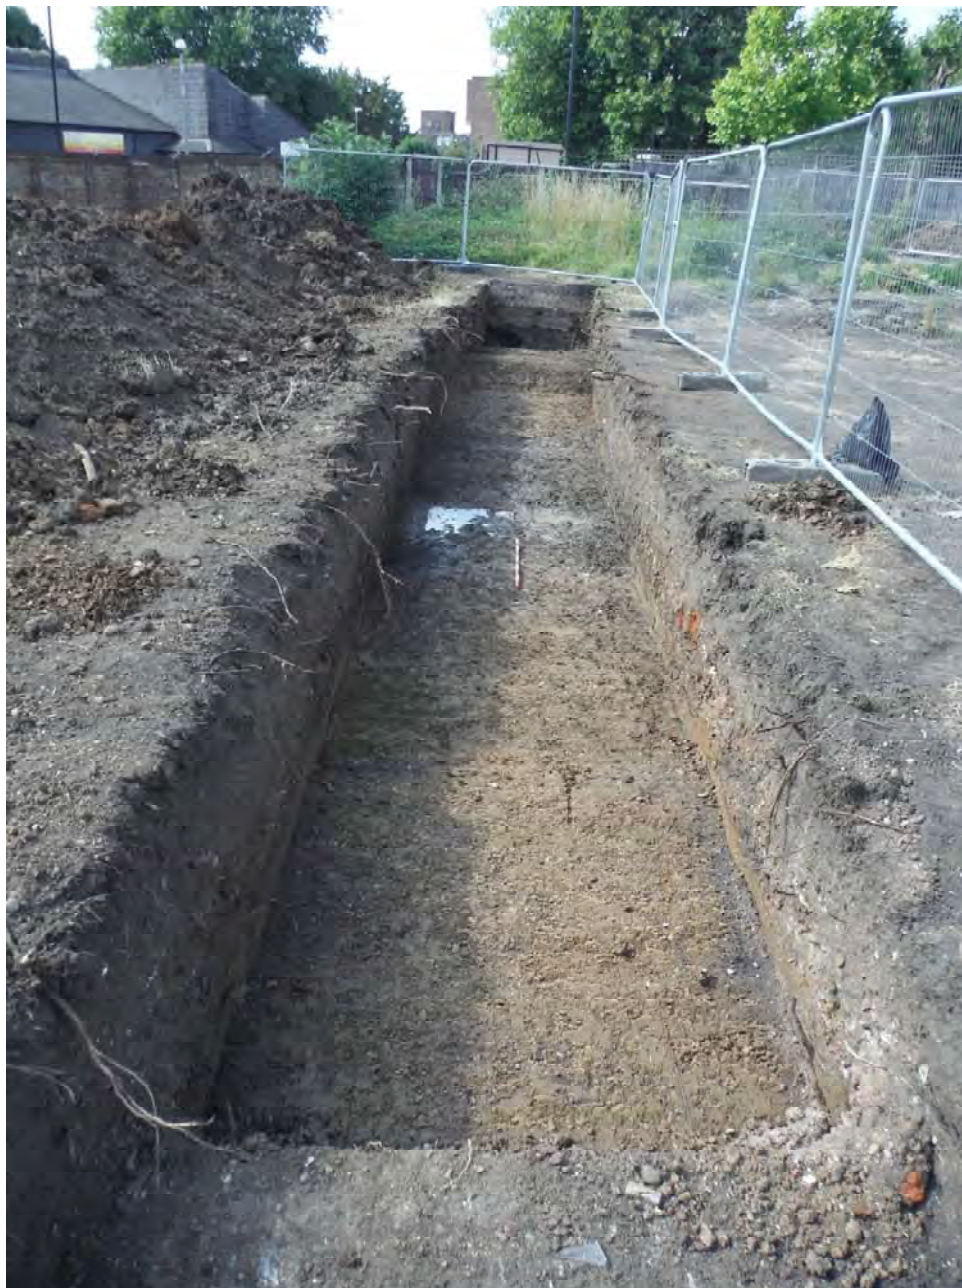
**Image 2: North-west facing view of Trench 2 (1m scale)**

## 7.2 Trench 2 (Figure 4 & Image 2)

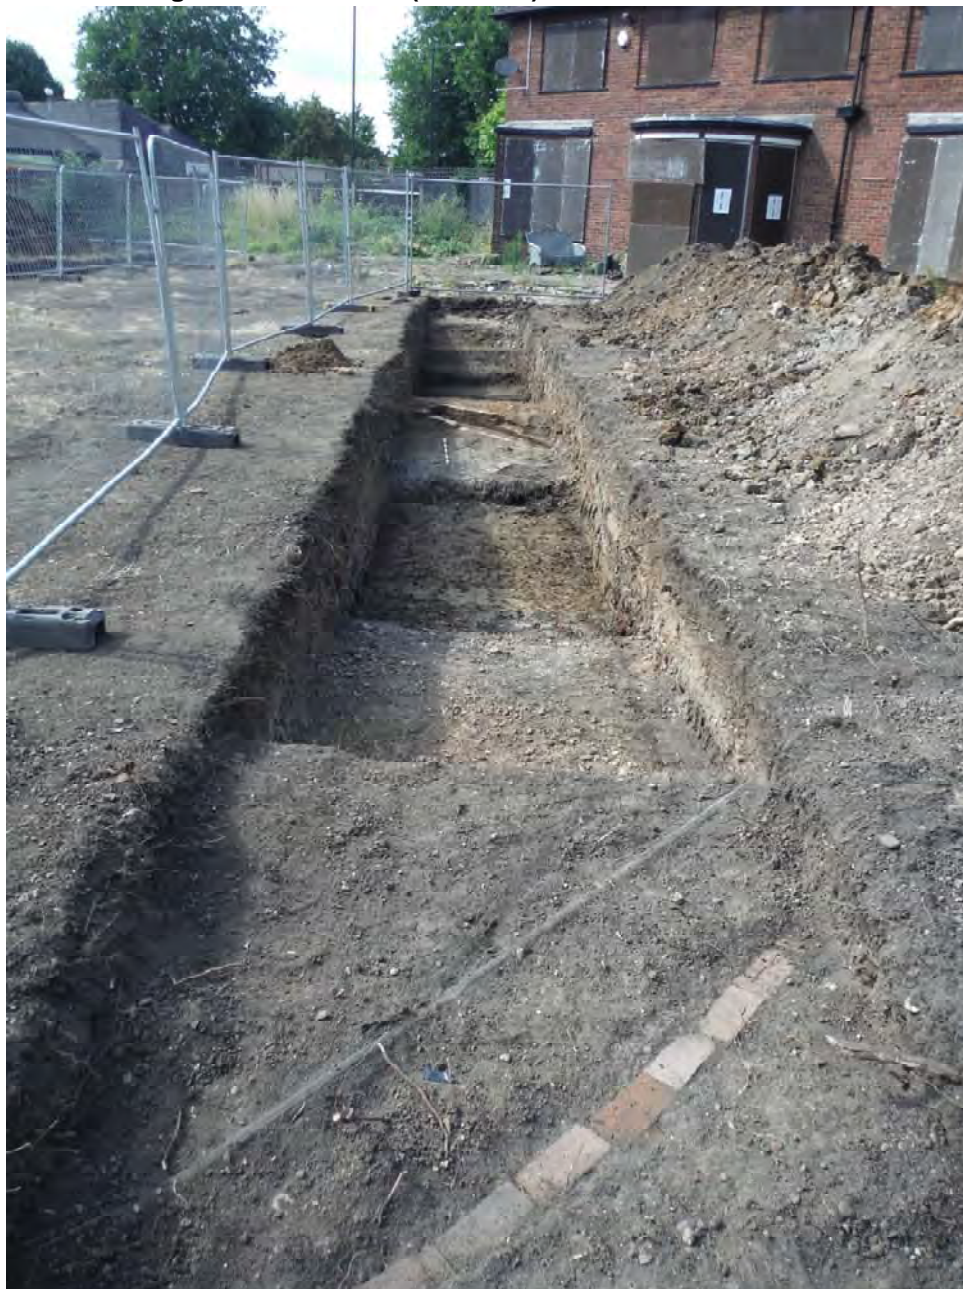
**Image 3: North-west facing view of Trench 3 (1m scale)**

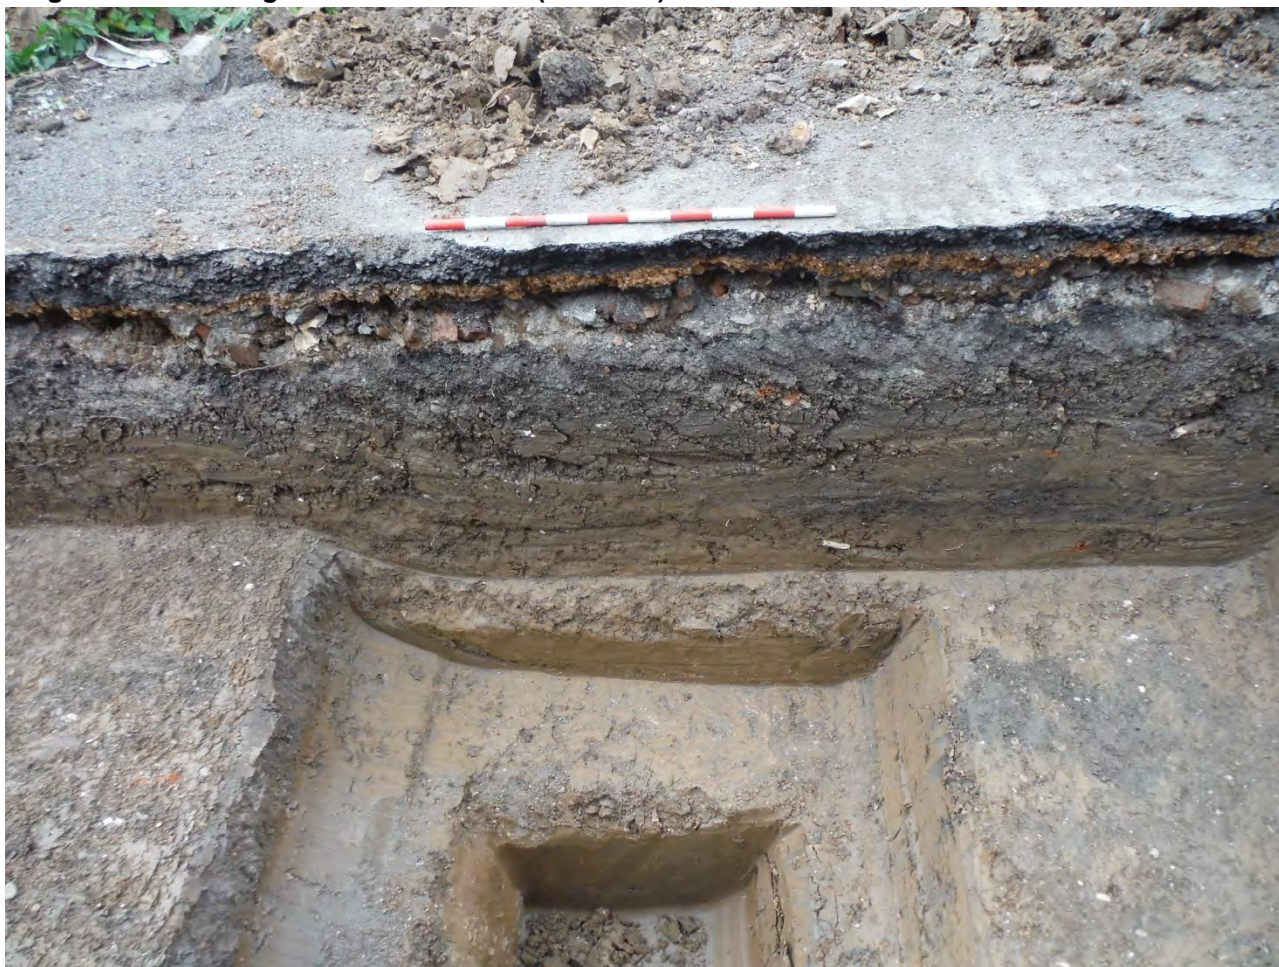
**Image 4: South facing section in Trench 1 (1m scale)**

7.1.11 Sealing garden soil [2] was a 0.25m thick layer of made ground composed of firm but friable dark-mid mottled blackish brown grey gritty sandy silt with frequent rubble inclusions, moderate root activity and coal flecks and occasional-moderate small sub-rounded and rounded pebbles [1]. It was found at maximum height of 34.94m AOD

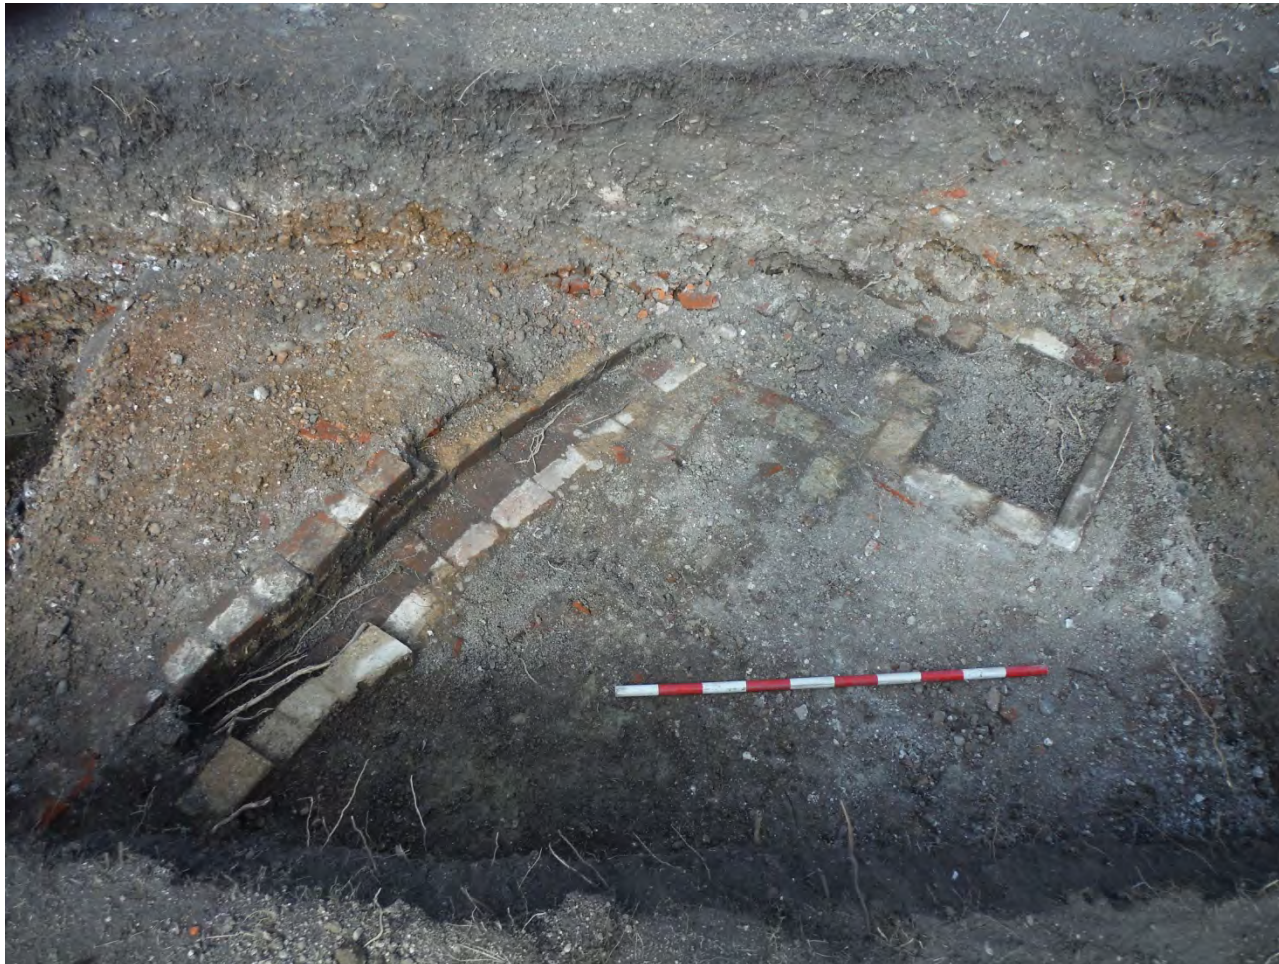
**Image 5: North-East facing view of masonry drain structures [19] and [21] within Trench 3 (1m scale)**
