**NORTH PORTSEA ISLAND
COASTAL FLOOD AND
EROSION RISK
MANAGEMENT SCHEME**

**AN ARCHAEOLOGICAL
WATCHING BRIEF ON
GROUND INVESTIGATION
WORKS**

REPORT NO: R12611

SEPTEMBER 2016

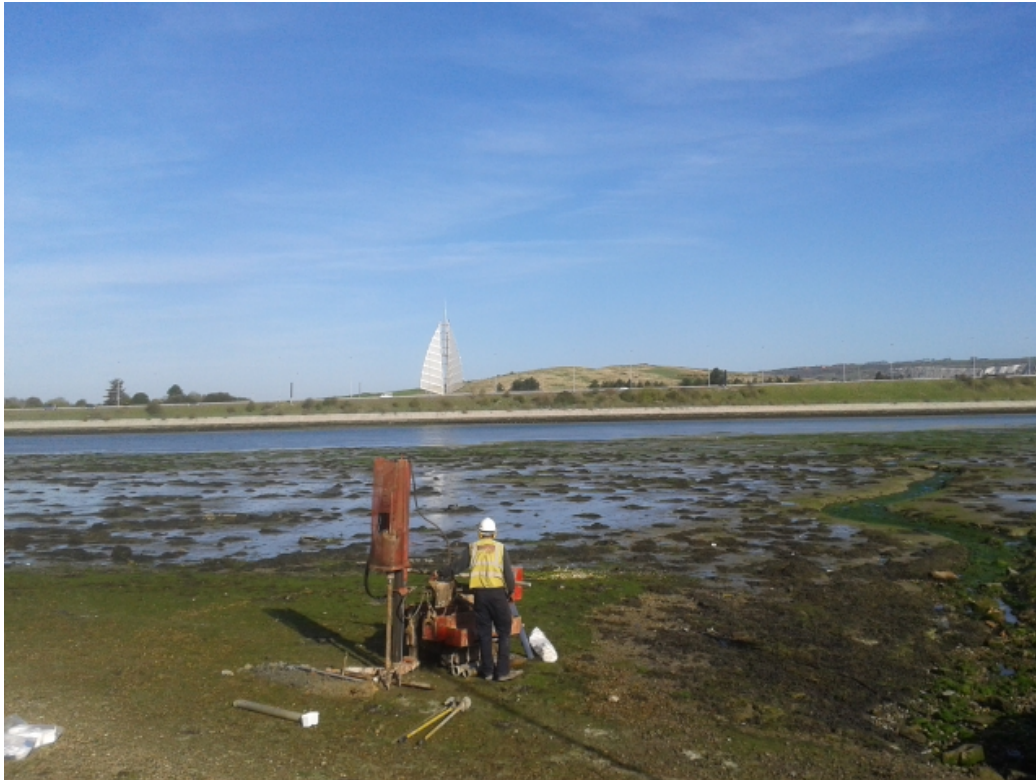
Plate 1, NPIWS03 – Frontage 1, Looking west.

- 4.3.2 Two general sequences were observed on Frontage 1, on the foreshore through window samples and trial pits, and behind the foreshore through the boreholes. The foreshore deposits comprised a gravely beach layer up to depths of 0.05m - 0.2m, beneath which was a black silty sand at depths of up to 0.3m- 0.8m and then Sandy Clay with gravel in places. NPIWS2 showed no evidence of the black silt layer before orange clay was encountered. Within NPITP06 a thin band of chalk was observed at 0.4, between the black silt layer and orange clay.

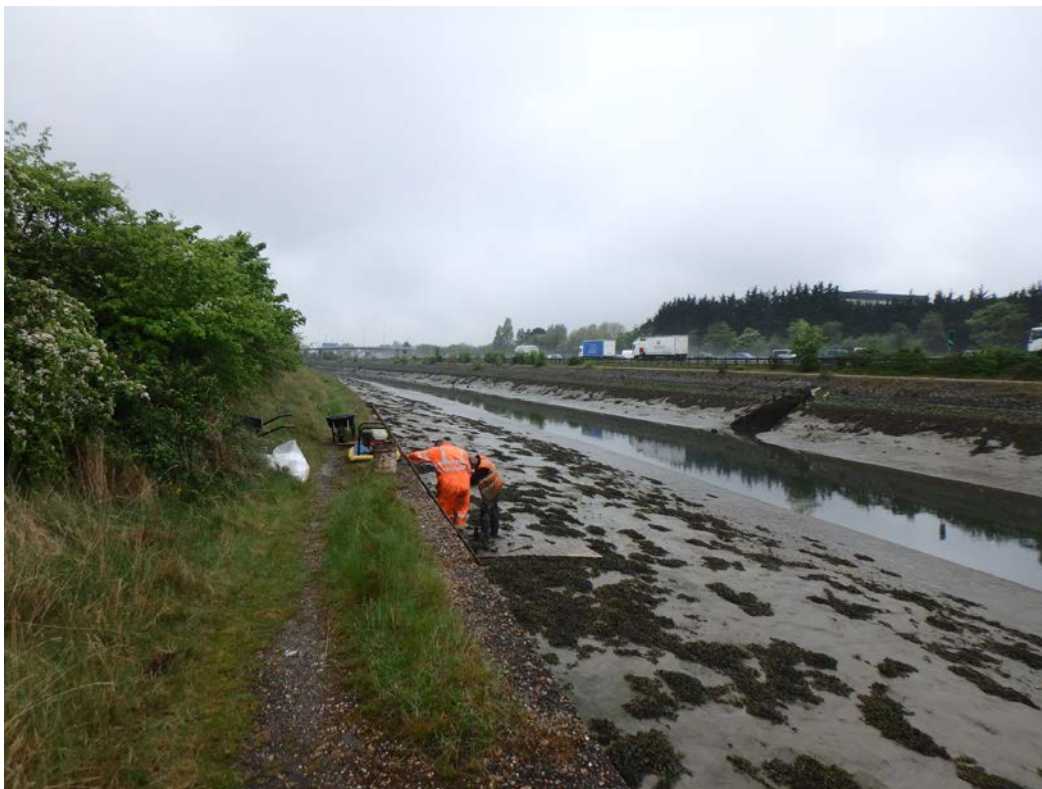
Plate 2, NPIWS12 – Frontage 2, Looking north-west

- 4.4.2 A general sequence was identified along Frontage 2, which was grey/black silt to depths ranging between 0.1m and 0.55m, pale orange sandy clay with grey and orange mottling to depths between 0.6m and 0.8m, which at greater depth contained chalky flecks. The Chalk bedrock was seen in the Window Sample cores at approximately 1-1.5m BGL.
- 4.4.3 The borehole starter pits and the one trial pit that was opened, within the Hillsea Lines, above the water table, revealed a disturbed chalky topsoil/ subsoil with patches of clay, which then became fine sandy clay. There was evidence of modern CBM within the topsoil.
- 4.4.4 Evidence of wooden posts seen in NPICS04, NPITP 13 and NPITP14, are thought to relate to the construction of the current sea wall.

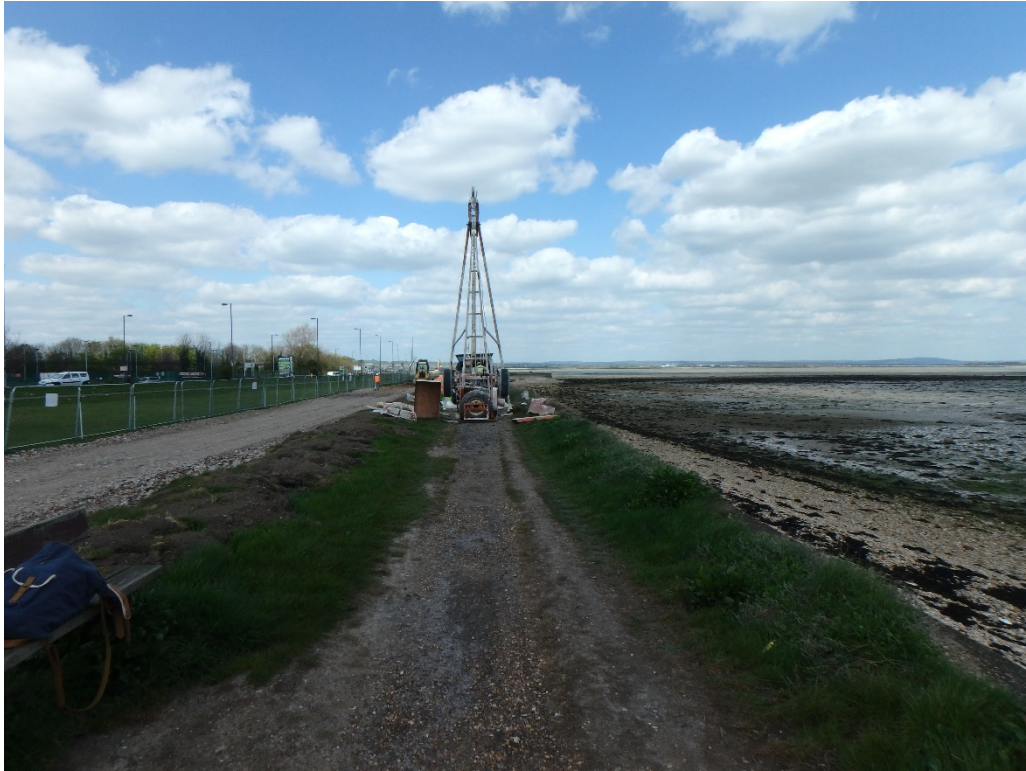
Plate 3, NPIBH20 – Frontage 3, Looking north

- 4.5.4 The Boreholes monitored on Frontages 3 presented a common make-up of layers within the starter pits with the exception of NPIBH21 and NPIBH17. Beneath the footpath was a sub-soil or made ground which was highly disturbed and contained CBM, pottery, glass “clinker” and clayey patches variously between 0.3m - 1.1m thick depending on location. Below this, in boreholes NPIBH15, NPIBH 16, NPIBH18 and NPIBH 20, was a silty clay which is common to the area of the site. BH 21 revealed a chalky sub-soil to a depth of 0.25, which overly chalk, seemingly part of the embankment next to the sea wall and Eastern Road. NPIBH19 contained a very sand clay from a depth of 0.2 to the bottom of the pit. The full depth of the starter pit was not reached on NPIBH17 as a tarmac layer was uncovered at 0.5m.

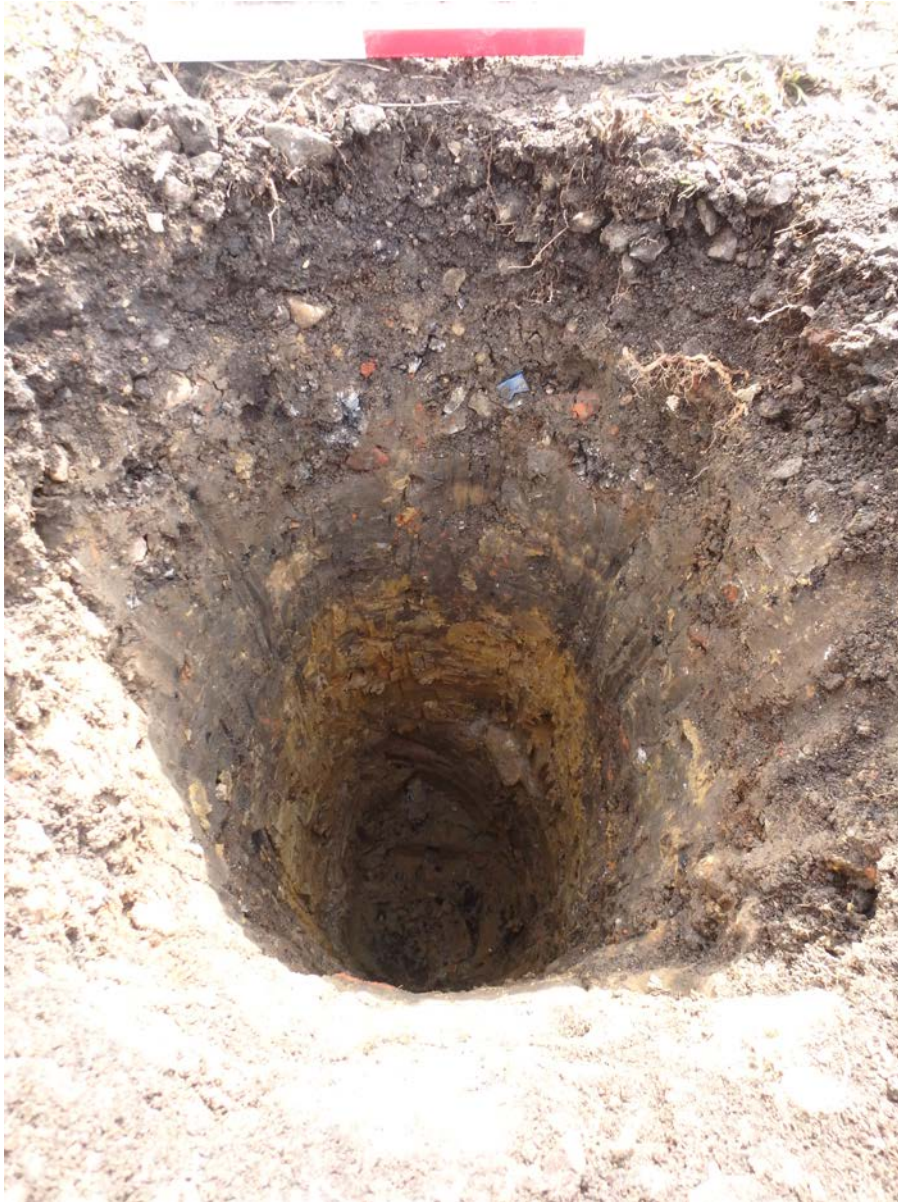
Plate 5 - NPIBH16 – Starter Pit, mixed made ground with clay below
