**Radlett SRFI, St Albans,  
Hertfordshire: An  
Archaeological Evaluation**

## AN ARCHAEOLOGICAL TRIAL TRENCH EVALUATION

Pre-Construct Archaeology Ltd	
Project Number	K4598
Report Number	R12623

**Central National Grid Reference:** TL 1558 0388

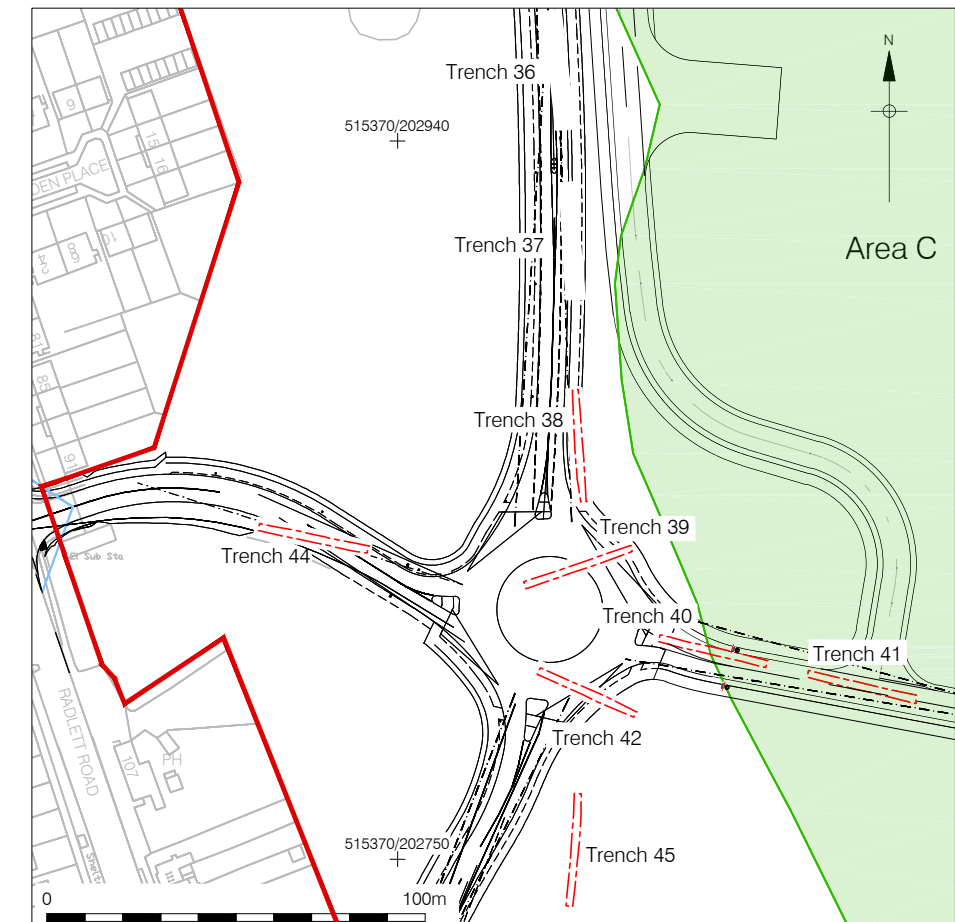
Figure 2  
 Trench Location and  
 Areas of Quarrying  
 1:20,000 and 2,000 at A3

- 1.1.4 The evaluation comprised 3 areas of trenching designated Areas A, B and C (Figure 2). A total of 46 Archaeological Trial Trenches were proposed (Figure 2). 43 of these trenches were excavated. Three of the trenches (Trench 21, Trench 43 & Trench 46) were abandoned due to site specific constraints.

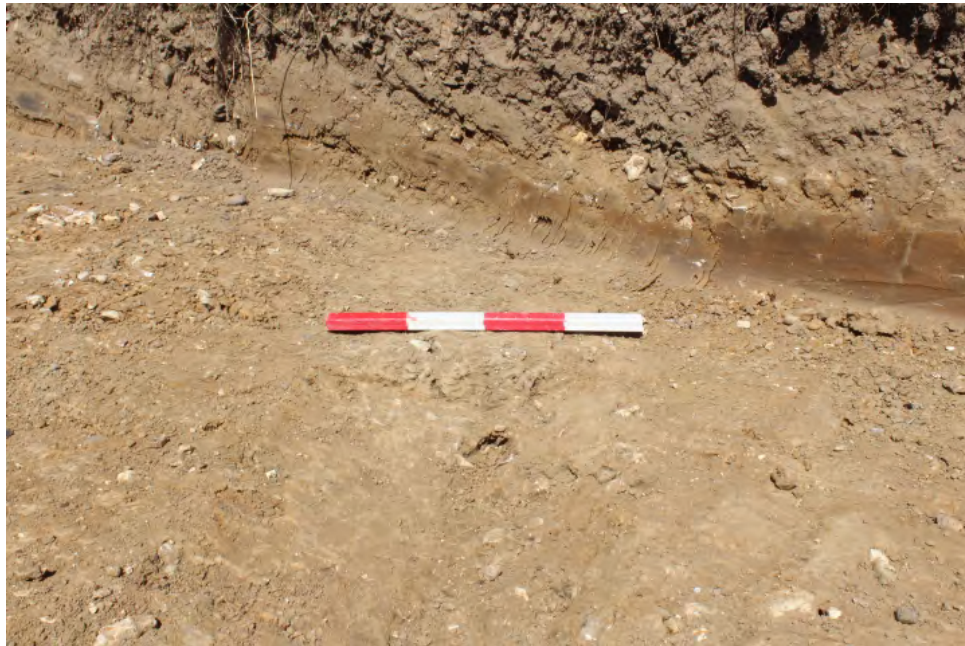
Plate 5: Trench 12 Ditch [12] view north.

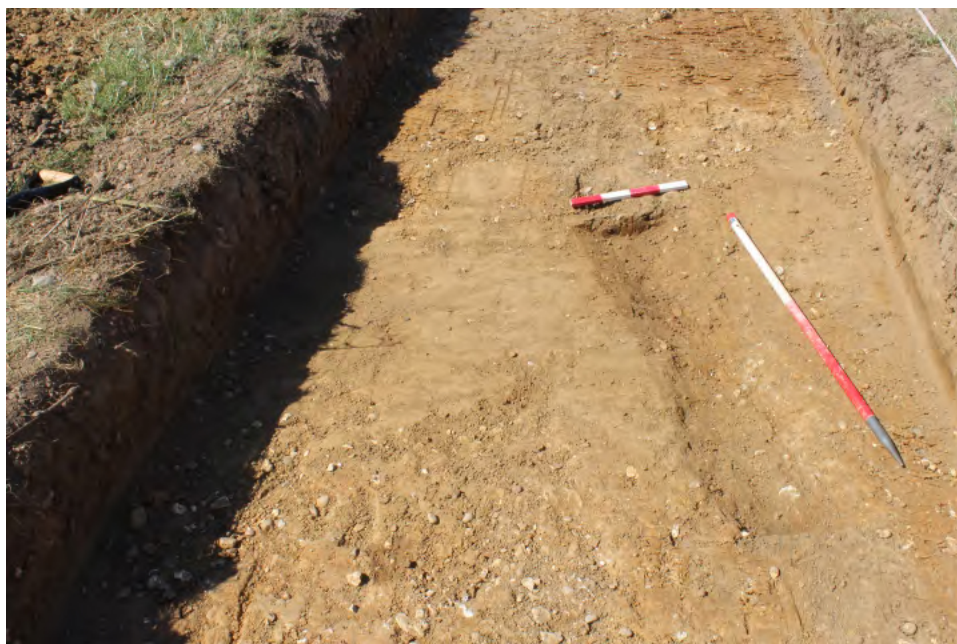
Plate 6: Trench 12 Ditch [15] view west.

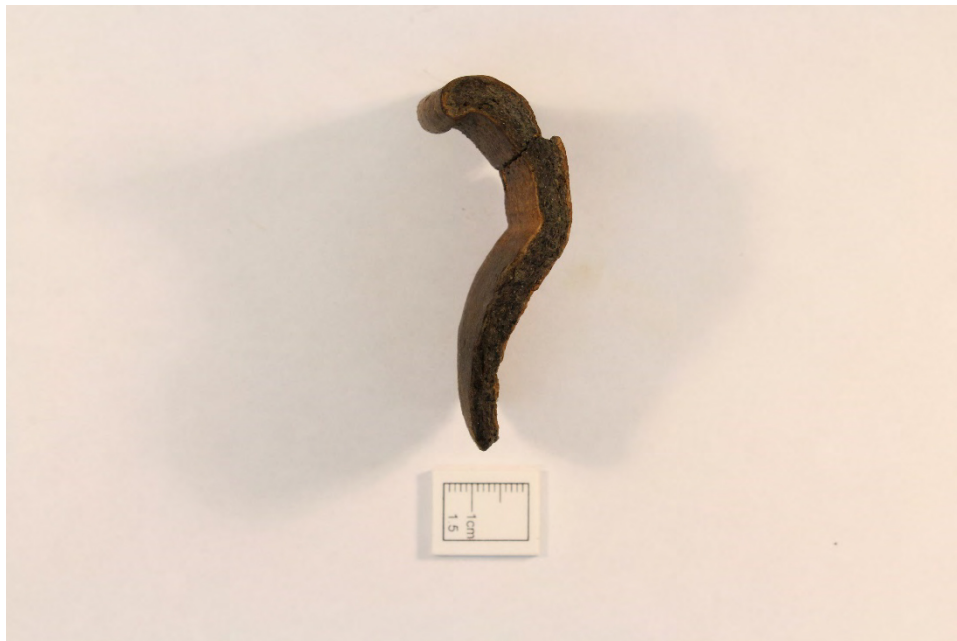
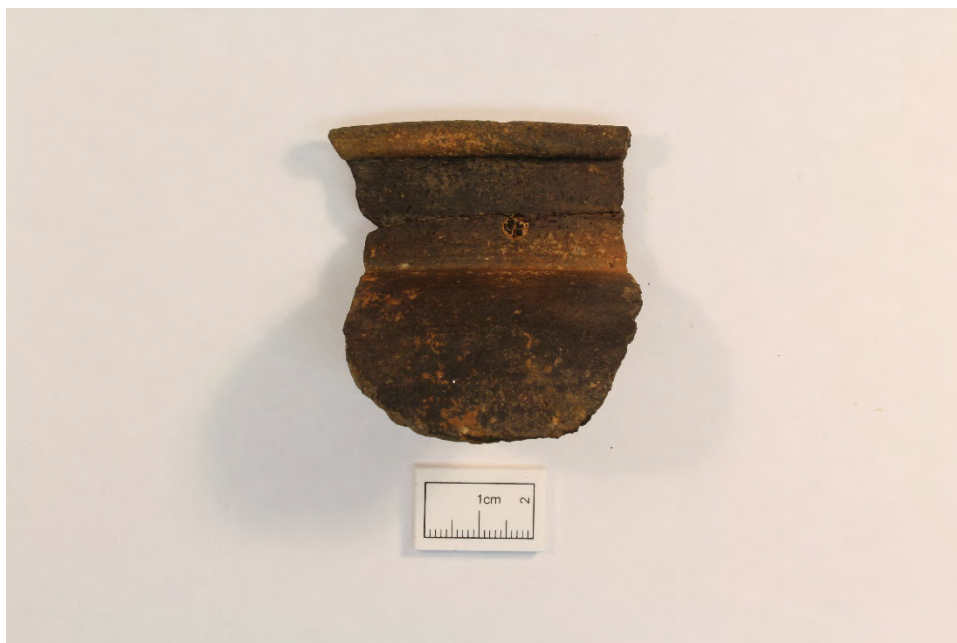
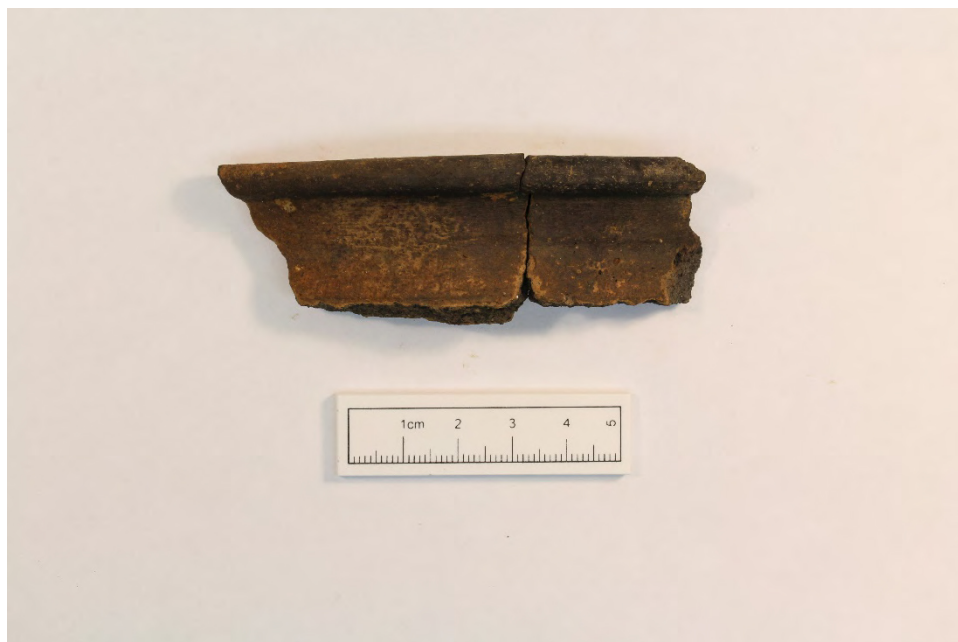
Plate 7: Late Iron Age rim sherd from Ditch [18].

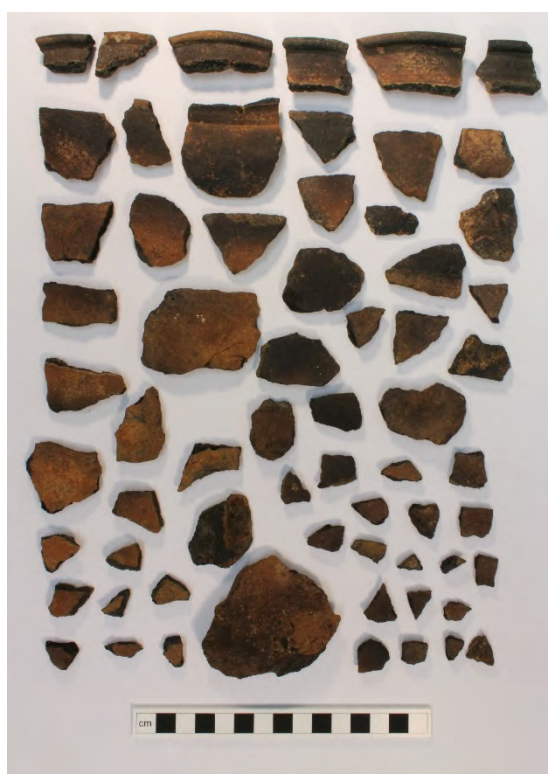
Plate 10: Late Iron Age pot from Ditch [18].

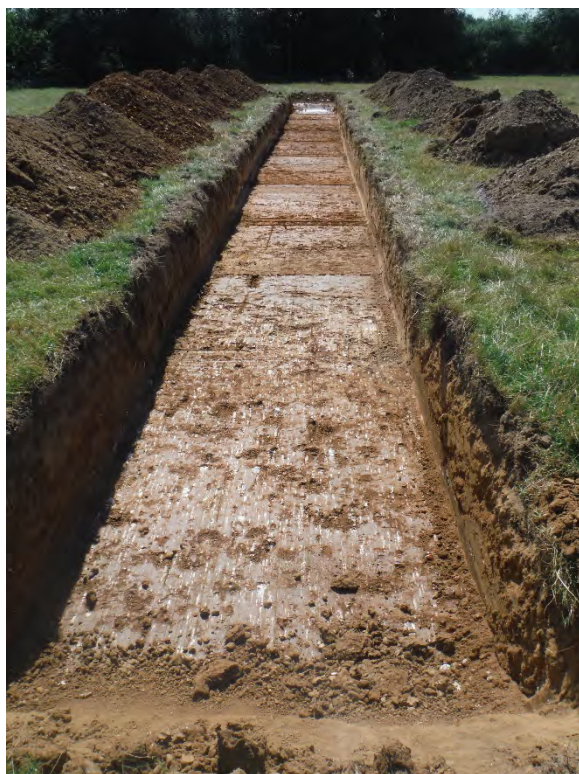
Plate 11: Trench 14. Chalky fill (28) of possible Romano-British dew pond [26] visible in foreground. View south.

- 5.16.4 [26] was a large shallow sided feature thought to be a dew pond probably for watering livestock. The profile of this feature (i.e. wide with gradually sloping sides) is consistent with this interpretation. The entirely clay natural encountered in this area would favour the location of such a feature. Despite extending the trench northwards by several metres with a machine, the northern edge of this feature was not observed. This feature as recorded was at least 8 m across and 1.60 m deep. The feature contained several fills (38, 28, 29, 27). Fill 28 was characterised by the presence of chalk pebbles and was overlain by 38 a greyish-brown gravelly silt possibly representing deliberate backfilling. The lower fills tended to contain few stone inclusions and may indicate gradual natural silting of the pond. The northern edge of this feature was not observed. The overall shape of this feature was impossible to discern within the confines of the evaluation trench. The base of this feature was 1.60 m below the modern ground surface. Occasional abraded Roman pot sherds and CBM were recovered from this feature.

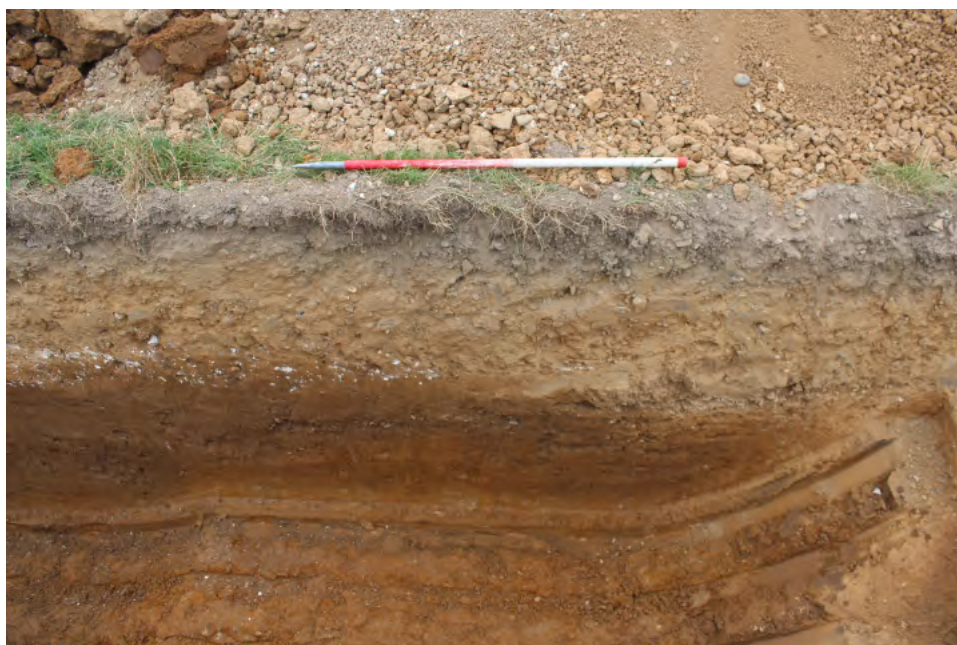
Plate 12: Pond Feature [26] top and left, overlying tree feature [24] bottom right. View east.

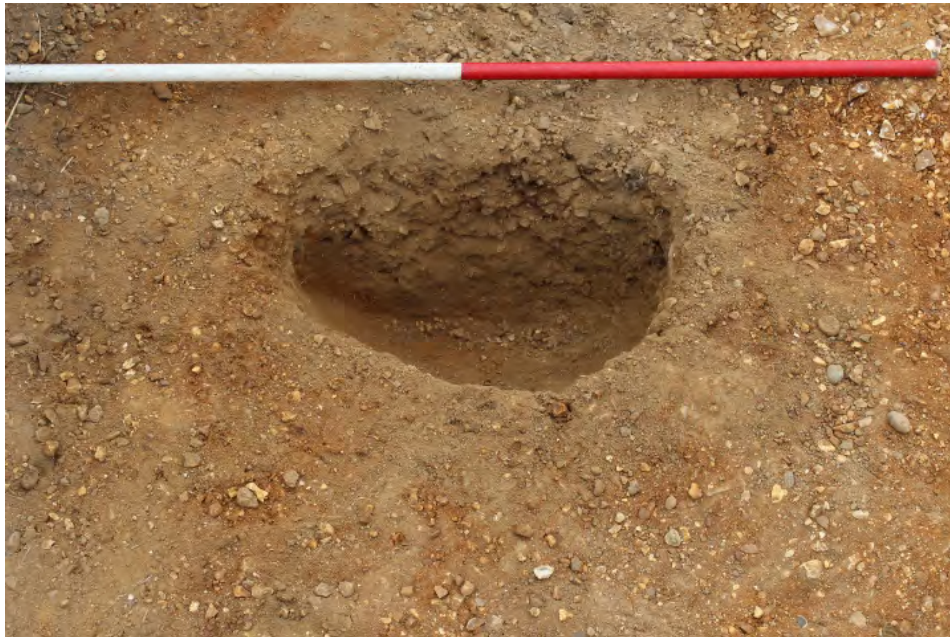
Plate 13: Trench 28 Posthole [33]. View west.

An undated posthole [33] was recorded. Variable natural (3) composed of sands, gravel and clay. Concentrations of manganese staining.

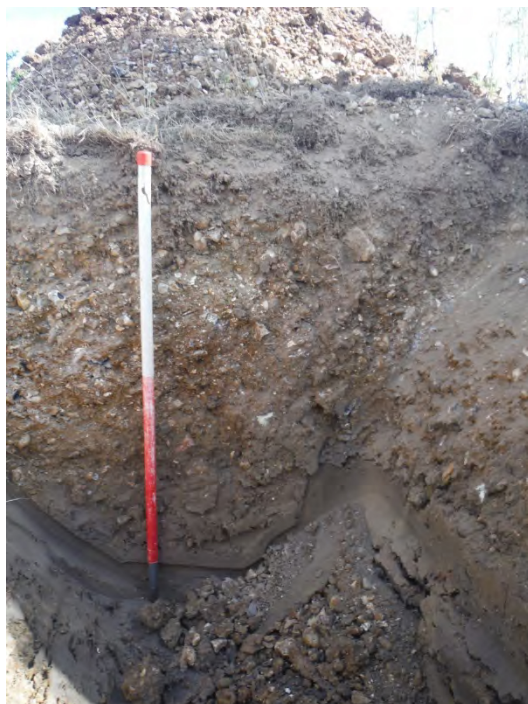
Plate 14: Trench 37 modern made ground. View east.

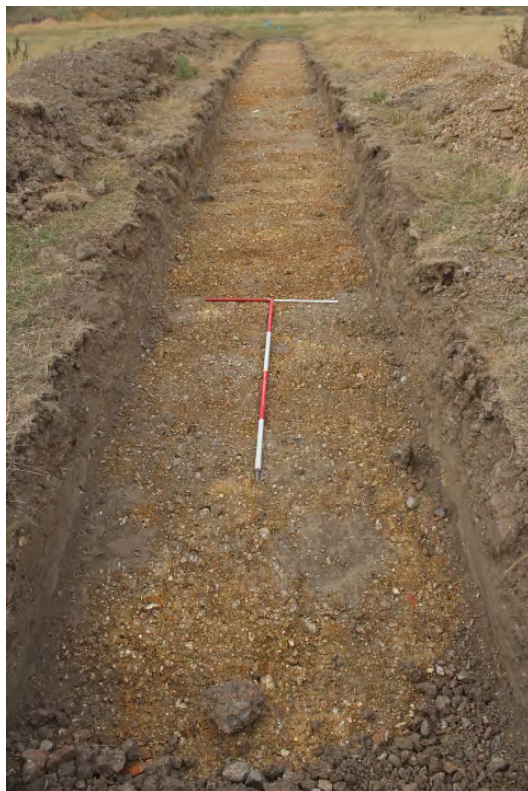
Plate 15: Trench 40 Quarry backfill in foreground. Undisturbed natural towards far end of trench. View west.

5.44.1 No archaeological features or finds were present in Trench 40. The edge of an area previously extracted for quarrying was clearly seen running north to south through the middle of this trench. Natural ground was present at a depth of 0.60 m on the western side of the trench. On the eastern half of the natural ground had been truncated. Here made ground (45), presumably quarry backfill was observed.

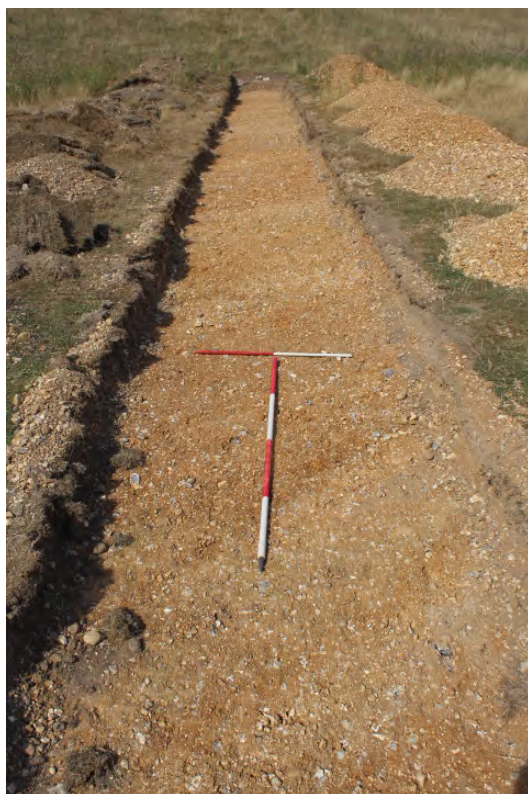
Plate 16 Trench 39. Undisturbed natural ground [44]. View north.

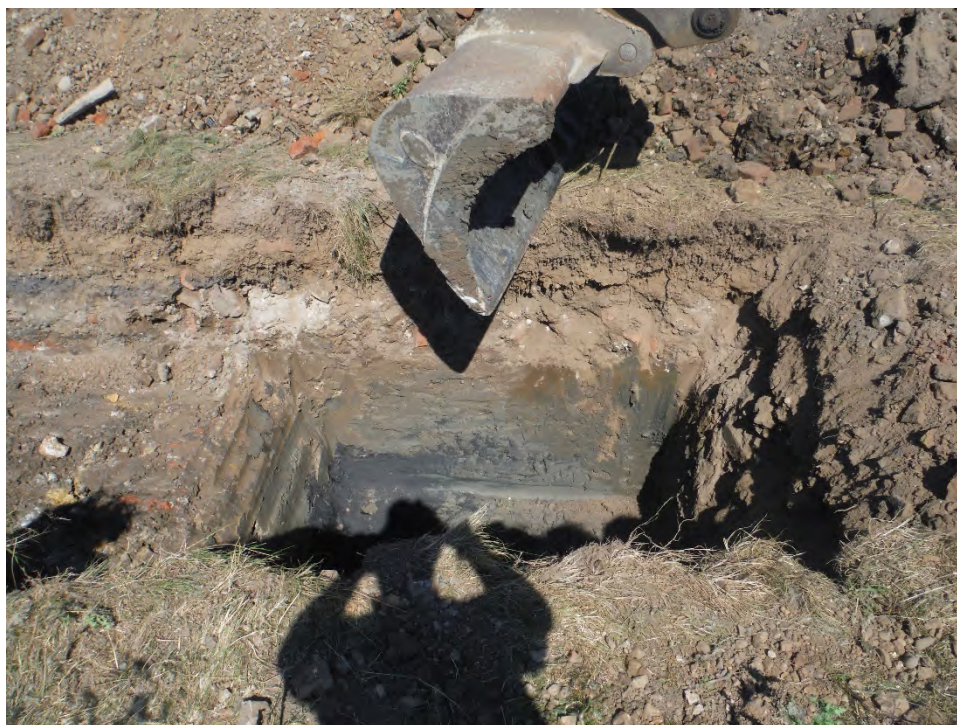
Plate 15: Trench 44 modern made ground [45] to 1.80 m + view north.
