**NEW MONK'S FARM, LANCING
WEST SUSSEX**

**ARCHAEOLOGICAL WATCHING
BRIEF; GEOTECHNICAL
INVESTIGATIONS**

**PCA REPORT NO: R12624
OCTOBER 2016**

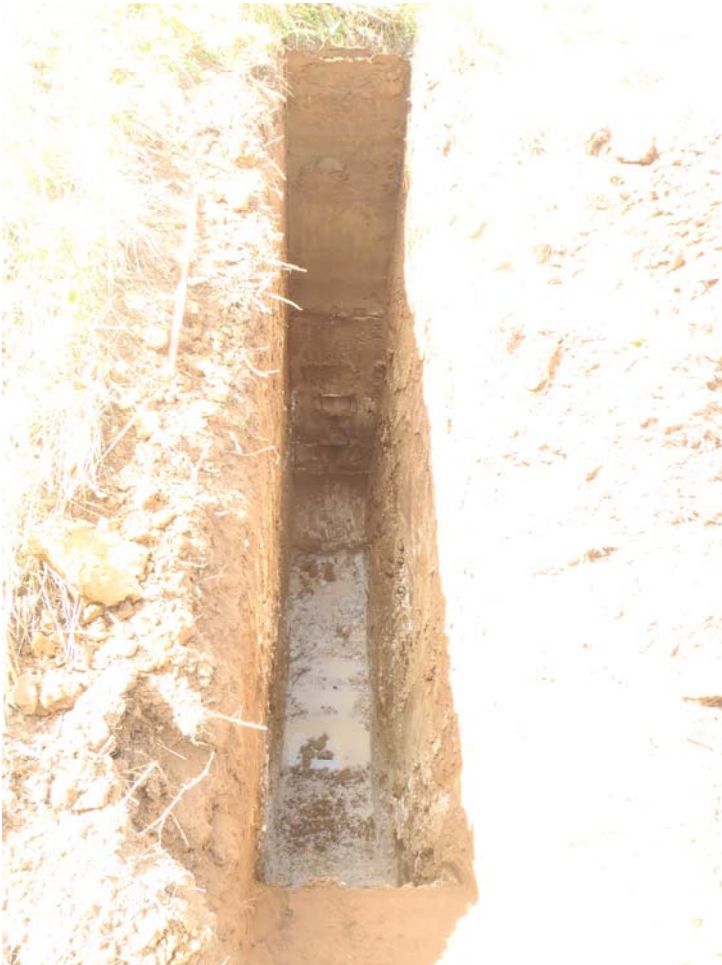
Plate 3 East facing section of TP20

- 7.1.1 The earliest deposits encountered consisted of firm off-white chalk [1] sealed by head material [3]. The head material varied from moderately firm, light brown to orangey brown sand, gravel and clay with inclusions of frequent small stones, chalk and flint nodules and rootlets.

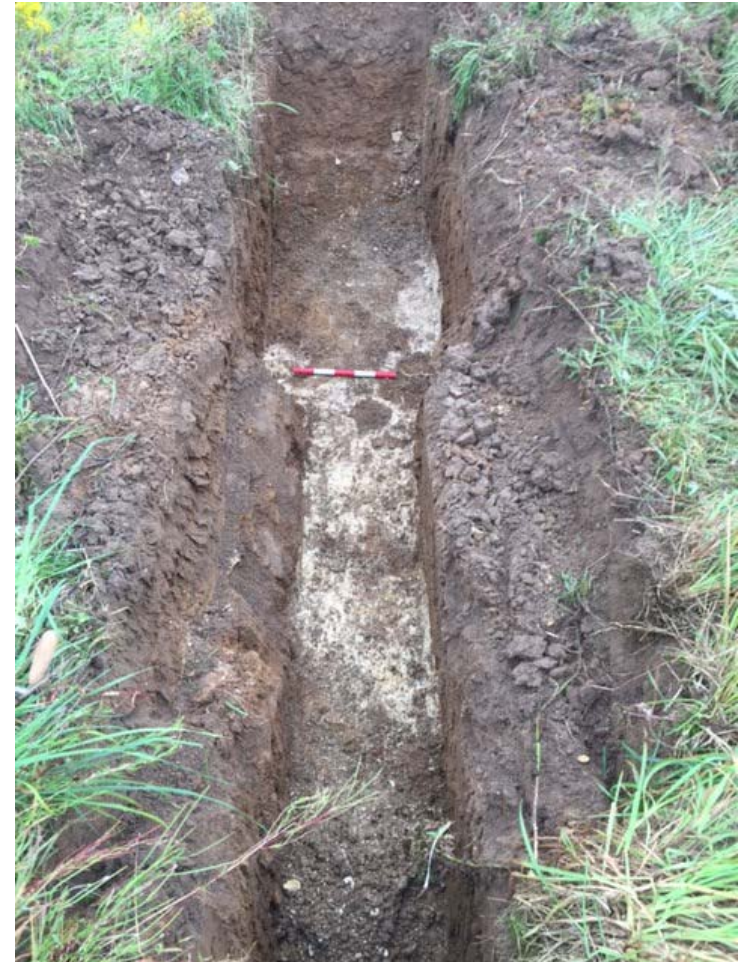
Plate 4: TP09 showing chalk surface [28] & Chalk pad [29] looking north

- 7.2.2 This layer produced evidence of what may represent archaeological activity in TP09. At a depth of 1.6m, apparently within the subsoil accumulation, a chalk 'surface' [28] was exposed measuring 0.5m wide and some 0.3m thick. A possible further 'pad' of chalk [29] was located adjacent to this surface to the north. Neither [28] or [29] was fully excavated, and while they may represent natural variation, the position of deposits apparently within the subsoil sequence may suggest an anthropogenic origin.

- 8.3 The only potential archaeological deposits encountered were a possible deliberately laid chalk surface and pad observed in TP09. These were apparently within the subsoil deposit and therefore inconsistent with the surrounding geological sequence. They may represent archaeological deposits although no dating evidence was recovered from the vicinity.

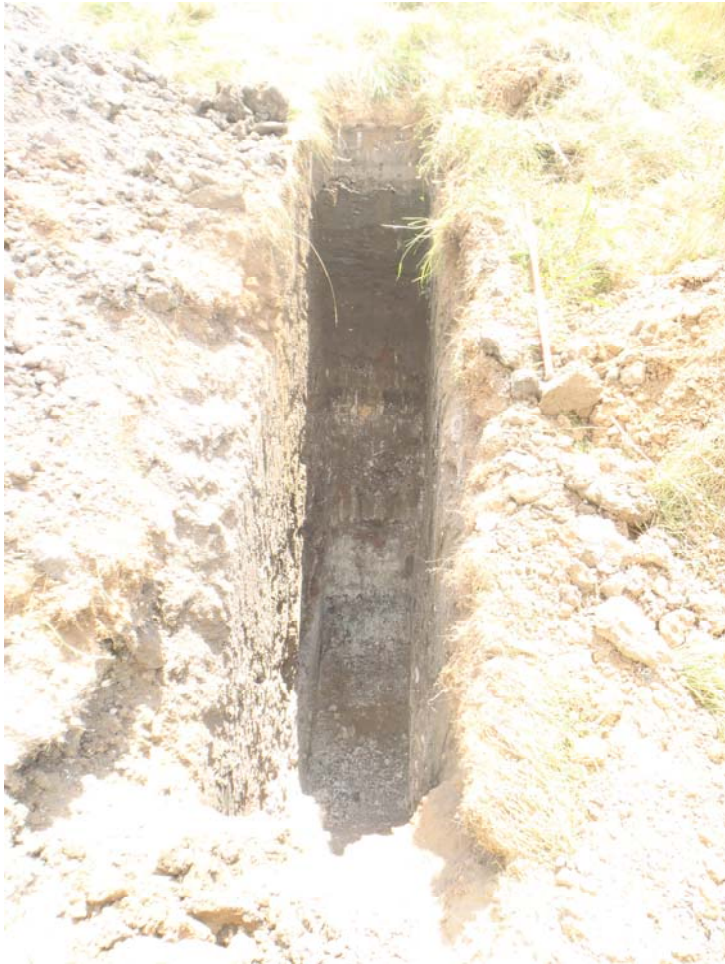
Plate 5: North facing section of TP55

- 7.4 The modern phase is represented most significantly by the presence of very thick deposits of made ground consisting of moderately firm, dark brown sand, clay and gravel with patches of orange and black [10] and [61]. This layer represents a deliberate landscaping deposit, and contained inclusions of CBM, concrete, plastic, glass, metal and tarmac. This layer was encountered in test pits to the east of Marsh Barn Lane, and was recorded at depths ranging from c. 0.3m and varied in thickness from 1.2m to 3.7m. This deposit represents significant reworking of the eastern area of the site during landscaping episodes.
- 7.5 The modern phase was completed by a layer of topsoil formed of moderately firm dark brown sand, and silty clay with frequent flinty gravel and turf [1]. This topsoil layer extended to a maximum depth of 0.5m below ground level.
