**ST SAVIOUR'S CHURCH,  
ST. SAVIOURS ROAD,  
LEICESTER,  
LE5 3HD:**

**AN ARCHAEOLOGICAL  
OBSERVATION REPORT**

**PCA Report No. R12625**

**September 2016**

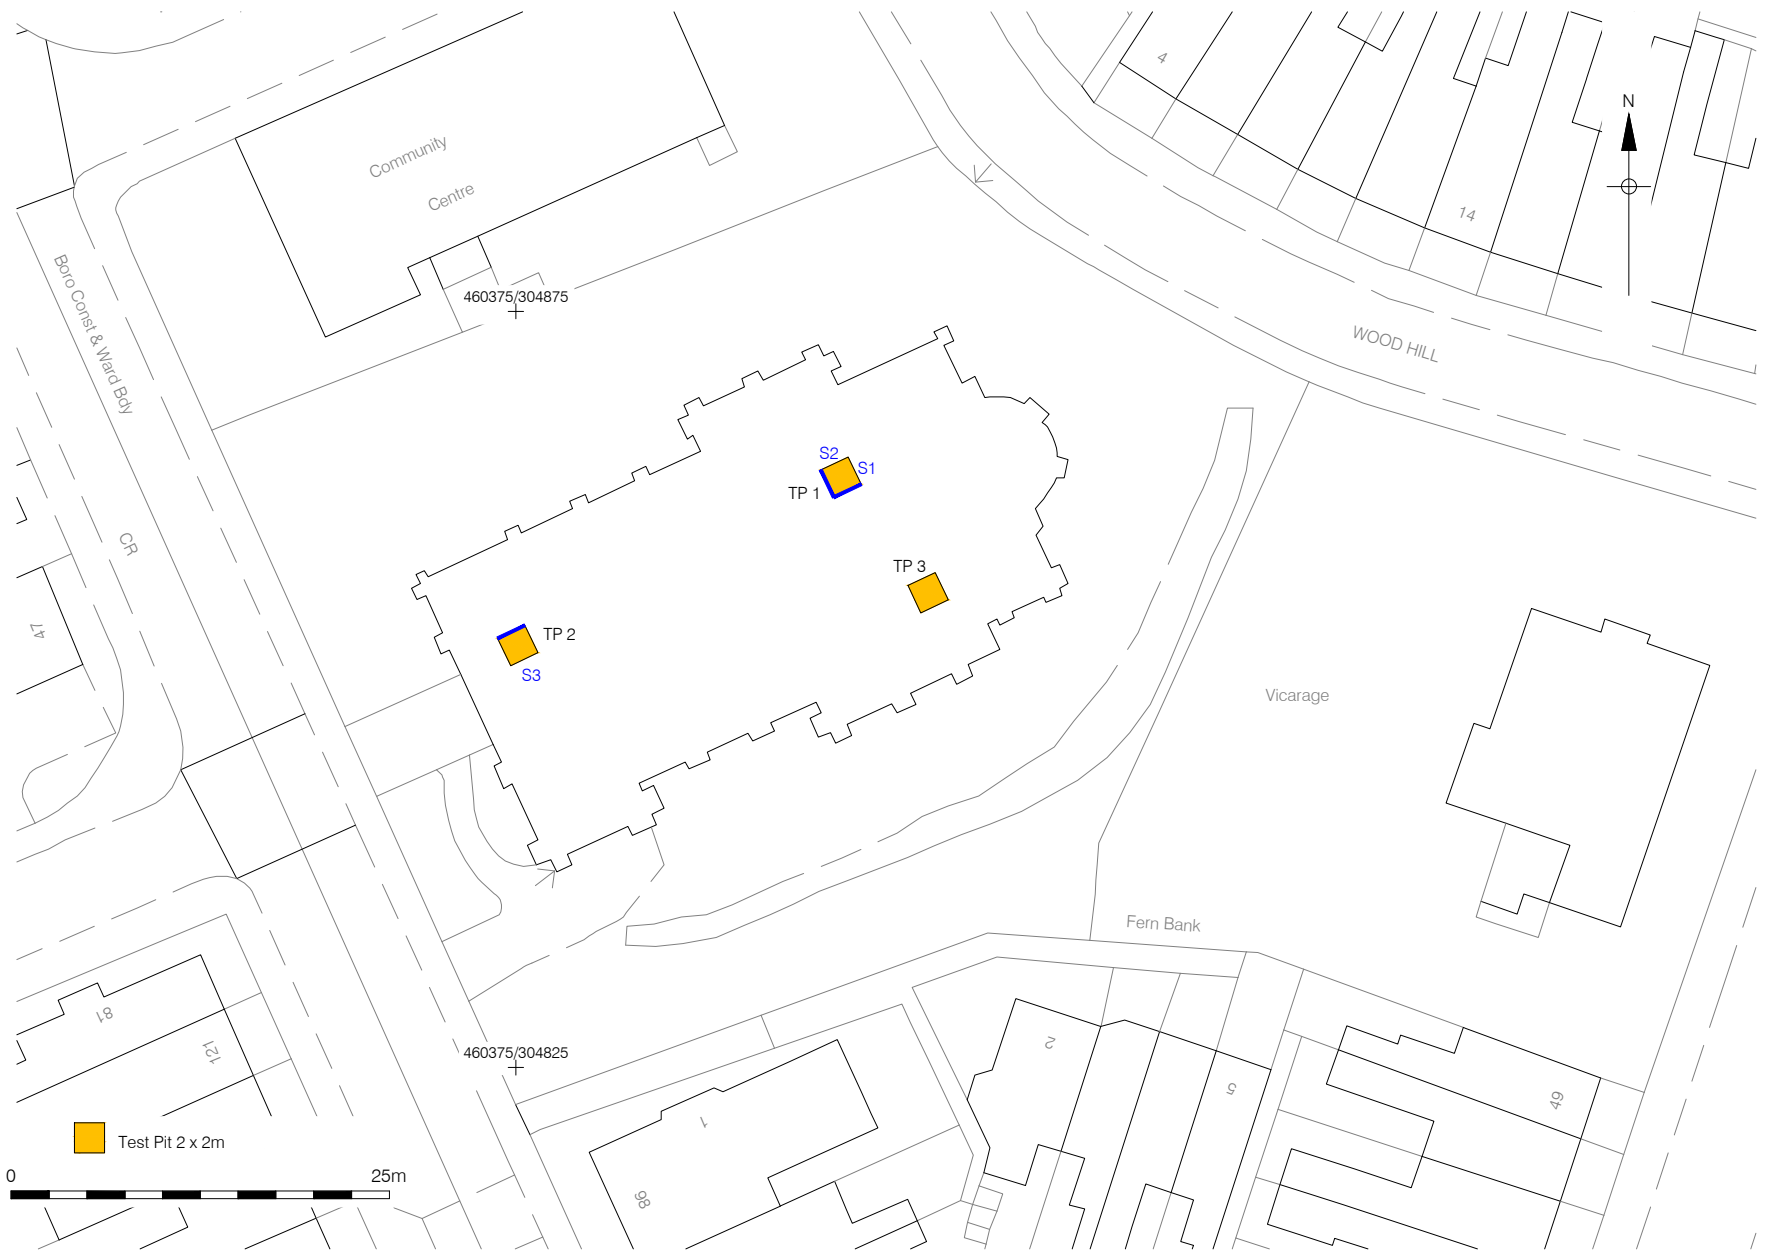
1.2.1 The Church is located adjacent to St Saviour's Road, within a gently sloping landscape. The works consisted of three Test Pits which were all located within the Church (**Figure 2**). A spot height taken at the entrance to the church was recorded at 75.384m AOD.

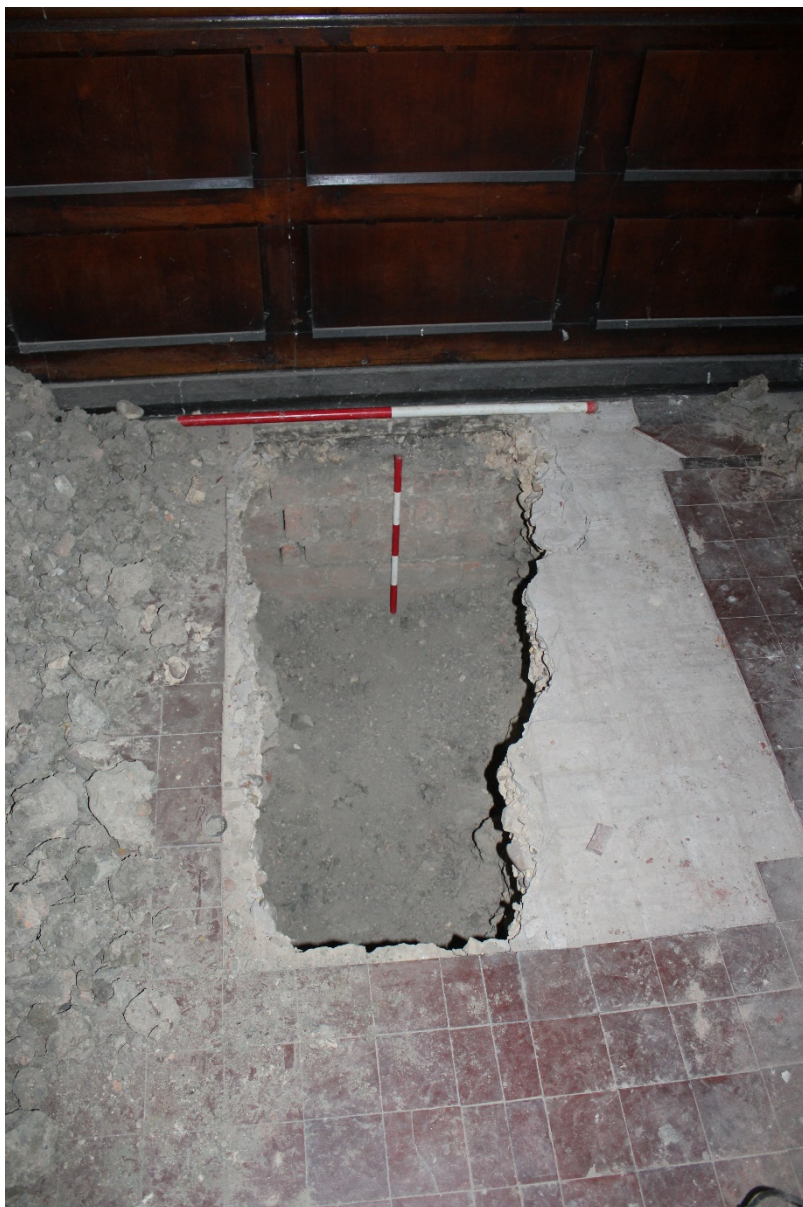
**Plate 2:** View of Section 1, taken from north-east.

1.3.2 The only probable natural deposit visible on the site was a firm, greenish grey-brown sandy clay which was visible in Test Pit 2, in the southwest of the church (context **06**); the deposit lay approximately 0.2m below the floor of the church and was >0.58m deep (see Section 1, **Figure 3**).

4.1.1 As mentioned previously the only probable natural deposit visible on the site was a firm, greenish grey-brown sandy clay (context **06**) which was visible in Test Pit 2, in the southwest of the church; the deposit lay approximately 0.2m below the floor of the church and was >0.58m deep.
