Stanton Nitrate Reduction  
Scheme, Stanton, Ixworth,  
Suffolk:

Archaeological Trial Trench  
Evaluation

October 2016

**Report No.** R12653

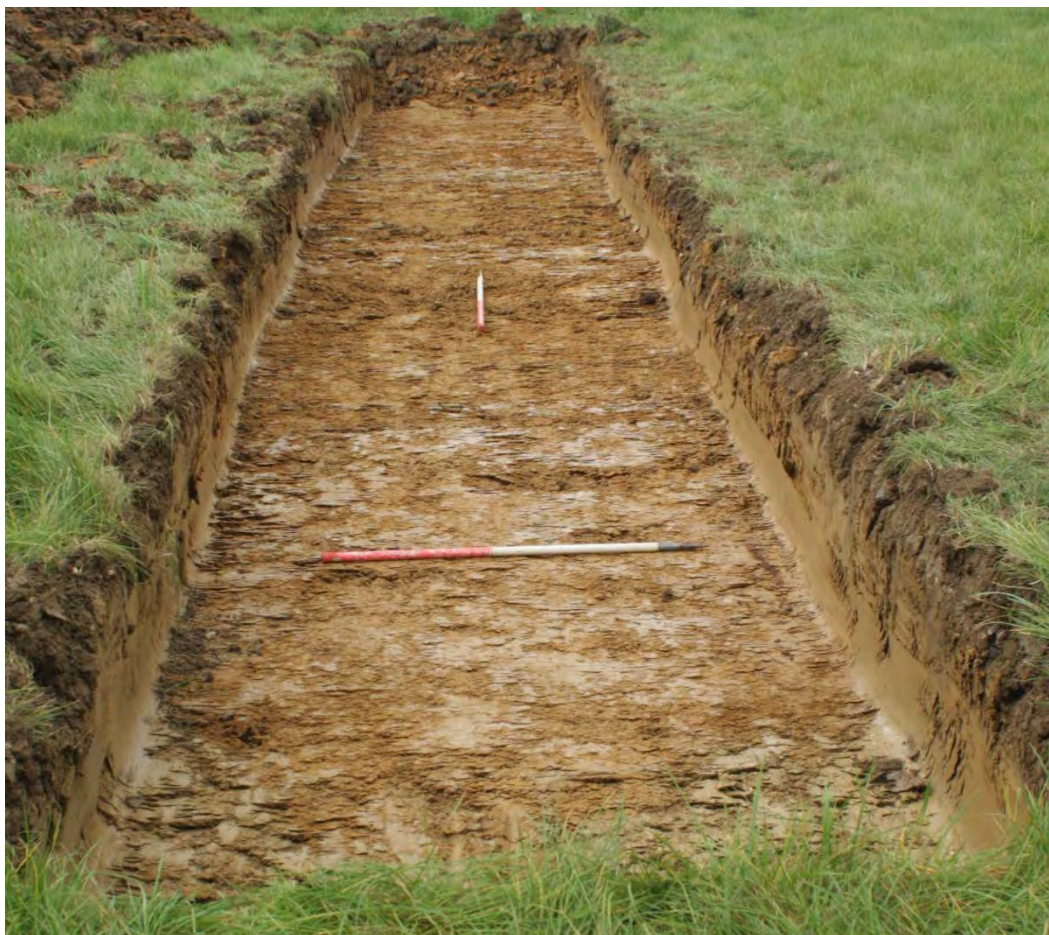
Plate 1: Trench 1, view north-west

TRENCH 1	Figure 2	Plates 1-2	
Trench Alignment: NW-SE	Length: 15m	Level of Natural (m OD): 52.69m - 52.74m	
Deposit	Context No.	Average Depth (m)	
		NW End	SE End
Topsoil	(101)	0.30m	0.25m

Subsoil	(102)	0.20m	0.25m
Natural	(103)	0.50m+	0.50m+
<b>Summary</b>			
Trench 1 was located close to the south-eastern boundary of the site.			
The trench contained no archaeological features but rather a relatively uniform and undisturbed sequence of natural sandy clay deposits overlain by a sterile subsoil, and a ploughsoil containing modern artefacts.

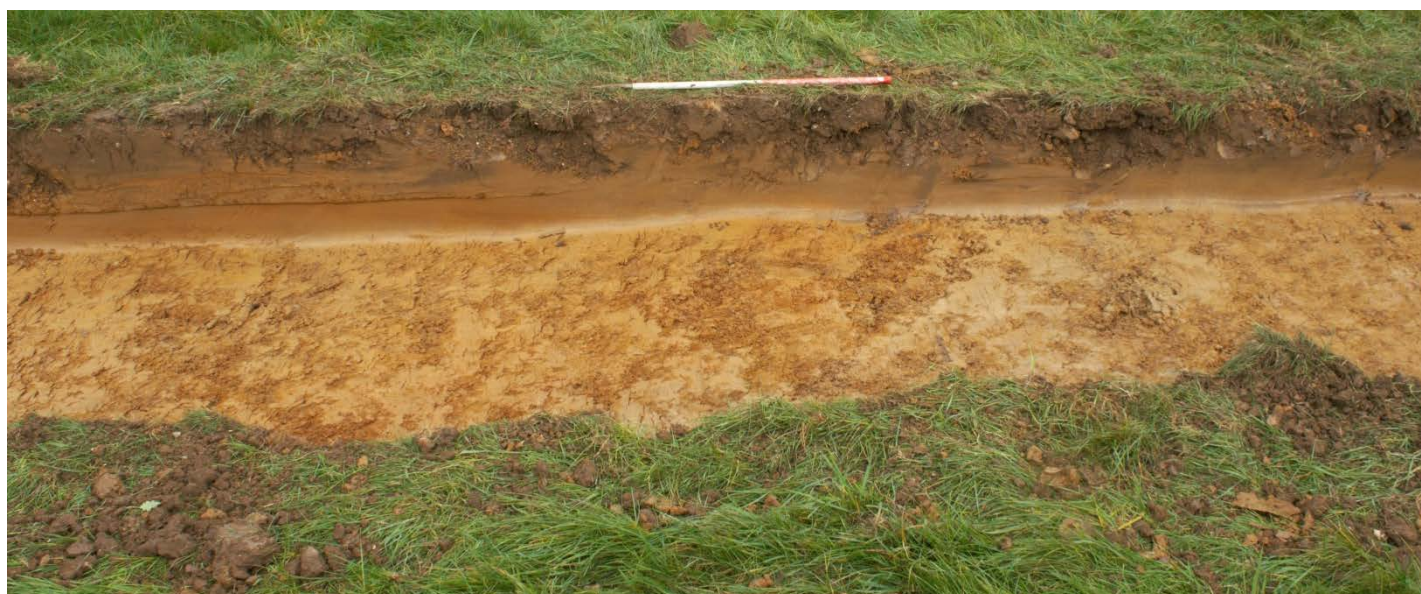
Plate 2: North-east facing section in Trench 1, view south-west

5.2.1 The natural geology (103) was encountered at a fairly uniform depth across Trench 1 at between 52.69m and 52.74m OD and comprised a firm, light reddish-brown deposit of sandy clay. Whilst disturbed in places by natural rooting, the natural geology in Trench 1 was not truncated by any archaeological features.

5.2.2 Natural deposits in Trench 1 were overlain by a 0.20m-0.30m thick deposit of firm, light yellowish-grey, clay subsoil (102). Excluding some disturbance from modern ploughing activity above, no cultural inclusions (e.g. charcoal, artefacts) were identified within the subsoil. This suggests that, during the period over which this layer was naturally deposited, there was likely a very minimal or even complete lack of human presence within the immediate area.

5.2.3 The subsoil in Trench 1 was overlain by a 0.20m-0.30m thick layer of ploughsoil (101); a friable, mid-greyish black silty clay containing occasional charcoal flecks and CBM (ceramic building material) fragments. This layer represents a phase of agricultural use of the site, lasting an unknown period of time but certainly into the modern period, as finds of modern metal and plastic were identified within it.

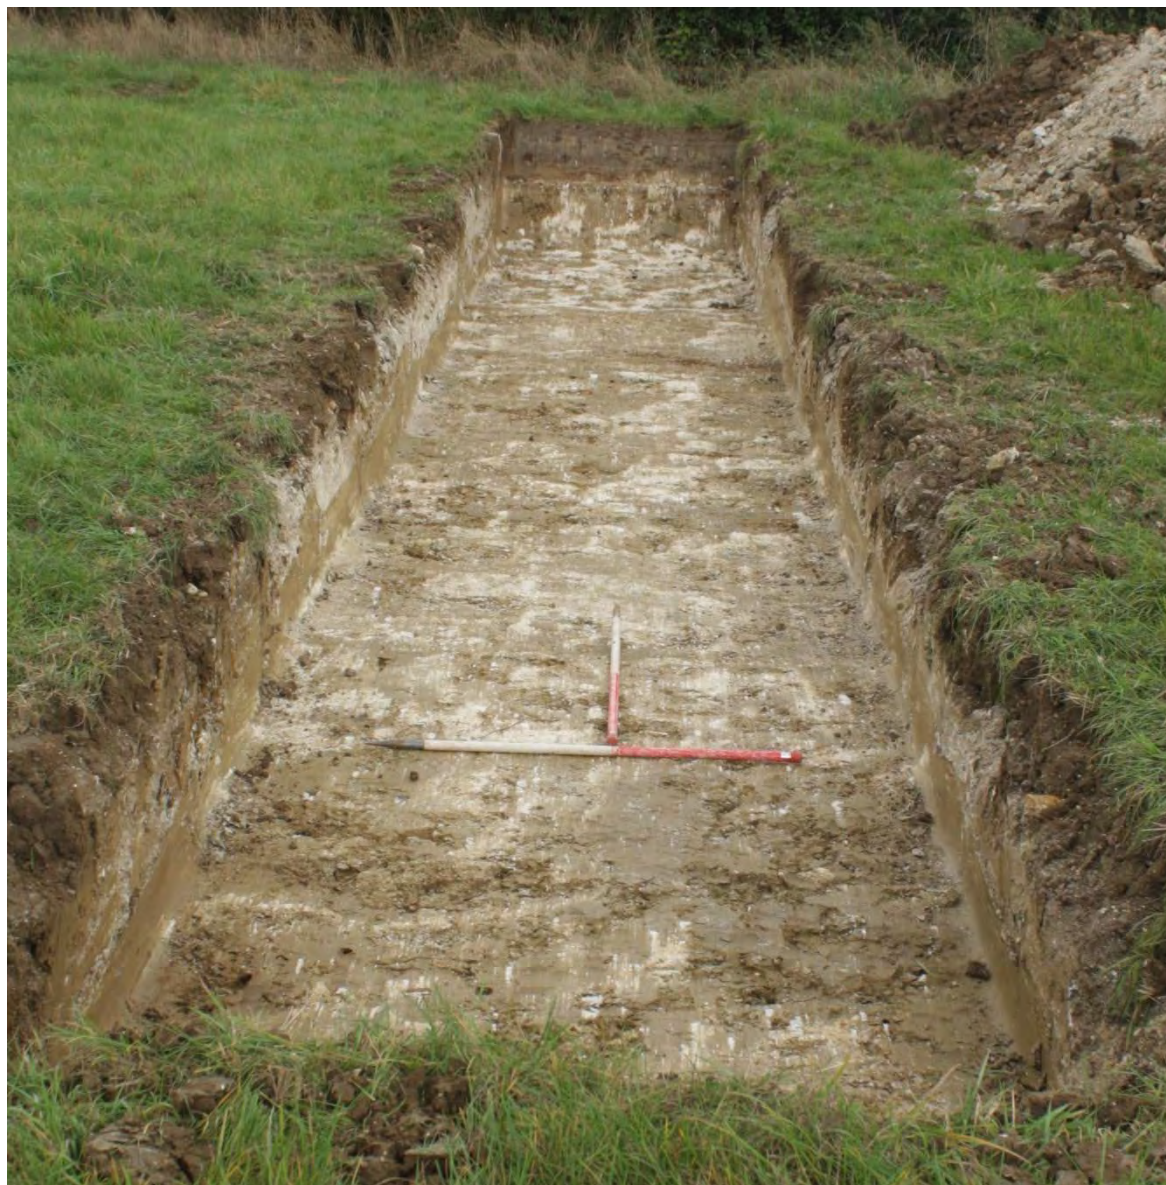
Plate 3: Trench 2 with rooting disturbance visible in the fore, view south-west

5.3.1 In Trench 2, the natural geology (103) was encountered at a height of between 51.87m and 51.96m OD but was substantially different to that identified in Trench 1, comprising instead a firm deposit of interspersed patches of white chalk and dark greyish-brown clay. This natural deposit was, however, also disturbed exclusively by natural rooting, with no cultural activity evident.

5.3.2 Natural deposits in Trench 2 were overlain by a relatively thick (0.30m-0.35m) subsoil (102), similar to that encountered in Trench 1 but including frequent chalk fragments, introduced from the underlying chalky natural. It had been somewhat disturbed by modern ploughing activity from above but otherwise contained no cultural inclusions, again suggesting a minimal or entire lack of human presence.

Trench 2 was located close to the centre of the site.  
 The trench contained no archaeological features but rather a relatively undisturbed sequence of natural chalk and clay deposits, overlain by a thick sterile subsoil, and a layer of ploughsoil. A significant change between the natural geology within Trenches 1 and 2 was also noted.

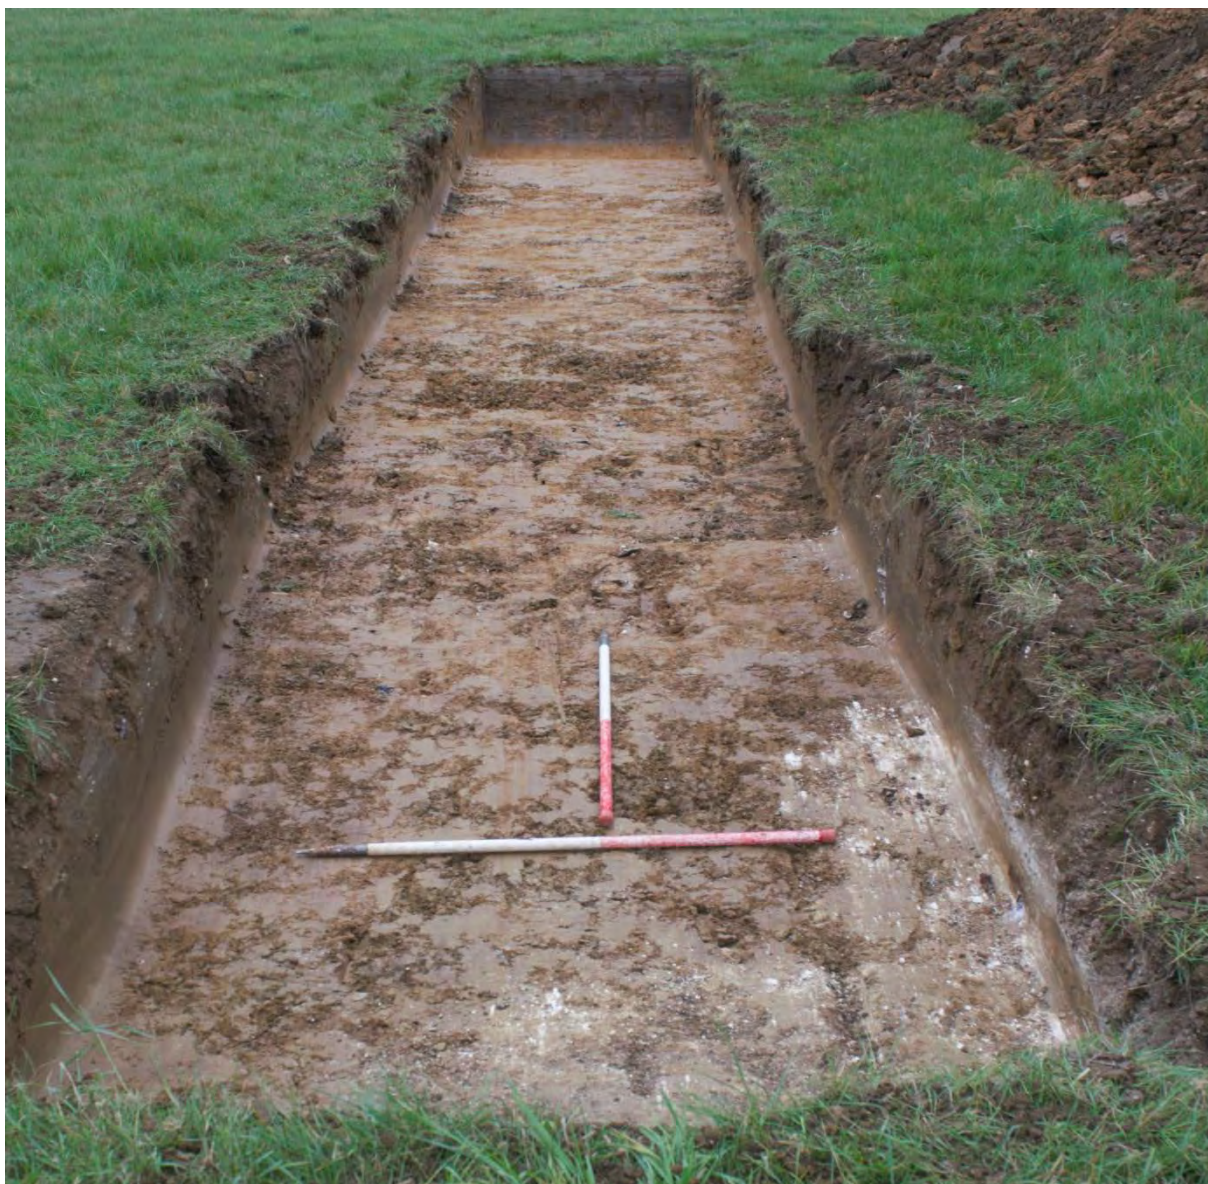
Plate 4: Trench 3 with change in natural geology visible in the fore, view south-east

5.4.1 In Trench 3, the natural geology (103) was encountered at a height of between 51.61m and 51.84m OD. For the most part comprising a mid orange-brown sandy clay similar to that encountered in Trench 1, the natural changed abruptly in the north-west corner of the trench to become a mixed chalk and clay deposit as encountered within Trench 2. No archaeological features were identified although some disturbance by natural rooting was again evident.

TRENCH 3	Figure 2	Plate 4	
Trench Alignment: NW-SE	Length: 15m	Level of Natural (m OD): 51.61m - 51.84m	
Deposit	Context No.	Average Depth (m)	
		NW End	SE End
Topsoil	(101)	0.27m	0.33m
Subsoil	(102)	0.17m	0.22m
Natural	(103)	0.44m+	0.55m+
<b>Summary</b>			
Trench 1 was located Trench 2 was located close to the centre of the site. The trench contained no archaeological features but rather the familiar, relatively undisturbed sequence of natural geology, overlain by subsoil and ploughsoil. A boundary

between the two different variants of natural geology noted on this site (orangey-brown sandy clay versus mixed chalk and clay) was noted in the north-west corner of this trench.

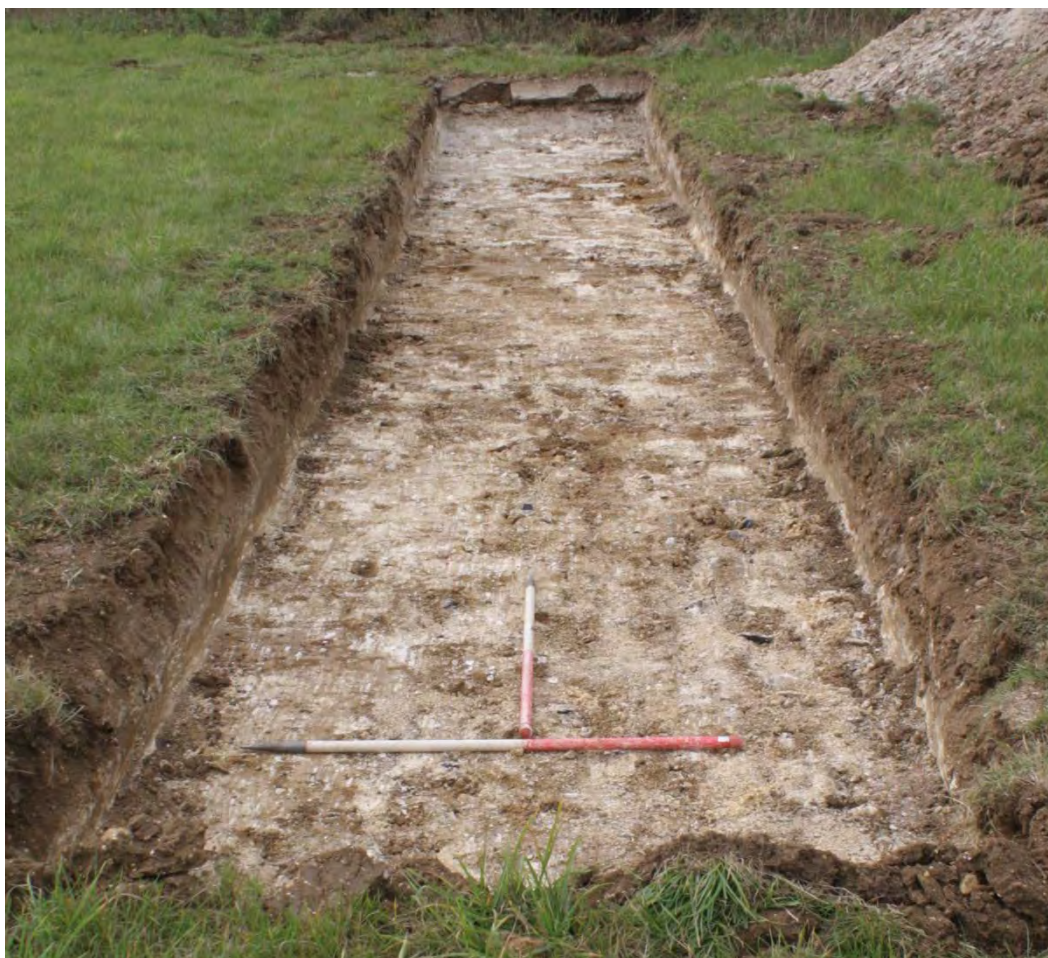
Plate 5: Trench 4, view south-west

5.5.1 Natural deposits (103) within Trench 4 were encountered at a height of 51.21m - 51.32m OD and comprised a mixed chalk and clay deposit equivalent to that encountered in Trench 2 and the north-west end of Trench 3. Despite some disturbance from natural rooting, the natural remained untruncated by archaeological features.

<b>TRENCH 4</b>	<b>Figure 2</b>		<b>Plate 5-6</b>	
Trench Alignment: NE-SW	Length: 13.4m	Level of Natural (m OD): 51.21m - 51.32m		
<b>Deposit</b>	<b>Context No.</b>	<b>Average Depth (m)</b>		
		<b>NE End</b>	<b>SW End</b>	
Topsoil	(101)	0.24m	0.25m	
Subsoil	(102)	0.16m	0.21m	
Natural	(103)	0.40m+	0.46m+	
<b>Summary</b>				
Trench 1 was located close to the northern boundary of the site.				
The trench contained no archaeological features but rather the familiar sequence of natural deposits overlain by subsoil and ploughsoil. The natural geology in Trench 4 comprised a mixed chalk and clay deposit, similar to that encountered in Trench 2 and part of Trench 3.

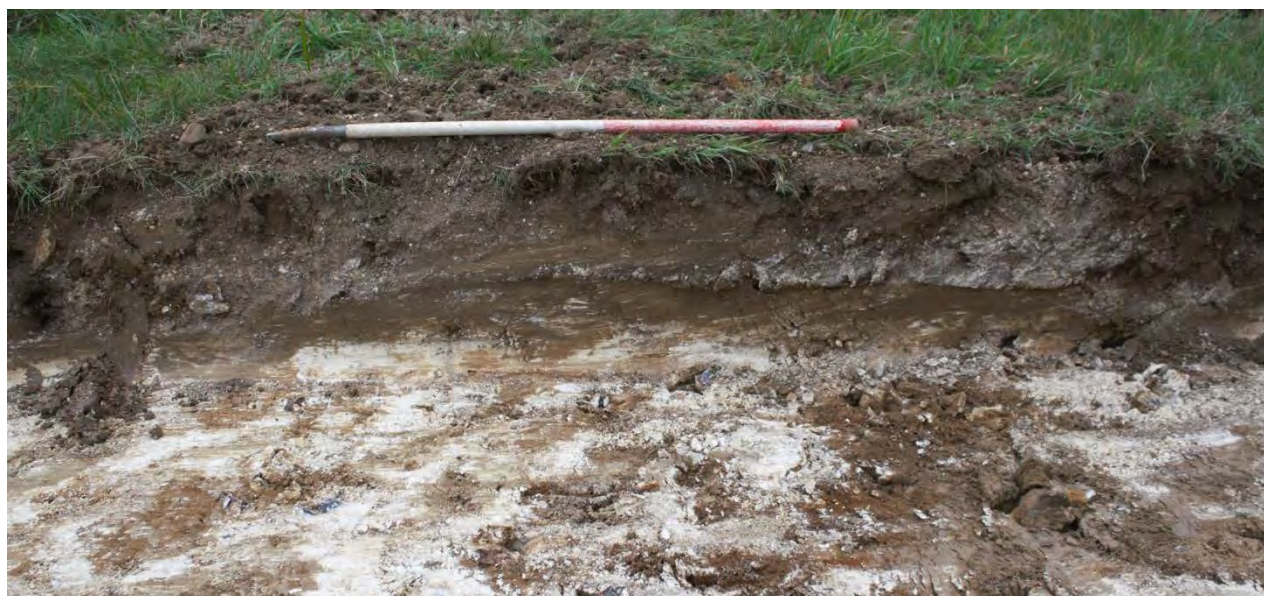
Plate 6: South-east facing section in Trench 4, view north-west

5.5.2 Natural deposits in Trench 4 were overlain by a fairly thin (0.16m-0.21m) subsoil deposit (102), similar to that encountered elsewhere on site although notably containing a large amount of redeposited chalk across the south-western end of the trench. The subsoil was a little disturbed by modern ploughing activity from above and otherwise contained few cultural inclusions.

5.5.3 Subsoil was overlain by a 0.25m thick layer of ploughsoil (101), equivalent to that encountered in Trench 1.
