**Former James Marshall House,
Leyton Road, Harpenden,
Hertfordshire**

An Archaeological Evaluation

PCA REPORT NO: 12648

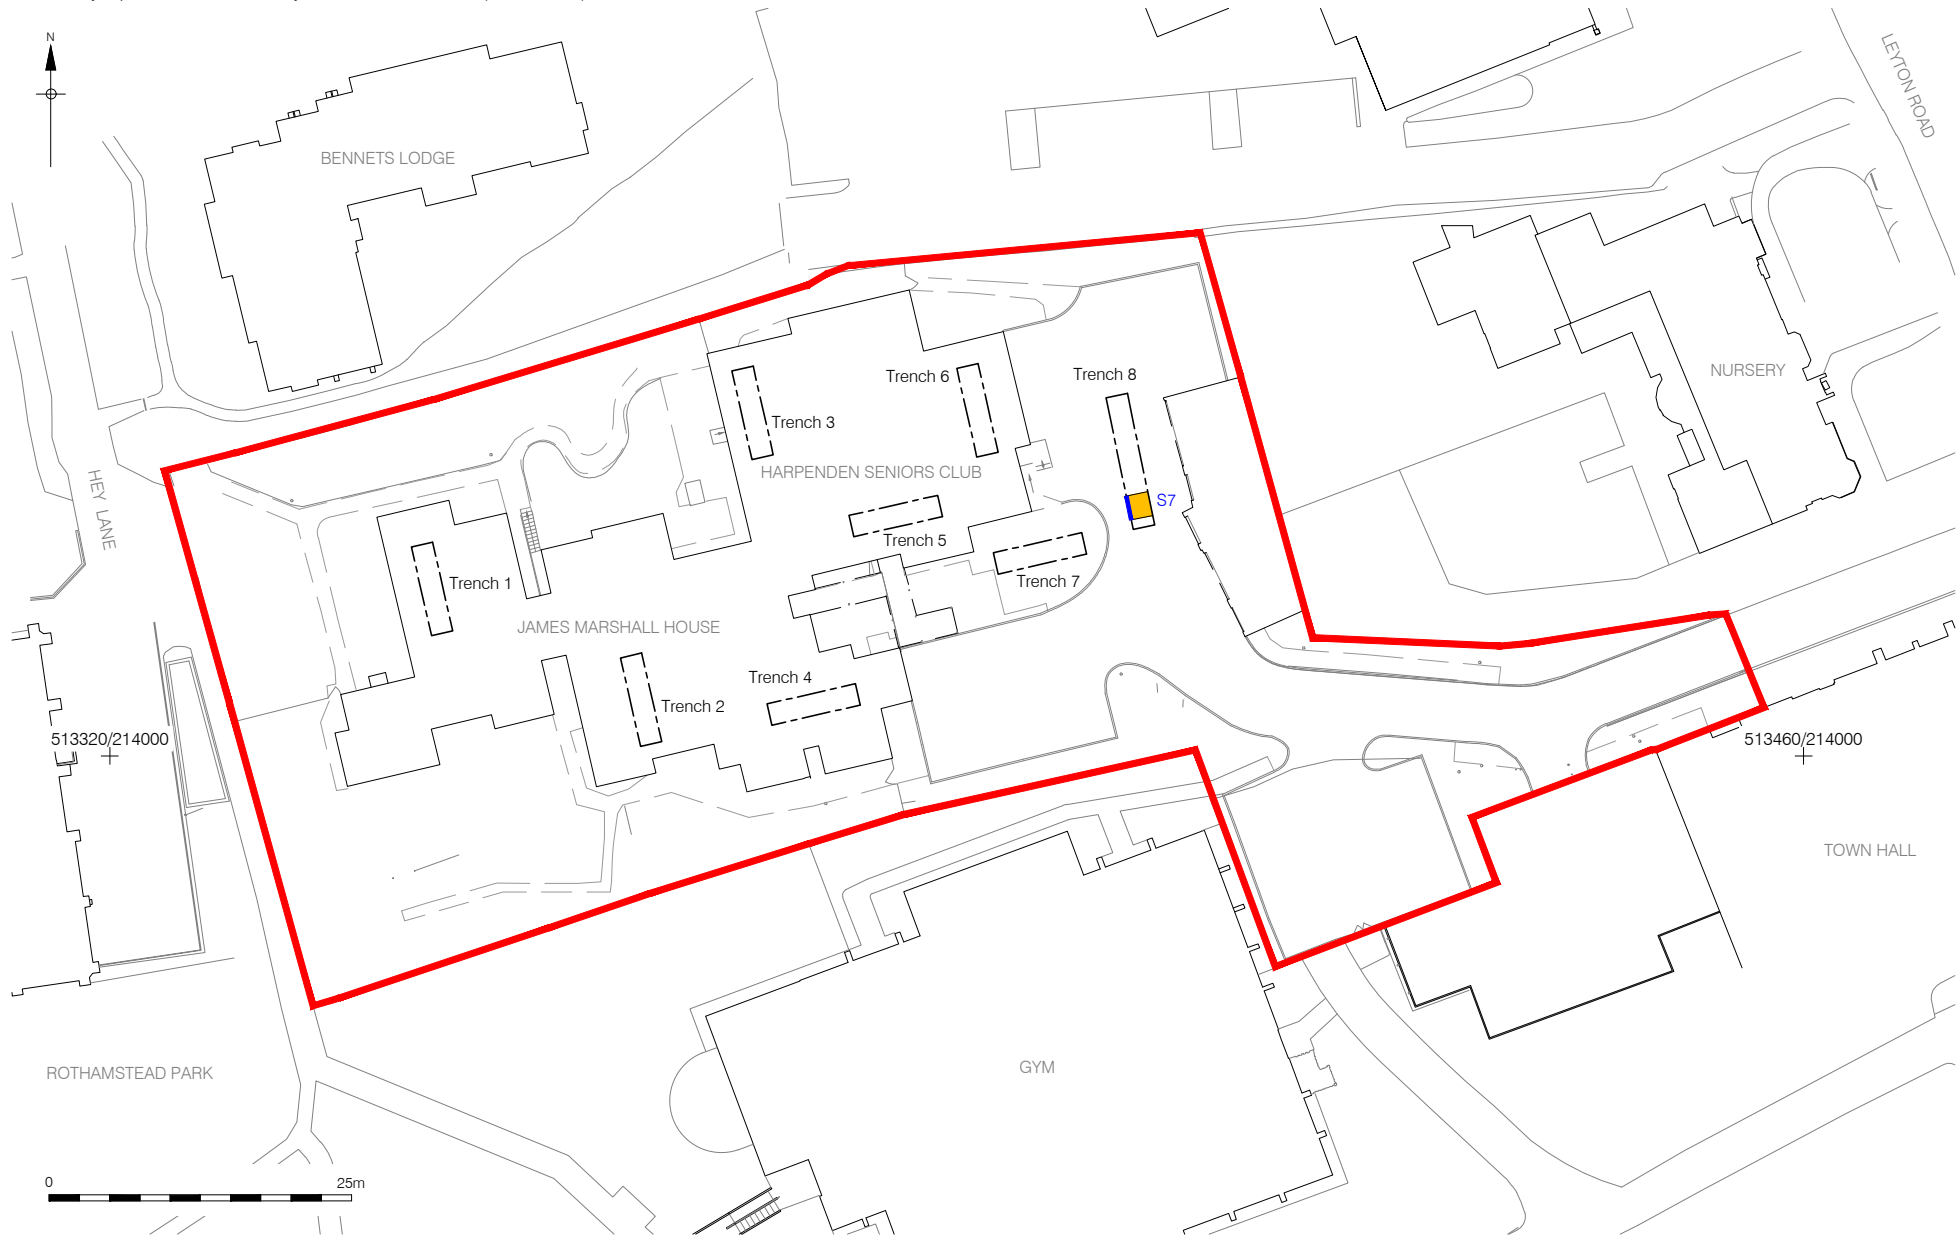
Figure 2
Trench Location Plan
1:625 at A4

5.3.1 Due to site specific circumstances the full length of Trench 2 could not be excavated in its proposed location (Brown 2016). The trench was repositioned slightly to the south (Fig.2).

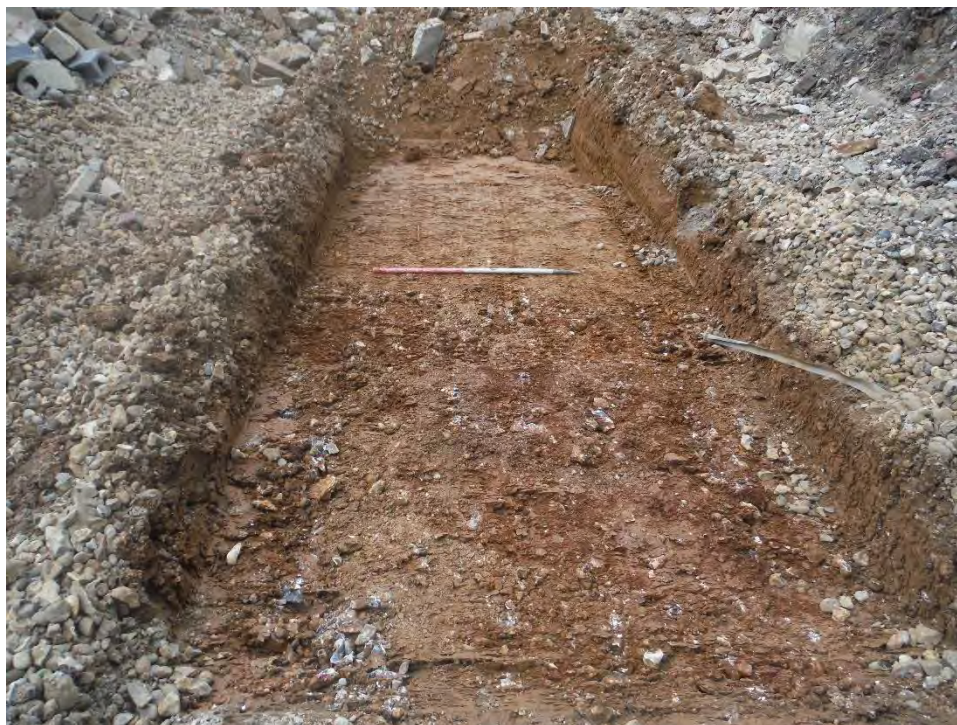
5.2.1 In this trench two types of natural ground were recorded. A reddish clay with coarse flint inclusions (102) and areas of yellowish-brown silty clay (111). A small machine sondage (0.38 m deep) was excavated at the southern end of Trench 1 into natural ground (111). On the recommendation of Simon West, St Albans District Archaeologist, the silty-clay natural deposit (111) in this trench was sampled to determine whether or not it was a brickearth.

TRENCH 1	Figure 2	Plate 1	
Trench Alignment: N-S	Length: 7.5 m	Max Machine Depth (m OD): 108.71 Level of Natural (m OD): 109.11	
Deposit	Context No.	Average Depth (m)	
		N End	S End
Modern Intrusion/Made Ground	103	0.50	0.50
Natural (max machined depth)	102/111	0.50 (102)	0.88 (111)
Summary			
No archaeological finds or features were recorded in Trench 1. Natural ground level (102)/(101) had been truncated by construction of James Marshall House.

Plate 1: Trench 1 view south.

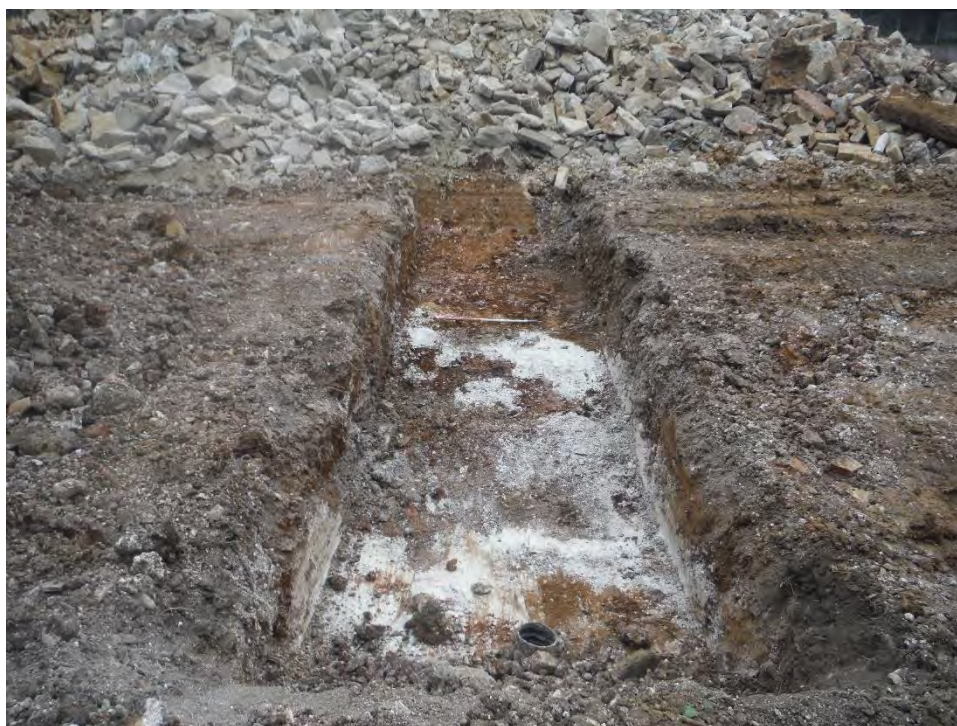
TRENCH 2	Figure 2		Plate 2	
Trench Alignment: N-S	Length: 9.5 m	Max Machine Depth (m OD): 106.71 Level of Natural (m OD): 107.74		
Deposit	Context No.	Average Depth (m)		
		N End	S End	
Modern Intrusion/Made Ground	103	1.0	1.20	
Natural (max machined depth)	102	1.0	1.20	
Summary				
No archaeological finds or features were recorded in Trench 2. Natural ground level (102) truncated by construction of James Marshall House. Ground has been disturbed by recent removal of modern footings.

Plate 2: Trench 2 view north.

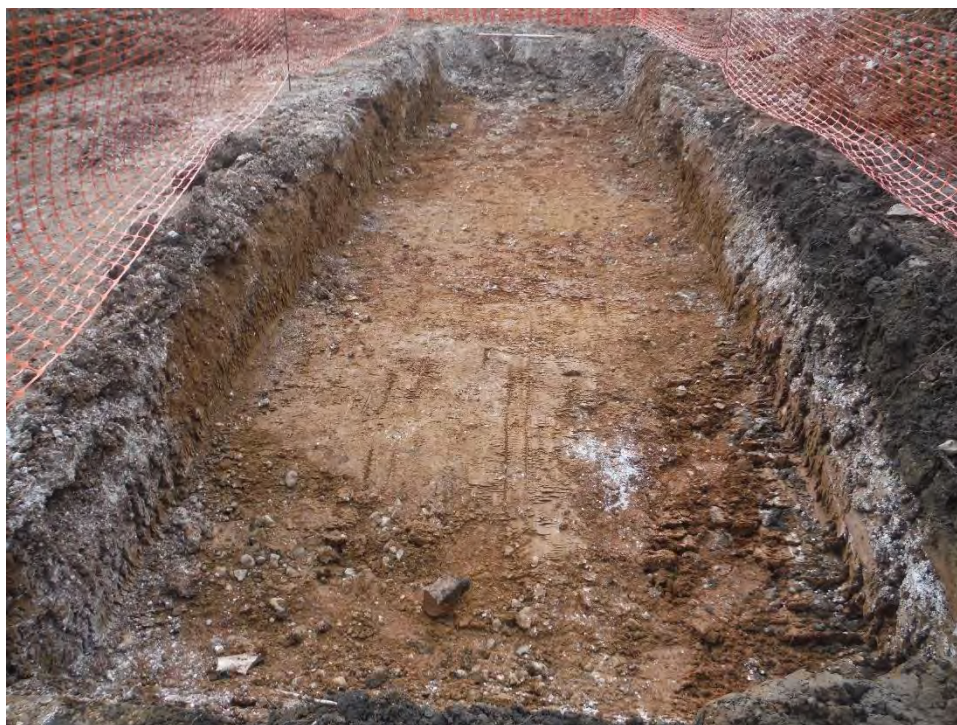
TRENCH 3	Figure 2		Plate 3	
Trench Alignment: N-S	Length: 9 m	Max Machine Depth (m OD): 107.06 Level of Natural (m OD): 107.22		
Deposit	Context No.	Average Depth (m)		
		N End	S End	
Modern Intrusion/Made Ground	103	0.60	0.70	
Natural (max machined depth)	102	0.60	0.70	
Summary				
No archaeological finds or features were recorded in Trench 3. Natural ground level (102) truncated by construction of James Marshall House. Ground disturbed by recent removal of modern footings.

Plate 3: Trench 3 view south.

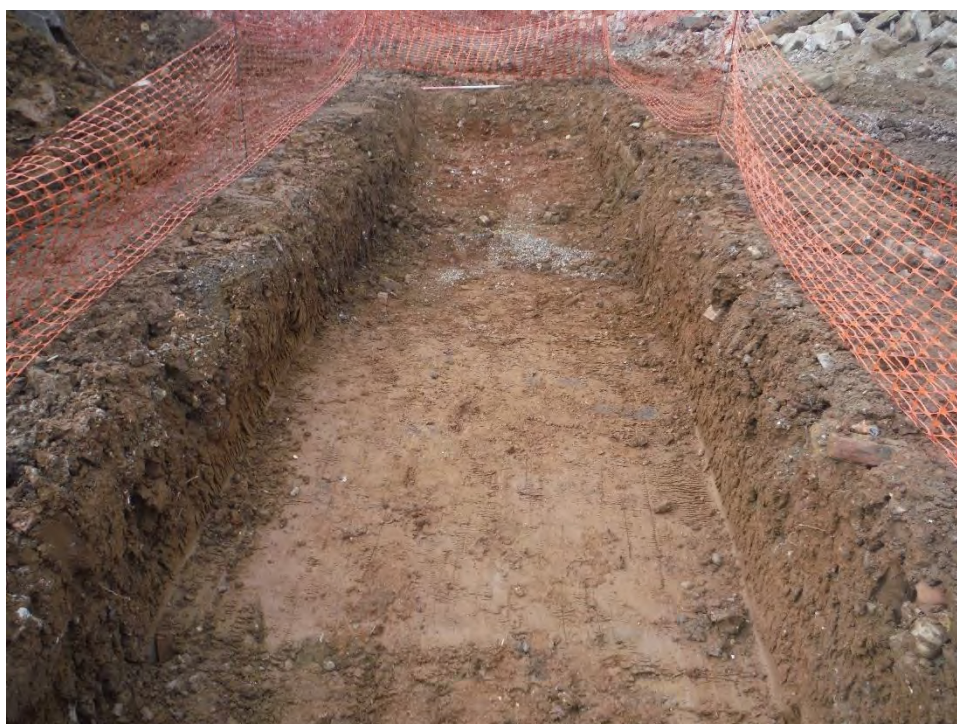
5.5.1 Trench 4 contained two types of natural. In addition to the reddish clay containing coarse flint inclusions (102) there was a yellowish-brown silty-clay

natural deposit (110). (110) was sampled to determine if it was a brickearth.

TRENCH 4	Figure 2		Plate 4	
Trench Alignment: E-W	Length: 9.5 m	Max Machine Depth (m OD):106.71 Level of Natural (m OD):106.71		
Deposit	Context No.	Average Depth (m)		
		E End	W End	
Modern Intrusion/Made Ground	103	0.40	0.50	
Natural (max machined depth)	102	0.50	0.80	
Summary				
No archaeological finds or features were recorded in Trench 4. Natural ground level (102)/(110) truncated by construction of James Marshall House. Ground has been disturbed by recent removal of modern footings.

Plate 4: Trench 4 view west.

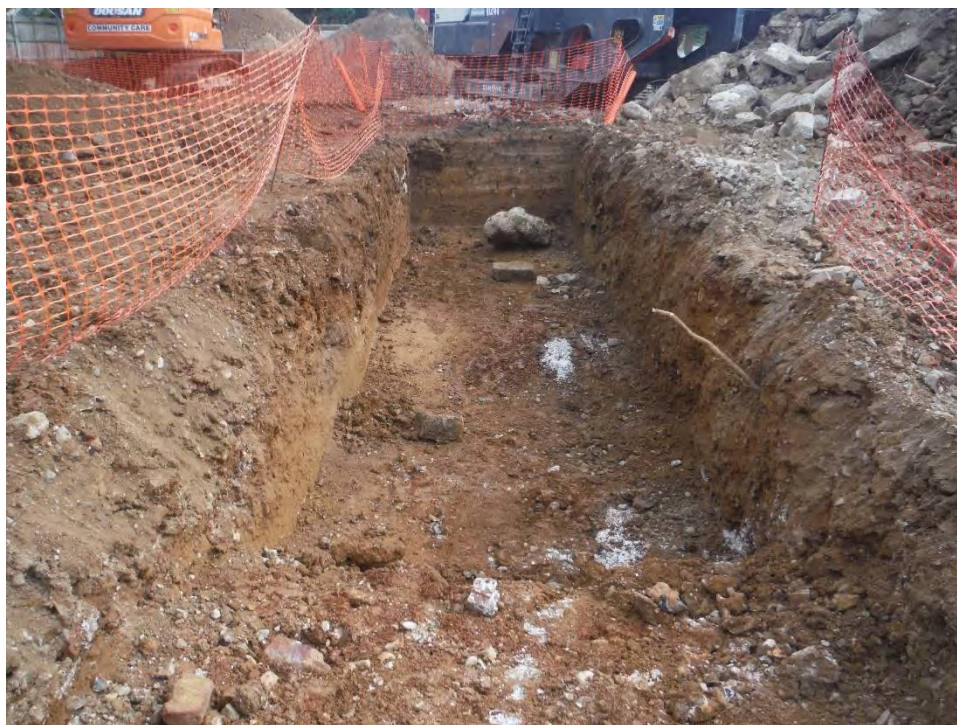
TRENCH 5	Figure 2		Plate 5	
Trench Alignment: E-W	Length: 10 m	Max Machine Depth (m OD):106.43 Level of Natural (m OD):106.43		
Deposit	Context No.	Average Depth (m)		
		E End	W End	
Modern Intrusion/Made Ground	103	0.60	0.60	
Natural (max machined depth)	102	0.60	1.10	
Summary				
No archaeological finds or features were recorded in Trench 5. Ground disturbed by recent removal of modern footings.

Plate 5: Trench 5 view east

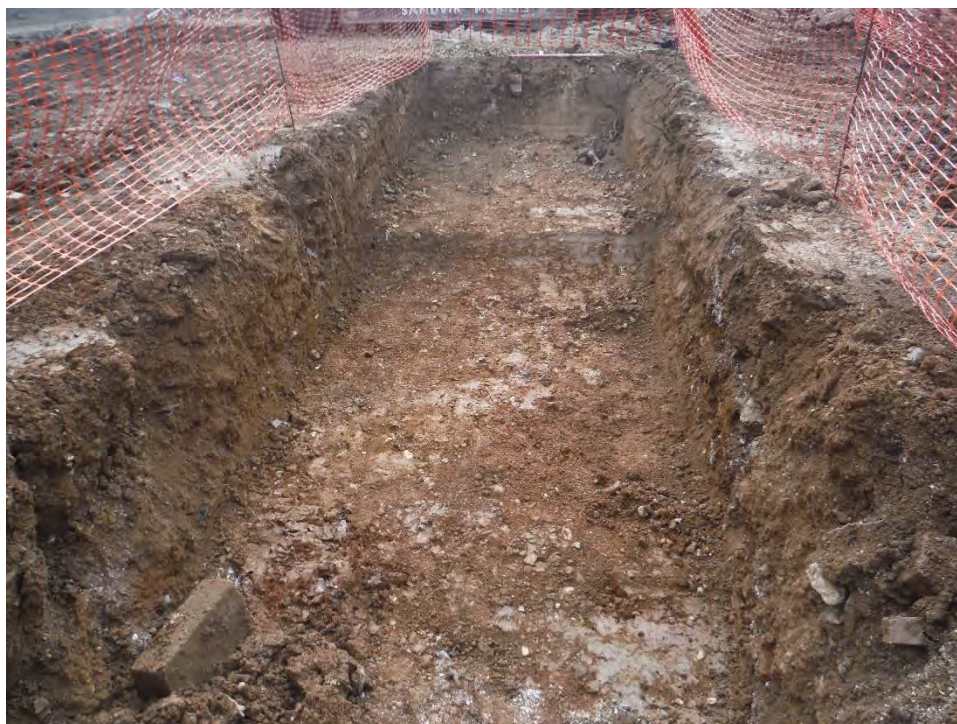
TRENCH 6	Figure 2		Plate 6	
Trench Alignment: N-S	Length: 8 m	Max Machine Depth (m OD):106.47 Level of Natural (m OD):106.42		
Deposit	Context No.	Average Depth (m)

N End	S End
Natural (max machined depth)	102	1.20	0.80
Modern Intrusion/Made Ground	103	1.20	0.80
Summary			
No archaeological finds or features were recorded in Trench 6. Ground disturbed by recent removal of modern footings.

Plate 6: Trench 6 view south.

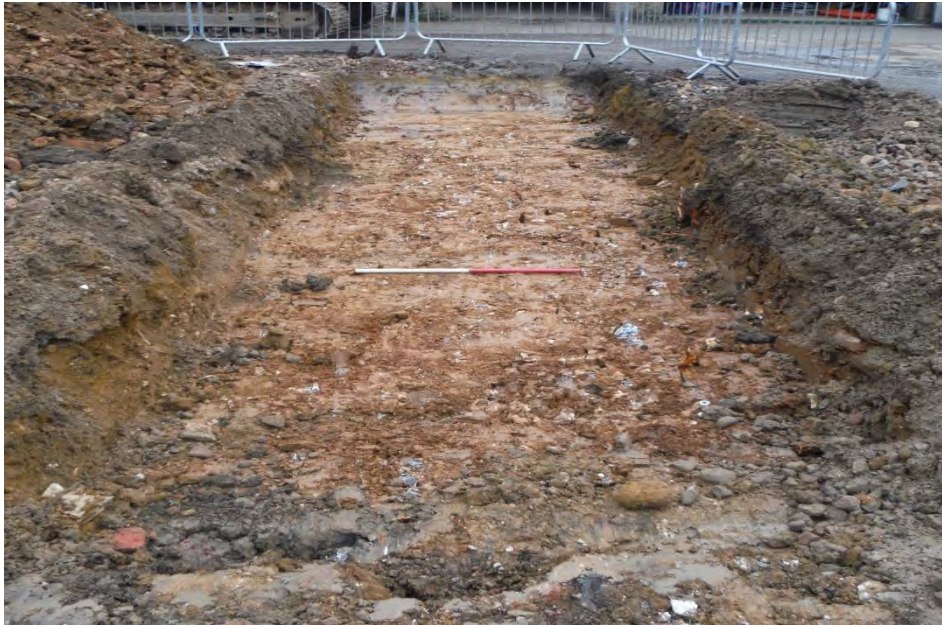
TRENCH 7	Figure 2	Plate 7	
Trench Alignment: E-W	Length: 8 m	Max Machine Depth (m OD):c.106.50 Level of Natural (m OD):c.106.50	
Deposit	Context No.	Average Depth (m)	
		SE End	NW End
Modern Intrusion/Made Ground	103	0.50	0.60
Natural (max machined depth)	102	0.50	0.60
Summary			
No archaeological finds or features recorded in trench 7. Level of natural ground not significantly truncated.

Plate 7: Trench 7 view east

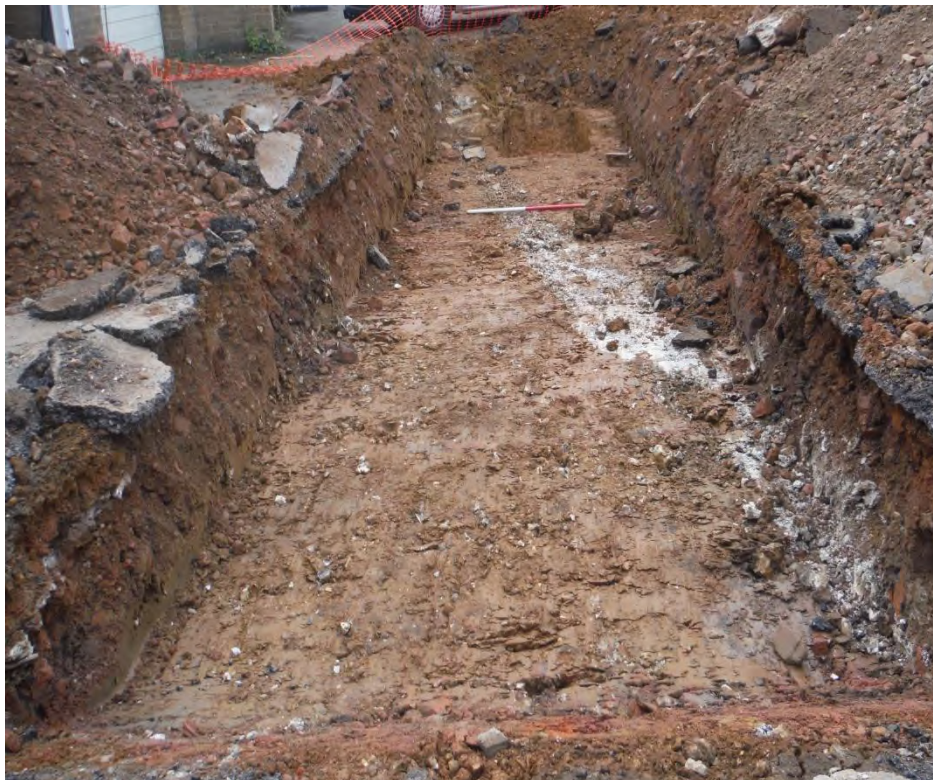
TRENCH 8	Figures 2 & 3	Plates 8 , 13	
Trench Alignment: N-S	Length: 9 m	Max Machine Depth (m OD):c.106.90 Level of Natural (m OD):c.106.90

Deposit	Context No.	Average Depth (m)	
		S End	N End
Modern Material/Made Ground	103	0.67	0.68
Natural (max machined depth)	102	0.67	0.68
Summary			
A tree throw [106] was located at the southern end of trench 8. No finds were recovered from this feature.

Plate 8: Trench 8 view south

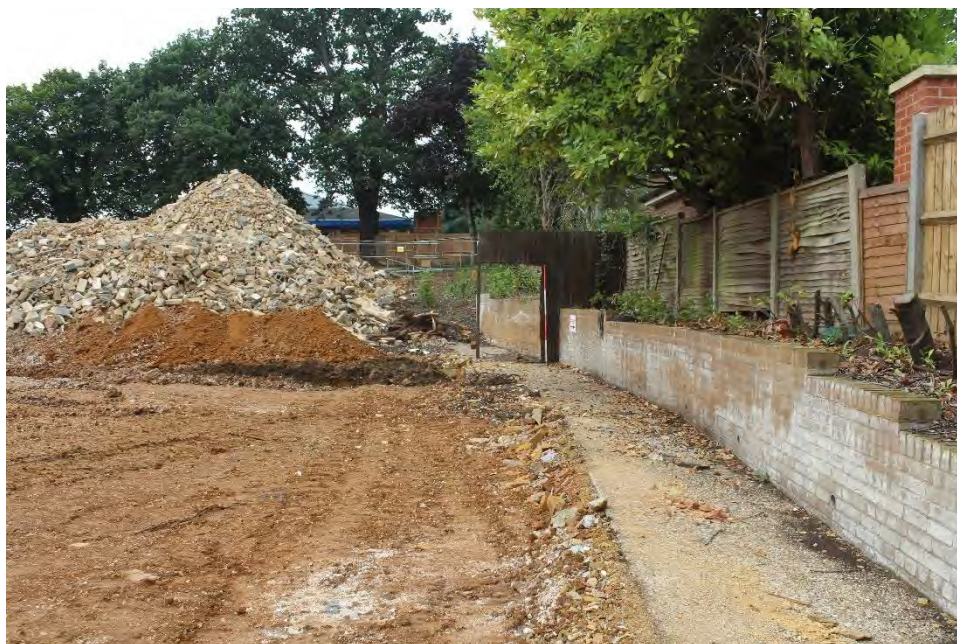
2.2.2 Prior to the construction of James Marshall House the site had sloped broadly from east to west across the site. The construction of James Marshall House involved considerable truncation of the ground level towards the west of the site (c. 2 m). The original slope of the ground can be observed surviving at the edges of the site and in neighbouring properties.

Plate 9: View west along northern edge of the site showing increase in ground level east to west.

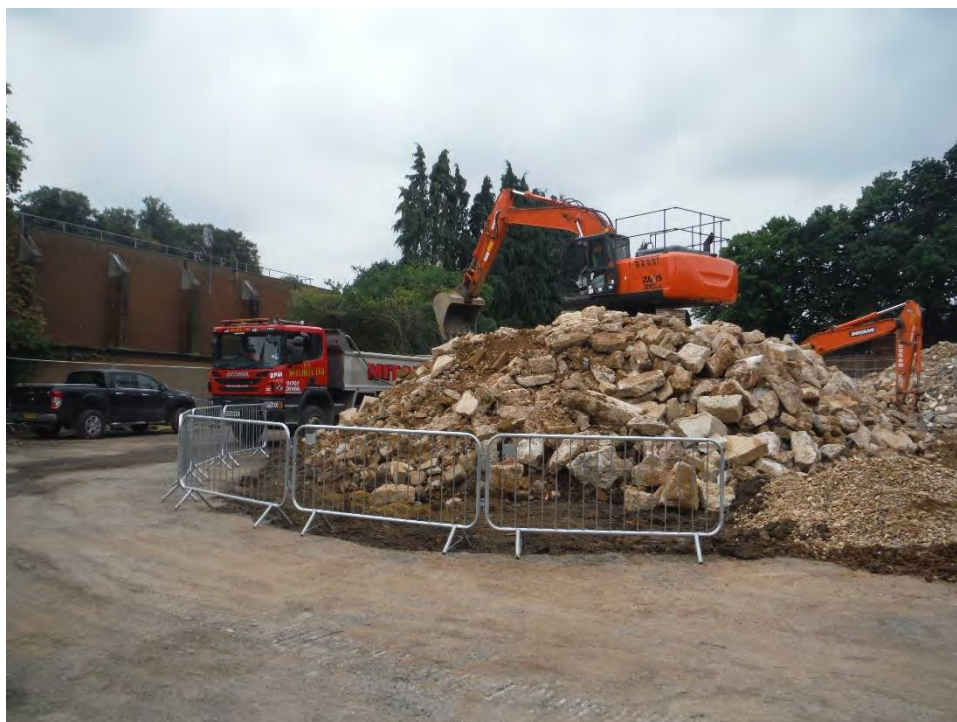
Plate 11: Tarmac area surviving at eastern end of site.

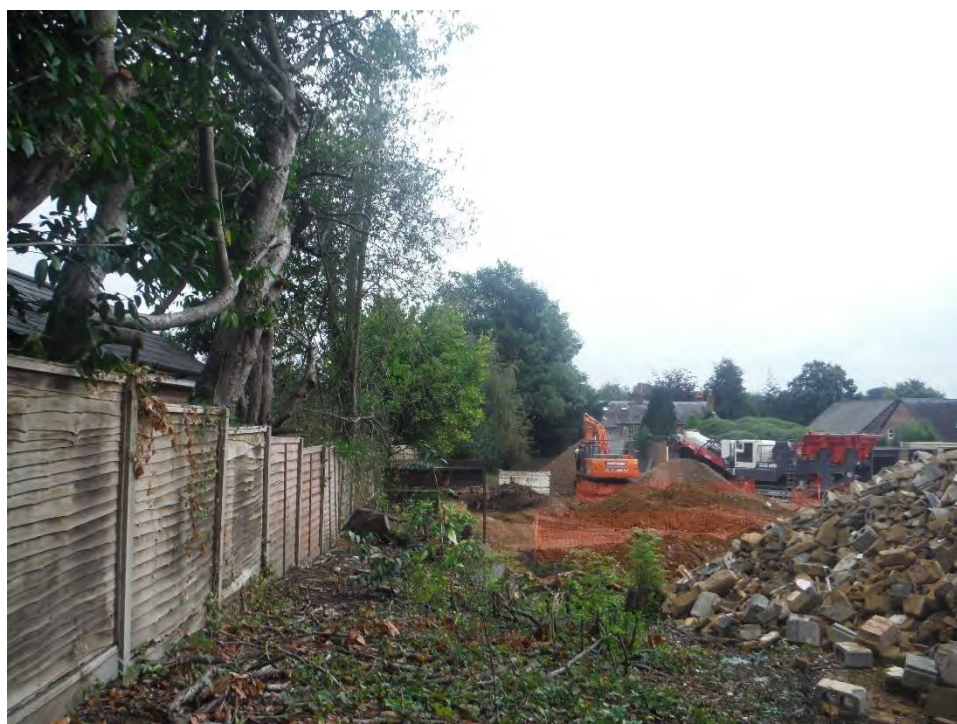
Plate 12: View east along northern edge of site showing decrease in original ground level from west to east.

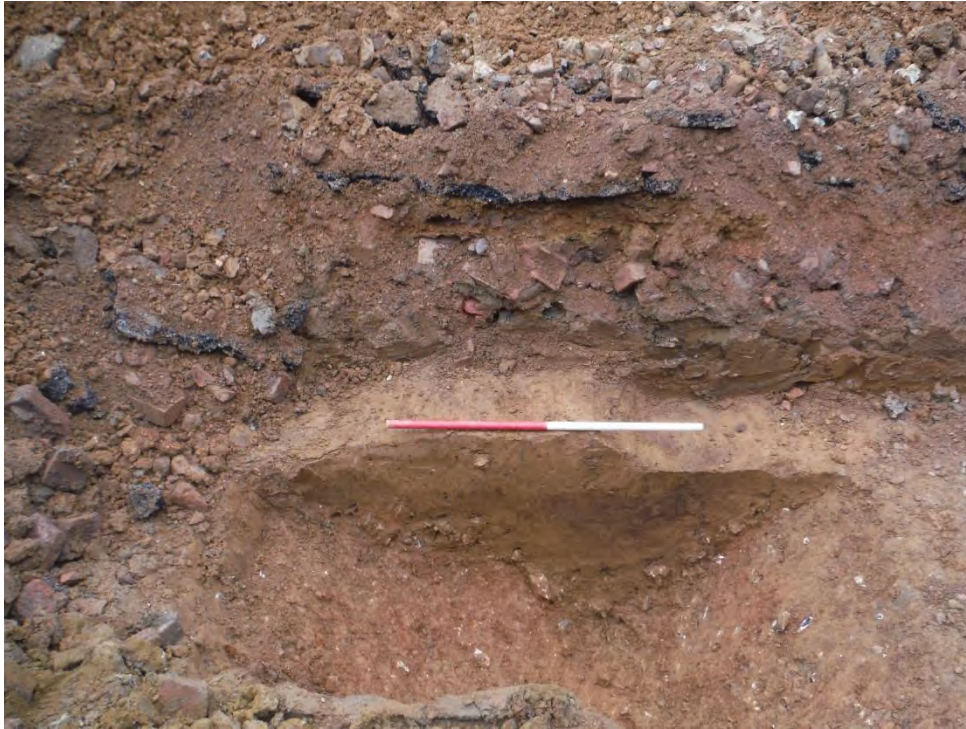
5.9.2 Tree throw [106] measured 1.95 m wide and was 0.77 m deep with steep sides and a convex base. It had four fills (105), (107), (108) and (109), all of which were of a clayey-silt composition. No archaeological finds were found in any of the fills. On the recommendation of Simon West, District Archaeologist, St Albans, the fills of this feature were sampled.

Plate 13: Trench 8. Section of tree throw [106] view west.
