**FIRST STREET PLOT 11 (8),
MANCHESTER M15 4FN**

**A SUMMARY OF AN
ARCHAEOLOGICAL EVALUATION**

ARCHAEOLOGICAL SITE CODE: FSS16

OCTOBER 2016

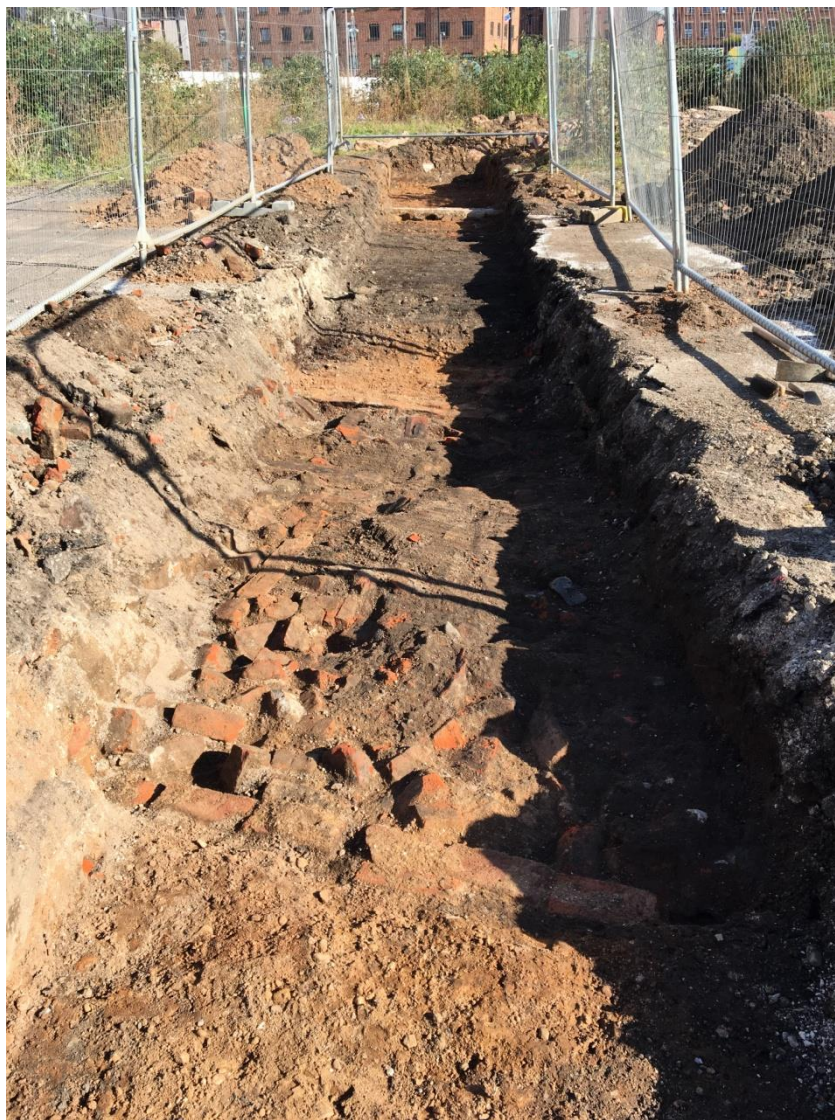
Plate 2: Late 18th or early 19th infilled cellar in Trench 1. Looking northeast.

2.8.1 The earliest deposit observed was the natural sand and gravels, [89], which occurred at a maximum height of 33.63m OD. In the middle part of the trench the natural was cut by the construction of a cellared building constructed from bricks dated to the late 18th or early 19th century. The external walls of the dwelling, [83] and [87], survived, as did an internal partition wall, [91], within the cellar. When the building was demolished, the rubble seems to have been used to backfill the cellar. It is uncertain to what depth the cellar survives as the backfill

was not excavated during the current investigation. Bancks' map dated 1831 (Figure 4) shows buildings along what later became Mount Street. The northernmost of these buildings seems to correspond with the building remains recorded in Trench 1. On the map, the dwelling is shown at the northern end of a terrace of houses with gardens to the east and west.

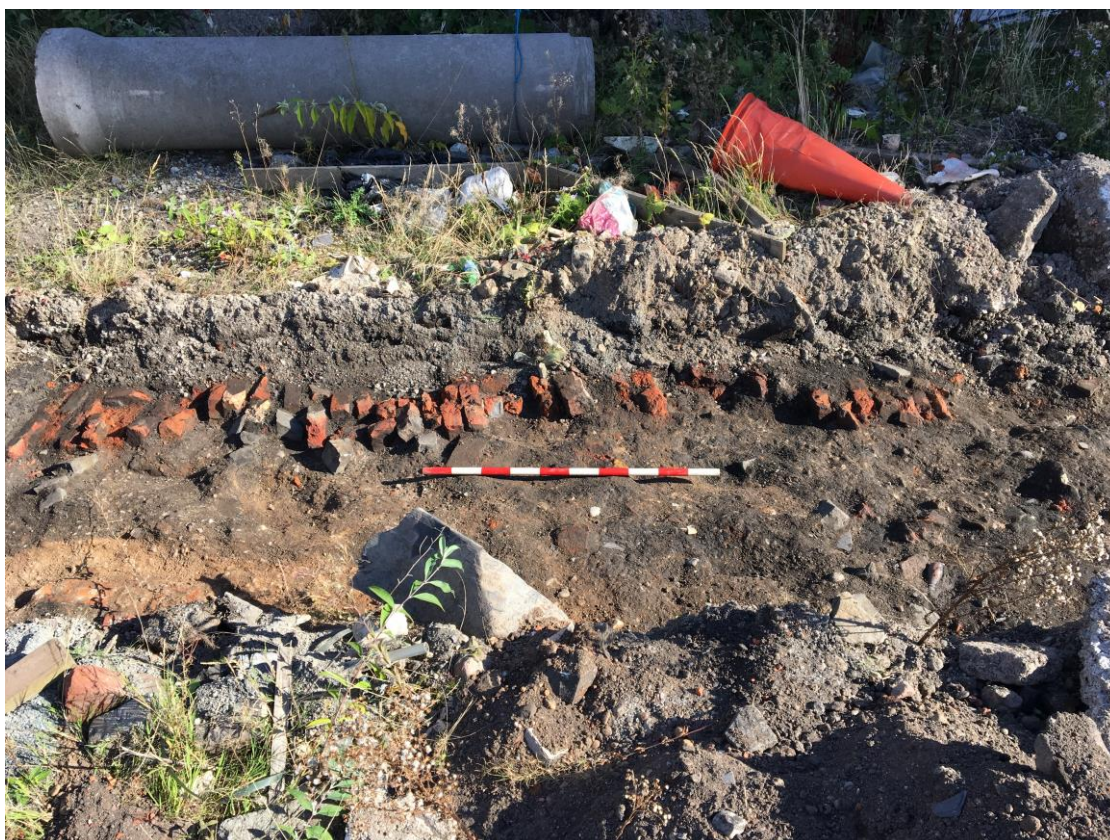
2.11.1 The southern half of the trench was occupied by the basement of Ebenezer School or the later engineering works and can be seen as the continuation of part of the basement recorded in TT202. While the southern end of Trench 4 was situated almost entirely within the compliance works basement, the northern end demonstrated the partial survival of the foundations and associated surfaces of the dwellings along the now extinct Galloway Street and Ebenezer Street. Here the foundations of the east wall, [69], of one of the dwellings facing Galloway Street survived. It consisted of unfrogged red bricks set in a mid-grey sandy lime mortar with frequent shell flecks. To the east of this were the truncated remains of a brick surface. As can be seen from Figure 5, which overlays the archaeological features onto the 1844-49 OS map, the brick surface corresponds with the area between the two easternmost buildings on the south side of Galloway Street. It presumably represents the paving of a passage leading to the latrines shared by the Galloway Street back to back houses. If this is indeed the case, then it is likely that a rectangular brick lined feature, [74], [75] and [76], at the

southern end of the paved area represents the remains of the communal cess pit.

Plate 4: Truncated brick surface in Trench 4 (1m scale). Looking northeast.

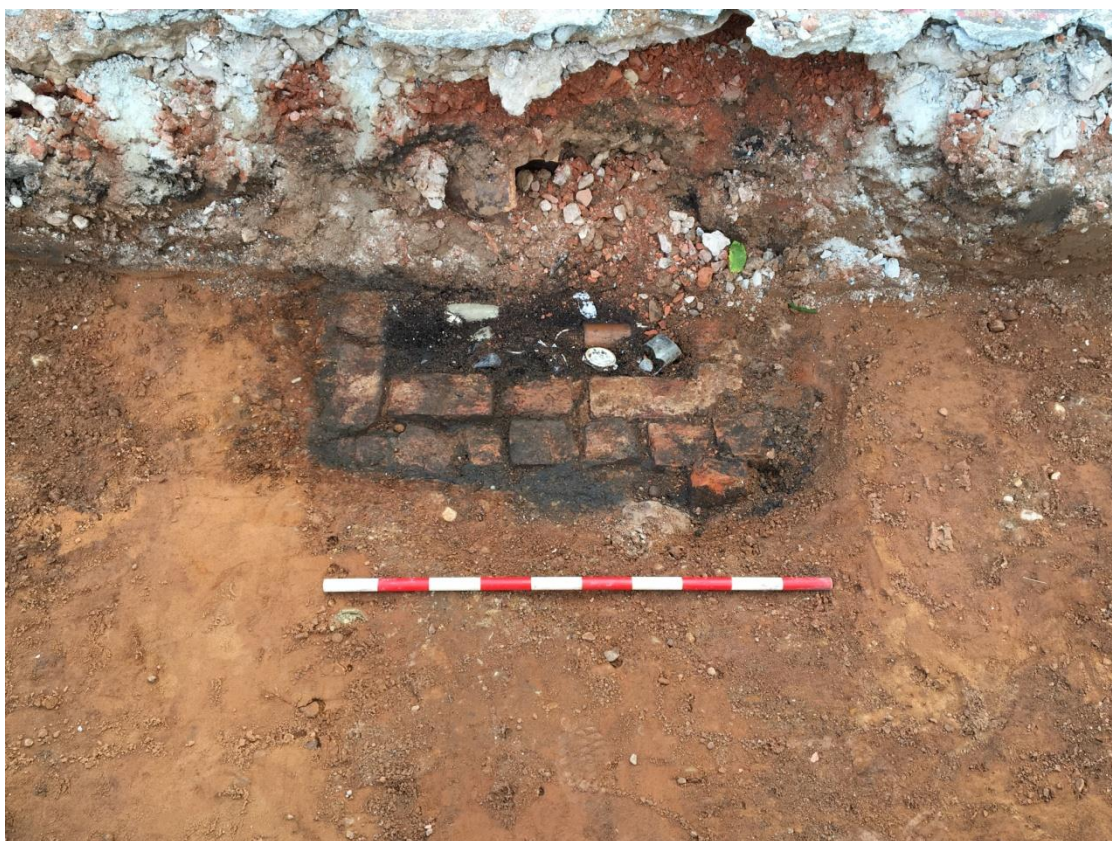
2.12.1 At the southern end of Trench 5, the natural sand was cut by a small square brick lined ash pit/cess pit, [58]. Although all but the lower 0.4m of the structure had been removed by later truncation, the surviving part of the fill, [57], contained a high quantity of finds including several almost intact stoneware bottles, and a wealth of mid-19th century pottery sherds. The structure itself consisted of a single skin of bricks laid in a stretcher bond. At the bottom of the pit, bricks were laid in order to form a solid base. Approximately 1.3m the north of the ash pit, an east-west aligned brick wall, [62], was recorded. Both of these appear to be of 19th century date, and are likely to relate to one of the properties backing onto Cream Court from at least the 1840s (see Figure 5).

Plate 5: Ash pit / cess pit [58] in Trench 5 (1m scale). Looking northeast.

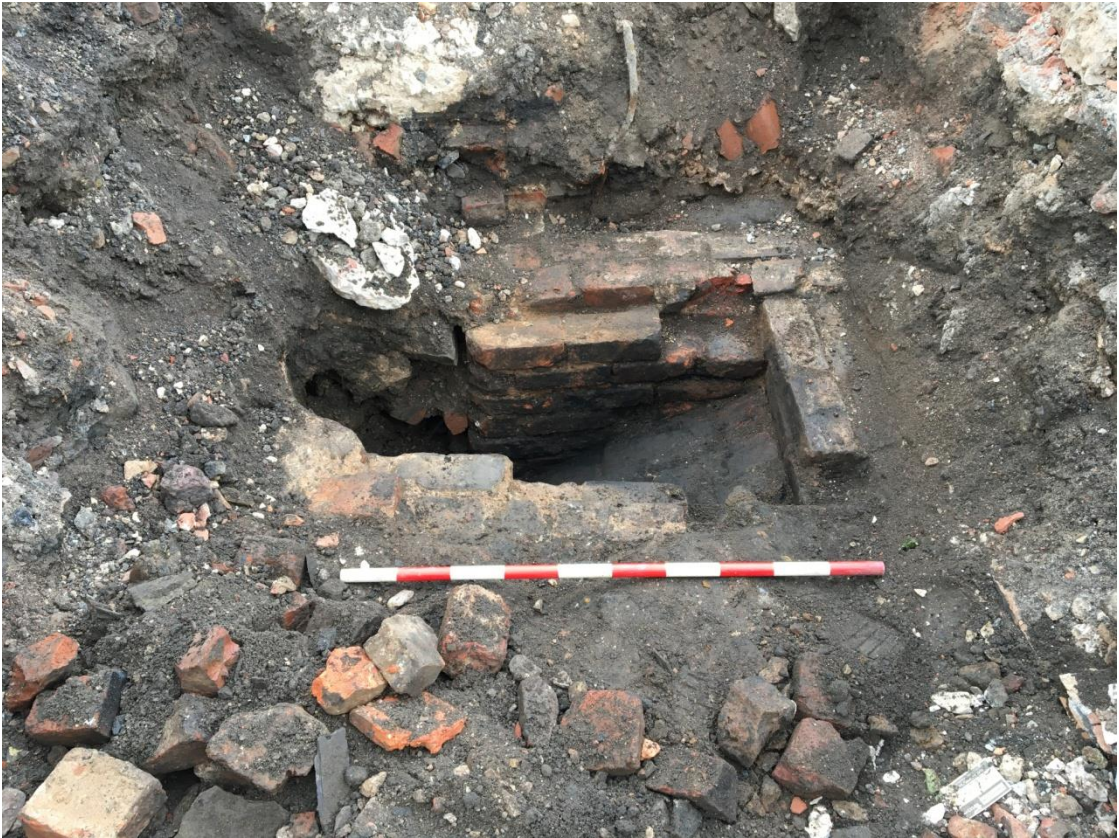
2.12.2 At the northern end of the trench, the natural sand was sealed by a compact clinker rich layer of gravelly sand, [65], which likely formed the bedding for Park Street. Extending into the northern end of the trench was another brick lined feature, [68], which was initially thought to be another ash pit. However, excavation of the fill revealed a moderately steeply sloping brick base. It is more likely that the feature forms the remains of a coal chute for one of the properties fronting the north side of Park Street. If this is indeed the case, then it is likely that the associated cellar of the building survives to the north of the trench.

Plate 6: Coal chute [68] in Trench 5 (1m scale). Looking northwest.

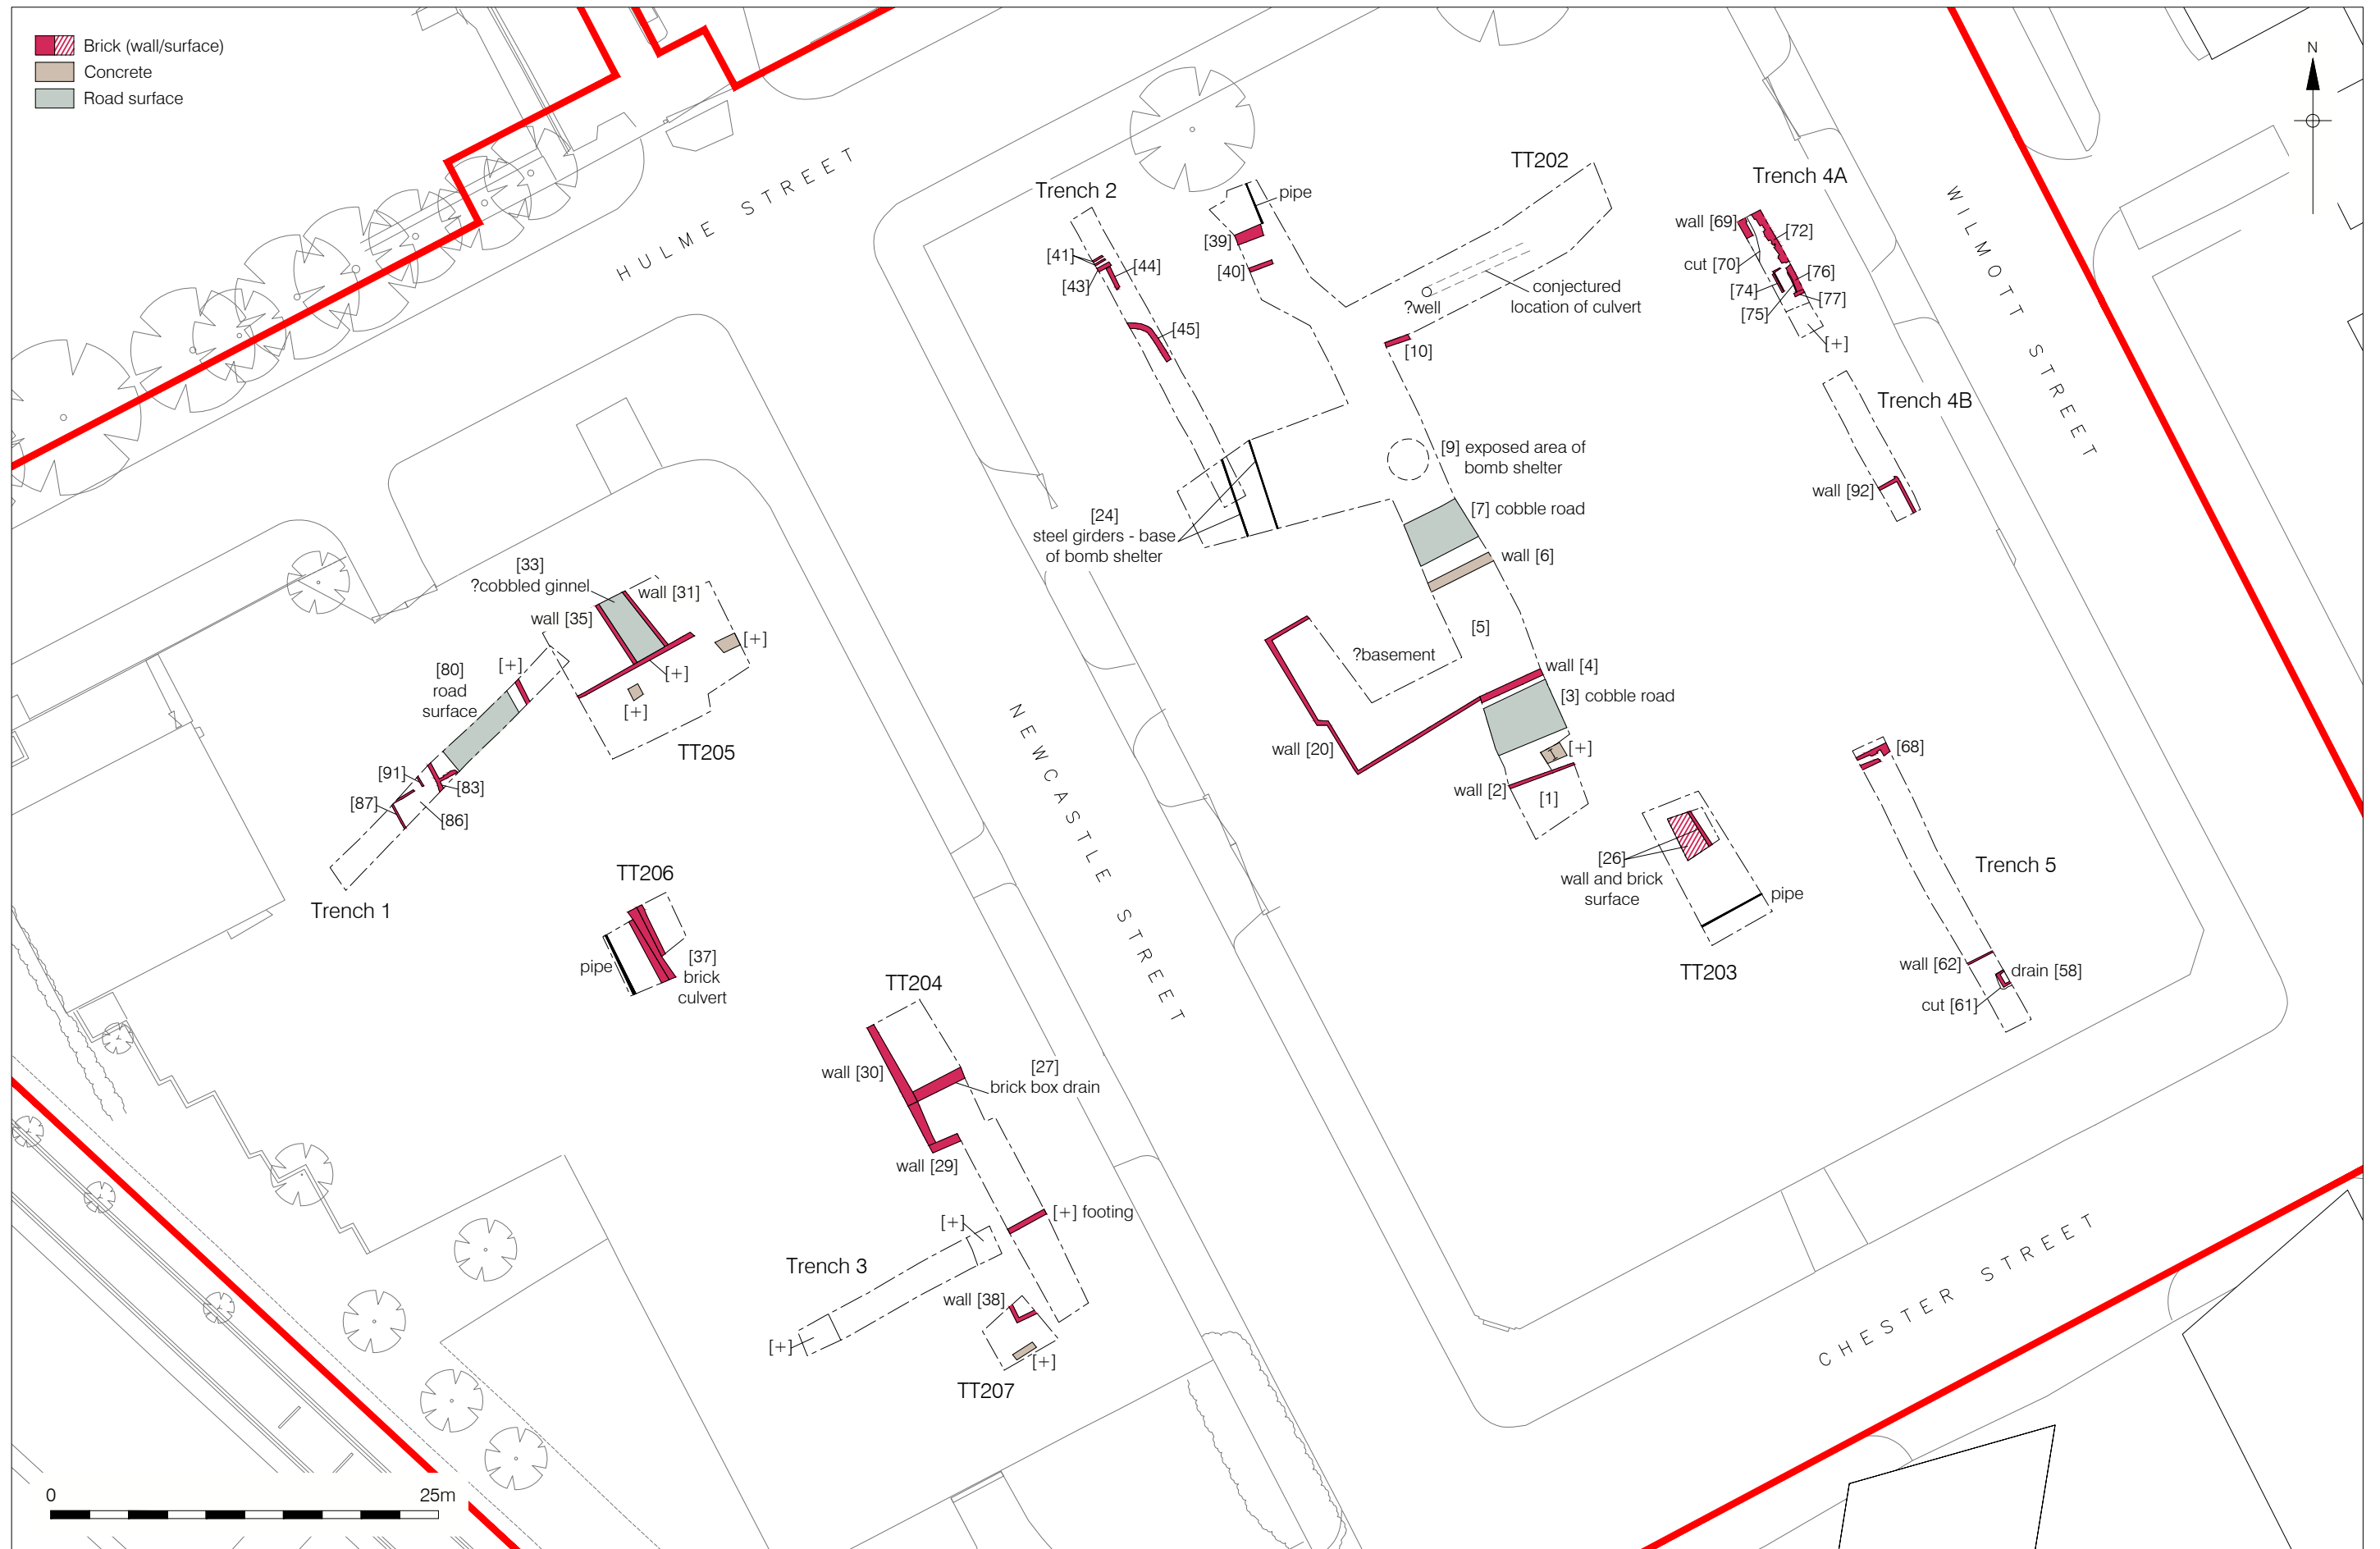
Figure 3
 Plan of all archaeological features
 1:400 at A3

2.2.3 Two large WWII air raid shelters, [9] and [24] aligned along a roughly north-south axis were recorded to the north of Ebenezer Street (Figure 3). Only the westernmost of these was exposed to its full width (2m) and measured at least 5.96m in length – the base of the western shelter was at a depth of approximately 32.54m OD, roughly 1.6m below the current ground surface. Only part of the northern end and a small part of the central part of the eastern

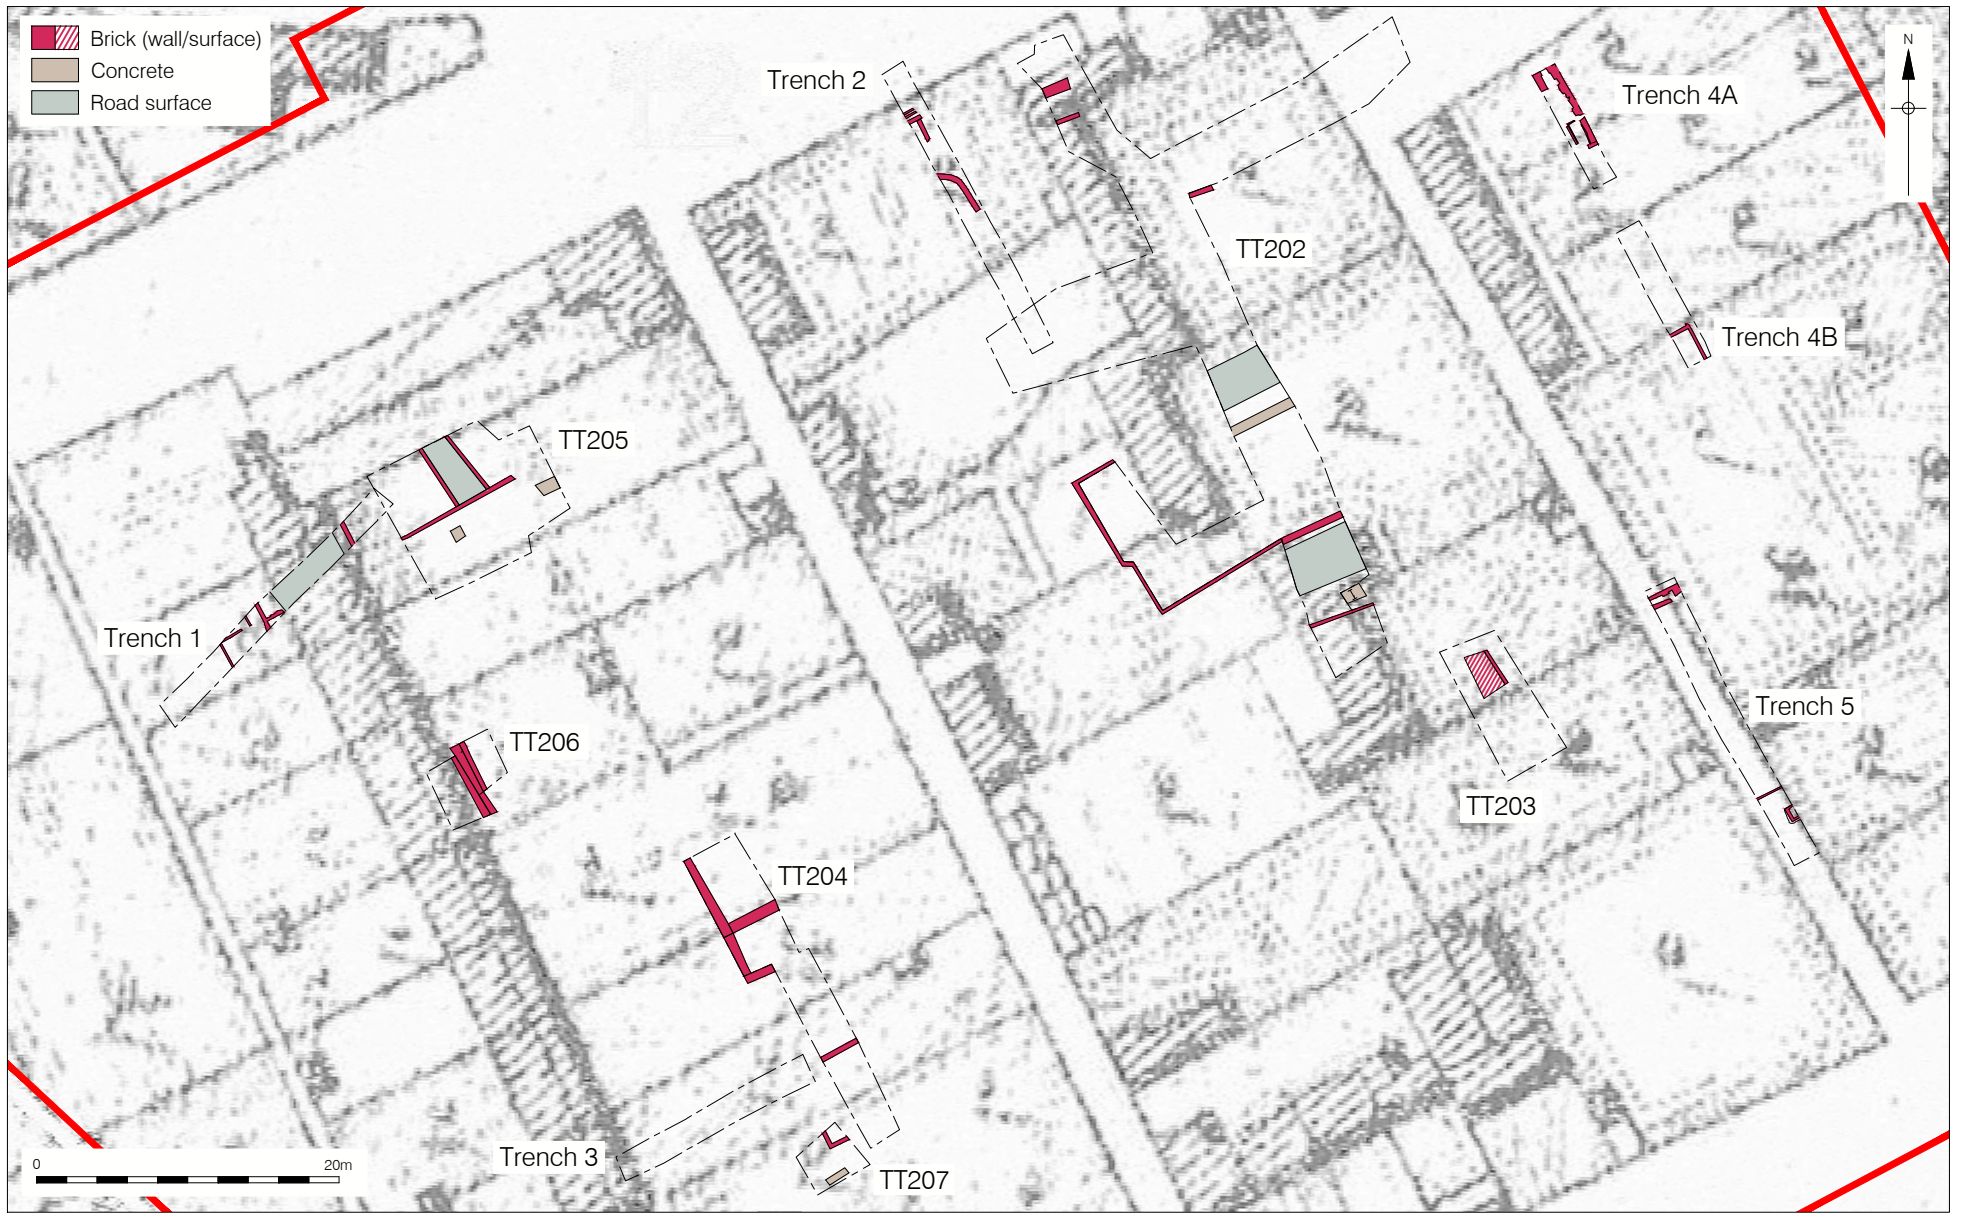
Figure 4
Features overlain on a detail from Bancks' map, 1831
Approx. 1:500 at A4

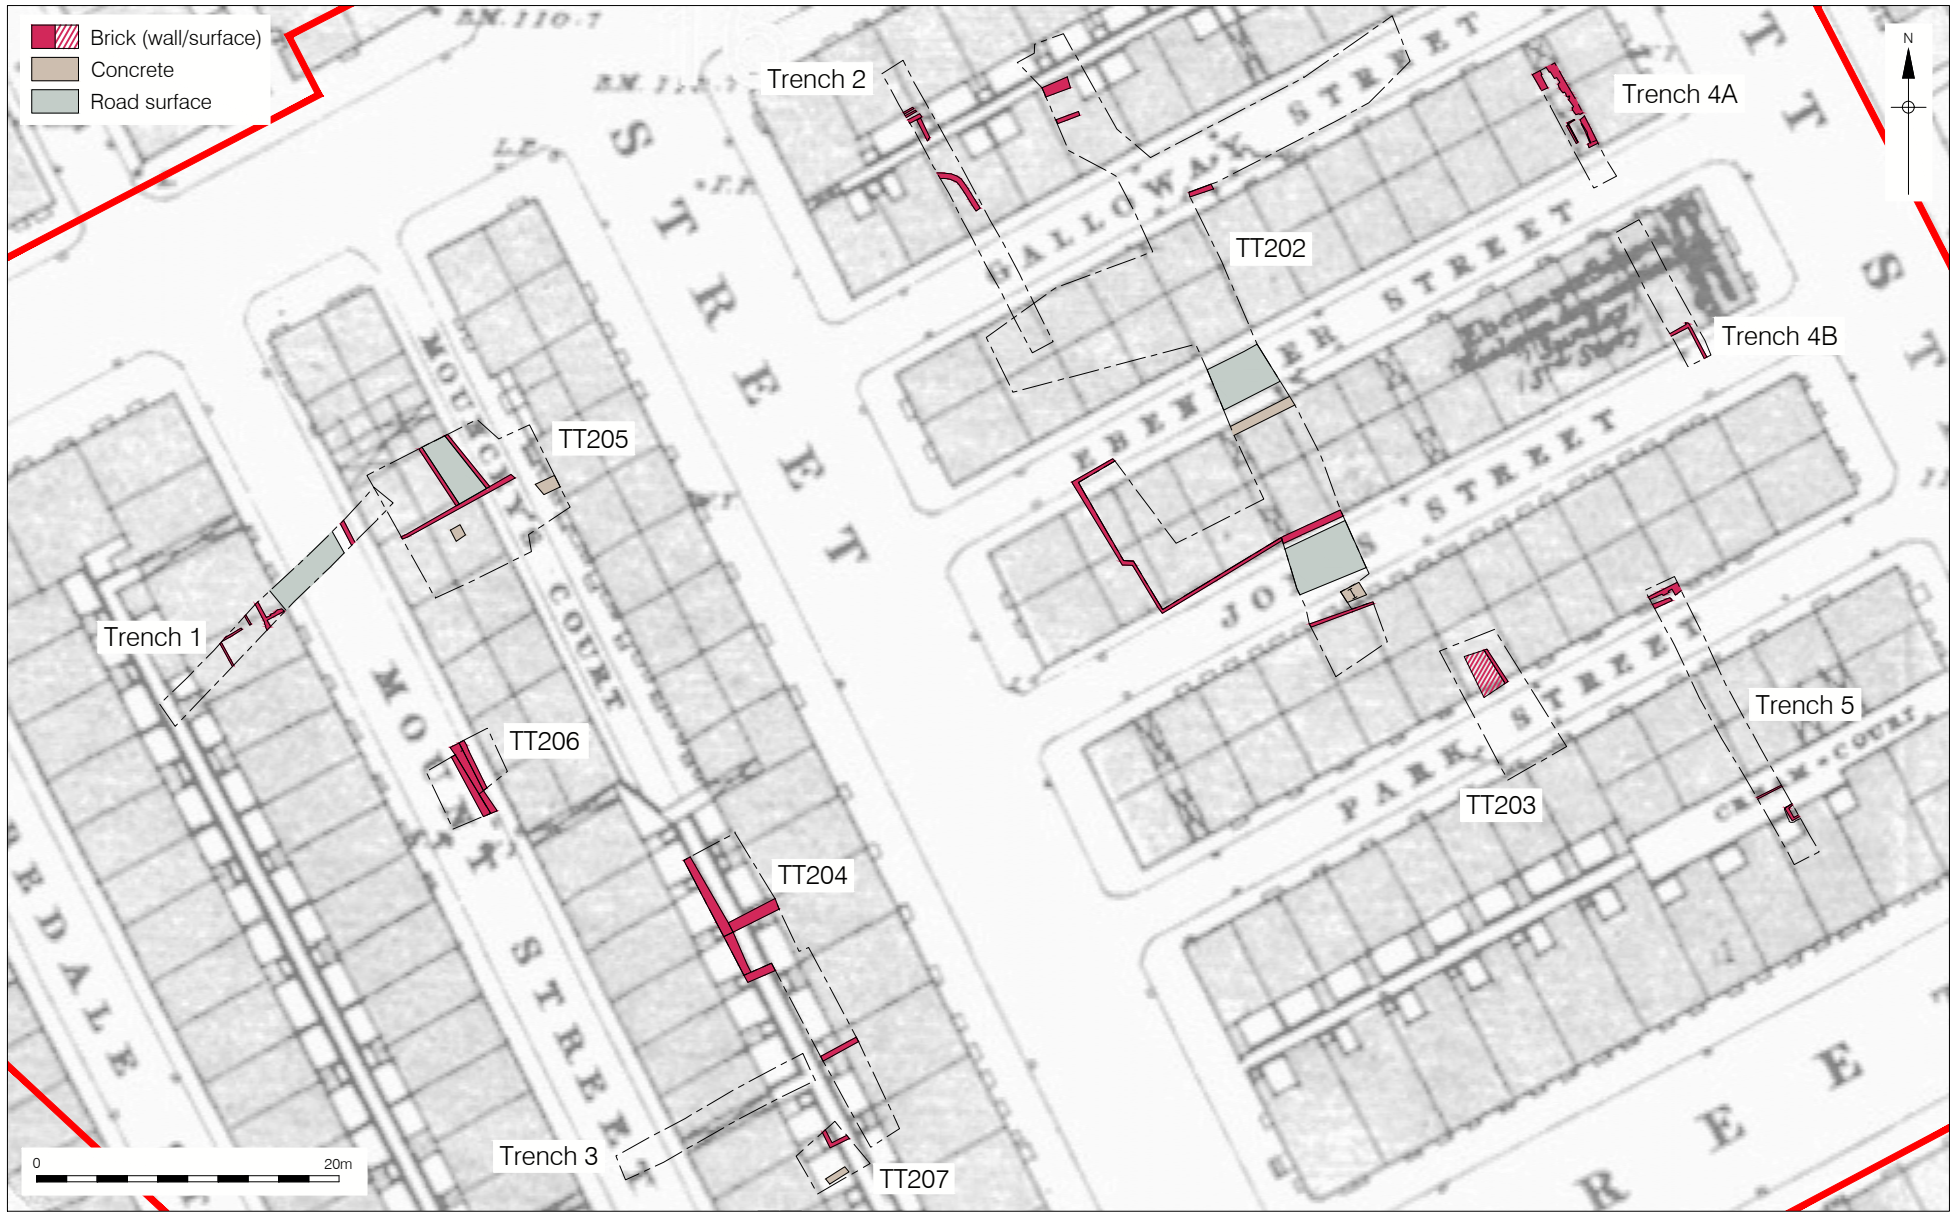
- 2.9.1 In Trench 2, the natural gravel was sealed by what appeared to be a 19th century yard surface, [48], comprising a relatively compact deposit of clinker and gravel set in a sandy silt matrix. Near the northern end of the trench, the yard surface was truncated by an east-west aligned brick box drain, [41]. To the south of this, the yard surface was butting against the north-eastern corner of a brick building, [43] and [44]. The surviving brickwork seems to roughly correspond to one of the buildings shown fronting Hulme Street on the 1844-49 OS map (Figure 5).

Figure 5
Features overlain on a detail from the Ordnance Survey map, 1844-49
1:500 at A4

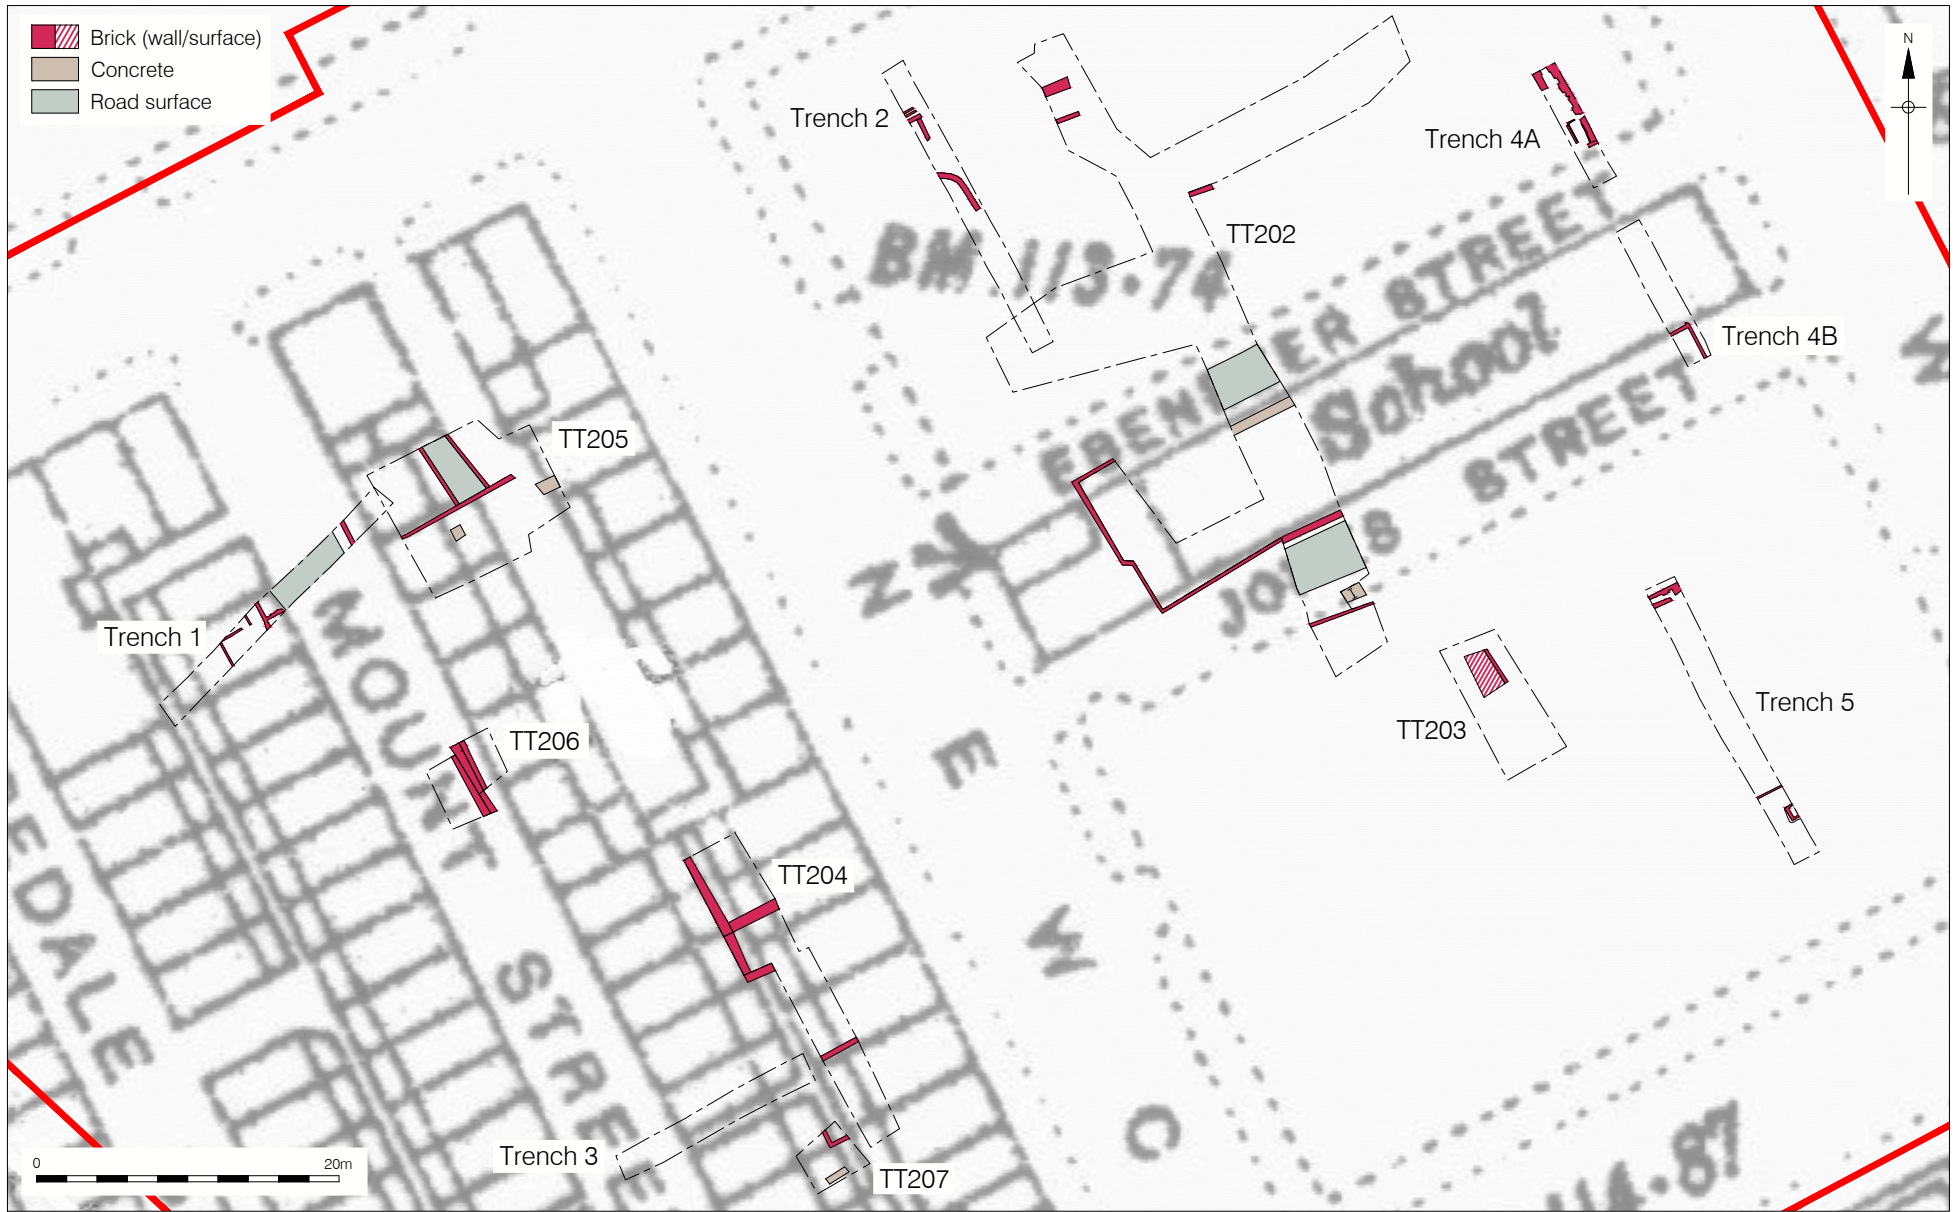
Figure 6
Features overlain on a detail from the Ordnance Survey map, 1932
1:500 at A4
