**BURLINGTON HOUSE,
BURLINGTON CLOSE, FELTHAM
TW14 8JU**

**AN ARCHAEOLOGICAL
WATCHING BRIEF**

SITE CODE BGT16

PCA REPORT NO: 12669

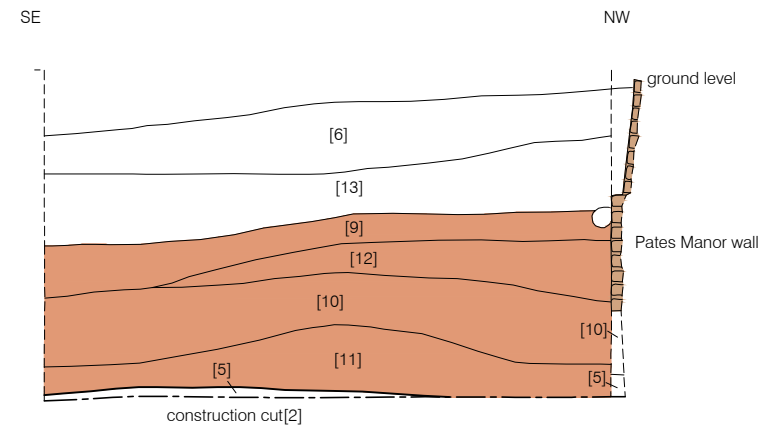
Section 8: Section through Made-Ground and construction cut backfill
North East Facing

7.3.5 In comparison, the construction cut backfill to the west of the wall (St Mary's Church side) consisted of three different fills (Figure 4, Plate 7) along most of its length, with an additional layer of fill to the northern end. The lowest of which was a pale yellow brown sandy silt with occasional gravels [11] to a maximum thickness of 0.35m, above which was a layer of demolition rubble [10], consisting of a pale yellowy white mortar with mid reddy orange brick fragments and lenses of pale grey sandy silt. To the north of the trench was a layer of pale grey brown silt [12] to a maximum thickness of 0.34m tapering out towards the south, that is capped by a mid orange yellow, heavily compacted layer of gravely sand [9] up to 0.22m thick, in which were found two disarticulated long bones from a juvenile, these were most likely disturbed during the original construction of the wall and redeposited within [9] during backfill. On the interface between [9] and [13] were lenses of charcoal to a maximum

thickness of 20mm. The concentration of building rubble within the backfill to the west suggests that the wall was most likely constructed from St Mary's Church side.

- 7.4.2 On the western side of the wall, at its northern extent, there is a deposit of mid grey brown gravely silt [13] (Figure 4), this heavily rooted deposit also contains occasional CBM and brick fragments, within this layer was also found a disarticulated human femur and a partial human skull (Plate 10) with two circular holes towards the rear which could be pathological as there was evidence that the wounds had healed prior to death. This layer appears to be redeposited soil from elsewhere within the graveyard, causing a rise in the ground level against the north-south wall [7] and east west boundary wall to Pates Manor (Plate 9). Over time excess spoil has been deposited here most likely from a number of sources in a practice which continues to this day, as reported by the Church Warden, during the burial of ashes at this site excess soil is scattered in this corner under the tree.

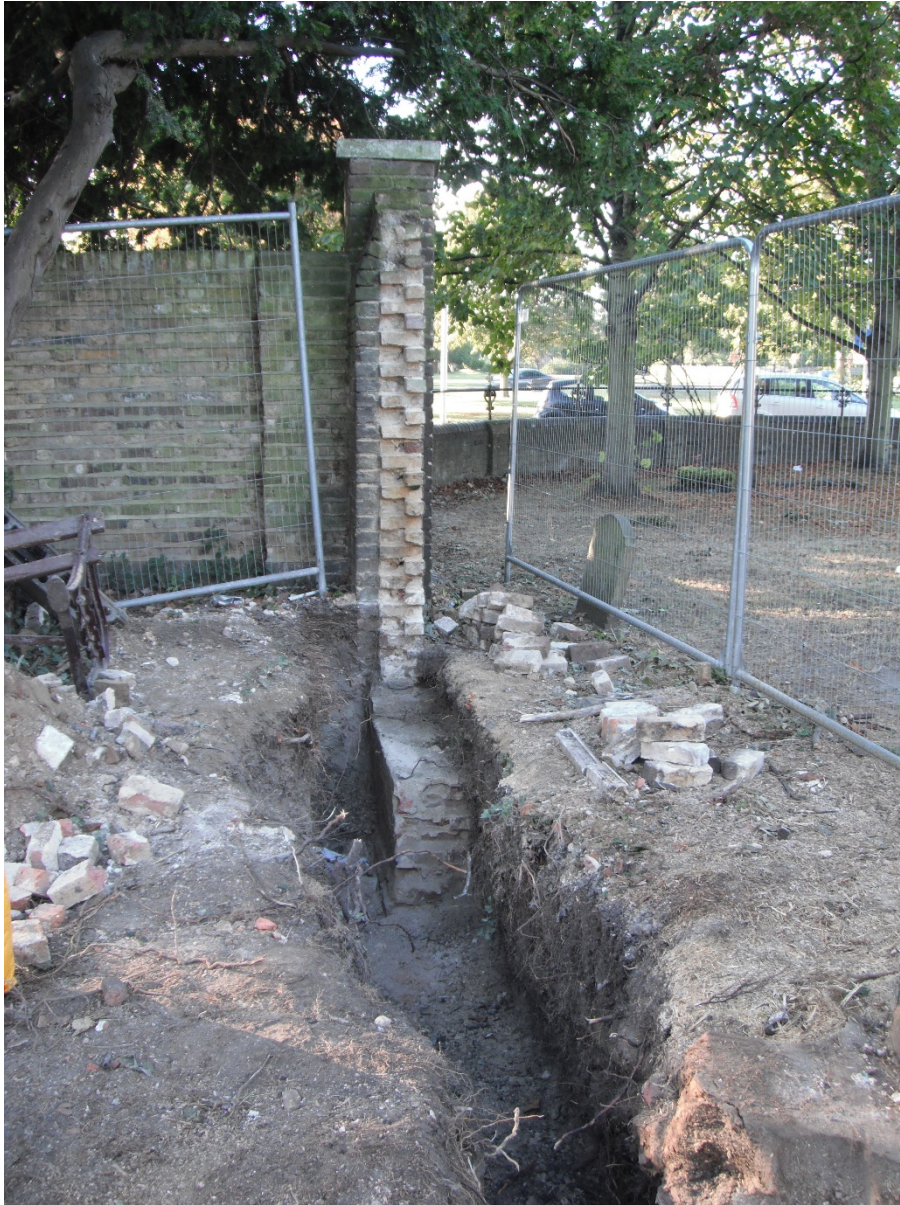
Plate 3: Looking south, north-south wall [7]

7.3.1 Along the full length of the trench was the construction cut [2] for the Grade II listed masonry wall [7] (Plate 3) and doorway [15] (Plate 5). The construction cut [2] measured 44.3m north to south, and a minimum of 0.70m east to west (its western extent is unknown as it extended beyond our LOE) and extended to a depth of between 0.80m and 1.59m BGL.

7.3.2 The 18th century masonry wall [7] (Figure 3 and 4, Plate 3) extended the full length of the trench, abutting an earlier east to west masonry boundary wall to the north marking the extent of Pates Manor, and continues to the south beyond the extent of the trench where it turns east to continue as the boundary wall for Burlington House. The bricks measured 220mm by 100mm by 60mm, were unfroged and of either a mid red- orange, mid pinky red and occasionally a mid purple colour. The wall consisted of 31 courses of brick in a Flemish bond, and was 0.22m thick, with the lowest two to four being below current ground level courses (up to 10 at its northern extent on the graveyard side due to soil build up). Below the wall was a 10 course foundation, where the upper 8 courses were to 0.34m thick and the two lowest were 0.46m thick forming a step (see Figure 4).

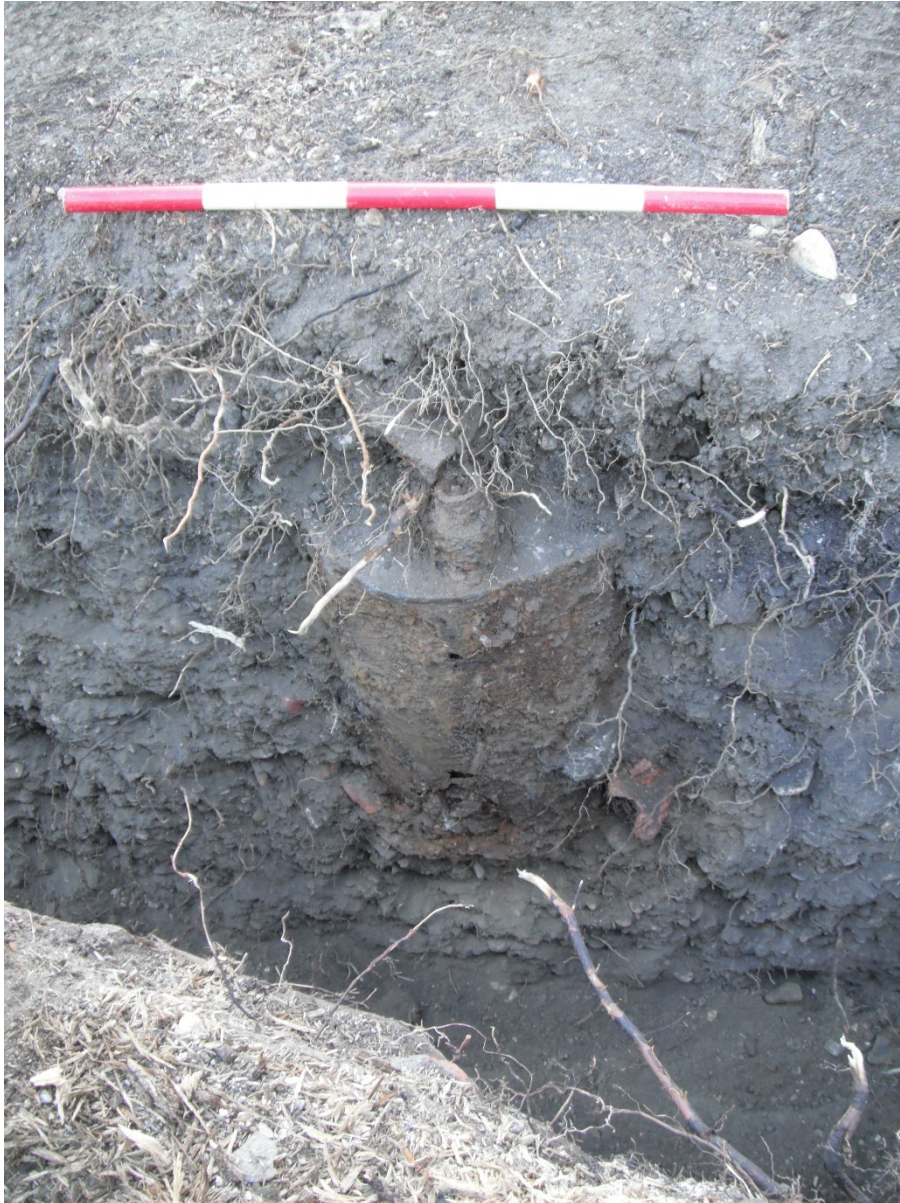
Plate 4: Looking east, southernmost lamp post base [14]

7.3.4 On the eastern side of the wall (Burlington House side) there was only one backfill within the construction cut (Plate 4), a mid grey brown sandy silt with occasional CBM, brick fragments, gravels and mortar flecking [1].

- 7.4.1 Along the eastern side of the wall were found a series of 7 hollow, heavily corroded, 450mm by 226mm metal cylinders [14] (Plate 4). These were spaced between 4.40m and 4.80m apart beginning 4.45m from the southern extent of the wall (Figure 3). They are most likely the bases for gas-fuelled lampposts erected within the garden of Burlington House.

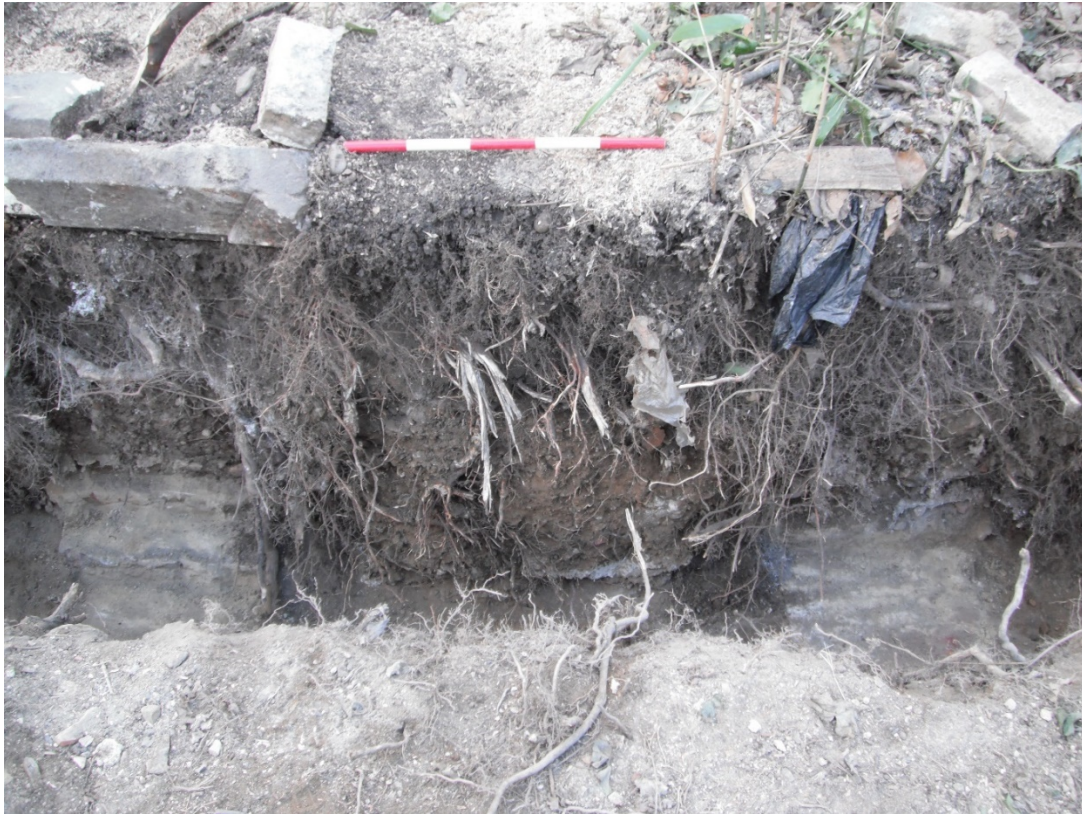
Plate 5: Looking west, foundation for doorway [15] within wall [7]

7.3.3 The centre of the wall is notable as it is the location of a doorway [15] (Plate 5). This doorway consisted of a wooden six panel door which was flanked by brick pillars to the same construction and dimensions as the corner pillar at the southern extent of the wall. The brick pillars extended at least one course of masonry below the rest of the wall foundation (limits on excavation depth meant that further excavation was not possible).

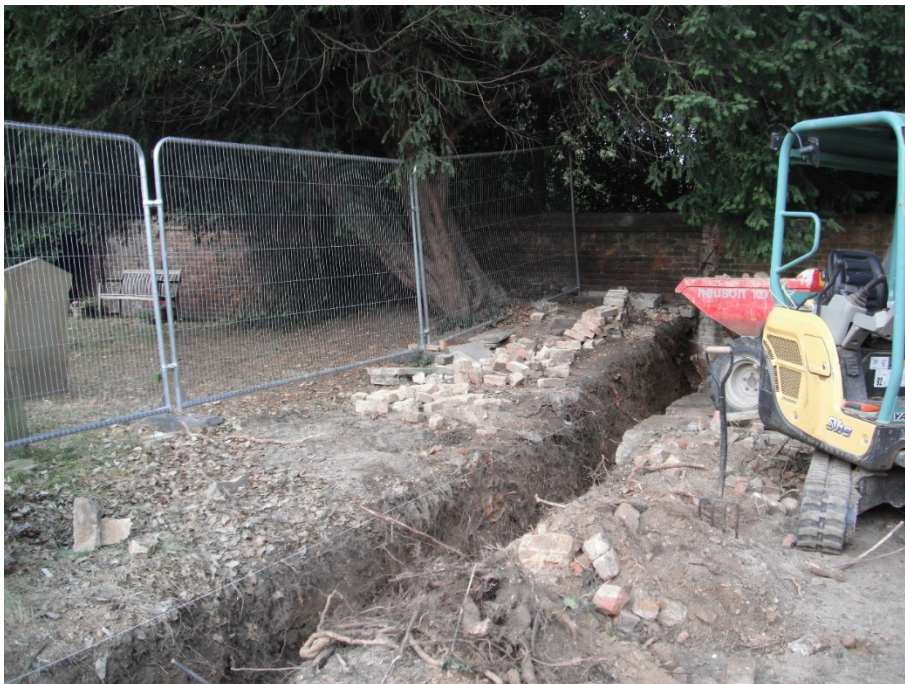
Plate 8: Looking northwest, raised ground around the base of established Yew tree.

- 8.5.4 Preservation was good mostly due to the lack of modern intrusion, most likely due to the Grade II listing status of the wall, however some damage has occurred due to the large size and wide roaming roots of the established trees on site.
