**ST. MARGARET'S CHURCH,
WESTMINSTER ABBEY,
LONDON**

**AN ARCHAEOLOGICAL WATCHING
BRIEF**

PCA REPORT NO: 12704

SITE CODE: MCH15

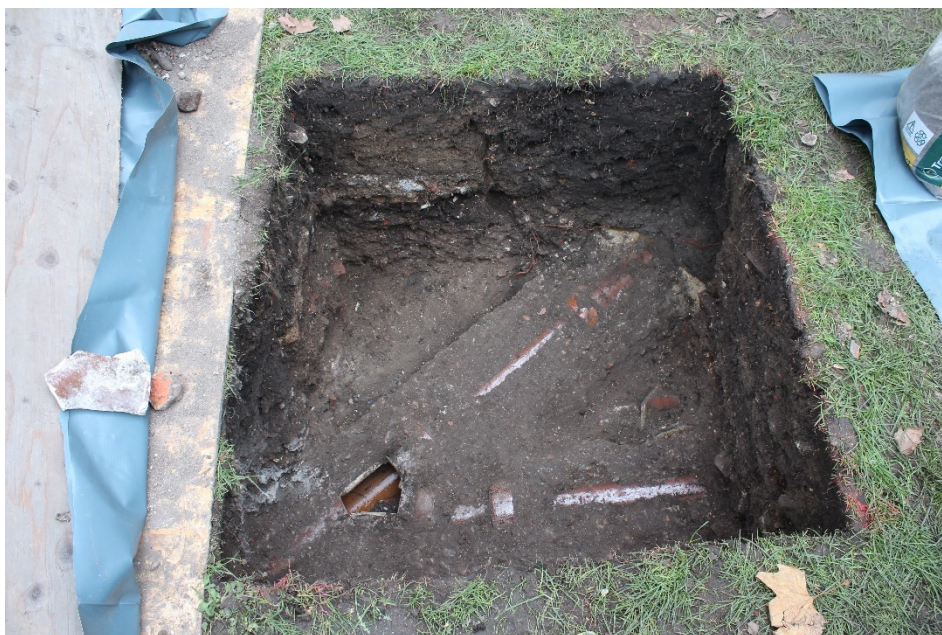
Plate 2: Trench B, view west

6.2.1 The earliest deposit encountered was a layer of demolition rubble, [20], recorded at a maximum height of 3.87m OD. It comprised loose brick and mortar rubble in a mid-grey fine grained silty sand matrix with occasional mollusc shell flecks. This was sealed by additional and contemporary demolition deposits, [17]-[19]. The top of the demolition sequence was recorded at 4.29m OD and culminated with the deposition of layer [17]. This sequence could be dated to the mid-18th/early 19th century based on the pottery recovered from its deposits. Cartographic evidence shows that from at least the middle of the 18th century the area between the east end of the church and Margaret Street was occupied by buildings. These were cleared sometime between 1806 and 1808 (Thornbury 1878). The artefactual evidence from the demolition sequence fit within the period of the clearance of the buildings and it is probable that the layers can be attributed to this event.

- 6.2.2 Two successive layers of made ground, [13] and [16], sealed the demolition sequence with the top of the upper layer seen at a height of 4.56m OD. Both of these produced finds dated to the late 19th century. The upper layer, [13], was cut by a small 0.25m deep pit, [15], with vertical sides and a flat base. Due to later truncation the shape of the pit could not be determined. The pit was filled with [14], which comprised loose dark brownish black silty sand with occasional small sub-angular stones.
- 6.2.3 The archaeological features and deposits were only seen along the east and west sides of the trench as the junction of the two drain pipes targeted by the trench was located in the centre of the excavated area. As such, the construction trench for the drains had cut through all of the archaeological deposits.

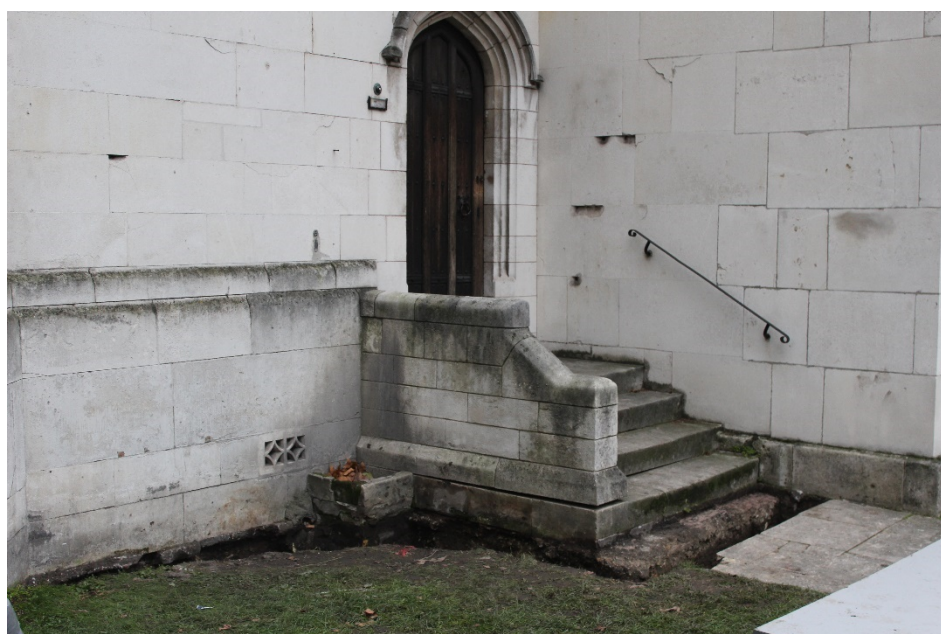
Plate 3: Overview of Trench C, looking north

- 6.3.2 This had been truncated by the construction cuts for the east wall of the vestry, [21], and the access stairs, [4] to the west and north respectively. Of these, the construction cut for the vestry was the earliest. It had been truncated by a later construction cut, [9], to the south and to the east by a modern drainage trench. The foundation, [12], of the vestry occupied the western part of the construction cut. Like foundation [38] in Trench A, it was constructed using red unfrosted bricks measuring 230mm x 100mm x 70mm and bonded with pale to mid-grey

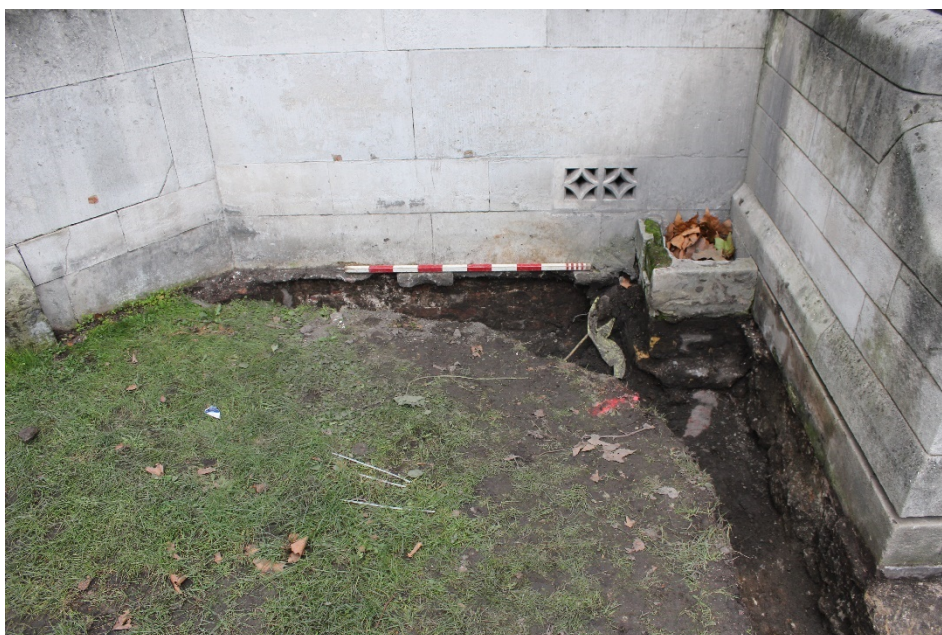
Plate 4: Overview of Trench C, looking west

- 6.3.3 To the south, the footing was abutted by [9], which formed the construction cut for the southeast buttress of the vestry, [10]. The buttress was stood on a foundation of red bricks bonded with hard mid-grey lime mortar. It is probable that the buttress and the footing are contemporary although they seem to be contained within separate cuts. Cartographic evidence seems to confirm this. Filling the construction cut for the buttress and sealing both footings [10] and [12] was a deposit of loose fine grained mid-reddish brown sandy silt, [8].

- 6.3.4 At the northern end of the trench, layer [2] had been truncated by the construction cut, [4]/[6], for the foundation for the access stairs to the vestry, [11]/[5]. The cut, which was seen at a maximum height of 4.49m OD, measured 0.80m in width by 0.34m in length by 0.23m in depth. It was much wider than the footing for the stairs, indicating that this had been constructed freestanding within the cut. The footing, [11]/[5], had been constructed using roughly hewn blocks of Kentish ragstone laid in regular courses bonded with mid-grey lime mortar. While the exact date for the construction of the access stairs at the east end of the vestry is not known, it can be gathered from historic maps of the area that they must have been constructed between 1878 and 1895. Filling the construction cut was a friable deposit of dark blackish brown clayey silt and ragstone rubble, [3]. Excavation of the fill produced a few residual sherds of pottery dated 1740-1830.

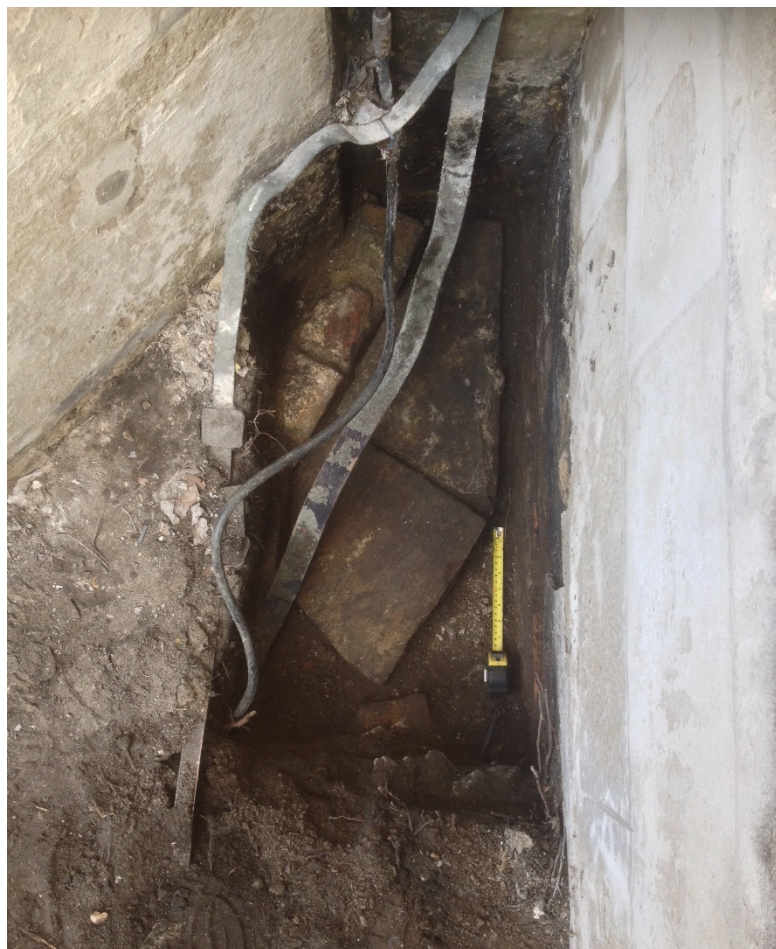
Plate 5: North end of Trench L, looking east

- 6.6.1 The earliest feature exposed was the late 15th century Kentish ragstone footing for the west wall, [55], of St Margaret's church. This extended below the base of the excavation (4.41m OD), so only the upper 0.40m of the footing were exposed. Even so, this was enough to show

the transition between the Portland stone facing and the roughly hewn blocks of ragstone. If the exposed area is representative of the west wall as a whole, then the 18th century refacing of the wall started only 80mm below the current ground surface.
