**HISTORIC BUILDING RECORDING
OF COSBY PHARMACY,
67 MAIN STREET,
COSBY,
LEICESTERSHIRE,
LE9 1UW**

PCA REPORT NO: R12715

**NOVEMBER 2016,
UPDATED DECEMBER 2016**

Historic Building Recording

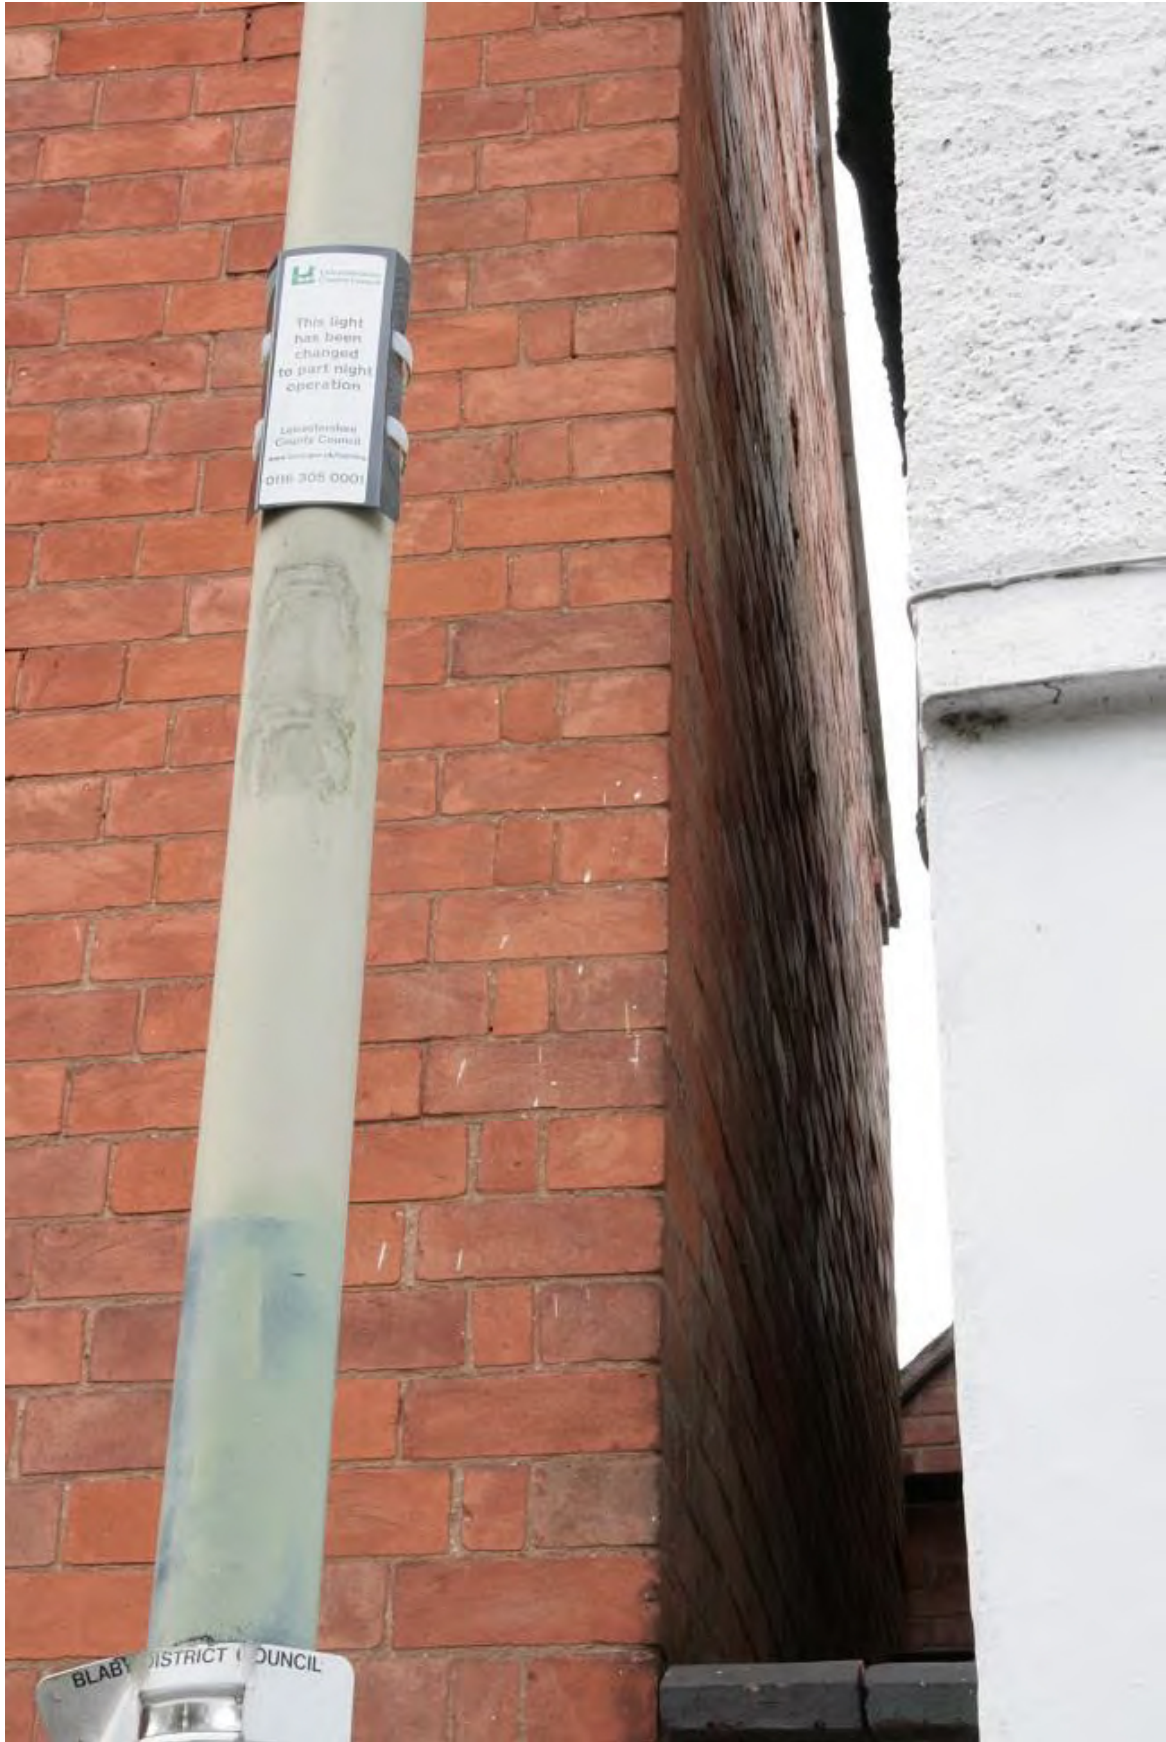
Plate 9: Oblique view showing north-east (side) elevation, looking up and north-west (LMSC16 D100 (116))

- 6.3.1 The north-east gable elevation was built blind (**Plate 9**) with a central chimneystack rising

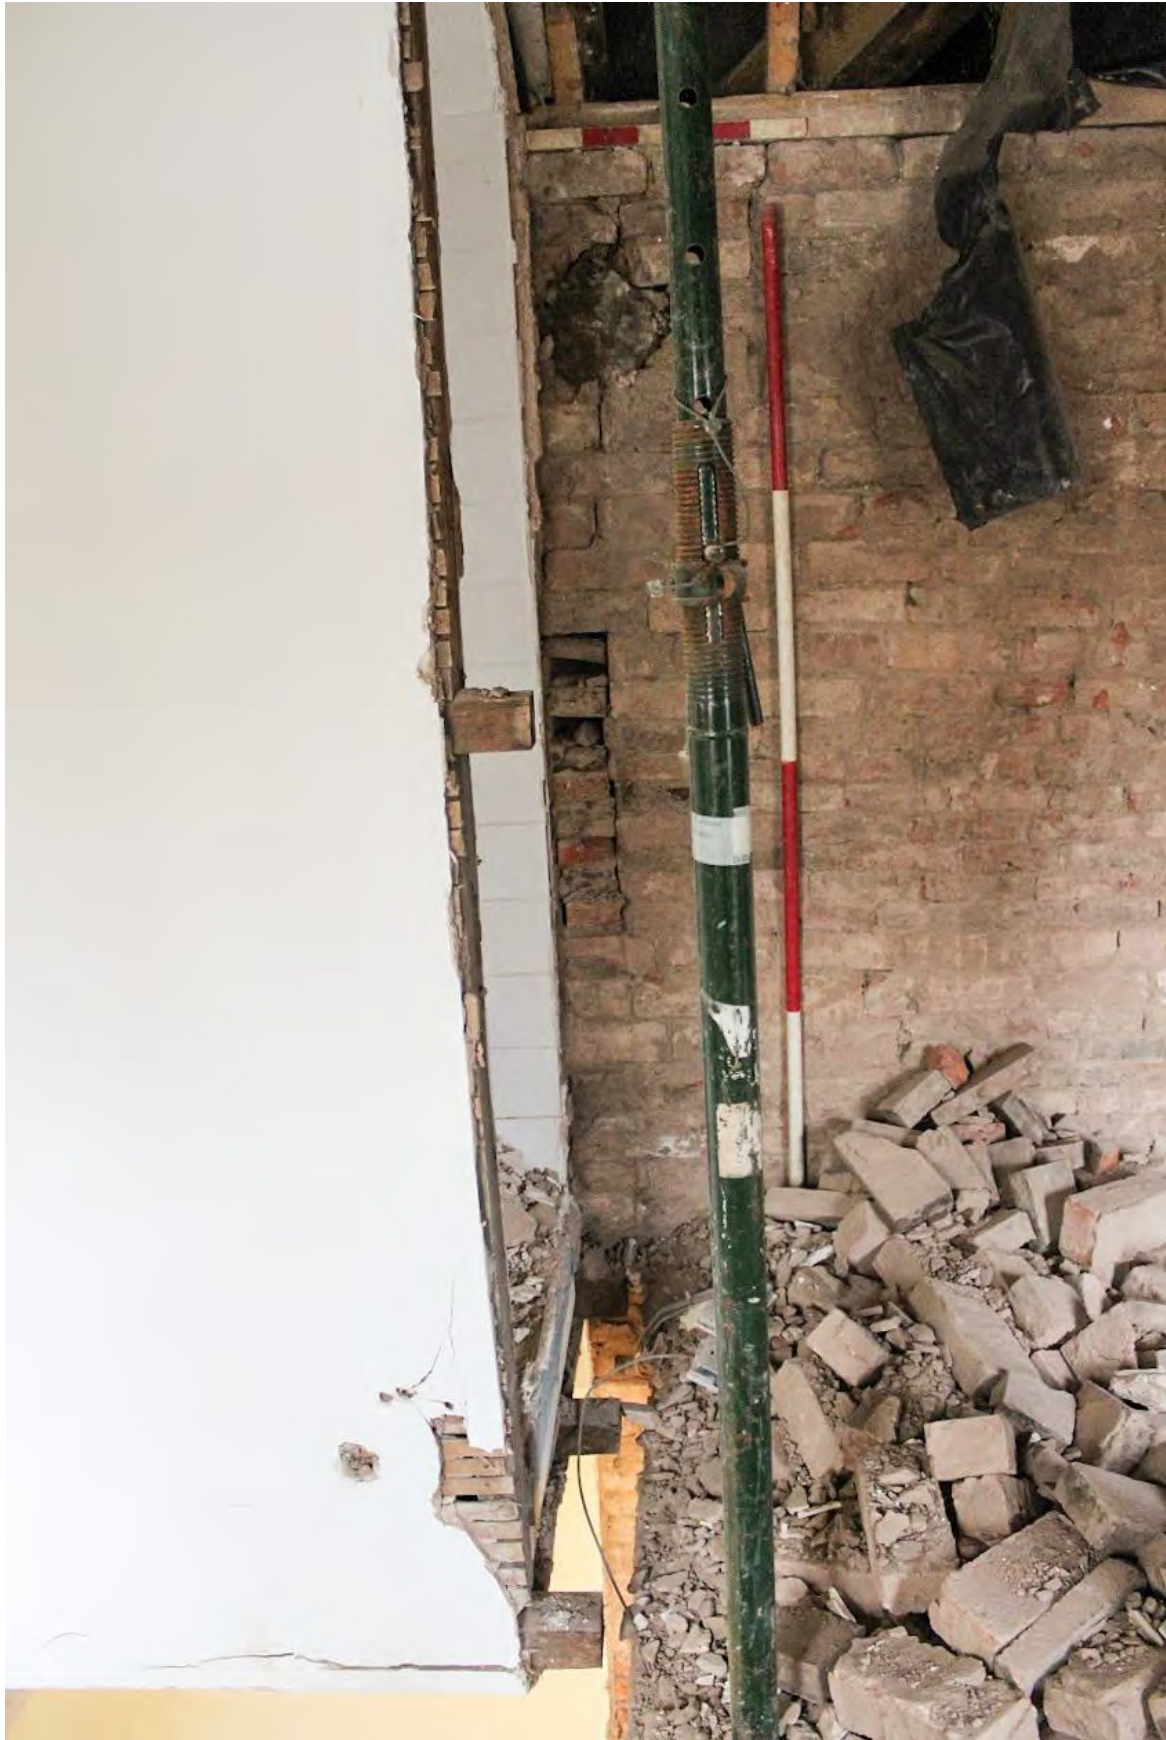
Plate 89: North-west wall of Staff Room following removal of the south-west wall, looking north-west (LMSC16 D103 (32))

- 6.6.23 The removal of the south-west wall of the Staff Room revealed the cut end of a timber in the north-west wall where the south-west wall had been removed (**Plates 89 and 90**). This timber was partially in the round and may relate to the late medieval or early post-medieval section of timber-framing observed in 2003 forming the gable end of the adjacent no. 69 Main Street.

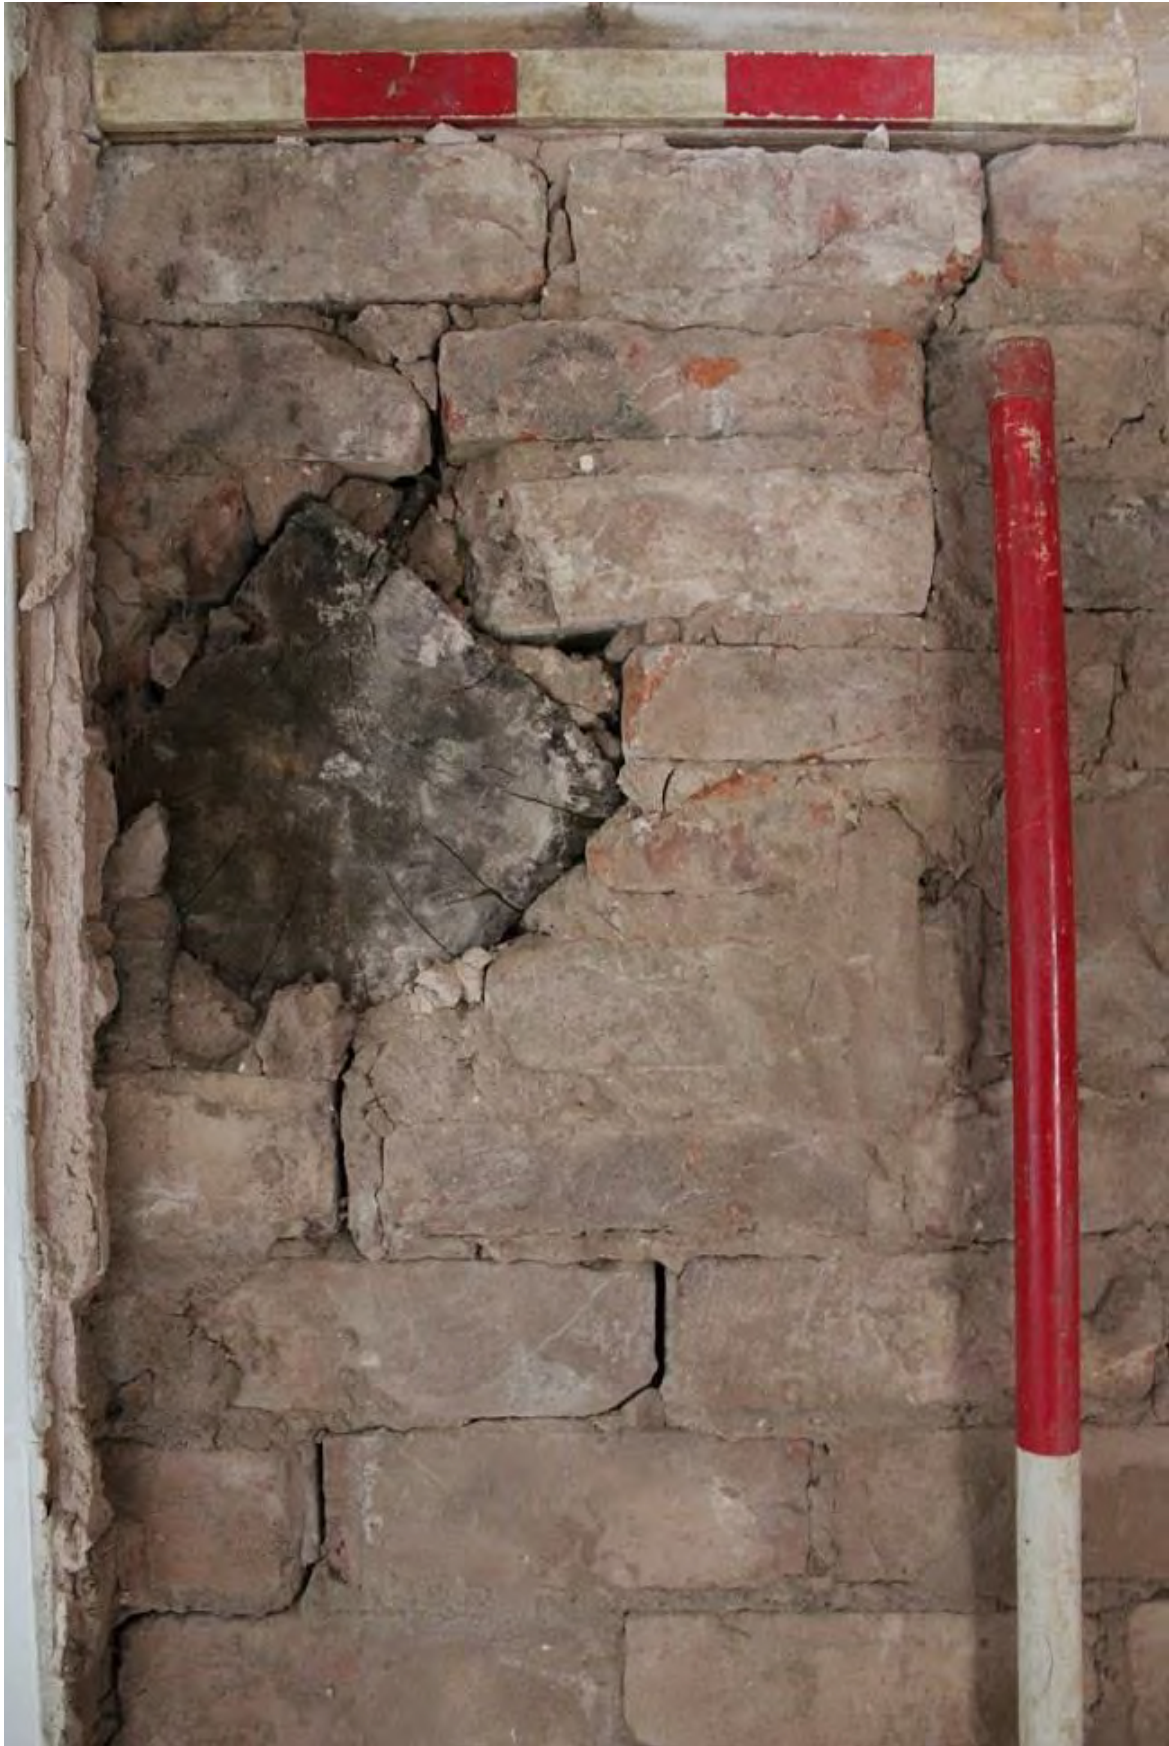
Plate 90: Detail of timber in north-west wall of Staff Room following removal of the south-west wall, looking north-west (LMSC16 D103 (35))

- 7.4 During the alteration works, the cut off end of a timber in the round was found in the gable wall between nos 67 and 69 Main Street. The timber may have been from an earlier wall plate. Soft stripping of the plaster from a number of internal walls revealed that some of the bricks were covered with whitewash suggesting that the bricks may have been reused. The lower part of an internal partition wall was found to have been constructed from narrow bricks much narrower than the rest of the brickwork suggesting that it was built of reused earlier bricks.

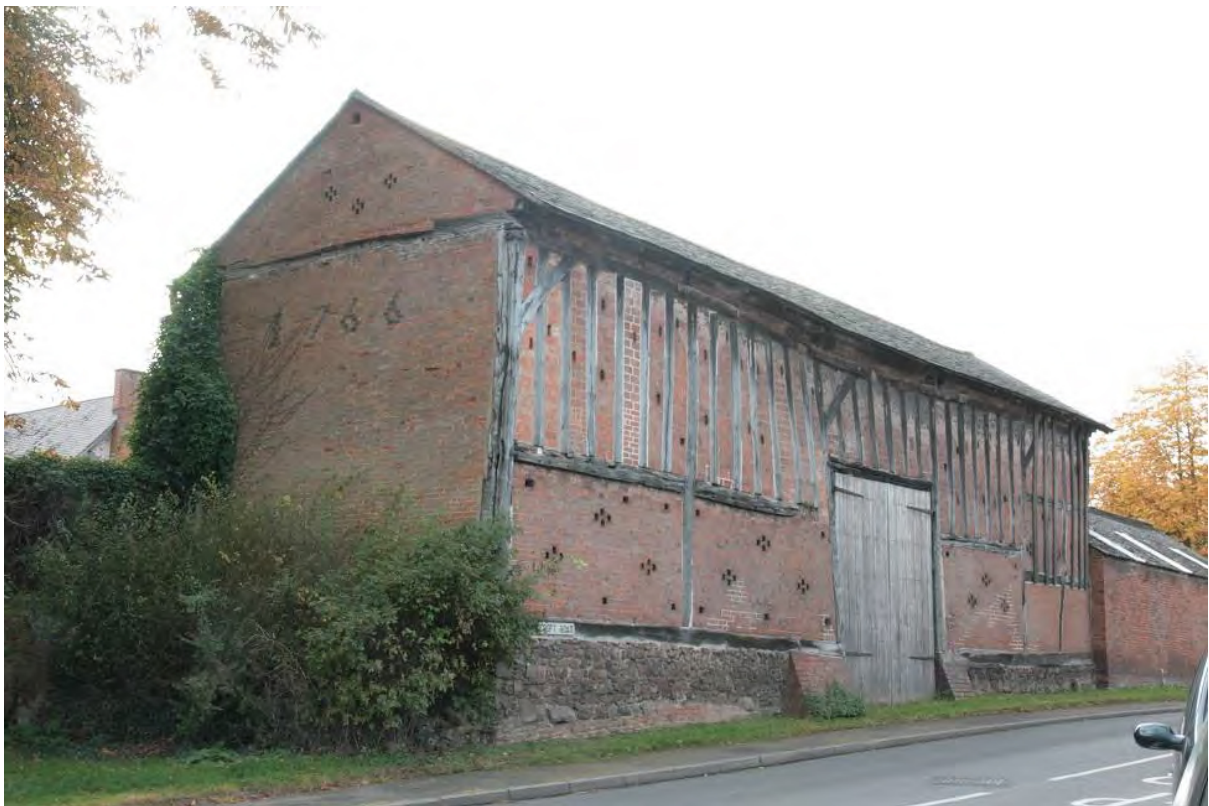
Plate 100: Late C16 Grade II Listed Barn, altered 1766, late C18, C19 and C20 on south side of Croft Road, Cosby with stone rubble plinth, looking west (LMSC16 D100 (132))

- 7.3 It appears that no. 67 Main Street was rebuilt in the late 19th century on the site of an earlier timber-framed building. A building is shown in this location on the 1833 map. A stone rubble plinth was observed during the building recording exercise running along the rear (north-west) elevation of no. 67 Main Street (Cosby Pharmacy) and rear (south-west) elevation of no. 67 Main Street (where it continued to the north-west as no. 69). Other earlier historic buildings in Cosby have similar stone rubble plinths including a timber-framed barn within the grounds of Cosby House.
