**HISTORIC BUILDING RECORDING
OF HOLLY COTTAGE,
NO. 20 ROOKERY LANE,
GROBY,
LECESTERSHIRE,
LE6 0GL**

PCA REPORT NO: R12737

DECEMBER 2016

Historic Building Recording

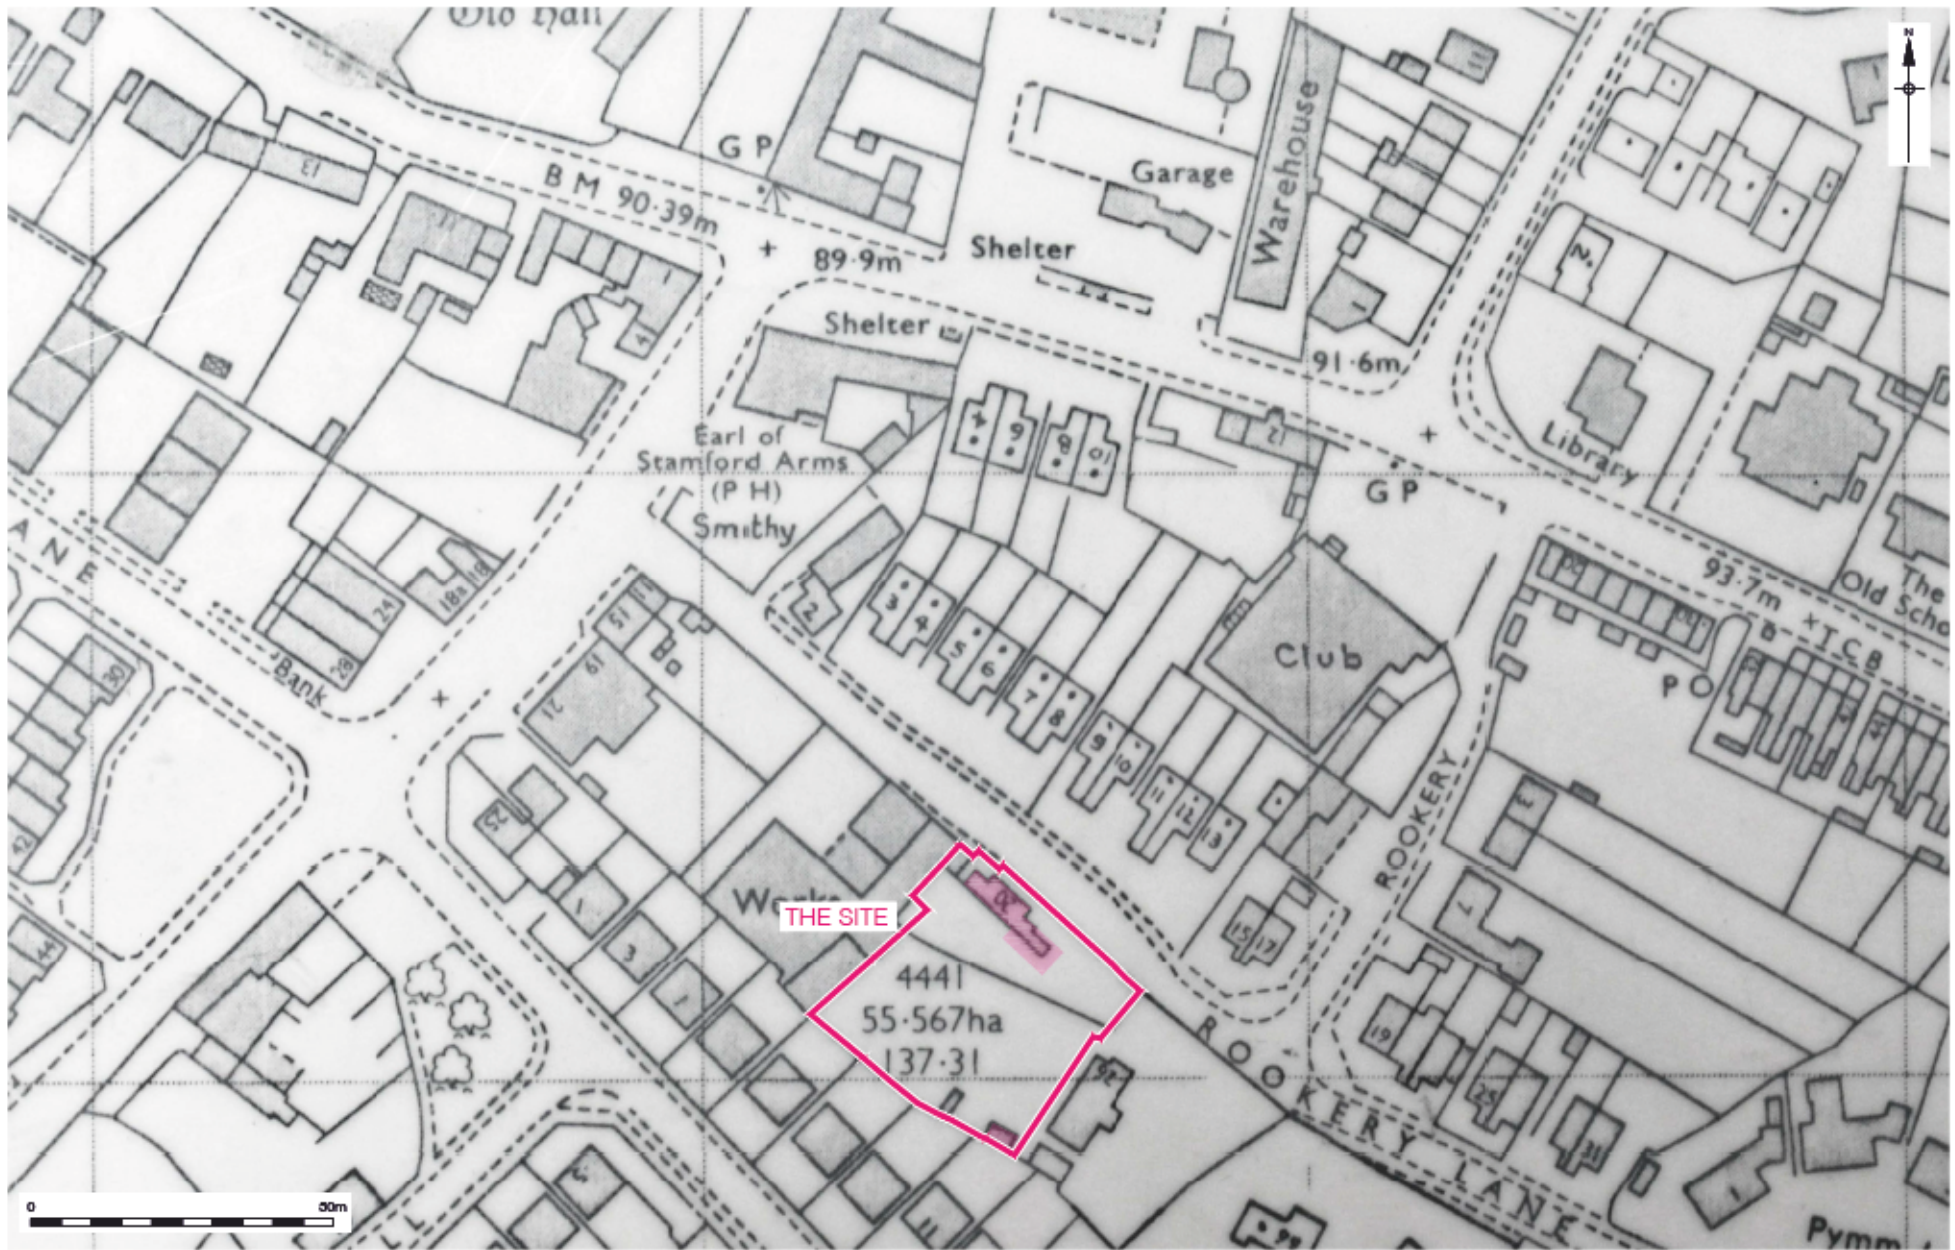
© Crown copyright 1987. All rights reserved. License number 36110309
 © Pre-Construct Archaeology Ltd 2016
 30/11/16 HB

Figure 11
 Ordnance Survey, 1987
 1:1,250 at A4

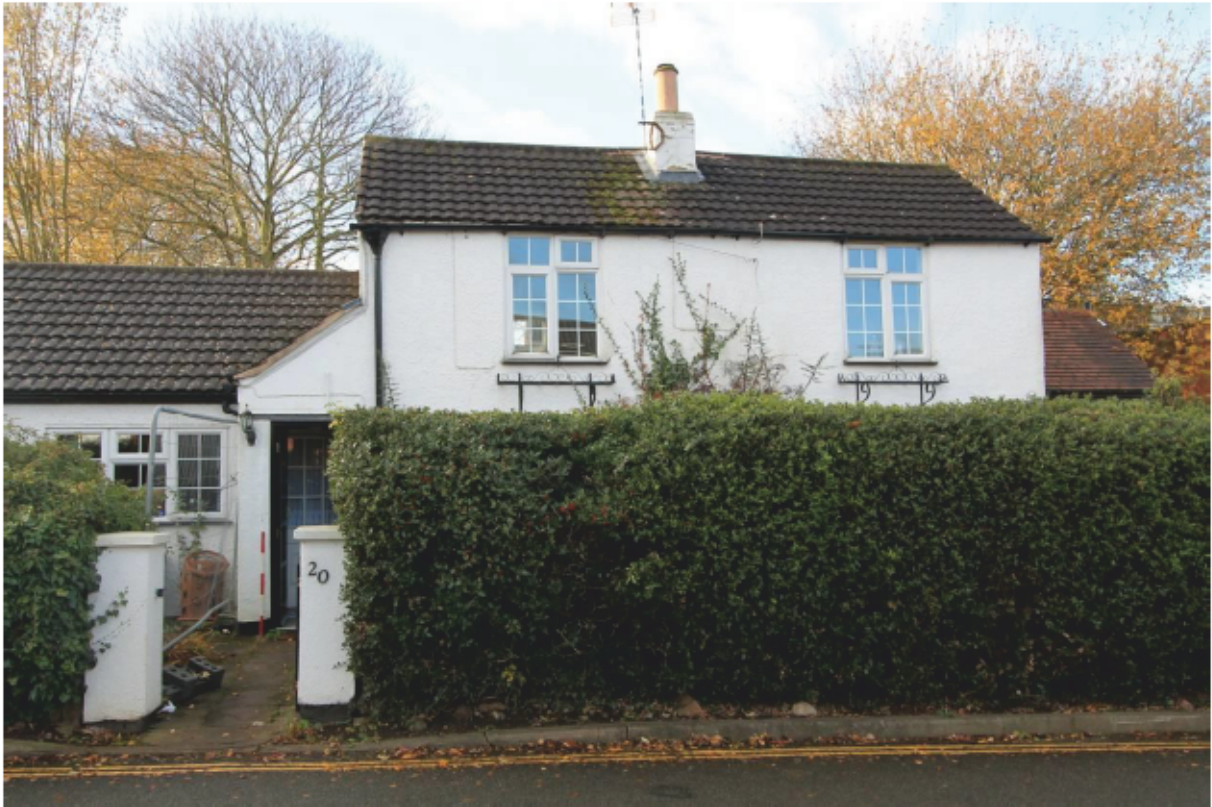
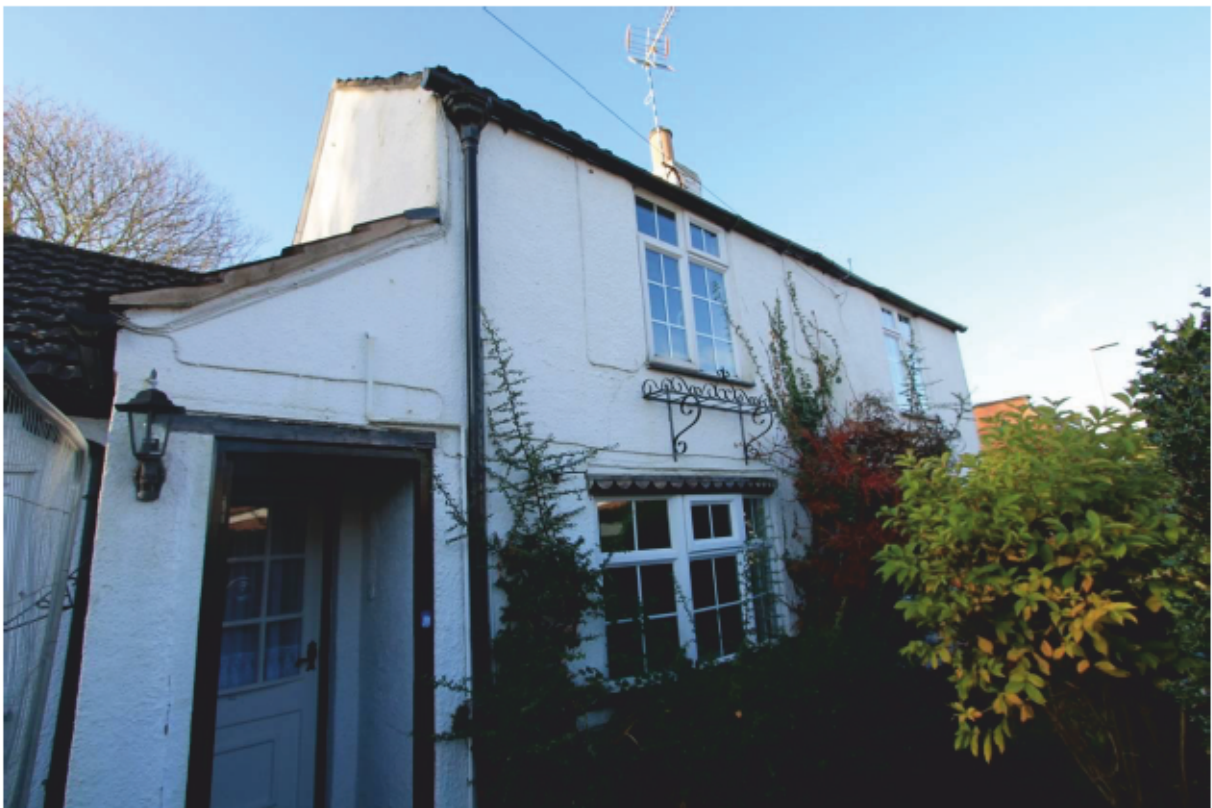
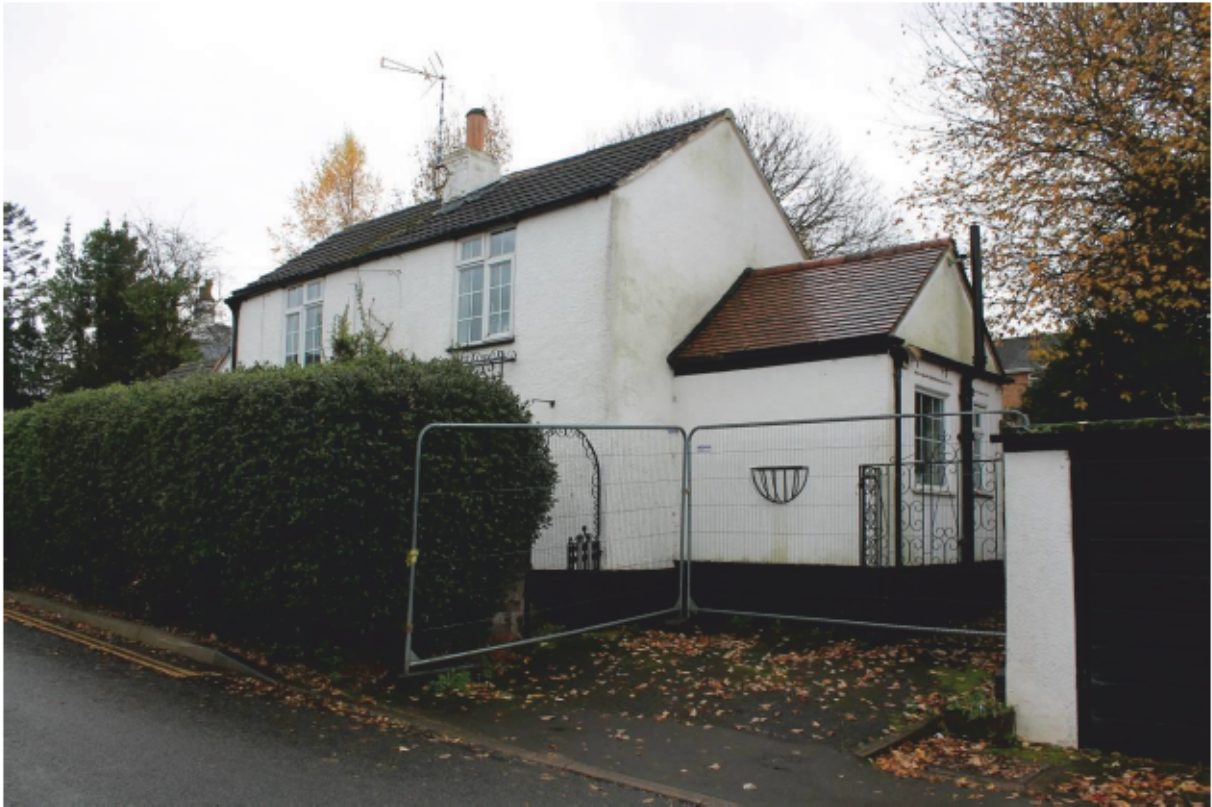
6.2.1 The north-east two-storey principal elevation of the cottage is plain in appearance and lacks historic architectural detailing (**Plates 1 to 3**). The elevation is rendered with modern roughcast pebbledash. The roof is covered with modern tiles, which are a replacement of the traditional Swithland slate. Plain painted brickwork is present along the base of the elevation, below the render. The eaves are shallow and are set immediately above the top of the first floor windows. The in-line roof is gabled to the south-east and north-west and interrupted centrally by a rendered through-pitch chimneystack with a modern chimney pot, set close to, and forwards of the ridge. The fenestration comprises modern UPVC double glazed units fitted into enlarged window openings. Two bow-type bay windows, light the two principal ground floor rooms, while faux traditional cross casement windows are present at first floor level. The rainwater goods are modern, although they use a traditional style header.

Plate 1 No. 20 Rookery Lane, looking south-west

Plate 2 Facade of no. 20 Rookery Lane, looking north-west

Plate 3 No. 20 Rookery Lane, looking south

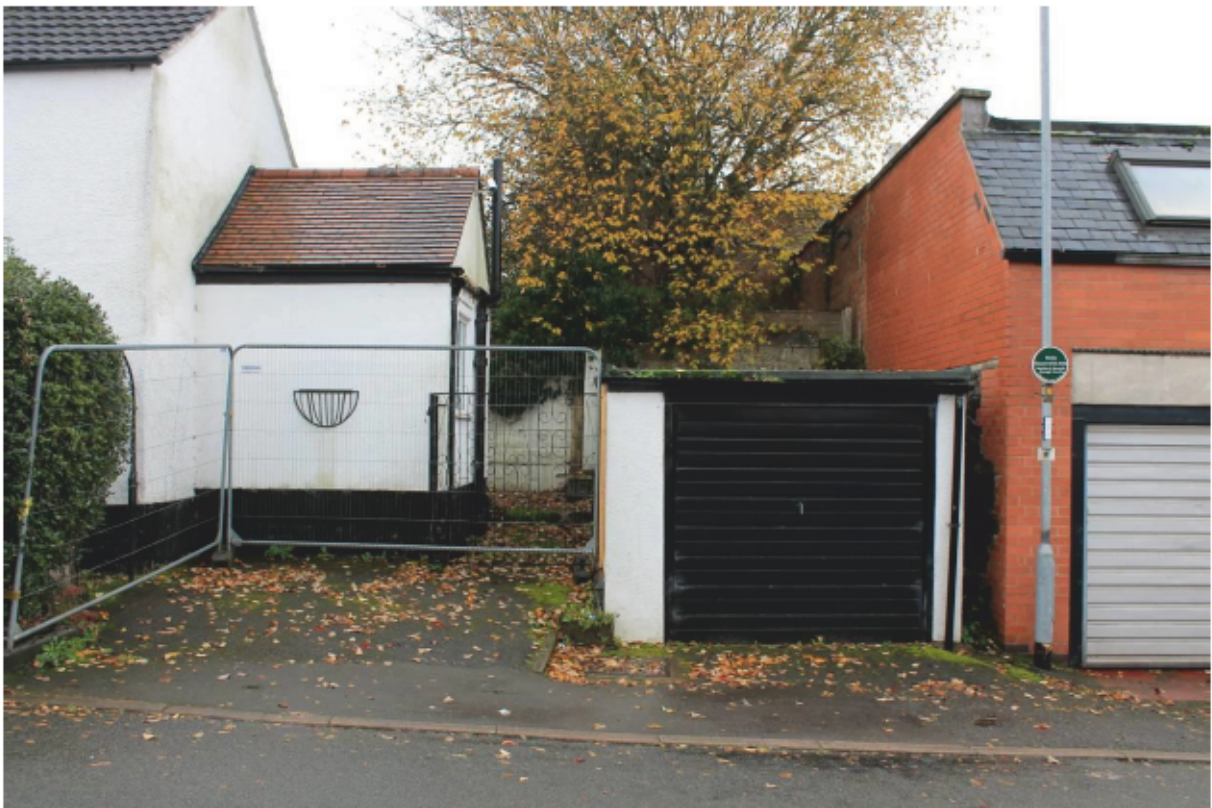
Plate 4 North-west extension and garage, looking south-west

6.2.3 The south-east extension adopts the same modern treatment as the cottage, built with pebble dash rendered elevations, a modern Roman tile roof and large modern UPVC windows (**Plate 5**). A small gabled extension (WC and bathroom) projects to the west of the cottage (**Plates 3 and 4**). It is also faced with pebble dash but uses modern red clay plain tiles to cover the in-line gabled roof. The free standing garage to the west is a modern flat roofed building.

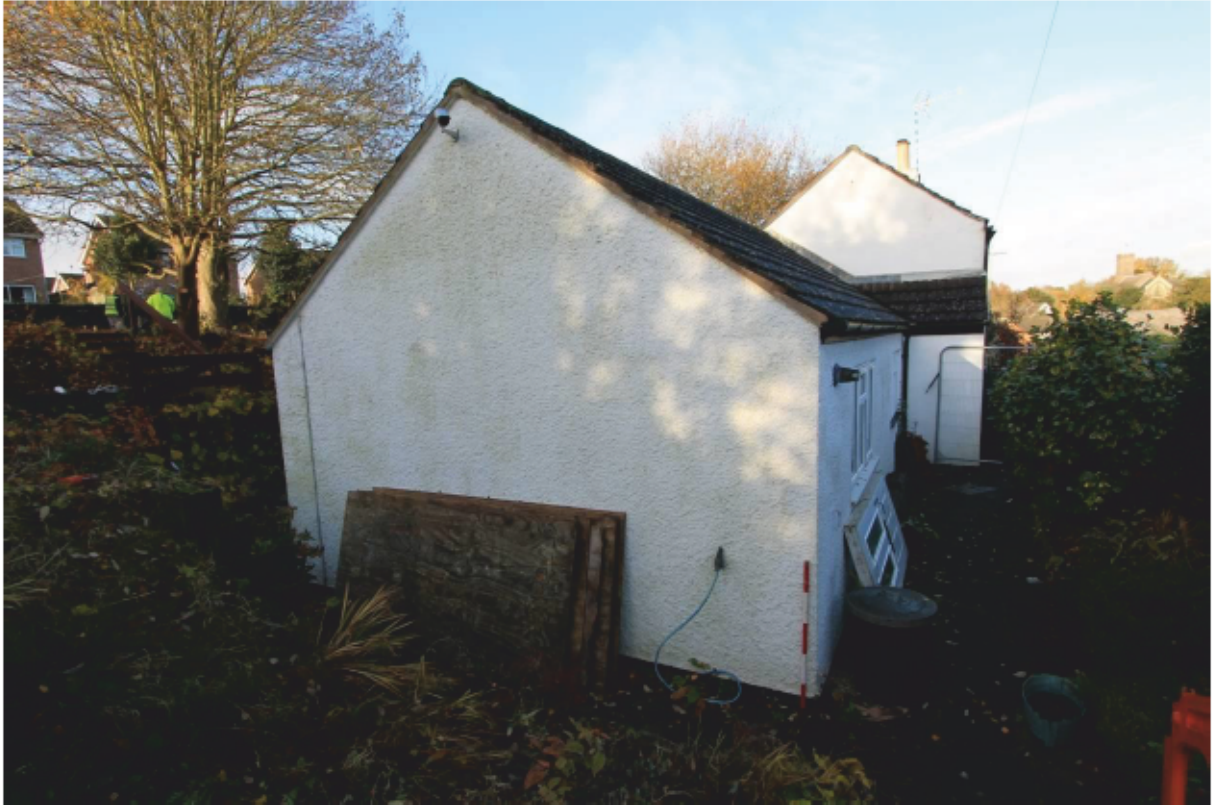
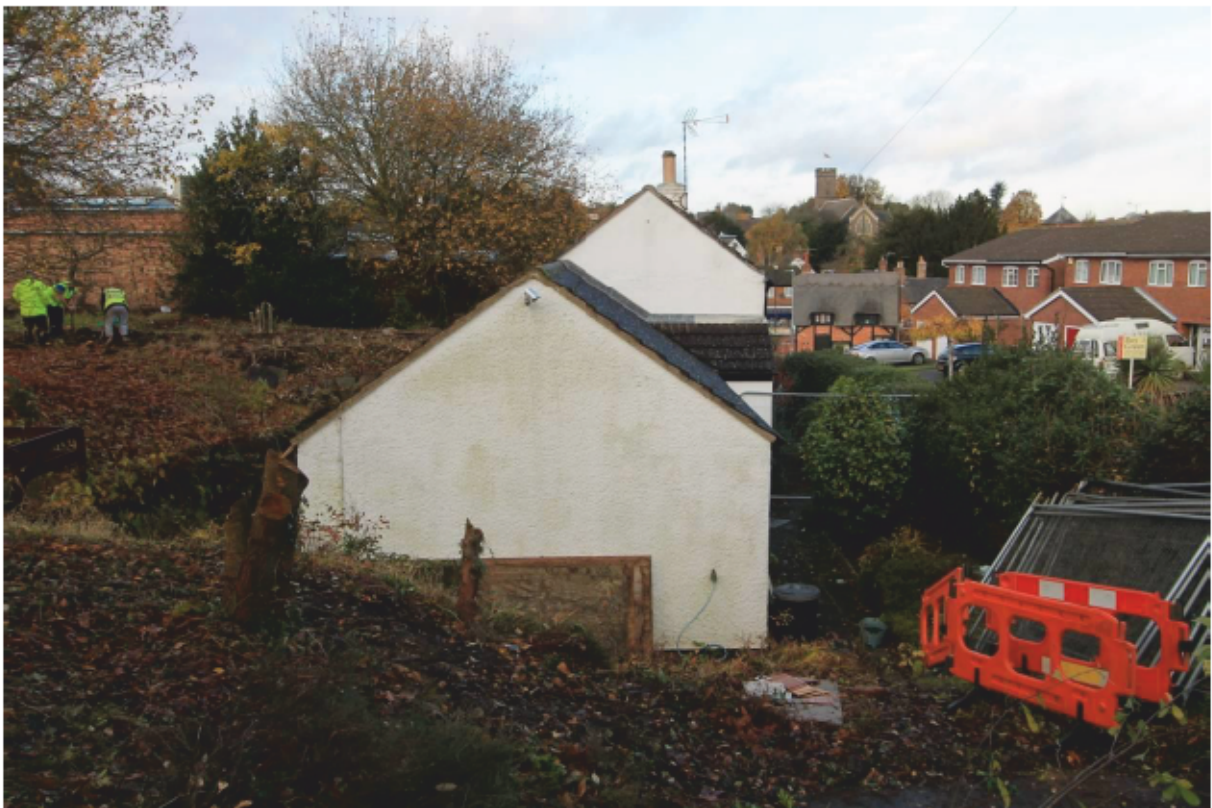
6.3.1 The south-east elevations present two blind gable ends: one to the two-storey cottage and one to the single storey south-east extension (**Plates 5 and 6**). Both are covered with painted pebble dash render and built with roofs that accord, built to a slack 35 degree pitch. The eaves treatment of both is plain, similarly shallow and without bargeboards.

Plate 5 South-east extension, looking north-west

Plate 6 South-east gable elevations, looking north-west

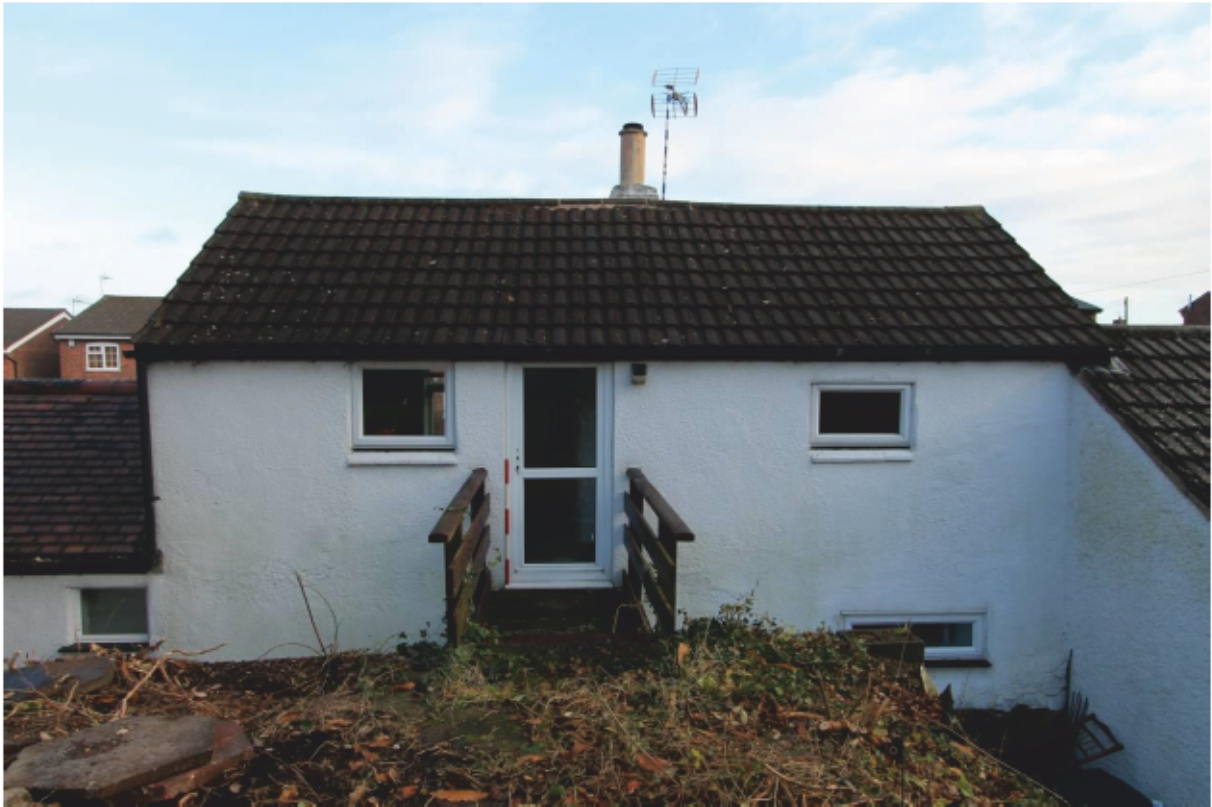
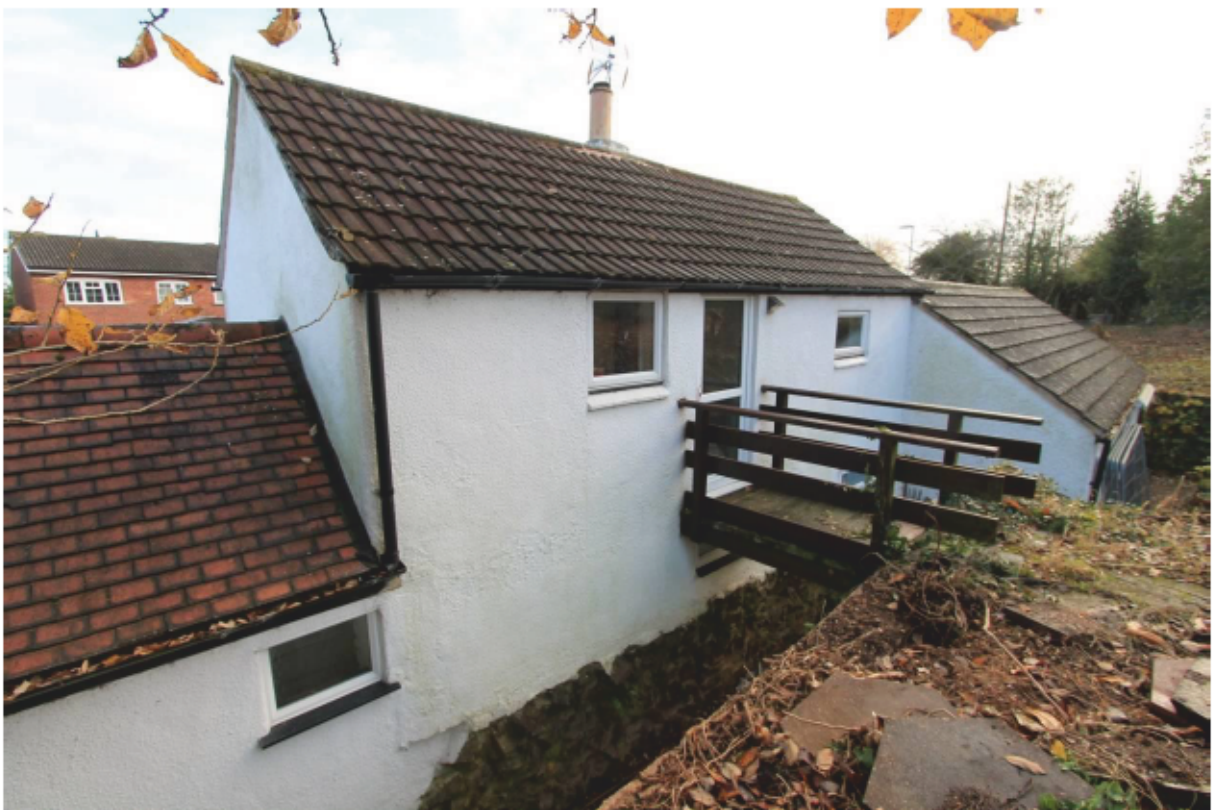
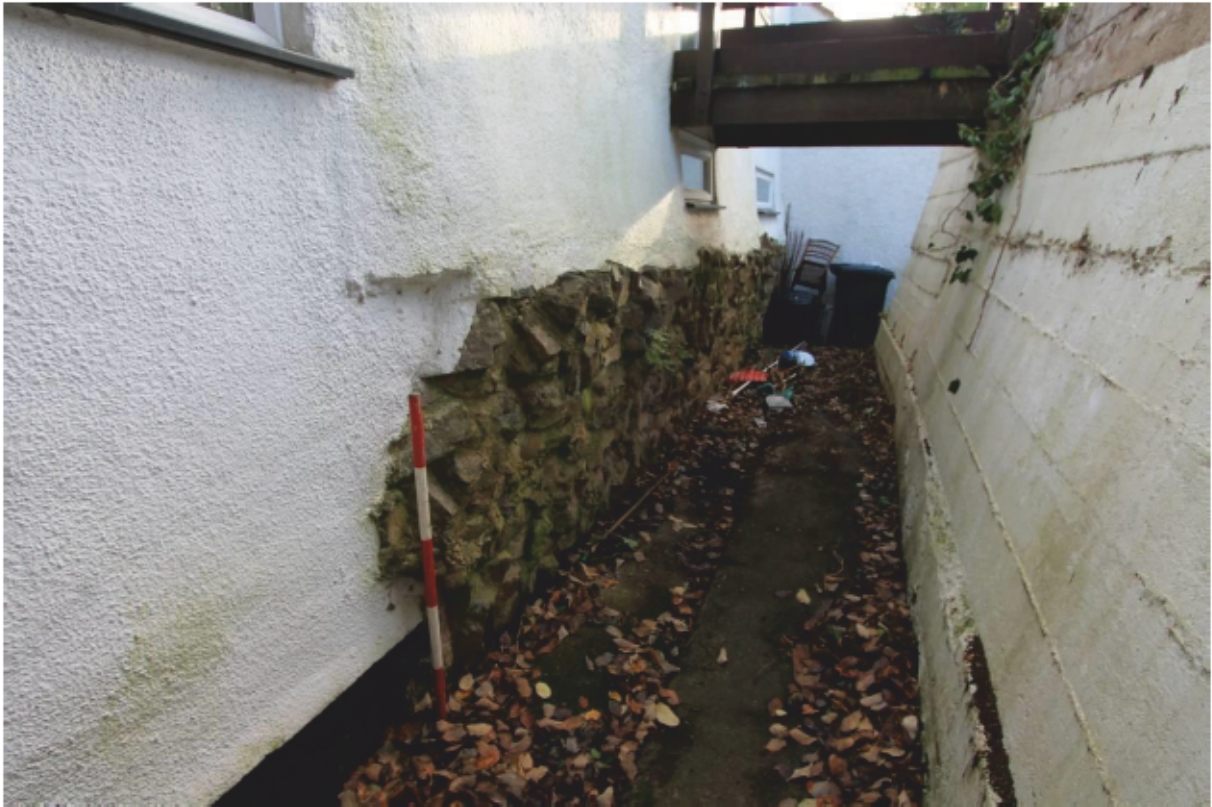
6.4.1 The lower walls of the south-west rear elevation of the cottage are obscured by the rising ground and the steep revetment bank to the rear (**Plates 6 to 9**). This is also the case for the adjoining north-west extension (**Plate 10**) although not so much for the south-east extension (**Plate 11**), as the site opens out to the south-east. Generally the elevations are rendered, although the lower wall to the cottage is built using randomly coursed masonry, rising up to a height of 1.20-1.25m from ground level. The masonry wall, built incorporating the local granite, was crudely laid, not faced up, badly coursed and re-pointed using a modern cement mortar (**Plate 9**). Above this exposed rough lower masonry, the wall gradually narrows in width (flare) to form a

regular vertical elevation. Given the character of the rough coursed masonry, it may have originated as wall foundation, latterly exposed by changes in the site levels to the rear (possibly due to damp in the rear wall). The fenestration to the lower wall comprises a pair of modern inserted horizontal openings with UPVC windows. Due to the rise in land to the rear, access to the first floor from the rear garden could be gained via a modern timber bridge, built off the rear revetment wall (**Plates 7 and 8**). The rear door and both rear windows to the first floor bedrooms were modern insertions. The south-west elevation of the north-west extension is set back slightly from the wall line of the cottage and incorporates a single modern window opening (**Plate 11**). Its roof is covered with red clay plain tiles. The rear (south-west) wall of the south-east extension is dominated by a set of sliding patio doors with a folding canopy (**Plate 10**).

Plate 7 South-west rear elevation, looking north-east

Plate 8 South-west rear elevation showing revetment/bank, looking east

Plate 9 Masonry lower wall/foundation and revetment, looking south-east

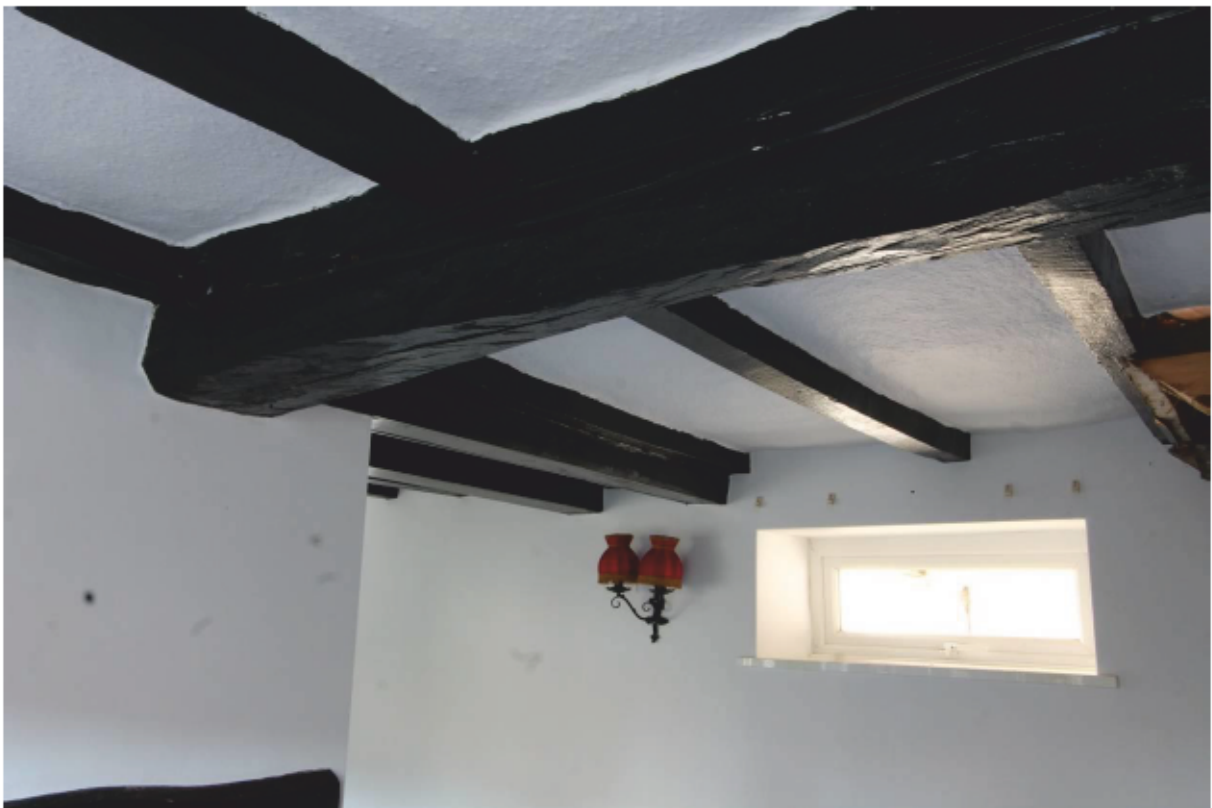
- 6.5.4 The most noticeable and historic feature of the ground floor was the structure of the ceiling/first floor, comprising two heavy axial bridging beams, over (G1) and (G2) incorporating and built off the central stack. The axial beam over (G1) was positioned roughly central to the ceiling and was slightly cambered. It was a heavy scantling oak beam measuring c.8-8½ inches thick with crudely cut chamfers to the soffit and a single run-out stop to the south-east end, south-west side (**Plates 12, 13 and 15**). The axial beam held eight common floor joists to each side, that were morticed into the upper section of the beam, to leave the axial beam visible (if a ceiling was added). The common joists were square or just off-square in section measuring 3 x 3 or 3 x 3½ inch scantling and spaced a 24 inch or 2ft centres. The joists appeared to be hand sawn, with irregular saw marks, and hard wood, probably oak.

Plate 14 Detail of bridging beam (G2), looking south

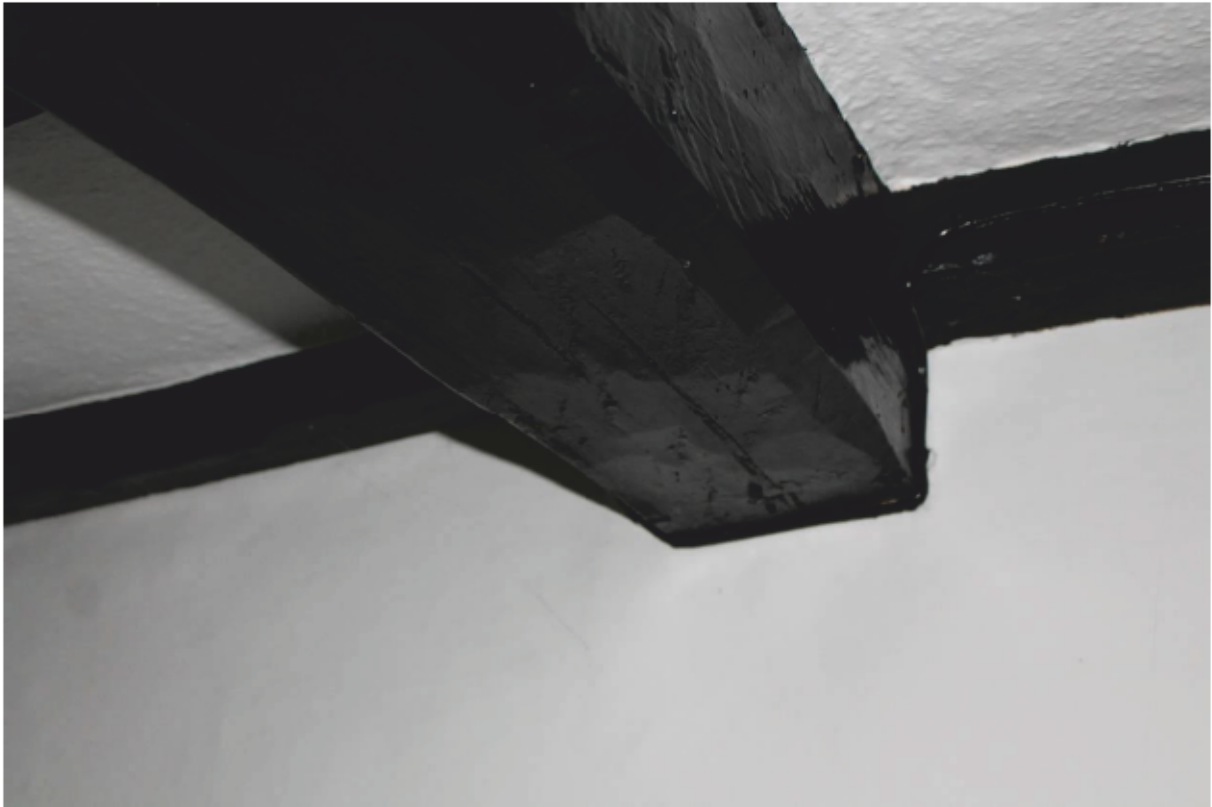
Plate 15 Run-out stop to soffit (G1), looking east

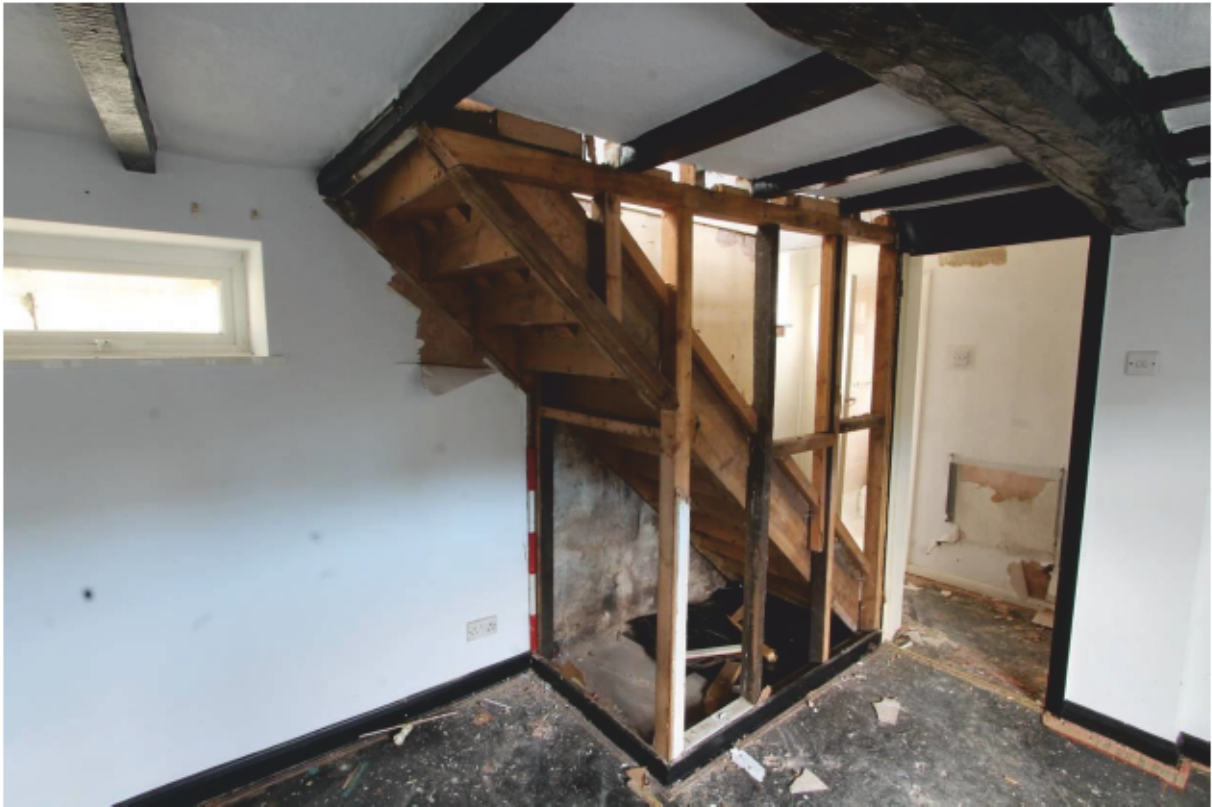
Plate 17 Modern inserted staircase (G2), looking west

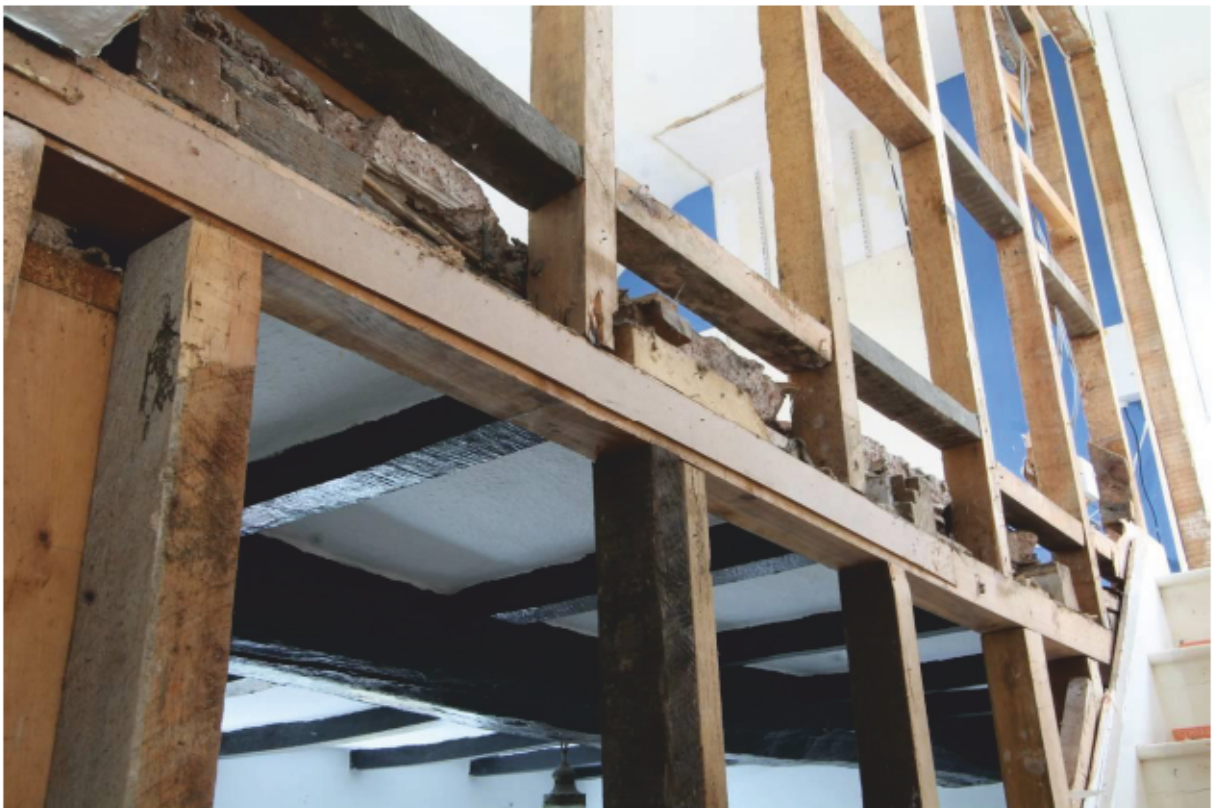
south-west side was a modern addition and extension of the partition wall enclosing the stair below. It was built using vertical studs and horizontal battens, nailed together using clasp nails and walled internally using thin hardboard. The window opening to (G6) had been enlarged to receive the present UPVC unit and accordingly the architrave, with a simple ogee detail, was also modern. The top of the window coincided with the eaves line. Whilst the walls were mainly plastered, a section of plaster was missing at the junction of the internal wall between (G6) and (G7) and the north-east wall to the facade. This showed two different types of wall construction and fabrics. The brickwork to the north-east wall comprised large red, orange and burnt bricks measuring 220-230mm x 70mm x ? while the eight courses of brickwork to the internal wall, which adjoined with the central chimneystack, comprised slightly narrower orange and dark red bricks laid in a lime rich mortar, measuring 220mm x 65mm x ? This wall also incorporated a softwood batten or timber bearer.

Plate 18 Modern stud wall enclosing staircase and bedroom (F6), looking east

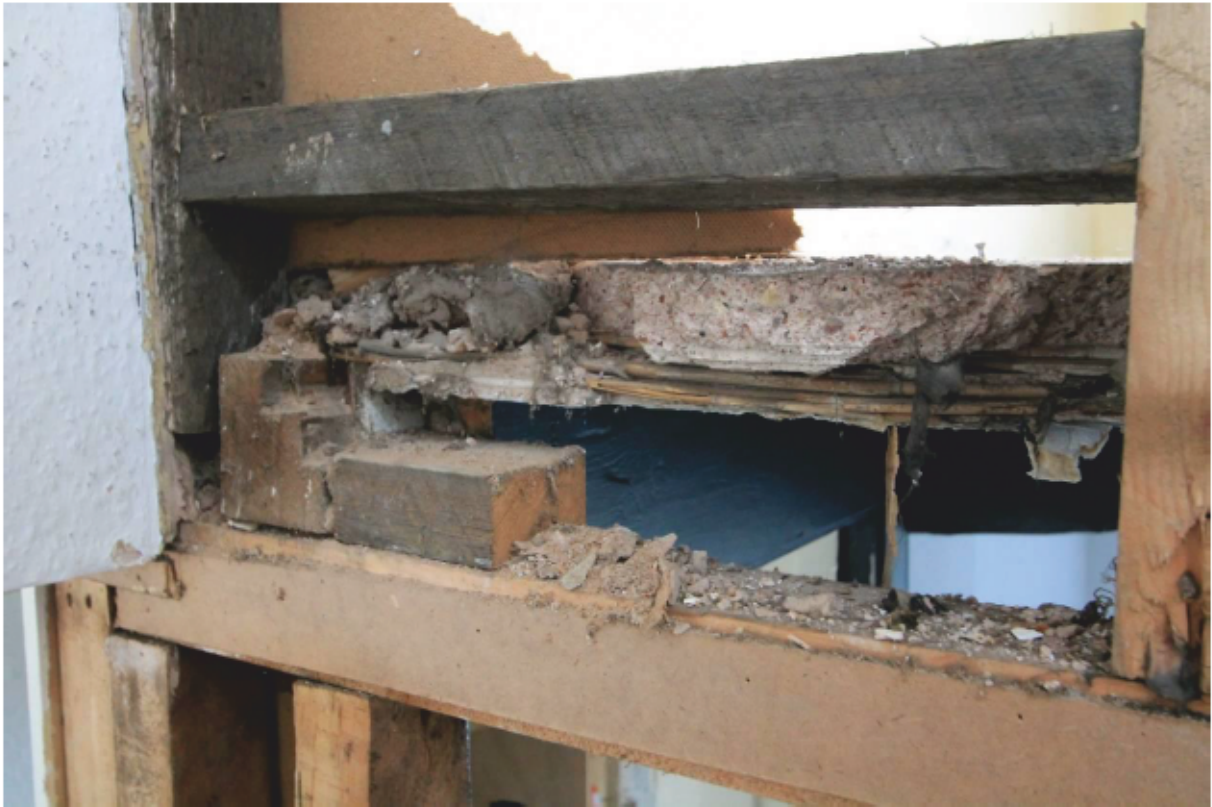
Plate 19 Dovetail lap joint (for trimmer) in end of common joist and lime ash/reed floor, looking north

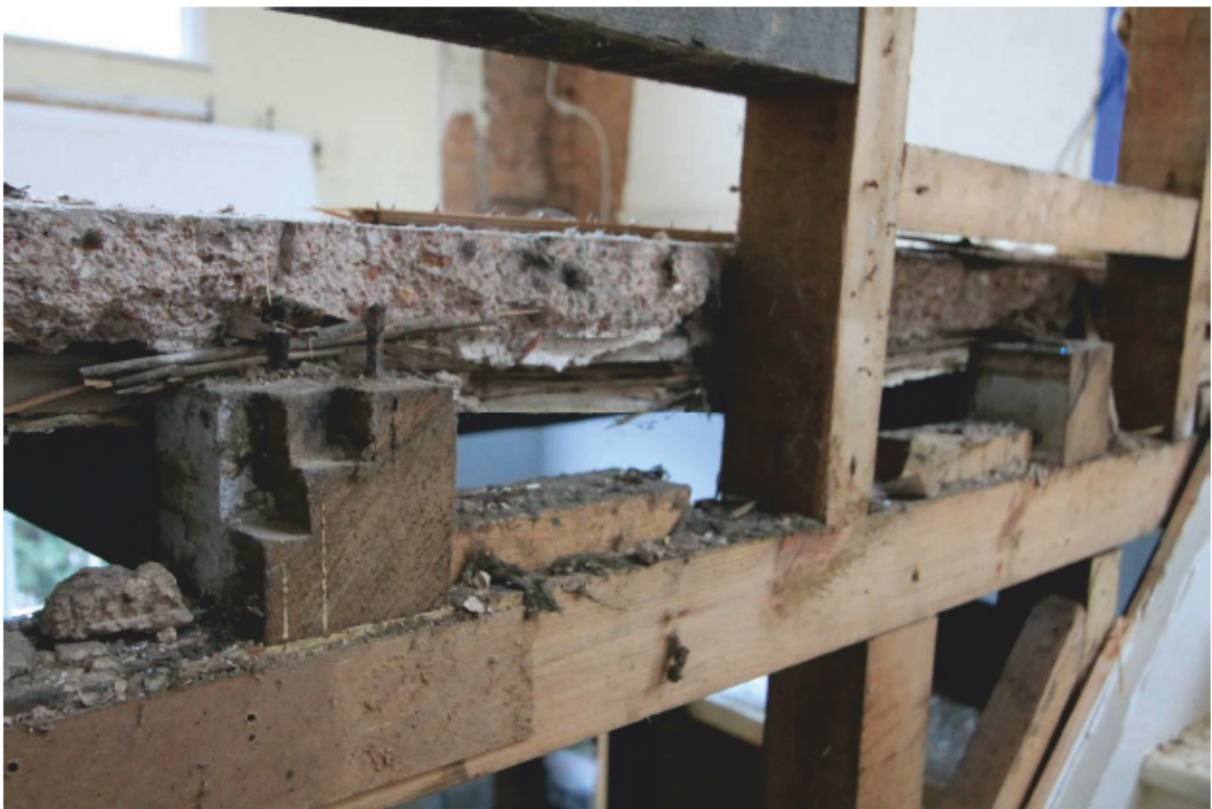
Plate 20 Corresponding (mirror) dovetail lap joint to north-west, looking east

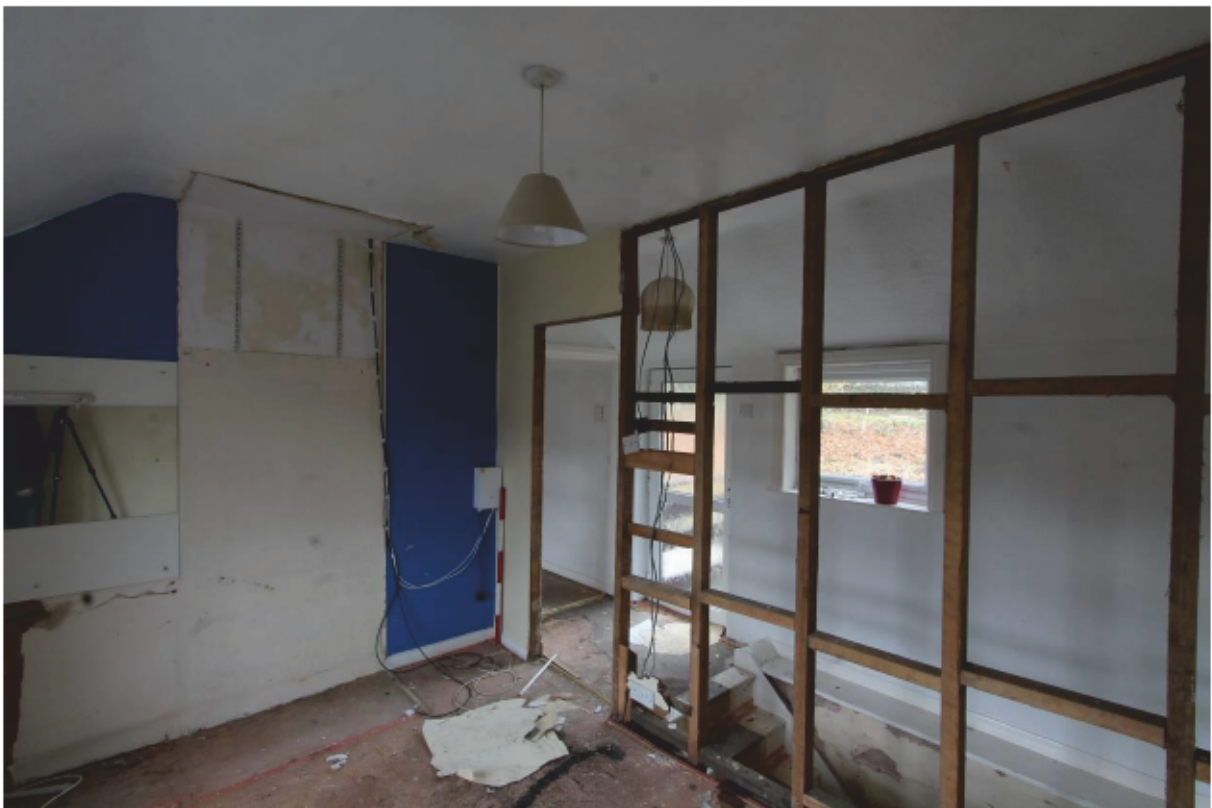
Plate 24 Bedroom (F6) showing inserted stud wall, looking south

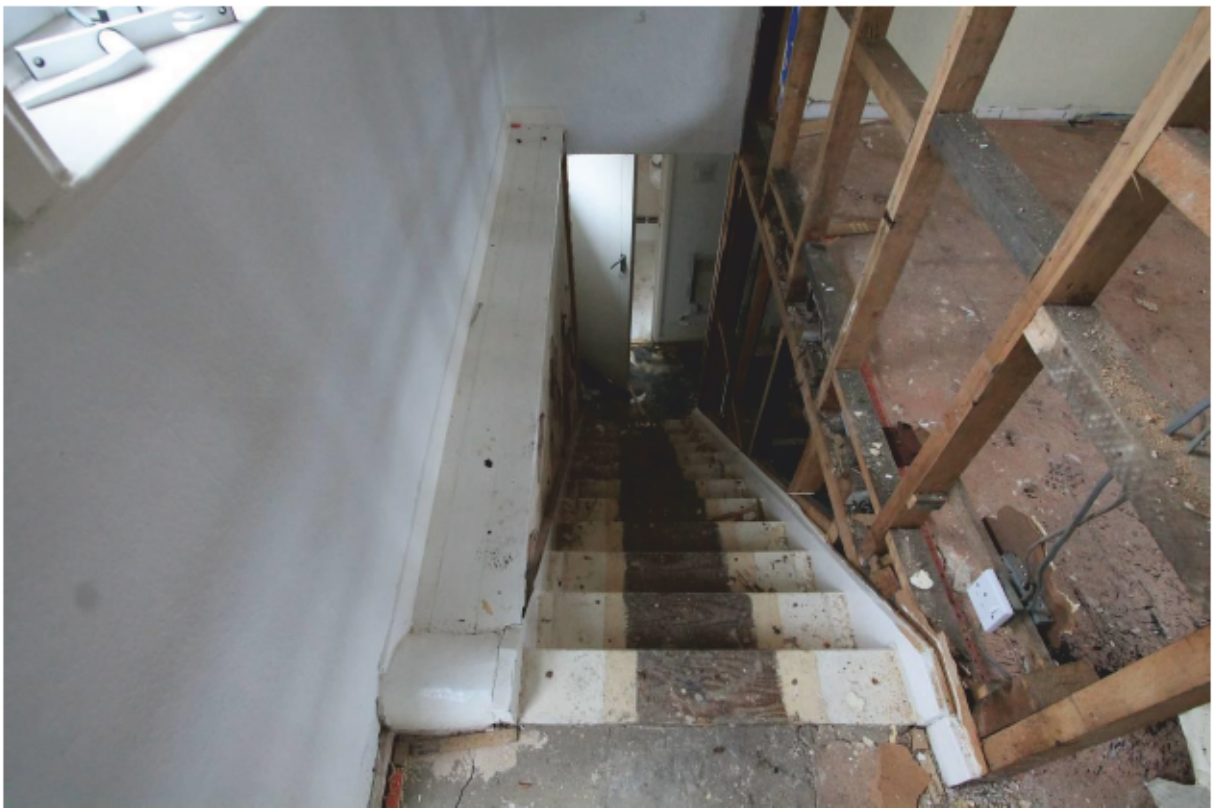
Plate 28 First floor landing showing heavier wall at ground floor level, looking north-west

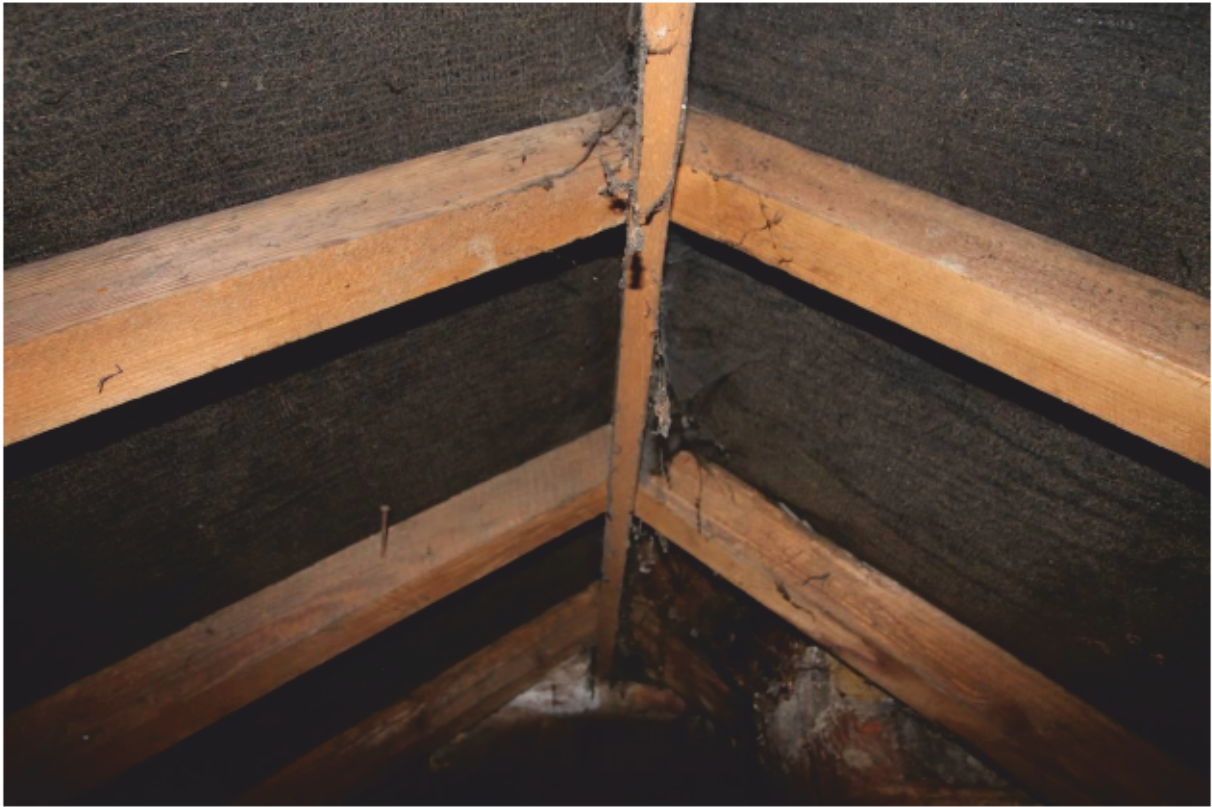
Plate 29 Replaced softwood roof structure

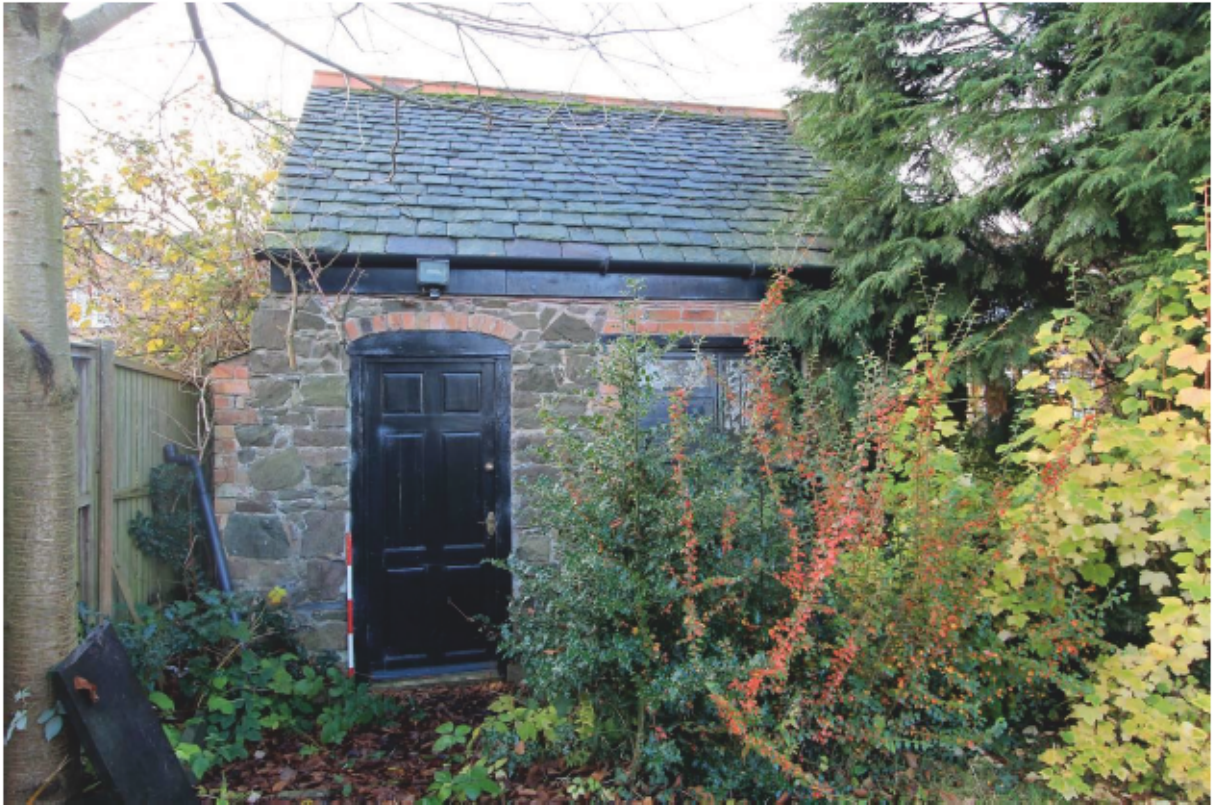
Plate 30 Outbuilding, looking south-west

- 6.11.1 A small masonry built outbuilding was located at the southern corner of the garden and towards the boundary with no. 26 Rookery Lane (**Figure 2**). It was built with regularly coursed and faced elevations incorporating local granite stone with red brick used as jambs or voussoirs to window and door openings and as quoining to angles (**Plate 30**). The roof was pitched with gables to the south-east and north-west and covered in local Swithland slate. The present casement windows and the door were modern replacements.
