**LAND AT FAIRVIEW ROAD,
HALESWORTH, SUFFOLK: AN
ARCHAEOLOGICAL EVALUATION**

**LOCAL PLANNING AUTHORITY:
WAVENEY DISTRICT COUNCIL**

PCA REPORT NO: R12751

AN ARCHAEOLOGICAL TRIAL TRENCH
EVALUATION

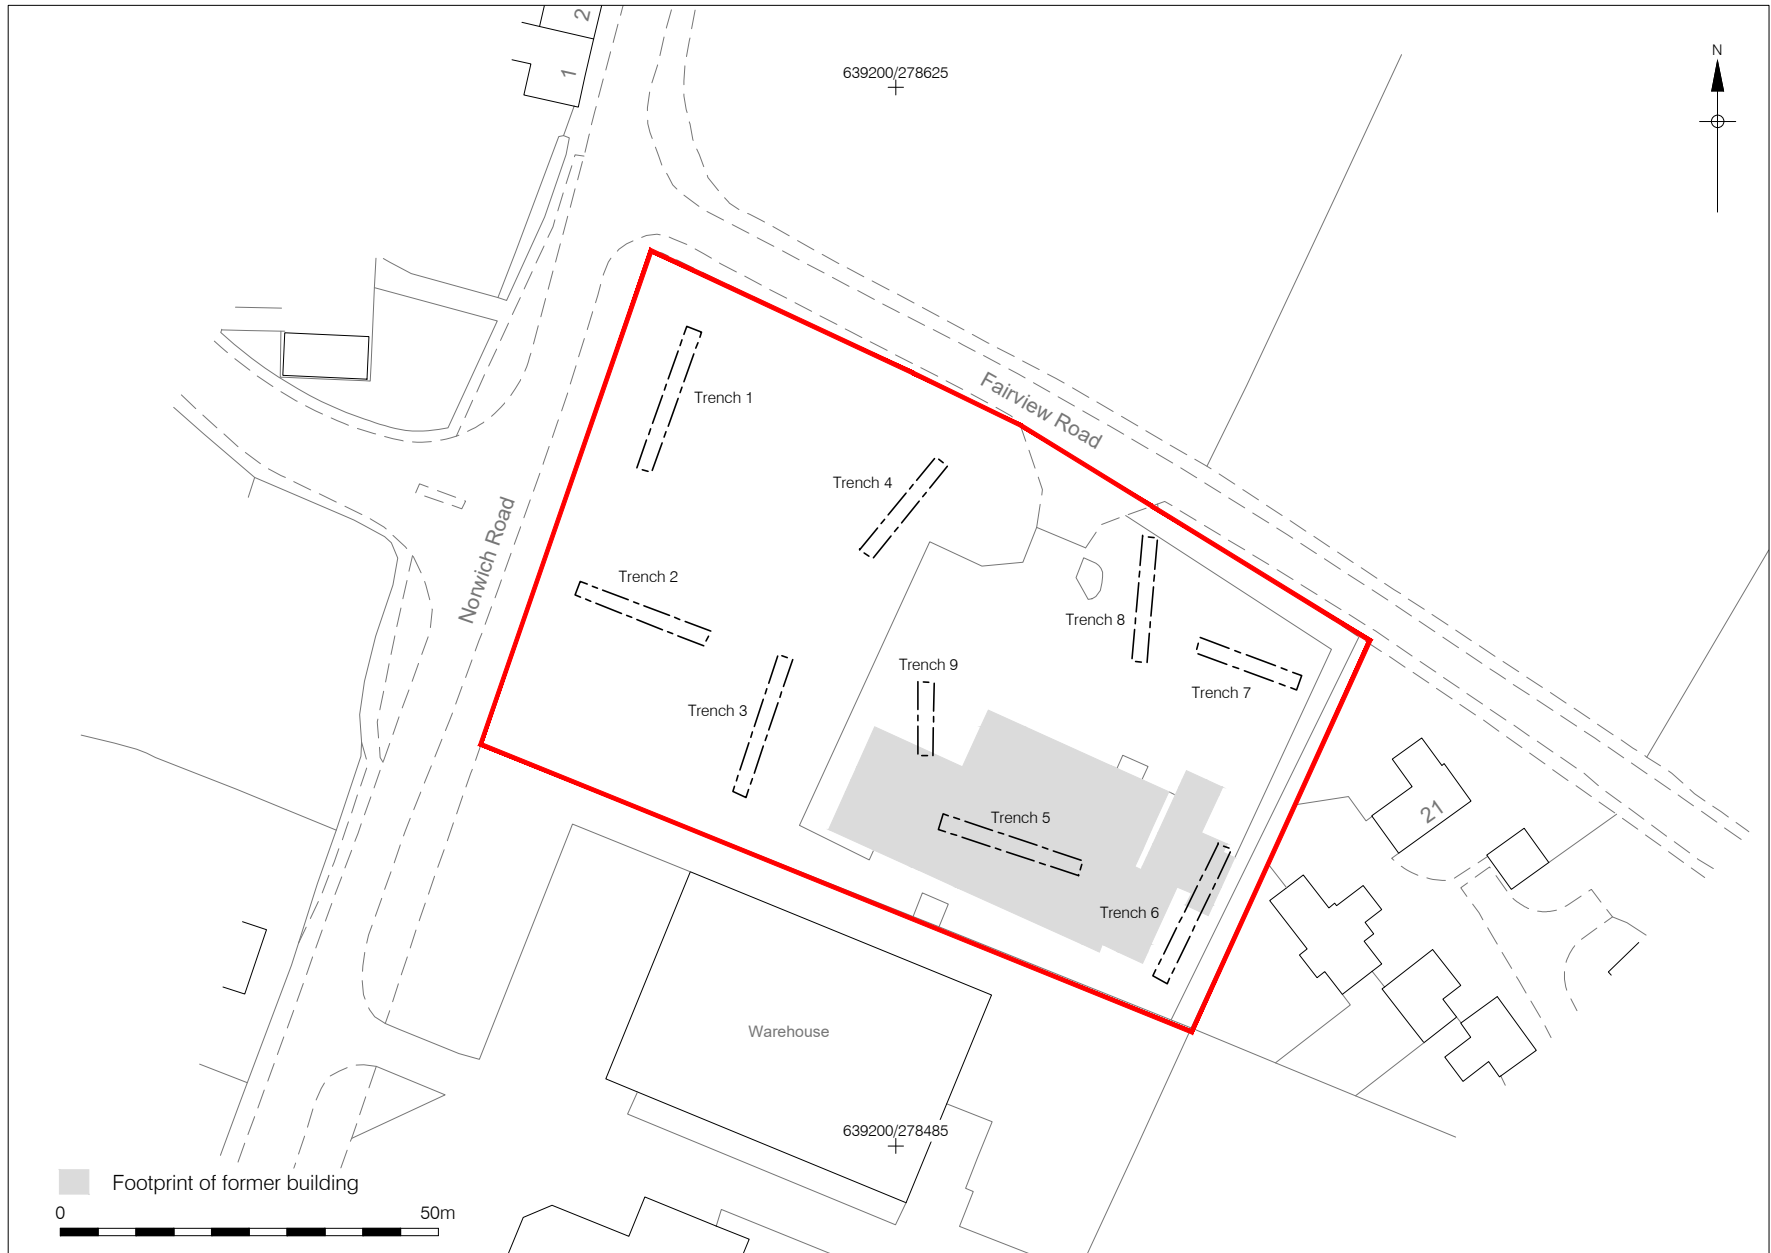
Figure 2
 Trench Locations
 1:1,000 at A4

4.1.1 The Written Scheme of Investigation for the evaluation proposed the excavation of nine trial trenches, distributed across the site (Figure 2). The trenches were positioned in order to obtain a representative sample of the 'blank' spaces on the site. Trench 9 had to be re-positioned to avoid cutting the access road.

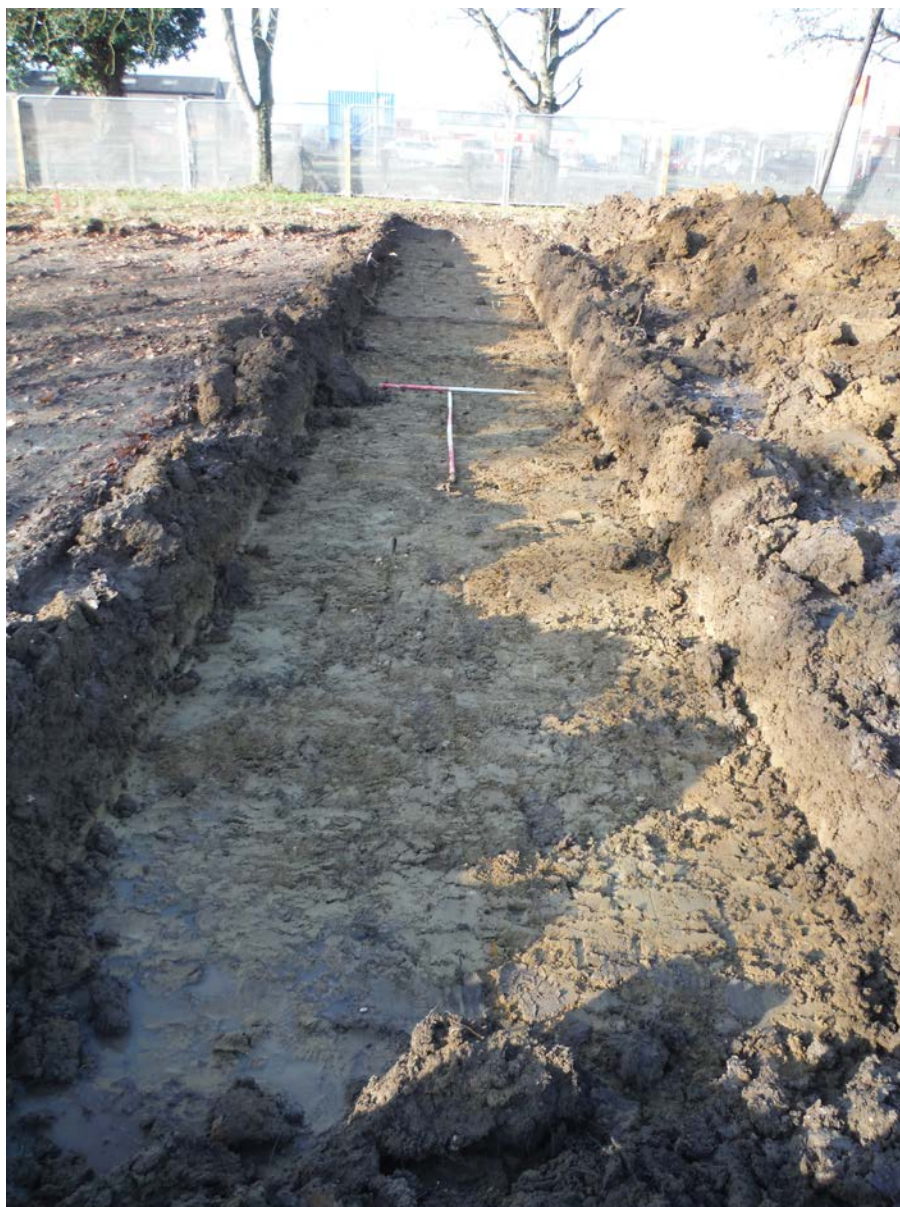
Plate 1: Trench 2, view north-west

5.3.1 The trench contained one undated ditch, aligned north-east to south-west.

TRENCH 2	Figures 2-3		Plates 2-3	
Trench Alignment: NW-SE	Length: 20m	Level of Natural (m OD): 36.68-36.75m		
Deposit	Context No.	Average Depth (m)		
		SE End	NW End	
Topsoil	(101)	N/A	0.28	
Subsoil	(102)	0.28-0.45	0.28-0.45	
Natural	(103)	0.45+	0.45+	
Summary				
Trench 2 was located close to the western boundary of the site.

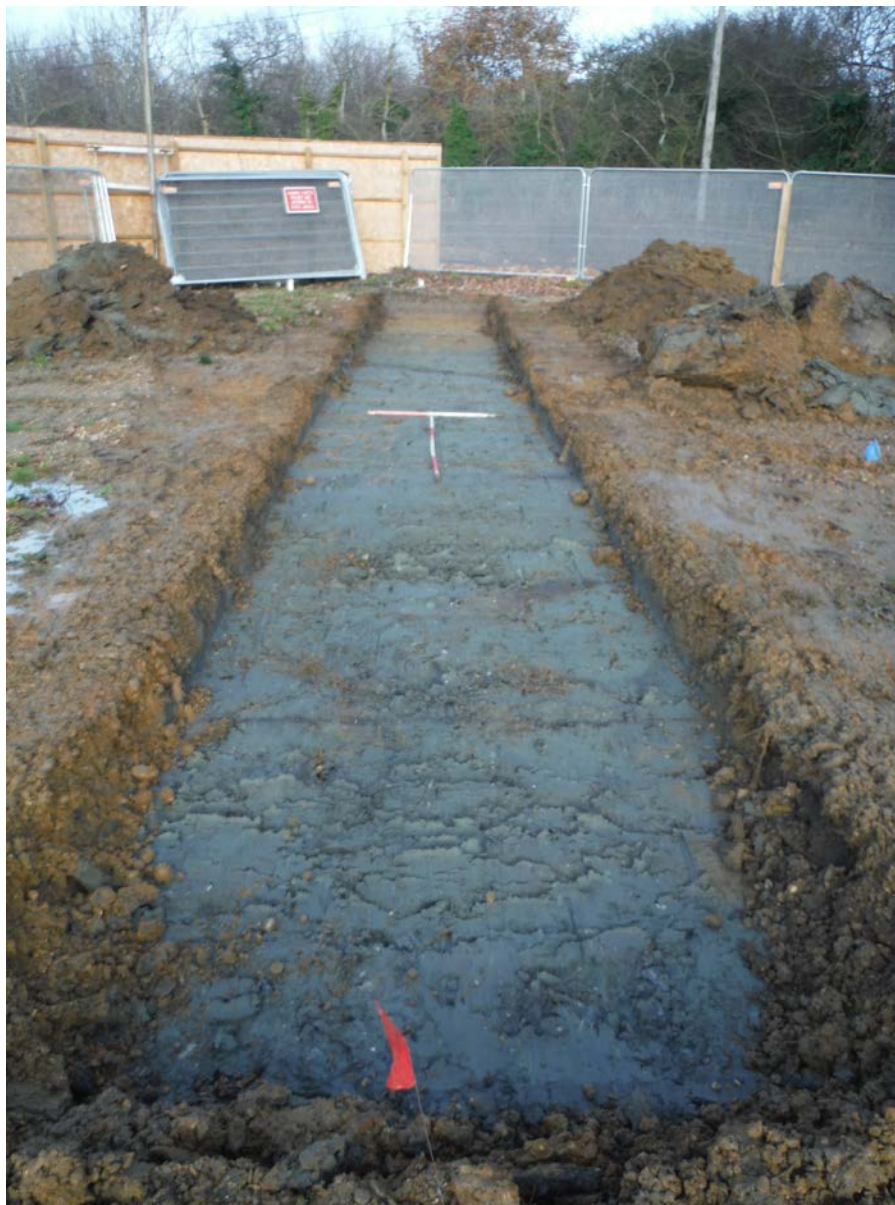
Plate 3: Trench 8, view north-east

5.9.1 No archaeological features were present in Trench 8.

TRENCH 8	Figure 2	Plate N/A	
Trench Alignment: NE-SW	Length: 20m	Level of Natural (m OD): 36.55-36.64m	
Deposit	Context No.	Average Depth (m)	
		NE End	SW End
Made ground	(100)	0.06	0.10
Topsoil	(101)	N/A	N/A
Subsoil	(102)	0.06-0.37	0.10-0.19
Natural	(103)	0.37+	0.19+
Summary			
Trench 8 was located in the north-eastern corner of the site. No archaeological features were present.

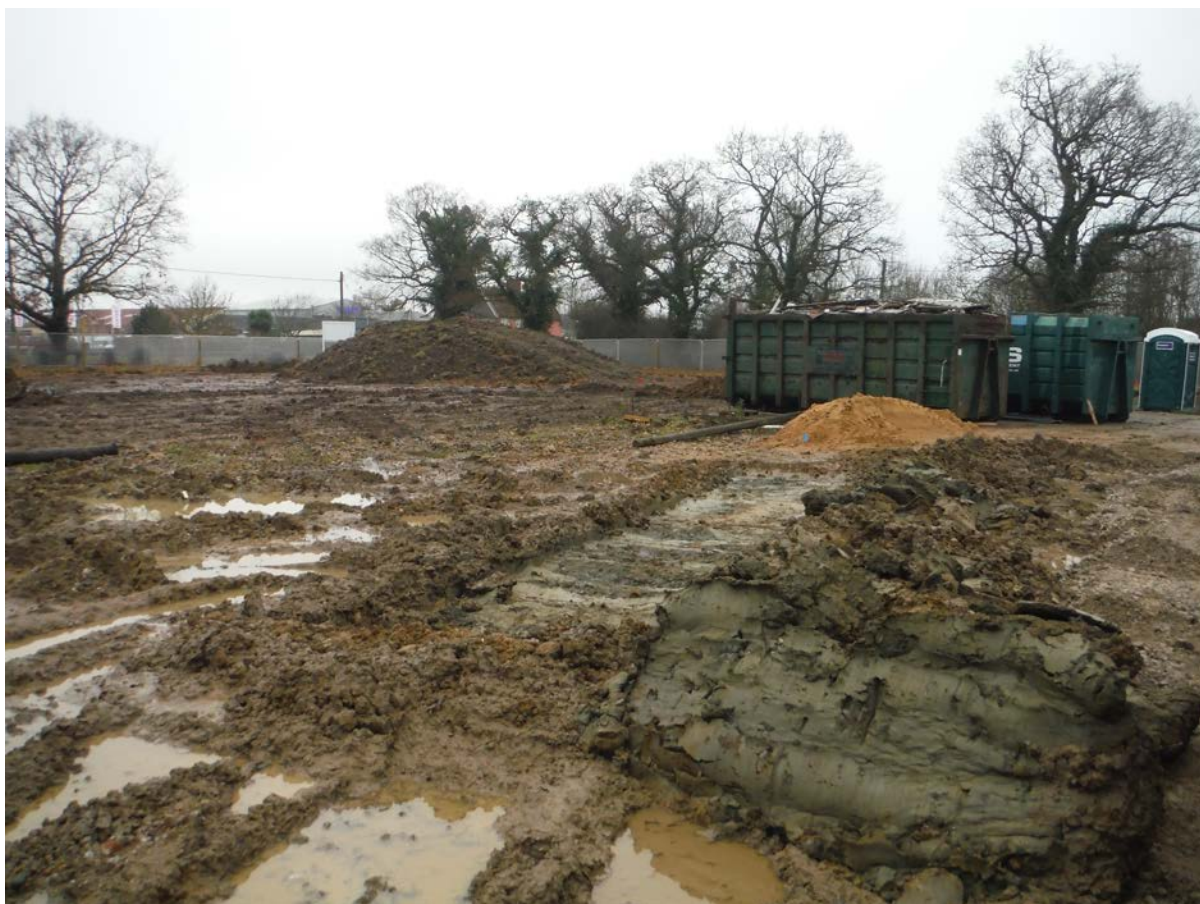
Plate 4: The site and Trench 9, view north

5.10.1 No archaeological features were present in Trench 9.

TRENCH 9	Figure 2	Plate 4	
Trench Alignment: NE-SW	Length: 10m	Level of Natural (m OD): 36.49-36.55m	
Deposit	Context No.	Average Depth (m)	
		NE End	SW End
Made ground	(100)	0.09	0.14
Topsoil	(101)	N/A	N/A
Subsoil	(102)	N/A	N/A
Natural	(103)	0.06+	0.14+
Summary			
Trench 9 was located in the centre of the site. No archaeological features were present.
