**FORMER XYLONITE FACTORY,
FACTORY LANE, BRANTHAM,
SUFFOLK, CO11 1NH**

HISTORIC BUILDING RECORDING

PCA REPORT NO: 12763

JANUARY 2017

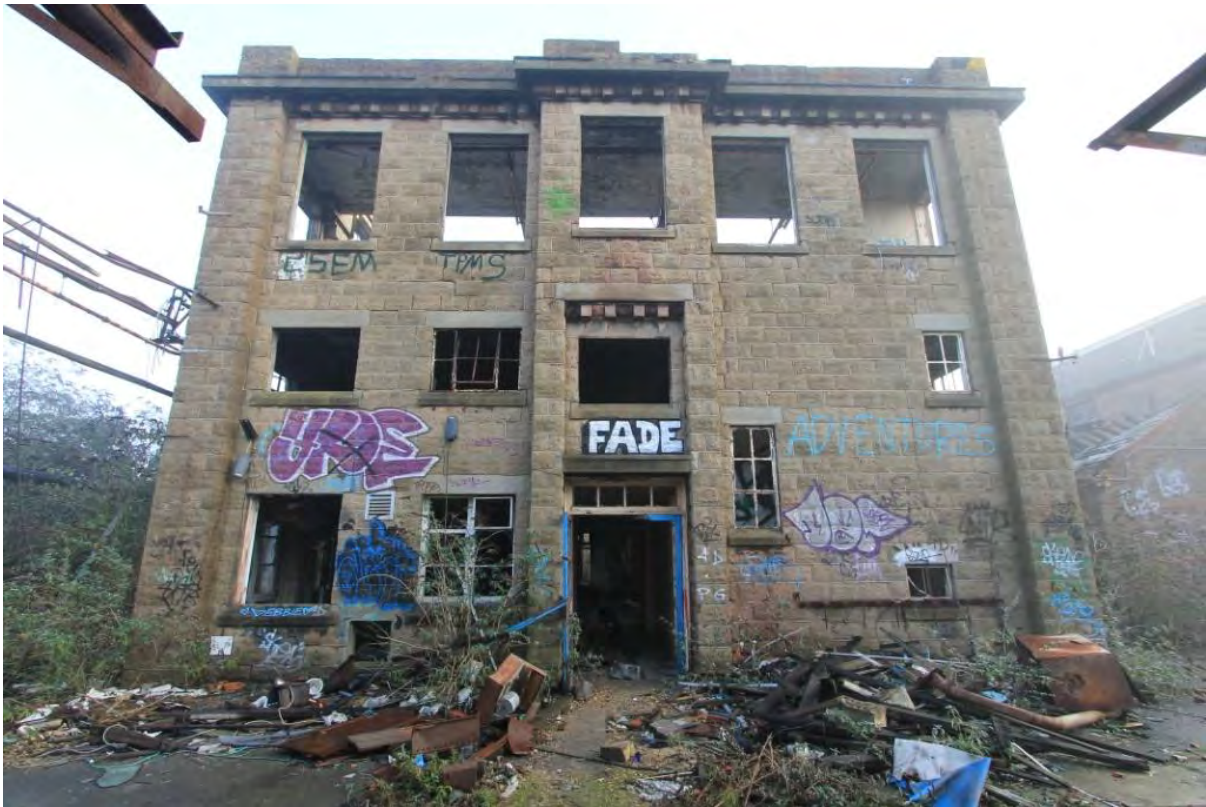
Plate 37: Building 1, south-west facing elevation

5.1.1 Building 1 is the first building encountered to the south of the railway line. It is a relatively large building, raised over two storeys and with a lower contemporary adjoining range to the east side. The laboratory had lost its roof structure and most of the windows were either missing or lost. In architectural terms it was built to be appreciated, clad in an outer skin of concrete, rustic ashlar blocks, an eaves cornice and simple parapet wall. The roof line to the more visible northern elevation (to the railway) was embellished with symmetrical gable-ended dormers, one still retaining a ball finial at the foot of the gable parapet. The arrangement of fenestration was symmetrical, the window openings to both floors flat headed with exposed lintels (concrete), plain sills and a dentil eaves band above the first floor openings. The latter were fitted with large wrought iron-framed fixed windows of either 4 x 4 or 6 x 4 lights (some examples with a central-pivoting ventilator) and smaller windows to the less visible elevations. The main entrance was situated within a slightly forward set central bay within the western elevation and whilst the door was lost a four-light glazed door light remained.

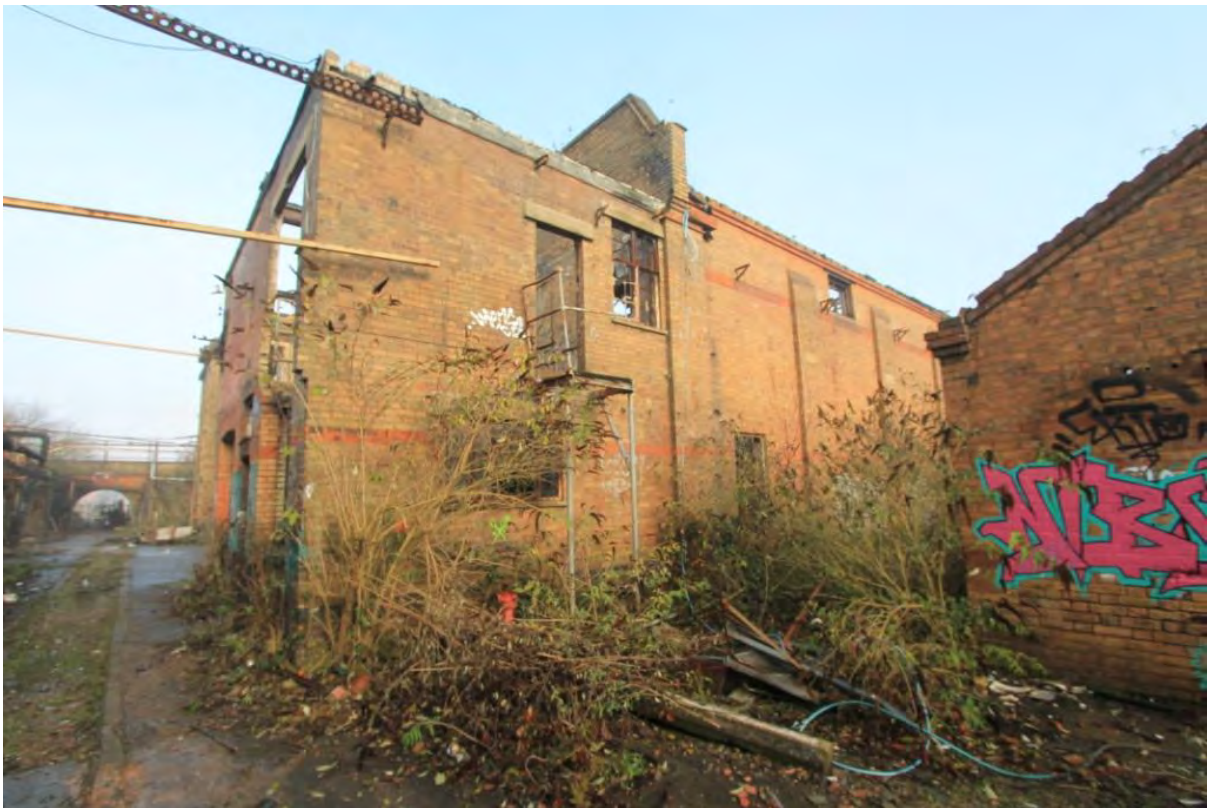
Plate 46: Building 2 as viewed from south

5.2.2 The smaller gable ended range was built in yellow stock ornamented with contrasting red brick used for banding, voussiors and eaves detail. Whilst the building was in a poor condition having lost most of its roof structure through fire and collapse, the king post trusses and a few examples of iron-framed casements (similar to those in 1) still remained. The large fitters shop was built using similar brick treatments with contrasting red and yellow stocks to three elevations, but much plainer brickwork to a later, lower extension, also built with a three-light, north-light roof, to the east. The flank elevations to the earlier taller range were built in pier and panel, with visible external pilasters at bay intervals (supporting the roof trusses). A series of single storey accretions were added along the southern wall, most of which had partially collapsed and a gable ended range built onto the north wall of the later north-light extension. The latter still contained plant used to heat treat/bake materials.

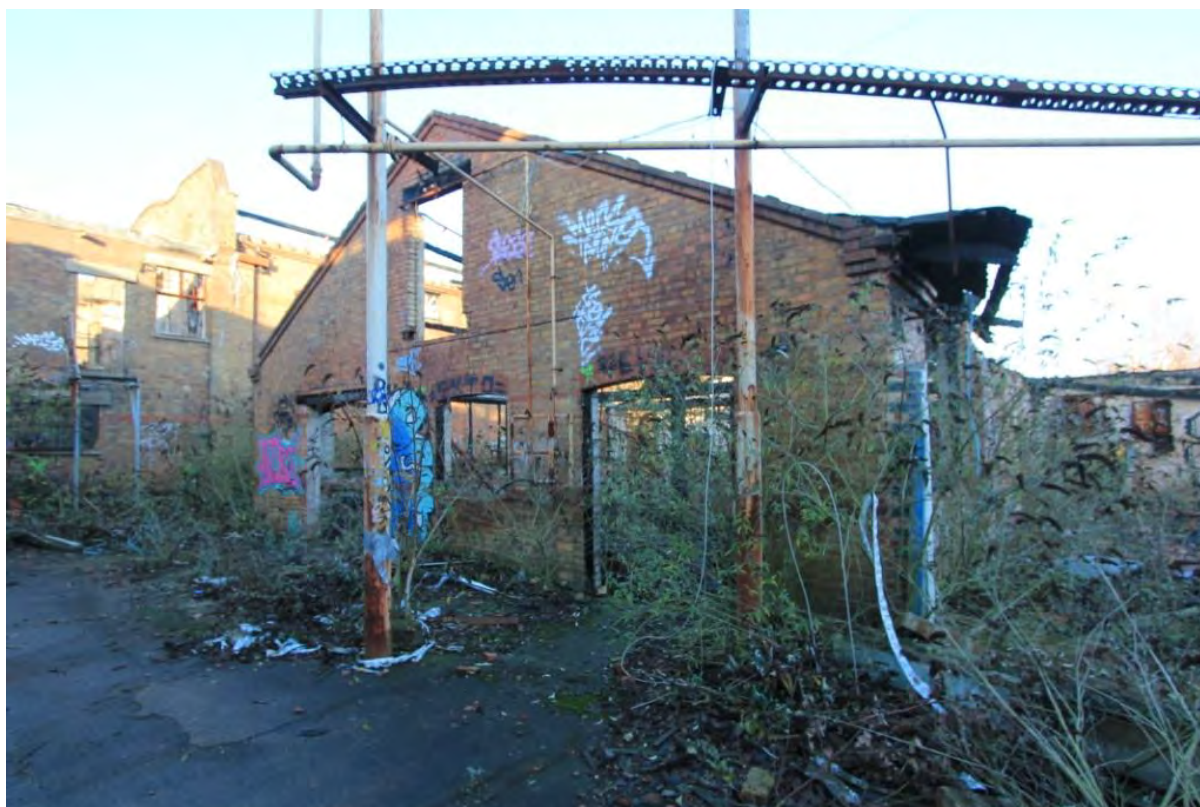
Plate 58: Building 4, viewed from south-west

5.4.1 Building (4) was located immediately to the south of (2) and was a small brick-built and gable ended range presenting its long elevations to the north and south. The building was in a poor condition due to extensive fire damage and had lost all evidence of fenestration. The original openings seen in the western end wall were built with rough on-edge brick voussoirs, while those openings to the flank walls were plainer and larger. A taking-in door central to the gable over the main entrance gave access to attic storage, possible by the use of a queen post truss, burnt examples of which, still retaining their back purlins, remained.

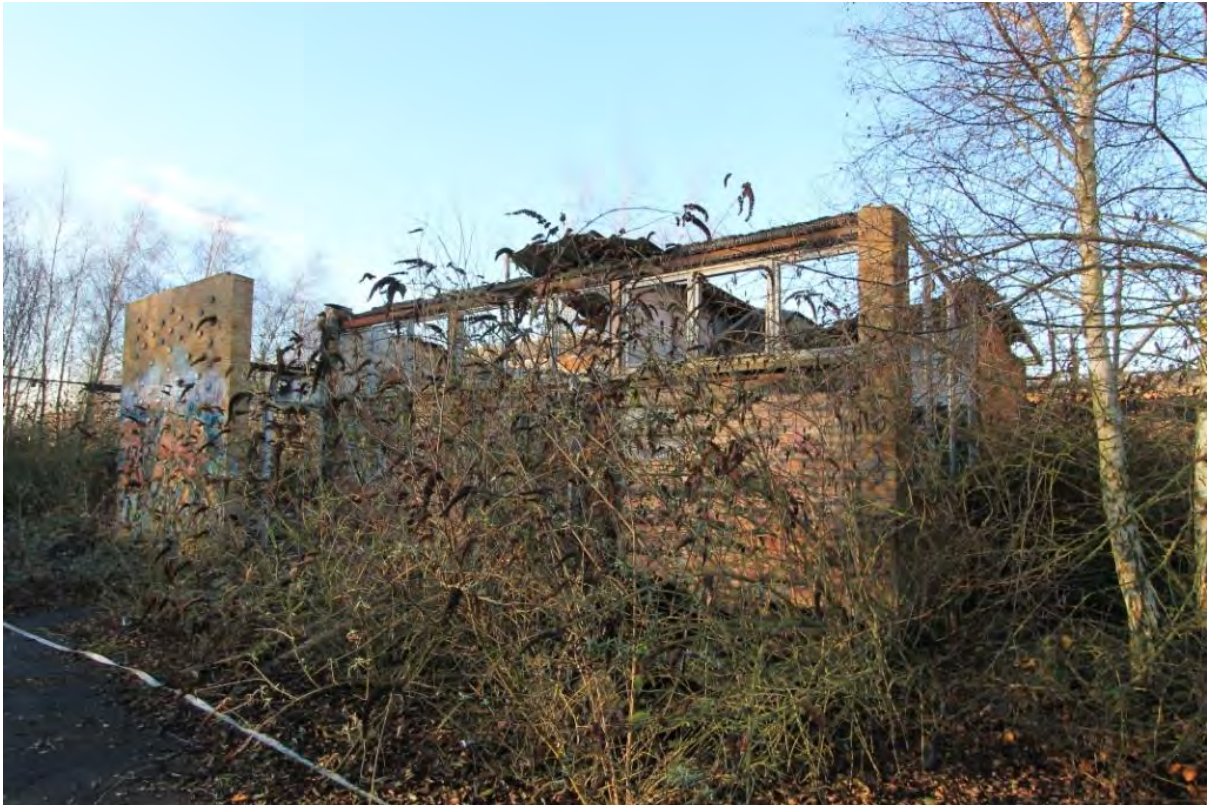
Plate 71: Building 10, viewed from south-east

5.10.1 Building (10) is represented by the remains of a brick-built formerly flat roofed structure. During the site visit with the client there were suggestions that this was once used as a dedicated smokers room. The interior was lit, to the south side, by a band continuous glazing located high in the wall and below the eaves line. The southern wall had also been in part rebuilt in recent years using yellow brickwork and an symmetrical pattern of prominent blue brick headers. The building was in a very poor condition having lost its roof structure. Interesting graffiti was noted on the exterior (see Appendix 2).
