**GREENWICH WHARF, 79 BANNING
STREET, LONDON BOROUGH OF
GREENWICH SE10 0NT**

**AN ARCHAEOLOGICAL
FORESHORE SURVEY**

PCA REPORT NO: R12793

SITE CODE: BNT16

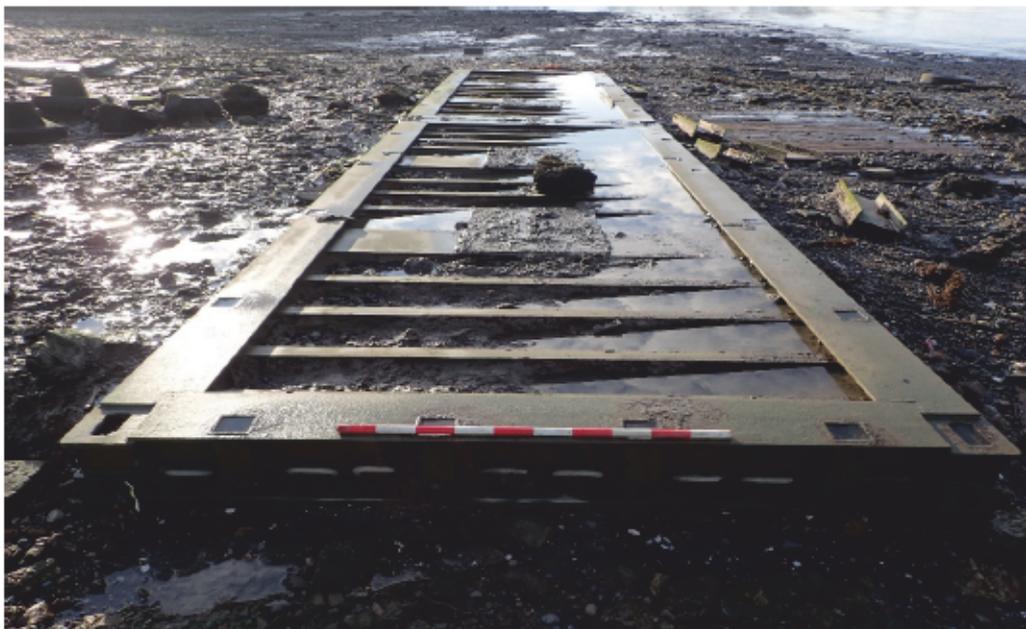
- 5.4 To the west of the main wooden barge-bed structure and closest to the Low Tide line, two steel frames [1] & [4] - possibly forming a gridiron - were recorded (see *Plate 1*). They were roughly on the same alignment to the barge-bed but were slightly offset and mounted much lower than the timber-framed structure itself. It would be difficult to reconcile these structures with the wooden barge-bed but it is possible they may have been part of the same structure. Each of the two steel structures consisted of welded steel frames upon which further parallel bars or panels arranged perpendicular to the frame had been welded into place. They were 12.10m long by 2.43m wide and had a thickness of 0.26m. Various mounting and suspension slots were noted around the frame as well as metal loops for attaching ropes or chains for lifting. Each frame had been laid and secured in place by a concrete bed and located at the Low Tide mark. This arrangement had been laid over a series of flat wooden planks [3]. The interpretation of the frames as forming a grid iron is based upon the form taken by their timber counterparts which consist of rectangular bays made up of horizontal timbers secured by vertical timber posts. Gridirons, like barge-beds, were built to provide a stable working surface on which vessels could be grounded at high tides for a number of tasks including the off and on loading of cargo, reparation of the barge and other maintenance tasks (TDP 2010).

Plate 1: Steel gridiron [4] view to the south, scale 1m

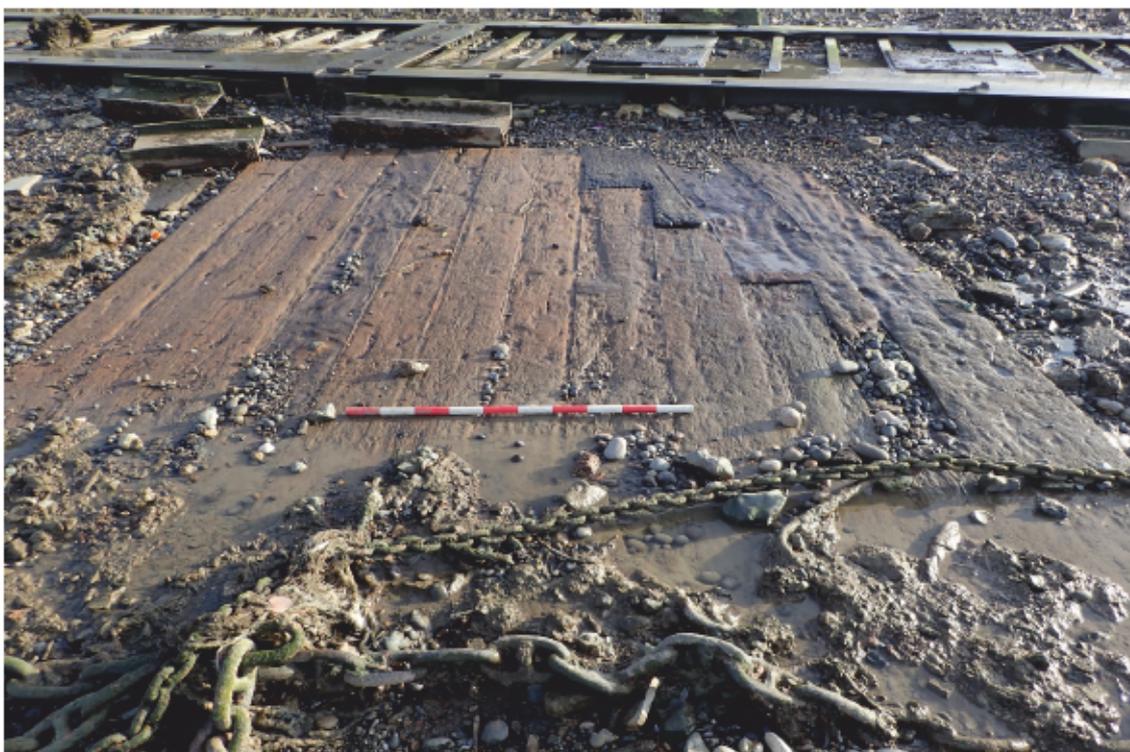
- 5.5 Beneath the steel gridirons [1] & [4] and layer of bedding concrete described above was a series of large horizontal wooden planks laid edge to edge, some of which had been sawn to create a curving edge [2] / [3] (see *Plates 2 & 3*). The main span of planks was exposed by the tide between the two steel gridirons but some planks were clearly visible protruding from under the western edge of [1]. Their form and function is unknown but in all likelihood they were laid to provide a 'hard' or work surface.

Plate 2: A series of wooden planks [2] / [3] which pass under the gridirons [1] & [4], view to east, 1m scale

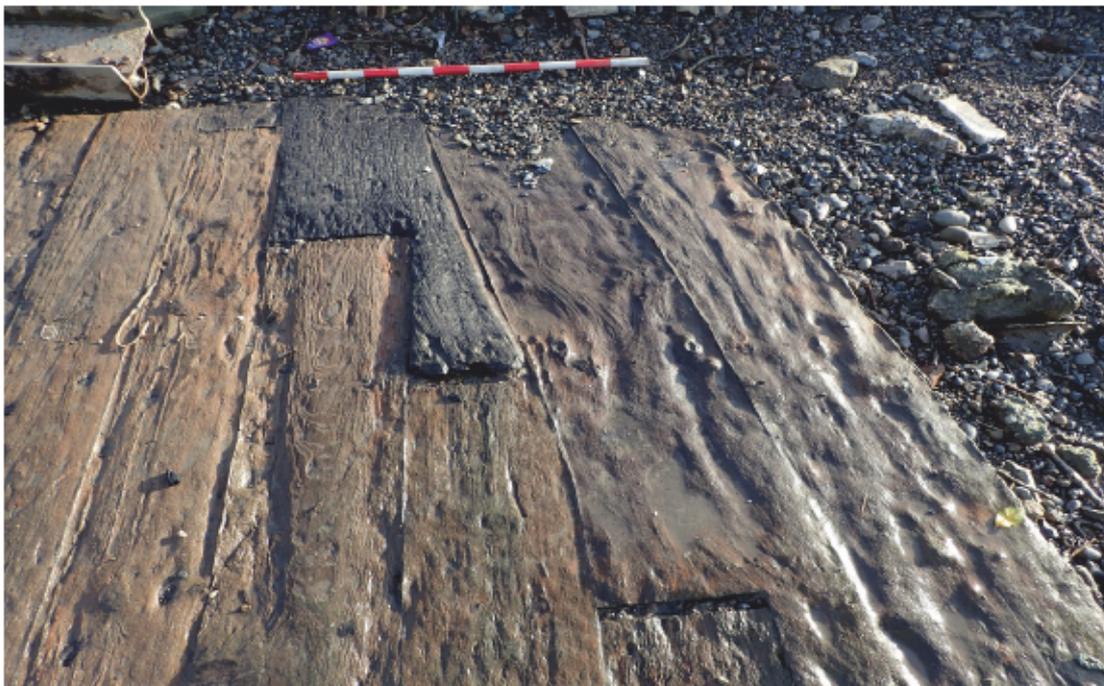
Plate 3: Plank surface [2] / [3] detail showing cut edges, view to the east, scale at 1m

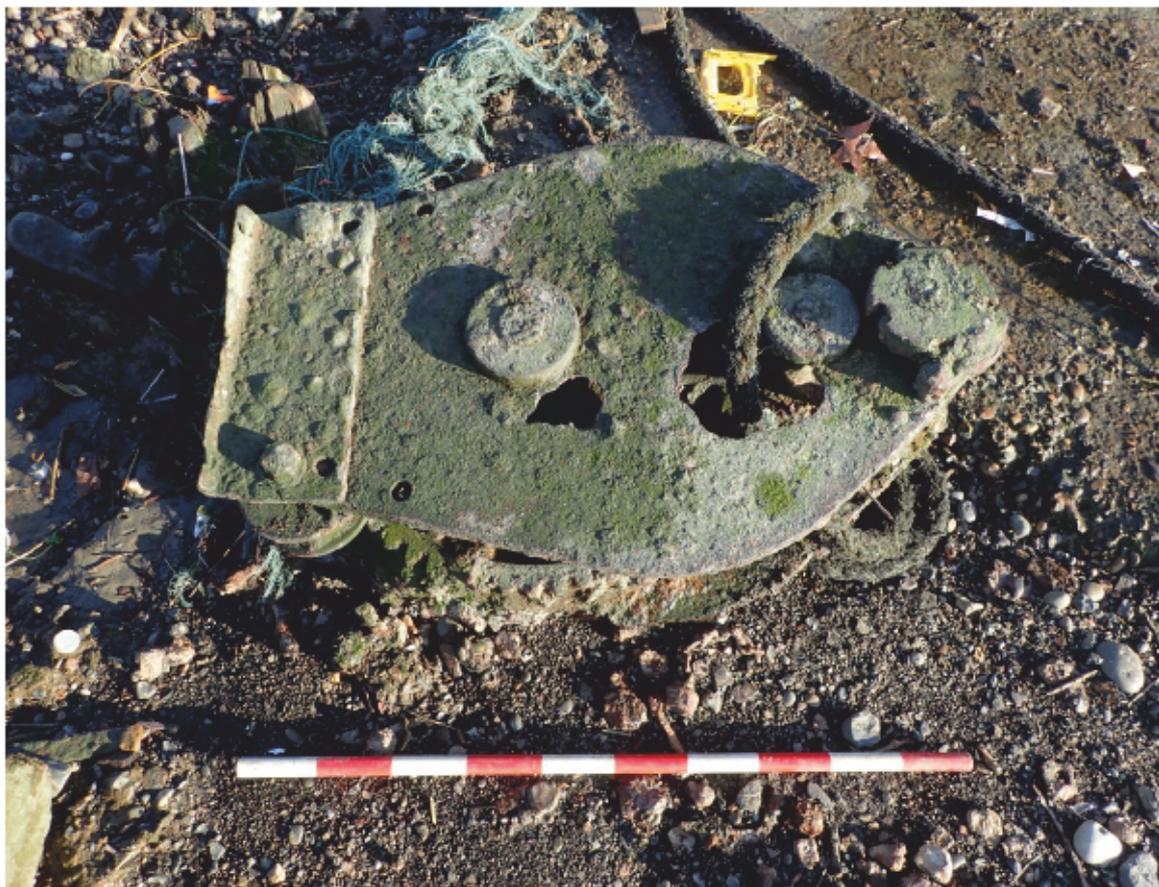
Plate 4: Metal pulley on foreshore (un-numbered in survey), view to south-west, scale 1m

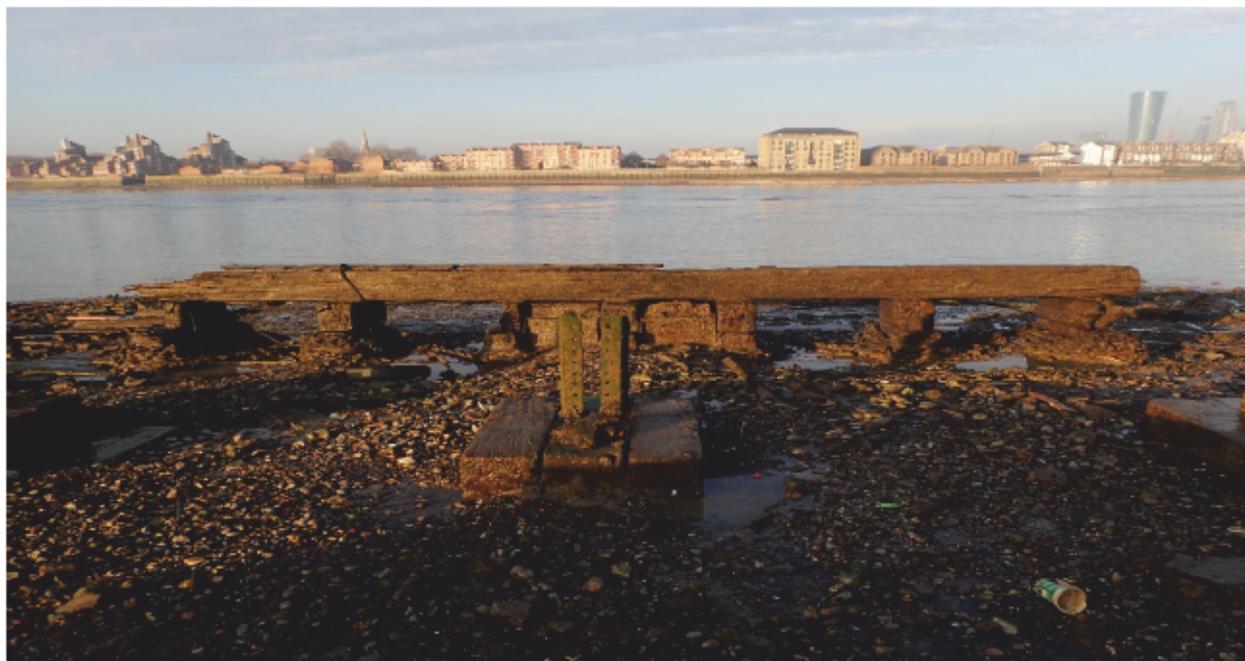
- 5.7 The largest structure on the foreshore consisted of five timber crossbeams set upon timber pillars that created one cohesive barge-bed upon which a large barge could be rested. However, two of the five ‘rests’ had lost their horizontal crossbeams leaving a series of eroded pillars. The ensemble of structures measured 28m long by 8m wide and was oriented roughly east-west, parallel to the shoreline. The timbers were interpreted as a barge-bed on account of their size and the presence of packing and in-filling between the timbers. It is this additional packing, including the concrete, which suggests that it is a barge-bed based upon the TDP designation (TDP 2010). This represents a substantial structure sufficient to receive a large vessel. The barge-bed had consisted of five horizontal timbers set perpendicular upon a series of timber pillars to create a series of ‘rests’ upon which the hull of the barge could have rested. Two were ruinous, having either lost their crossbar or having deteriorated leaving just the supporting pillars *in situ*. Working from the west and travelling up the foreshore the first structure consisted of very large lateral timber [7] resting upon seven pillars (grouped as [8]) of short, horizontal timbers bolted into place, all of which, in turn, rested upon four laterally running planks (grouped as [9]) (see *Plate 5*).

Plate 5: View to west of stanchion [12] in the foreground with the horizontal barge-bed [7] / [8] / [9] immediately behind it. Isle of Dogs on the horizon with the Thames at Low Tide

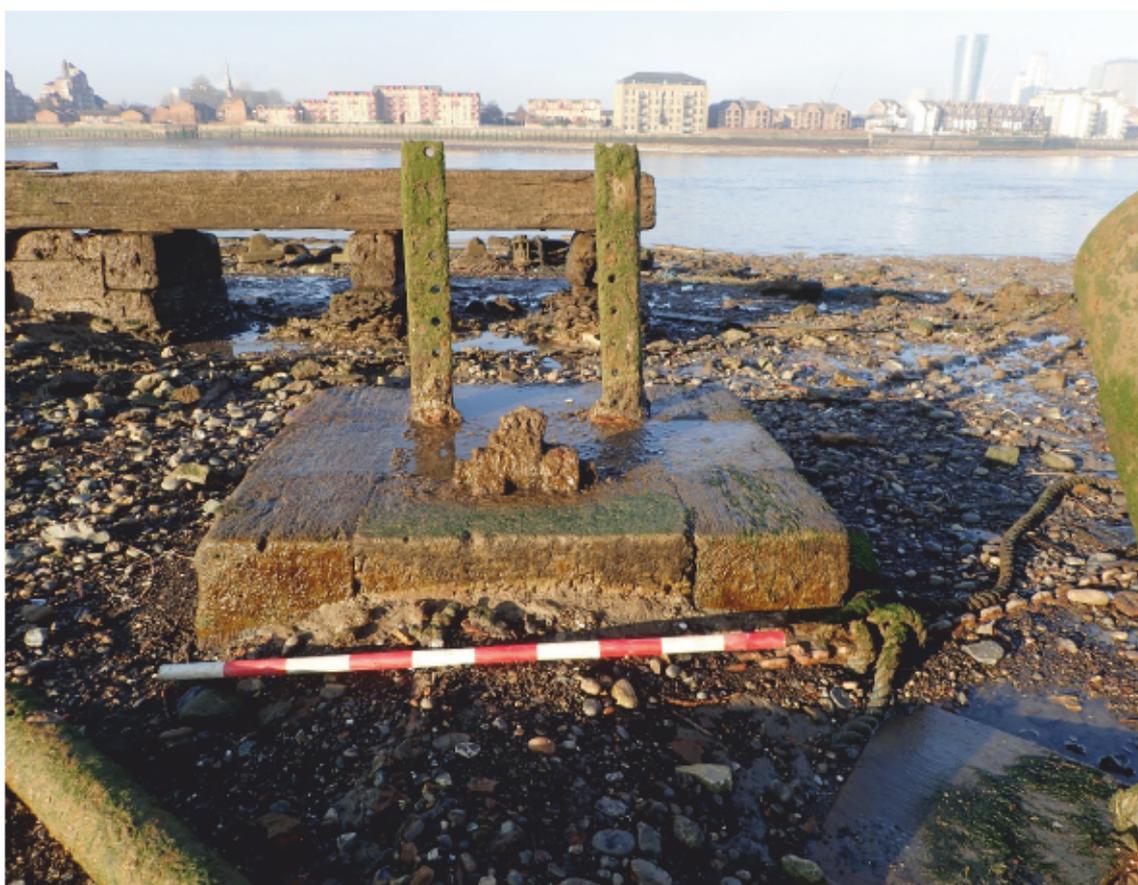
Plate 6: stanchion [11], view to the west, scale 1m

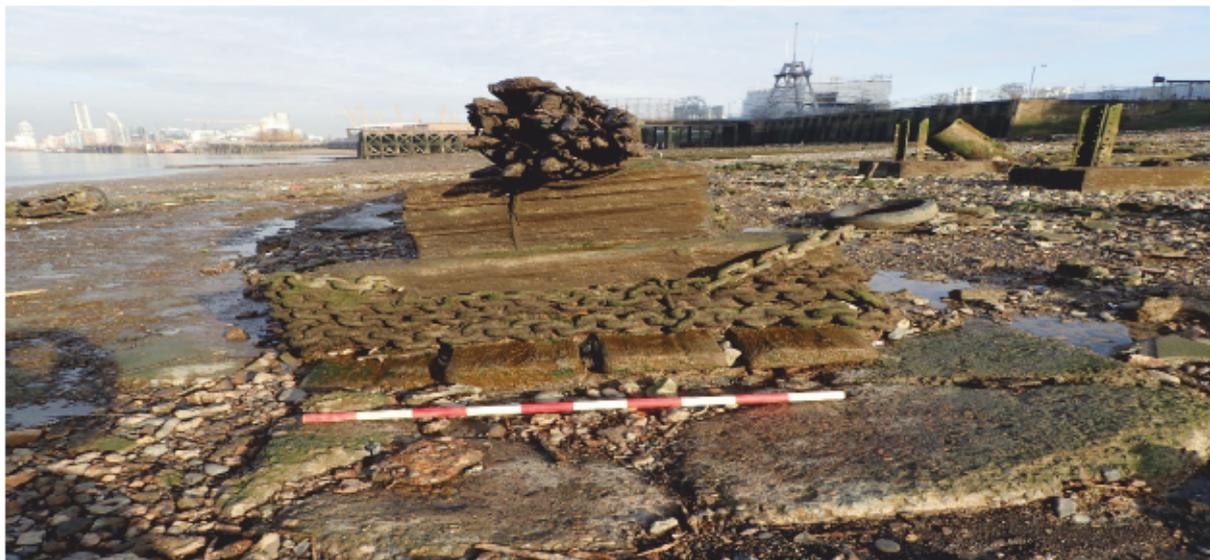
- 5.9 The third component of the barge-bed was another horizontal timber [16] (comprised of two squared timbers strapped together) set upon three pillars [17, 18 & 19] much the same as [7] described above (see *Plate 7*). The horizontal timber was 8m in length and the combined height of the structure was 0.54m. In this case it could be seen that pillar [19] sat on (or was set into) a concrete bed.

Plate 7: Barge-bed structure with horizontal beam [16] on three pillars [17] , [18] & [19], view to the north, scale 1m

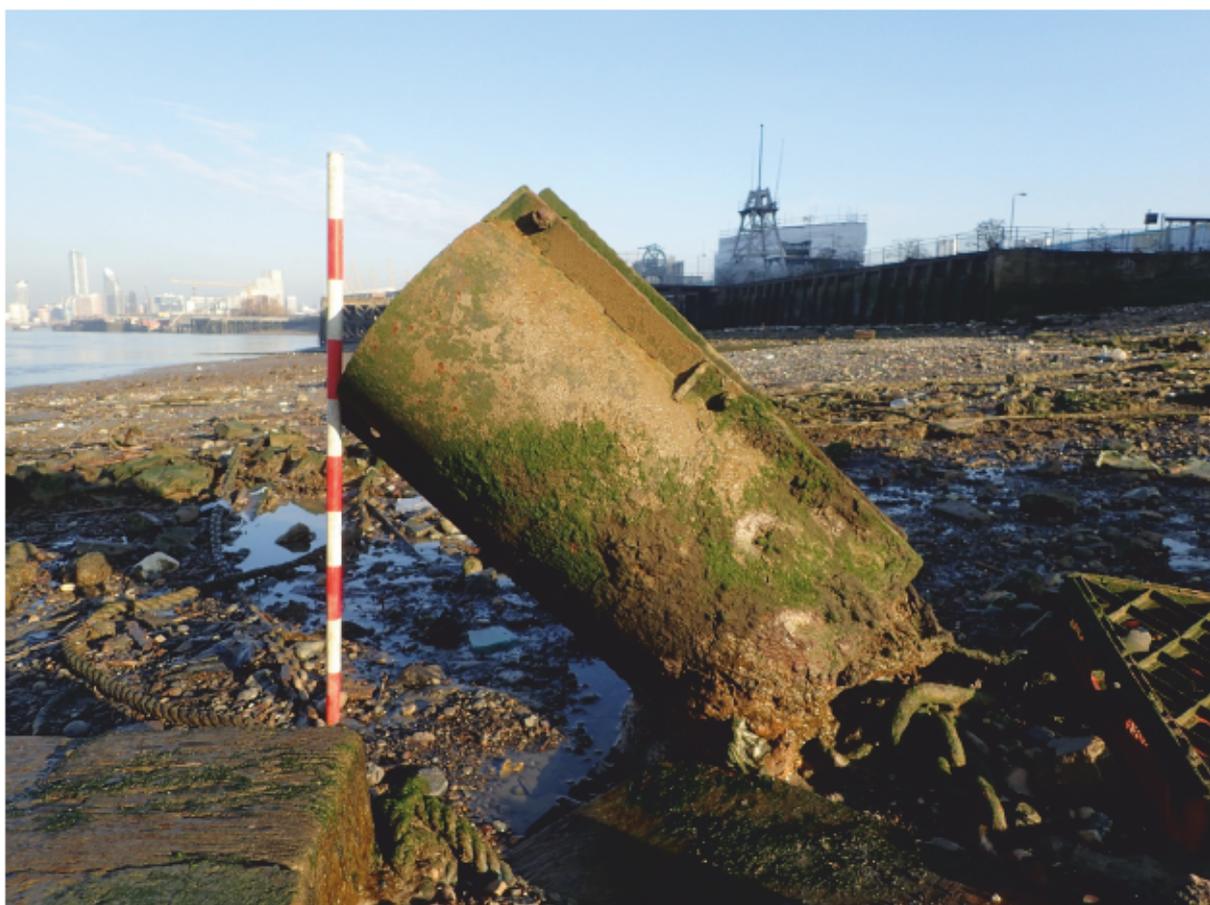
- 5.10 To the north of this row of three stanchions a large vertical wooden post [14] was recorded, enclosed in a metal cylinder measuring 1.05m high and 0.38m in diameter. This seems likely to have been a mooring post to hold (or direct) the barges onto the barge-bed horizontals (see *Plate 8*).

Plate 8: Mooring post [14] with metal cylinder or sheath, view to the north, scale 1m

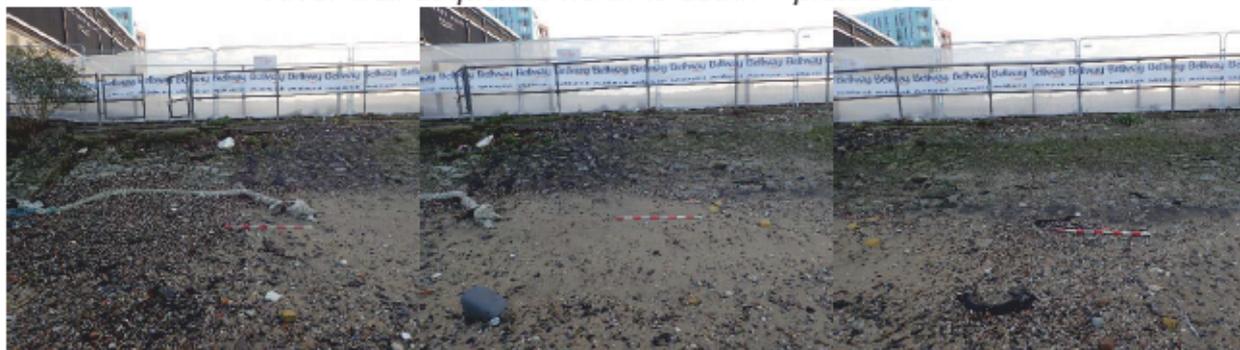
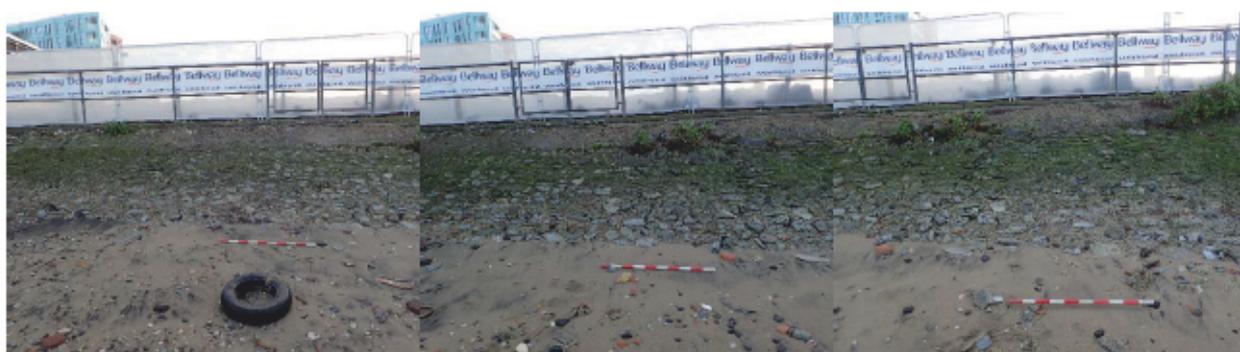
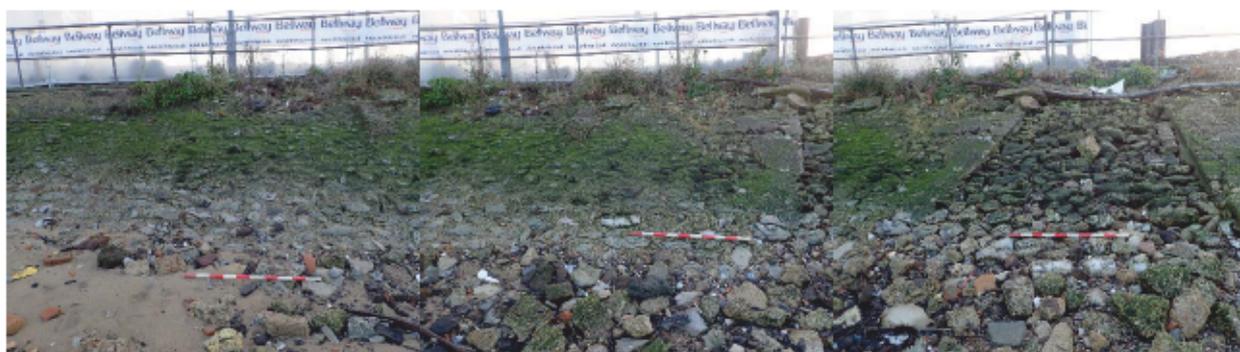
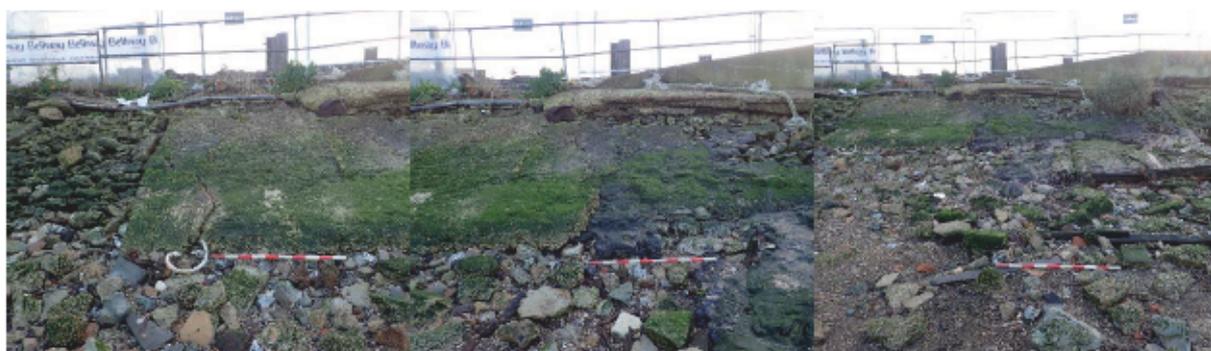
River wall sequence north to south – plates 9 -27

- 5.17 The river wall was systematically photographed from the north to south in sequence. For most of its length the wall itself was obscured by a setting of cobbles which formed a ramp at 45 degrees which sloped down to the shingle. This continued until it reached the ruined wharf structure [27]. From this point onwards the river-wall was block built, the west facing side further strengthened by steel sheet piling (Wharf 1) (see *Plates 9 -36 for the entire riverwall sequence*).

Stone cobbles laid at 45 degrees
View to east, scale 1m

Old stairway filled with cobbles

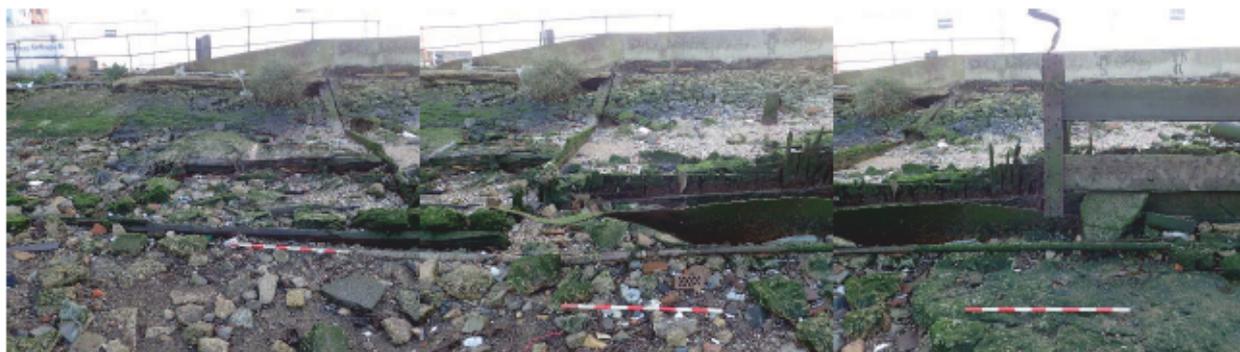
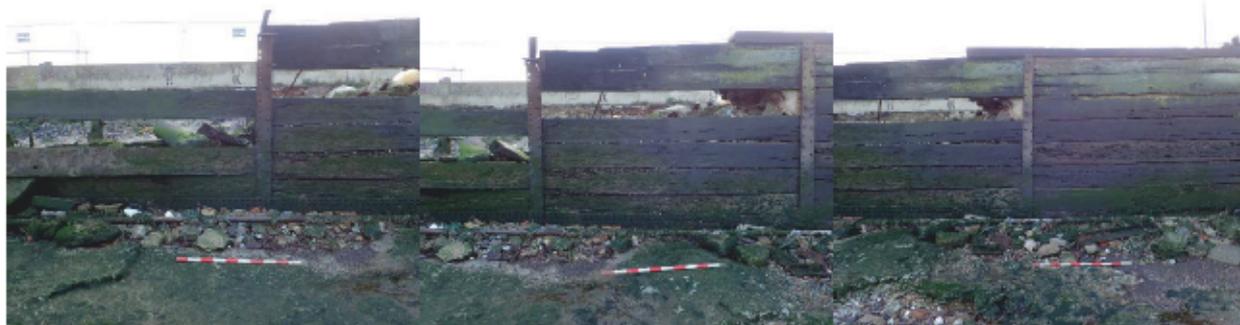
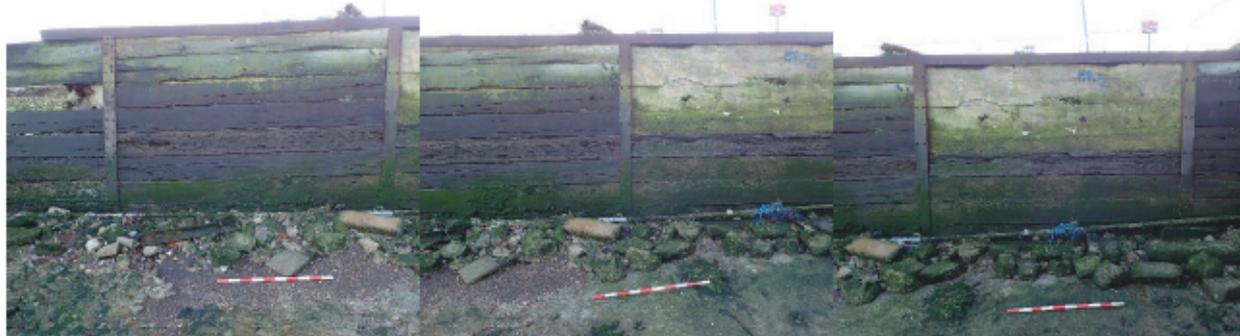
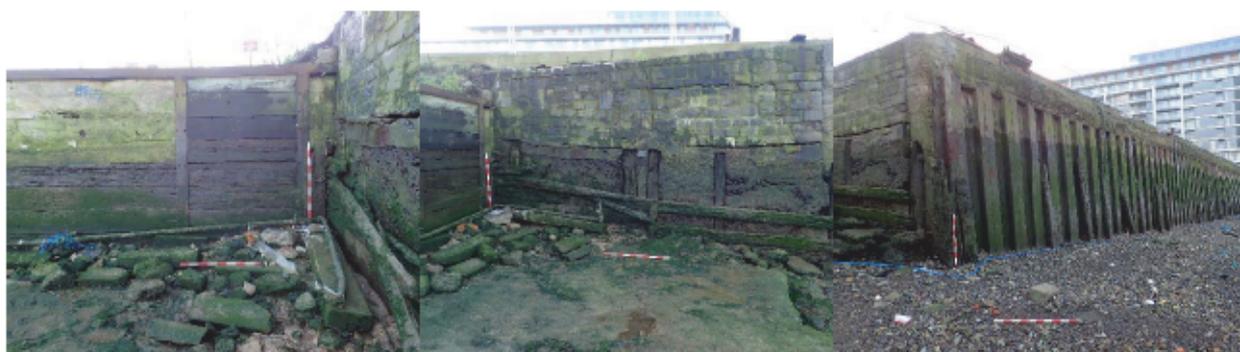
- 5.15 The Thames Discovery programme defines wharves as platforms constructed parallel to the shore (or indeed extensions of the shore itself) for loading and unloading cargo and therefore are generally more substantial in form (TDP 2010). However, as they are generally discovered in their degraded, eroded form and, if they are only partially exposed, they may be confused with a line of revetting or river defence palisade. This was certainly the case of the collapsed wharf structure in the south east of the site - the structure appeared to have been a later addition to an existing stone-built river wall. Wharf structure [27] (Wharf 3) consisted of panels created by horizontal planks having been stacked vertically on edge within a steel 'H' frame. These, for the most part, remained standing even though the interior had collapsed. Structure [27] comprised of five such panels; the northernmost of which was only partial as it had been heavily eroded away (see *Plate 9*).

- 5.16 The collapsed wharf structure revealed two internal components; an earlier wharf structure [28] (Wharf 2) which had been superseded by [27] and a row of parallel posts [29/30/31]. Two further posts, [32] & [33] were internal supports to the wharf structure having the remains of a metal bracing tie attached to them that would have braced the structure internally.

Ruined wharf (Wharf 3) [27]

Ruined wharf [27], wood panel 1

Ruined wharf [27], wood panel 2

Ruined wharf [27], wood panel 3

Ruined wharf [27], wood panel 4

Ruined wharf [27], wood panel 5

View to south-east, iron shuttering

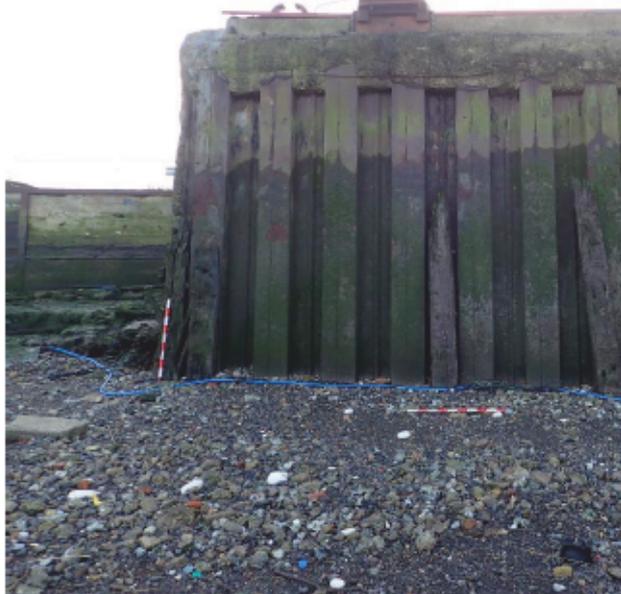
Plate 33: River wall shuttering, (Wharf 1) view to east, scale 1m
