**LAND SOUTH OF CHURCH LANE,
PAPWORTH EVERARD:
ARCHAEOLOGICAL TRIAL TRENCH
EVALUATION**

**LOCAL PLANNING AUTHORITY: SOUTH
CAMBRIDGESHIRE DISTRICT COUNCIL**

**PLANNING APPLICATION NUMBER:
S/0623/13/FL**

PCA REPORT NO: R12794

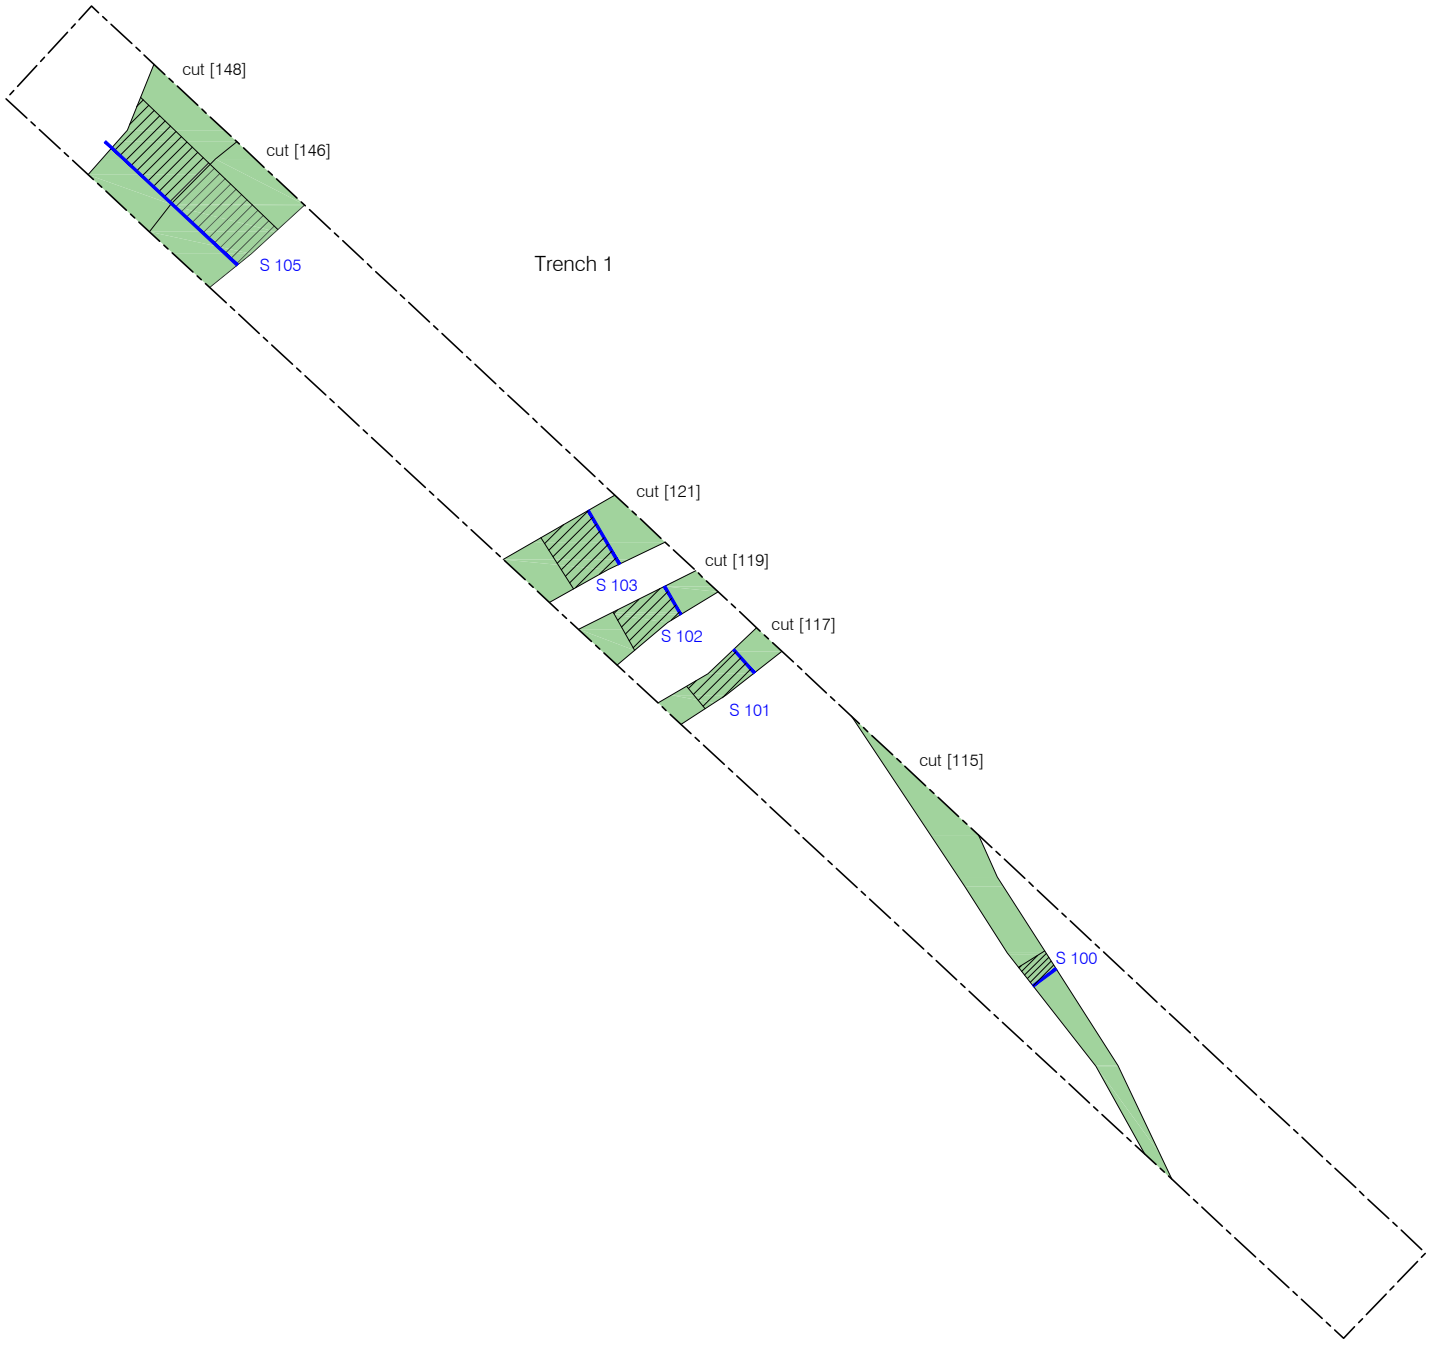
Figure 4
Plan of Trench 1
1:125 at A4

5.2.1 Trench 1 contained six ditches; five were aligned north-east to south-west, with the remaining example being aligned north-west to south-east.

5.2.8 These features are likely to be boundary ditches, with the density of similarly aligned features within the trench reflecting the repeated reinstatement of a boundary line. The quantity of features within the trench suggests the boundary line represented by the ditches may have been active for a longer duration of time, although the small quantities of finds suggest the boundary line may not have defined an area of direct settlement. The proximity of the these ditches to the historic core of the village to the west, and the in general parallel alignment to the nearby Church Lane suggests that these boundaries may have related to smaller plots of land radiating off this route.

TRENCH 1	Figures 2 and 4	Plate 4, 5 and 6
Trench Alignment: NW-SE	Length: 30m	Level of Natural (m OD): 45

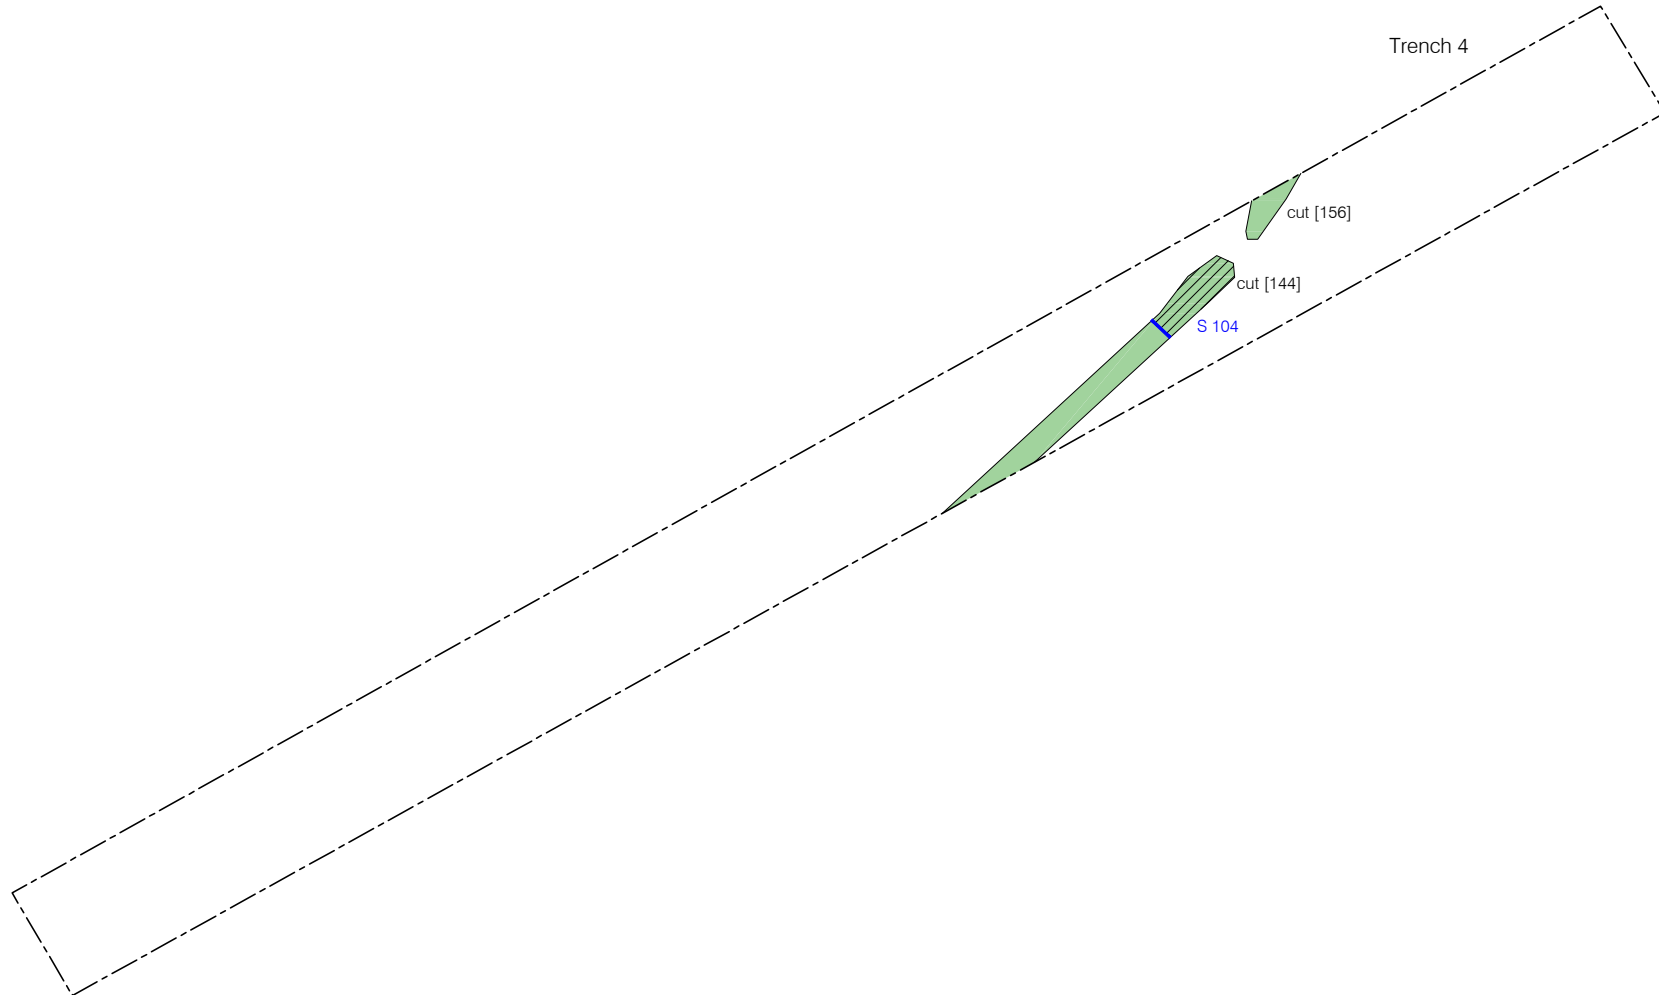
Figure 5
Plan of Trench 4
1:125 at A4

5.5.1 Trench 4 contained two ditches; both of which were aligned north-east to south-west.

5.5.4 These features are likely to be ditches defining the same boundary line. The gap in the boundary line between the two ditches may represent an entrance

into the plot. Although the two ditches did not produce finds assemblages, based on shared alignments, profiles and the similarity of the feature fills it is likely that these features also date broadly to the medieval period. As such they may relate to the same system of land division attested to by the features in Trench 1.

TRENCH 4		Figures 2 and 5		Plate N/A	
Trench Alignment: NE-SW		Length: 30m		Level of Natural (m OD): 42-43	
Deposit	Context No.	Maximum Depth (m)			
		NE End	SW End		
Topsoil	(100)	0.50m	0.55m		
Subsoil	(101)	0.90m	0.95m		
Natural	(102)	0.90+m	0.95+m		
Summary					
<p>Trench 4 was located near the southern boundary of the site area.</p> <p>Trench 4 contained two ditches; both of which were aligned north-east to south-west. No finds assemblages were recovered from the features in the trench, although the features are considered likely to be broadly medieval in date.</p>

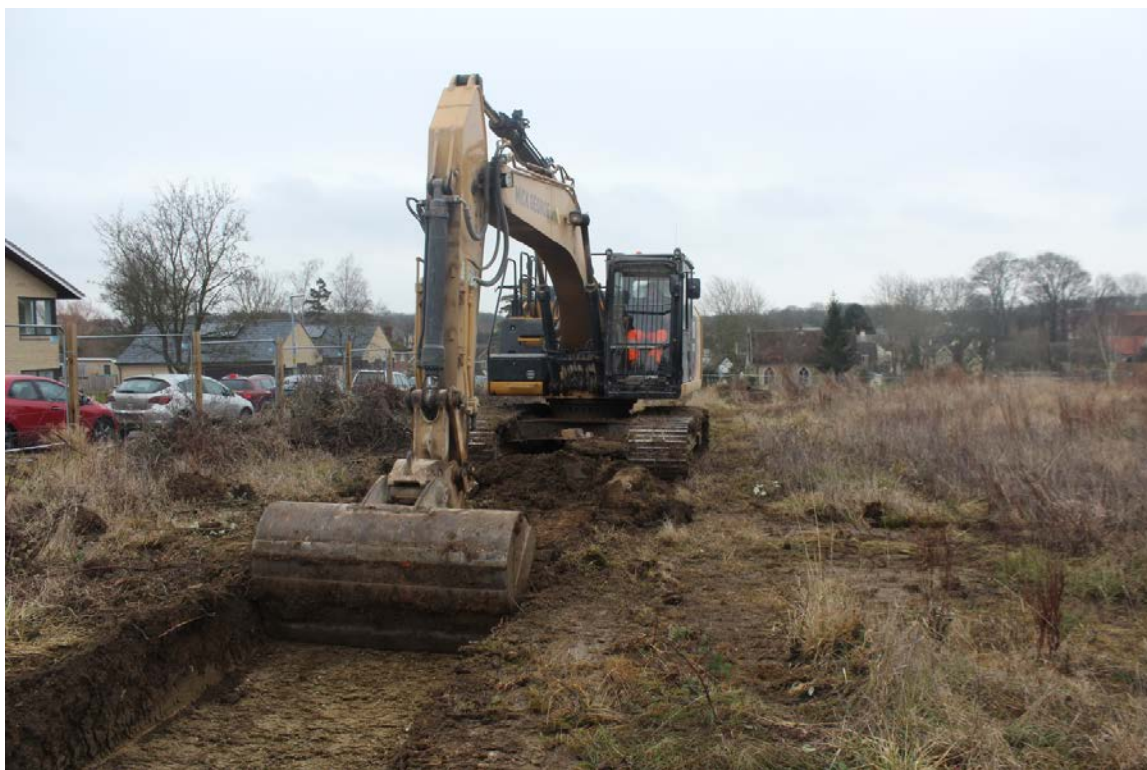
- 4.1.2 Ground reduction was carried out under archaeological supervision using a 20-ton tracked mechanical excavator fitted with a 1.8m-wide toothless ditching bucket (Plate 3). Topsoil, subsoil and built-up ground deposits were removed in spits down to the level of the undisturbed natural geological deposits where potential archaeological features could be observed and recorded. Where the level of the natural could not be reached, the trenches were excavated down to maximum safe depth, usually 1.20m. Exposed surfaces were cleaned by trowel and hoe as appropriate and all further excavation was undertaken manually using hand tools. Overburden deposits were set aside beside each trench and examined visually and with a metal-detector for finds retrieval.

Plate 3: Machining the western plot, view north-east

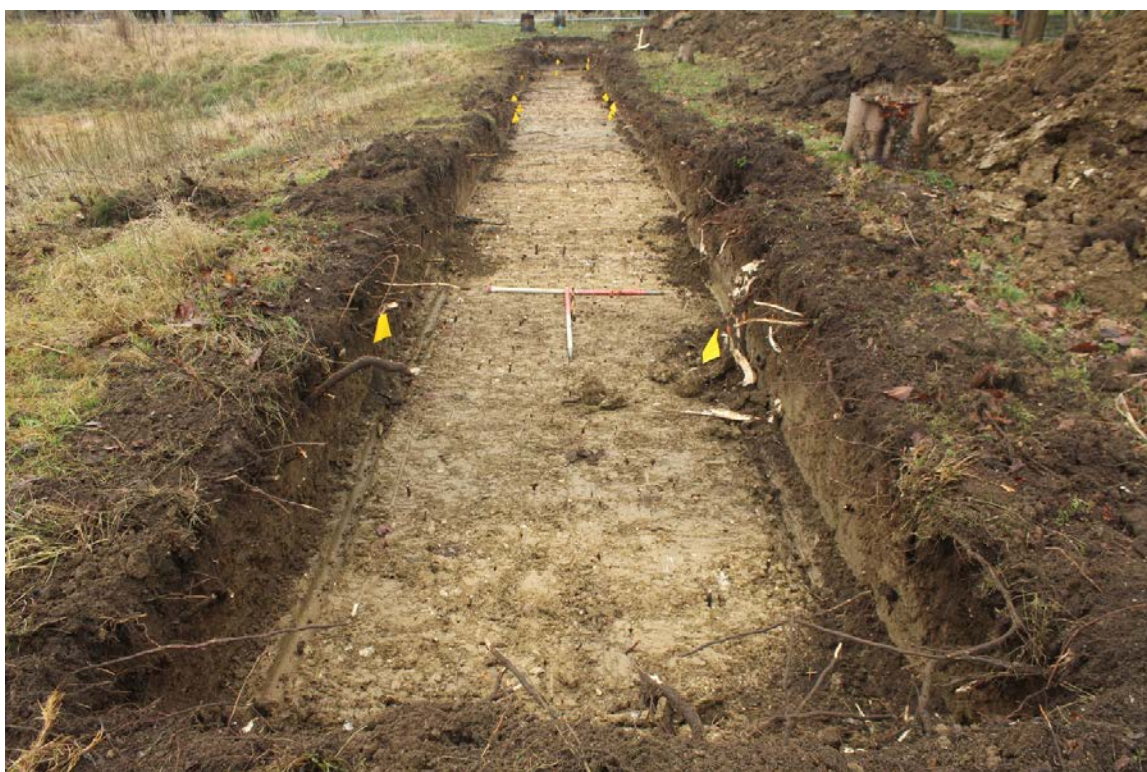
Plate 4: Trench 1 pre-excitation, view south-east

5.2 Trench 1 (Plate 4)

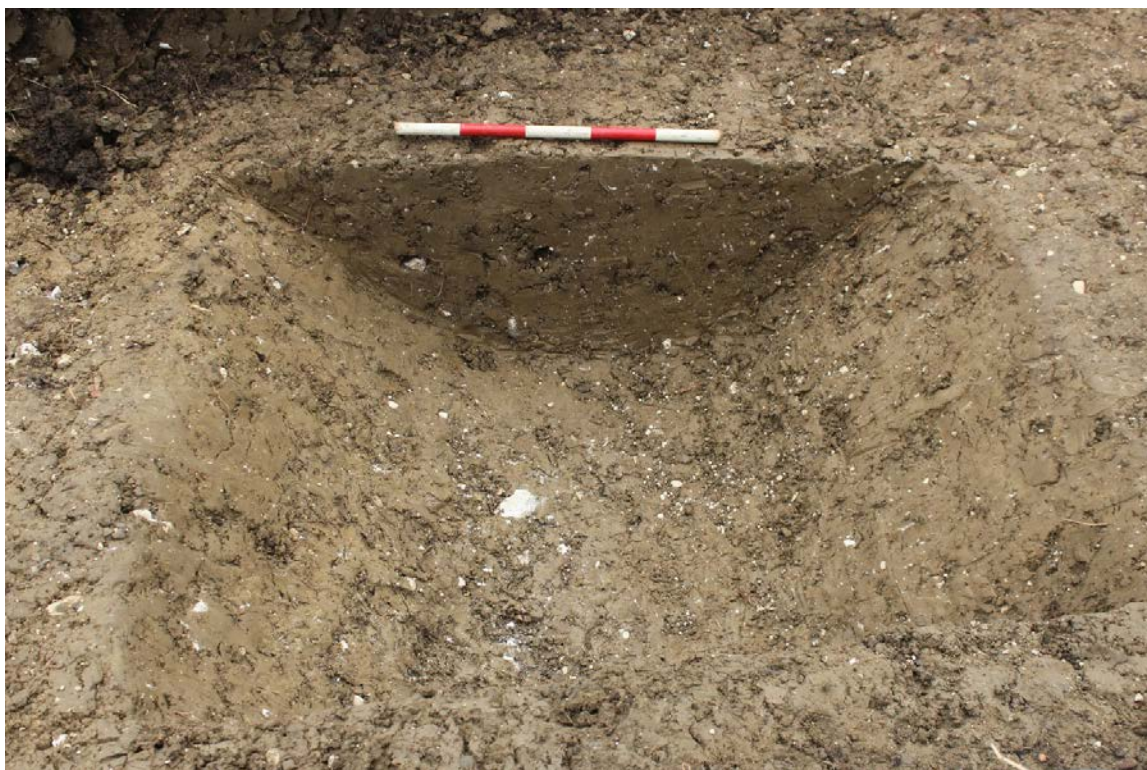
5.2.5 Ditch [121] (Plate 5) was located centrally within the trench and was aligned north-east to south-west, carrying on out of the limits of excavation in both directions. It was moderately wide and deep, measuring 1.10m wide by

0.41m deep, with a rounded profile. It contained a single fill (120), a mid-brown-grey silty-clay which contained two sherds (9g) of St Neots-type ware pottery and a small quantity of animal bone.

Plate 5: Ditch [121], Trench 1, view north-east

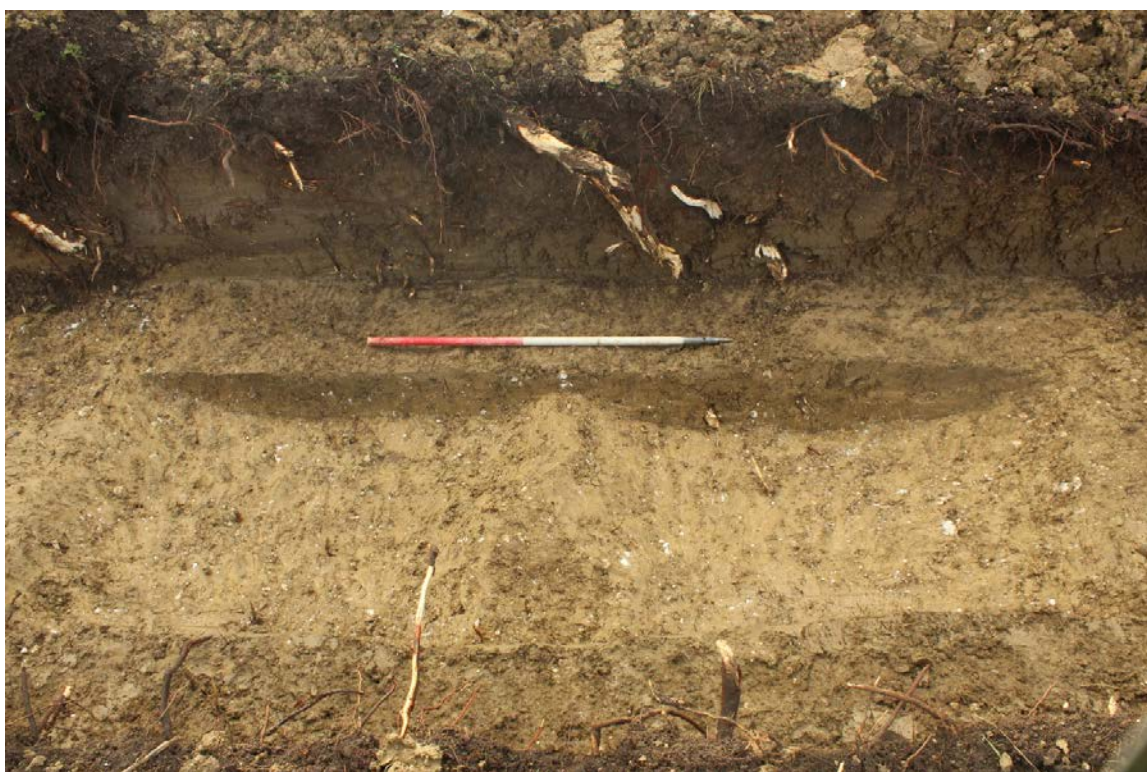
5.2.6 Ditch [146] (Plate 6) was located to the north-west within the trench and was aligned north-east to south-west, carrying on out of the limits of excavation in both directions. It was wide and shallow, measuring 1.39m wide by 0.18m deep, with a rounded profile. It had two fills; an upper fill (145), a 0.14m thick light grey-brown silty-clay which contained a single sherd (1g) of St Neots-type ware and a single sherd (>1g) of Early medieval sandy ware (1050 - 1200AD); a small amount of animal bone was also present. The lower fill (151) was a 0.05m thick mid-brown-grey clay which contained no finds. The ditch cut Ditch [148].

5.2.7 Ditch [148] (Plate 6) was located to the north-west within the trench and was aligned north-east to south-west, carrying on out of the limits of excavation in both directions. It was wide and shallow, measuring 1.55m wide by 0.22m deep, with a rounded profile. It had two fills; an upper fill (147), a 0.16m thick mid-dark brown-grey silty-clay which contained a single sherd (3g) of Huntingdonshire Early Medieval ware (1050 - 1300AD) and a lower fill (152), a 0.08m thick mid-light brown-grey clay which contained no finds. The ditch was cut by Ditch [146].

Plate 6: Ditches [146] and [148], Trench 1, view south-east
