**INTERFACE LAND, CHATHAM,
KENT: AN ARCHAEOLOGICAL
WATCHING BRIEF ON
GEOTECHNICAL WORKS**

SITE CODE: KCDG17

MARCH 2017

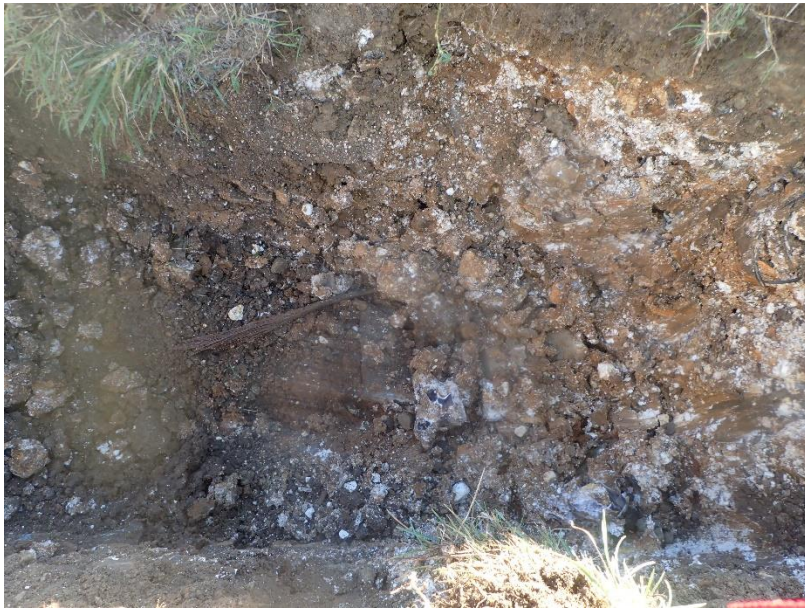
Plate 1: ETP3

- 9.5 ETP 1 was targeted on the location of the Wessex Archaeology Trench 1. The test pit found 2.10m of modern made ground, suggesting that the test pit was located in the backfill of the trench. ETP3 was located within Wessex Archaeology Trench 2. No evidence for the structures encountered in the trench were seen. The test pit was terminated at 0.60m below ground level due to the presence of a modern wall.

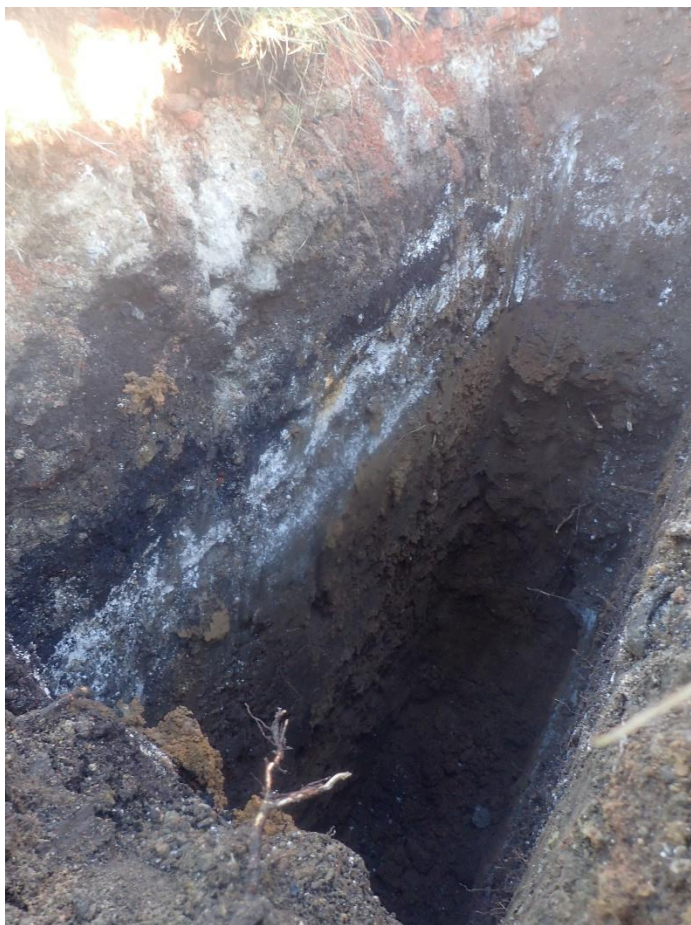
Plate 2: ETP 2

8.4.1 Modern made ground and topsoil was present in all of the test pits. The made ground was of varying thickness. Test pits of note included ETP2, where the modern made ground was 1.9m thick over a concrete slab. In ETP3, a concrete and brick wall was found at 0.60m below ground level and so the test pit was abandoned. In WTP1, the modern made ground was 2.4m thick. WTP2 found modern made ground to a depth of 2.57m OD, where the test pit was abandoned. In WTP11, the modern made ground was 2.00m thick and directly overlay the natural gravel, suggesting heavy modern truncation in this area. In WTP12, the modern made

- 9.6 ETP 2 was targeted on a historic railway line, however as it was moved slightly to the west, no evidence for the railway was encountered.
- 9.7 ETP4 was targeted on a sawpit. Only layers of made ground and natural sand were seen in this test pit.

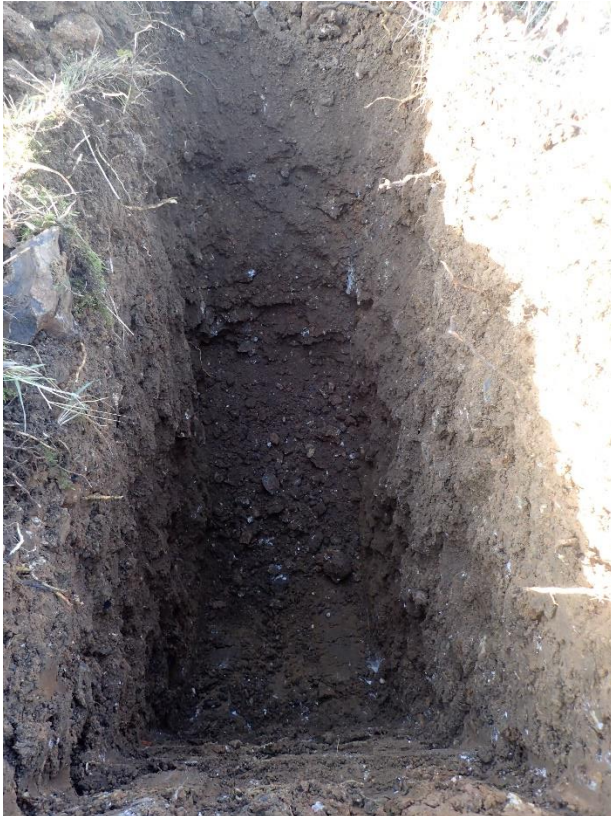
Plate 5: ETP6

thick and in ETP 6, the post-medieval made ground was 1.00m thick. In ETP 6, a layer of clay with flint cobbles was present below the made ground, it was unclear if this was natural or not. In ETP7 a layer of probable post-medieval subsoil was present from 0.40m to 1.50m below ground level. This layer was much cleaner, with little cultural material present, than the made ground seen in the other interventions.

- 9.8 ETP6 was also targeted on a saw pit. Again, there was no evidence present for the saw pit, although the test pit was moved slightly out of the saw pit area.

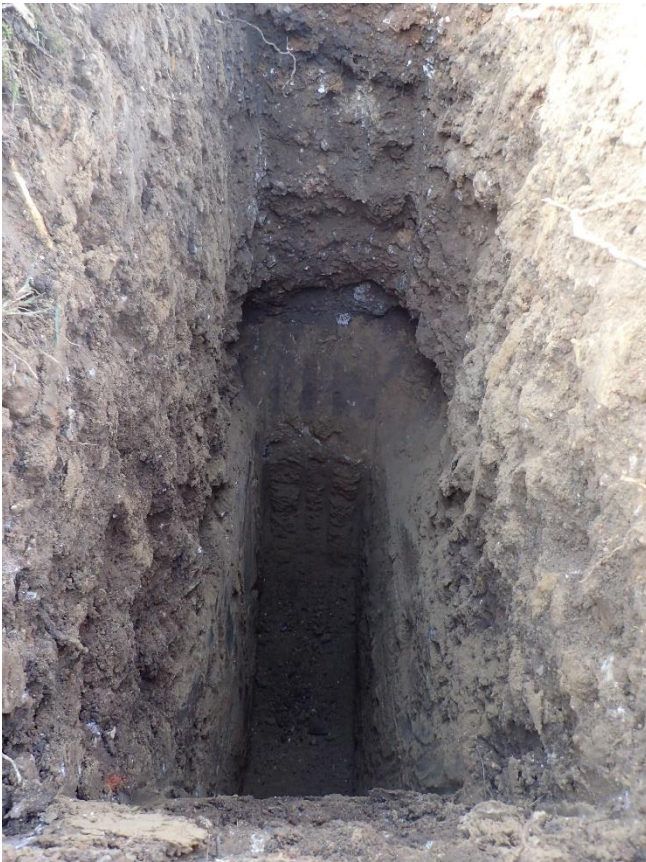
Plate 6: ETP7

- 9.9 ETP7 was located to target a historic wall. No masonry remains were found in the test pit.
- 9.10 ETP8 was also targeted on a wall and railway line. This test pit was moved south, off the alignment of both, and found no evidence of any structures.

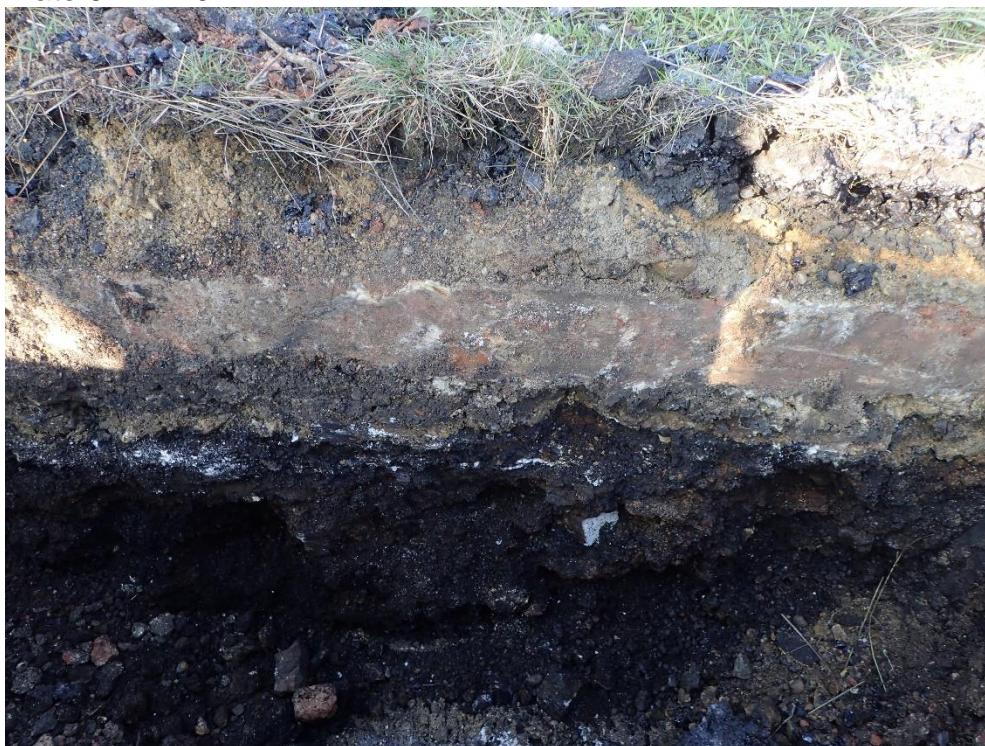
Plate 10: WTP7

8.2.3 In WTP7, natural sand was found at 1.14m OD, with an alluvial layer intact above it. However, the alluvial layer contained brick fragments and so was assigned to the post-medieval period (below).

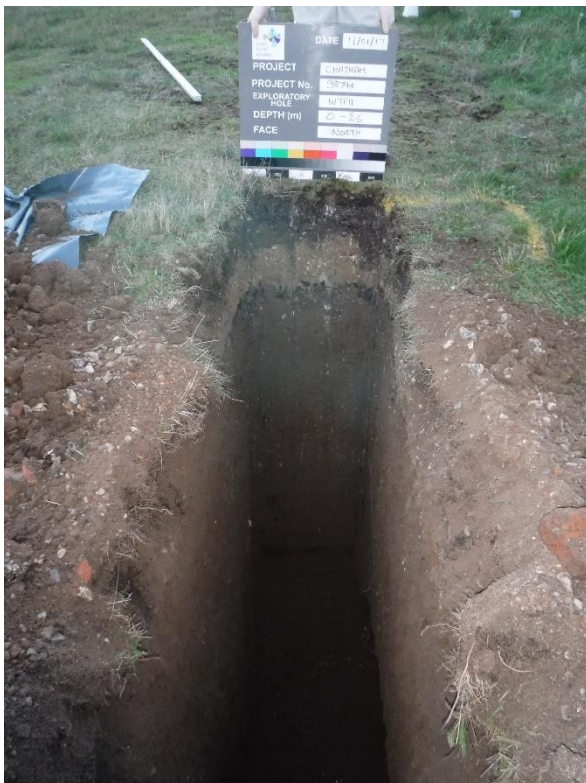
Plate 12: WTP11

- 9.13 WTP11 was targeted on Slipway No. 8. Only modern made ground overlying gravel was found in this test pit.

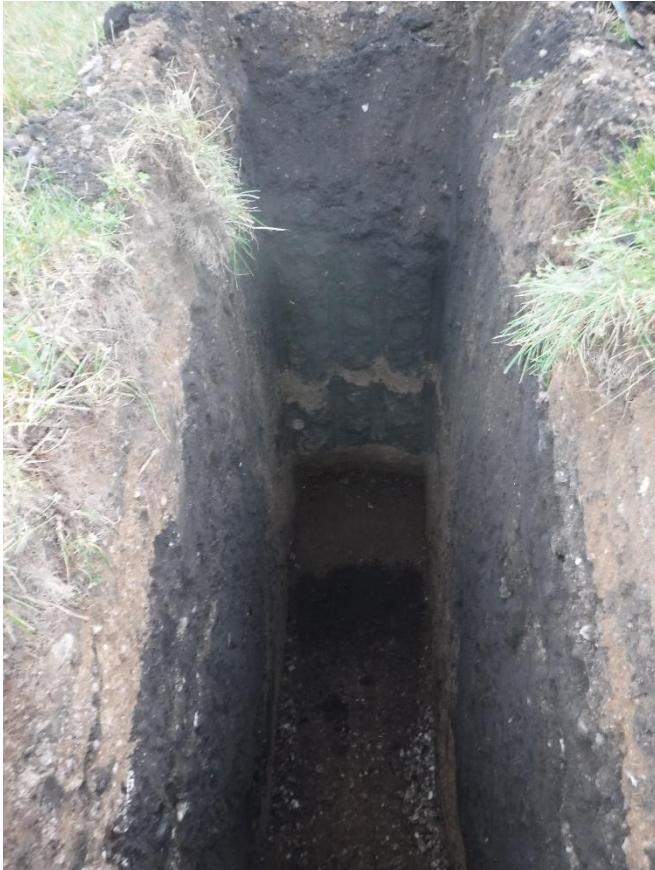
Plate 15: WTP15

ground was 2.8m thick, again directly over the natural gravel and 2.10m of modern made ground overlay the gravel in WTP15. A brick wall was noted at 2.7m below ground level in WTP10 (assigned to Phase 2), and as WTP10, 11, 12 and 15 were located near to each other, there may have been a large modern or post-medieval intrusion in this area.

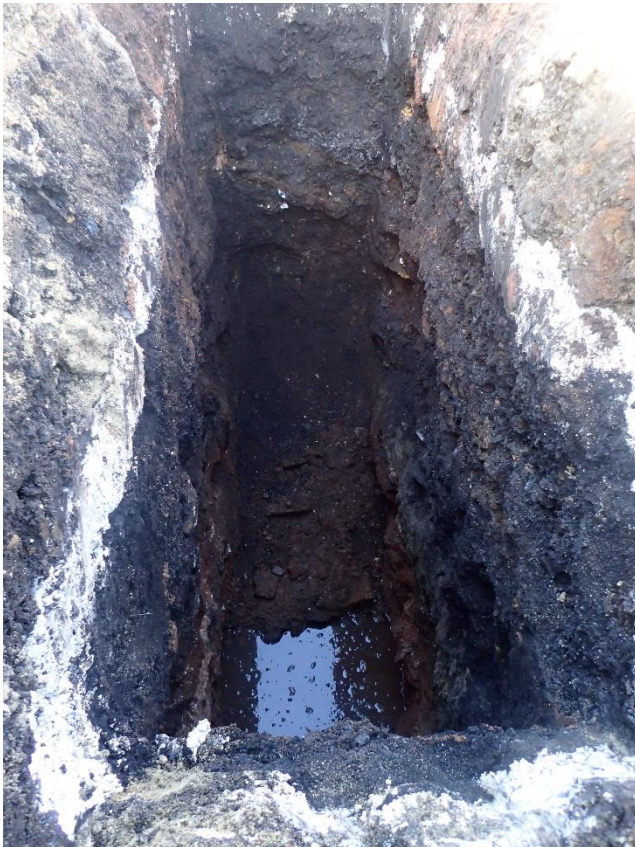
Plate 16: WTP10

8.3.3 Post-medieval made ground was present in some of the test pits. In WTP10, a 2.4m thick layer of post-medieval made ground was present, at the base of which was a brick wall. Due to the presence of the wall, which was not believed to be modern, the test pit was stopped at this depth (1.48m OD). In WTP12, a subsoil was present which was devoid of finds, but was assigned to the post-medieval period as it sealed alluvium. This layer was 1.55m thick, and the top of it was at 3.47m OD. In WTP5, post-medieval made ground was present between 1.20m and 2.6m below ground level, sealing the natural alluvium. In WTP6 post-medieval made ground was present between 0.65m and 1.40m below ground level, sealing alluvium. In WTP7 post-medieval made ground was present between 0.50m and 1.65m below ground level. In WTP8 post-medieval made ground was present between 0.50m and 2.8m below ground level-the test pit was stopped at 2.8m depth.

8.3.4 No structures or features of post-medieval or earlier date were identified in the test pits, other than a brick wall in WTP10 which was of probable post-medieval date. There was no evidence for the historic structures associated with the Dockyard.
