**THE FORMER BBC SITE,  
OXFORD ROAD, MANCHESTER**

**PHASE 1B: PLOT 14 (MSCP)**

**A SUMMARY OF AN  
ARCHAEOLOGICAL EVALUATION**

**PCA REPORT NO: R12830**

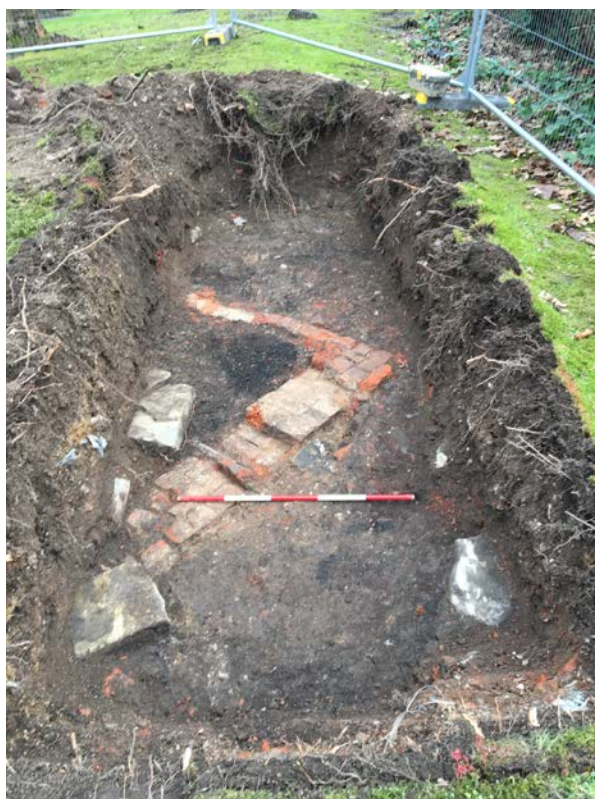
*Plate 1: Overview of Trench 1, looking east-southeast (1m scale).*

2.2.2 The remains recorded in Trench 1 consisted of a substantial brick foundation, [4], aligned roughly north-south and a narrower brick wall, [5], aligned perpendicular to this. Sondages were excavated on both sides of the narrow brick partition, showing that the walls survived to a height of at least 1.10m (35.79m OD), although an internal floor surface (if present) could not be

reached. This suggests that the narrower wall may well have been the partition separating the cellars of the two dwellings which fronted Heron Street. Brick and mortar samples taken from the two brick walls indicated that they were likely dated 1850 to 1900, which therefore leads to the likelihood that the structures at this location on Heron Street were reconfigured around this time when the Wheatsheaf Inn was developed.

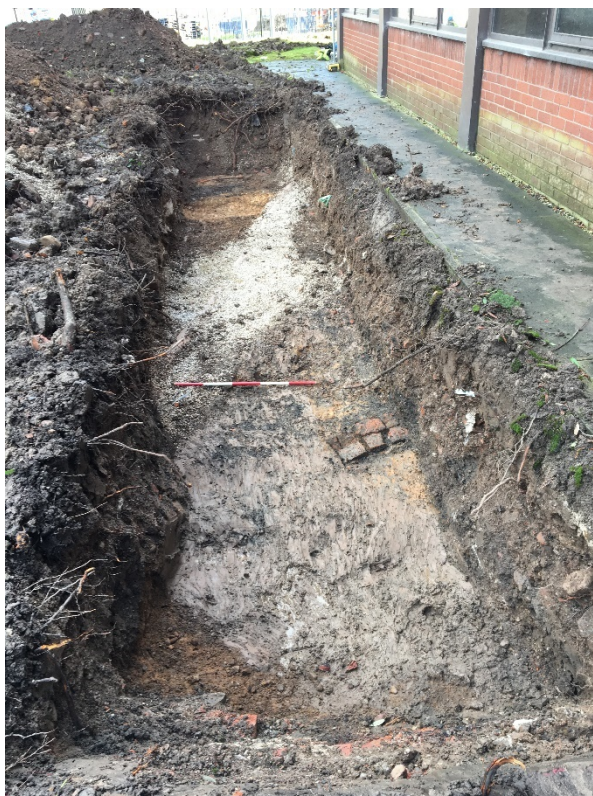
- 2.3.1 This trench contained a modern ceramic drain which had caused heavy truncation to the archaeological sequence throughout much of it. However, two small areas survived undisturbed in the eastern and western parts of the trench. In the western part of the trench, the natural clay, [8], was sealed by a brickearth-like subsoil, [11], recorded at 35.31m OD, which had been cut by the construction cut, [16], for a roughly north-south aligned brick footing, [14]. Only the lowest course of the footing survived, at 35.24m OD. It had been constructed using dry laid unfrogged red bricks dated sometime between 1830 and 1900. The footing was sealed by a demolition deposit, [10], which had been truncated by cut for the modern drain pipe.

*Plate 2: Overview of Trench 2, looking east (1m scale)*

- 2.3.2 In the eastern end of the trench, the natural clay was also sealed by the aforementioned subsoil, which was recorded as [12] at 35.28m OD. To the east, the subsoil had been cut by a linear cut, [18], aligned roughly north-south. It was filled by a black coal and clinker rich fill, [13],

producing both CBM dated 1850-1900 and pottery dated 1790-1820. The single piece of CBM recovered was found at the very top of the deposit, and is likely intrusive. As such, the likely spot date for the context, considering the entire pottery assemblage recovered (16 sherds), is 1815-1835. To the east, the fill of the cut had been truncated from a height of 35.35m OD by the construction cut, [17], for a red brick footing, [15], aligned along a roughly north-south axis. The bricks and mortar used in the construction of the footing were consistent with a 1850-1900 date.

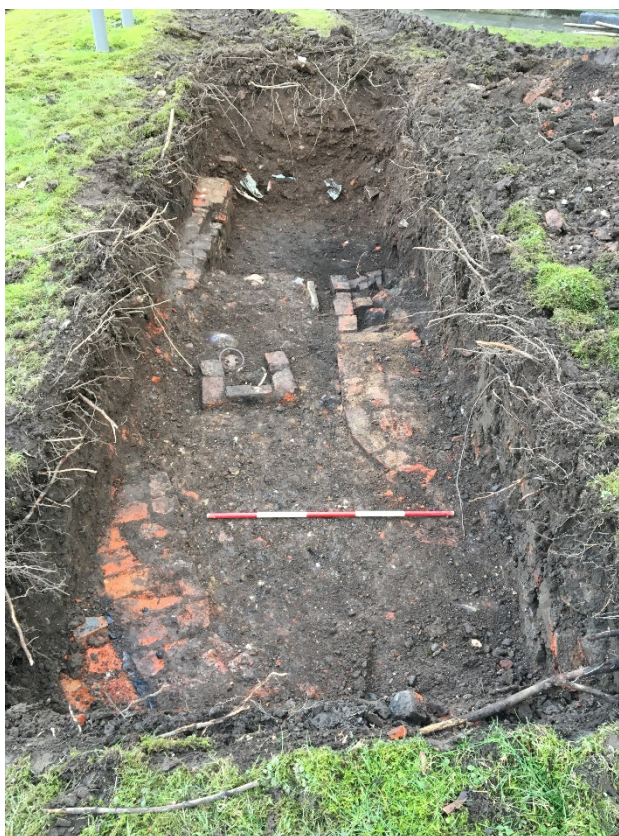
- 2.4.1 The natural clay in Trench 3 was sealed by a dump or levelling layer, [26], located at 35.54m OD; the pottery assemblage recovered from the layer suggests a deposition date of 1815-1835, which is therefore contemporary with the earliest development of the area as suggested from historic maps.

Plate 3: Overview of Trench 3, view to south (1m scale).

- 2.4.2 To the east layer [26] had been truncated by the construction cut for a brick footing, [20]/[22]/[23], and to the east by the construction cut for a curvilinear footing, [6], and a small wall initially thought to be a fireplace, [7], joining on to it to the south at 35.57m OD. The bricks

used in the construction of both the curvilinear footing and the postulated fireplace are suggestive of a 1830-1900 date, while the footing to the east was dated 1850-1900. The interior of 'fireplace' [7], was filled with loose brick rubble in a sand, ash and charcoal matrix, [24]. Unfortunately, excavation of the rubble fill did not produce any datable finds, but it can be assumed that the fill is a result of the building's demolition in the 20<sup>th</sup> century. In the centre of the trench, with no discernible relationship with either of the other brick walls, was a "U" shaped drain support, [19], constructed of red unfrosted bricks. Like the remaining brick structures, it is likely to date to between 1830 and 1900. Sealing the entire trench was a layer of modern made ground laid down to landscape the site following the demolition of the buildings in the 20<sup>th</sup> century.

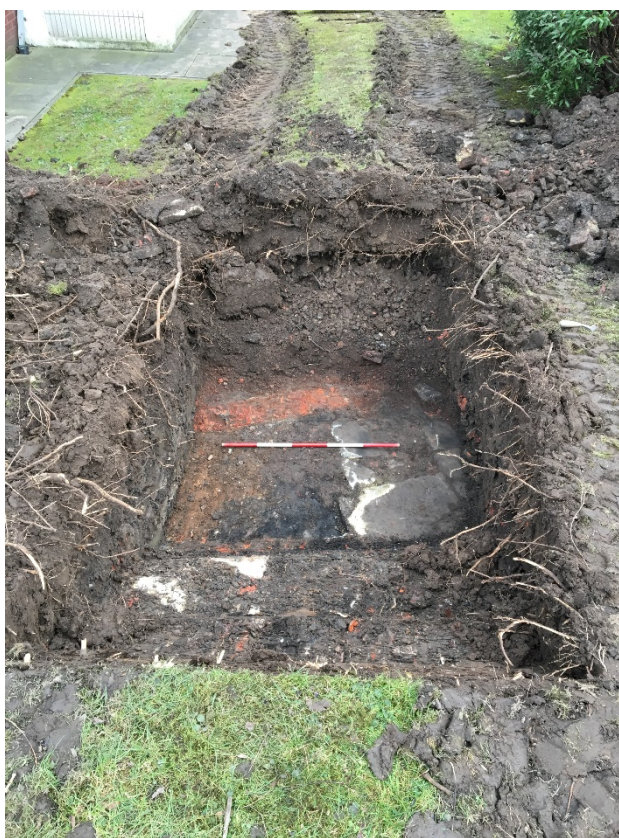
Plate 4: Overview of Trench 4, view north (1m scale).

Armstrong House. The archaeological sequence here consisted of natural clay at 35.67m OD, overlain by a 0.18m-thick layer of made ground, [28], comprising compact mid-brown sandy gravel with frequent pockets of ash and charcoal. At the northern end of the trench, this was truncated by the construction cut for an east-west aligned brick wall, [31]. The brick wall had been constructed using unfrosted red bricks measuring 235mm x 120mm x 80mm laid in stretcher bond, one skin thick. On both side of the wall, Yorkstone slabs had been laid to form paved surfaces. To the north, the stone surface was recorded as [30], while to the south of the wall, the surface was recorded as [29]. The stone surface to the south of the wall occurred at 35.93m OD, while the one to the north was laid roughly 0.10m lower. Sealing both stone surfaces was a layer of modern made ground raising the ground to its current level.

- 2.5.2 These remains correlate closely to the 1849-50 OS map (Figure 6), and imply that the wall represents the street frontage boundary to the dwellings on former Crossley Street, and the slabs are the remain of pavements.

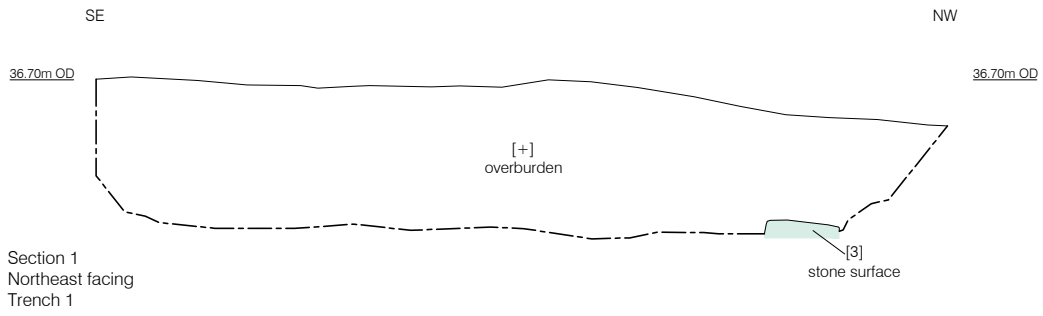
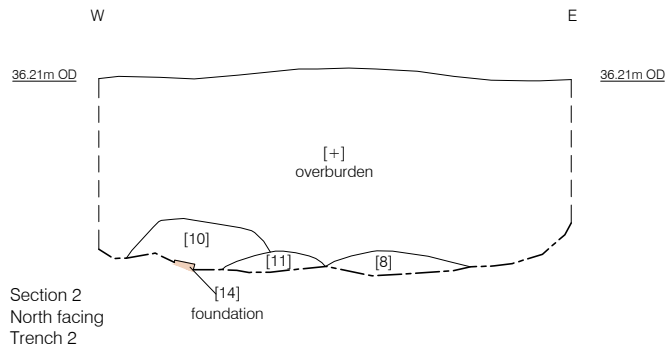
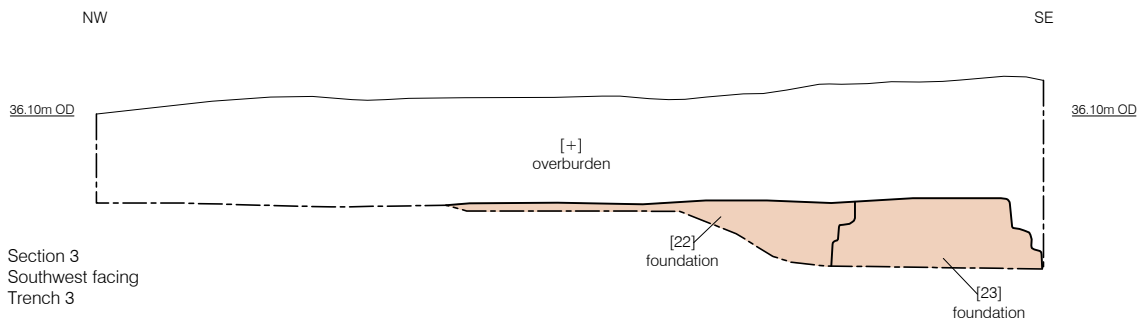
Figure 4  
Sections 1 to 3  
1:40 at A4

- 2.2.3 When the building was demolished in the middle of the 20<sup>th</sup> century the basement was backfilled with demolition rubble recorded as [1] and [2]. Following the demolition, a Yorkstone surface, [3], was laid across this part of the site (Figure 4), at a height of 35.96m OD.

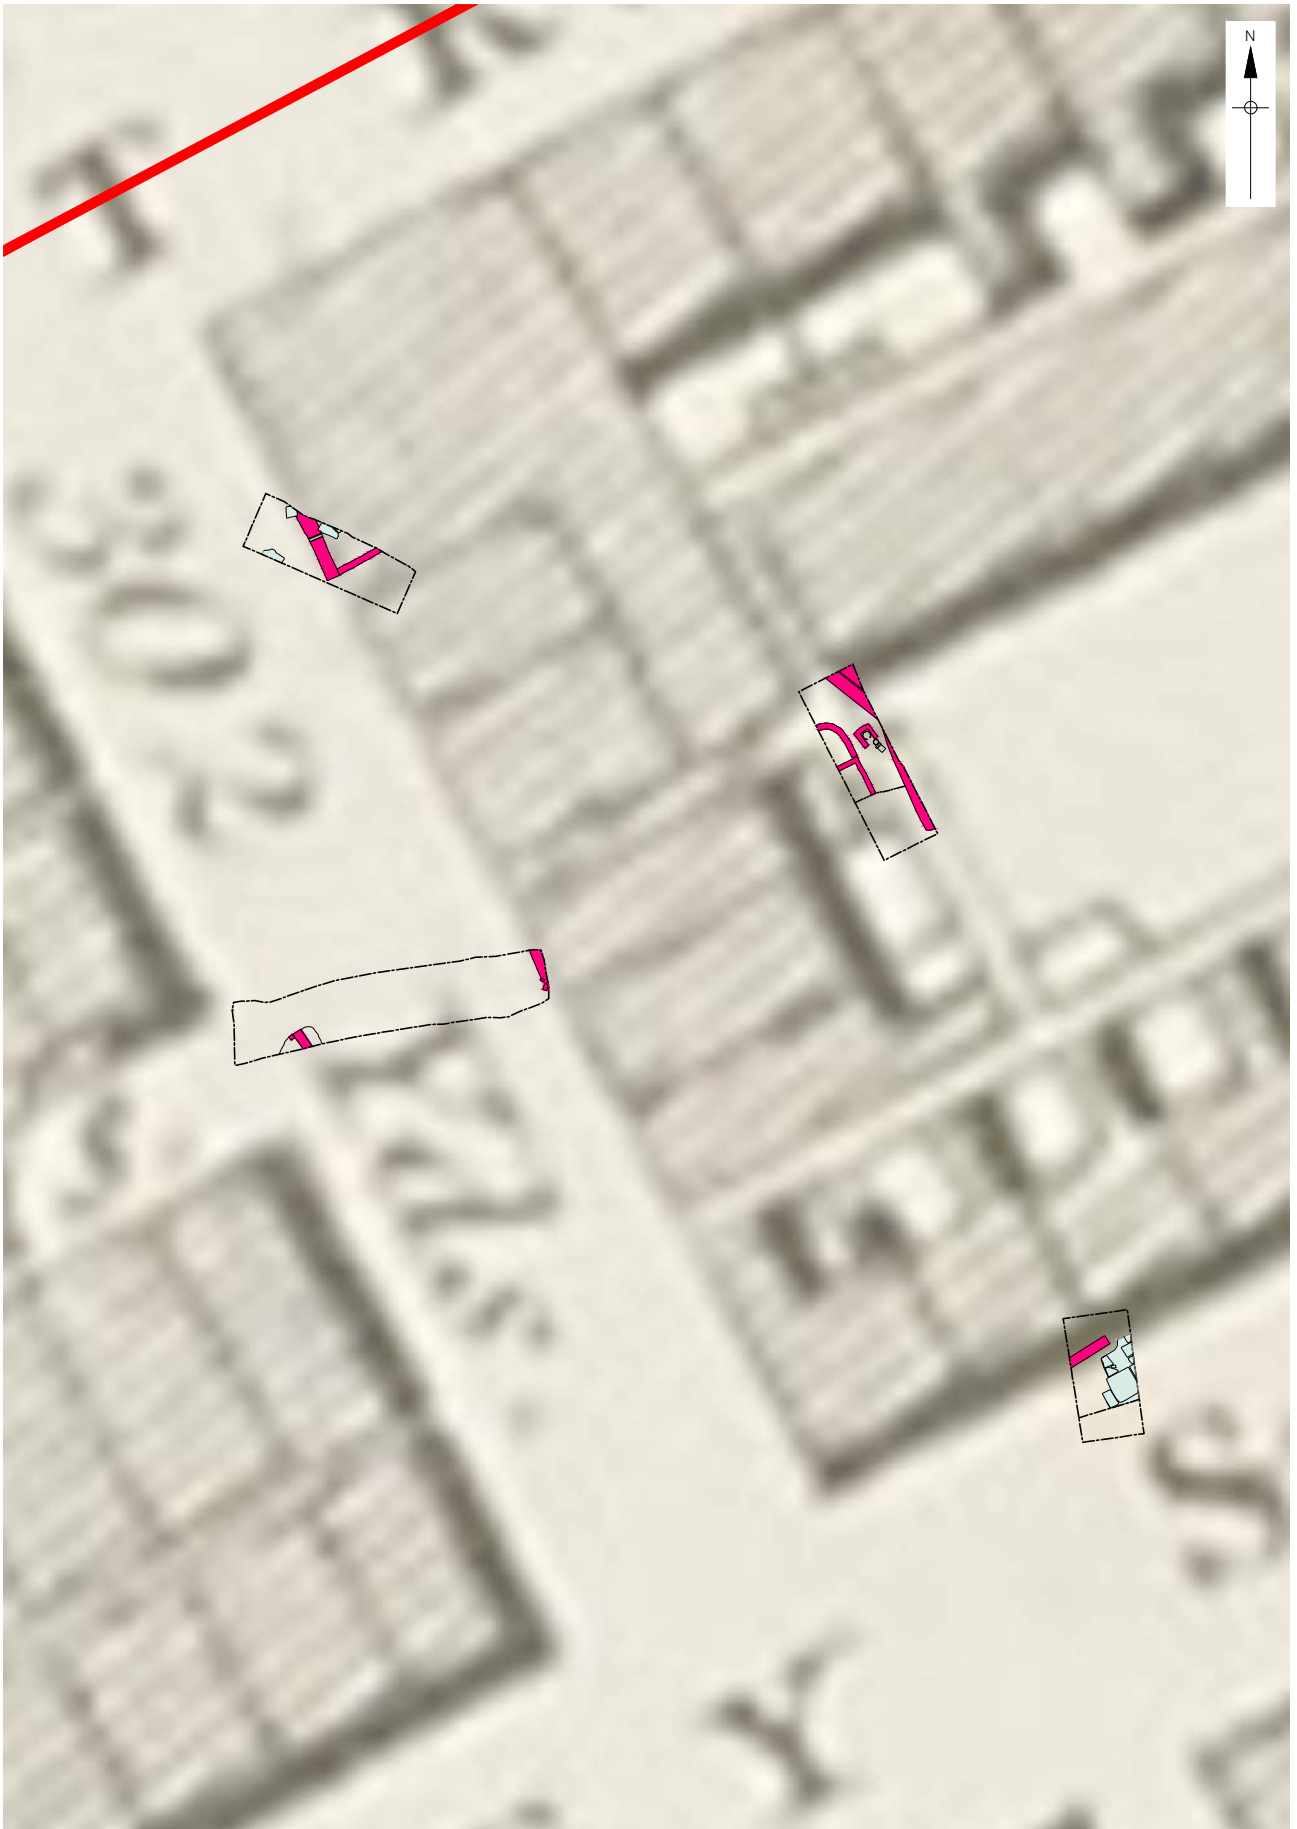
- 2.3.3 The brick footing at the western end of the trench is shown from map regression (Figures 5 and 6) to be beneath the former Heron Street, and it is thus likely that the remains may be part of a service. The brickwork at the eastern end is likely the footing for one of the dwellings shown on the same map along the east side of Heron Street.

Figure 5  
Masonry features overlain on an extract from Banks  
& Cos. Plan of Manchester and Salford, 1831  
1:200 at A4

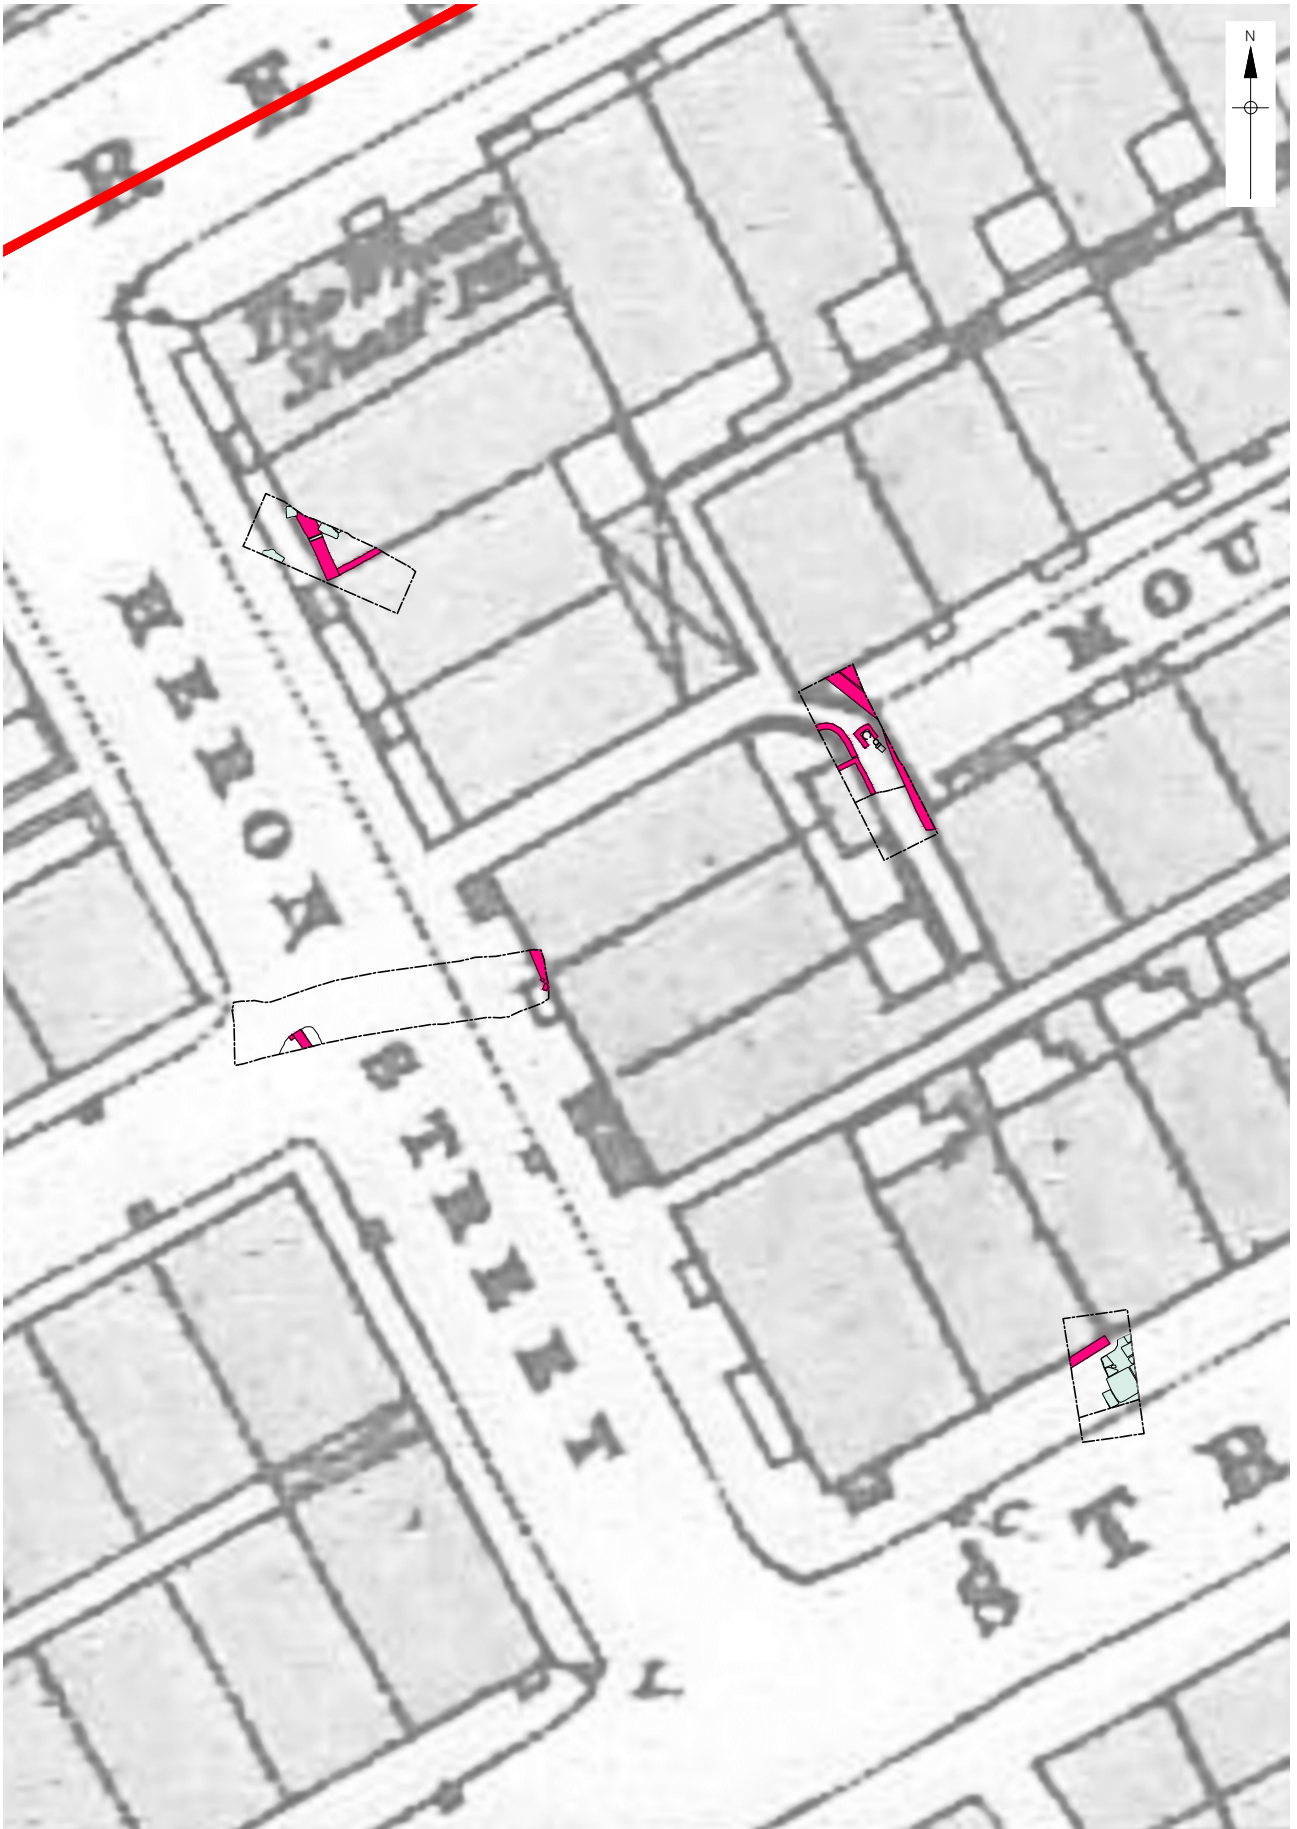
- 2.4.3 The enclosed space within wall [7], thought to be a fireplace, correlates closely on the 1849-50 OS map (Figure 6) with an outbuilding to the rear of the dwellings which fronted Heron Street. It is therefore probable that this wall represents the remains of an ash pit.
- 2.4.4 The curved wall [6] can also be closely matched to a wall on the 1849-50 map which enclosed the rear yard of the dwelling. Walls [20] and [21] may relate to the wall which formed the opposite side of the alley at the rear of the properties, itself enclosing the rear, western end of the Mount Place terrace.
