**FAIR FIELD, COLLEGE ROAD,
CROYDON CR0 1PF: AN
ARCHAEOLOGICAL WATCHING
BRIEF ON GEOTECHNICAL WORKS**

**LOCAL PLANNING AUTHORITY:
LONDON BOROUGH OF CROYDON**

SITE CODE: CLL16

MARCH 2017

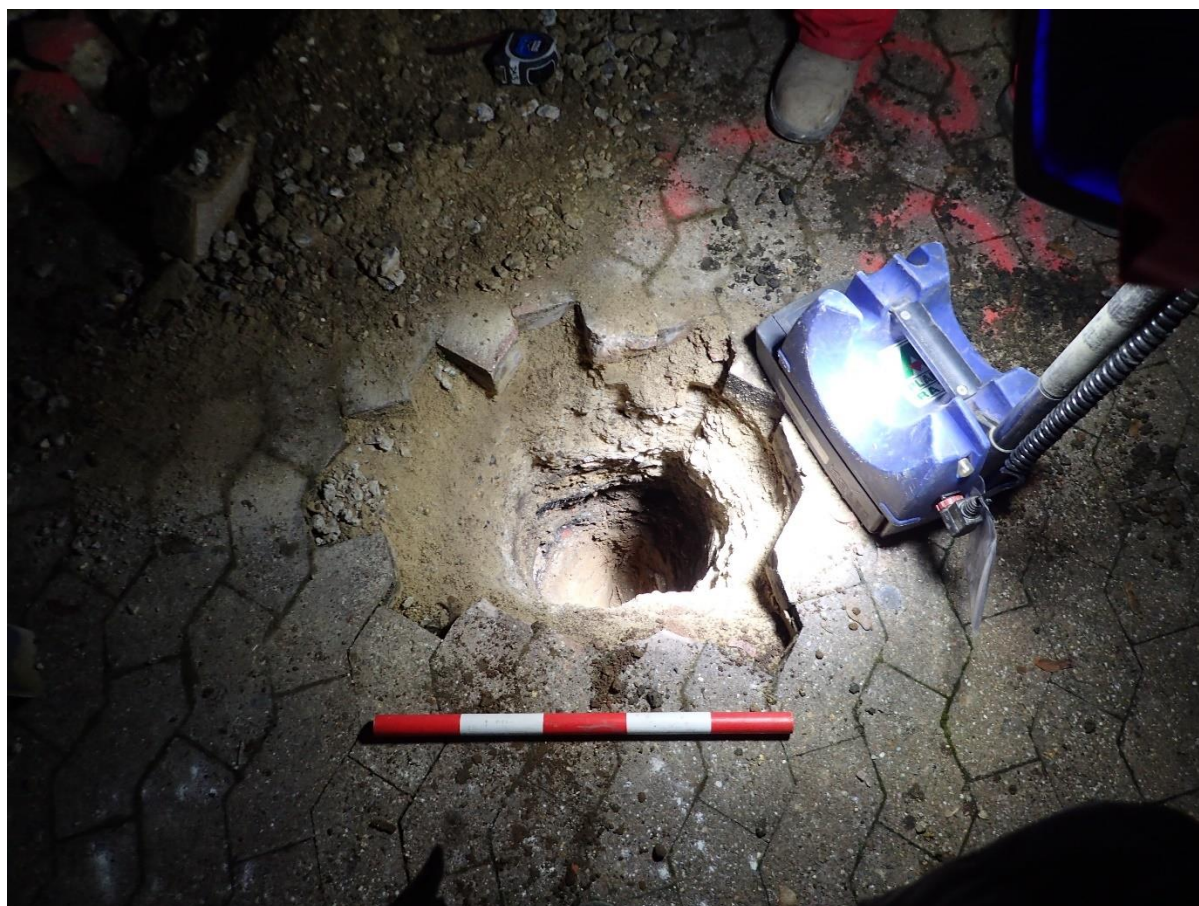
Plate 2: East Facing Photo of DCP01-01

8.2.1 DCP 01-01, located at 59.40m OD

Context Number	Description	Depth B.G.L.	Thickness
+	Paving Stones	0-0.12	0.12m
+	Modern Made Ground	0.12-0.30m	0.18m
1	Silty Sandy Gravel	0.30-0.50m	0.20m
2	Post-Medieval Made Ground	0.50-0.80m	0.30m
3	Sandy Gravel	0.80-1.20m+	0.40m+

8.2.2 DCP 01-01 was located to the west of Fairfield Halls and was hand dug with a circumference of 0.40m to a depth of 1.2m below ground level. The DCP was located at a level of 59.40m OD. Sandy gravel [3] was located at 58.60m OD and was sealed by a post-medieval layer [2] which contained chalk flecks, ceramic building material flecks and oyster shell flecks and could relate to the site's use and development in the late 19th and early 20th Century. This layer was overlaid with silty sand gravel [1] as part of the construction of the area into a forecourt/car park.

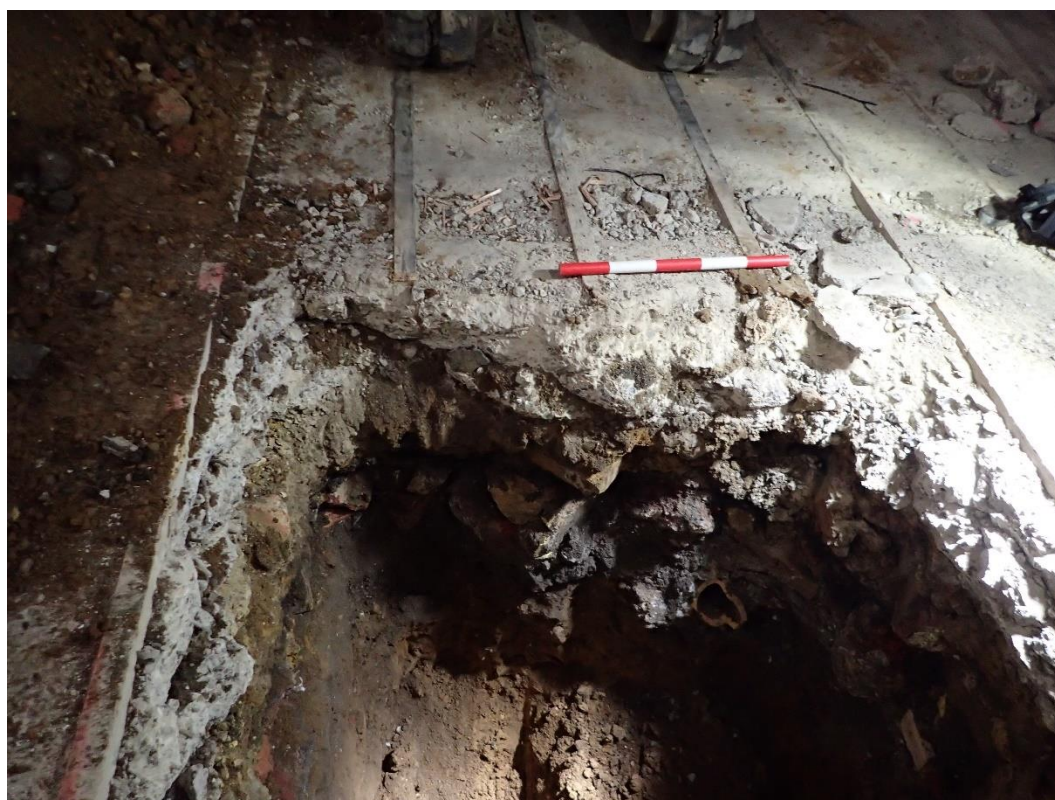
Plate 3: North Facing Photo of OP01-04

8.5.1 Dimensions: N-S 1.50m E-W 1.50m Depth 2.0m, located at 60.35m OD

Context Number	Description	Depth B.G.L.	Thickness
+	Concrete	0.0-0.30	0.30m
+	Made Ground Clay	0.30-0.50m	0.20m
16	Made Ground Brick Rubble	0.50-0.80m	0.30m
17	Post-Medieval Made Ground	0.80-1.10m	0.30m
18	Silty Sand with Clay	1.10-1.30m	0.20m
19	Silty Sand	1.30-2.00m	0.70m
20	Gravel	2.00m+ (NFE)	NFE

8.5.2 Natural gravel layer [20] was just visible at 2m B.G.L. (58.35m OD) and was sealed by silty sand layer [19] which contained flints and showed some evidence of root disturbance. This was overlaid by a layer of silty sand with clay inclusions [18] which also contained flint. Above this layer was a layer of post-medieval made ground [17] containing CBM flecks, chalk flecks and charcoal flecks. There also was a disused ceramic pipe in the north-east corner of the pit which looked as though it may have been truncated as part of the construction of the foundations of the Gallery as it had been used as part of the backfill. This was overlaid with modern made ground brick rubble [16] as a leveling layer for the floor of the Arnhem Gallery.

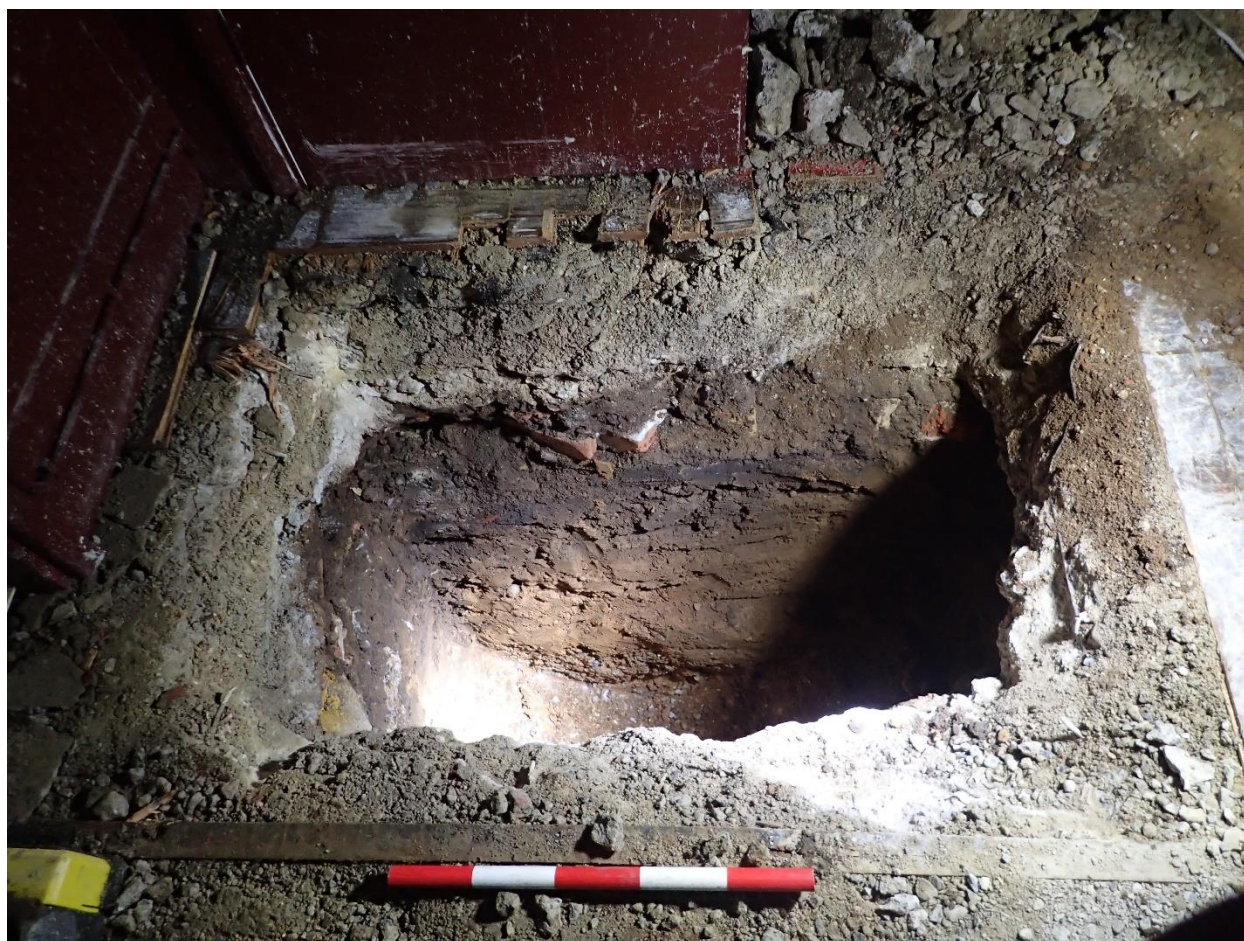
Plate 4: East Facing Photo of OP01-08

8.6.1 Dimensions N-S 1.50m E-W 1.0m Depth 2.0m, located at 60.34m OD

Context Number	Description	Depth B.G.L.	Thickness
+	Concrete	0.0-0.30m	0.30m
+	Modern Made Ground	0.30-0.50m	0.20m
21	Silty Clay	0.50-0.80m	0.30m
22	Silty Sand	0.80-1.30m	0.50m
20	Gravel	1.30-2.00m+	0.70m+

8.6.2 Natural sandy gravel layer [20] was located at 59.04m OD and was sealed by silty sand layer [22] which was overlaid by post-medieval made ground containing CBM flecks and chalk flecks. This was all sealed by the made ground [+] that was the creating and leveling layer for the Gallery construction.

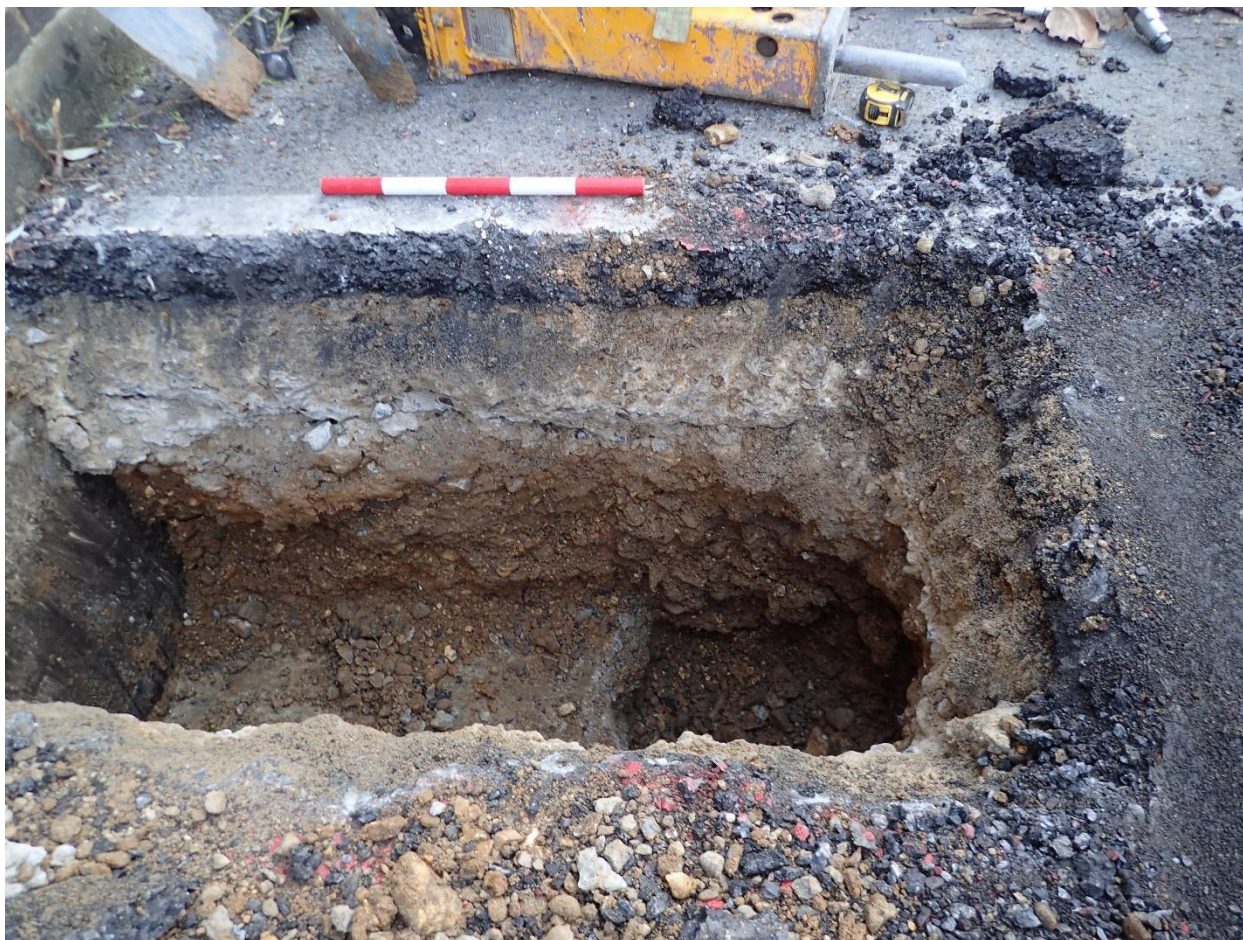
Plate 5: South Facing Photo of OP03-03

8.8.1 Dimensions N-S 0.75m E-W 1.50m Depth 1.10m, located at 56.67m OD

Context Number	Description	Depth B.G.L.	Thickness
+	Tarmac	0.0-0.12m	0.12m
+	Concrete	0.12-0.40m	0.28m
10	Clay with Gravel	0.40-0.85m	0.45m
11	Sandy Clay with Gravel	0.85-1.10m	0.25m
12	Concrete footing	0.85-1.0m	0.15m

8.8.2 Concrete footing [12] was found between 0.85m and 1.0m B.G.L and was backfilled with sandy clay with gravel [11]. The pit was not excavated any deeper and the natural was not seen as the trench was located wholly within the construction cut for the wall, although the backfill does appear to be made up of redeposited natural. The concrete footing and the sandy clay was sealed by a clay with gravel [10] which was used as a levelling layer for the concrete and Tarmac [+]. There was no digging below 1.10m and the natural was not reached. The top of the OP was located at 56.67m OD.

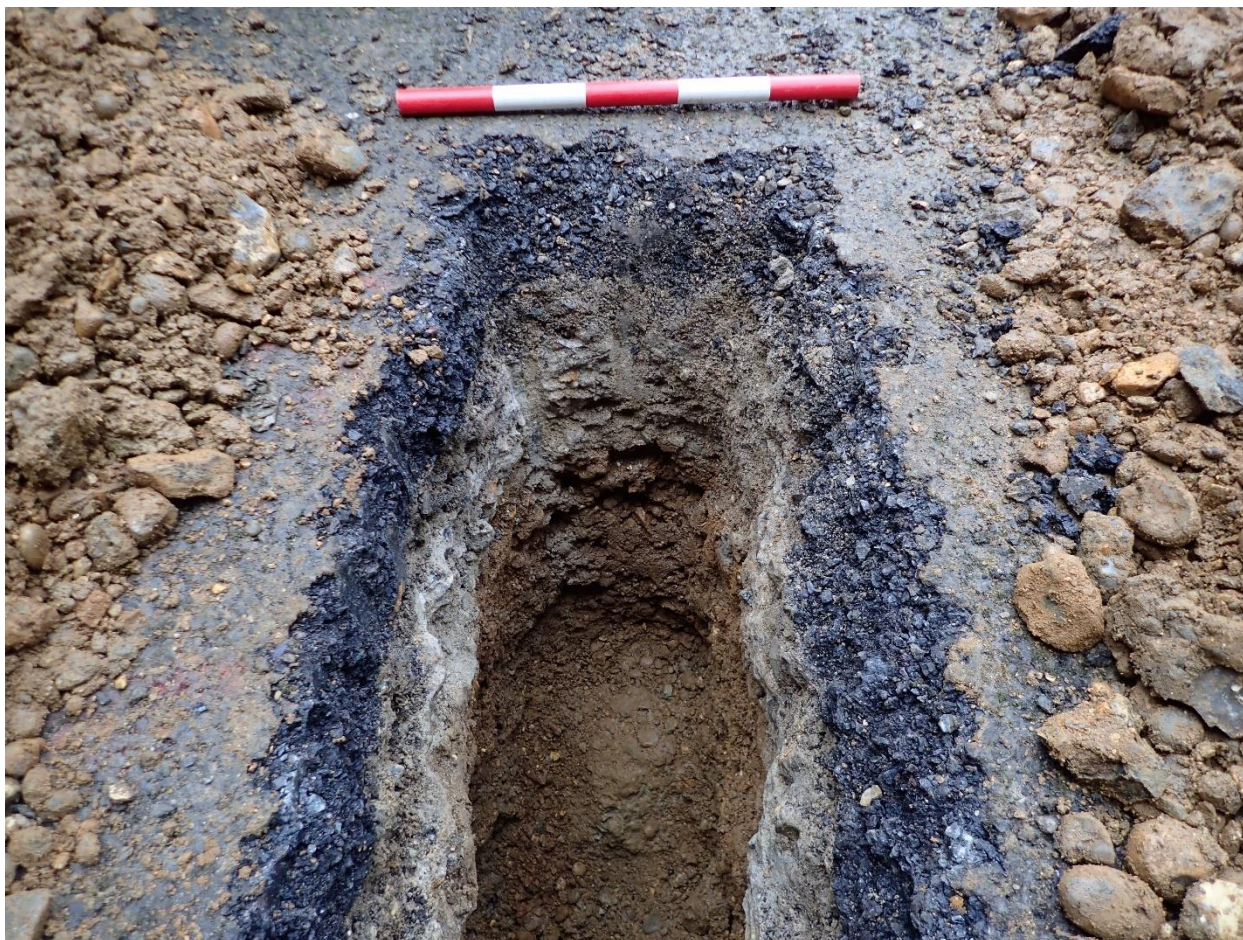
Plate 6: North Facing Photo of OP03-07 Showing Concrete Block

8.10.1 Dimensions N-S 1.50m E-W 0.40m Depth 0.90m, located at 56.63m OD

Context Number	Description	Depth B.G.L.	Thickness
+	Tarmac	0.0-0.12m	0.12m
+	Concrete	0.12-0.38	0.26m
23	Sandy Clay Gravel	0.38-0.60m	0.22m
24	Sandy Clay Gravel with concrete	0.60-0.90m	0.30m
25	Concrete block	0.80-0.90m	0.10m
26	Concrete Foundation	0.90-N.F.E	Not known

8.10.2 Concrete foundation [26] was found at 0.90m and no further excavation was able to be carried out. At the north end of the pit there was a concrete block [25] that appeared to be different to the foundation, this was not able to be fully investigated as the sides of the trench were not stable enough to enter and there was only a small amount visible in the trench. Above the concrete there was a sandy clay gravel [24] that had concrete inclusions and a sandy clay gravel [23] layer which was used as a leveling layer for the concrete and Tarmac [+]. The

deposits seen did not extend beyond the backfill of the construction cut for the wall. The top of the OP was at 56.63m OD.
