**HISTORIC BUILDING RECORDING  
AT  
BISHOP WOOD'S ALMSHOUSES,  
LOWER CLAPTON ROAD,  
LONDON BOROUGH OF HACKNEY,  
E5 0QH**

**PCA REPORT NO: R12869**

**MAY 2017**

Historic Building Recording

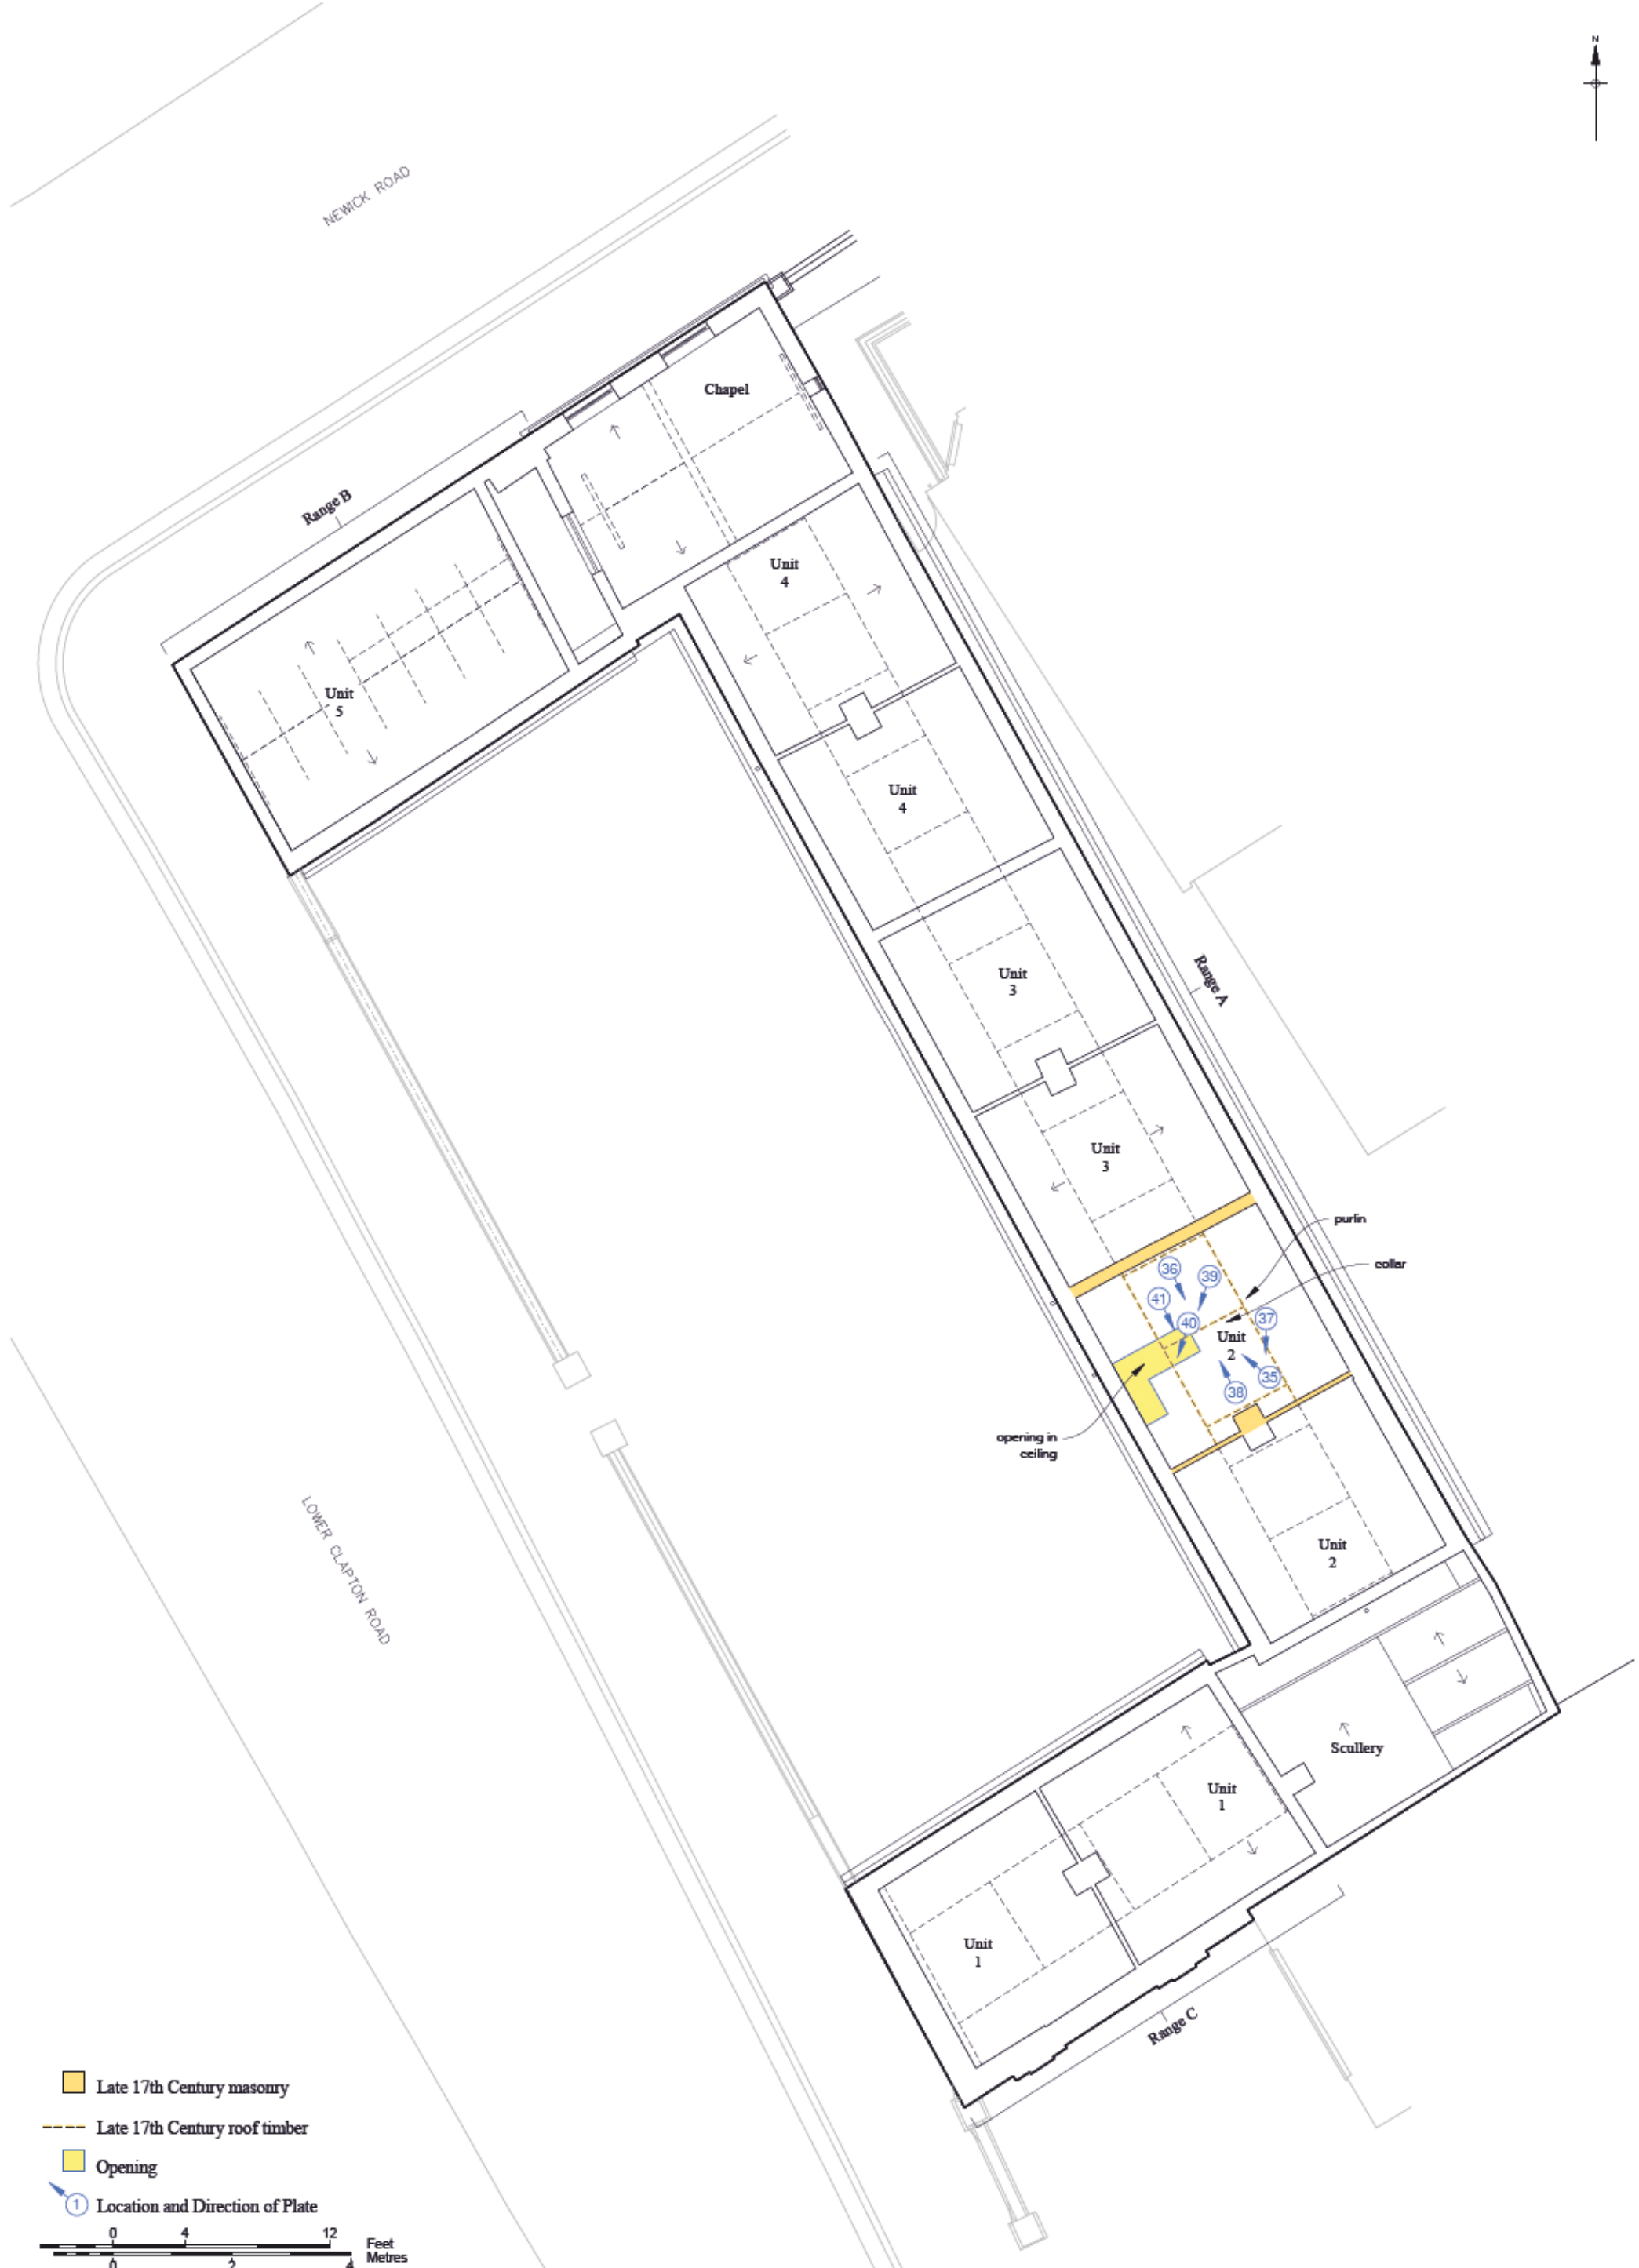
Figure 19  
 Phased Loft Floor Plan (Unit 2) with Plate Locations  
 1:125 at A3

- Late 17th Century masonry
- Late 17th Century roof timber
- Opening
- 1 Location and Direction of Plate

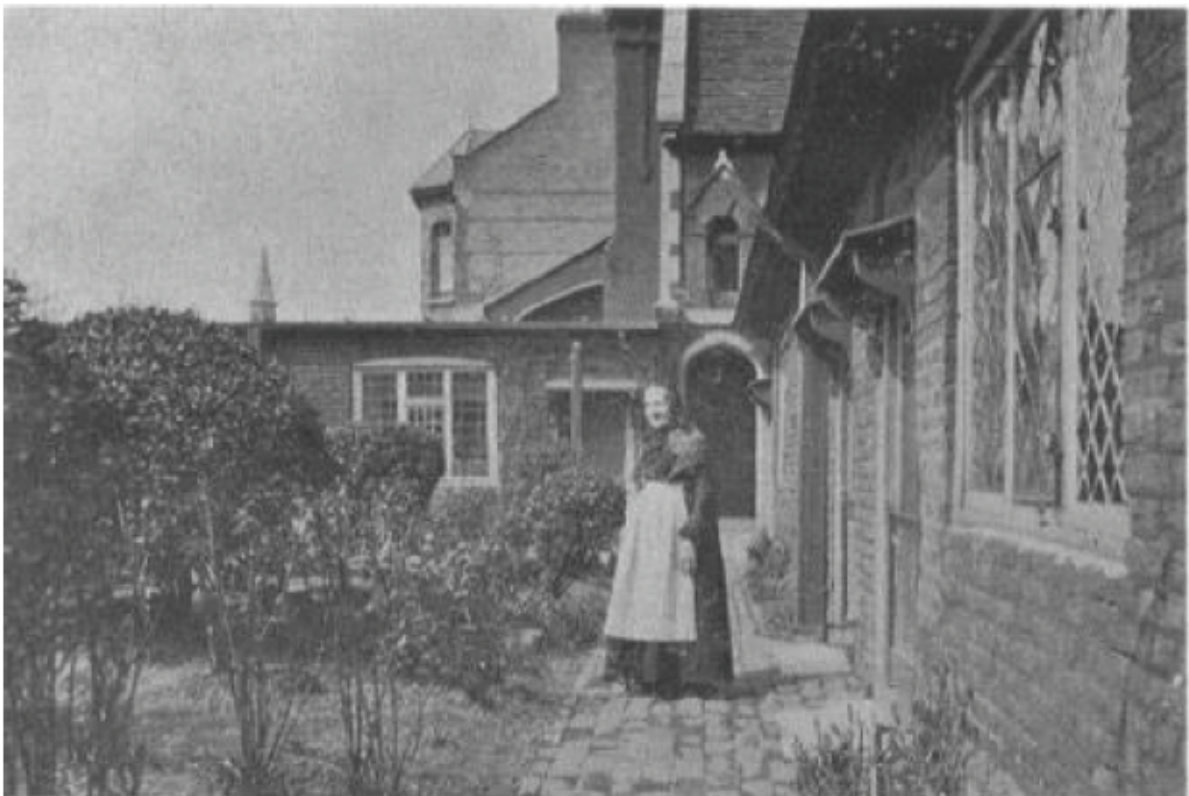
Plate D: Photograph of Bishop Wood's Almshouses, c. 1910, looking north (© Hackney Archives and Local History)

- 5.1.21 A photograph of the almshouses taken c.1967/68 (**Plate H**) shows replacement windows and doors. The windows have changed from the lead lights (shown in the c.1910 photograph; **Plate D**) to more standard glazing bars. The photograph also shows that the chimney pots had been removed from the chimney stack at the west end of the Chapel.

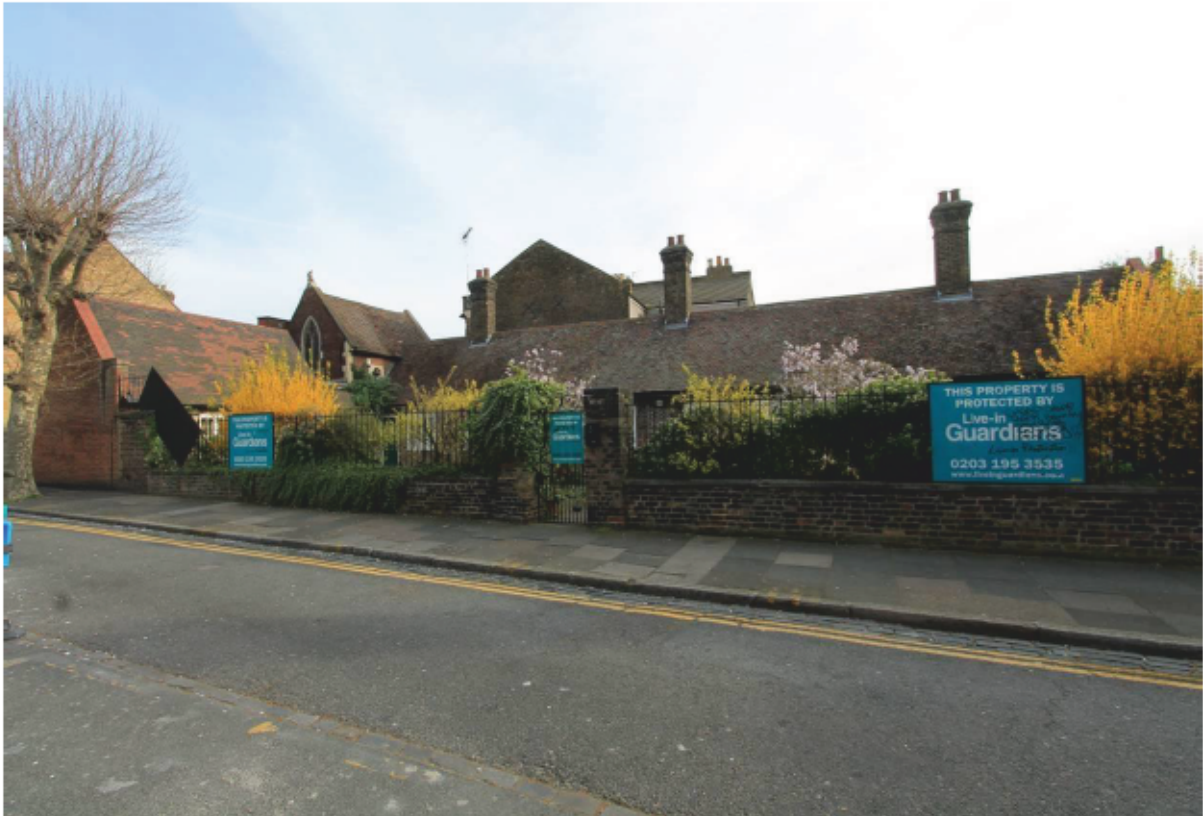
Plate 1 The Almshouses, looking north-east from Lower Clapton Road

2.1.4 The almshouses were sold by the Doctor Spurstowe and Bishop Wood Almshouses Charity in 2014 and thereafter were boarded up, and more recently occupied by live-in guardians (**Plate 1**). At this time, they were placed on the Historic England 'Heritage at Risk' Register (ref 1688050), described as: 'small chapel and almshouses are partly occupied by live-in guardians, but are in a deteriorating condition. Discussions are ongoing between a potential new owner and the Local Authority to explore options for repair and re-use'.

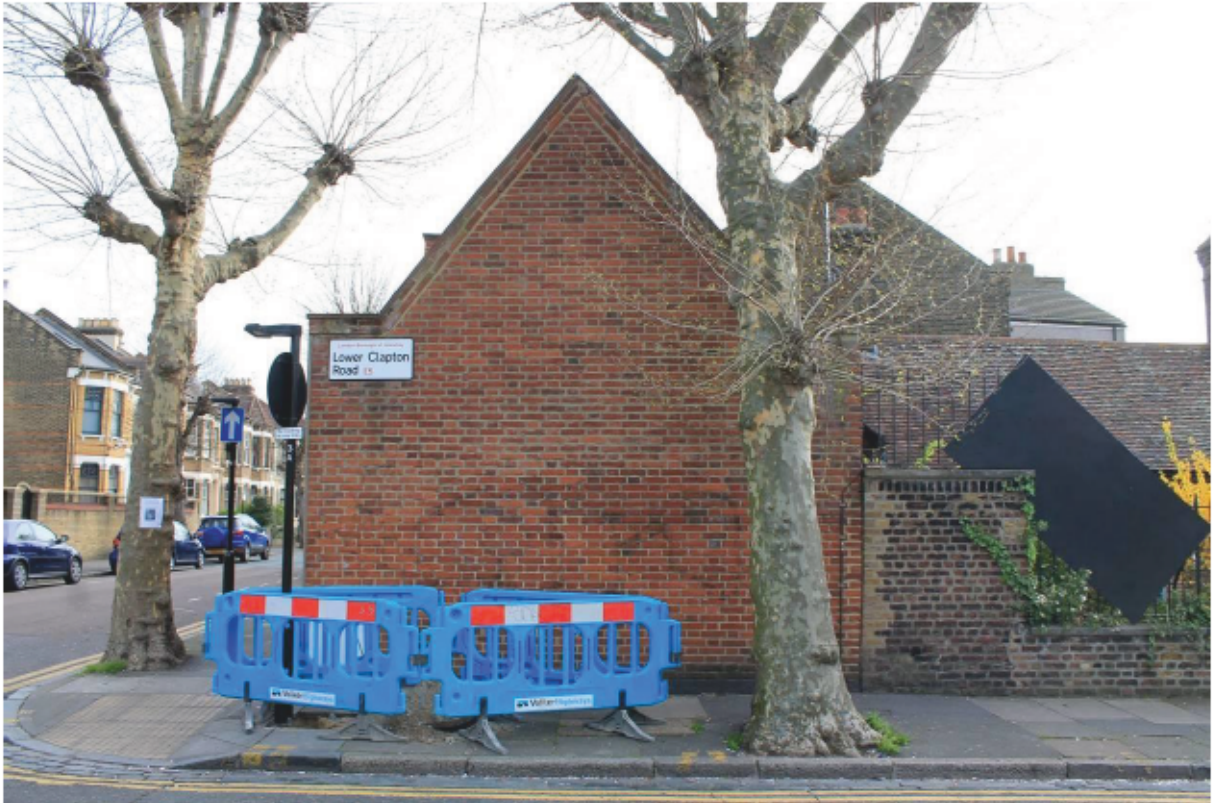
Plate 7 Rebuilt gable elevation of north range, looking east

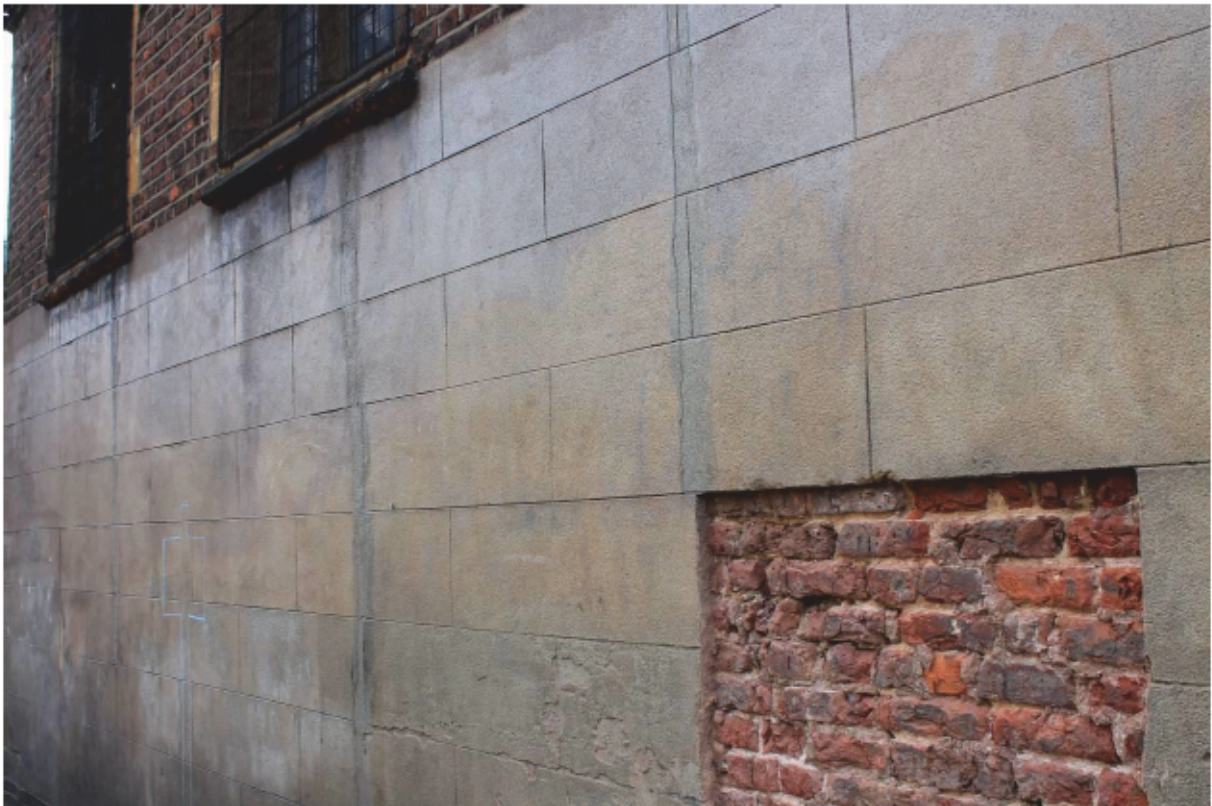
Plate 10 Hard cement 'Ashlar' render to lower wall.

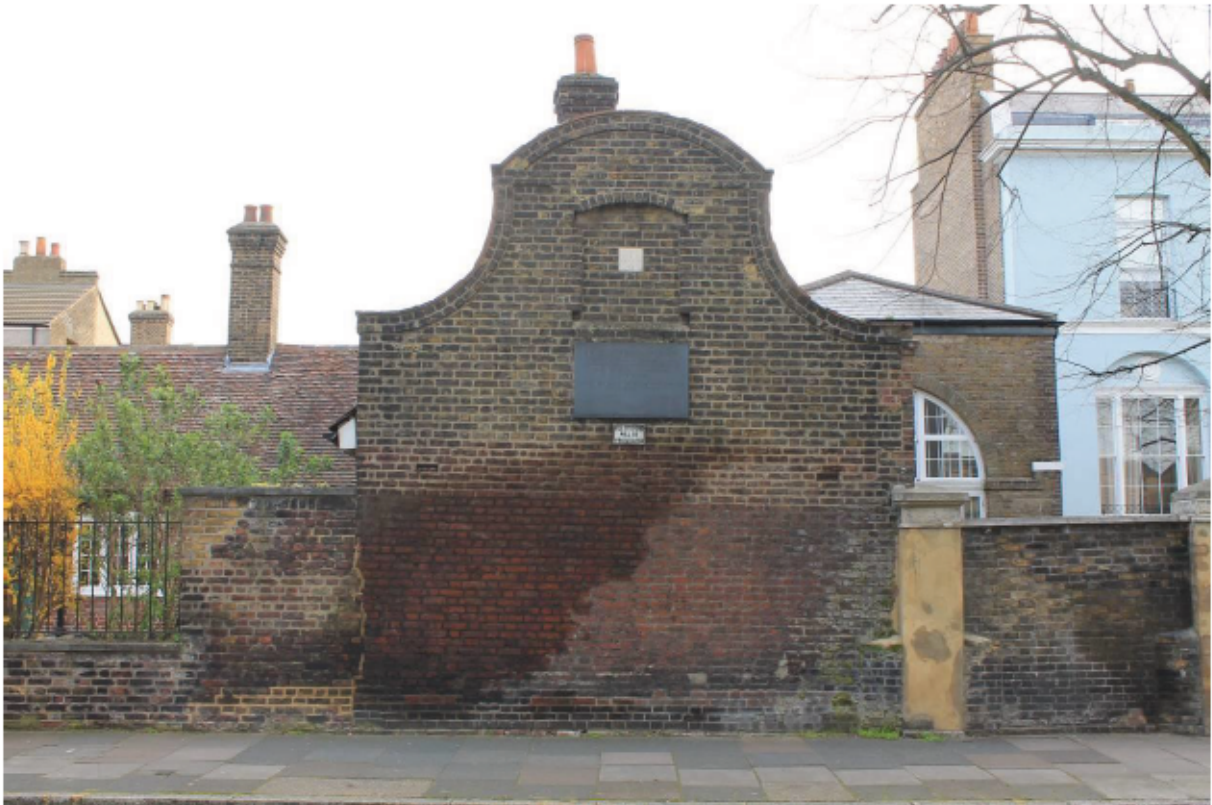
Plate 11 Rebuilt shaped gable elevation to south range, looking east

- 2.2.4 The almshouses date to 1690, when they were established under the will of Thomas Wood, Bishop of Lichfield and Coventry, who owned Clapton House which lay some 100m to the north (see **Figure 5**). The buildings form a U-shape around a recessed courtyard (**Figure 2**), protected from the road by a low brick wall and iron railings (**Plate 1**). The single storey cottages still retain some 17th century brickwork although much of what survives dates to the mid-late 19<sup>th</sup> century renovations, when a small Gothic chapel was added (**Plate 2**) or to 1930s and late 20<sup>th</sup> century restorations. The buildings have clay peg tiled roofs (**Plates 1 to 6**), small segmental arches over the casement windows and doors (**Plates 2 to 6**) and a Dutch-style shaped gable, facing Lower Clapton Road (**Plate 11**).

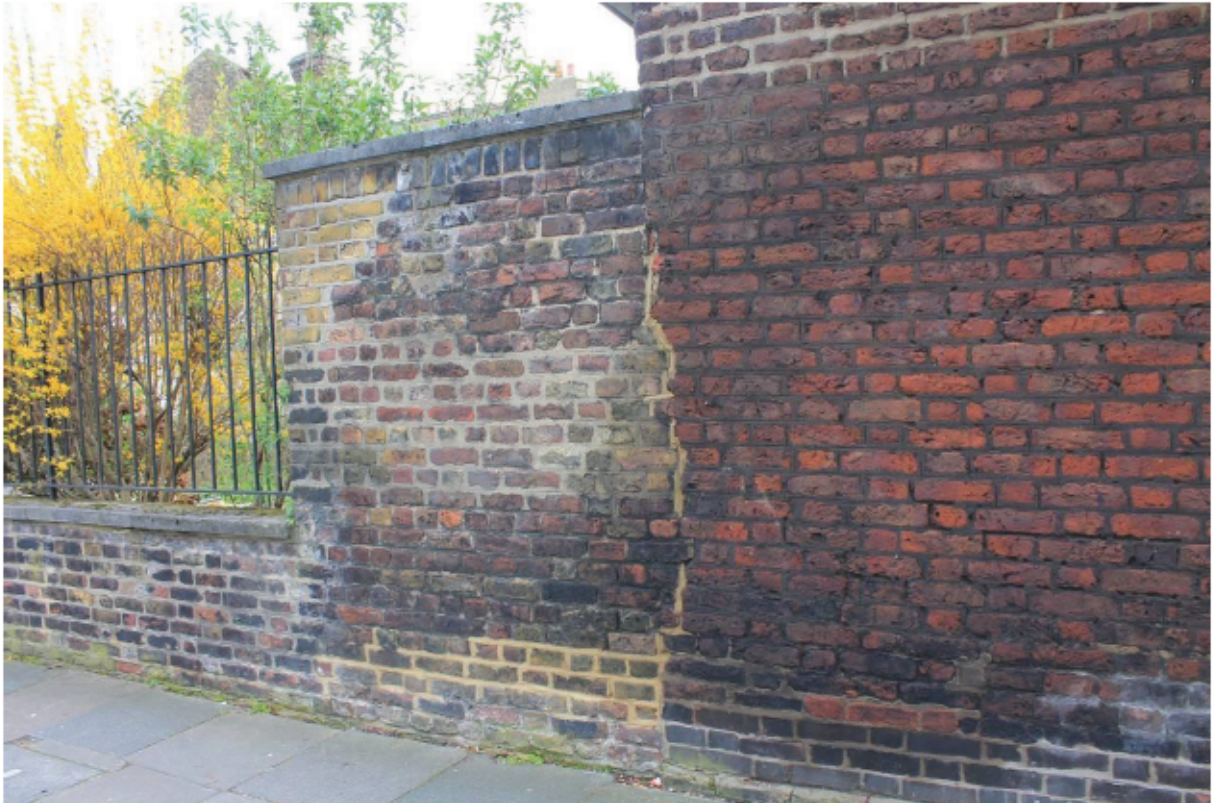
Plate 13 Boundary elevation looking north-east

H. Reginald Ross, Architect'.
- 6.2.6 The brickwork of the boundary walls is a later addition which clearly post-dates the southern range and were built using red stock bricks (with some later repairs) in English bond with concrete saddleback copings (replaced during the 1958-60 works) and wrought iron railings (**Plate 13**).

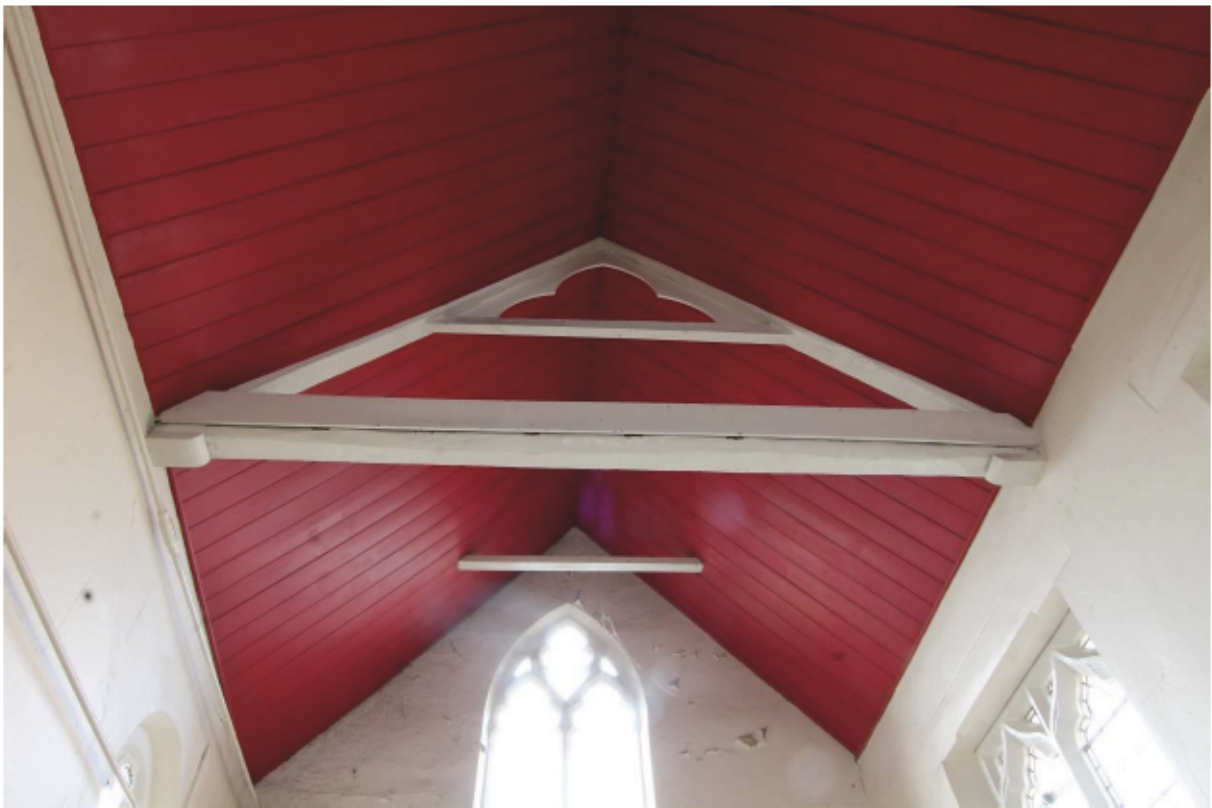
Plate 20 Chapel; Central roof truss, looking west

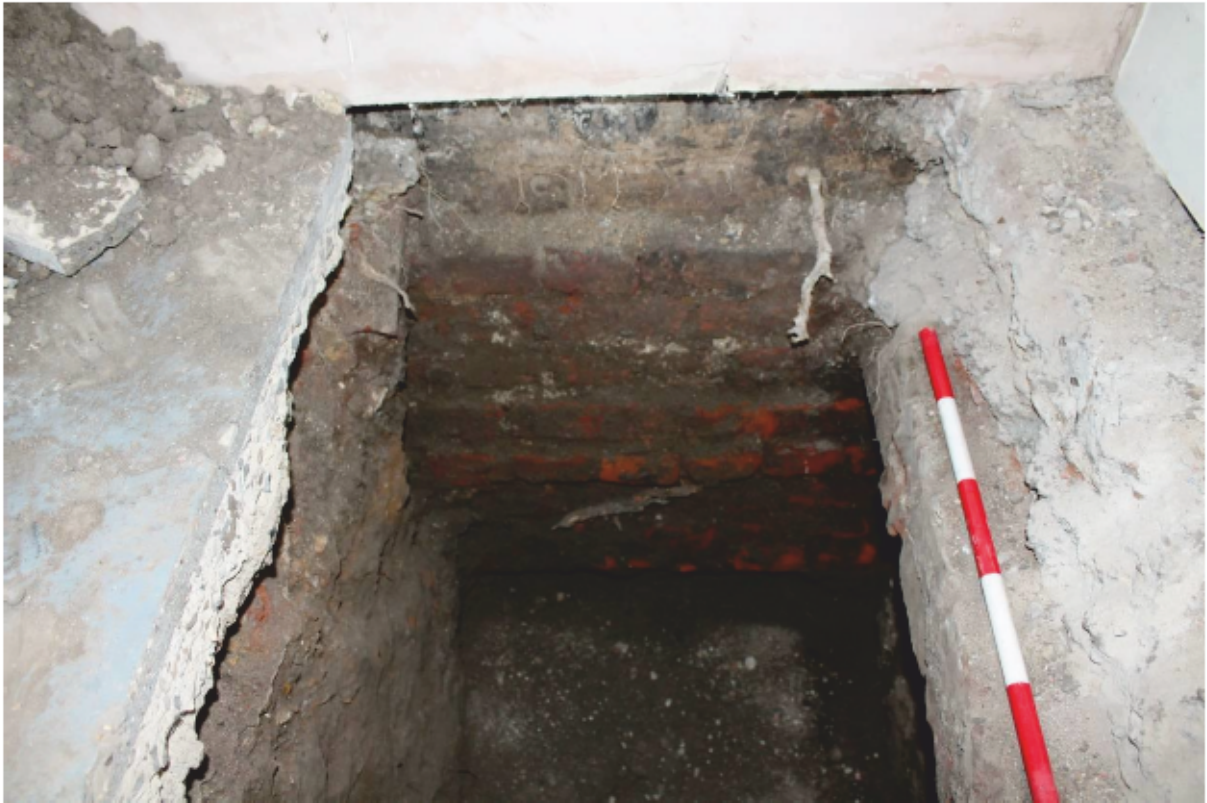
Plate 31 Brick Foundation to rear eastern wall

- 6.3.7 The floor structure within Unit 2 is a modern concrete floor (c.200mm deep). Test pit excavations undertaken to view the wall foundations, showed that the rear (east) wall (in the bedroom area) was built upon a foundation wall of 7 courses, stepping out by half a brick width (**Plate 31**), while the front (west) wall (in the former kitchen) was built with a similar step-out of 6 courses (**Plate 27**). The opening to the front elevation also exposed lower brick courses. Here the bottom three courses, were markedly different in character of the brickwork, using yellow and red stocks in a hard grey mortar, than the brickwork above. This may represent works associated with the addition of a damp course, relating to the course of engineering bricks present at the base of the wall (external face). The brickwork of the walls, seen in investigative openings, was also covered internally by a coating of bituminous paint (**Plate 32**), possibly an historic attempt to arrest damp penetration, and was covered using a modern gypsum plaster. The ceiling finishes were also modern, comprising plaster board attached to an historic ceiling structure. The removal of the door architrave between the bedroom and kitchen area, shown that this wall, to the east of the chimney breast, had been rebuilt and incorporated re-used brick and cinder blocks to the opening, the latter a device to more easily receive the fixings for the architrave, a feature commonly used during the interwar period, so perhaps part of the c.1935 restoration.

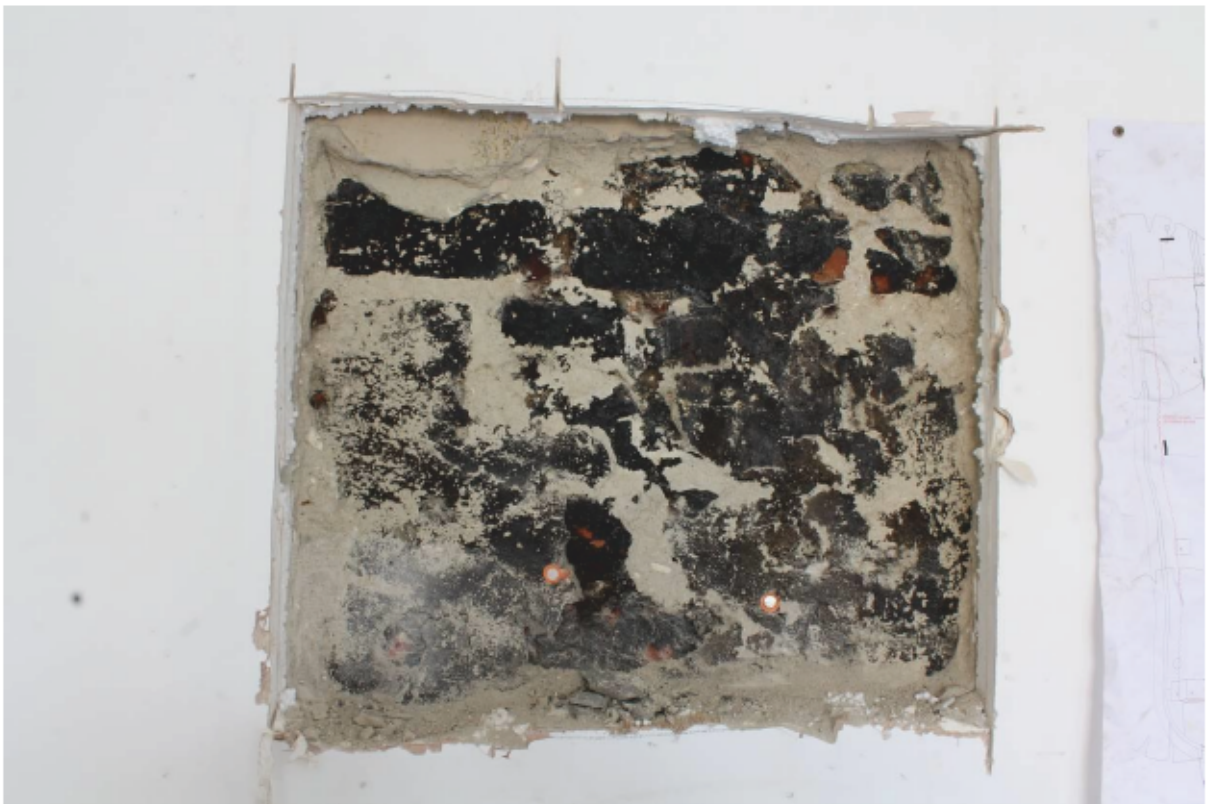
Plate 32 Bituminous paint covering to interior walls

- general laundry capabilities.
- 7.1.7 Possibly the most extensive alterations to the functional and spatial integrity of the almshouses occurs during the c.1935 restoration works when adjoining tenements are combined to provide five larger units, comprising distinct bed/sitting room and kitchen/bathroom either side of the central fireplace/stack. The window joinery was renovated, and although still mullioned, the former lead-light glazing (seen in early 20<sup>th</sup> century photographs) was replaced with small rectangular panes and glazing bars. The doors to each unit were also replaced with new two panel internal doors between the bed/sitting room and kitchen. These works also saw the renovation of the back to back fireplaces, rebuilt with a smaller opening to the bed/sitting rooms (see plan of 1958; **Figure 15**). These fireplaces/chimneystacks have received the most attention. The brickwork of the chimney above the fireplace (and within the roof space) survives as the original 17<sup>th</sup> century work. The visible chimneystacks above the ridgeline were rebuilt in 1888. The fireplaces were remodelled c.1935 and later blocked-in and encased (in blockwork) during the late 20<sup>th</sup> century (1985? work). Limited observations also suggest that the internal walls which house the internal door between the bedroom and kitchen were rebuilt during the c.1935 alterations and in an attempt to address damp, the bare brickwork of the internal walls were daubed with a bituminous paint.

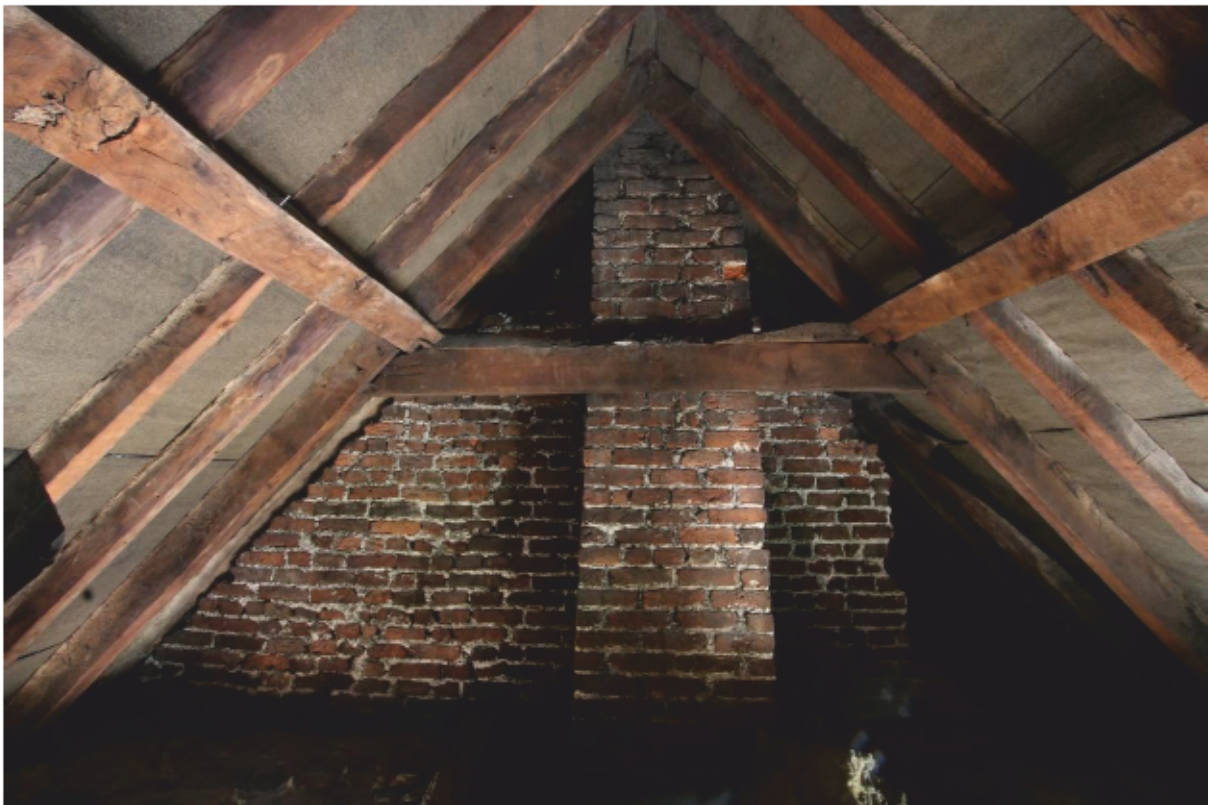
Plate 36 Oak clasped side purlin roof looking south (unit 2) to original stack and cross-wall

- 6.3.9 The roof structure, observed in this area above unit 2, has however seen some alterations, principally and perhaps unsurprisingly given its age, the replacement and re-use of common rafters. The main roof structure, comprising the principal rafters, collars and purlins are all in oak. The trusses, formed by the slightly heavier scantling principal rafters, are a simple A frame using a clasped side purlin construction (**Plate 36**). The collars (7 x 2½ inch) are correctly pegged into the principal rafters, each side using two face pegs (**Plate 37**), while the common rafters are all simply pegged where they meet at the ridgeline. A ridge board or plank, features more typical of a late 18<sup>th</sup> or 19<sup>th</sup> century date, were not in use. The clasped purlins (5 x 4½ inch) were also rebated, using shallow trenches, into the underside of the principal rafters and

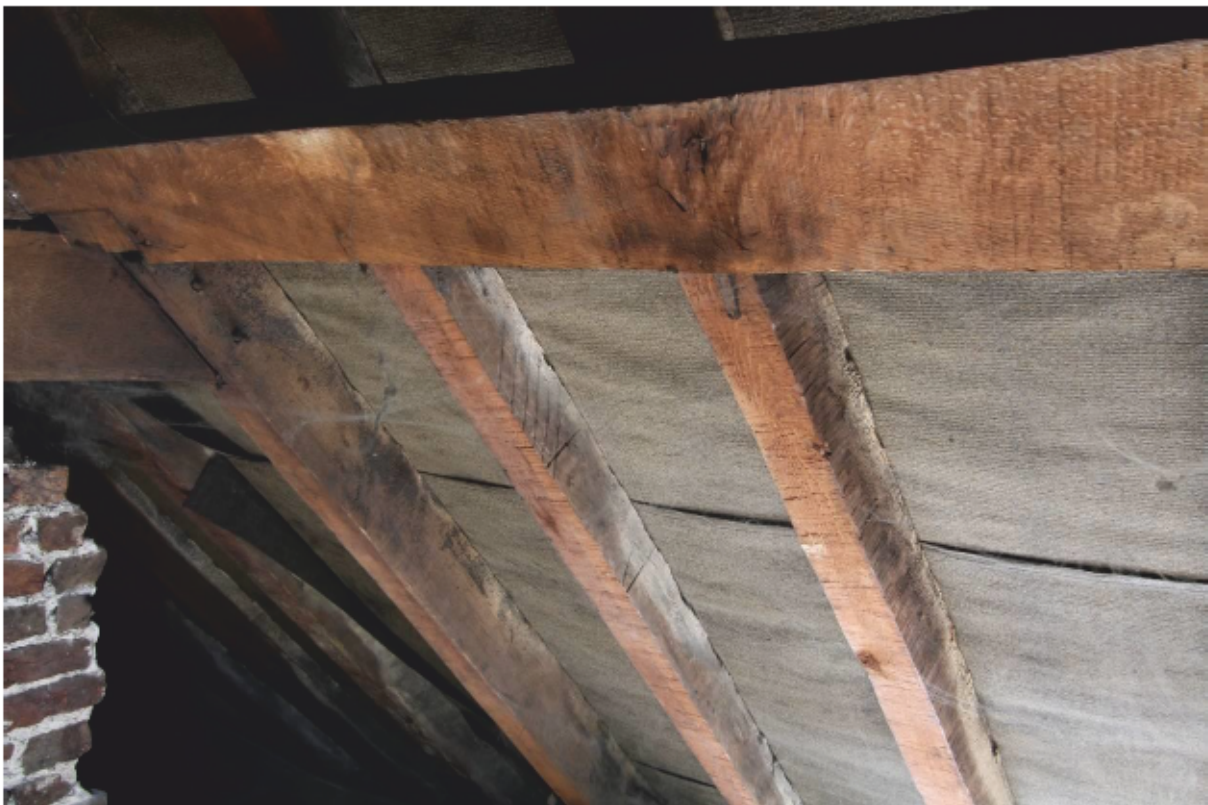
Plate 40 Oak rafters showing carpenters marks

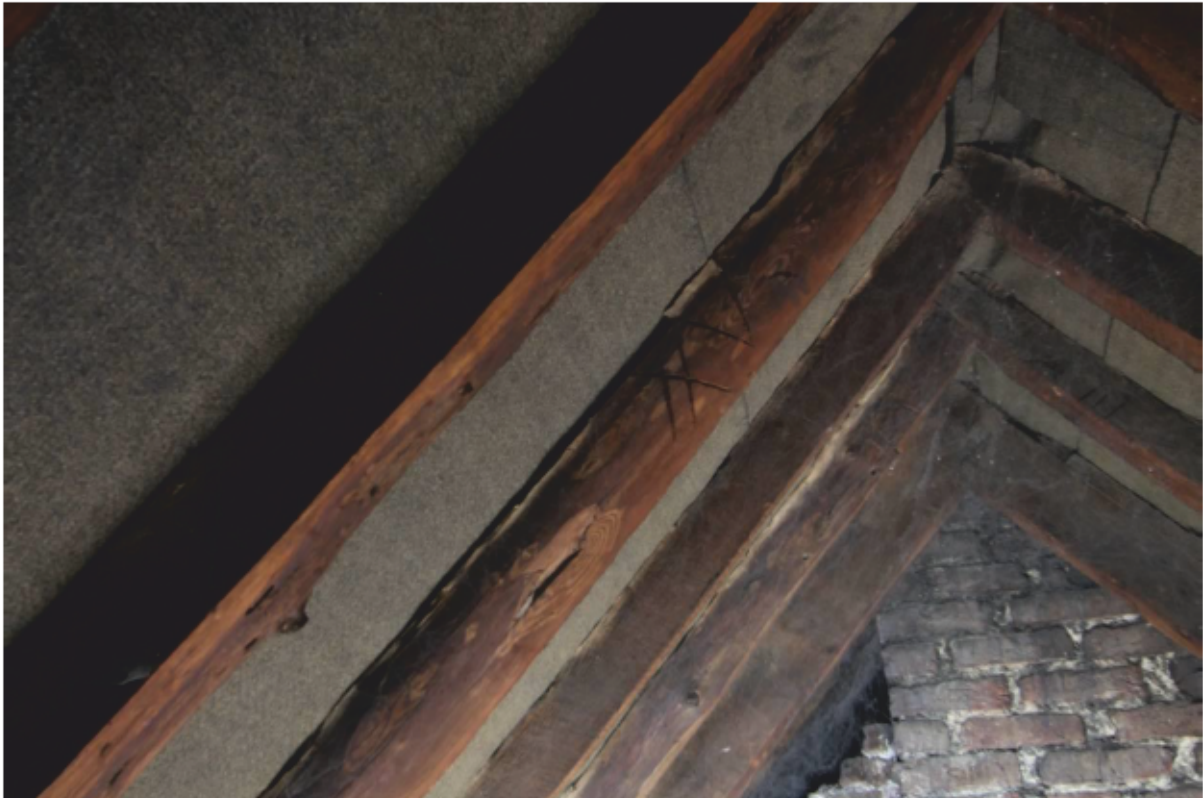
Plate 41 Mixture of hard and softwood rafters, pegged at ridge

- 6.3.10 The common rafters have seen the most alterations. They were a mixture of oak, hand sawn rafters, averaging 3½ x 4 inch in scantling and later replacement softwood quarter poles. All are pegged at the ridgeline (**Plate 41**) and rest upon timber plates (4 x 5 inch), set upon the top of the flank walls. A number of the rafters carry scribed carpenters marks shown as Roman numerals (**Plates 40 and 41**). There does not appear to be any sequence to the numbering and both the oak and softwood rafters display similar character to their markings, suggesting that the roof had at some point, been rebuilt, re-using existing rafters and adding new replacement quarter poles. A modern softwood rafter with a section of 75x100mm was present within the western pitch, suggesting a recent repair, possible when the present roofing felt was laid.

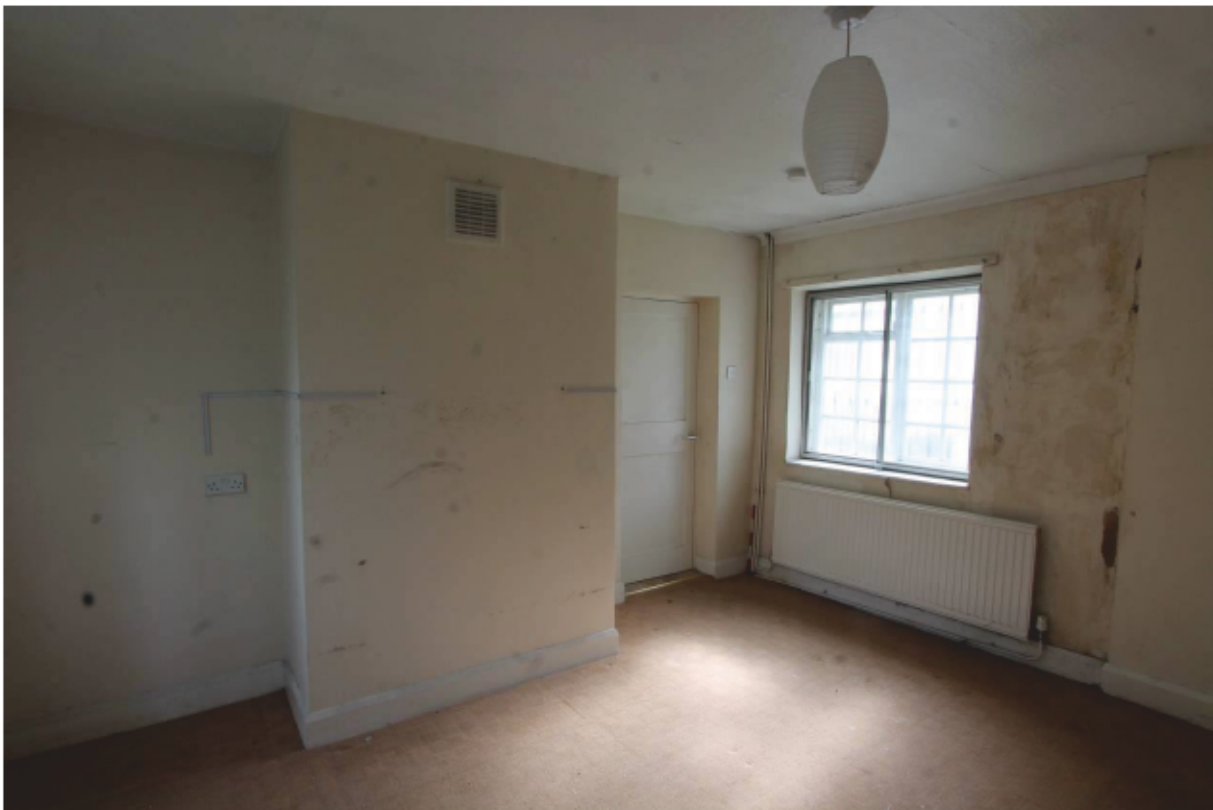
Plate 42 Unit 1 bedroom, showing inserted window (of 1961)

- 5.1.20 Upgrades were carried out in the early 1960s, which are mentioned in Building Notices of 1960, with works including the insertion of damp courses, reinstatement of floors, and 'minor repairs'. One notice also mentions the insertion of a window 'overlooking boys club (Pond House)'. This window is shown on the 1985 plan (**Figure 17**) in the south elevation of unit 1 facing the front courtyard of Pond House and is still extant (**Figure 20; Plate 42**).
