**BUILDING RECORDING  
WATCHING BRIEF AT THE  
BROAD ARROW TOWER,  
HM TOWER OF LONDON,  
LONDON BOROUGH OF TOWER  
HAMLETS**

**SITE CODE: TOL 151**

**PCA REPORT NO: R12903**

**JUNE 2017**

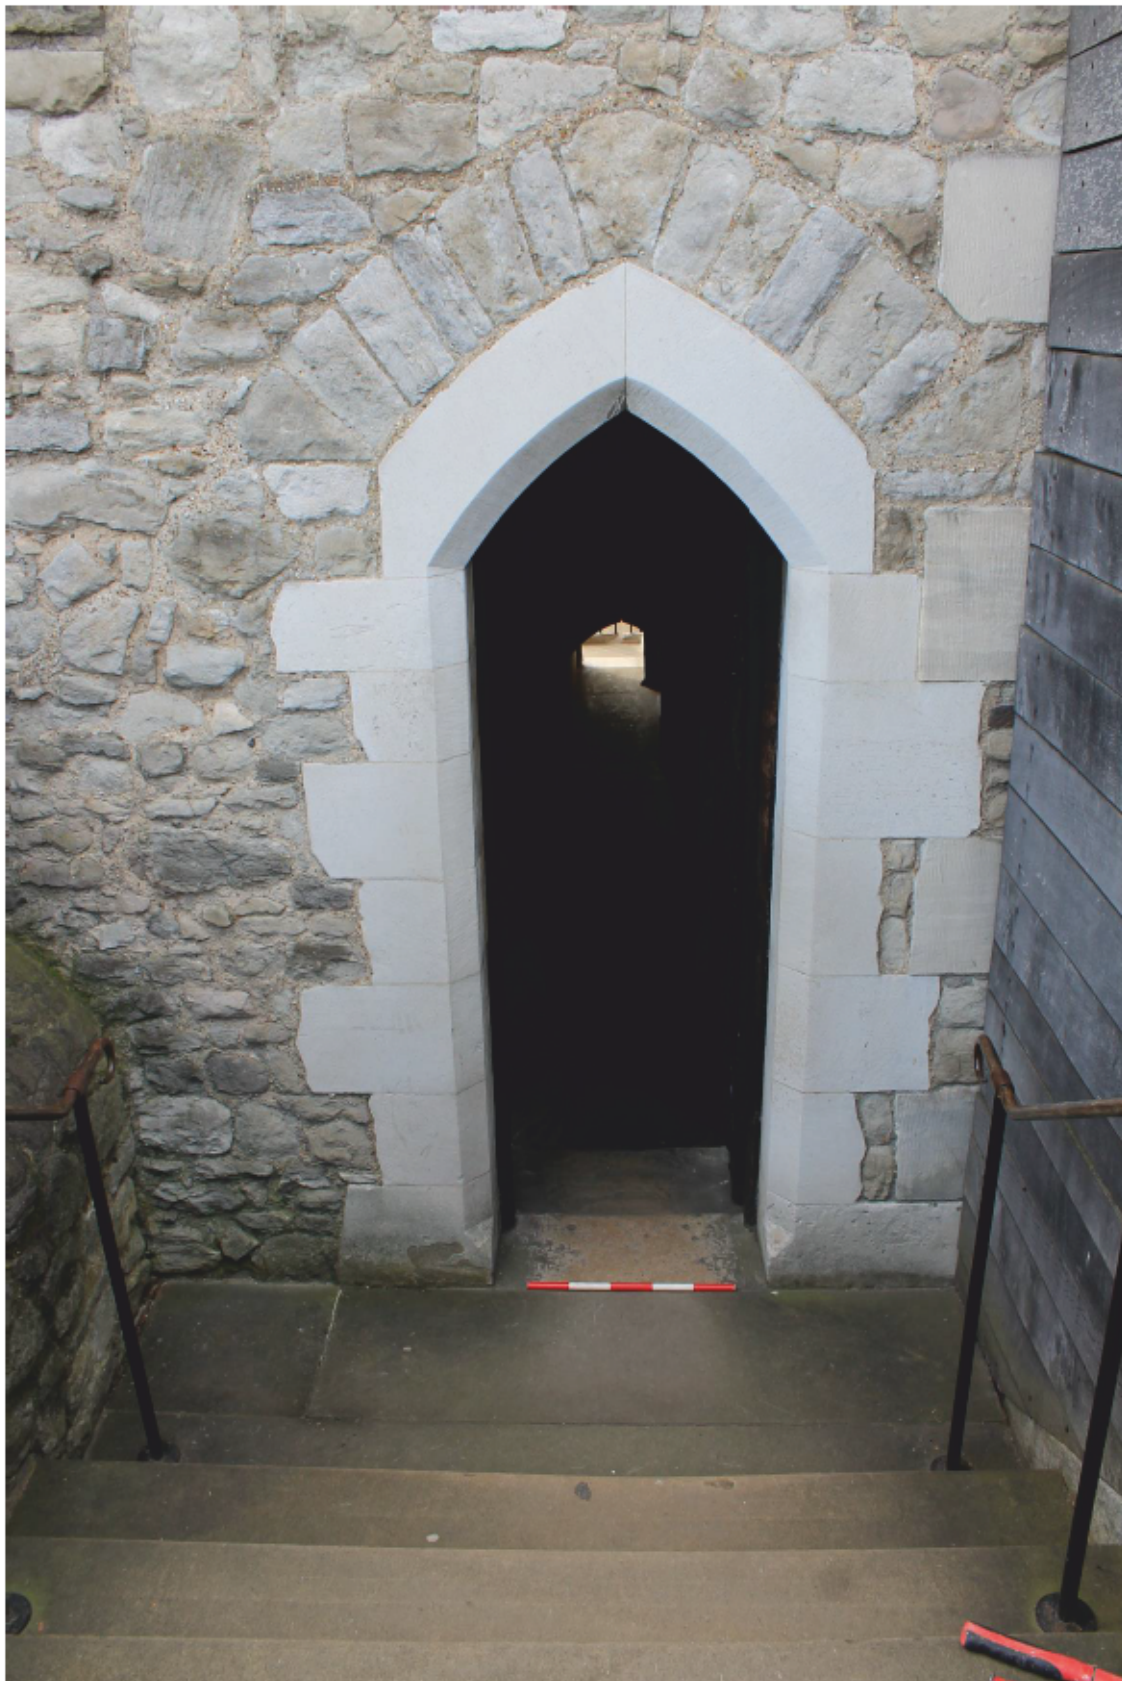
Plate 1a North first floor doorway of the Broad Arrow Tower looking south from wall walk

- 5.3.1 The northern door opening to the wall walk is built with Portland stone dressing and a pointed two-centred arched head (**Plate 1a**). The internal Yorkstone steps fall away immediately beyond the threshold, down to the level of the first floor, via a quarter landing to the northern stair turret (**Figures 3 and 4; Plate 1b**). The door threshold is built flush with the level of the Yorkstone paving to the wall walk, hence the problems with water run-off from the wall walk down into the tower (**Plate 2**). This issue was

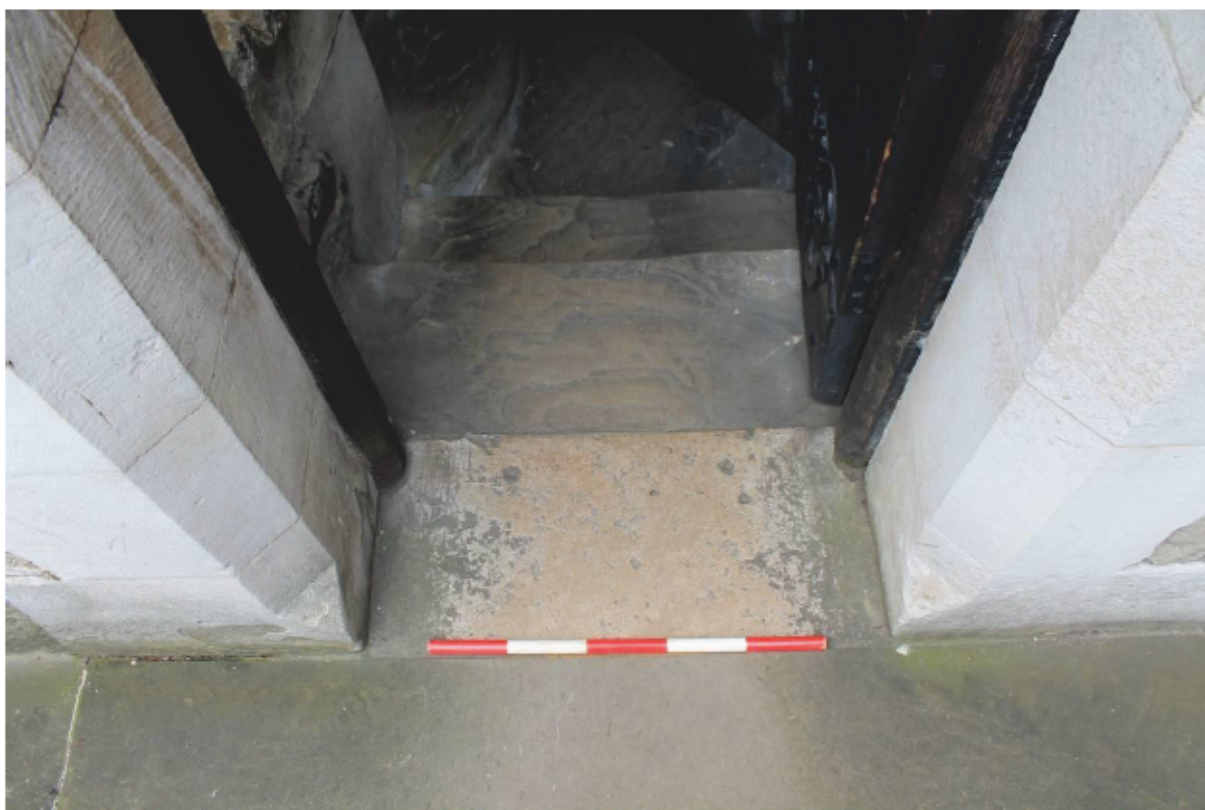
Plate 2 Flush threshold to northern first floor door opening looking south

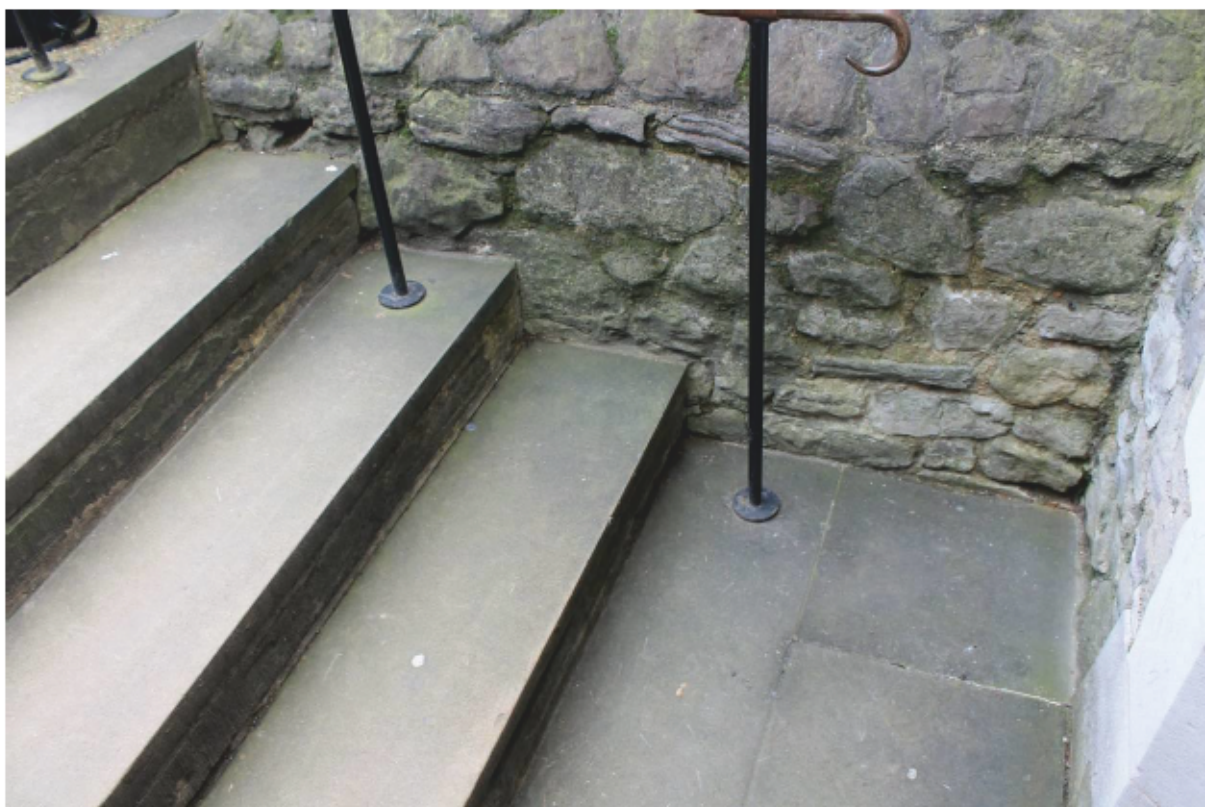
Plate 3 Machine cut steps from wall walk leading down to the Broad Arrow Tower, looking east

probably further exacerbated by a short flight of (four) steps to the north, built to address the differential in level between the wall walk and the north door opening, which indirectly creates a 'sump' (**Plate 3**).

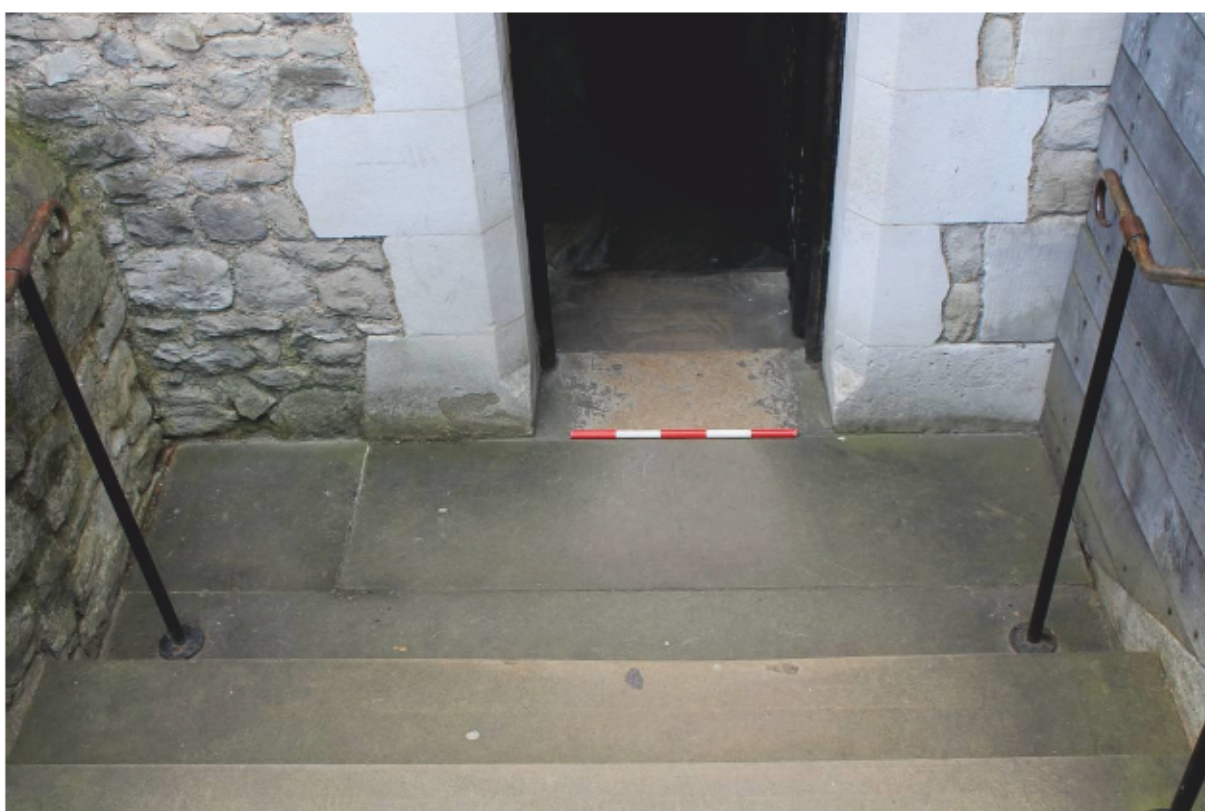
Plate 4 First floor door threshold and flagstones before works, looking south from wall walk

- 5.3.3 The machine cut Yorkstone flags to the north of the door opening (**Plate 4**) all measured just over 5cm (2 inch) in thickness. That closest to the wall walk steps was 195cm in length (i.e. the full pedestrian width of the wall walk) and 32cm wide and the two flagstones to the south (those to be lifted) 151cm and 45cm long by 44cm wide (**Figures 3 and 4**). The flagstones were laid with fine, tight joints and dry laid, not mortared into place. Yorkstone flagstones that covered the threshold to the door opening and the adjoining steps to the south were cleaved and not machine cut.

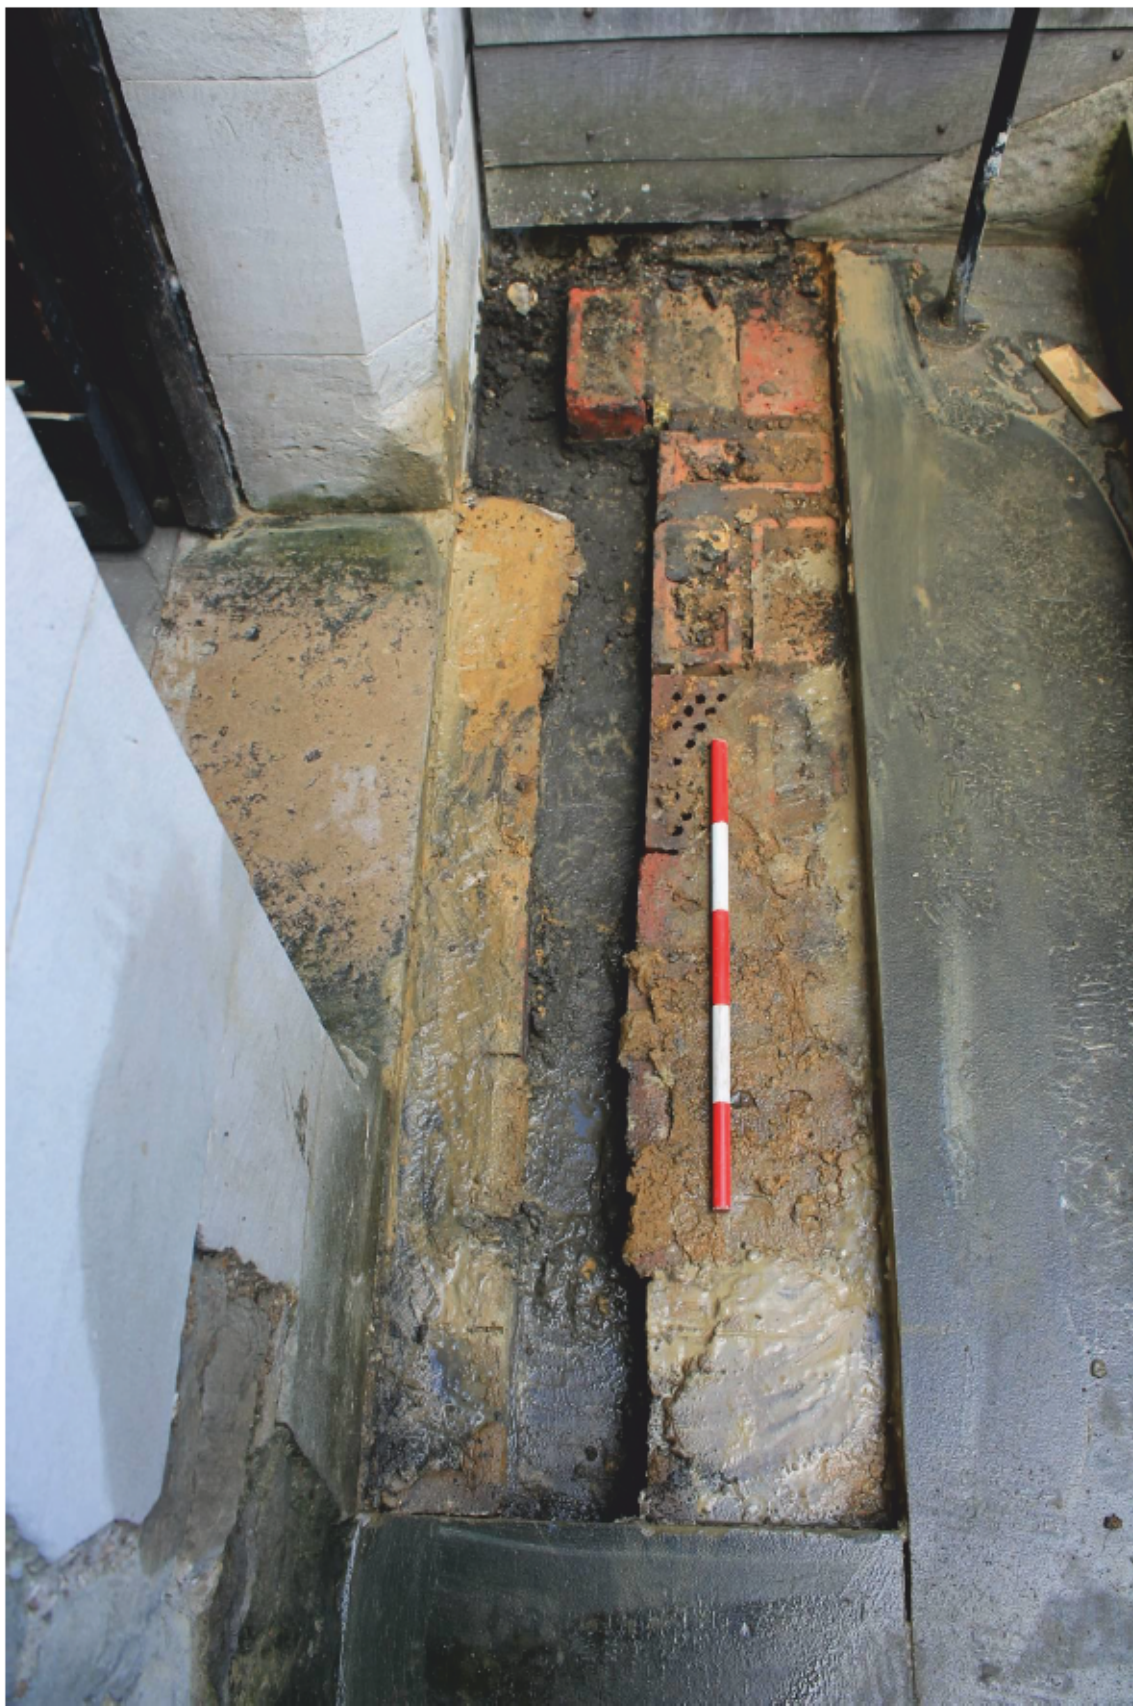
Plate 5 Modern drain revealed, looking west

- 5.3.4 The removal of the larger machine cut flagstone adjacent to the door (only possible by cutting a narrow section from the eastern end) uncovered the extant structure of a former drain (**Figure 4; Plates 5 to 7**). It was clearly a modern drain, built re-using a selection of bricks including mainly machine-made Flettons with large frogs, and also re-used yellow stock and modern perforated bricks. The drain gulley extended east to west across the front of the door threshold with a dog leg (half brick in length) back to the wall line to the west of the threshold and probably the same to the east. The brickwork was mortared together using a weak sand/cement mortar and laid onto a Yorkstone flagstone, used as a base to the gulley. It was unclear whether this base was in fact an earlier floor surface to the wall walk or was used specifically as a base for the drain.

- 6.1.1 The survey works at the Broad Arrow Tower revealed, following the removal of a large machine-cut Yorkstone flagstone adjacent to the northern first floor door threshold, the structure of a modern brick-built drain. It was constructed re-using a selection of modern/post-war bricks built onto a Yorkstone base. Given the character of the bricks forming the gulley and the smooth machine-cut Yorkstone used for the overlying flagstones and the contemporary flight of steps to the wall walk, the drain was most certainly built or improved within the recent past, at most within the last 35 years. No evidence of a former historic drain was observed. It was not clear if the underlying Yorkstone was re-used to form the base to the drain or if the drain was constructed onto a pre-existing former Yorkstone floor surface to the wall walk because no further intrusive works were carried out. No Yorkstone flagstones were archaeologically recorded when the wall walk surface between the Bowyer Tower and Brick Tower was removed in 2015. Here, asphalt overlay a levelling layer of packed mortar over a thin sand layer, which covered a peg roof tile surface, which in turn overlay a brick surface (OA, 2015).

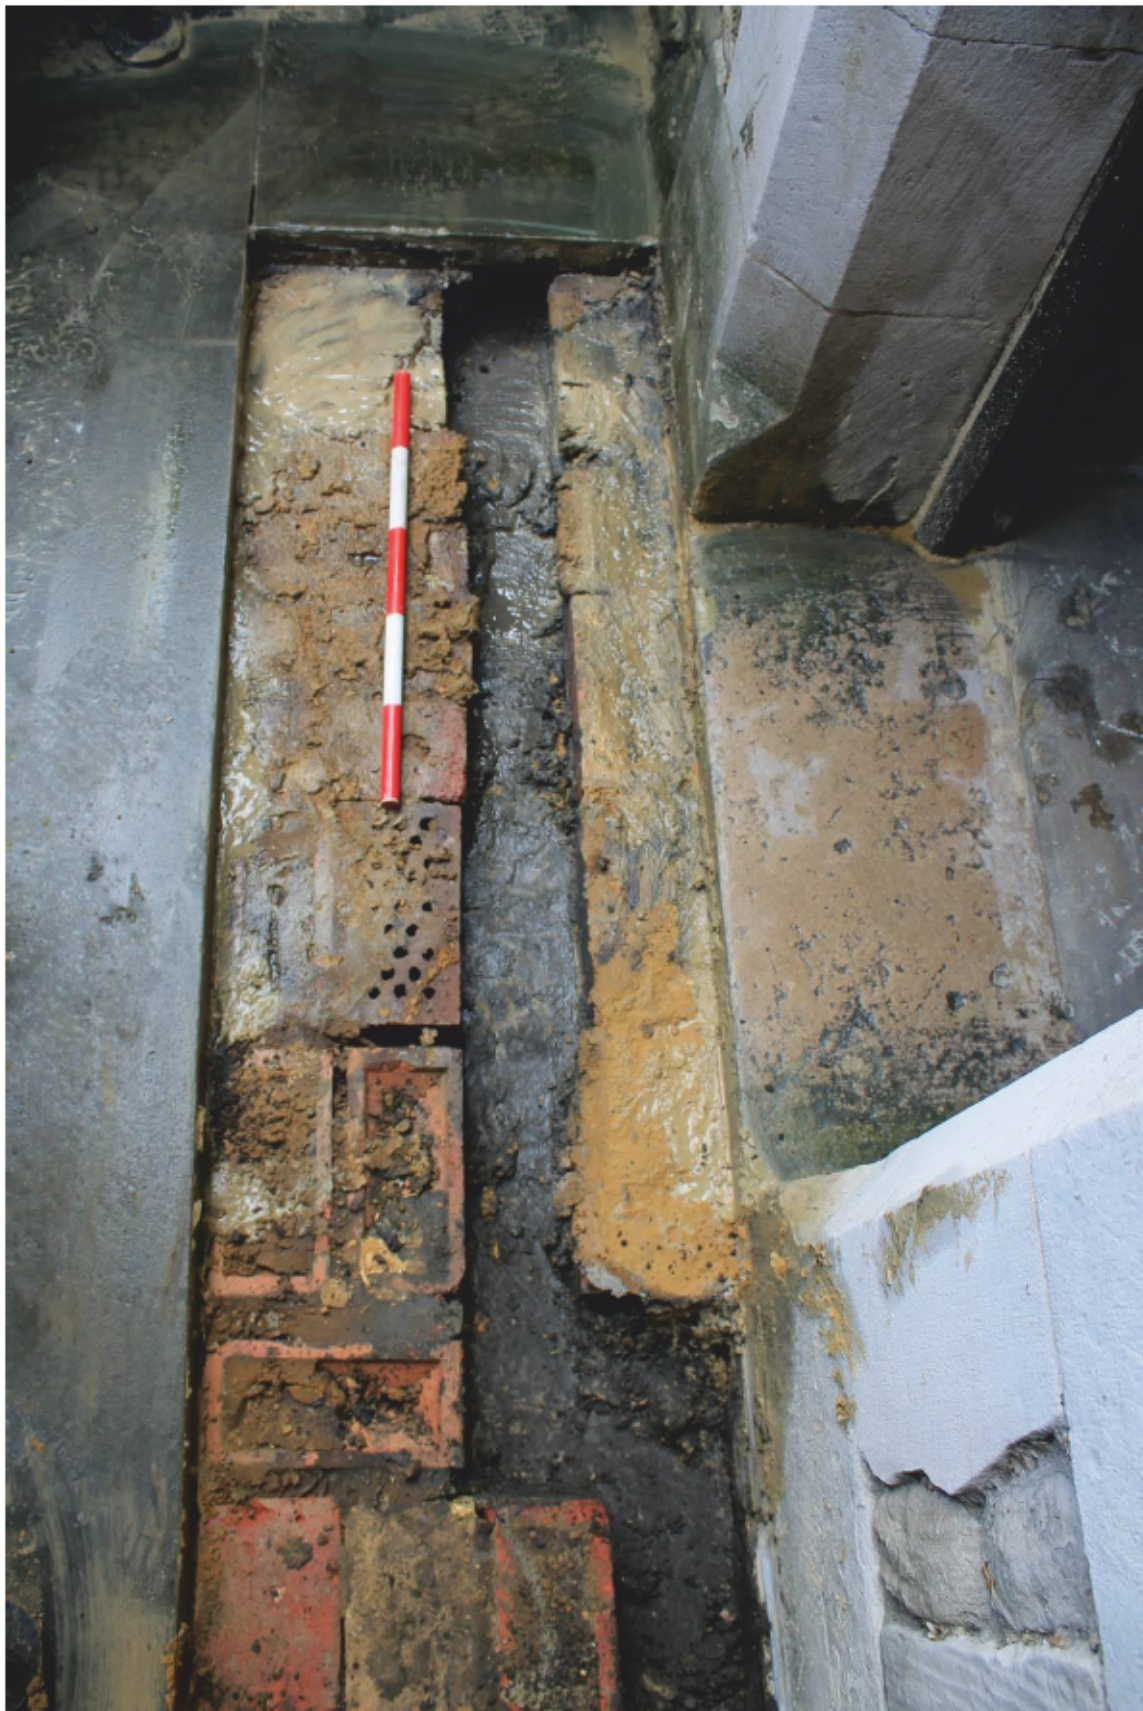
Plate 6 Modern drain looking east

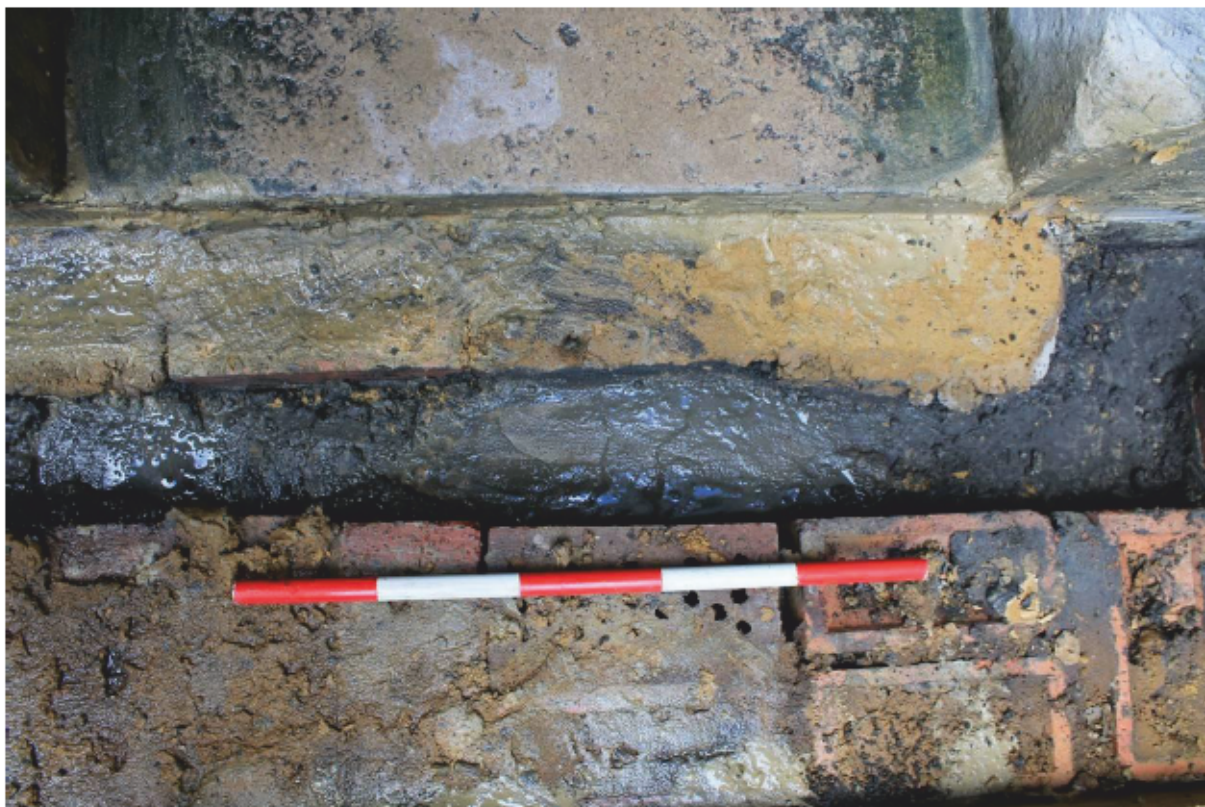
Plate 7 Yorkstone base to drainage gully

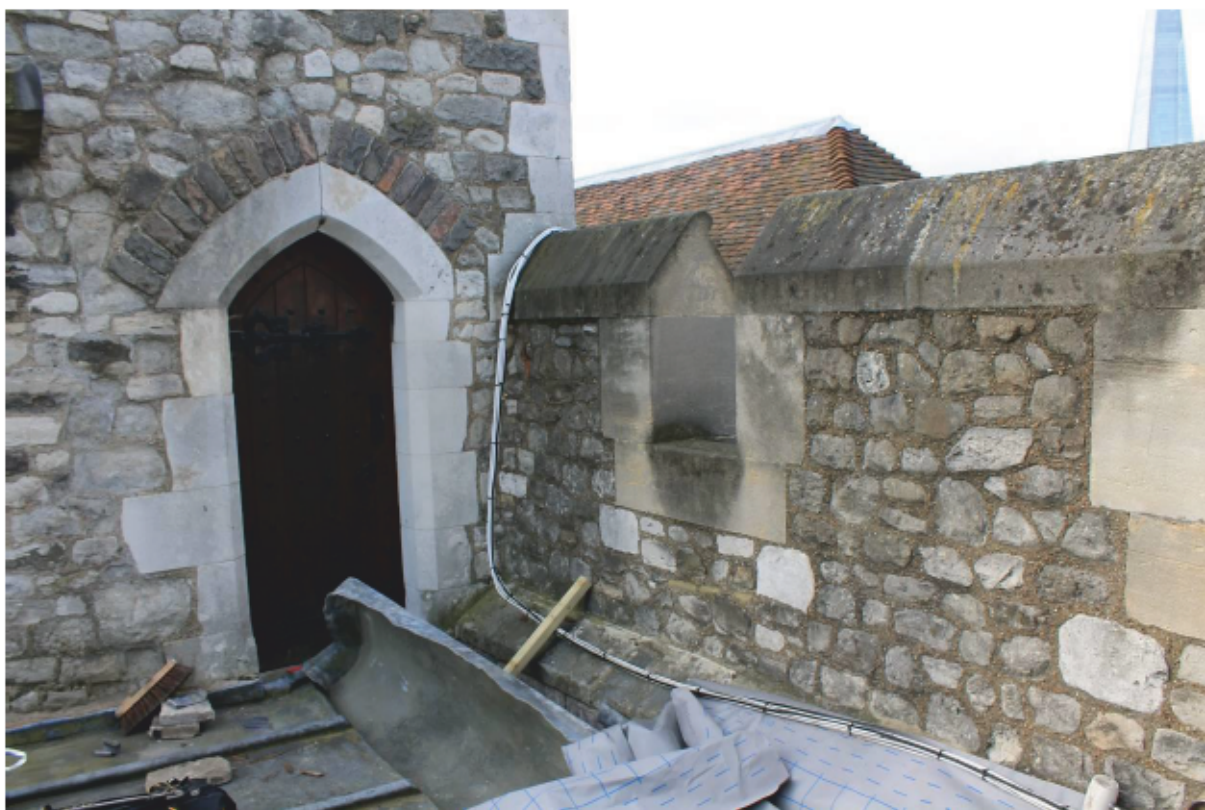
Plate 8 Roof of the Broad Arrow Tower showing location of joist (below leadwork) looking south-west

- 5.3.7 At the time of the site visit, the code 8 leadwork to the drainage gulley along the western side of the roof of the Broad Arrow Tower had been 'peeled back exposing a small section of the flat roof structure adjacent to the threshold of the southern turret door (**Plate 8**). This revealed, below the softwood roof boards (6 inch scantling) for the flat roof, two joists running east-west across the roof (**Plates 9 and 10**). The southernmost joist was much decayed and in need of replacement (**Plate 10**). It was a regular cut joist measuring 4x4 inches, heightened, by the addition of a narrow strip of modern timber (18mm thick) nailed onto the upper surface of the joist (as a spacer). The same treatment was given to the adjacent joist to the north, which had also been locally bedded onto a pad of re-used plasterboard. Clearly these works were associated with a recent reworking or repair to the flat roof, possibly as part of improvements to the roofs surface drainage.

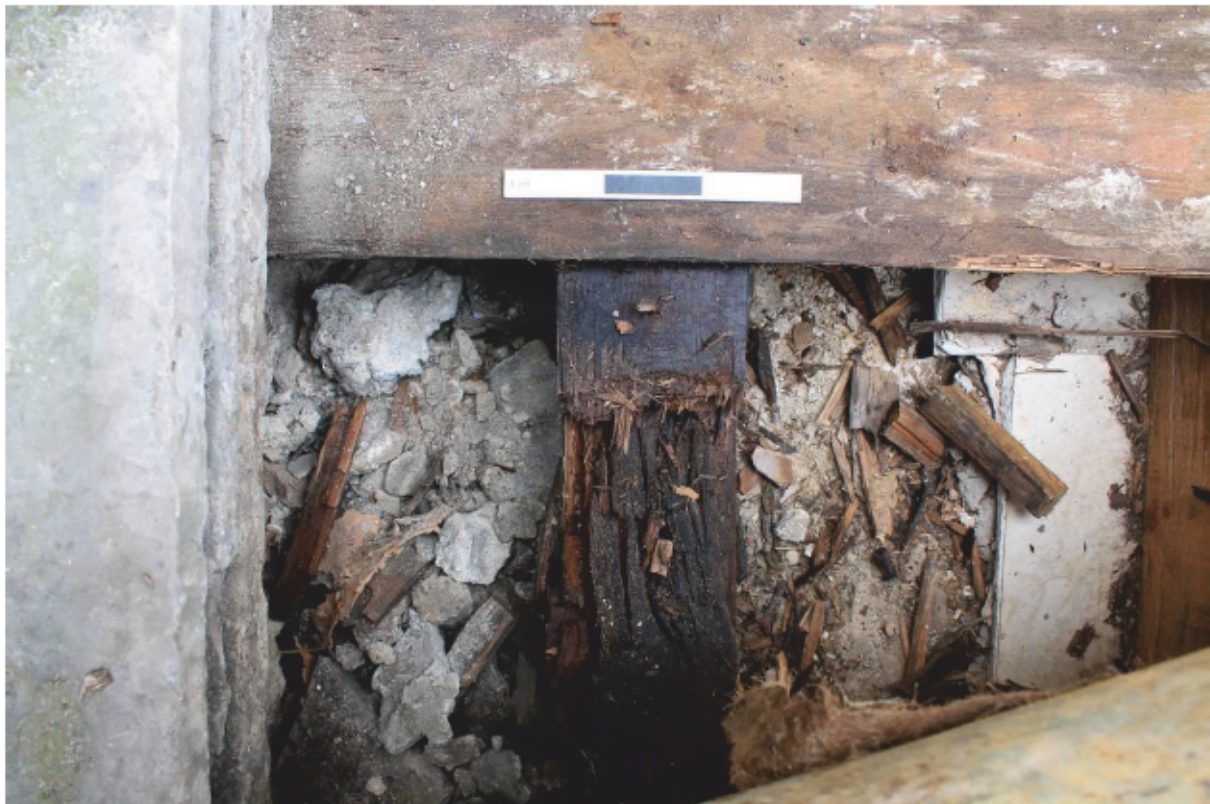
Plate 10 Decayed roofing joist to be replaced (note re-used plasterboard below adjacent joist), looking west

- 6.1.3 The observation of a small area of the leaded flat roof structure of the Broad Arrow Tower revealed that it was constructed using modern timber and plasterboard. This repair work was possibly as an attempt to improve surface drainage. Both this roof repair and the construction of the drain by the north door of the Broad Arrow Tower may have been part of the same work completed at the tower during the early 1980s.
