**ST MARY'S CHURCHYARD,
CHURCH ROAD, LEYTON, LONDON
BOROUGH OF WALTHAM FOREST
E10 5JX: AN ARCHAEOLOGICAL
WATCHING BRIEF**

**LOCAL PLANNING AUTHORITY:
LONDON BOROUGH OF WALTHAM
FOREST**

SITE CODE: MCY17

MAY 2017

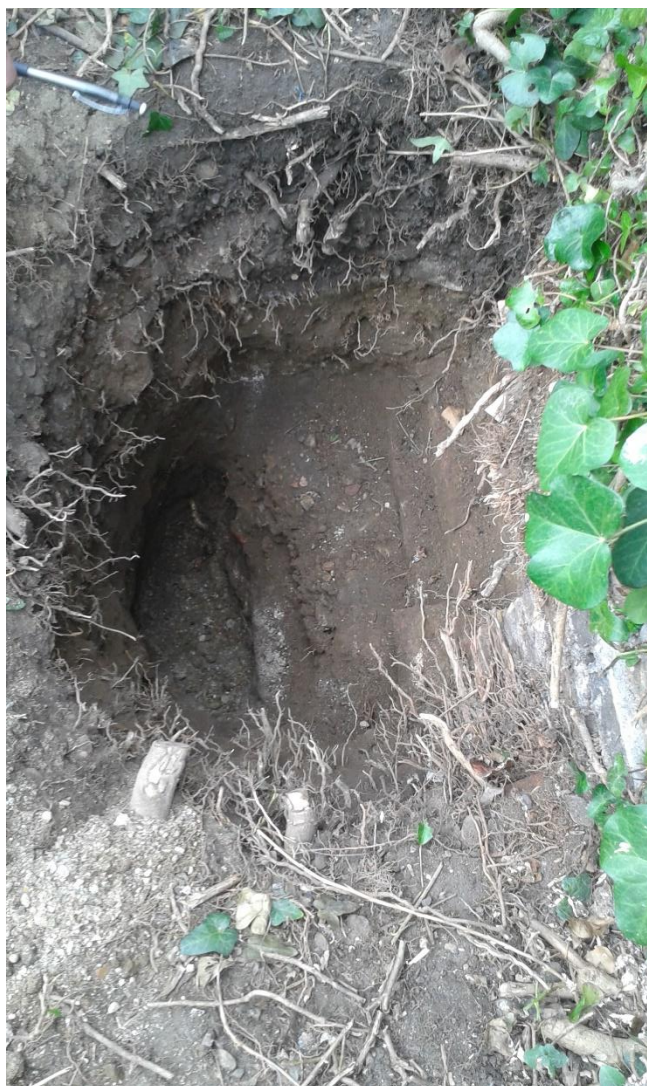
- 8.1.2 The natural gravel was identified 1.30m below ground level. Sealing the natural gravel was a layer of 19th century made ground [2] which comprised a bedding layer for the concrete foundation of the churchyard wall. This layer was 0.05m thick and comprised a layer of crushed mortar and limestone. It was a light whitish yellow in colour.

- 8.1.3 Above layer [2] was layer [1], which comprised the backfill of the construction cut for the churchyard wall. This layer was 0.70m thick and contained frequent coal, CBM and 19th century pottery. The cut for the wall was not found as the test pit was not extended far enough to the west. The wall itself was constructed on a 0.50m thick layer of concrete.

- 8.1.4 Sealing the backfill layer was a 0.55m thick layer of topsoil and grass.

Plate 1: Test Pit 1 facing north. Concrete foundation is on the right of the base of the test and natural gravel is on the left.

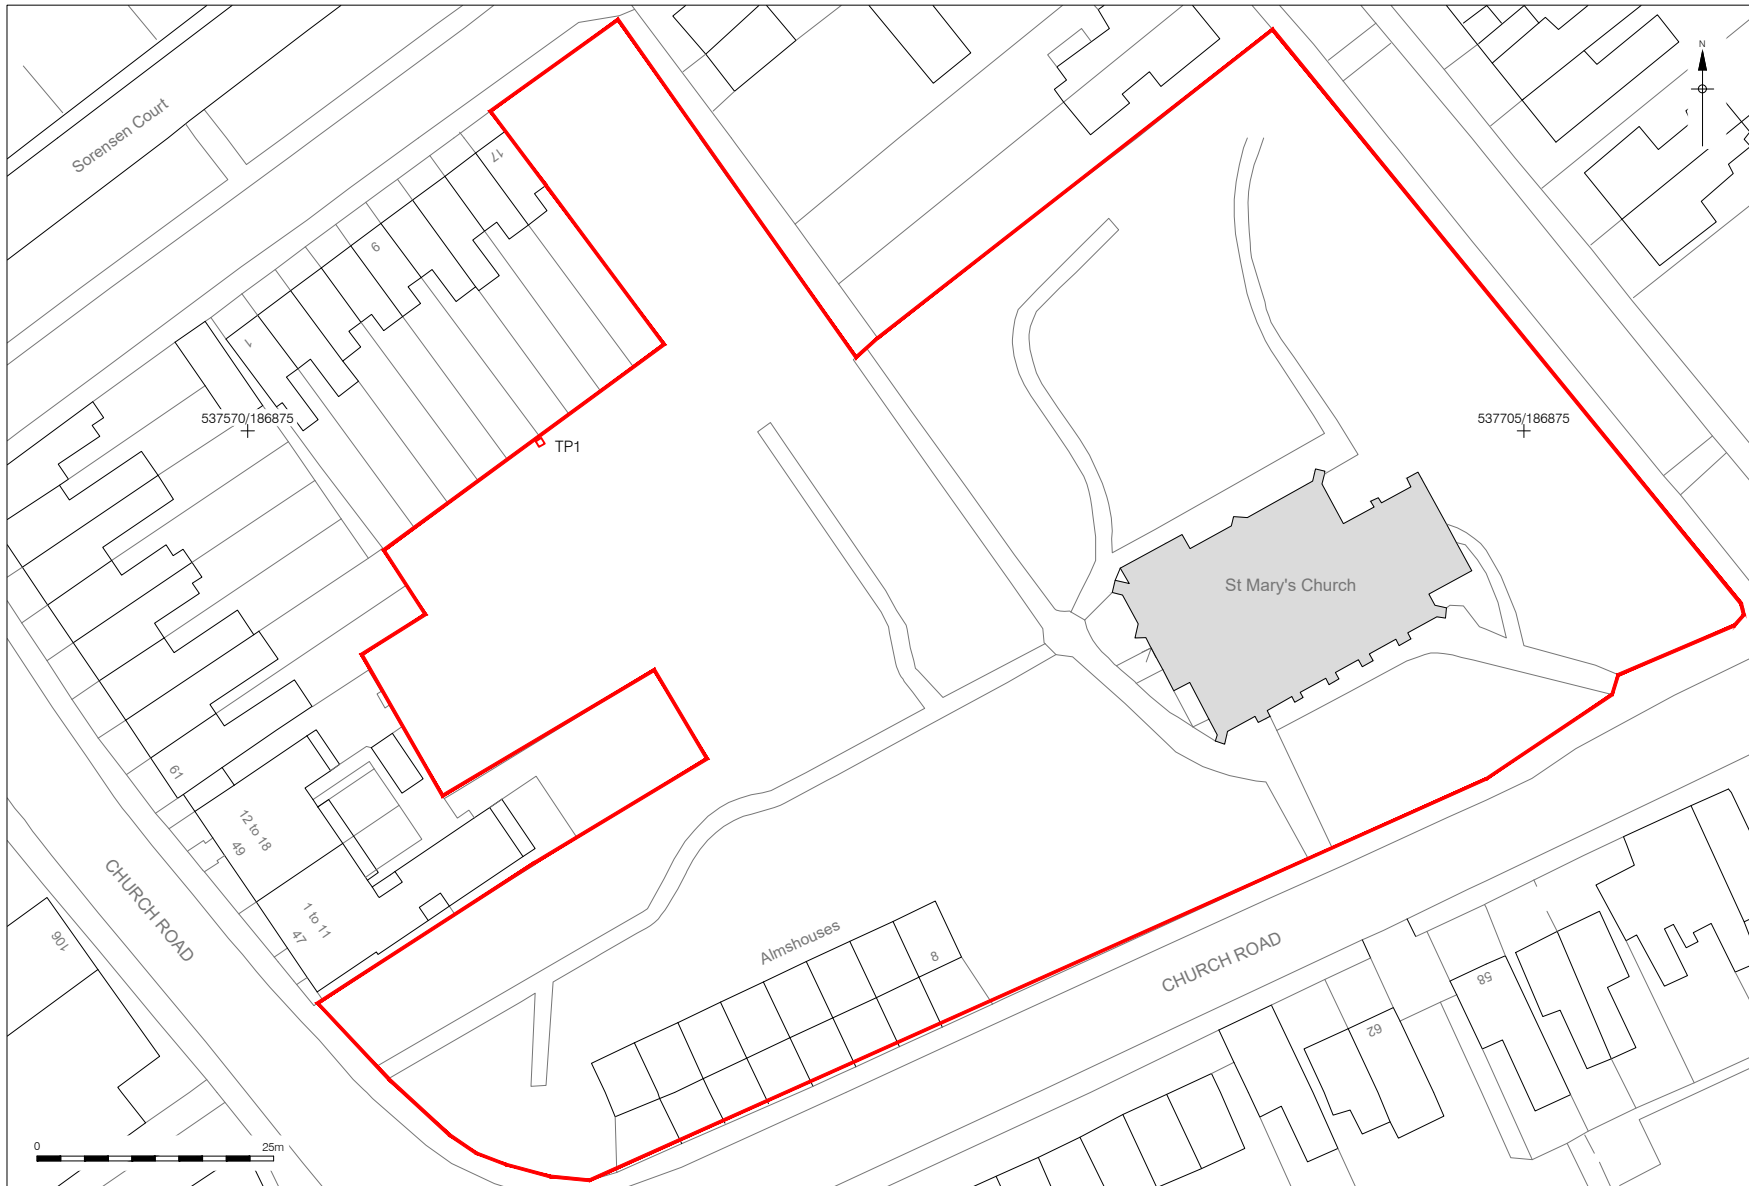
Figure 2
Test Pit Location
1:800 at A4

- 8.1 The test pit location is shown in Figure 2 and test pit photographs are shown below.
- 8.1.1 The test pit measured 0.70m x 0.70m and was 1.30m deep.
