**FIRST STREET PLOT 11 (8)
MANCHESTER, M15 4FN**

**ASSESSMENT OF AN
ARCHAEOLOGICAL EXCAVATION**

PCA REPORT NO: 12915

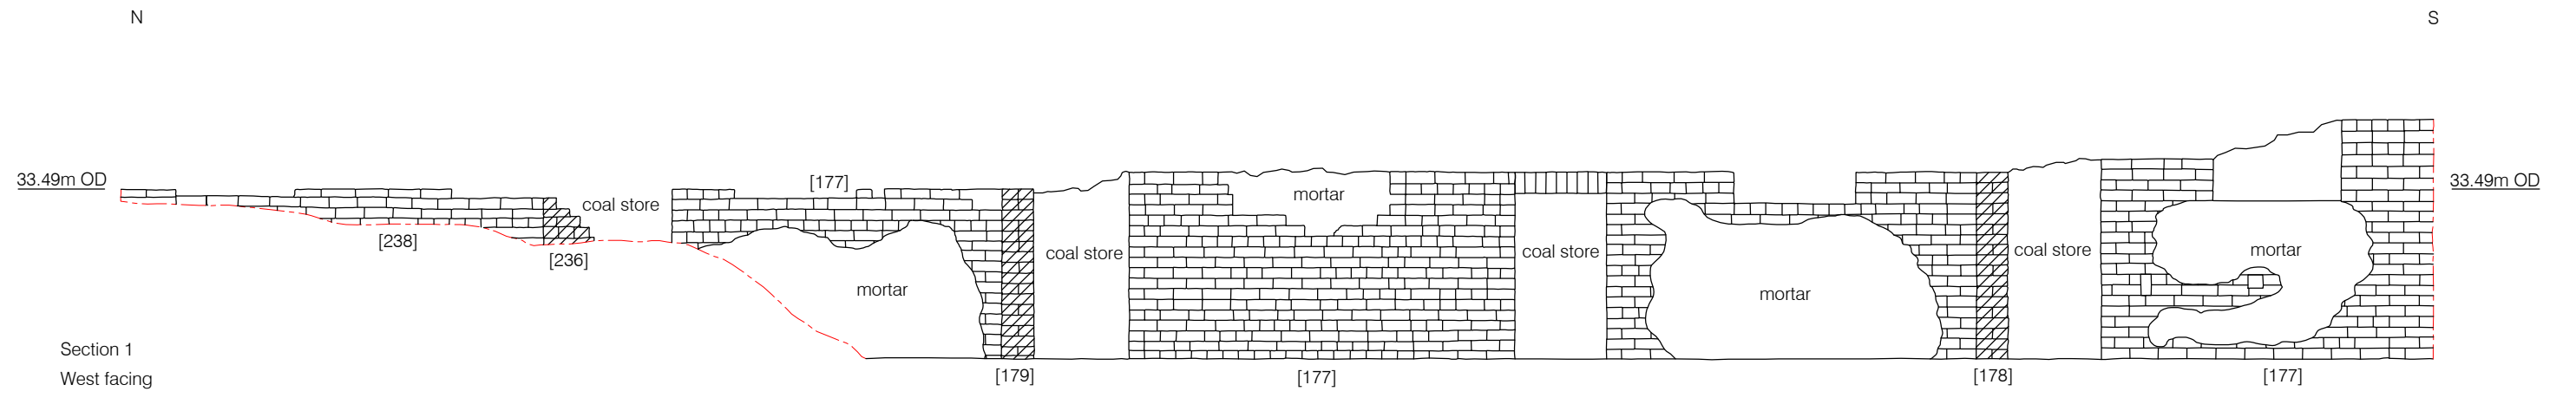
Figure 10
Elevation of wall [177]
Area 1, West facing
1:50 at A3

Section 1
West facing
Area 1

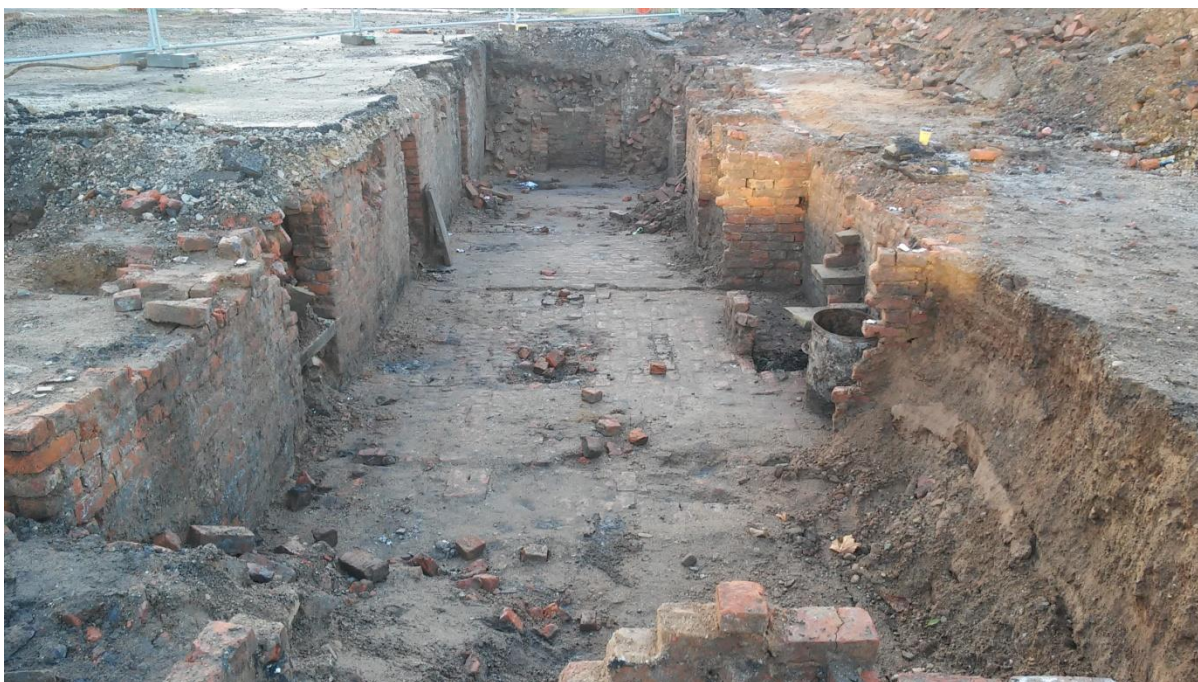
Plate 2: Internal wall [257] in floor [239] looking north-east

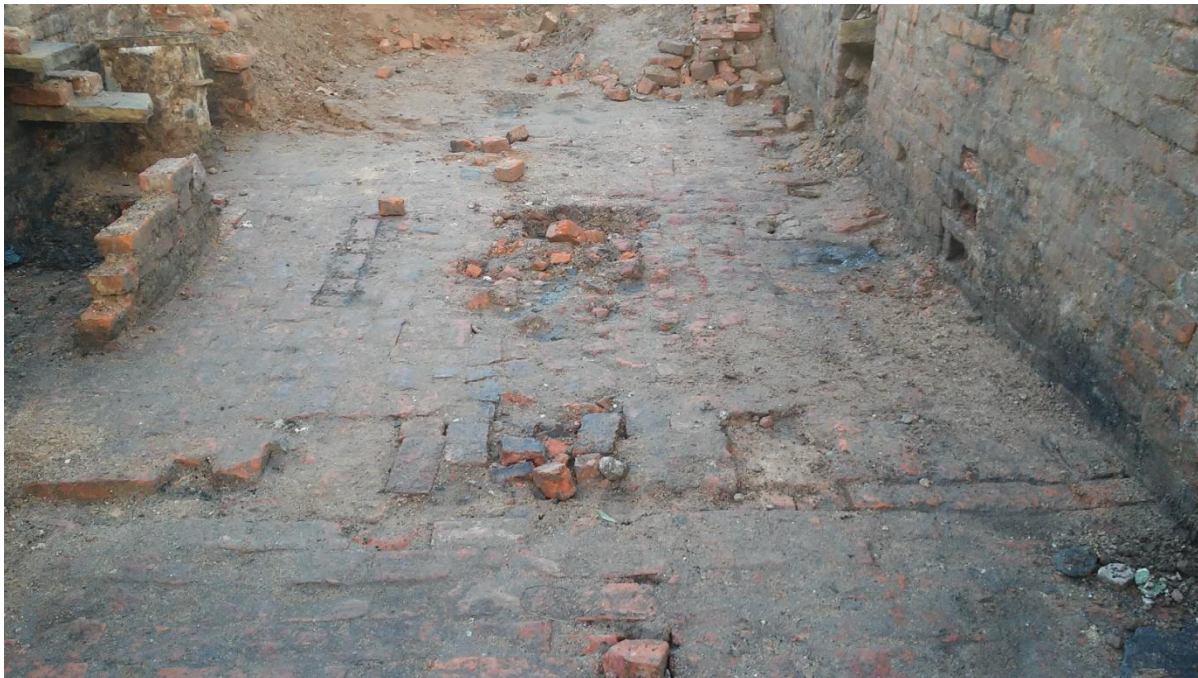
Plate 3: [178], [184], [185] and [257] looking south-west

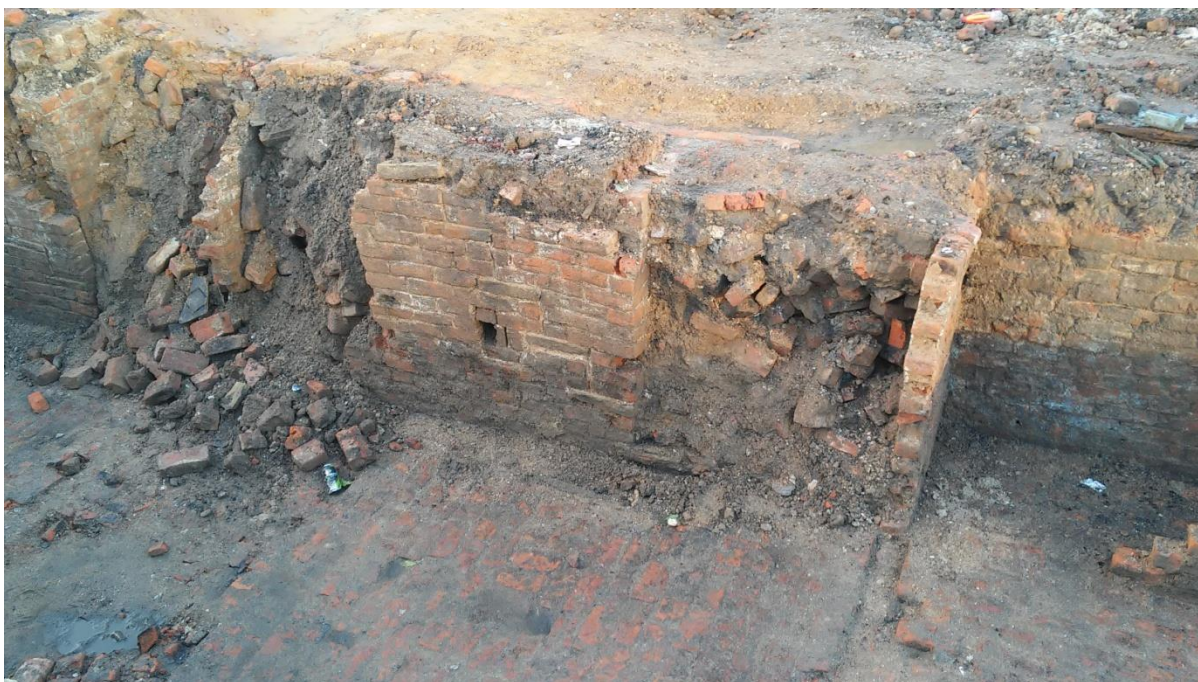
Plate 4: Brick and stone stairs [188] and wall alteration [191] looking south-west

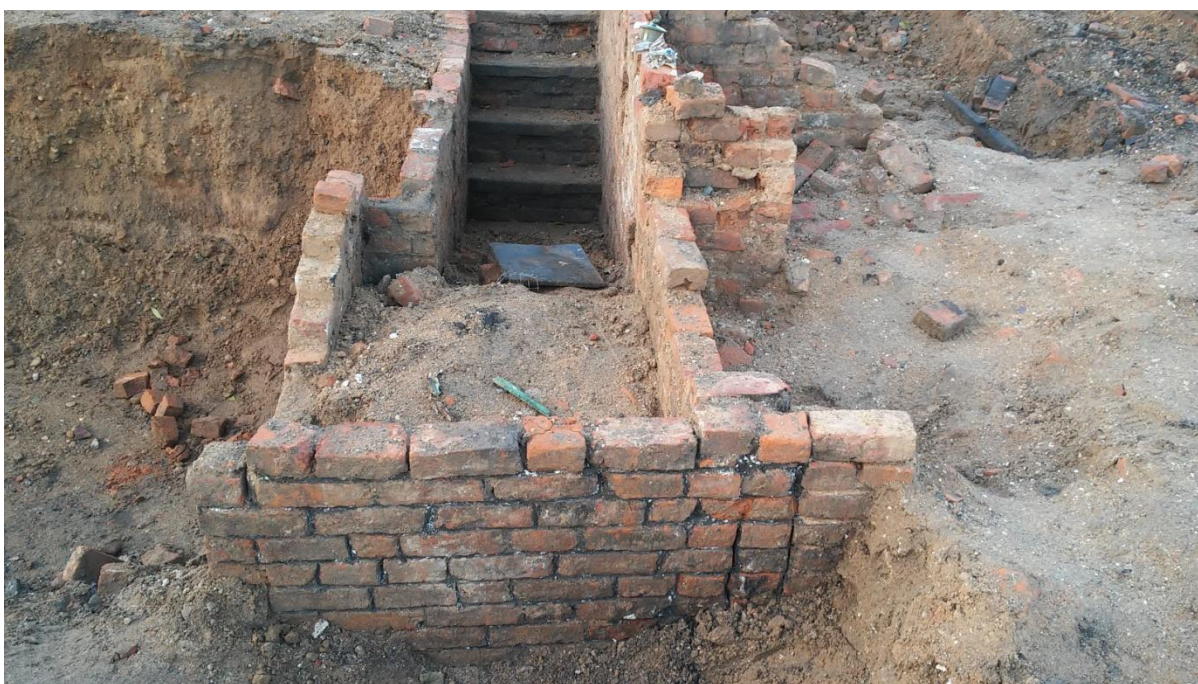
Plate 5: Brick coal store [236] and [237] looking south-east

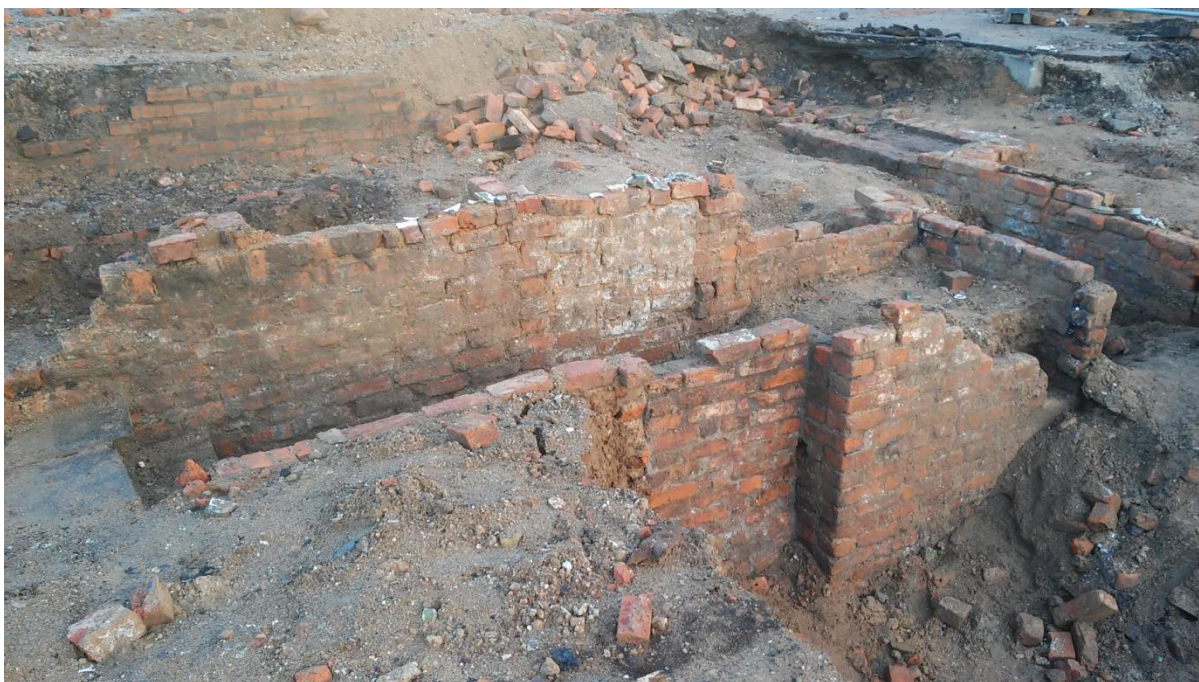
Plate 8: Ash pit [58] looking north-east

- 7.3.13 An ash pit, [58], and associated wall, [62], were recorded during the evaluation in Trench 207, and would have formed part of a house accessible from Cream Court, which extended west from Wilmott Street (Figures 3 & 7; Plate 8). These features were both constructed of red unfrosted brick, typically measuring 220mm x 110mm x 70mm. Laid as stretchers, they were

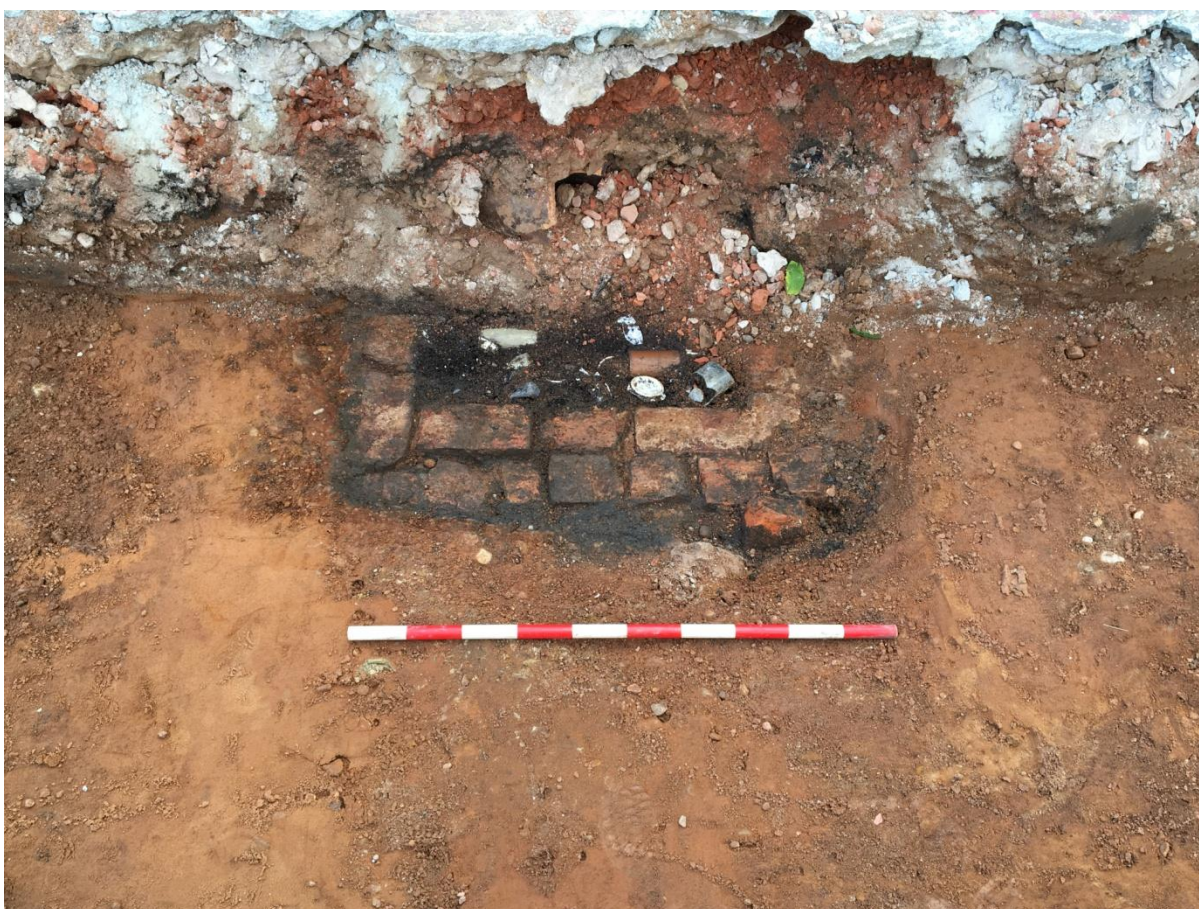
Plate 9: Coal chute [68]

7.3.15 In Area 3 a curving brick coal chute, [68], extended down from what would have been Parker Street into the cellar of one of the houses (Figures 3 & 4; Plate 9). Brick walls [253], [254] and [255] formed the exposed walls of the cellar, which measured just over 5m in length. The remains of a York stone paved floor [256] was observed. An adjoining cellar was recorded to the east, and was formed of walls [250], [251], [252], and [253]. This property would have had a frontage measuring 3.6m and also extended back c. 5m, creating an internal area of around 19m². The walls forming the terraced back-to-backs on Park Street were all built of red unfrogged brick laid as stretchers. The bricks measured 220mm x 110mm x 65mm and were bonded with a mid-brown sandy lime mortar.

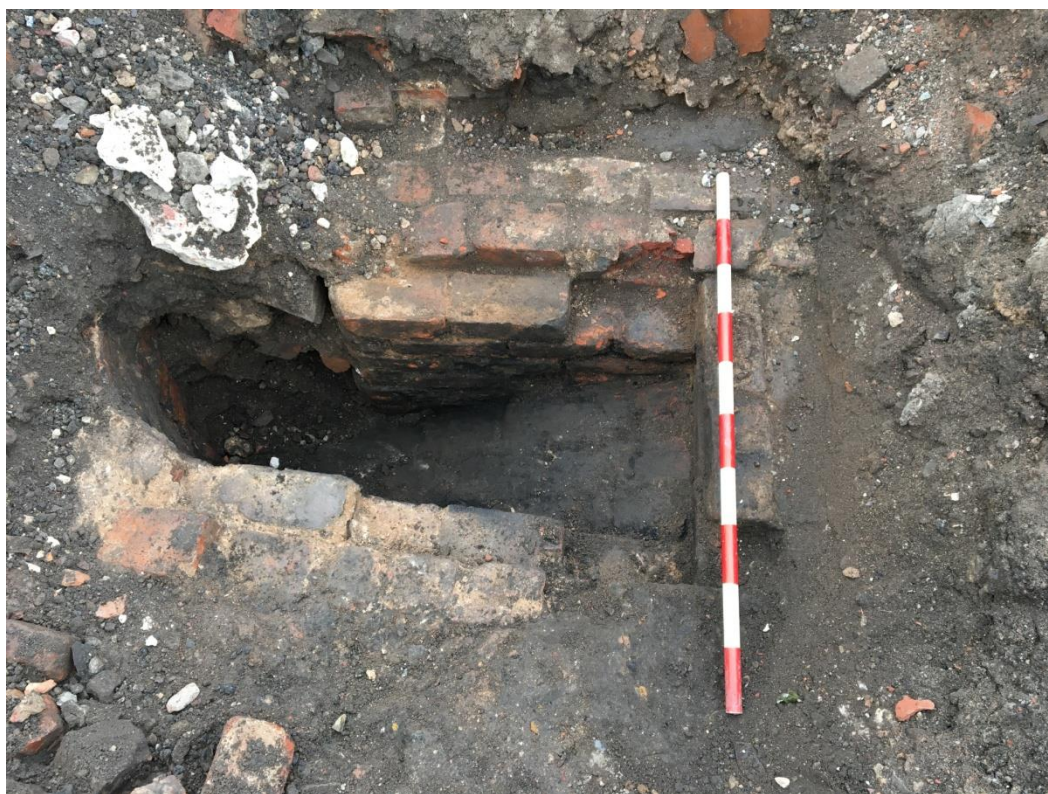
Plate 10: Brick tank [74], [75], [76] and [77] looking north-east

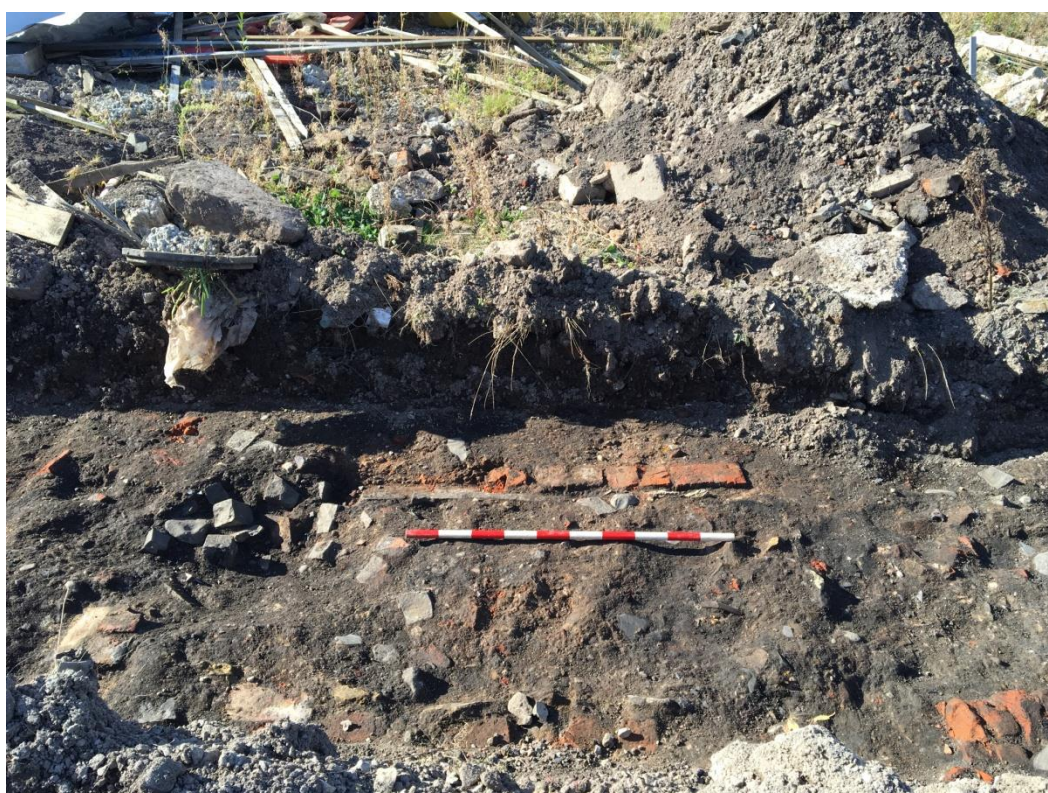
Plate 11: Brick air raid shelter [168], [151] looking south-west

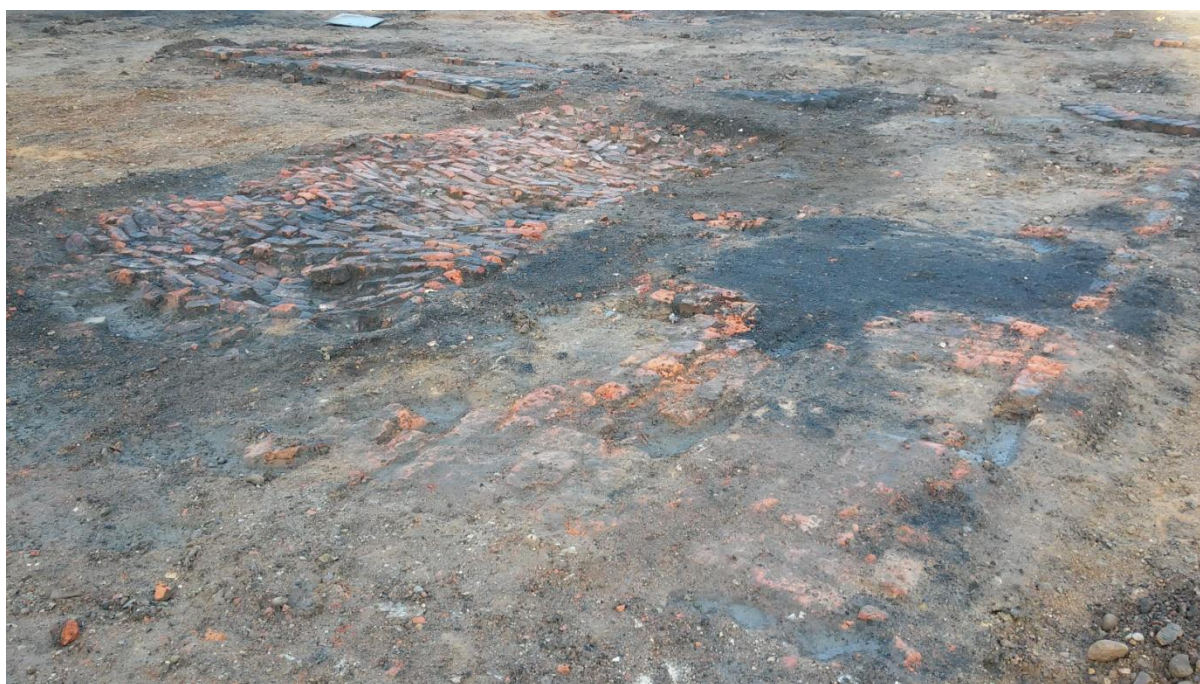
Plate 12: Drain [41] and walls [43], [44] looking south-west

7.3.18 In Evaluation Trench 2 wall [43] formed the back wall of a house fronting George Street (now Hulme Street), joining with wall [44]/[197] to form the boundary of the property. Both walls were built of red unfrosted brick, typically measuring 230mm x 110mm x 65mm, and bonded with a yellow-brown lime mortar. A similar wall [198] ran parallel to wall [44], possibly originally forming an ash pit or coal chute, comparable to those seen across site. A brick box drain, [41], ran parallel to wall [43], continuing into the western section of the site (Plate 12). North-east to south-west running brick wall [42] was located at the northern limit of excavation, and had the same construction as walls [43] and [44]. Immediately to the south was pit [27], measuring 1.0m x 0.70m. The fill, [26], was very similar to [57], the fill of ash pit [58] in the south-east of the site – loose dark brown sandy ash, which contained 19th-century pottery (see Appendix 2; Plates 34-37).

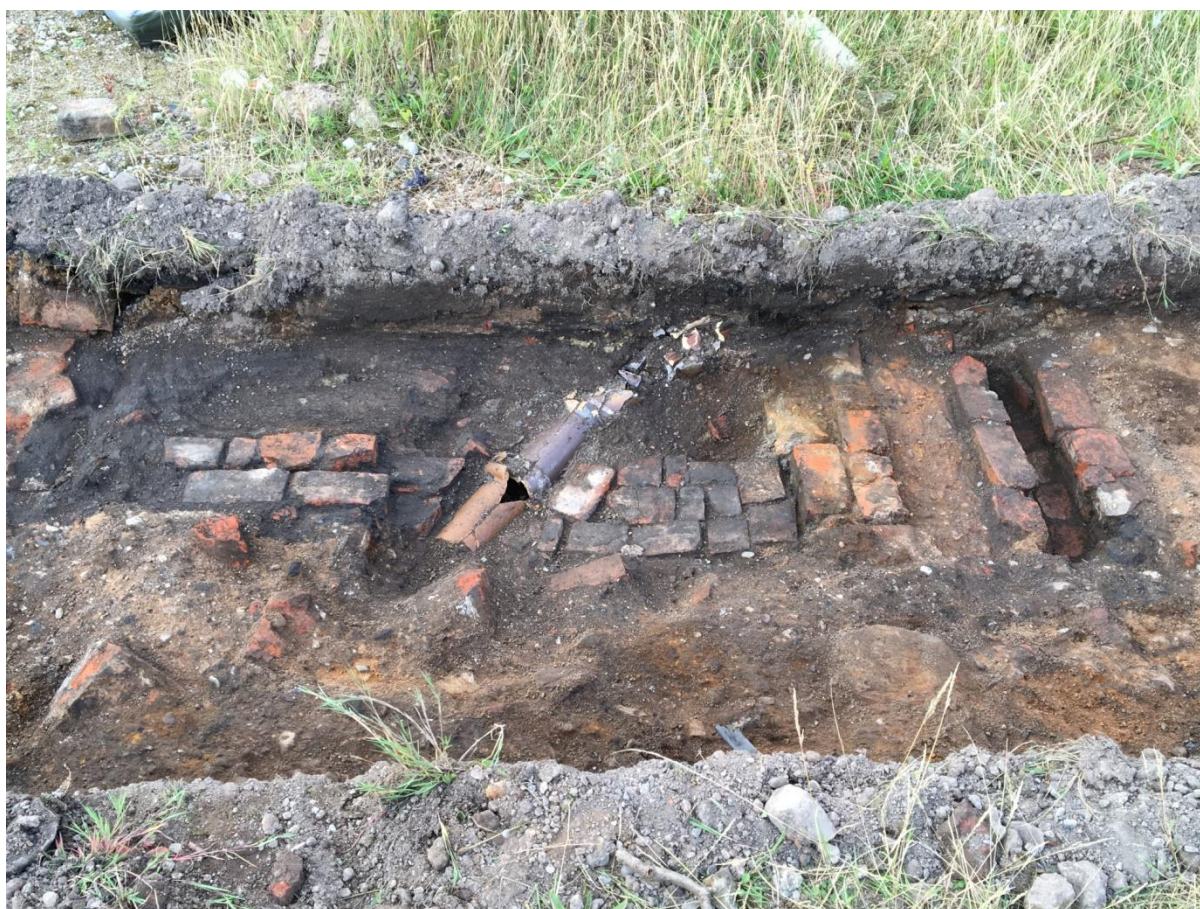
Plate 13: Coal store [126] looking south-west

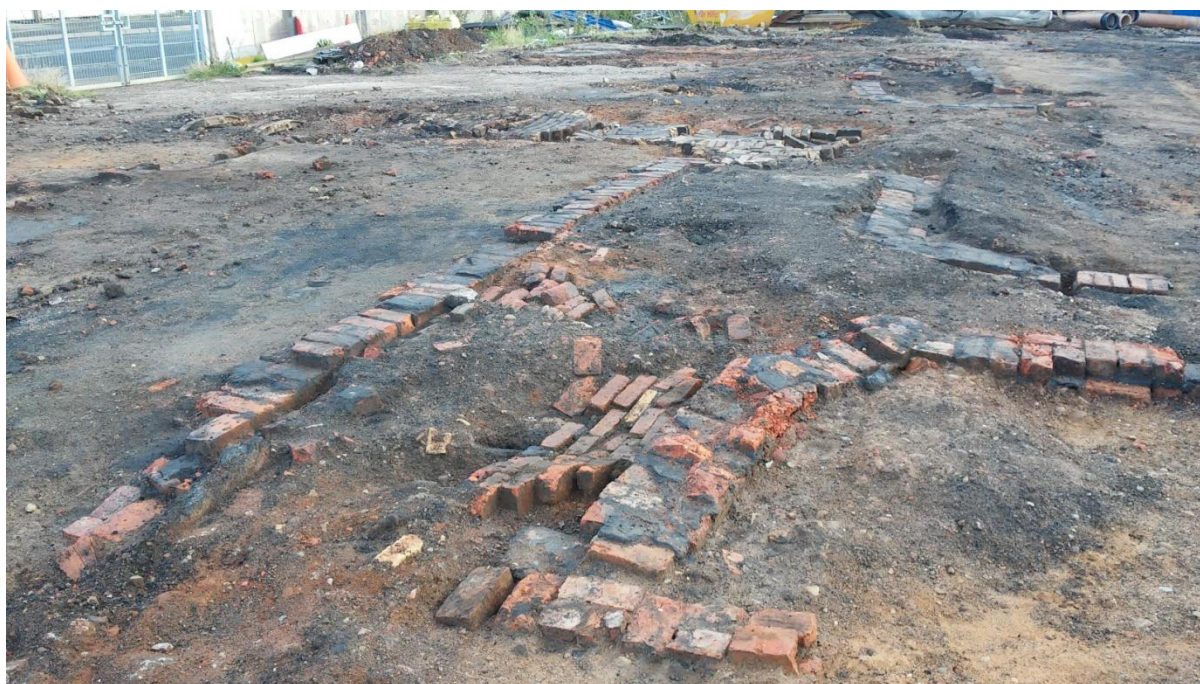
Plate 19: Air raid shelter 8 looking south-east

- 7.4.10 Only one wall, [149], remained of Entrance H, curving east towards Shelter 8, [152]. A slot was excavated between two ribs of Shelter 8 to expose its construction (Plate 19). Identical to the other air raid shelters on site, it was composed of corrugated metal sheeting curved over metal ribs to form a barrel vault.
