**FORMER RAF STORE,  
SULBY HALL,  
OLD DRIVE,  
SULBY,  
NORTHAMPTONSHIRE,  
NN6 6EZ**

**HISTORIC BUILDING RECORDING**

**PCA REPORT NO: R12936**

**JULY 2017**

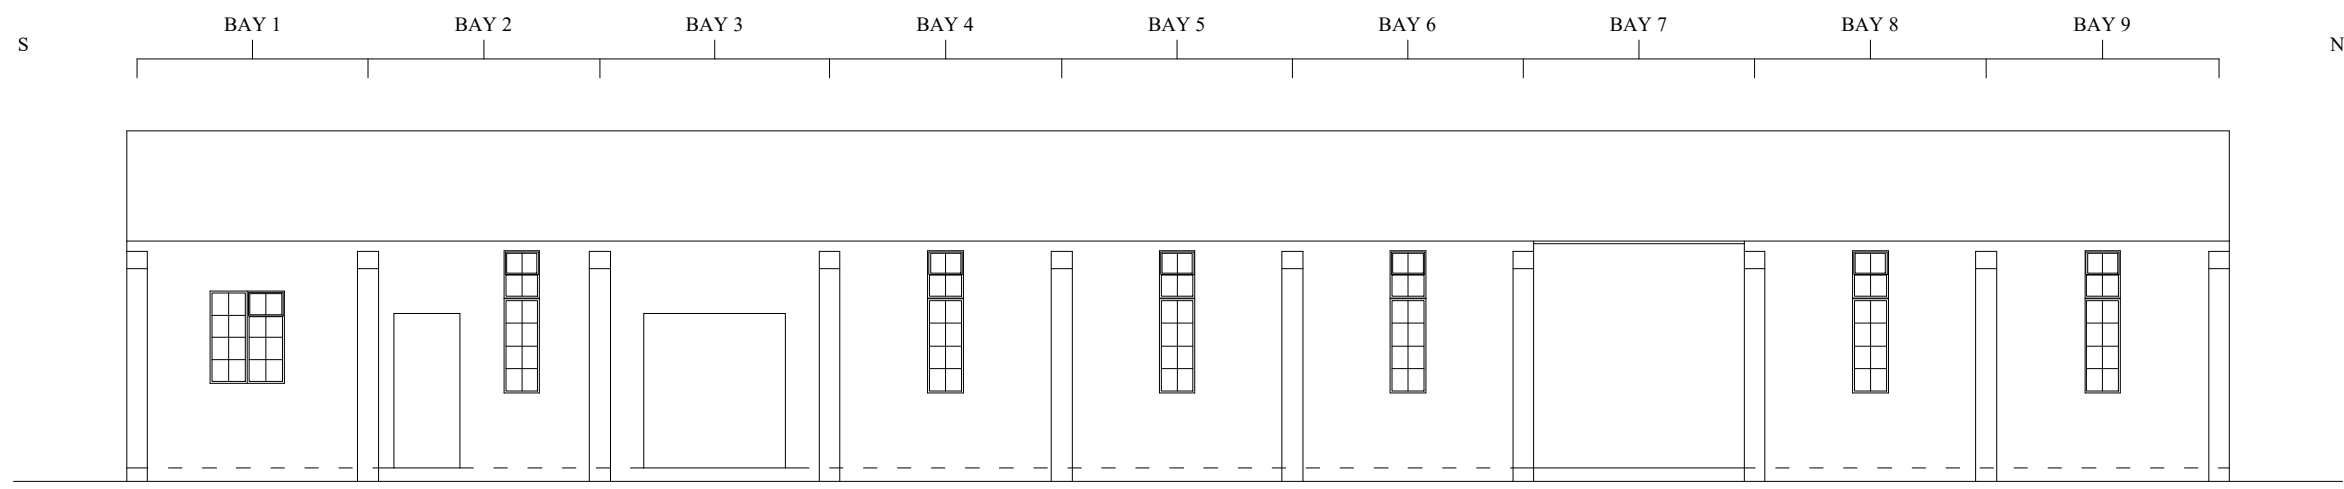
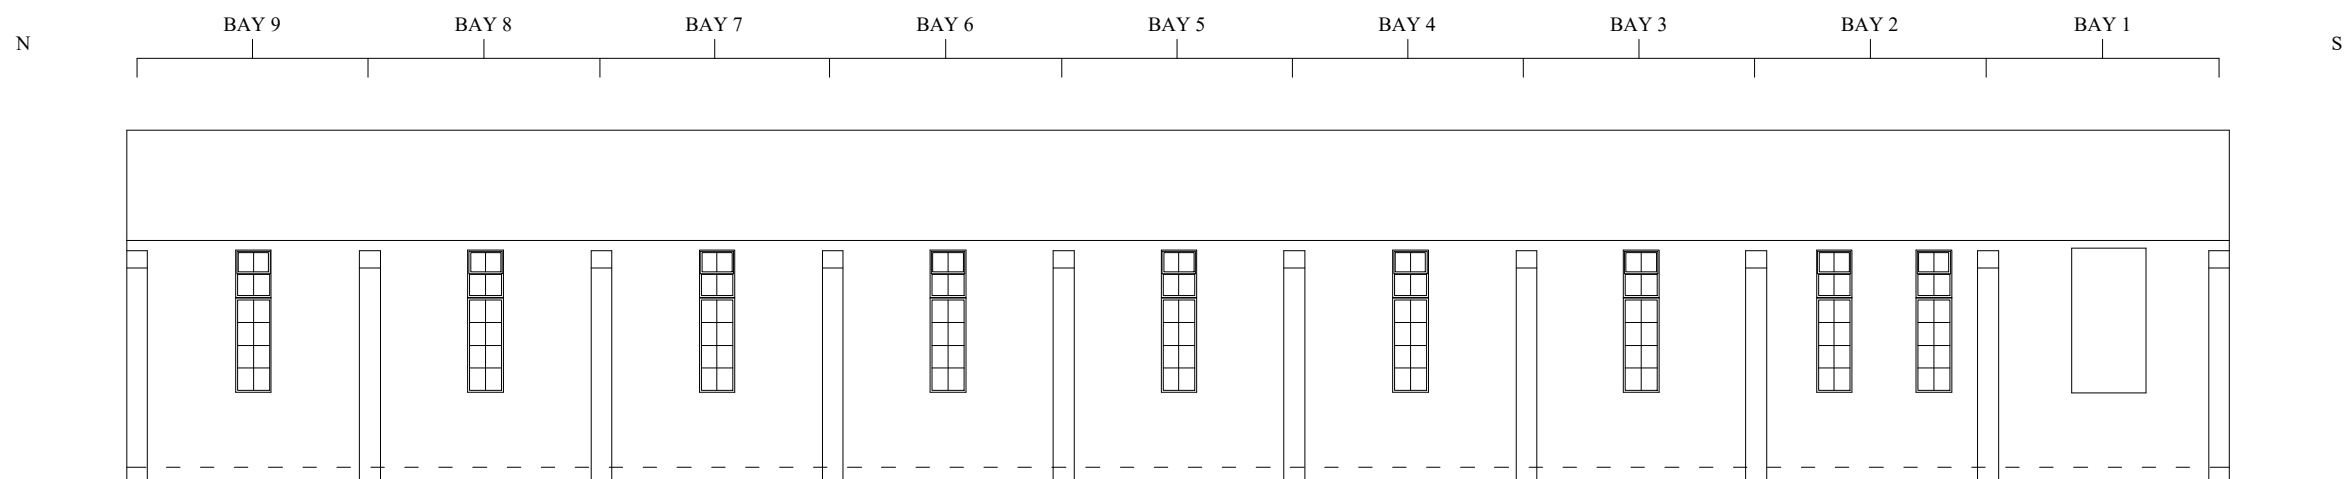
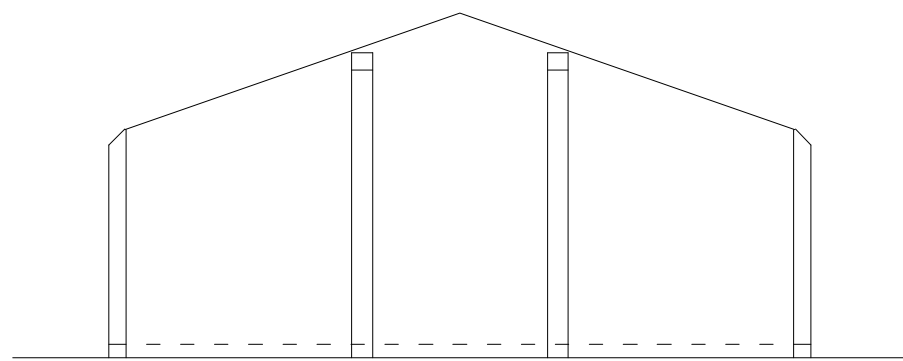
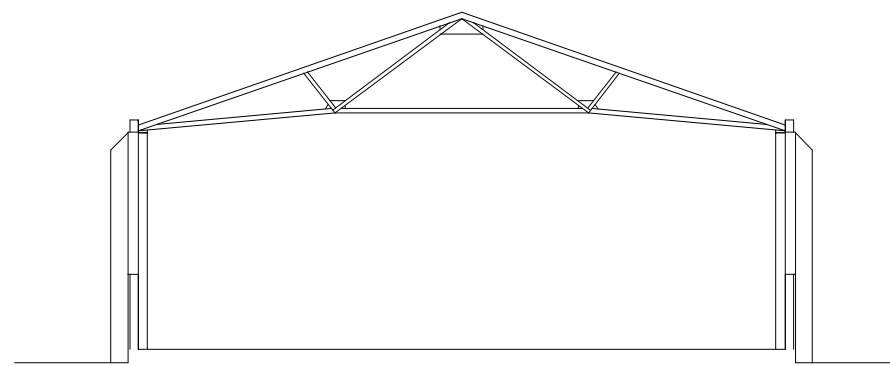
Figure 10  
 Existing Elevations & Section  
 1:100 at A3

- 4.3.1 The building survey was carried out on 23<sup>rd</sup> May 2017 to record the building prior to the commencement of works. A photographic survey comprising high resolution digital images was undertaken and a selection of these photographs have been included in this report as **Plates 1 to 25**. **Figures 2 and 9** show the location and direction of the plates.
- 4.3.2 The recording involved a full photographic record, accompanied by a drawn record and descriptive account. Measured drawings provided by the architect were used as base drawings for the building recording (**Figures 9 and 10**).

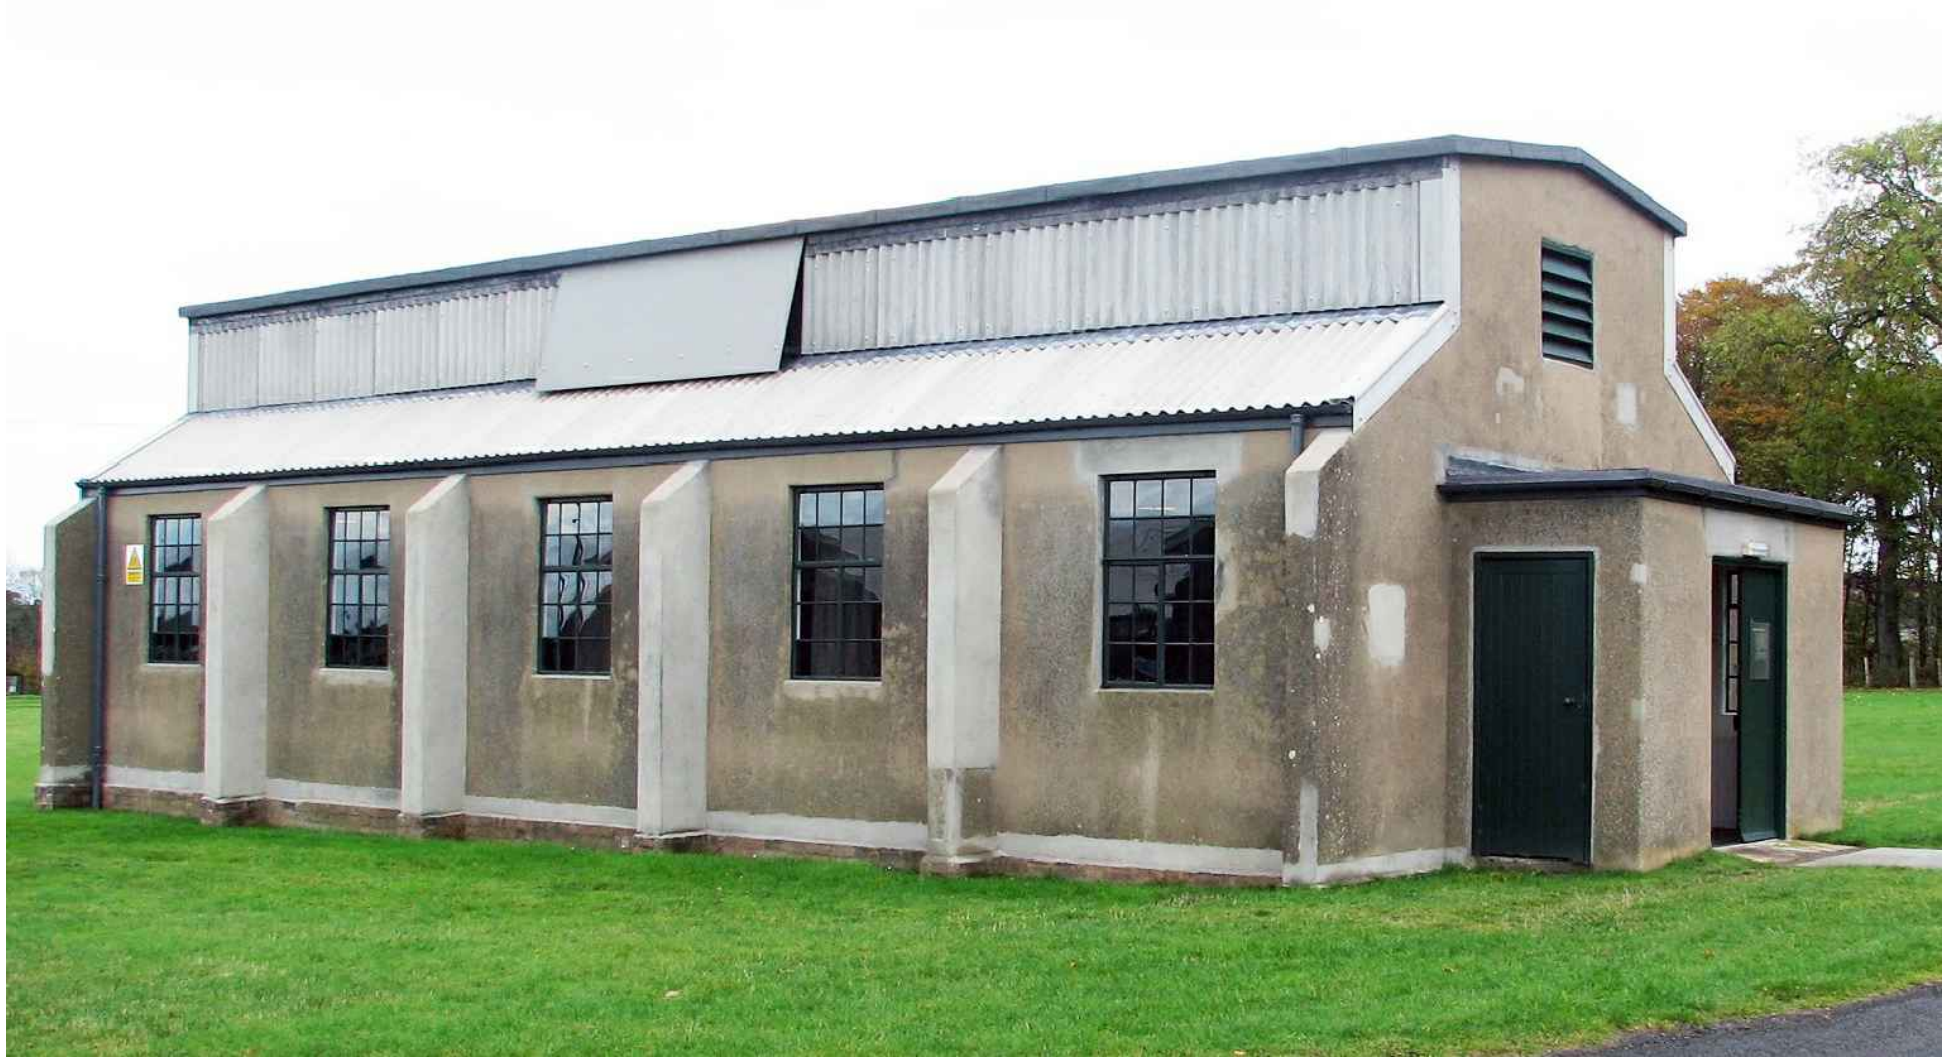
Figure 14  
Parachute Store  
at RAF Fortune

6.1.2 The RAF store presently forms part of a group of three buildings located on each side of a made farm trackway servicing Sulby Hall Farm, to the east. A modern brick and steel framed barn lies immediately north of the subject building and south of the farm track, while another WWII building, presently in use as a car repair workshop (D. D. Dorman & Son), lies to the north (**Figure 2; Plate 25**). This building, just visible on the aerial photograph of the airfield (**Figure 4**) and shown on the Airfield Plan (**Figure 5**) was built as a parachute store (building No. 14), its distinctive raised ridge, purpose built to provide the height to pack and hang the parachutes (see **Figure 14**).

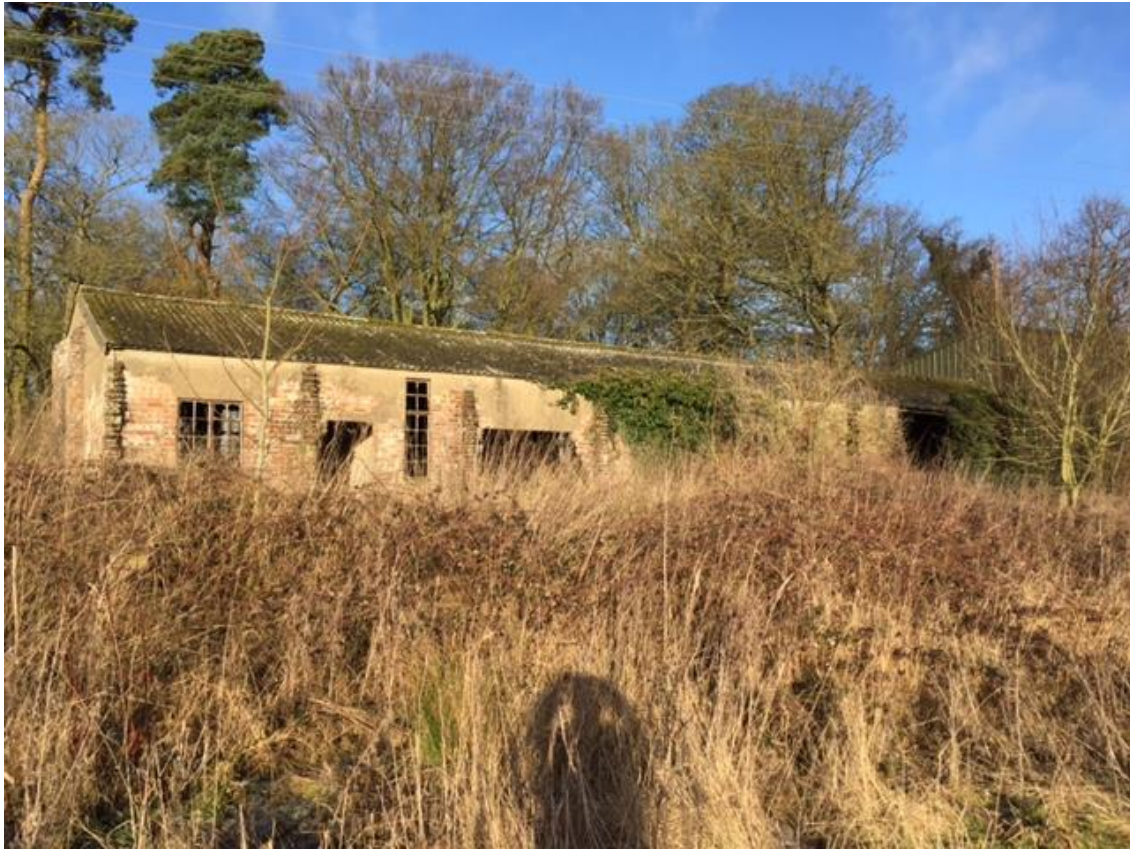
Plate A: Eastern elevation looking west (photograph provided by the Client)

6.2.1 Latterly used in an agricultural context, the building is orientated on a north to south axis, with its long elevations facing east and west and with gable elevations to the north and south (**Figure 2; Plates 1 to 6**). The building is very regular in form built with a rectangular floor plan (**Figure 9**) and over a single storey, off a concrete floor slab. The roofline is pitched at a slack angle (**Figure 10**) and although now unclad was previously covered with corrugated asbestos cement sheets (**Plate A**).

- 6.3.3 Whilst the building had lost its roof covering (**Plate A**) and internal ceilings (**Plate B**), the roof trusses and the softwood purlins remained. The trusses were simple triangulated trusses fabricated from mild steel extrusions, of flat or L-shaped section of 3 inch scantling, bolted together at the strut junctions (**Figure 10; Plate 21**). These connections were further strengthened by plate gussets or webs. The ends of the trusses were mounted directly onto the pilasters via a higher compressive concrete pad (**Plate 22**). The truss end was bolted through an L-shaped bracket to the concrete pad (**Plate 23**). The trusses were connected longitudinally by a series of softwood purlins, with three purlins to each roof pitch and a central ridge pole. The purlins were held in place by L-shaped cleats mounted on the top of the truss (**Plate 24**), while the ridge pole similarly pinched between two vertical brackets. The purlins were relatively lightweight at 4 x 2 inch scantling, some joined end on using simple splay scarfs. These are unlikely to be original and were probably added when the building was re-roofed using corrugated panels held by modern galvanised twist nails.

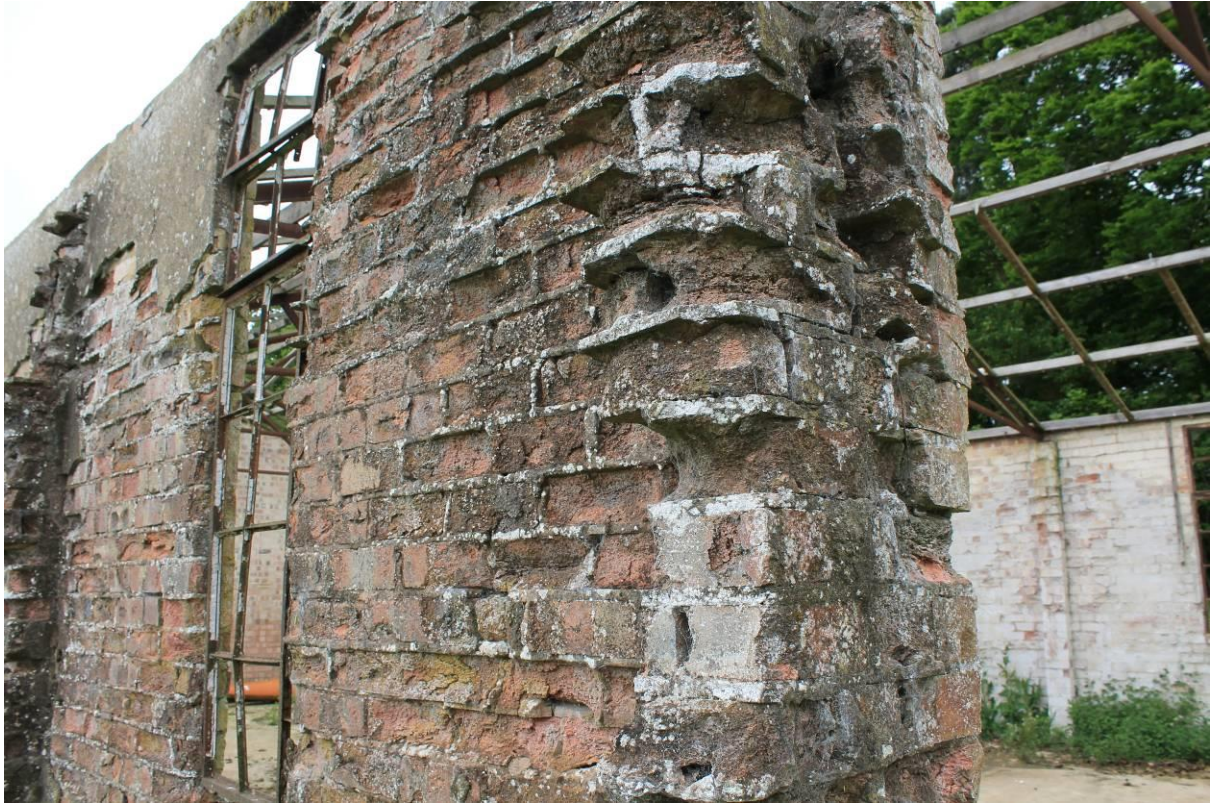
Plate 7 Detail of spalled brickwork

6.2.2 All elevations are brick built and were rendered externally using a hard cement render, which has mainly become detached. Exposed areas of brickwork reveal walls built using machine made Fletton bricks (220x70x110mm) laid in half lap stretcher bond and in a hard cementitious mortar. The walls are constructed to a pier and panel design, the piers, as pilasters project proud of the wall line (by half a brick) and are visible both externally and internally (**Figures 9 and 10**). Each pier (apart from those central to the gable elevations) support the outer ends of the axial roof trusses, which in turn determine the internal bay divisions (1-9; **Figure 9**). The brickwork of the wall panels (between the piers) is only a half brick in thickness and shows significant damage, from spalled brickwork (**Plates 7 and 8**), across all four external elevations. Additionally, possibly as a consequence of this deterioration, the walls in some areas were seen to be deforming, cracking or cranking over at the top.

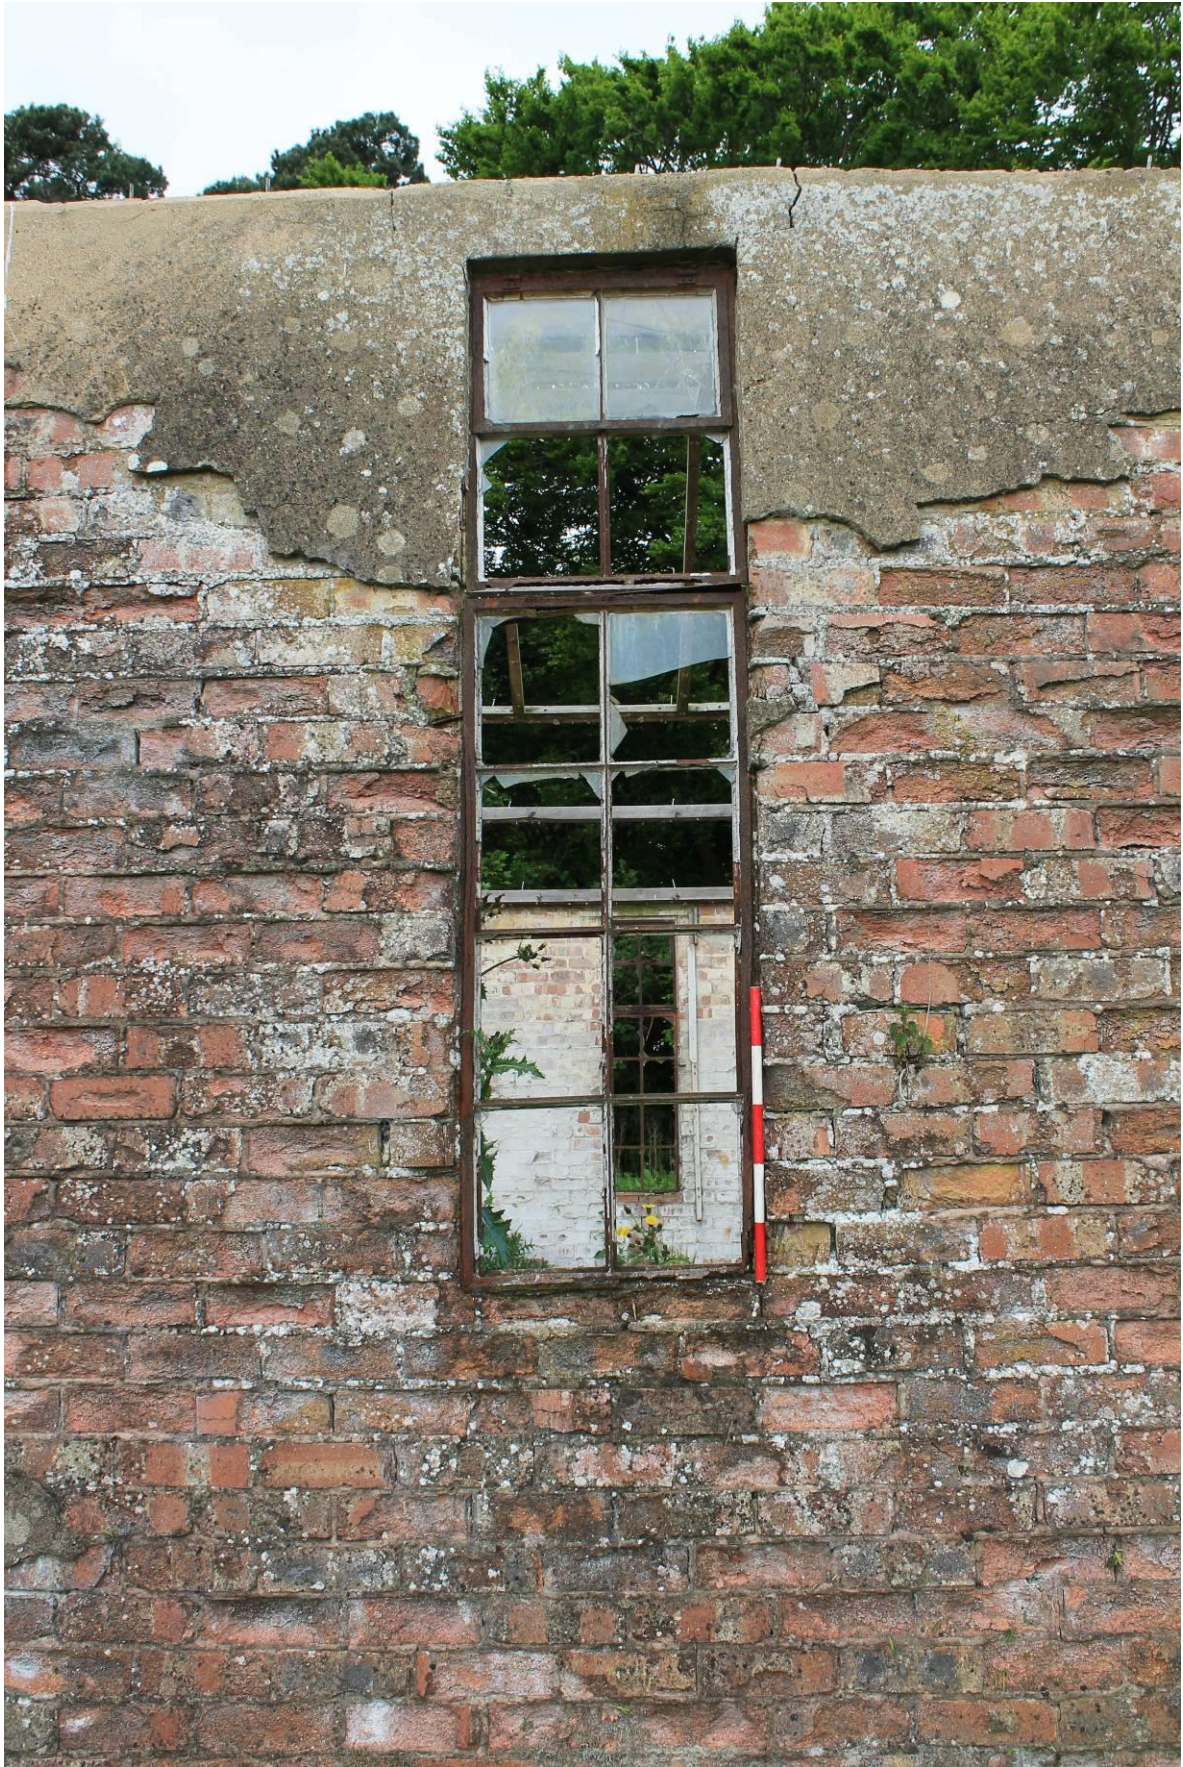
Plate 9 Typical tall window (external), looking west

6.2.3 The fenestration is relatively consistent in layout and form, mainly comprising tall narrow openings (measuring 73 x 20 inches) with mild steel framed single glazed windows, lying central to each bay and set high in the wall, with their heads, formed by plain concrete lintels, just below the eaves lines (**Figure 10; Plate 9**). A departure from the uniformity in fenestration is present in the southernmost bay (1), east side, which includes a wider squatter window of the same metal-framed design (**Figure 10; Plate 11**) and two of the tall narrow windows, paired together within bay (2) but set on each side of an internal partition wall (**Figures 9 and 10**). All of the casement windows are glazed using small panes (11 x 9 inch), with taller windows using a lower fixed casement of 2x4 lights and an upper casement of 2x2 lights incorporating a top hung ventilator of two lights. The larger window to bay (1) was simply a double width window comprising two of the 4x2 light casements and upper glazing of four lights, the northern two, a top hung ventilator. The glazing bars are T shaped in section and puttied from the exterior. The mild steel frames were tied into the walls by the use of integral metal tongues (**Plate 12**), set into the mortar joints of the surrounding brickwork and then torched into the opening. Window furniture was restricted to the upper ventilators, which used simple metal window stays (**Plate 10**). The openings to all the windows and the original door openings all used concrete lintels. Those above the windows were built flush with the top of the wall and a number were inscribed with number 25 (**Plate 13**), which are probably a batch number and not a building number, as this store was building No. 15. Both the window openings and all the extant metal framed windows are original to the building. This is not the case for the three door openings on the east

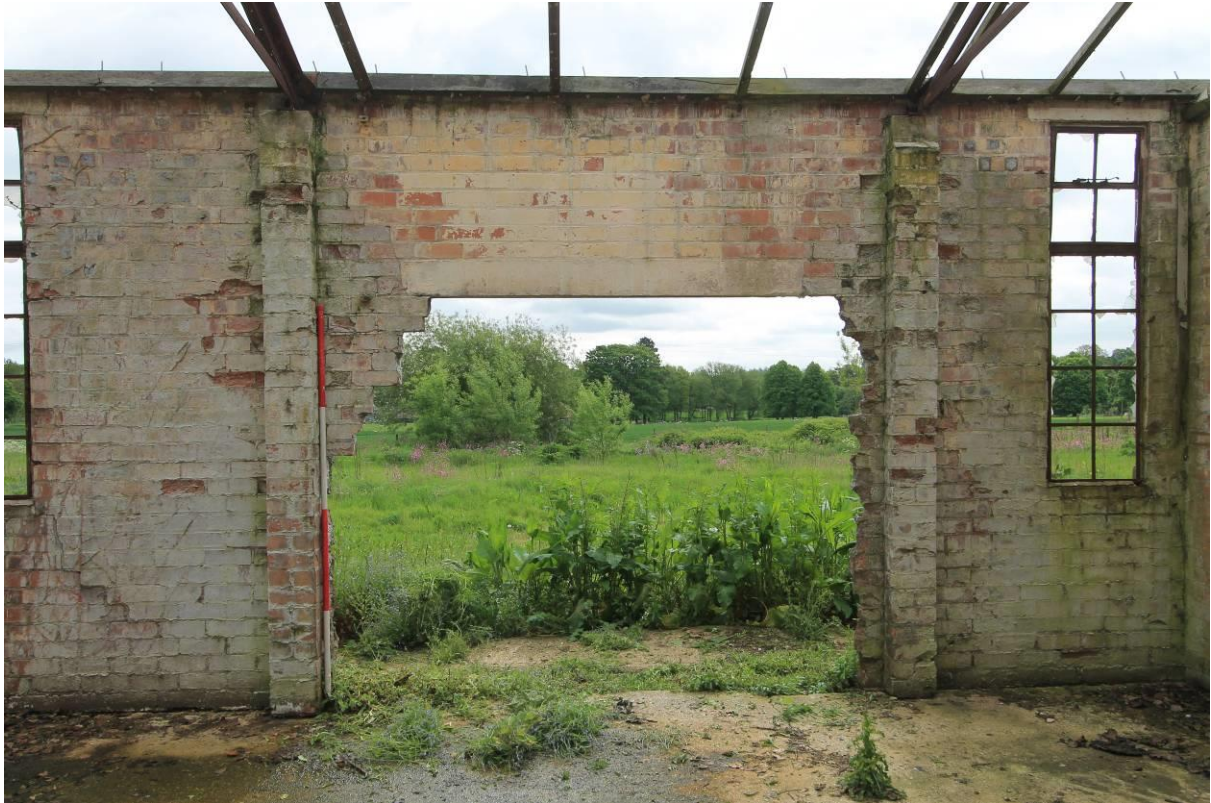
Plate 14 Original opening (part collapsed) to bay 3

side. The southern two openings to bay (2) and bay (3) were both built with the same style of plain concrete lintel used for the windows and were accordingly viewed as original (**Figures 9 and 10; Plate 14**). However the large bay wide opening to bay (7) did not incorporate a lintel, was open to the eaves (**Figures 9 and 10; Plate 15**) and appears to be an enlargement of two former door openings (see **Figure 6**), probably associated with its subsequent farming use.

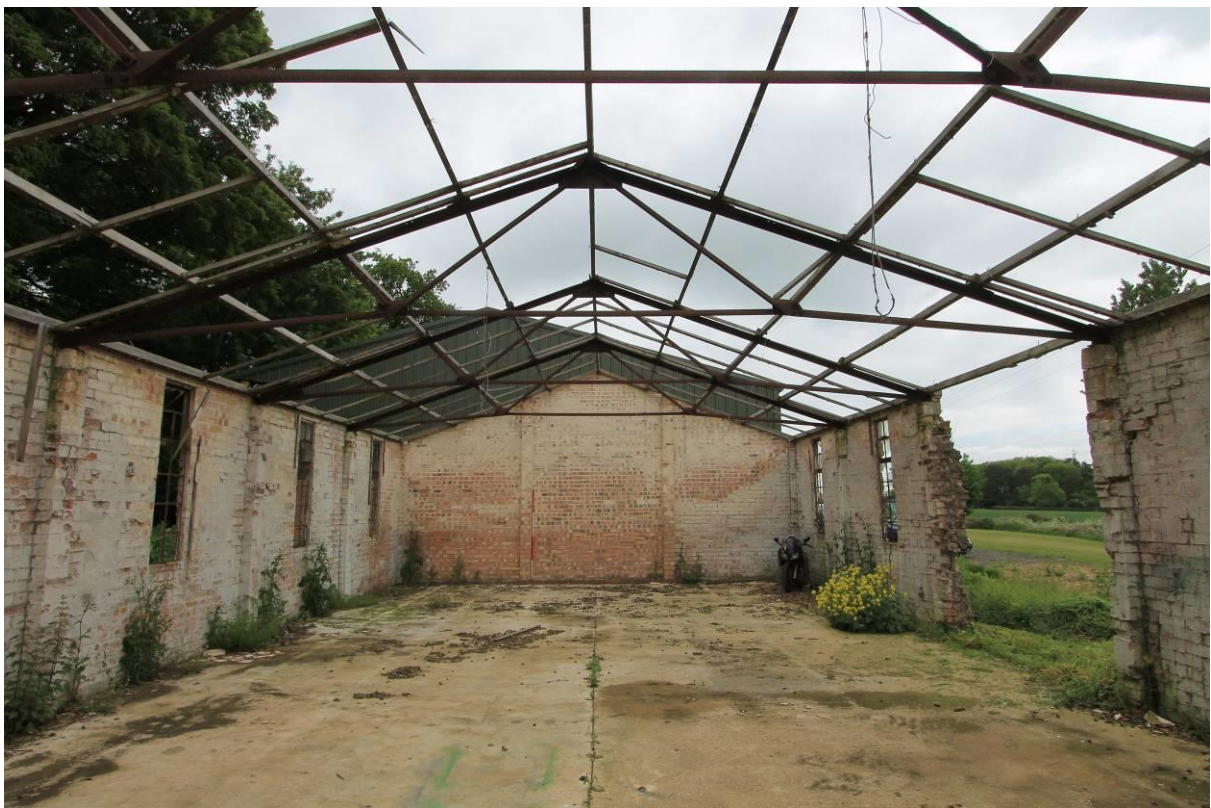
Plate 15 Interior (bays 3-9) looking north

- 6.3.2 The floor slab was formed in two halves, the join central to and running the full length of the building (**Plates 15 and 16**). An open exploratory geotechnical test pit to inspection the foundations revealed that the slab was 5 inches thick (**Plate 20**).

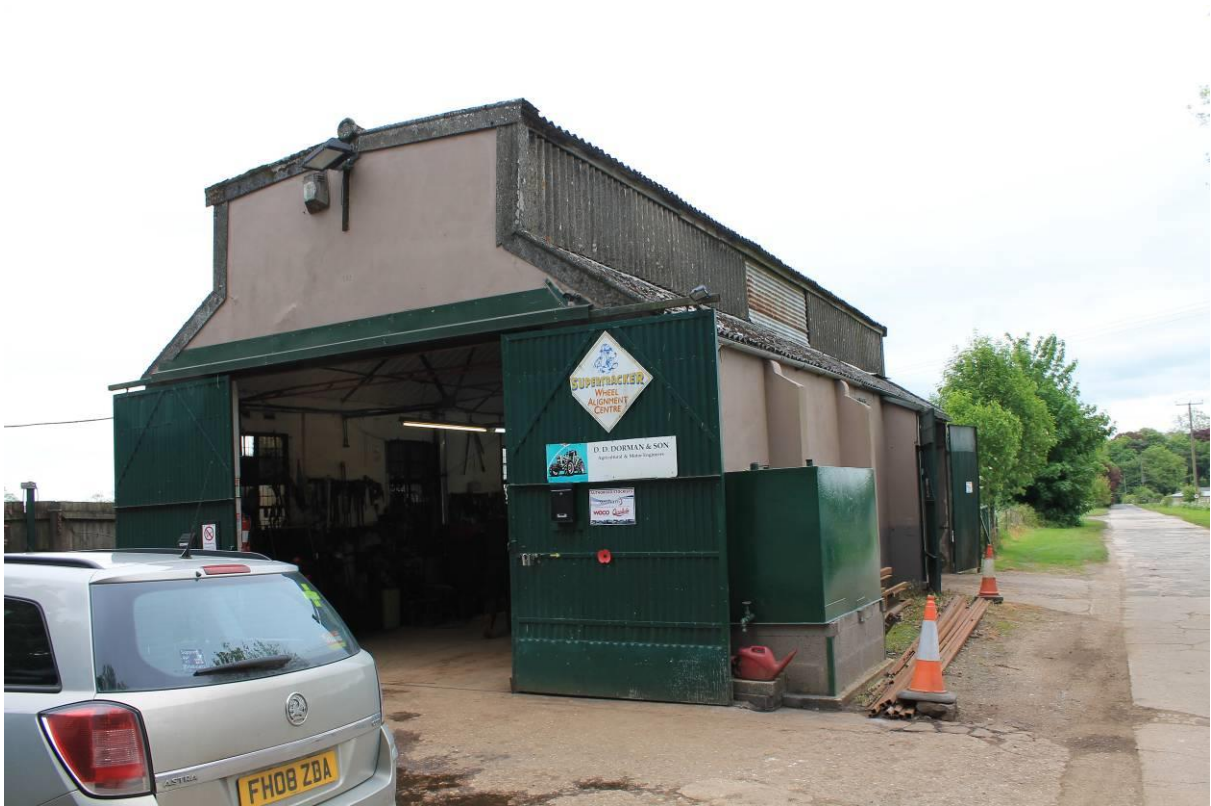
Plate 25 Former parachute shed (now car repair workshop) looking east

the north of the recorded building; **Figure 2**), Parachute Store (14), which still survives (**Figure 2; Plate 25**), Main Workshops (16), RAF Technical Latrines (23), Bulk Oil Installation (31), Station Maintenance Blocks (57-58), Rubber Store (74) and Towed Target Store and Workshop (402).

- 7.5 Clearly it was never the intention that these buildings should continue long after hostilities ceased and this is reflected in the construction of the store, built using the minimum of materials, with insubstantial brick walls off a concrete slab. The temporary brick huts were commonly built with 4.5 inch (half brick) walls laid in stretcher bond, strengthened at 10ft (c.3m) intervals by brick piers carrying the roof trusses and were particularly widespread (Brown et al, 1996). Examples of this simple temporary hut design were widely used in airbases across the country and for a disparate range of uses. A very similar hut, also used as clothing and respirator store, is still extant at RAF East Fortune, east of Edinburgh (**Figure 13**) or in use as part of the main stores at Llandwrog Gwynedd, built 1941. To illustrate the uniformity and extent of standardisation within Air Ministry building stock, the parachute store at RAF East Fortune (**Figure 14**) is almost identical with building (14) at Sulby (**Plate 25**).
