**ST. JAMES'S PALACE
FORECOURT: PUBLIC REALM
IMPROVEMENT SCHEME**

**ST JAMES'S PALACE, CITY OF
WESTMINSTER SW1A 1BG**

**A SUMMARY OF AN
ARCHAEOLOGICAL WATCHING
BRIEF**

PCA REPORT NO: R12956

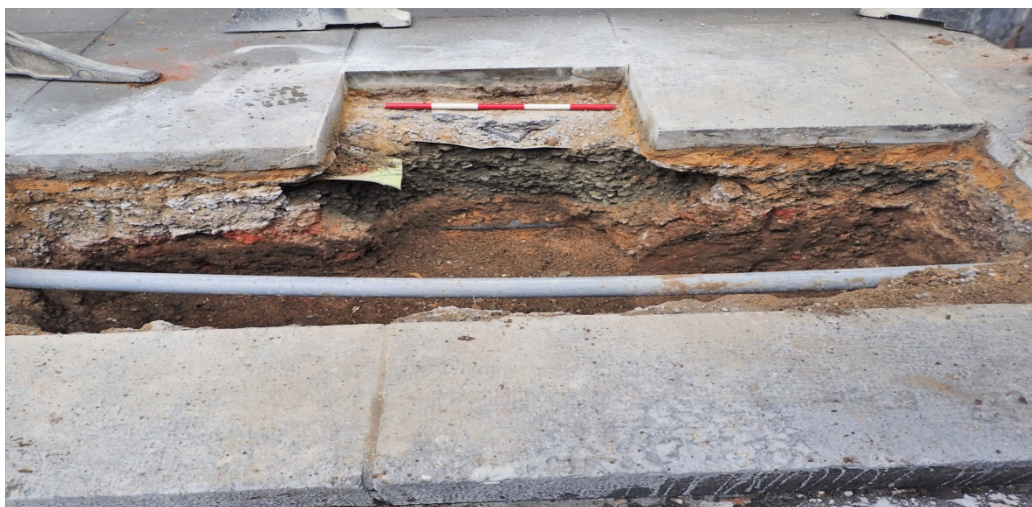
Plate 1: Trial Hole TH01 on St James's Street, view to the south-west with road kerb in the foreground. The grey plastic ducting and a black service cable can be seen. Underneath the modern concrete a layer of fragmentary brick [1] had been laid on compacted made ground [2]. Scale 0.5m

- 2.1.2 A breaker was used to break out both the tarmac surface and 0.22m thickness of concrete beneath it. The first layer encountered was a 'surface' of fragmentary, un-mortared bricks laid flat [1] which were a mid-red/terracotta colour (Plate 1).

- 2.1.3 The brick layer [1] had been laid on a layer of made ground consisting of compacted, mid brown silty-clay [2]. The layer contained fragmentary occasional tile, charcoal flecks and degraded mortar inclusions. A fragment of post medieval unglazed peg tile and an abraded sandy red brick recovered from this layer are very common and fall within a broad date range of AD 1480 – 1900 (Appendix 2). A fragment of clay pipe stem and a single sherd of refined whiteware saucer were also recovered, the former dating 'broadly' to the 17th century and the latter mid-to-late 19th century (Jarrett 2017, Appendix 3). The varying date ranges of the material suggests re-worked, re-deposited made ground.

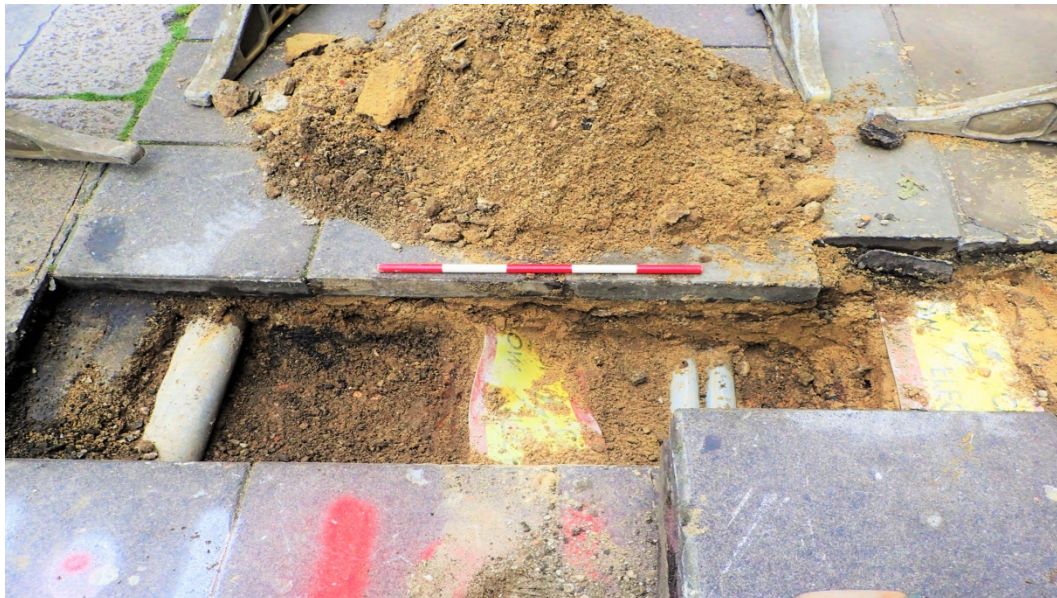
Plate 2: TH1:B1 view to north-west with roadside kerb to the left of the photograph. Multiple services were revealed directly below the paving slabs. Layer [9] was service trench backfill. Scale 0.5m.

cables and pipes had been back-filled by a brownish, mid-grey clayey-silt containing fragmentary ceramic building material (CBM), flecks of charcoal and degraded mortar [9] (Plate 2, Figure 4, Section B2).

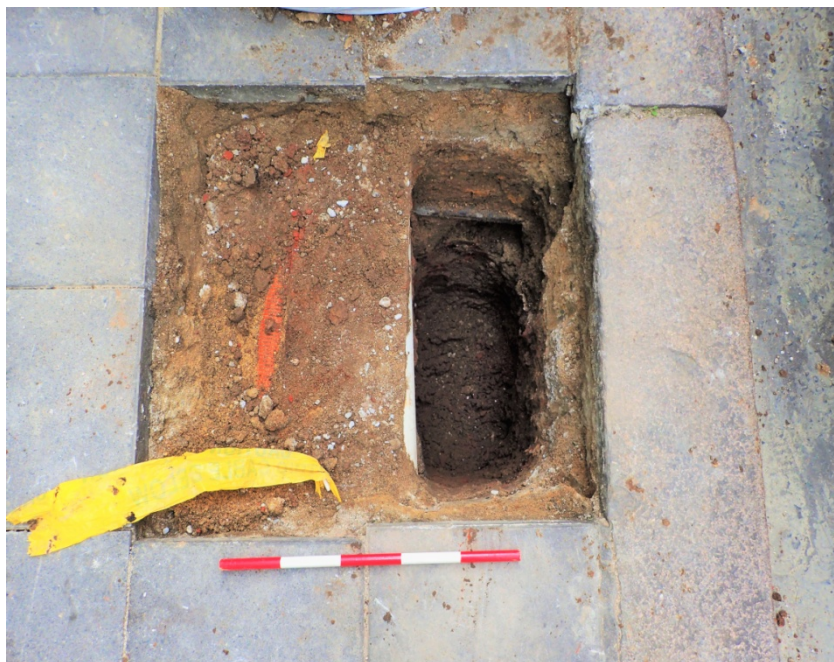
Plate 3: TH02 view to the south-east, roadside kerb on the right of the photograph. Services prevented the hole being excavated to its full size so a sondage was created on the western edge. Scale 0.5m.

2.3.1 TH02 was located on the east side of St James's Street c.83m north of the Palace's north gate. It was 0.82m long by 0.80m wide and a sondage was created between services which was 1.20m deep (Plate 3).

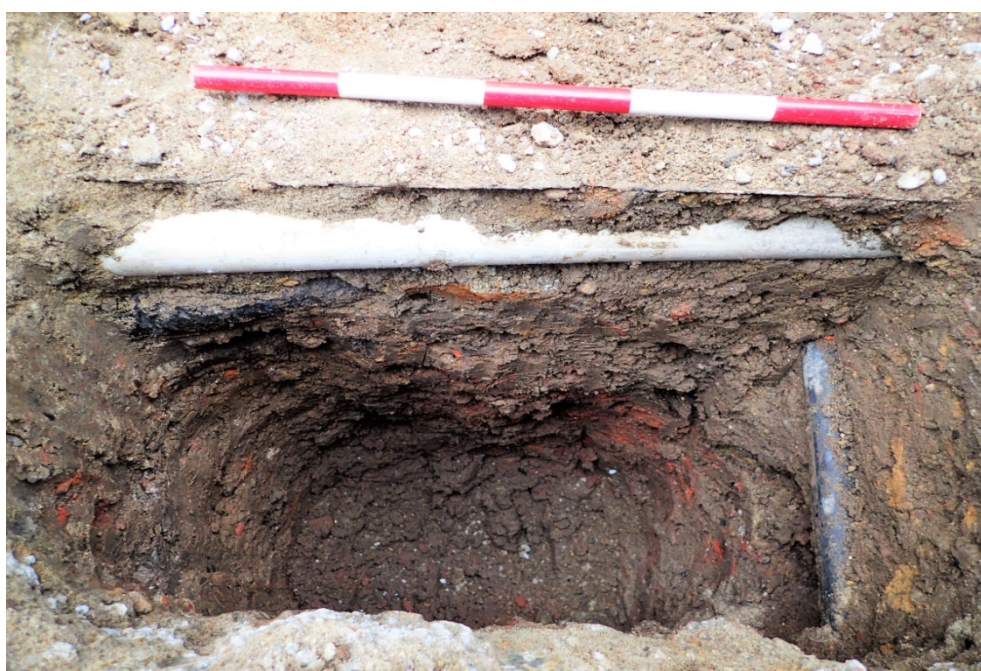
Plate 4: TH02 sondage, Section 2, view to north-east, Section 2B. Made ground below the service runs, fragmentary brick towards the base. Scale 0.5m.

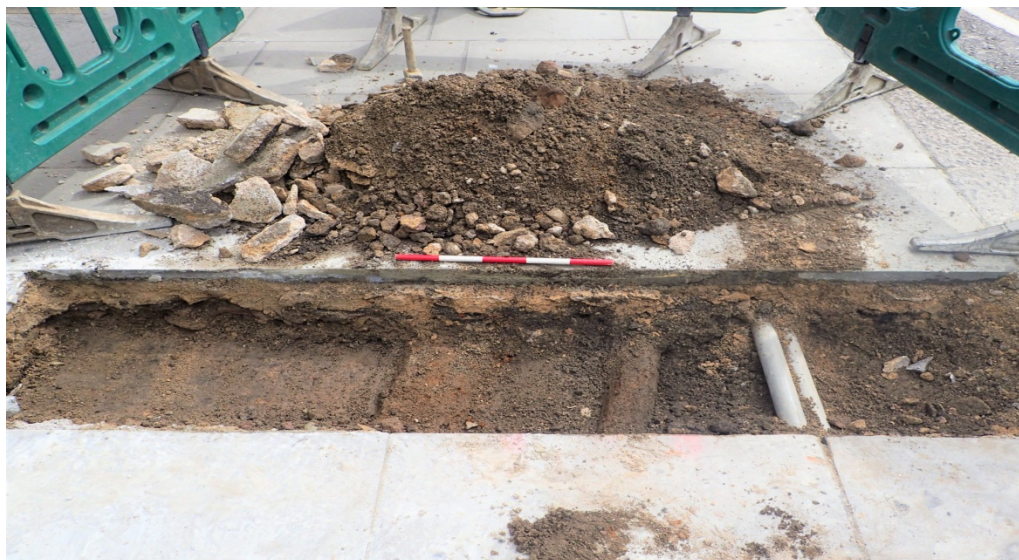
Plate 5: TH2:B2 view to the north-east, roadside kerb on the right of picture. A series of services prevented further excavation. Scale 0.5m

- 2.4.1 TH2:B2 was located on the south-east corner of St James's Street and Pall Mall, c.41m north of the Palace's north gate. It was oriented north-west to south-east, was 2.38m long by 0.42m wide and was 0.28m deep (Plate 5).

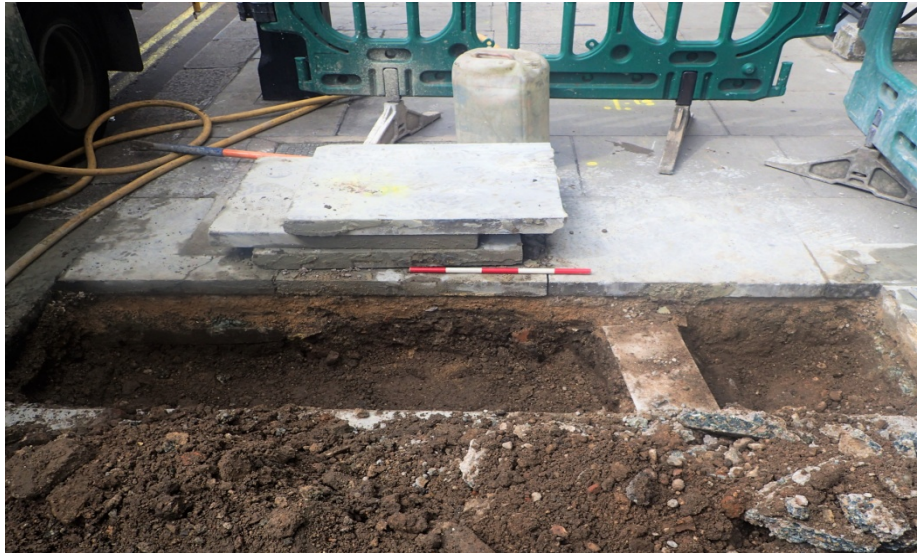
Plate 6: TH3:B3 view to the south-west, roadside kerb on the left of the photograph. The slab can be seen to the left of the photo directly below the bedding layer. To the right a steel plate protects live services. Scale 0.50m

2.5.1 TH3:B3 was located on the north side of Pall Mall close to the entrance to Crown Passage c.65m north-east of the Palace's north gate. It was 2.30m long by 0.62m wide and was 0.37m deep, oriented north-west to south-east (Plate 6).

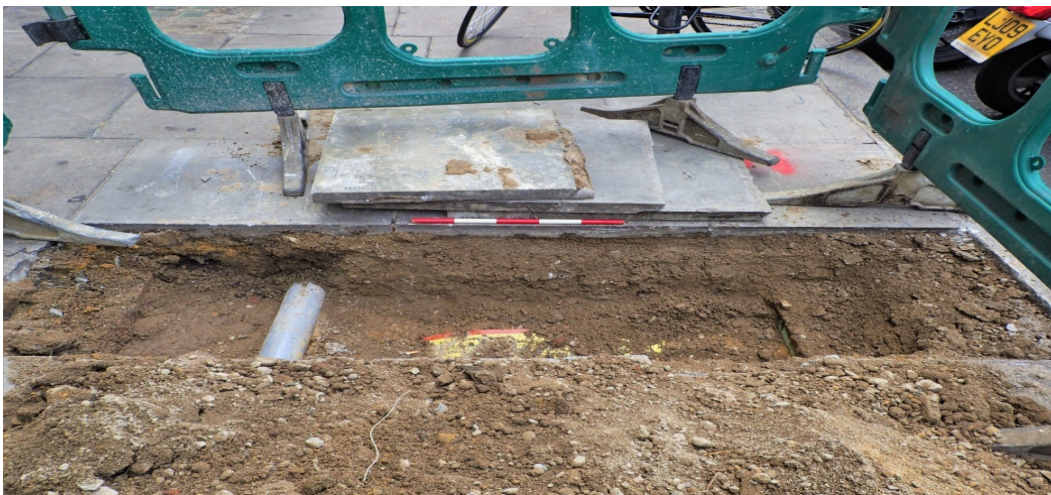
Plate 7: TH4:B4 view to the south-east, roadside kerb on the right of the picture. Services and made ground [4].
Scale 0.5m.

2.6.1 TH4:B4 was located on the south side of Pall Mall c.70m north-east of the Palace's north Gate. It was 1.80m long by 0.64m wide by 0.38m deep, and oriented north-east to south-west (Plate 7).

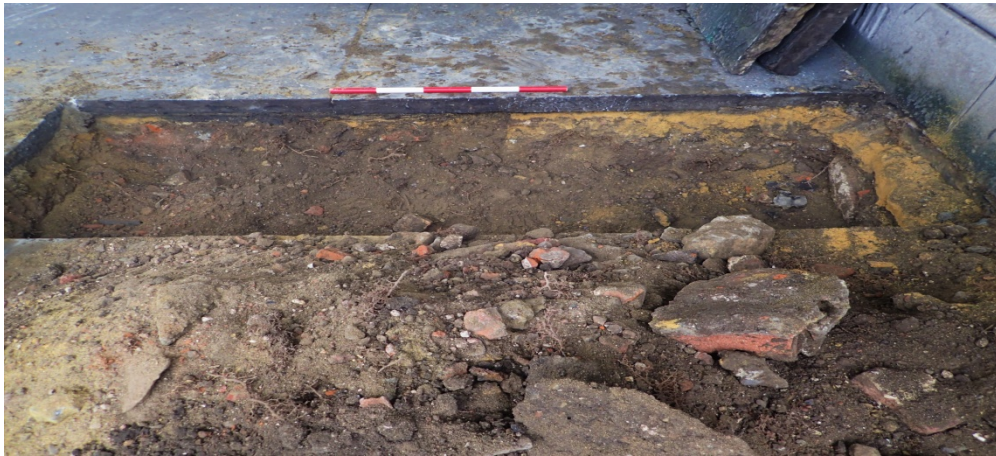
Plate 8: TH5:B5 view to the north-east, the road is to the left and building to the right. A cut can be seen to the left through the yellow bedding sand which is the result of a recent service trench excavated to install a new power supply from Marlborough Road and recorded as a watching brief by PCA in 2015. Made ground [12] is to the right. Scale 0.5m.

2.7.1 TH5:B5 was located on the east side of the northern end of Marlborough Road adjacent to an access road to the buildings to the east, c.57m north-east of the Palace's north gate. It was oriented north-west to south-east and measured 3.56m long by 0.66m wide, by 0.27m deep (Plate 8).

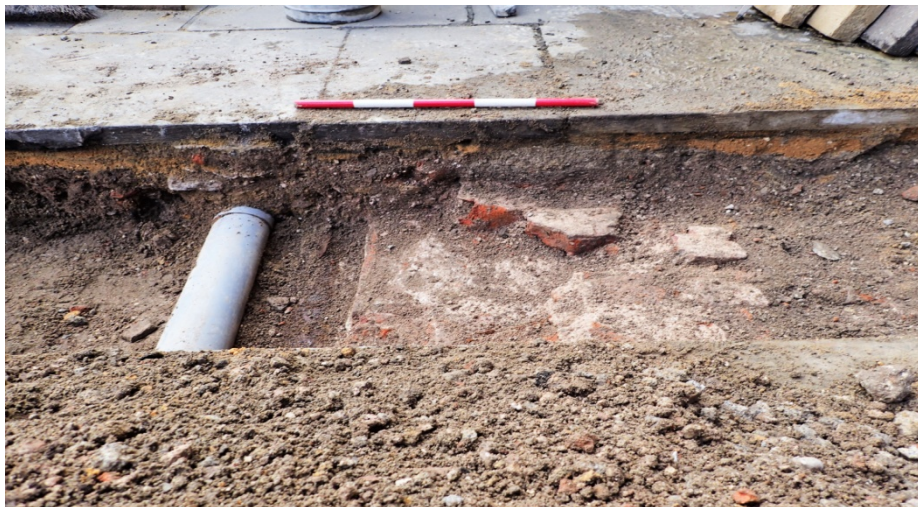
Plate 9: TH6:B6 view to north-east, the road is to the left and the north wall of the Palace to the right. The trench was oriented north-west to south-east and was 2.6m long by 0.64m wide and 0.57m deep. A layer of ash [5] can be seen on the right overlying the brickwork. Scale 0.5m

2.8.1 TH6:B6 was located directly adjacent to the north wall of St James's Palace. It was oriented north-west to south-east, and was 2.6m long by 0.64m wide by 0.57m deep (Figure 3; Plate 9).

2.8.2 The current surface of paving slabs and bedding sand was 90mm thick. Underneath these layers a modern service trench could be seen cutting a layer of made ground [7] which was a compacted, mid-grey clayey silt containing fragmentary CBM and degraded mortar inclusions at the north-west end of the trench. Closest to the building in the south of the trench two layers were found beneath the paving slabs and bedding sand. Layer [5] was composed of soft, whiteish light grey cinders and ash, 90mm thick from an upper height of 7.82m OD, which overlay a layer of compacted, mid grey clayey-silt which contained fragments of CBM and degraded mortar inclusions [6], 0.14m thick from an upper height of 7.74m OD. In turn, these layers sealed a band of brickwork [8], 0.56m wide which ran parallel to the north wall of the palace (Figure 3; Figure 4: Section 6B). A brick sample was taken whose form suggested that it was an early post medieval red brick form bonded in a white-hard lime

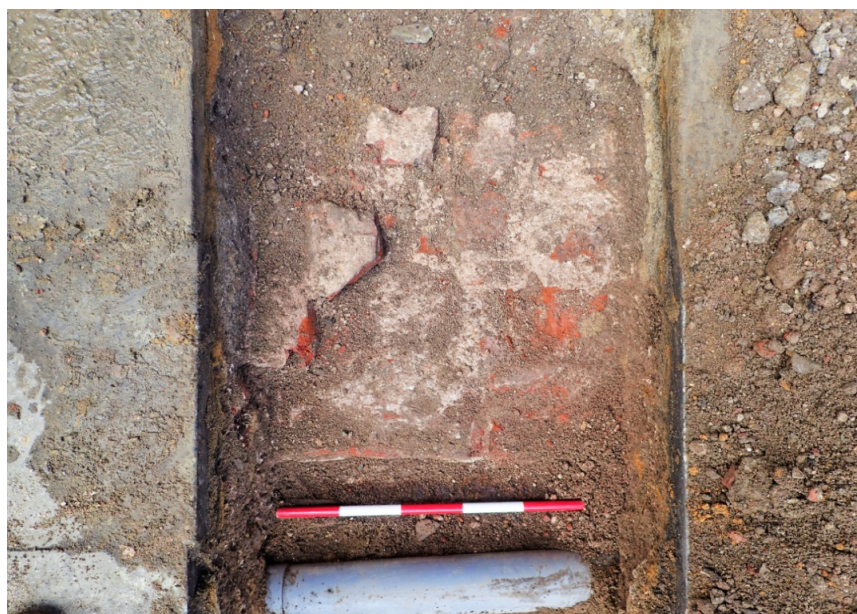
Plate 10: TH6:B6 in plan, view to south-east. The brickwork [8] may represent stepped footings parallel to the building or the roof or superstructure of a basement or cellar.

- 3.6 In TH6:B6 a short section of a brick-built structure was recorded parallel to, and 0.78m out from, the outer north wall of the Palace (Figure 3, Plan TH6:B6, Section 6B). It was 0.64m long by 0.56m wide but was only exposed to a depth of 0.57m BGL. The bricks were a mid-red or terracotta colour and bonded with a mid-pink mortar with shell inclusions. A spot date suggested they were fabricated between 1500-1800, dating them to the post-medieval period (Valcarcel 2017, Appendix 2) and raising the possibility they are original 'Tudor' brick. The nature of the structure is uncertain; it may be the stepped footing for the north wall of the Palace projecting to the north; it may be the roof or superstructure of a basement or cellar (although it would be outside the load-bearing walls) or it may be a brick-built conduit. A vaulted conduit was recorded north of Marlborough Gate (several meters north of TH5:B5) during a watching brief by PCA in 2015, although the form seems to be somewhat different (Turner 2015: 12).

- 3.7 In this instance it is most likely that the brick structure [8] is a stepped footing projecting out from the building although it is unknown if subsidiary, later brick structures were built along its exterior or, if indeed, the wall had at some time been underpinned or strengthened by the addition of bricks (re-used and recycled) or otherwise. Not enough of the structure was revealed to be certain of its purpose. However, taking the view that the bricks were part of the original structure of the palace, the exposed remains may be seen as original *in situ* bricks which were part of the pre-fire Palace. Accepting this interpretation, the thin layer of ash above [5] could also be construed as being the
