**ARCHAEOLOGICAL MONITORING AND RECORDING  
ON ROTHBURY BRIDGE, ROTHBURY,  
DISTRICT OF ALNWICK, NORTHUMBERLAND**

**Central National Grid Reference: NU 0588 0159**

**Site Code: RBN 07**

**© Pre-Construct Archaeology Limited  
August 2007**

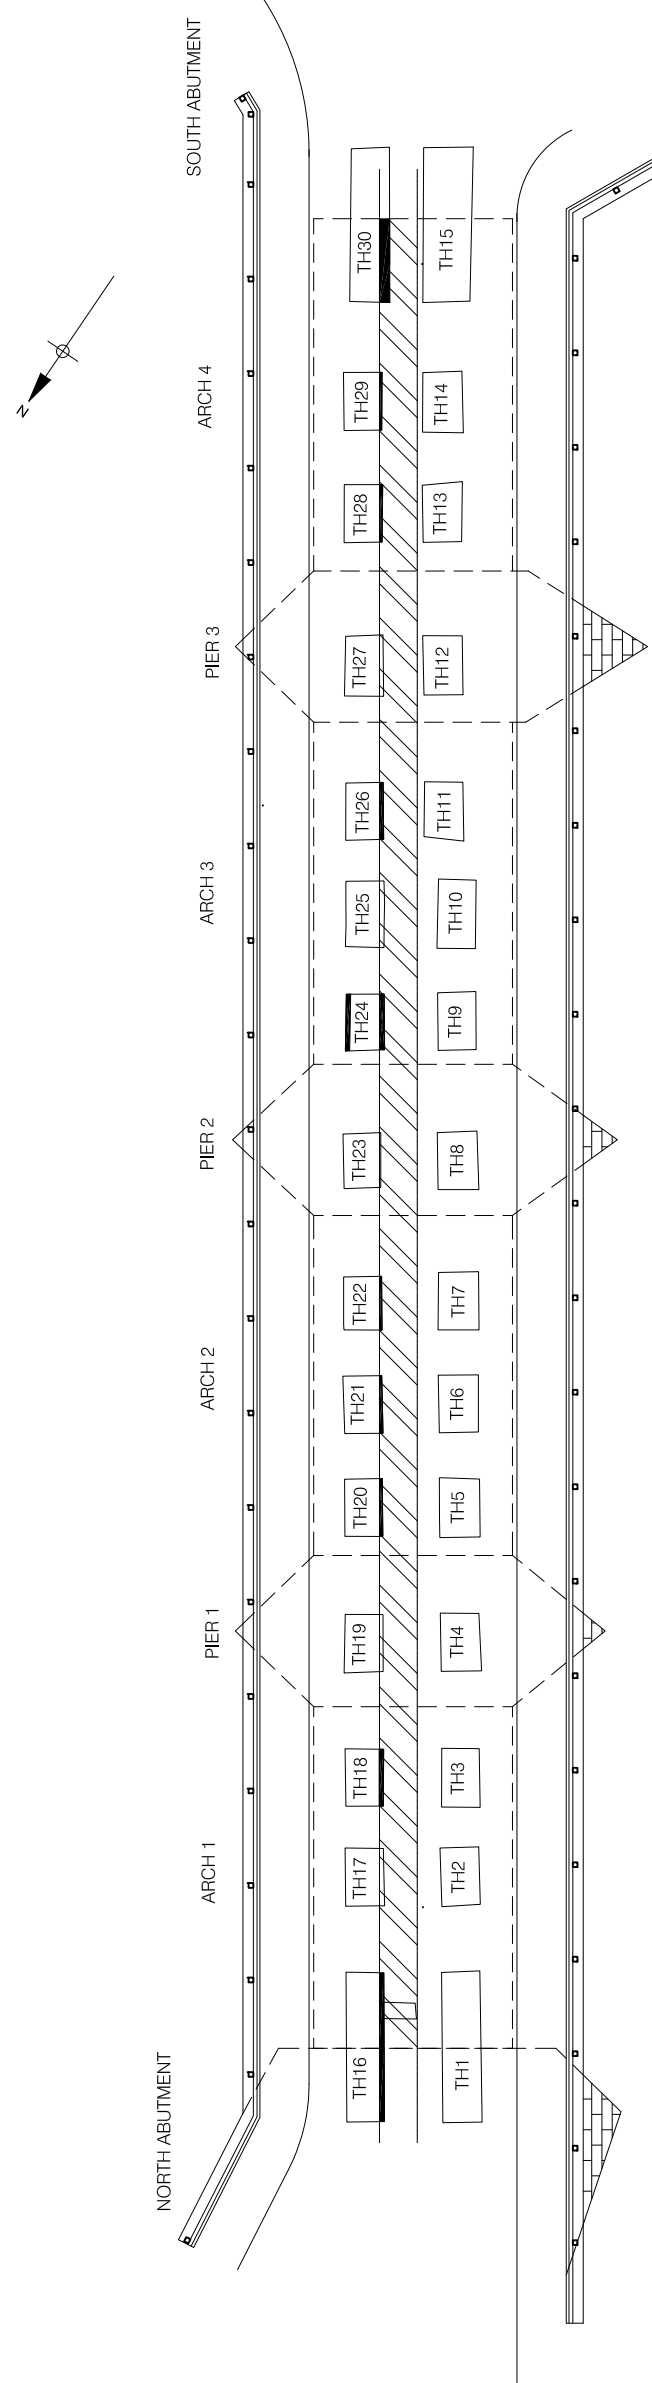
Figure 3. Plan and elevation of bridge showing Trial Hole locations  
Scale 1:200

PLAN ON BRIDGE

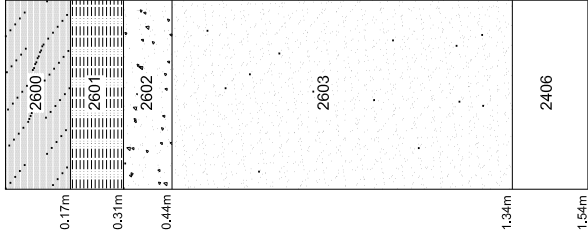
### Trial Hole 26

Modern road surface:  
Hard mid - dark grey tar and aggregate. Thickness: 0.17m

Modern road make-up:  
Strongly cemented mid - dark grey tar and aggregate. Thickness: 0.14m

Loosely compacted light pinkish grey coarse sand and aggregate. Thickness: 0.13m

Loose brownish yellow sand. Thickness: 0.90m

Structure. Arch, Span 3

- 4.1.8 In TH 26, located between the crown of Arch 3 and Pier 3, the original spandrel wall, [2605], was exposed along the full 1.50m length of the west side of the trial hole, to a height of c. 1.05m. Four courses of squared, generally regular, sandstone were exposed, mortared in similar fashion to that described above in TH 16. In the north-western corner of TH 26, three voussoirs of the original arch were exposed below the spandrel wall, along with a small portion (maximum height c. 0.15m) of the arch opening (infilled with later material) below the intrados.

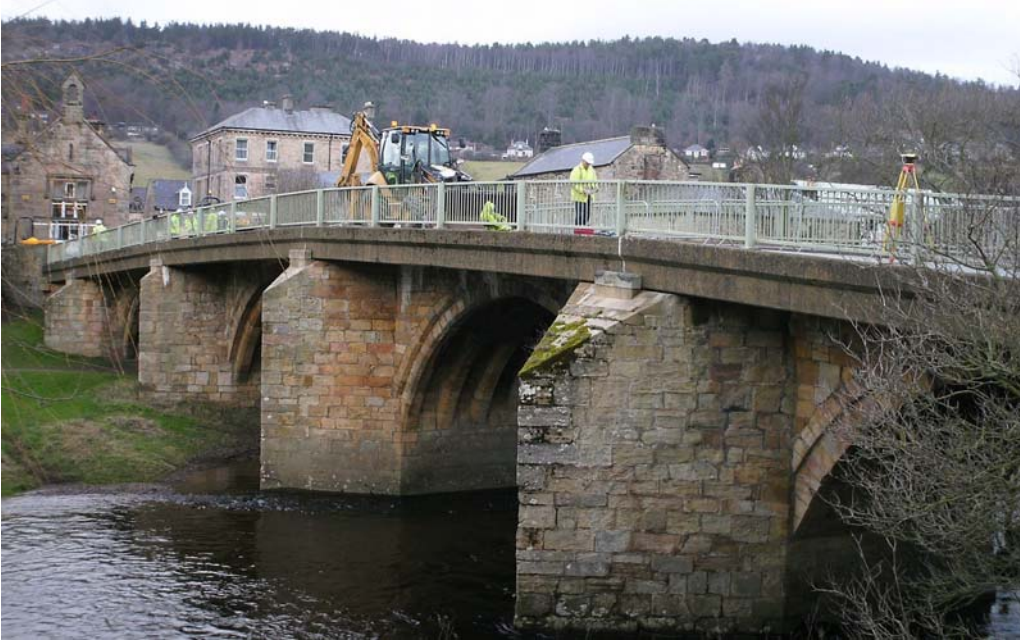
Plate 1. Rothbury Bridge, west side, from the south.

- 2.4.7 Rothbury Bridge was first mentioned in documentary records of the early 17th century, although the earliest elements of its structure are known to be of medieval date.<sup>4</sup> It has four segmental, almost semi-circular arches, the southernmost of which is reported to have been rebuilt in the 16th or 17th century. A feature of the three northern arches are the chamfered soffit ribs (Plates 1 and 2), while the rebuilt southernmost arch has plain soffits. The piers have pointed cutwaters, those on the west side with canted tops (Plates 1 and 2).

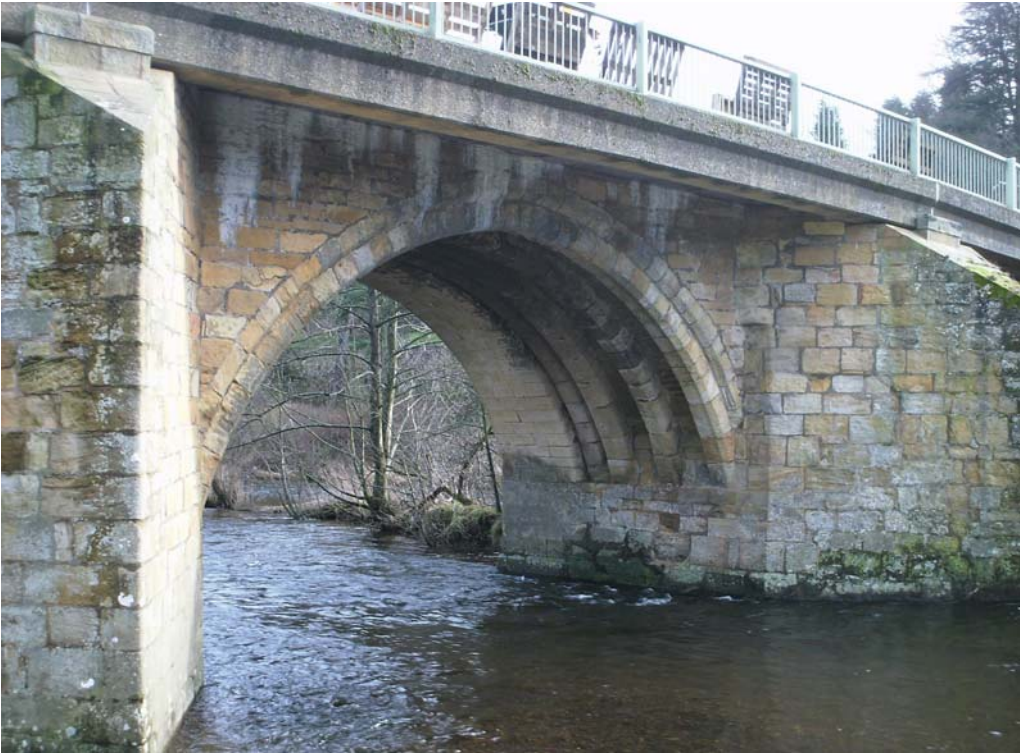
Plate 2. Arch 3 detail, from the west.

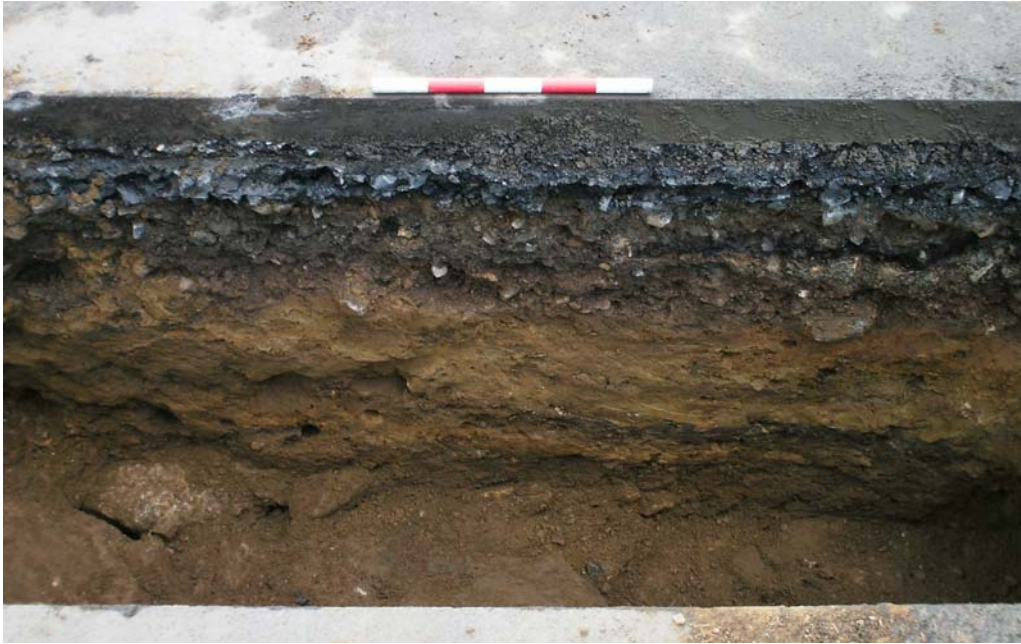
Plate 3. TH 1, Phases 2 and 5 deposits in section, from the east (*0.5m scale*).

- 4.2.2 In the three upstream trial holes located on Arch 1, namely THs 1, 2 and 3, each of the earliest sand deposits, [104], [204], [304], respectively, overlay the Phase 1 rubble 'backing' of the arch barrel. The maximum thickness of any of these layers was 0.26m and they were extended to depths, below the road surface, between c. 0.50m (TH 2), on the crown of the arch, and c. 1.0m (TH 1) (Plate 3). At each location, mixing between the sand layer and the rubble backing is perhaps indicative of this material being deposited broadly contemporaneously, possibly at the time of construction of the bridge. The three deposits described above were overlain by similar, distinctively lensed sand deposits, [103] (Plate 3), [203], [303], respectively. The maximum thickness of any of these upper sand deposits was c. 0.45m.

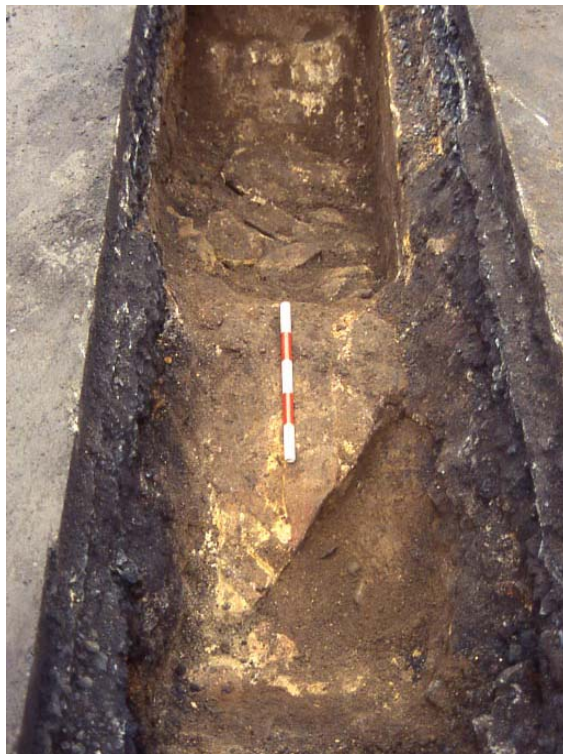
Plate 4. TH 16, wall [1606], from the north (*0.5m scale*).

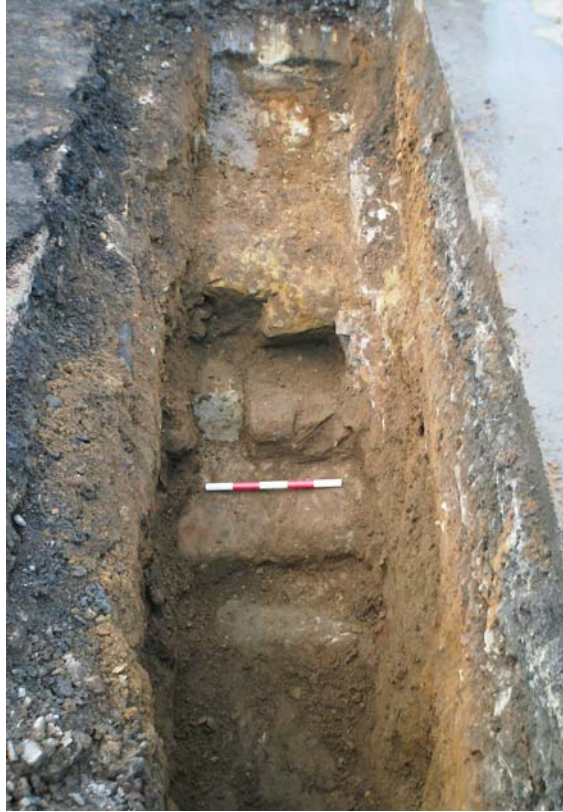
Plate 5. TH 15, masonry [1506], from the south  
(0.5m scale).

- 4.3.3 In TH 15, located on the south side of Arch 4, towards the south abutment, the basal exposure was masonry, [1506], comprising squared sandstone (up to 460mm x 360mm x 120mm), bonded with light greyish white sandy mortar and deliberately stepped above the curve of the arch (Plate 5). The form of this masonry, at a maximum depth of c. 1.45m at the south end of the trial hole and c. 0.95m deep at the north end, probably reflects its proximity to the south abutment.

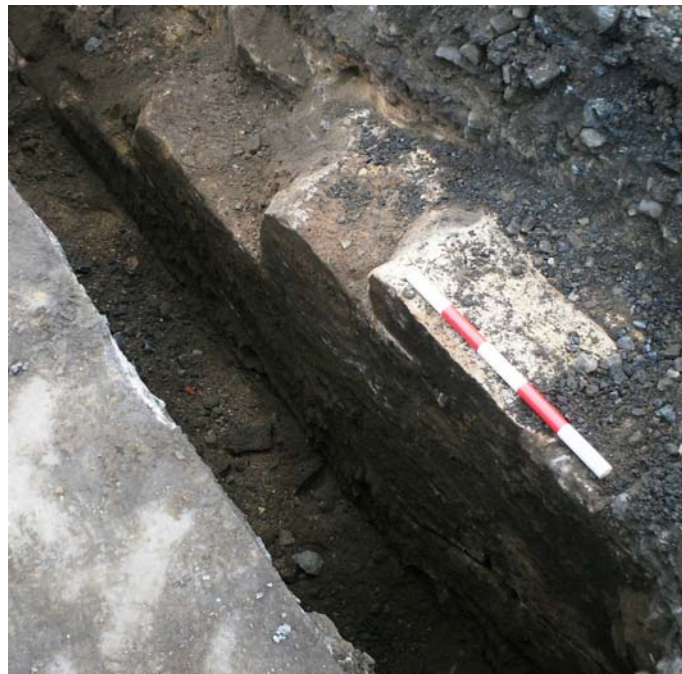
Plate 6. TH 30, wall [3005], from the north (0.5m scale).

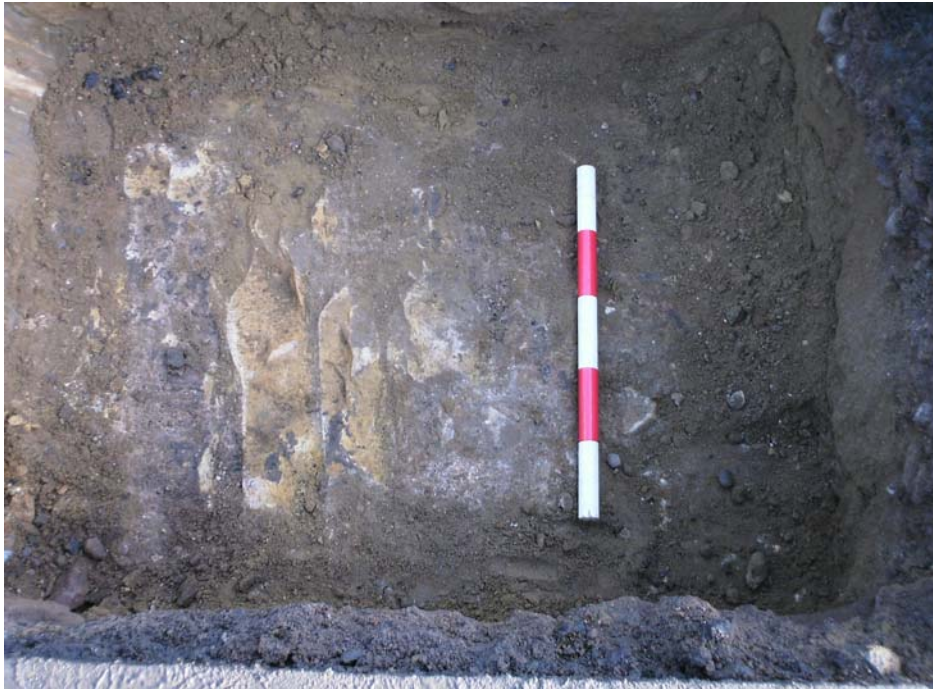
Plate 7. TH 6, masonry [605], from the west (0.5m scale).

- 4.1.4 In TH 6, upstream on the crown of Arch 2, mortared masonry, [605], representing the extrados of the arch barrel was exposed, at a depth of c. 0.75m below the road surface (Plate 7). As exposed, it comprised an evidently deliberately arranged series of squared sandstone (the largest block measuring 640mm x 140mm in plan), aligned east-west, and bonded with lime mortar.

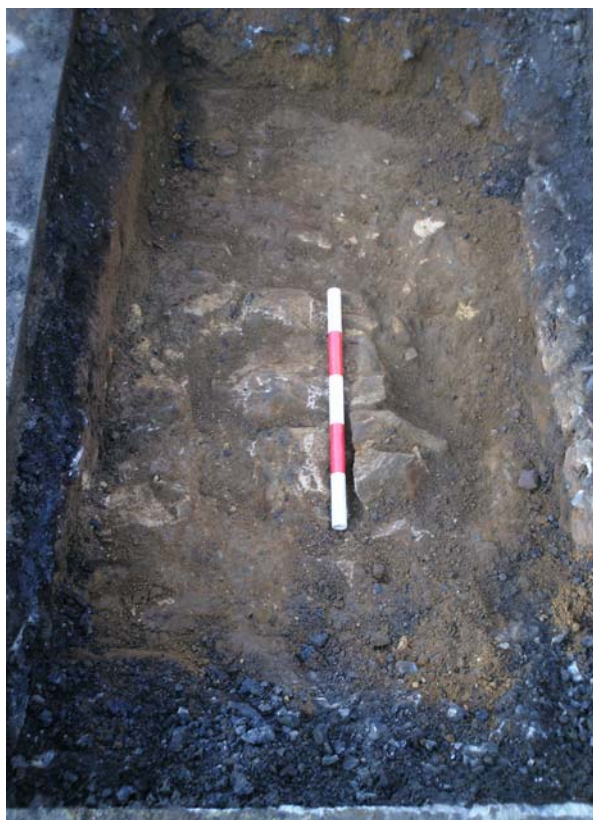
Plate 8. TH 14, masonry [1404], from the south (0.5m scale).

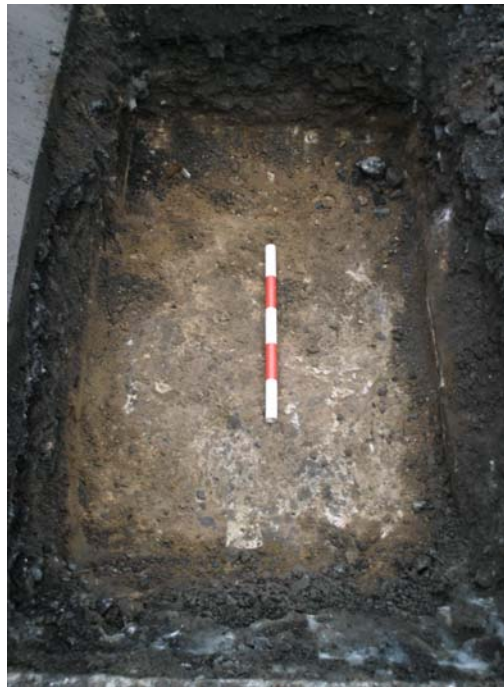
Plate 9. TH 17, masonry [1704], from the south  
(0.5m scale).

- 4.4.2 Further parts of the same arch barrel were exposed in THs 17 and 18, masonry [1704] (Plate 9) and [1804], respectively, where similar masonry was recorded, at depths of c. 0.60m and c. 1.10m, below the road surface, respectively. Overlying the masonry of the arch barrel and abutting the former spandrel wall in TH 16 was a deposit, [1605], comprising loose sandstone rubble; this interpreted as a deliberate backing dump for the arch. The rubble had a matrix of mid greyish brown sand, with frequent small fragments of lime mortar throughout.

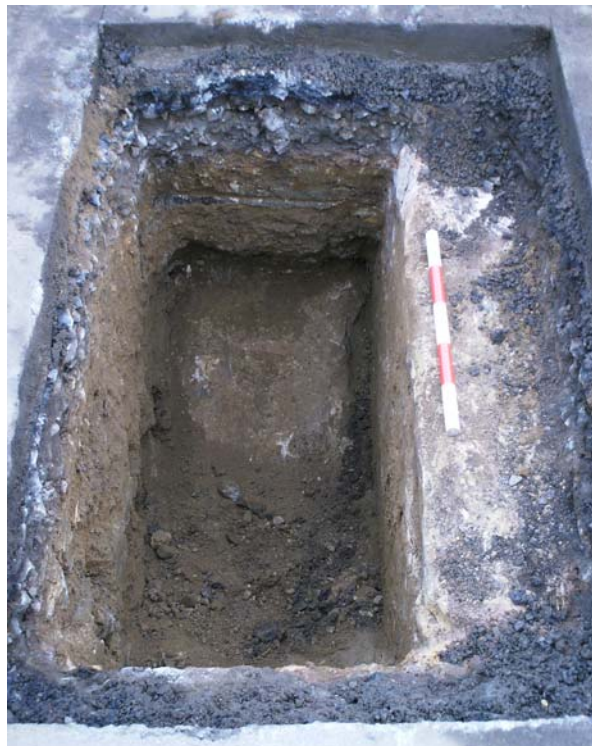
Plate 10. TH 28, wall [2805], from the north  
(0.5m scale).
