**POND FARM, 23 THE GREEN,
ELTISLEY, CAMBRIDGESHIRE:**

**ARCHAEOLOGICAL MONITORING
AND RECORDING**

PCA REPORT NO: 12997

SITE CODE: ECB5092

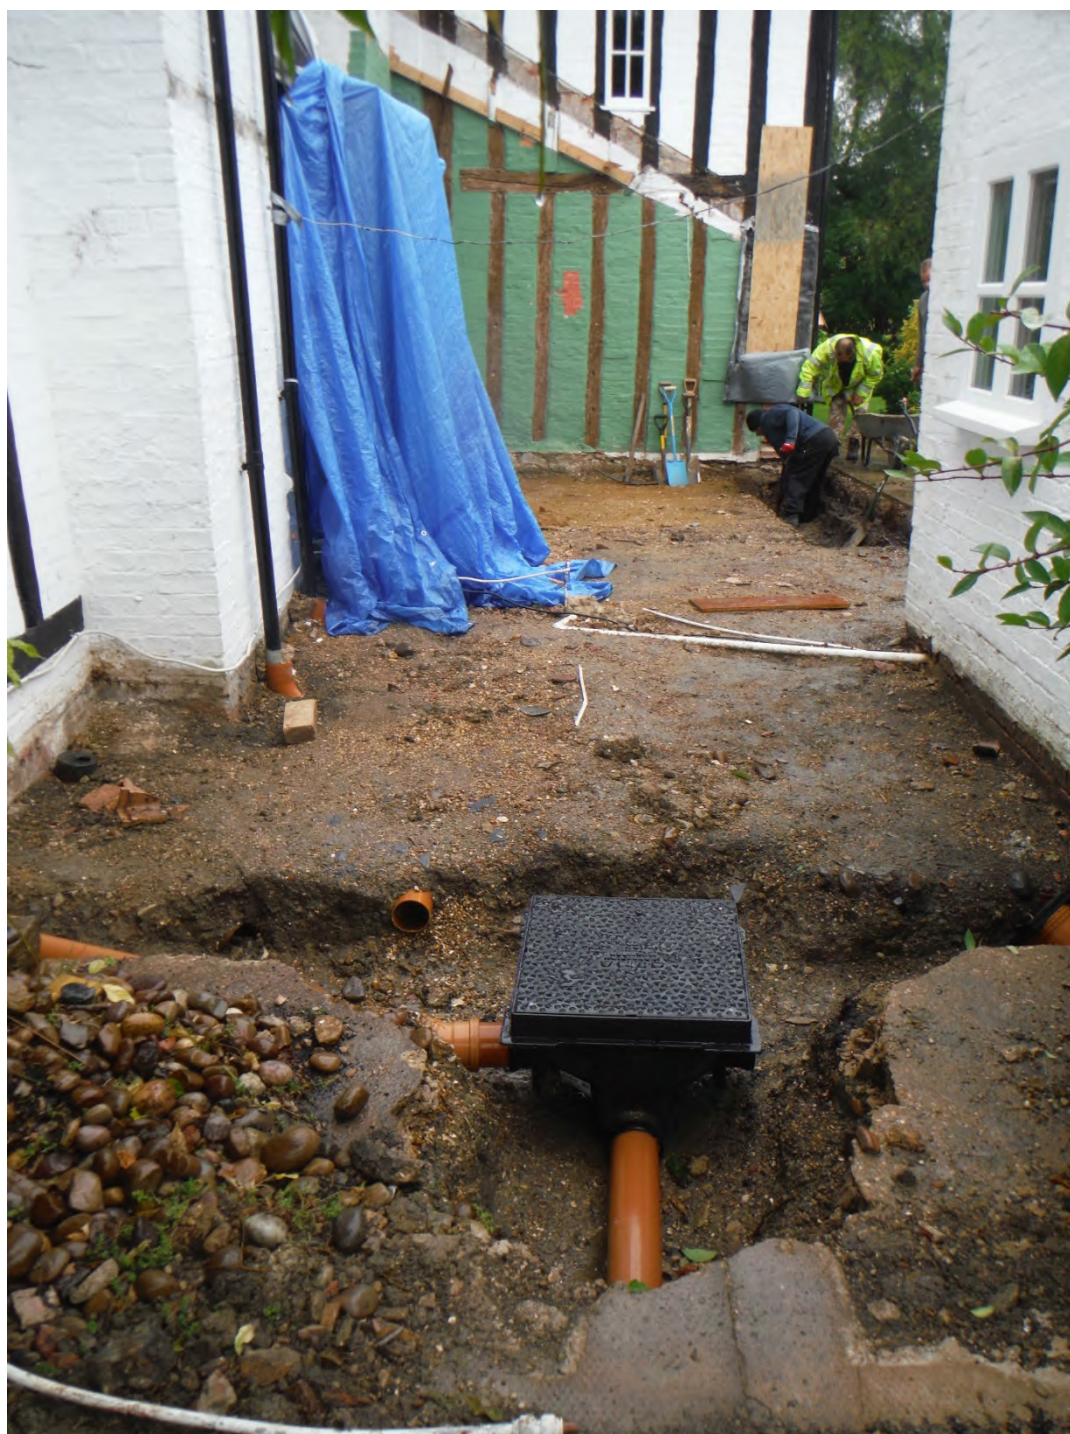
Plate 1: Overview of site, view north

2.1.3 The footprint of the proposed extension measures 8.8m long (north to south) by 4.3m wide (Plate 1), with an overall area of 38m², which includes the footprint of the current 20th-century study and boiler cupboard, which are to be demolished as part of the development.

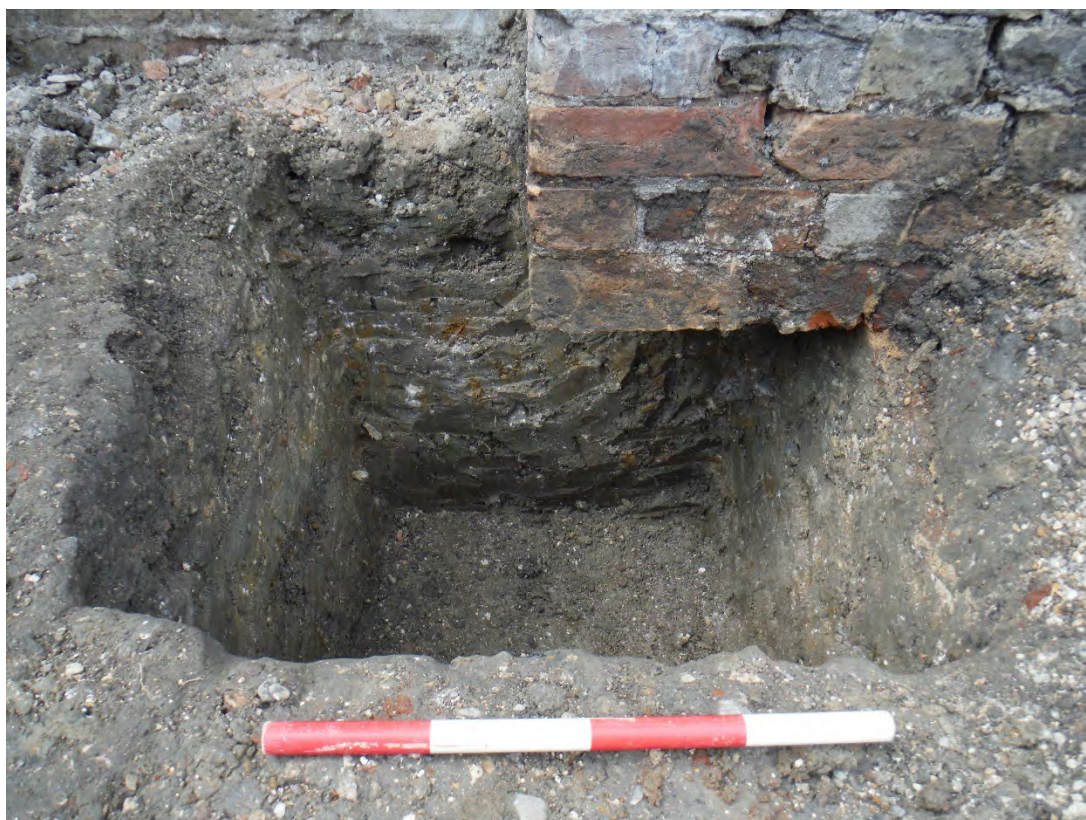
Plate 7: Footing 3, view west

FOOTING 3	Fig. 3	Plate 7
Alignment: n/a	Length: 0.8m	Level of Natural (m OD): n/a not reached
Deposit	Context No.	Max. depth below ground level (64.35m OD)
Wall of main house	+	0.38m (north side of trench)
Made ground	(101)	0.38m (south side of trench)
Made ground	(102)	0.78m
Made ground/ occupation layer	(103)	1.01m+
<p>Summary</p> <p>Footing 3 was located at the western edge of the development area, immediately north of Footing 2. The footings of the main house were exposed at the west side of the trench (see description in Footing 2, above).</p>

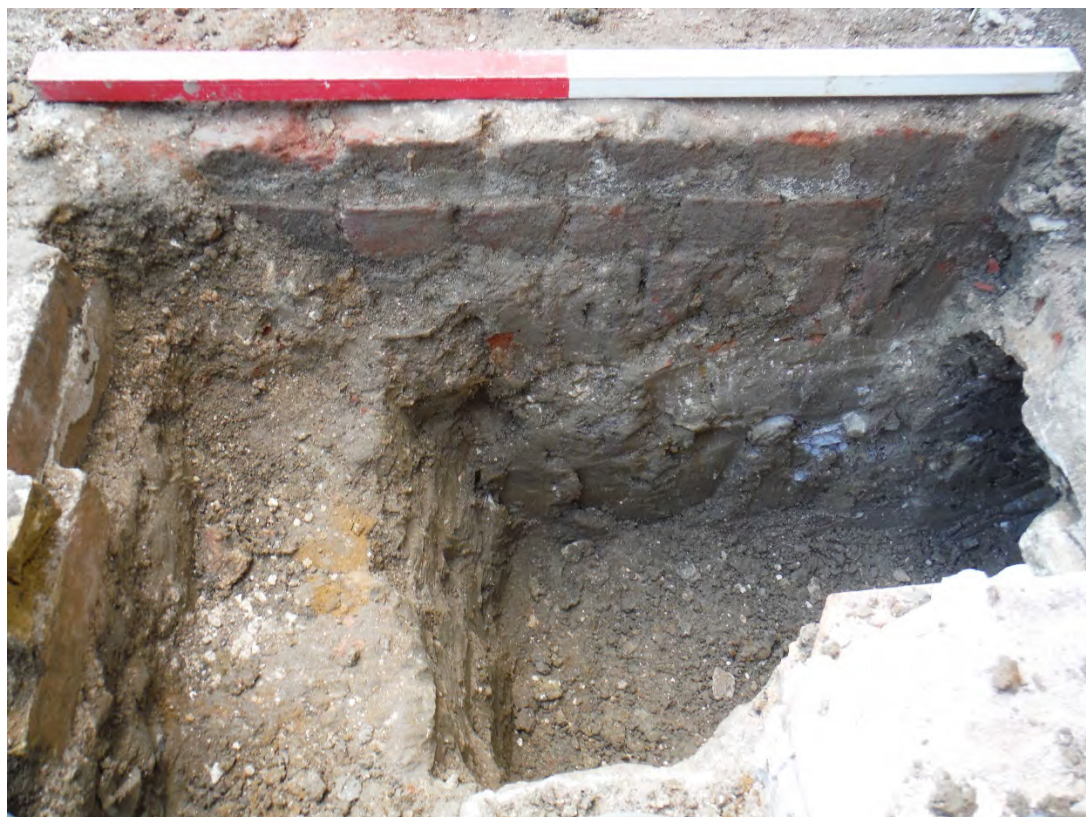
Plate 10: North-facing section of Footing 6

FOOTING 6	Fig. 3 and Fig. 4 Section 17	Plate 10
Alignment: E-W	Length: 0.8m	Level of Natural (m OD): n/a not reached
Deposit	Context No.	Max. depth below ground level (64.36m OD)
Farmhouse chimney stack	+	0.46 (W side of trench)
Made ground	(101)	0.32m
Made ground	(102)	0.96m+
Summary		
<p>Footing 6 was located centrally along the west side of the development area, north of Footing 3. The foundations of the existing house were exposed at the west side of the footing, on the south side of a fireplace. They are constructed of frequently poorly-made, wide red bricks bonded with lime mortar; their appearance and dimensions fit a Tudor date (see Hayward, Section 6.3).</p>

- 6.3.3 Very wide red bricks 220mm (long) x 120mm (across) bonded in a lighter pale lime mortar found close to the fireplace. These appear to be older and could be Tudor in age as bricks with this width (4¾ inches) are often of this date in London. The upper course has especially wide bricks and these seem poorly made. Suggested construction date: 1450–1700.

- 7.6 The appearance and dimensions of the bricks used in the foundation of the east elevation of the main farmhouse, recorded in Footing 6, are in keeping with Tudor brickwork and fit the suggested late-15th-/ early-16th-century date of the building. Residual peg roof tile in (101) also fits a late medieval to early post-medieval date.
