**ST. PAUL'S CATHEDRAL EQUAL
ACCESS SCHEME (TEST PITS), ST
PAUL'S CATHEDRAL, CITY OF
LONDON, EC4: AN
ARCHAEOLOGICAL EVALUATION**

St. Paul's Cathedral Equal Access Scheme (Test Pits), St Paul's Cathedral, City of London, EC4: An Archaeological Evaluation

An Archaeological Evaluation

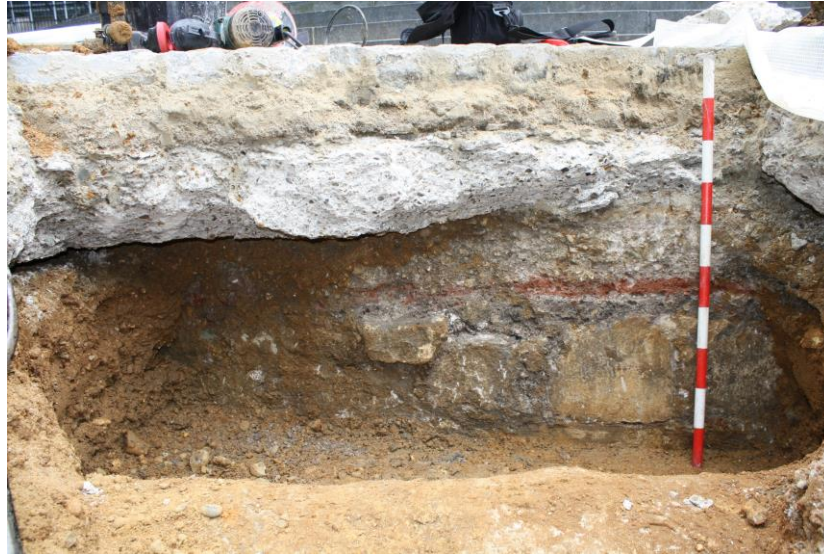
Plate 1: Section 2 in Test Pit 1 showing the foundation of the North Transept and the layers of made ground above it. Facing south, scale 1m.

7.1.3 The earliest layer observed in the test pit was a soft, dark grey sandy clay layer (15) which was placed directly on top of the cathedral's foundation step (16). The latter was seen in section only, therefore its full dimensions could not be recorded. Two courses of stones of varying sizes could be seen, ranging from 300mm to 510mm wide and 310mm high. The foundation step was bonded with a hard grey mortar with frequent small fragments of chalk and stone. Above this was a thin layer (0.03m) of crushed bricks (14). This was sealed by layer (13) which consisted of a mix of hard mortar with small to medium fragments of stone and bricks. The purpose of these layers was that of made ground, placed in order to fill the cut created for the placement of the foundation steps. A layer of concrete c. 0.12m thick sealed the made ground and was sealed by a layer of modern sand (approximately 0.10m thick). This in turn was sealed by a layer of modern paving slabs and cobble stones (approximately 0.13m thick).

7.1.4 This test pit therefore disclosed the edge of the foundation of the North Transept steps, which formed a vertical edge at least 0.36 m high. Unfortunately, because of the small section revealed by the test pit, it was not possible to ascertain whether the foundation was straight or curved, following the curvature of the steps leading into the entrance (Figure 8).

7.1.5 The construction of the underground car park during the 1970s had caused the removal of all archaeological features within this test pit. The only surviving deposits were those found on the southern section of the test pit, above one of the foundation steps of the cathedral (Plate 1).

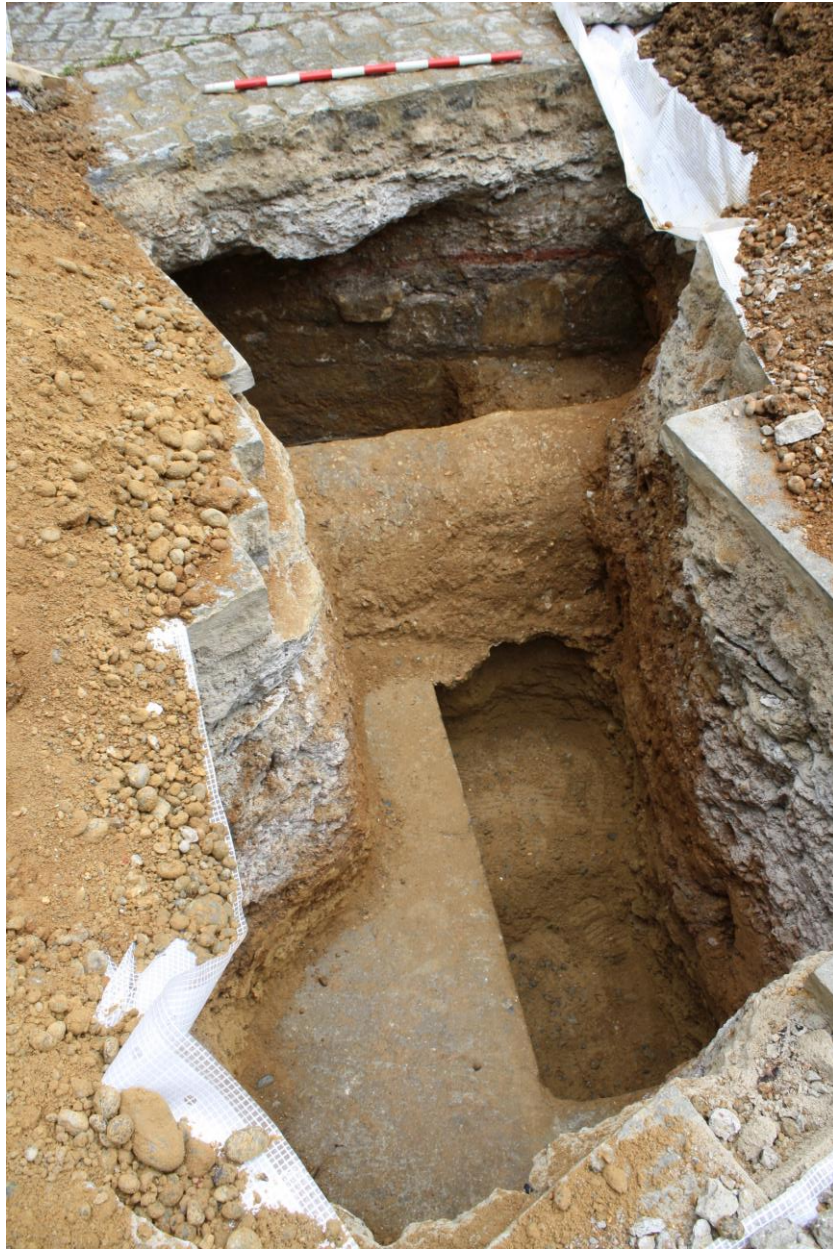
Plate 2: Test Pit 1 showing the concrete associated with the underground car park and services, facing south-west.

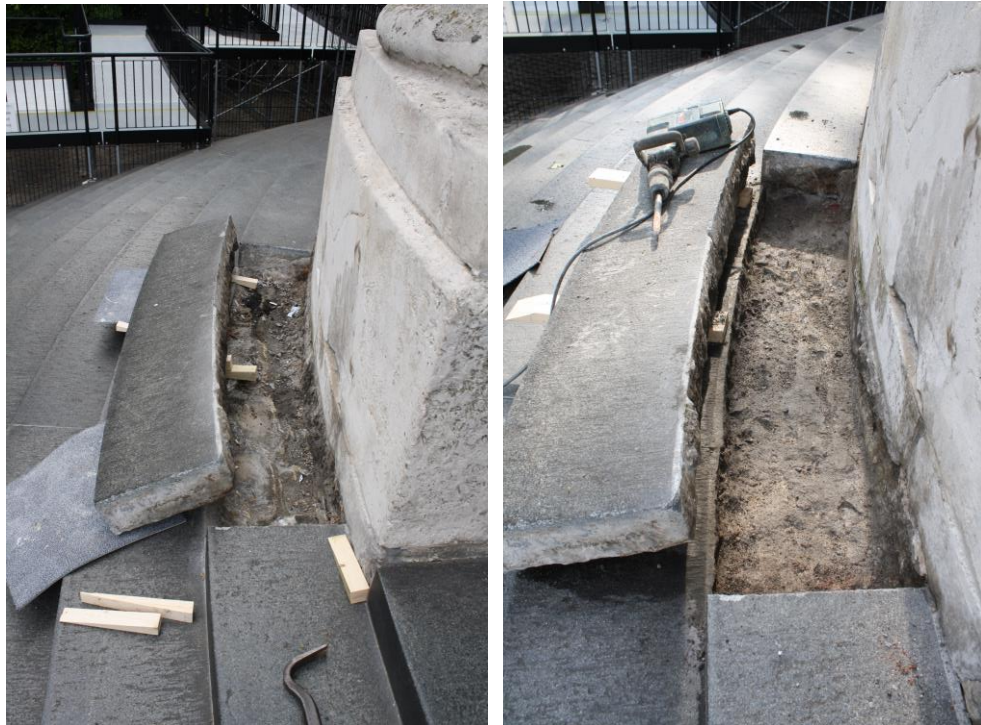
Plates 3 and 4: Test Pit 2, before and after the removal of the bedding, facing east.

7.2.1 The purpose of Test Pit 2 was to investigate the bedding material below the steps. A slab of stone was removed by the Cathedral Works team revealing, as expected, a deposit of mortared brick and rubble. The material was very similar to the mortar observed in Test Pit 1 (13) and Test Pit 4 (5). The test pit measured approximately 1.65m EW by 0.36m NS at a depth of 0.20m.

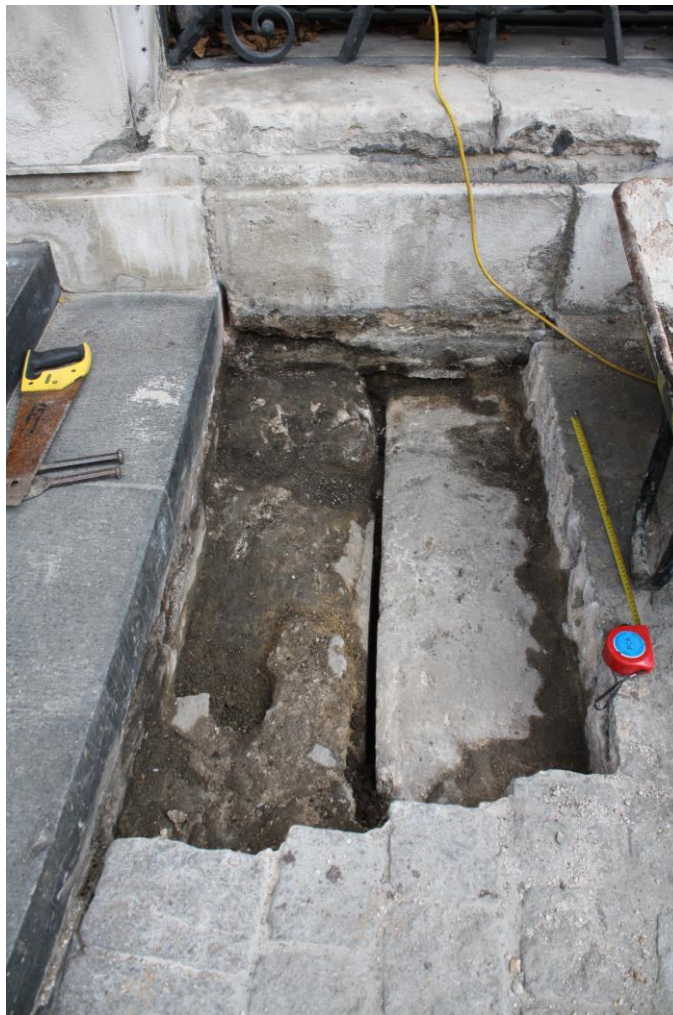
Plate 5: Test Pit 3, the Cathedral's foundation can be seen to the left.

- 7.3.1 Test Pit 3 measured a maximum width of 1.36m north-south by 1.78m east-west and was excavated to a maximum depth of 0.20m. It was located directly to the north of the St Paul's North Transept just to the south of Test Pit 5 and its purpose was to pinpoint the location of the cathedral's foundation (Figure 4).
- 7.3.2 After the removal of the surface cobbles, the foundation could be clearly seen to the east of the pit, measuring approximately 0.54m east-west (Plate 5). Next to it, to the west, a layer of concrete was also identified, most likely associated to the works undertaken during the 1970s. A small gap was present between the foundation and the concrete. As the main objective had been achieved, the excavation ceased.

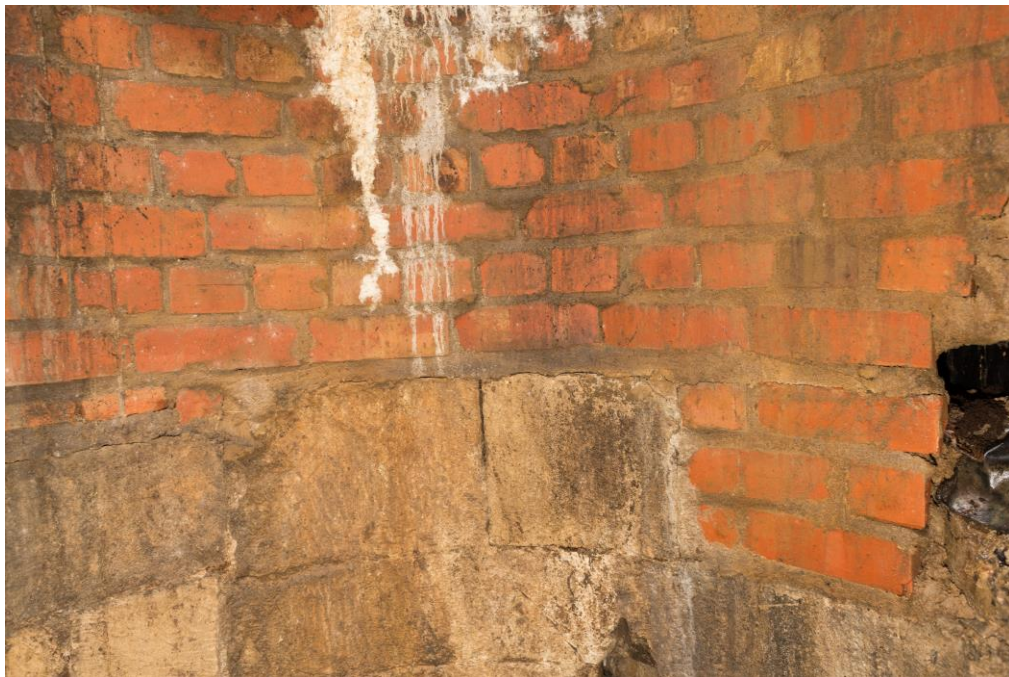
Plate 6: Investigation 4, the well. Point where modern bricks were used to rebuild part of the structure, facing north-west.

- 7.4.3 A photographic record was created of the interior of the well using a remote controlled camera, with pictures of the brick and stone work in 0.50m intervals. Examples of the record are shown by Plates 6 and 7.

- 7.4.4 The top 1.74m (16.64m to 14.90m OD) consisted of modern bricks; most likely a reconstruction or level raising done after its excavation during the underground car park works. The remaining structure was built with ashlar blocks of various stone materials. The measurements and exact type of these stones could not be recorded due to their location within the well at a low depth, although the stone is possibly Portland stone (pers comm Dr Kevin Hayward) which may suggest a post-Great Fire date.

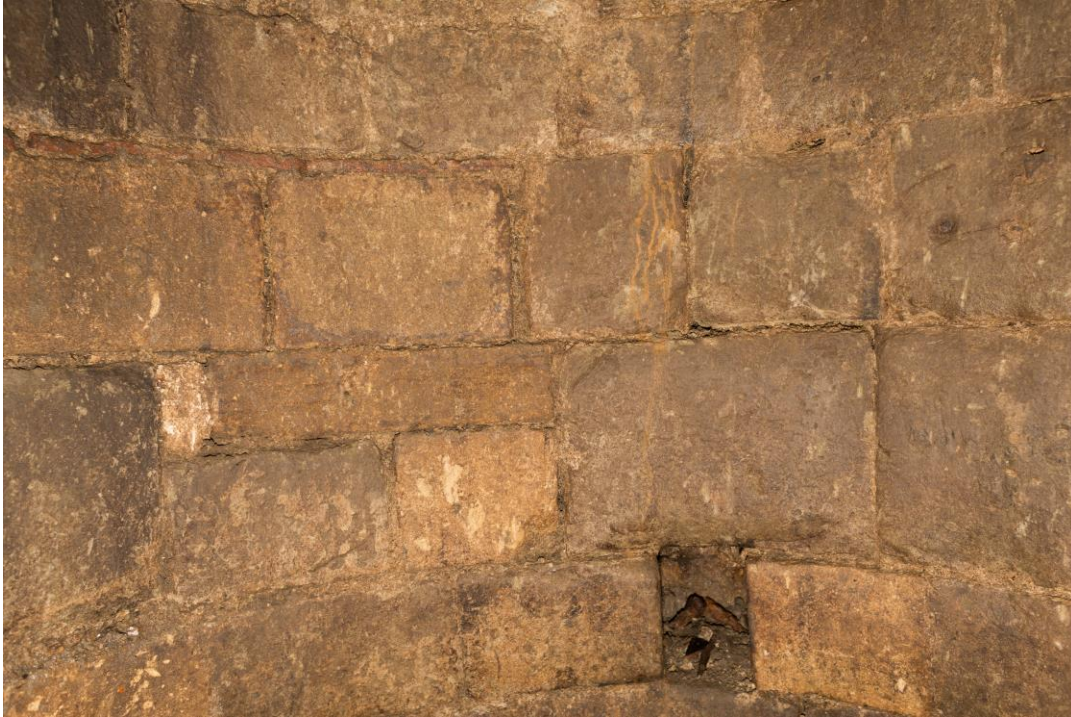
Plate 7: Investigation 4, the well. Original stone, facing north-west.

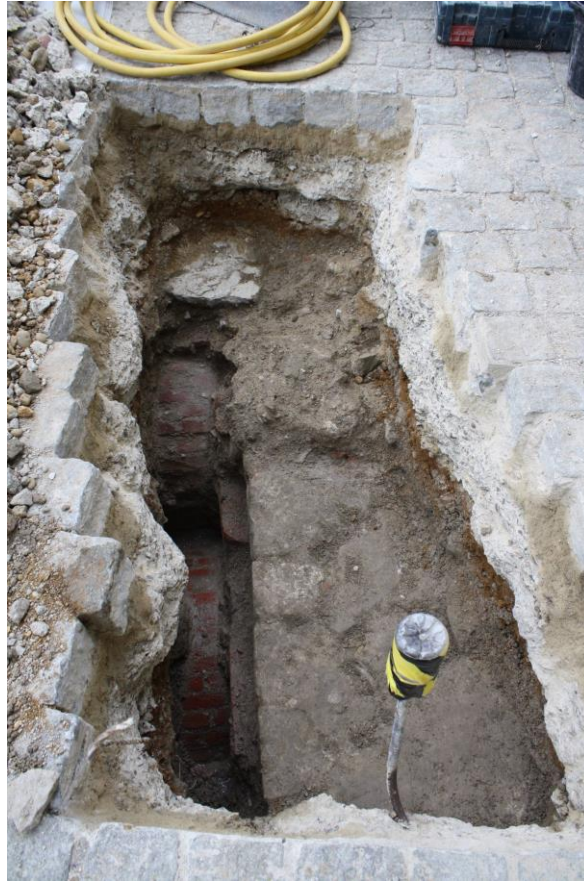
Plate 8: Test Pit 5, facing north. Cathedral's foundation can be seen to the right and culverts the left..

- 7.5.4 It is clear that the foundations of the North Transept (4) were built on top of the culverts. The materials used to construct the foundations comprised stones of varying sizes as well as a hard grey mortar, which contained frequent small fragments of chalk and stone.

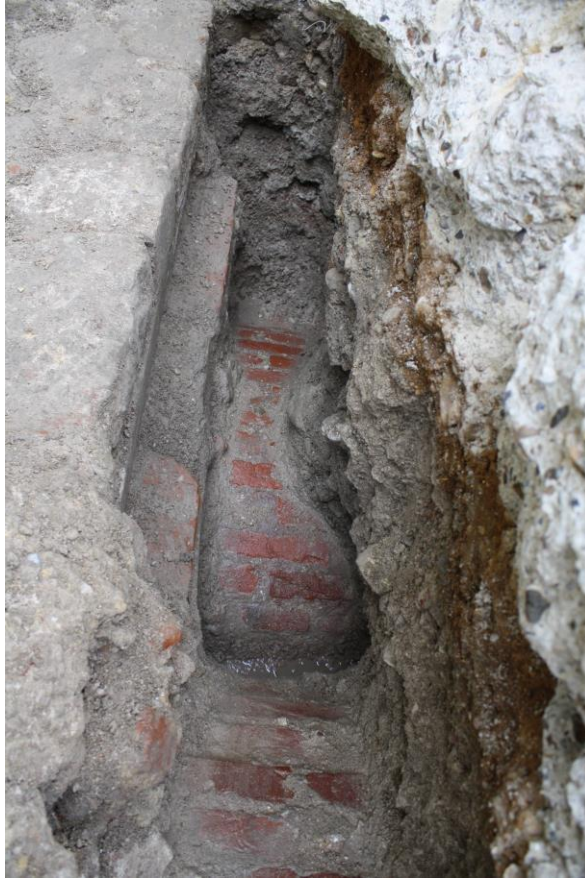
Plate 9: Test Pit 5, facing south. Culverts [11] and [12] and associated brick line [10].

- 7.5.2 The earliest features noted in the test pit were culverts (11) and (12) (Figure 5). These structures seemed to be contemporary, as could be observed by the similar fabric of the bricks and mortar used in both culverts. Moreover, the fact that they possibly shared a wall would corroborate this (Section 1). The exposed area of the culverts was only 0.25m in width, making access and full analysis difficult. The dimensions of whole bricks, for example, could not be determined. Nevertheless, brick and mortar samples were recovered from a borehole cut through culvert [12] and dated to a period between 1500 and 1700. The culverts had been backfilled with concrete in the 1970s and therefore their depth could not be ascertained.

- 7.5.5 At the same time that the culverts were constructed, a line of bricks (10) was added on top of the structures and against the foundations, most likely to ensure the culverts remained sealed.

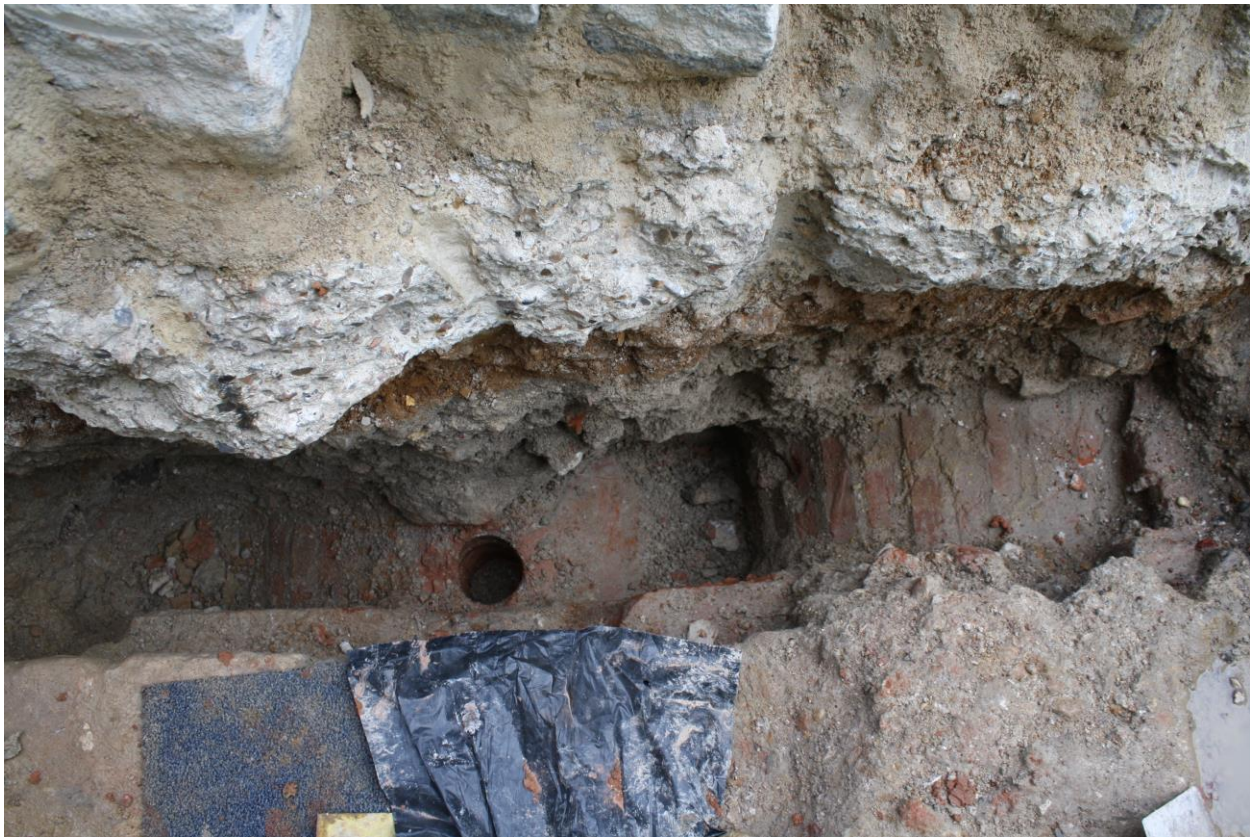
Plate 10: Bore hole in culvert [12] in Test pit 5, facing west.

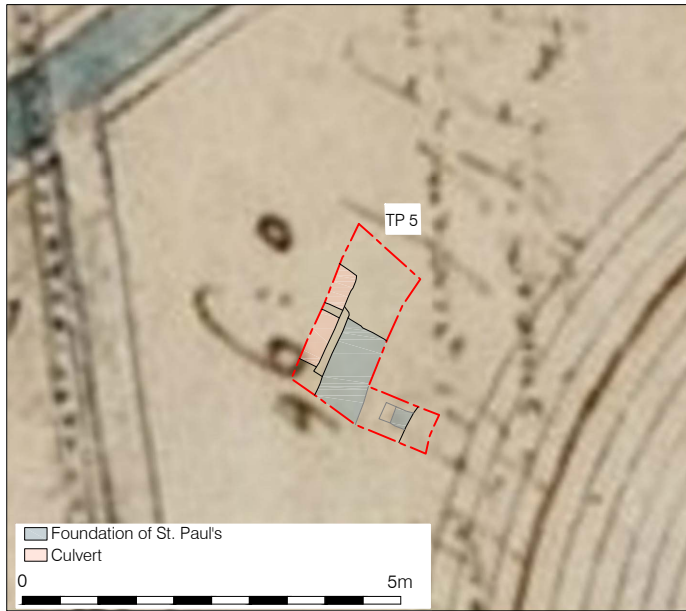
Figure 5
Pre and Post-Excavation Plans and Sections of Test Pit 5
Plans 1:40 and Sections 1:20 at A4

- 7.5.8 Deposit (7) was cut by a feature to the south, cut [3]. The actual dimensions and depth of the cut could not be recorded because of the small size of the test pit. Nevertheless, one of its edges can be seen in Section 1 (Figure 5). Fill (2) was within this cut and it was found to also contain demolition material. It consisted of a loose, sandy mortar, with frequent fragments of bricks and tiles. Assessment of this material has revealed the presence of medieval floor and peg tiles, as well as post-medieval peg tiles and bricks, dating the feature to a period between 1600 and 1800 (Appendix 2). However, the function of the pit is unknown; it is likely that it was the result of some repair works after the construction of Wren's cathedral during the 18th and 19th centuries.

- 7.5.9 Another feature of interest is that of a stone slab (6) within a mortar deposit (5). The mortar seems to have been part of cut [17] for the placement of this slab; a cut which could also be seen on the east facing section of this test pit and also cut layer [7] (Figure 5). Unfortunately, only one fragment of pottery was recovered from the fill of this cut (8), which dates it to a period between 1580 and 1750 (Appendix 2). Below the cut, three bricks (9) were reused as a leveling deposit for the stone slab. The function of the slab, however, remains unknown.

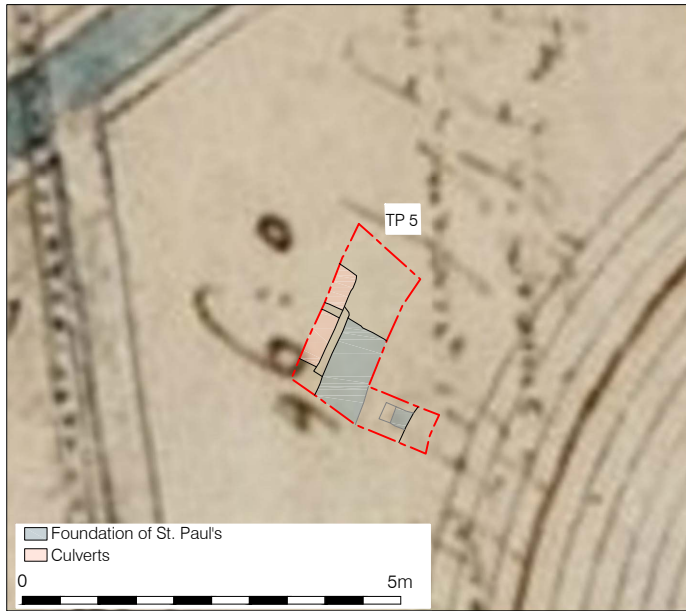
Figure 6
 Test Pits overlain on Wren's Plan of Drains
 1:1,000 and Inset 1:100 at A4

- 7.5.3 The culverts can be identified as part of Wren's drainage system from the 1680s, which took rain from the roof of the cathedral to be drained down Ludgate Hill (Schofield 2017), even though these specific branches were not drawn by W. Dickinson in the final plan (Figure 6).
