**TEMPLE CIRCUS GYRATORY,
BRISTOL**

**AN ARCHAEOLOGICAL WATCHING
BRIEF; FINAL REPORT**

**SITE CODE: BRSMG 2017-115
REPORT NUMBER: R13920
NOVEMBER 2019**

**TEMPLE CIRCUS GYRATORY, BRISTOL
FINAL REPORT**

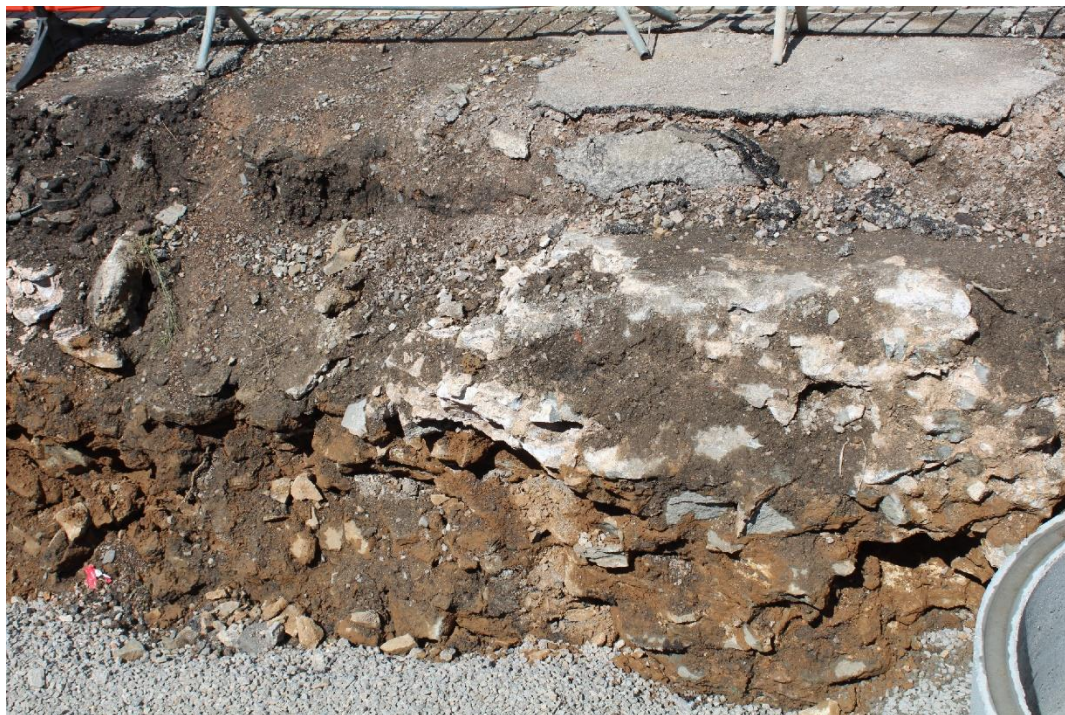
Plate 1, Photo of the Portwall (1129) looking north being impacted by later developments (1133)

- 5.4.2 The earliest stratigraphic remains found was the 13th century medieval Portwall, recorded in this location as **(1129)** (Plate 1). This was encountered at a depth of 7.49m OD and comprised of large unfinished sandstone blocks set into an orangish soft sandy mortar. While the full width and height of the wall were not observable, the composition of the wall was consistent with the core of the Portwall previously observed in Test Pit 2 as **(1117)** (see paragraph 5.3.2 above). The wall had been heavily impacted by 20th century activity, most notably foundation construction works in the area, with the outer face of the wall either destroyed or robbed away leaving only the sandstone core described above.

- 5.4.4 Directly above the Portwall **(1129)** was a later rebuild **(1133)** (Plate 1). This was recorded at 8.24m OD and was only observed towards the north-eastern end of the trench. It was comprised of re-used sandstone blocks set into a hard clinker-based mortar. The composition of the wall was consistent with other 19th century walls observed in the area which also used the original Portwall as a footing. The consistent alignment of this wall represented further proof of the continued use of the Portwall as a boundary into the 19th century.

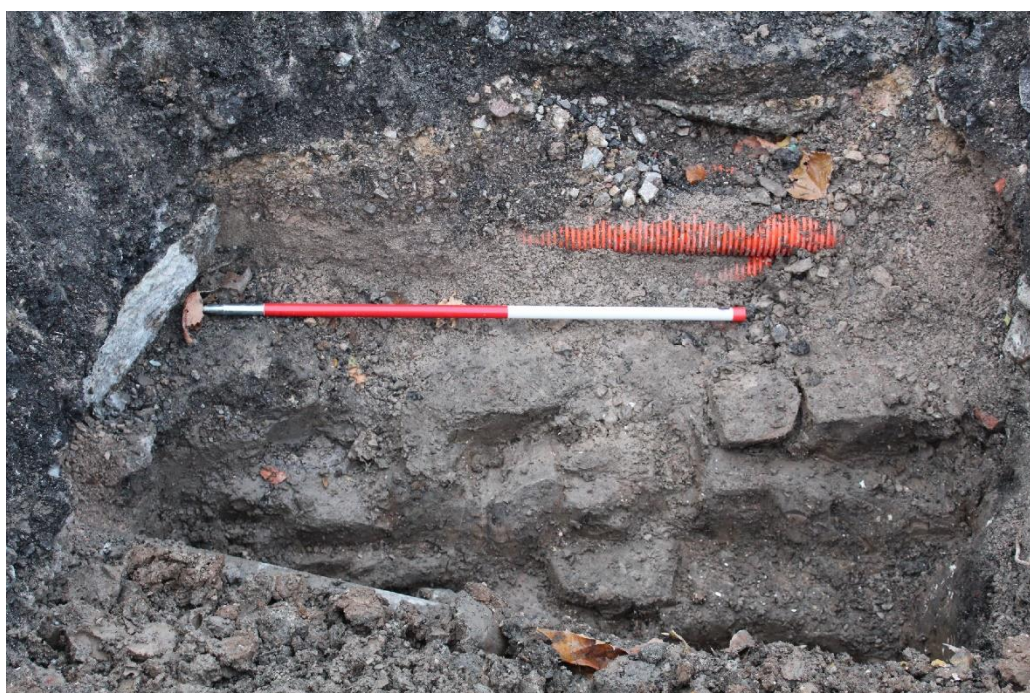
Plate 2, Photo of the Portwall (1147) within Test Pit 5, showing survival in the area before being impacted by the district heating main trench

- 5.5.7 The earliest stratigraphic remains found was a section of the 13th century medieval Portwall (1147) (Plate 2). This was encountered at a depth of 8.11m OD with an east to west alignment. It was comprised of large red sandstone blocks bonded by a reddish orange sandy silty mortar. In this location the wall appeared to have some of the large sandstone blocks associated with the outer face of the wall. The survival and structural integrity of the section of wall exposed within Test Pit 5 was good with apparently no impact from services (1146) and (1148).

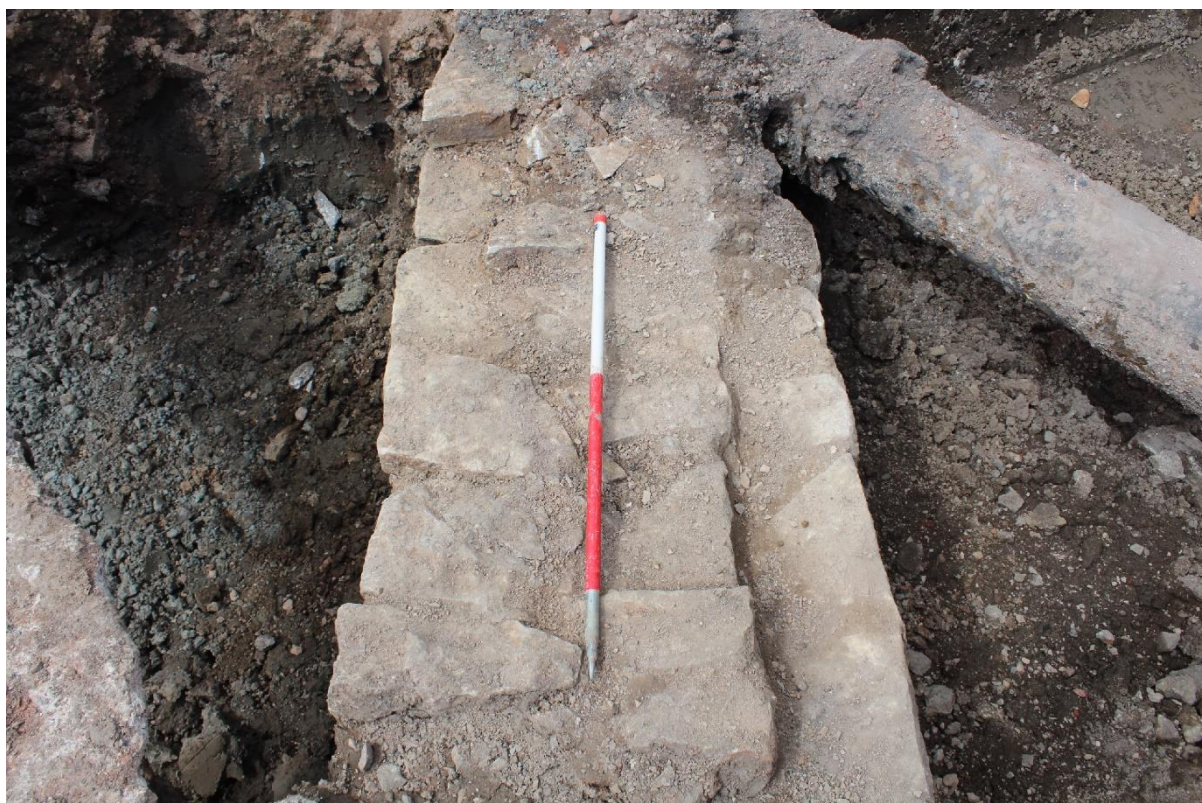
Plate 6, Photo of Wall (1167)

- 5.6.4 Running parallel to the Portwall **(1166)** and 4.09m north of it was a further stone wall **(1167)** (Plate 6; Figures 7 & 8). This was comprised of a mixture of limestone and occasional sandstone (average size of 180mm x 320mm x 220mm) and was bonded together with a yellowish sandy mortar. Only a portion of the wall **(1167)** was observed within the trench. Here it had a width of 0.98m, a length of 3.20m and was 0.69m thick with five courses being observed. Within the fabric of the wall **(1167)** was a pottery sherd of Saintonge ware (BPT 156) with a mottled green glaze, dated 1250–1400 and imported from south-western France, providing a broad date range for the structure.

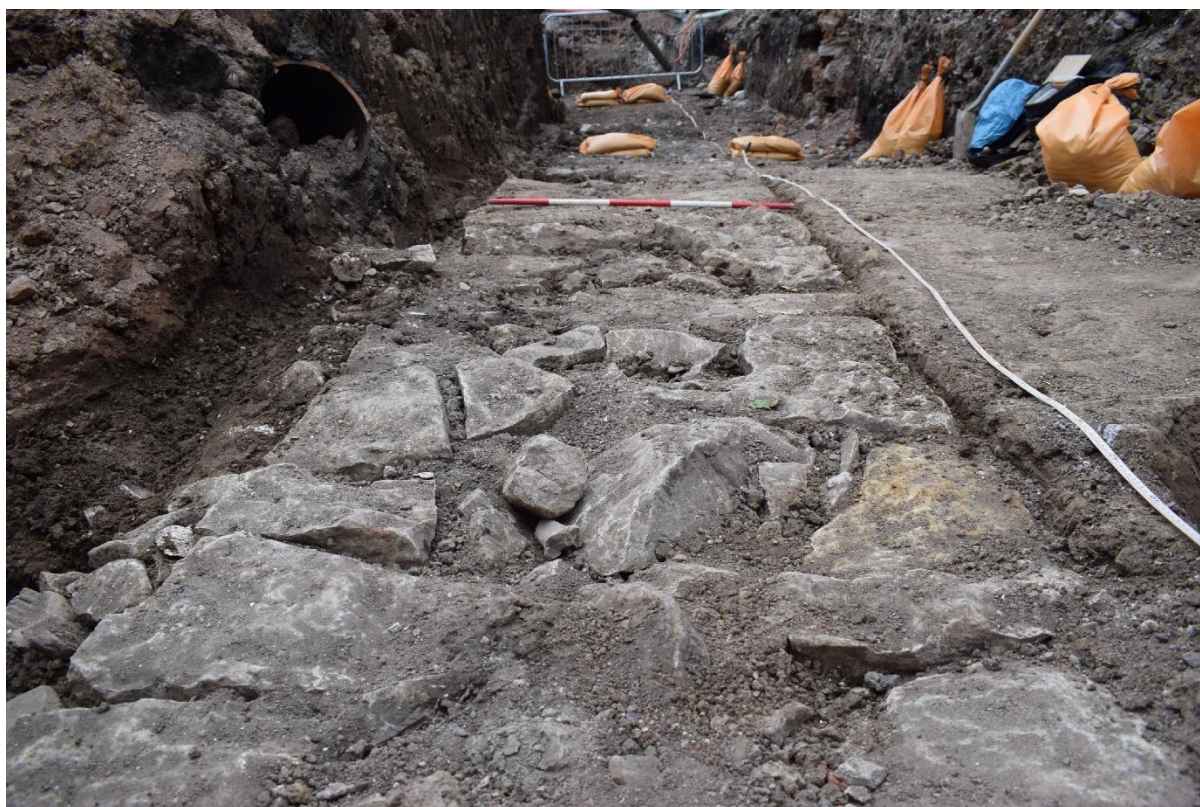
Plate 7, Photo of the continuation of wall (1176) looking west

5.6.8 Following the main excavation of the north to south District Heating Main a secondary trench with an east to west alignment was installed. The earliest observed stratigraphic layer was **(1175)** which was a packing base layer for wall **(1176)** (Plate 7). Wall **(1176)** was a continuation of wall **(1167)** to the east, and had been removed by modern development to a depth of 7.18m OD, leaving only one course remaining *in situ*. The wall **(1176)** was abutted by a layer of clay **(1182)** consisting of a compacted dark brownish clay. This layer appeared to be contemporary with the medieval wall **(1176)** and may represent part of a medieval ground level. It was observed at the same height as the remains of the wall suggesting it was perhaps truncated from above previous groundwork.

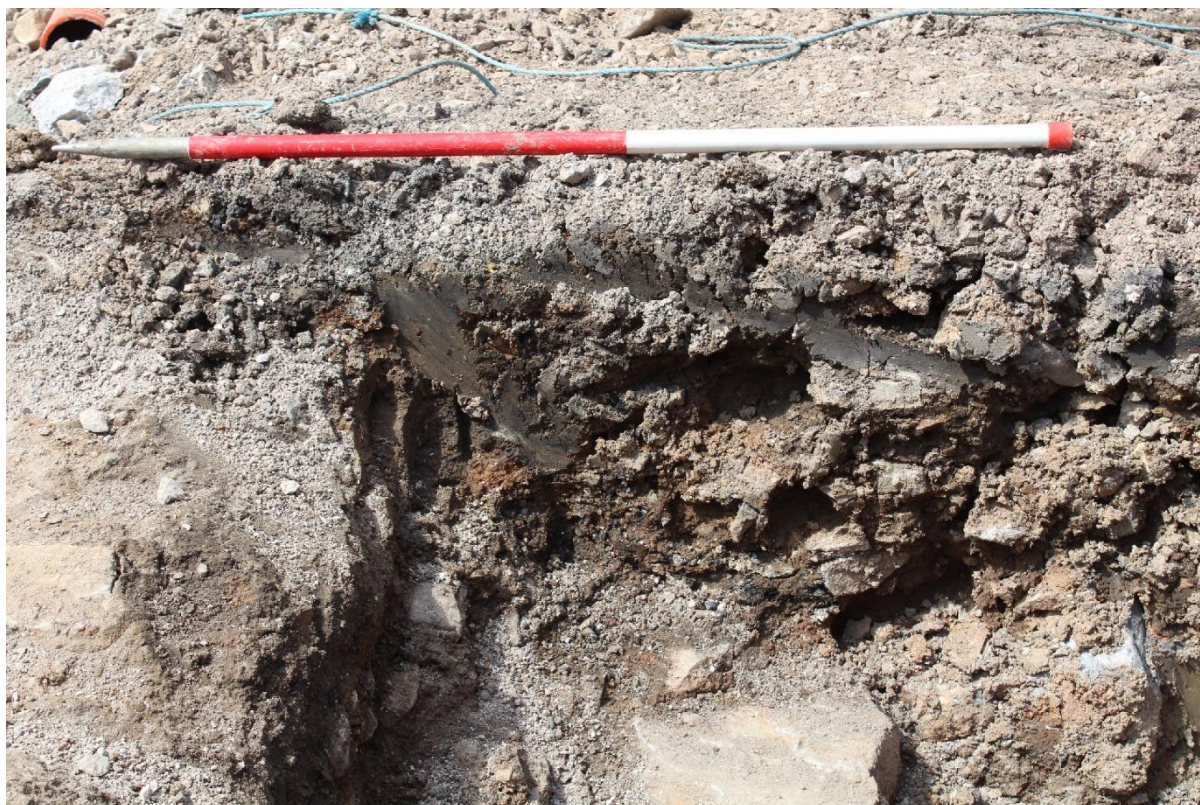
Plate 8, Photo of robber cut [1168] effecting the Portwall (1166) within the district heating main trench.

total depth of 0.74m within the base of the cut **[1168]** being observed at 7.44m OD. The cut **[1168]** had a width of 0.95m cutting into the Portwall **(1166)**, resulting in 0.95m of the entire exposed northern side of the Portwall **(1166)** being removed to a depth of 7.44m OD. The primary fill **(1170)** of the robber cut **[1168]** consisted of a friable yellowish-brown sandy silt and contained glass and pottery sherds recovered dating the robbing activity to the 17th-18th. This was sealed by the secondary fill **(1169)** which consisted of a very dark friable silty clay with moderate inclusions of charcoal. This series of deposits within robber cut **[1168]** is likely associated with the robbing of the Portwall **(1166)**.
