**WIMBLEDON GREYHOUND
STADIUM, PLOUGH LANE, LONDON
BOROUGH OF MERTON SW17 0BL:
AN ARCHAEOLOGICAL
EVALUATION**

AN ARCHAEOLOGICAL EVALUATION

SITE CODE: POG17

CENTRAL NGR: TQ 26155 71817

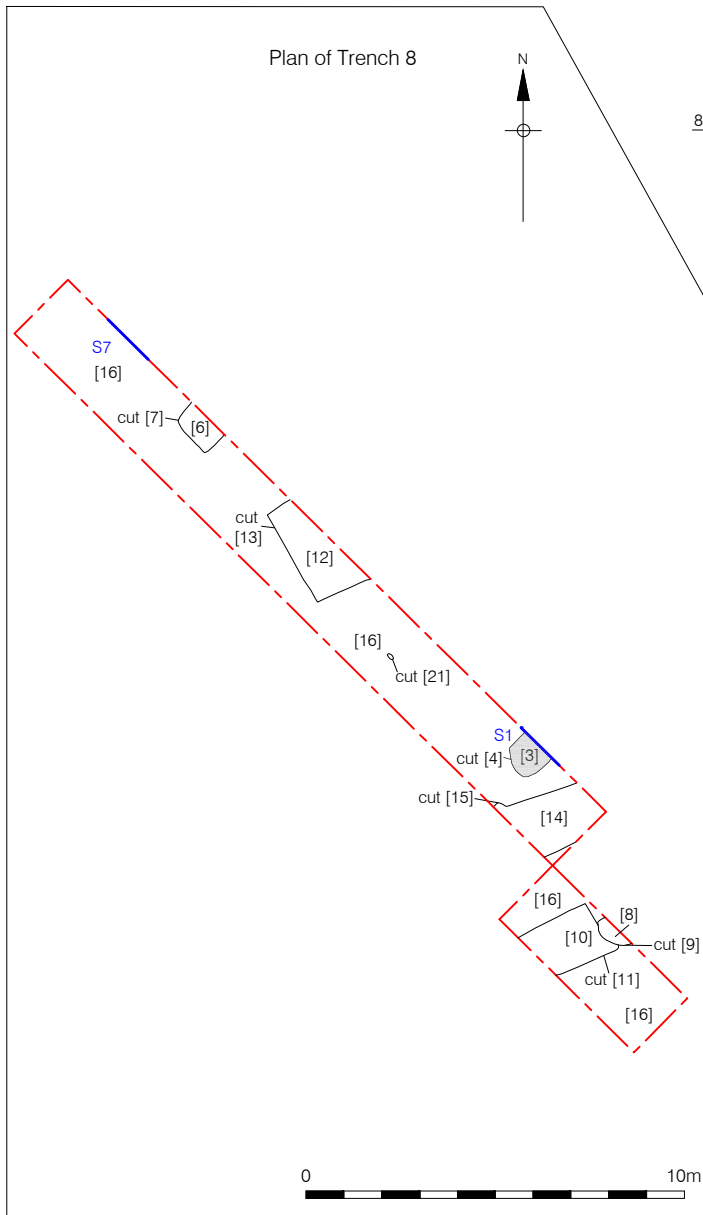
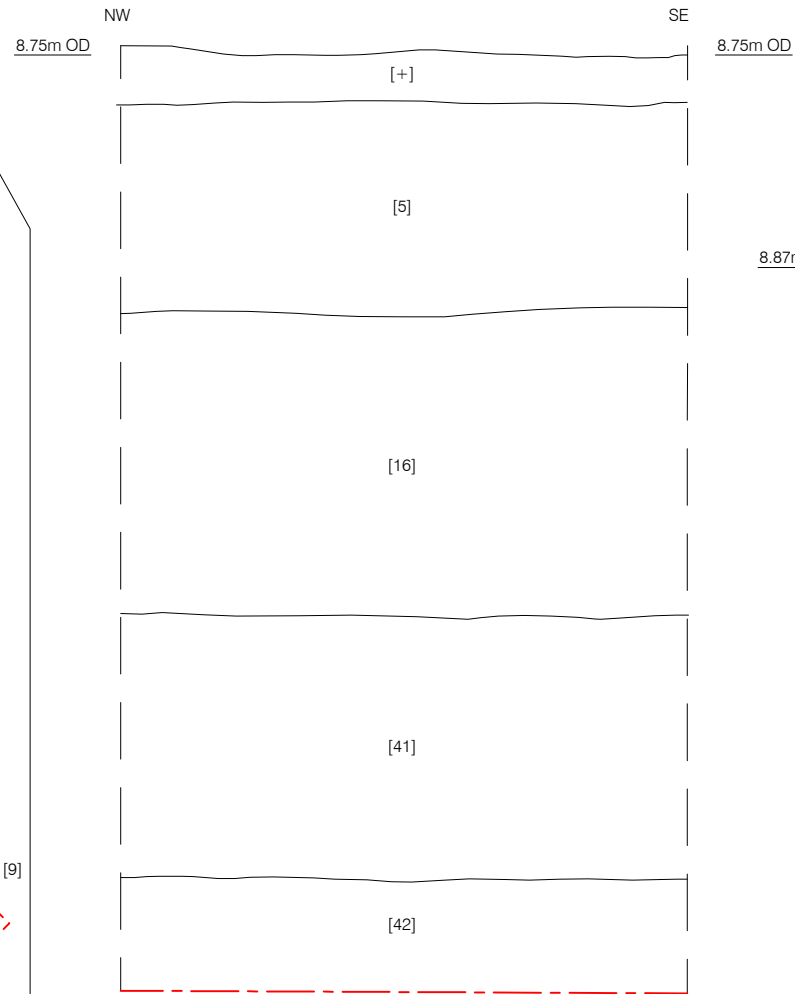
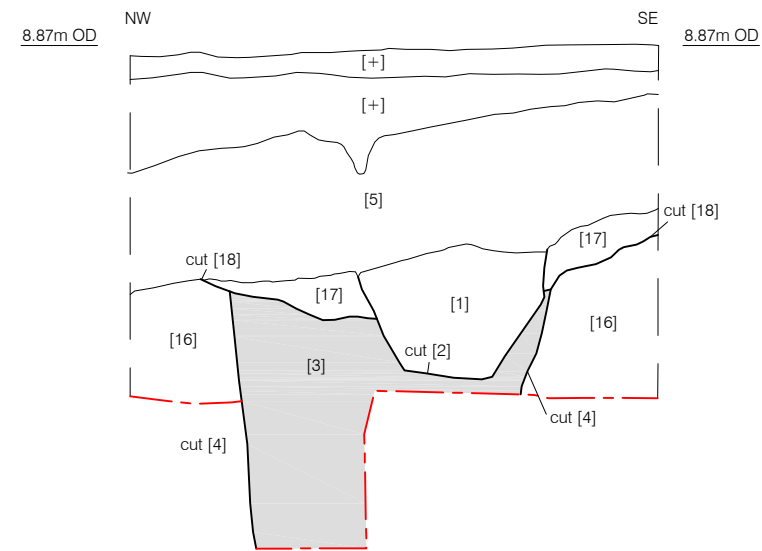
Figure 9
Trench 8: plan and sections
Plan at 1:200, section 1:20 at A4

Section 7
Trench 8
Southwest facing

Section 1
Trench 8
Southwest facing

- 7.2.3 Trench 8 revealed a series of post-medieval features, all of which would have been located within the rear gardens of properties facing onto Summerstown, and which were cut into alluvial layer [16]. These features consisted of three rectangular pits [7], [11] and [13], a circular pit [9] and two post holes [4] and [21]. Rectangular pits [7] and [13] both contained highly organic sandy clay fills [6] and [12] respectively. The other rectangular pit [11] contained a dark clay silt fill [10], and circular pit [9] was filled with a mid brown grey clay silt [8]. All of the pits contained a mixture of artefactual remains with pottery recovered from fill [6] giving a spot date of 1840-1845. Post hole [21] was just 0.15m in diameter and 0.05m in depth, filled with a soft dark grey brown silty clay, whilst post hole [4] contained fills [17] and [3], the earlier of which, fill [3], had a pottery spot date of 1835-1900 and what appears to be a post pipe [2] containing a dark grey brown silty clay [2].

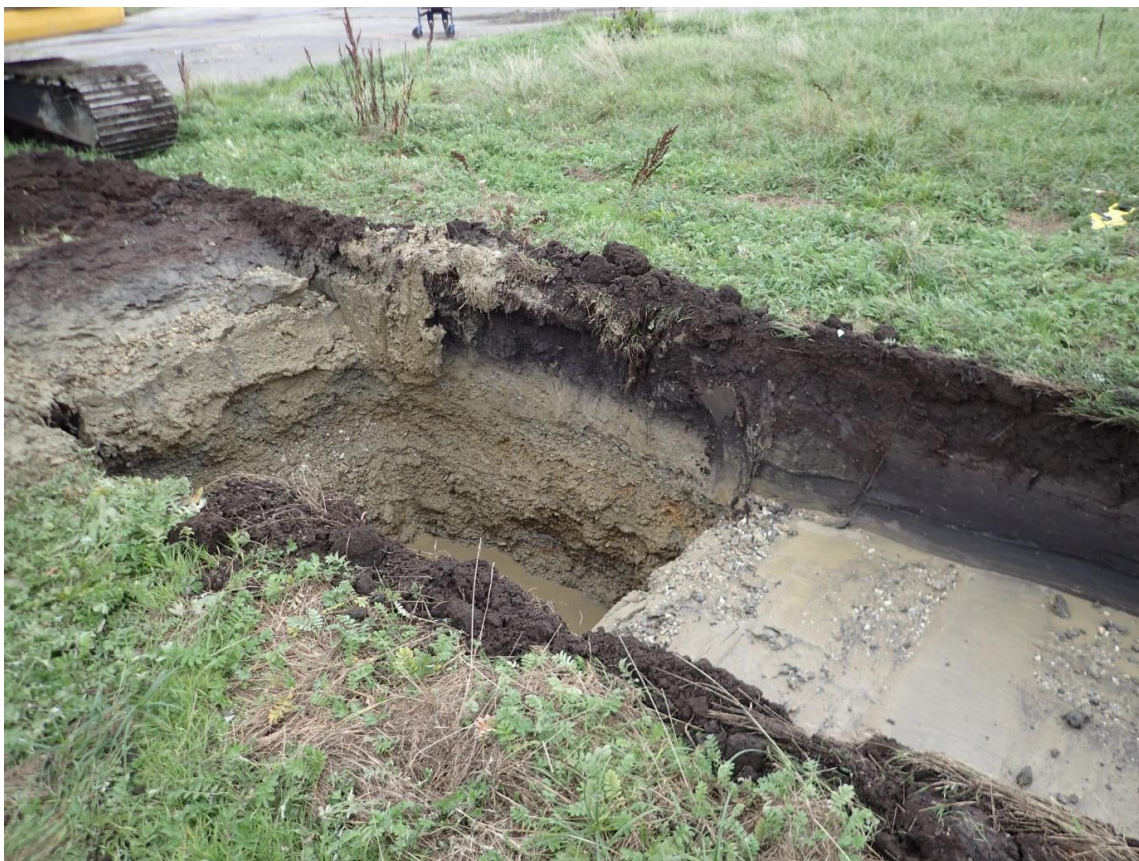
Plate 1: Trench 2, looking north, alluvium layers [27] and [22] over gravels [25]

- 7.1.2 Overlying the natural clay within Trench 2 was a 1.76m thick layer of mid greyish yellow gravel [25] (Plate 1). This gravel layer was also seen in Trench 1 [24], Trench 7 [87] and Trench 11 [83], at a height of between 6.40m and 6.97m OD.

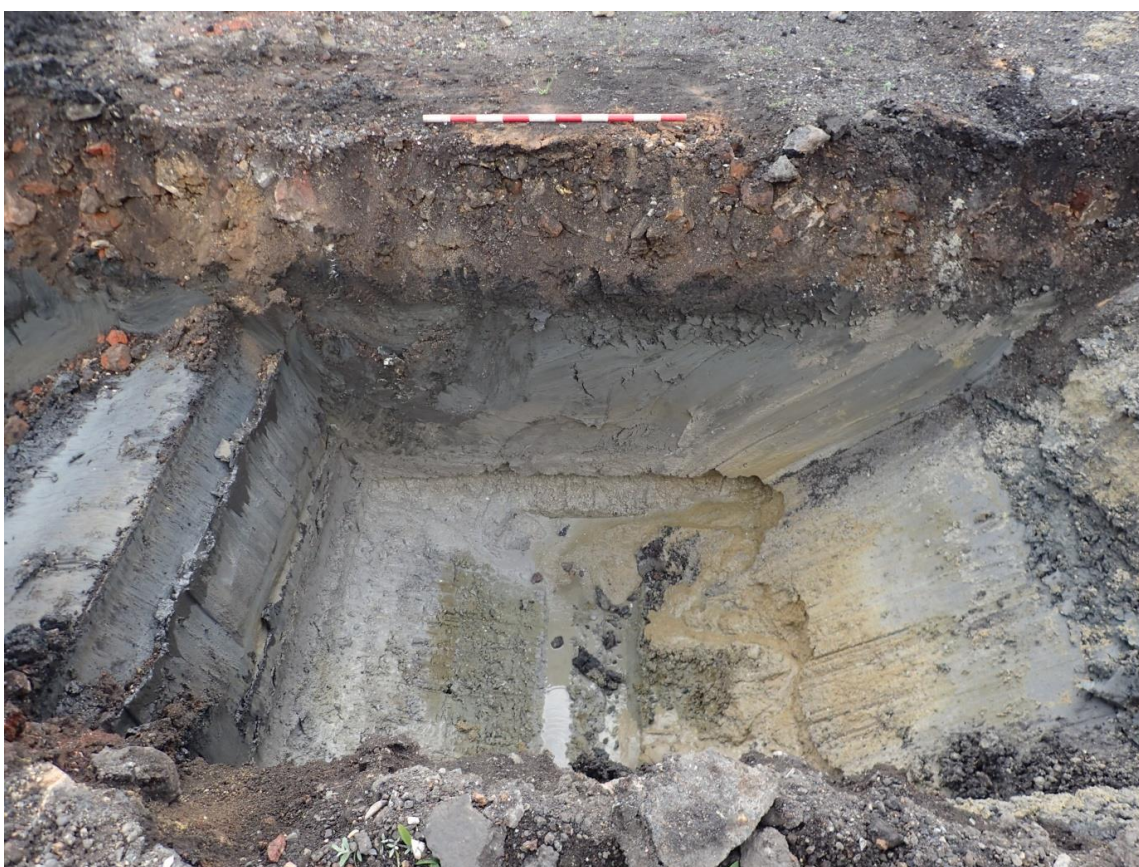
Plate 2: Trench 10, looking southeast, layers [55], [59] and [60] (1m scale)

- 7.1.3 Within Trenches 8 and 10 the earliest deposits were layers of natural yellow grey sand [42] (Plate 3) and [60] (Plate 2). These layers were seen at a height of 6.47m and 6.58m OD. Within Trench 10 this layer was overlain by a 0.26m thick layer of light blue clay sand [59].

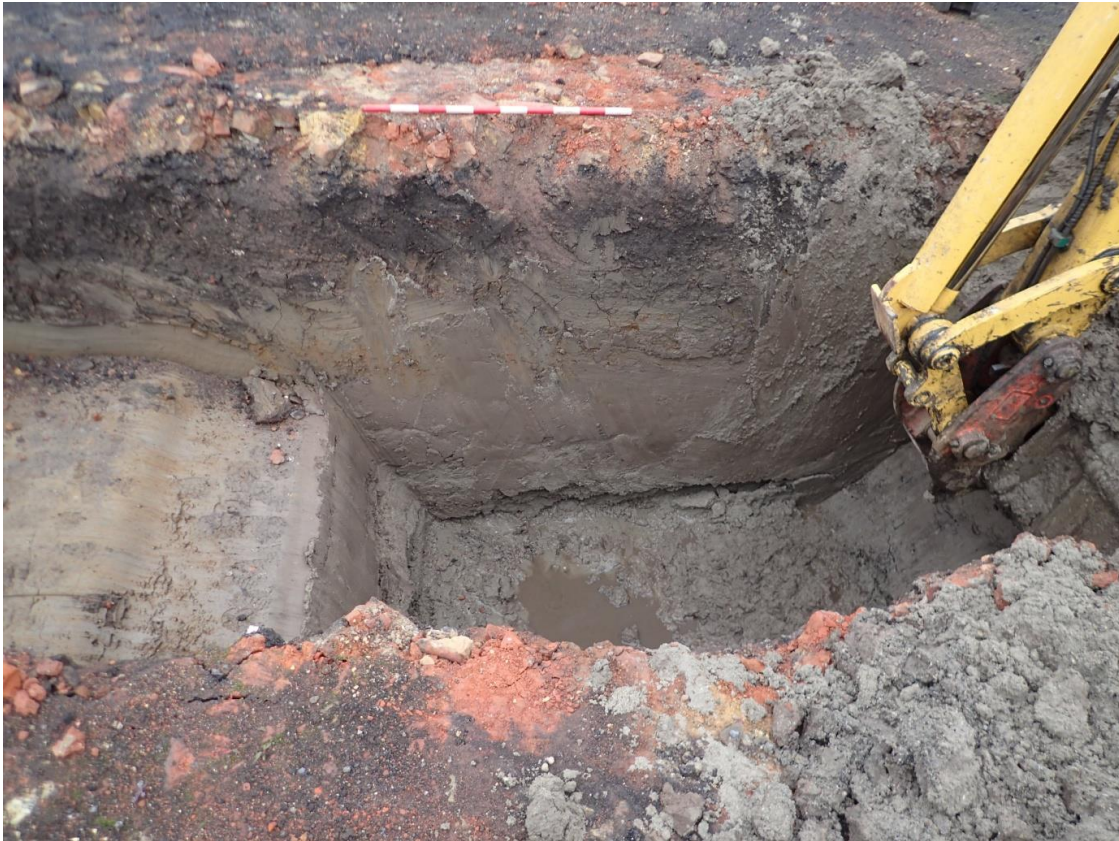
Plate 3: Trench 8, looking south-west, made ground layer [5] over alluvium layers [16] and [41] over natural sand [42] (1m scale)

- 7.1.5 Across most of the site was a layer of mid grey yellow silty clay alluvium [22], [23], [41], [52], [63], [68], [72], [79] (Plate 3) and [81], seen between 7.24m and 8.07m OD. This layer was not seen within Trenches 9 and 10, at the northern extent of the site.

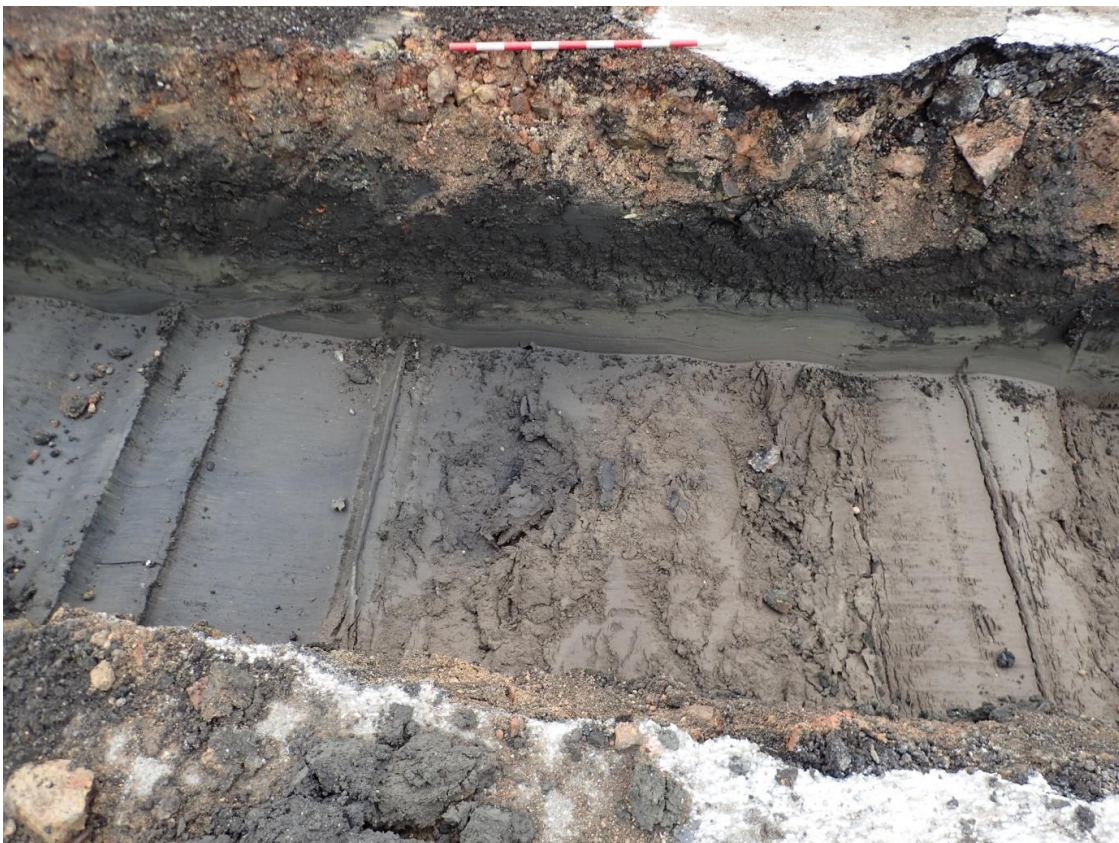
Plate 4: Trench 3, looking south, on the left, channel [66] / [67] can be seen cutting alluvial layer [68] (1m scale)

- 7.1.6 Within Trench 3 the alluvial layer [68] was cut by a 2.60m wide east-west channel [67] (Plate 4) from a height of 7.24m OD. This channel was filled by a firm dark brownish grey silty clay [66]. This feature was not fully excavated and continued below the limit of excavation (LOE) below a depth of 6.70m OD.

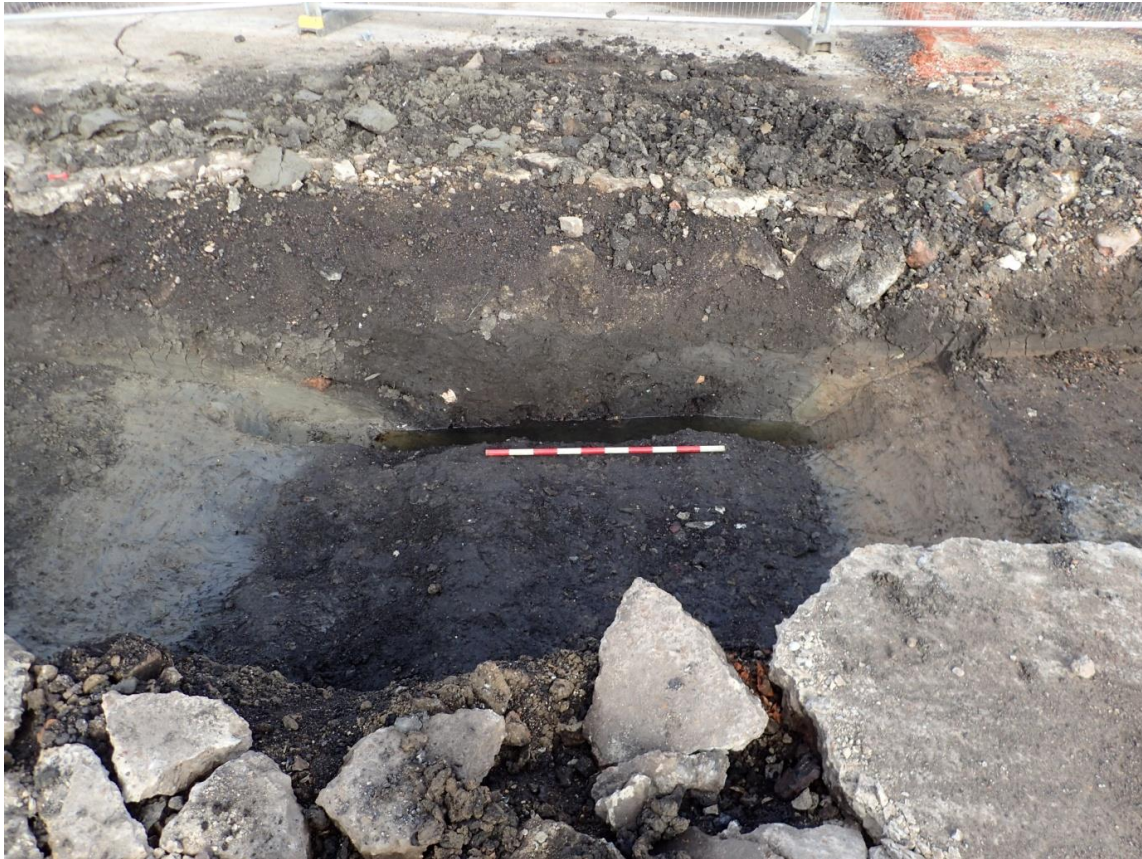
Plate 5: Trench 9, looking north-west, post-medieval ditch [38] [39] (1m scale)

- 7.2.1 Across the northern part of the site a number of the trenches were found to contain ditches. In Trench 6 the ditches were numbered [86]/[84], in Trench 9 they were [39]/[38] (Plate 5), in Trench 10 the ditches were [54]/[53] and in Trench 12 they were [64]/ [65] (see Figures 7, 10, 11 and 12). These ditches most likely relate to the agricultural use of the land in the later post-medieval period. This area is shown on historical maps to contain drainage ditches from the mid-1800s until the construction of the stadium in 1928, and is labelled on several maps as a Nursery. Pottery retrieved from fill [38] was spot dated to 1830-1900, and pottery from fill [53] was spot dated 1740-1830. The fills probably relate to the backfilling of the ditches during the early 1900s when the Stadium was first constructed.

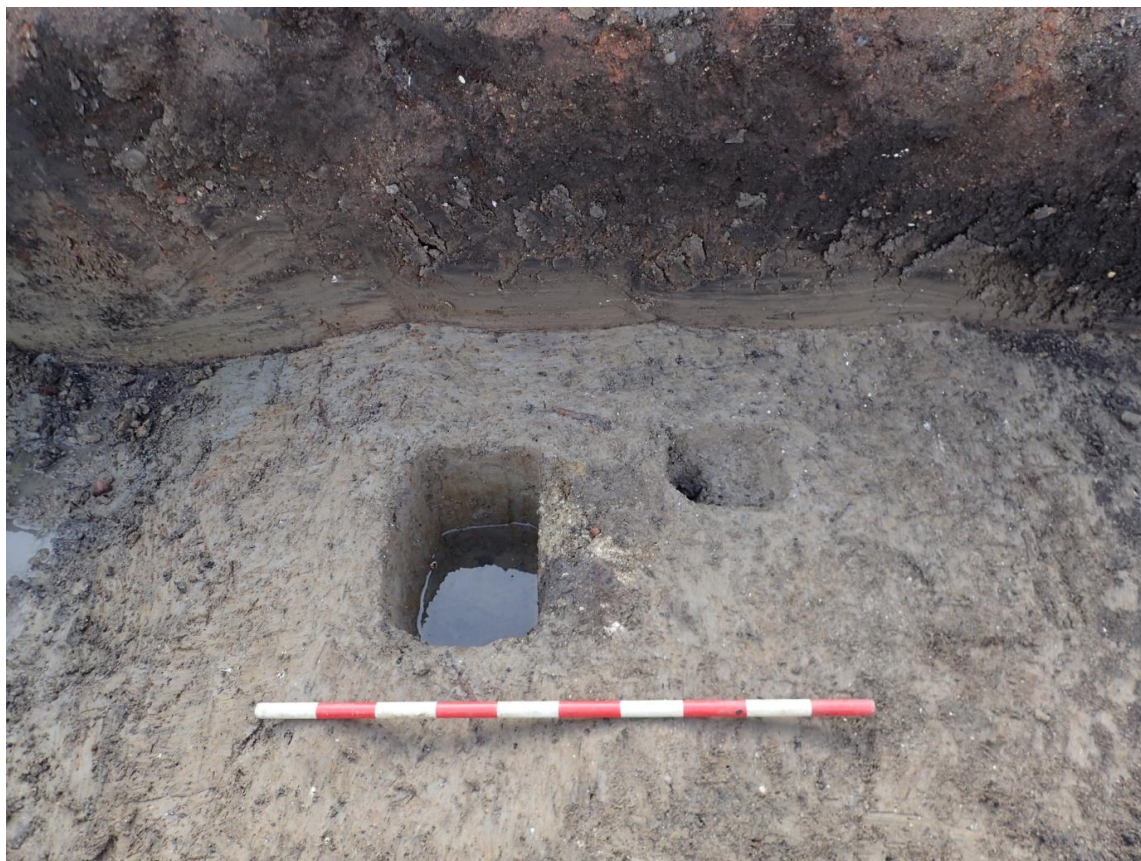
Plate 7: Trench 9, looking southeast, post holes [56]/[61] and [57]/[62] (1m scale)

- 7.2.4 Trench 9 had, in addition to the ditch mentioned earlier, two post holes [61] and [62] (Plate 7) towards its eastern extent which were most likely related to the use of gardens to the rear of properties fronting onto Summerstown. These two post holes contained dark grey brown silt

with frequent pieces of decayed wood suggesting that the posts had not been removed but allowed to decay in situ. Towards the centre of the trench the eastern edge of the now culverted watercourse [47] was seen. This linear feature contained two fills, the lower of which was a 0.27m thick grey clay [46] containing glass, CBM and pottery, for which a spot date of late 1850-1910 was obtained. This fill was overlain by a grey yellow clay [45]. Along the eastern edge of this feature four post holes were seen, cuts [31], [33], [35] and [37]. These all contained a dark brownish grey clay silt and most likely were placed to demarcate the edge of the watercourse at the bottom of the residential gardens.

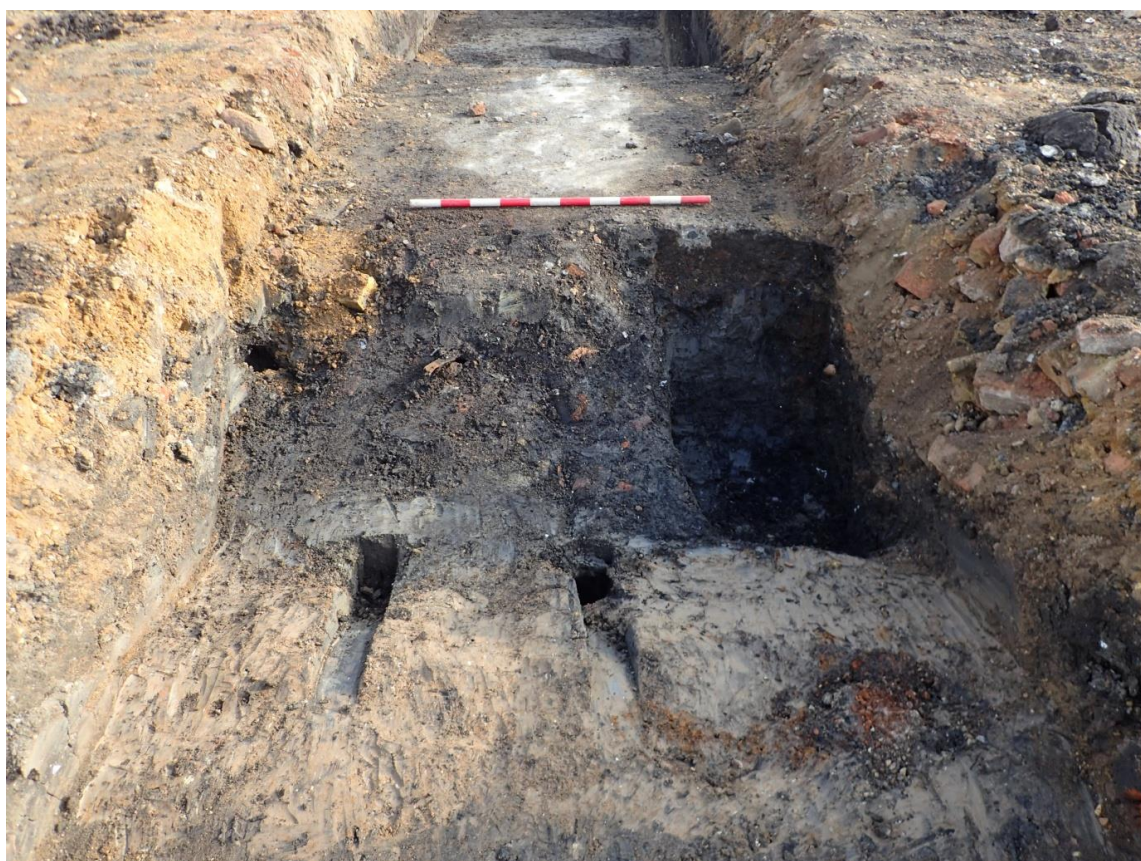
Plate 8: Trench 9, looking southwest, the culvert for the River Wandle [43]/[44] with post holes [49] and [50]

- 7.3.1 Within Trench 9 the modern culverted watercourse [44] (Plate 8) was seen to cut through the post medieval backfill of the watercourse [47]. The modern construction cut [44] contained the concrete culvert and had been backfilled with a black silty clay [43] containing frequent glass, bone, CBM, CTP and pottery which was spot dated to the mid to late 19th centuries, although the culvert was clearly constructed at a later date than that suggested by the finds. Two posts [49] and [50] were seen just outside of the western edge of the construction cut. Both posts [28] and [29] were still in situ and most likely formed edge support during the construction of the culvert.
