**HISTORIC BUILDING RECORDING  
WATCHING BRIEF DURING  
INVESTIGATIVE WORKS AT  
THE OLD DEANERY,  
DEAN'S COURT,  
CITY OF LONDON,  
EC4V 5AA**

**Historic Building Recording Watching Brief during Investigation Works at the  
Old Deanery, Dean's Court, City Of London EC4V 5AA**

Historic Building Recording Watching Brief  
during Investigation Works

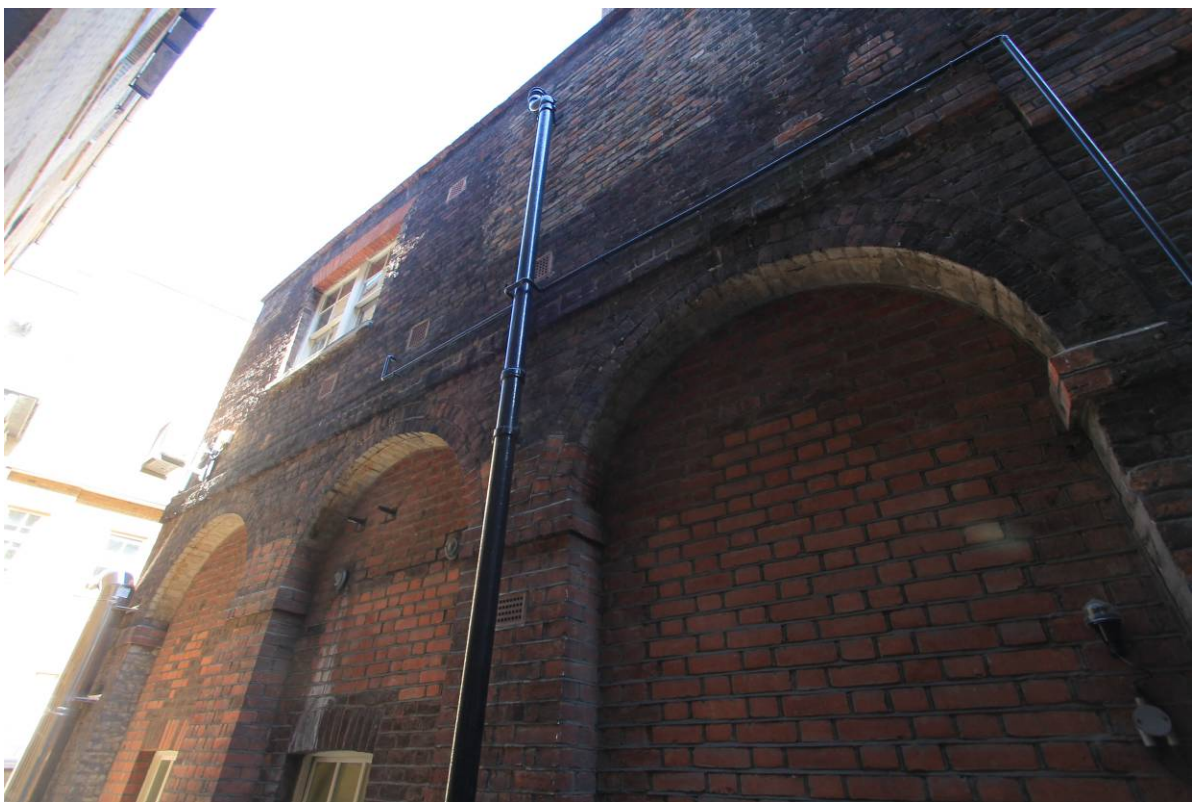
Plate 1b Rebuilt and blocked arches of early 19<sup>th</sup> century 'covered way' extension, looking north-west

1.1.38 The investigation of a floor void through a ceiling hatch (**G1**) in ground floor Corridor GF09 revealed the original external elevation of the 17<sup>th</sup> century south wall of the house to the north and the external elevation of the west wall of the stair bay of the 17<sup>th</sup> century house to the east. This area (GF08 to GF11; **Figure 7**) is thought to have been enclosed in the early 19<sup>th</sup> century (Musson, 2014, Fig.27) and is described in the 1955 Bill of Quantities as a 'covered way' (*ibid.* p.96). The very tops of the wide brick arches, seen externally as three in-line arches (**Plate 1b**), were also visible in the floor void in the south wall of this early 19<sup>th</sup> century 'covered way'.

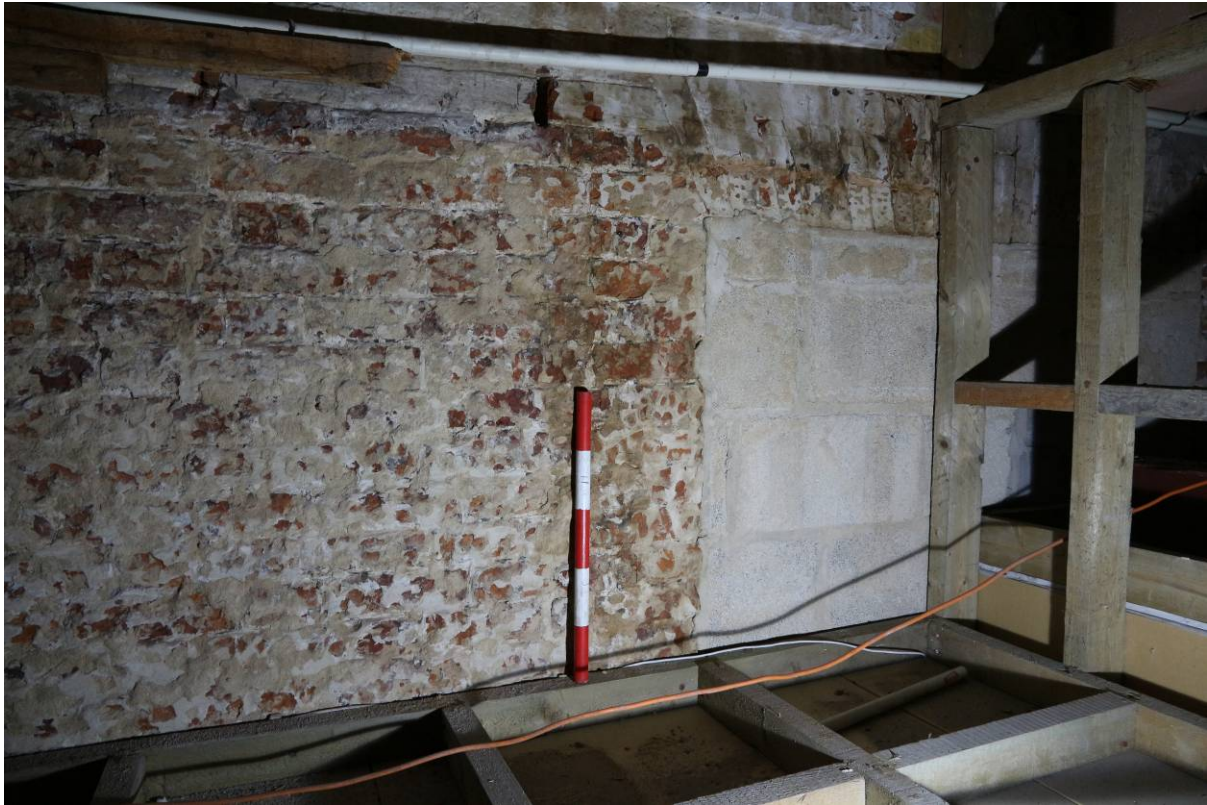
Plate 1c Blocked window in former external south wall visible in void above hatch (G1) above GF09, looking north-east

1.1.39 The 17<sup>th</sup> century external south wall incorporated an original window opening (**Plate 1c**), which was located centrally within this section of wall and had latterly been blocked using modern blockwork. The window opening was built with a flat head of gauged brick voussoirs with deep skewbacks and is shown as a double mullioned window on William Leybourns' survey of 1677 (**Figure 3**). Evidence of plaster still adhering to the wall showed that this elevation had once been rendered and whitewashed in the past (perhaps when the early 19<sup>th</sup> century 'covered way' was added), which had subsequently been hacked off to reveal the brickwork beneath. This rendering may have been contemporary with the rendering of the facade, which is thought to have been undertaken in 1820. The 'covered way' is first depicted on the 1878 Ordnance Survey map (**Figure 4**) and is shown on the 1886 Goad Insurance Plan (**Figure 5**) as being three storeys high and 'open to 2<sup>nd</sup>'. The latter Plan shows that the 'covered way' provided access between the courtyard to the east and the stable yard to the west at the Dean's House (the Old Deanery).

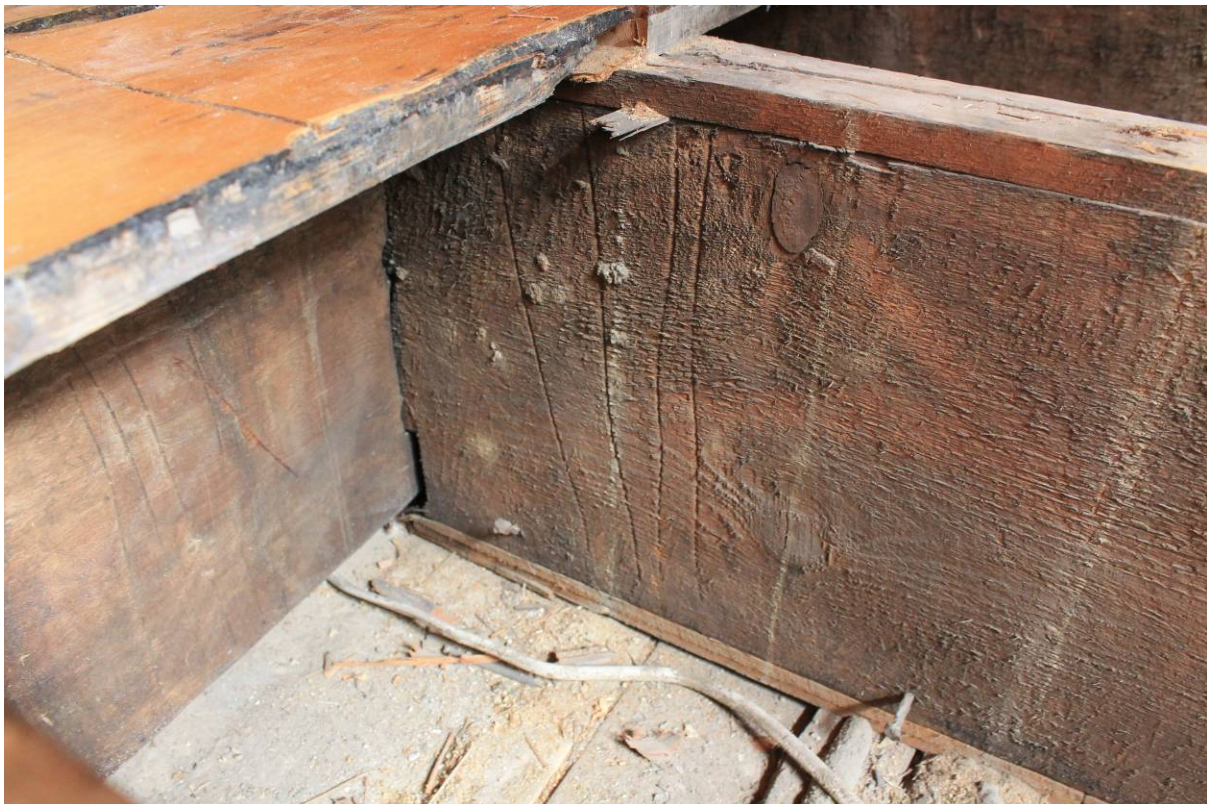
Plate 2 Floor Joist and bridging beam showing carpenter's marks (scribed IIII) following removal of floorboards (F1) in FF01, looking north-west

1.1.44 A section of the softwood floor boards (opening **F1**) was removed to investigate the floor structures in Drawing Room FF01 (**Figure 8**). This revealed three deep section common floor joists (11 x 2½-3 inch) running east-west across the shortest width of the room and a heavier north-south bridging joist, into which the common joists were tenoned. The bridging joist lies broadly central to the front east main building (i.e. Drawing Room FF01 and stair bay FF07). The common joists, laid at 15 inch centres, were both oak and softwood. They showed evidence of circular carpenter marks (scribed IIII; **Plate 2**) and were connected to the heavier bridging joist using a double tenon. The bridging joist was oak and still partly 'in the round', possibly suggesting a shortage of adequate scantling oak after the Great Fire. The observed floor structure is consistent with a 17<sup>th</sup> century date.

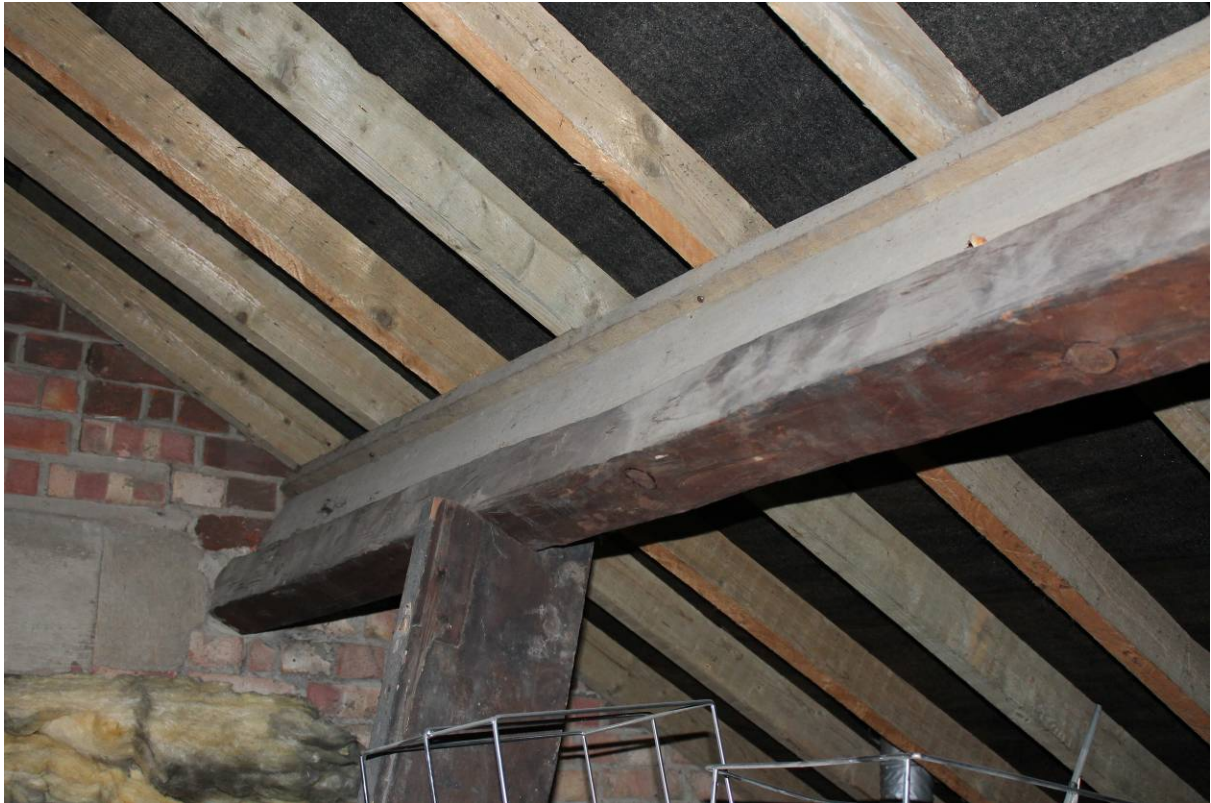
Plate 3 19<sup>th</sup> century and modern roofs over FF09 seen through hatch (F3), looking south-east

1.1.46 The hatch over FF08 (**F3**; **Figure 8**) provided access into the roof void of the early 19<sup>th</sup> century 'covered way', which had small rooms at first floor level as shown in the ground and first floor plans published by the Wren Society in 1936 (WS XIII, opp p54; not illustrated here). The present common rafters in the roof were modern replacements although they overlay and were built off a 19<sup>th</sup> century softwood, single side purlin roof structure (**Plate 3**), comprising a re-used purlin supported by crude raking struts.

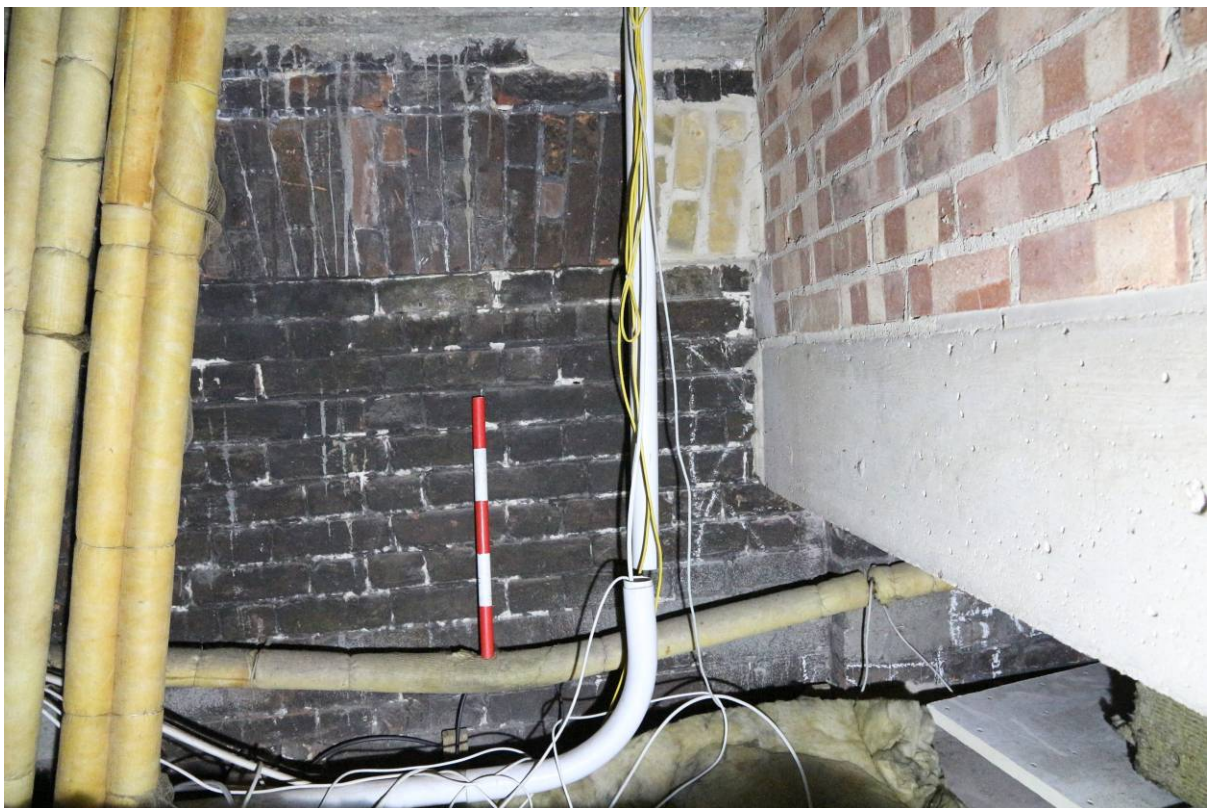
Plate 4 Blocked 17<sup>th</sup> century window in former 17<sup>th</sup> century former south wall (over FF09) seen through hatch (F3), looking north-east

1.1.47 The external 17<sup>th</sup> century south wall of the house was visible within the void above this hatch (**Plate 4**). The original brickwork of this wall incorporated a central window with a gauged brick flat head with a 1½ brick deep voussoir (identical to that recorded in **G1** at ground floor; **Plate 1c**). It was 'blocked' using very similar brickwork to the rest of the 17<sup>th</sup> century external south wall and may have originally been built blind (**Plate 4**). The wall and blind window were soot blackened and did not appear to have been rendered as at ground floor level (see **Plate 1c**). A north-south concrete beam with Fletton brickwork above had been inserted at right angles into the historic south wall on the east side of the blind window (**Plate 4**). This 1980s work is directly associated with the lift shaft and adjoining flat roofed access/hall space above.

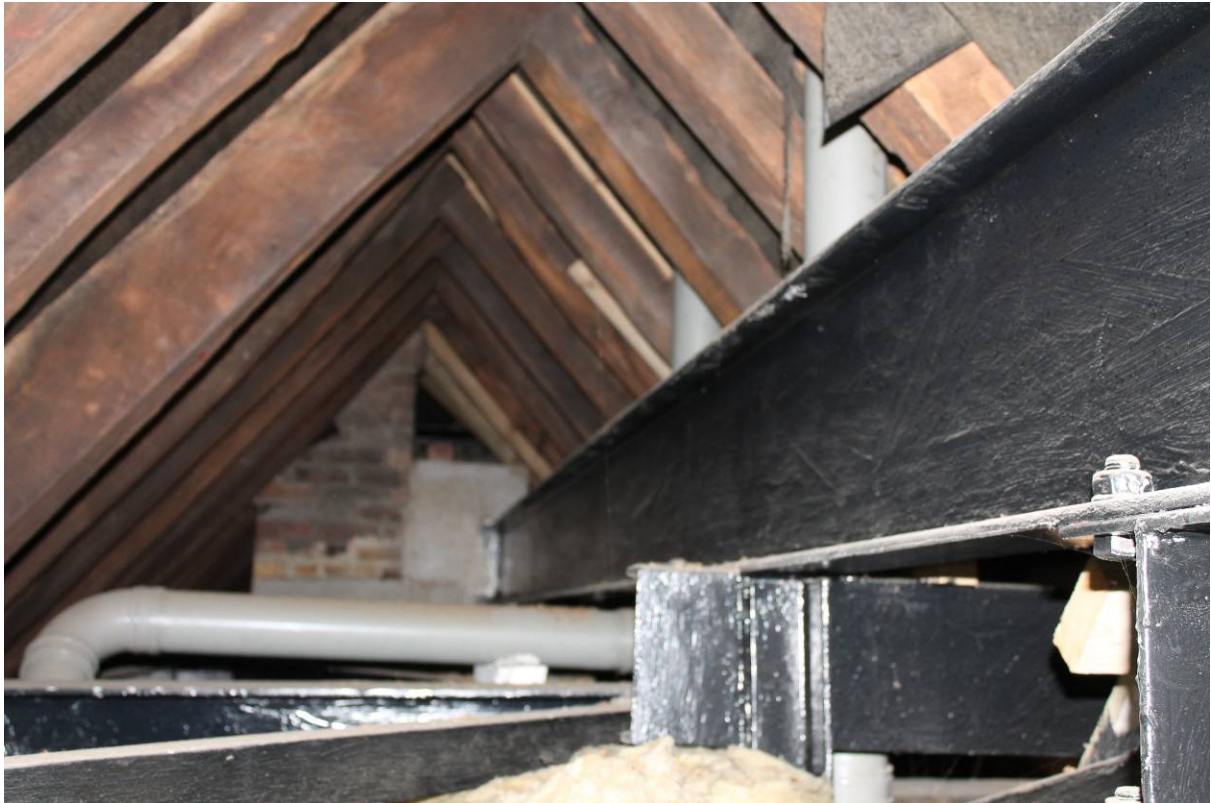
Plate 5 North roof and RSJ (from S2), looking east

1.1.50 Hatch (**S2**; H03) over Study SF05 enabled observation of the north roof structure and the returning west roof as the hatch was located close to the hip and north-west chimneystack (**Figures 9 and 10**). The common rafters of the north roof structure were all heavy scantling oak timbers, pegged at the apex, with heavier principal rafters continuing down to the eaves, via butt purlins, along the outer roof line, and cut-off below the level of the butt purlins of the inner pitch to the former central well (**Plate 16**). A flat roof over SF07 and the western part of SF03 had replaced the former well in the 1980s (**Figures 9 and 10**). The demolition of the central roof well also involved the removal of the common rafters below the butt purlins (their positions seen by empty mortices in the purlins) and the truncation of the lower halves of the hip rafters to the well. This removal and the

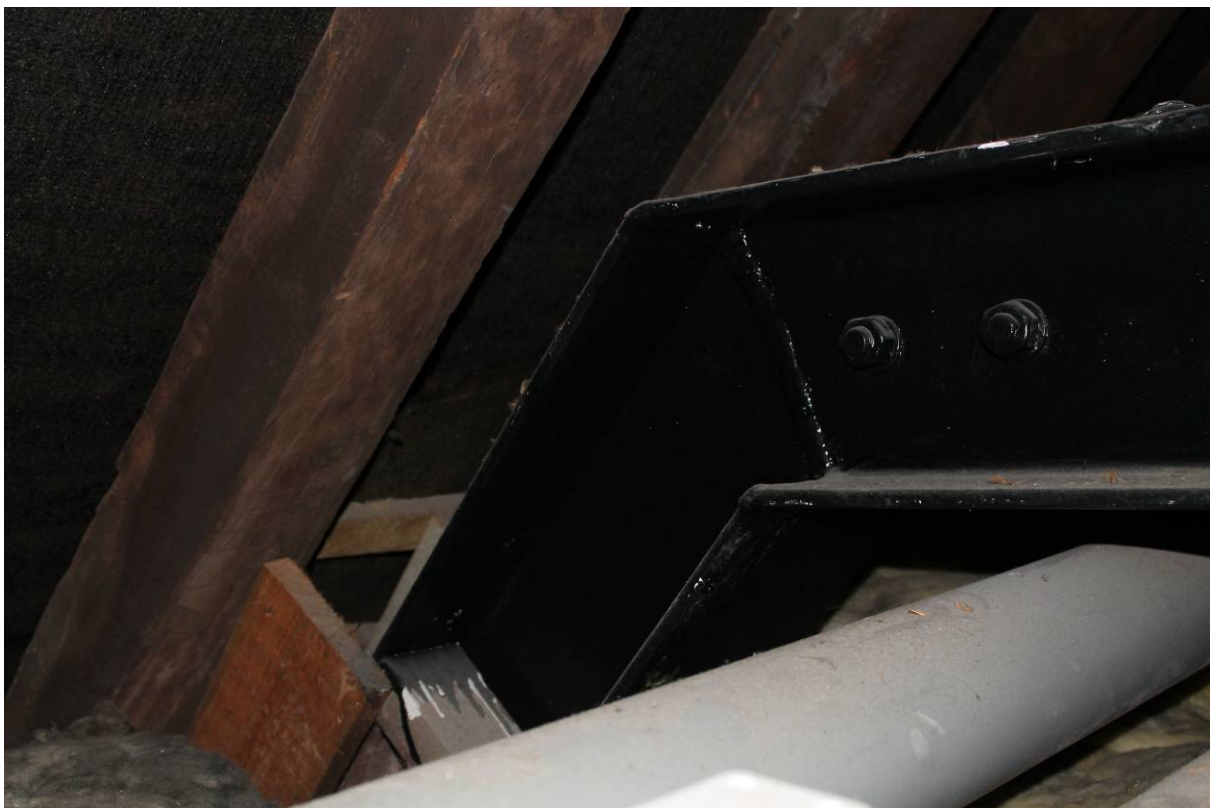
Plate 6 North roof and steel 'principal' bracing (from S2), looking north-east

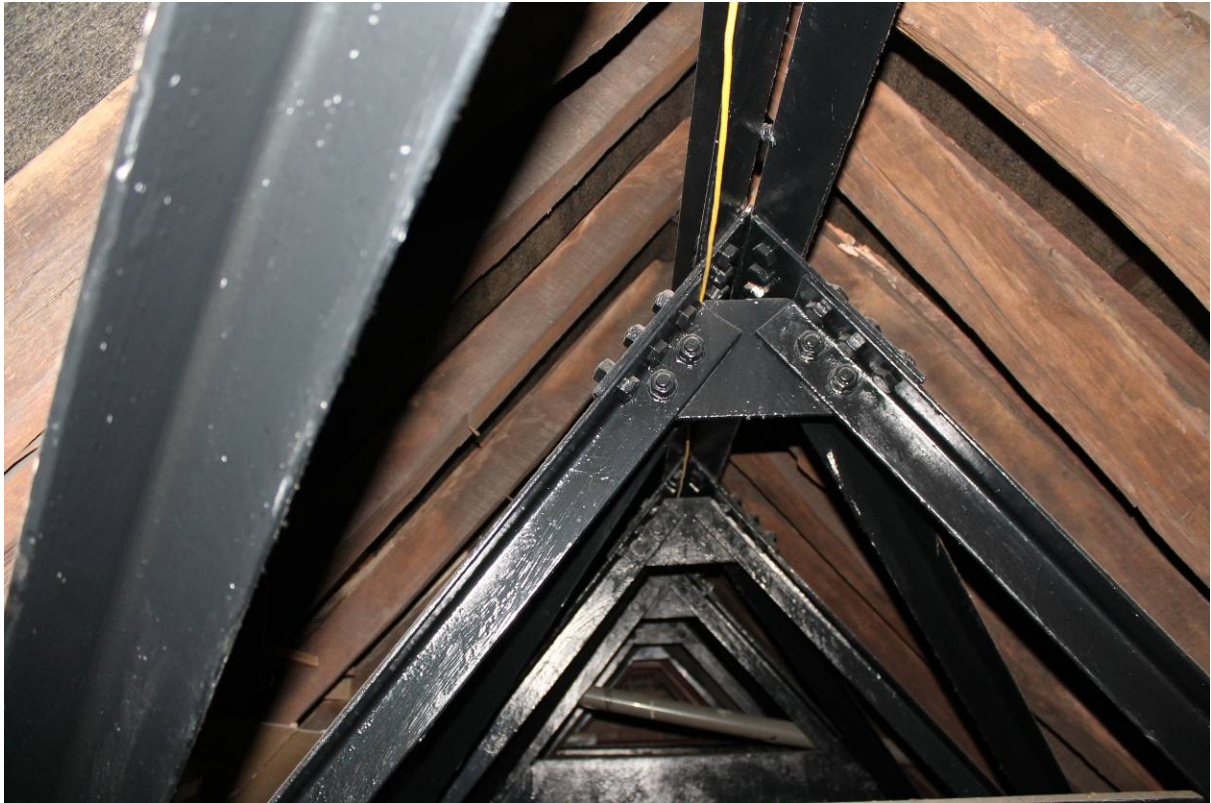
Plate 7 West roof and steel sub-structure, looking south

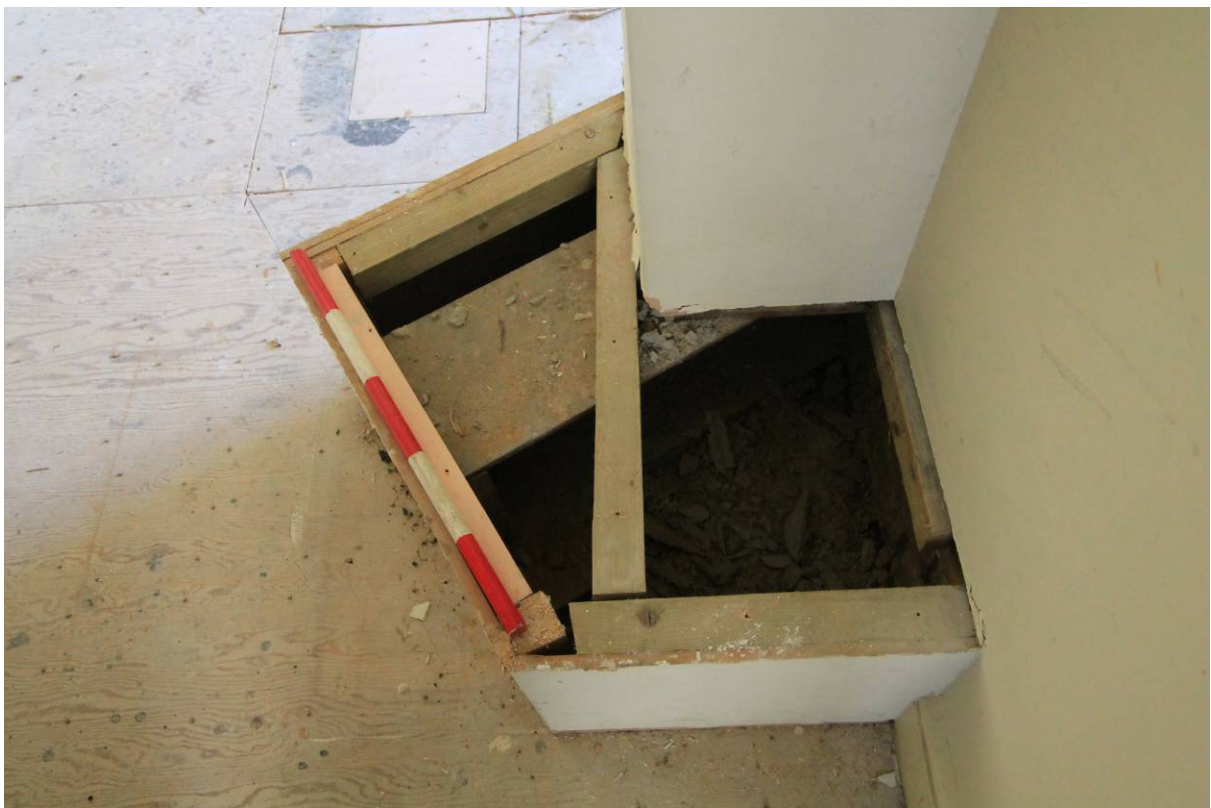
Plate 8 Steelwork carrying post, seen in (S5), looking south-west

- 1.1.53 The removal of the top of an area of boxing (**S5**) to the east, and at the base, of the north-west chimneystack in SF06 revealed a short stub of north-east to south-west RSJ cantilevered out from the corner of the chimneystack (**Plate 8**). This stub of steelwork appears to support a vertical steel stanchion, which rises in elevation alongside the chimneystack to underpin the inner 'plate' of the modern supporting steel structure within the western roof.

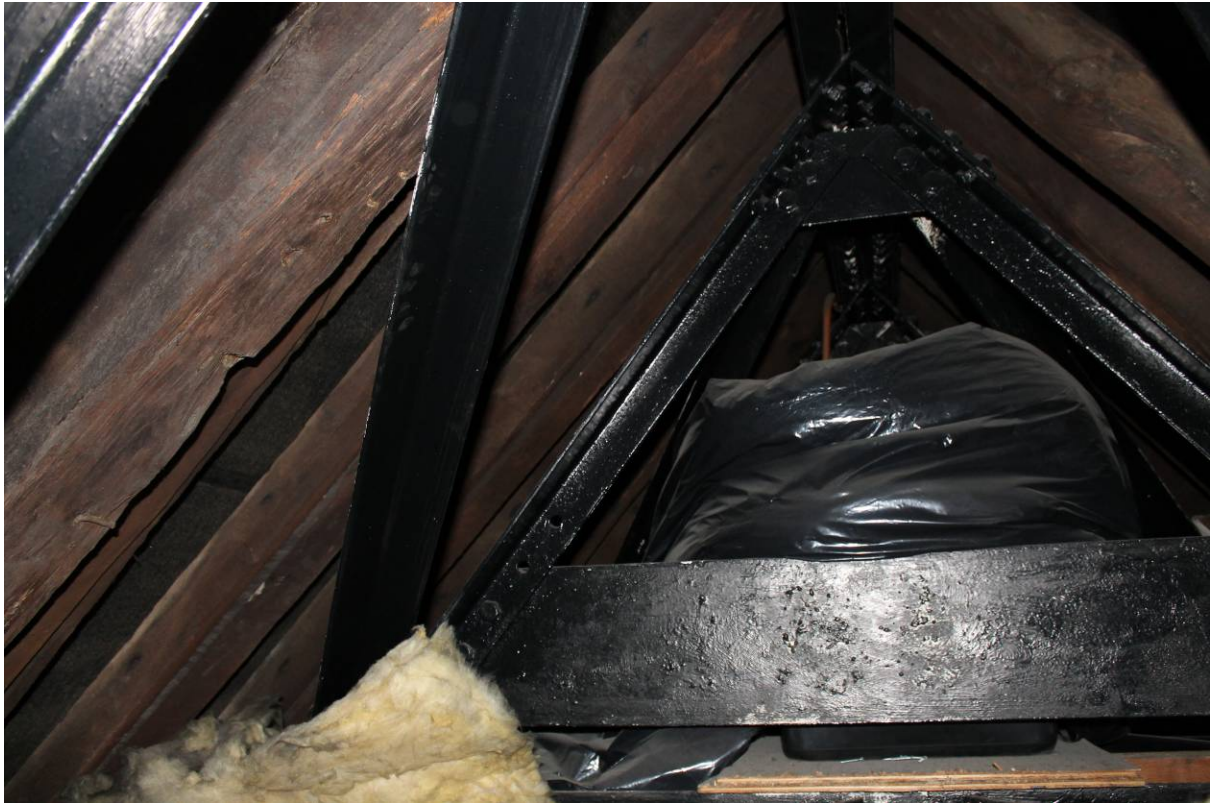
Plate 9 East roof and sub-structure, looking south from (S6)

- 1.1.54 The removal of a section (**S6**) of plasterboard ceiling in front (south) of the north-east chimneystack in SF03 revealed the eastern end of the axial RSJ seen in (**S2**). It was supported by a brick and concrete structure (**Plate 10**) that encased the historic chimneystack on three sides. The original 17<sup>th</sup> century eastern roof structure remained (same as described in **S2**) although the inner hip at this junction was a composite modern softwood replacement. A pitched steel-framed sub roof, identical to that in the corresponding western range extended the full

- length of this roof (**Plate 9**).
- 1.1.55 A small opening (**S7**) in the plywood floor on the western side of SF03 within the 17<sup>th</sup> century house revealed similar deep section common floor joists as those recorded in (**F1**; **Plate 2**) and (**S4**). The east-west joists measured 11 x 2½ inch and were overlain by modern softwood joists. The floor void was 43cm deep.

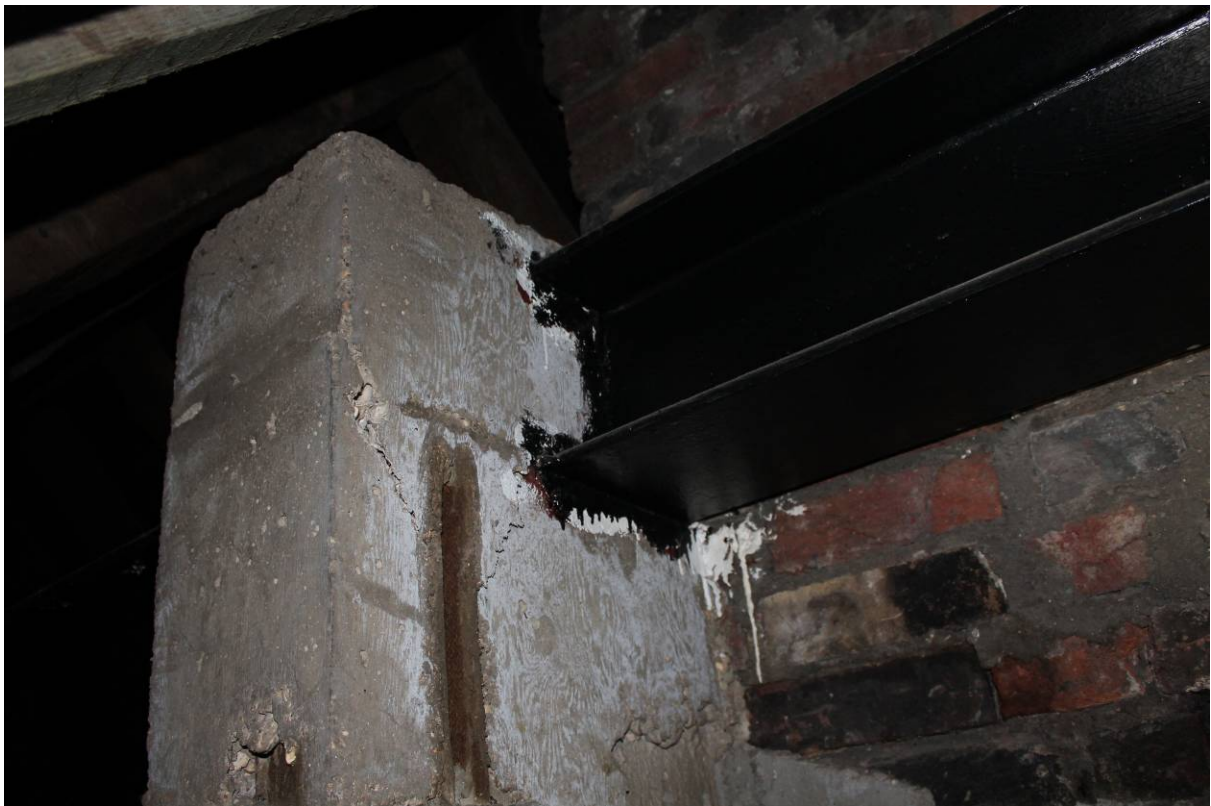
Plate 10 Supporting concrete structure tied into chimneystack looking north-west from (S6)

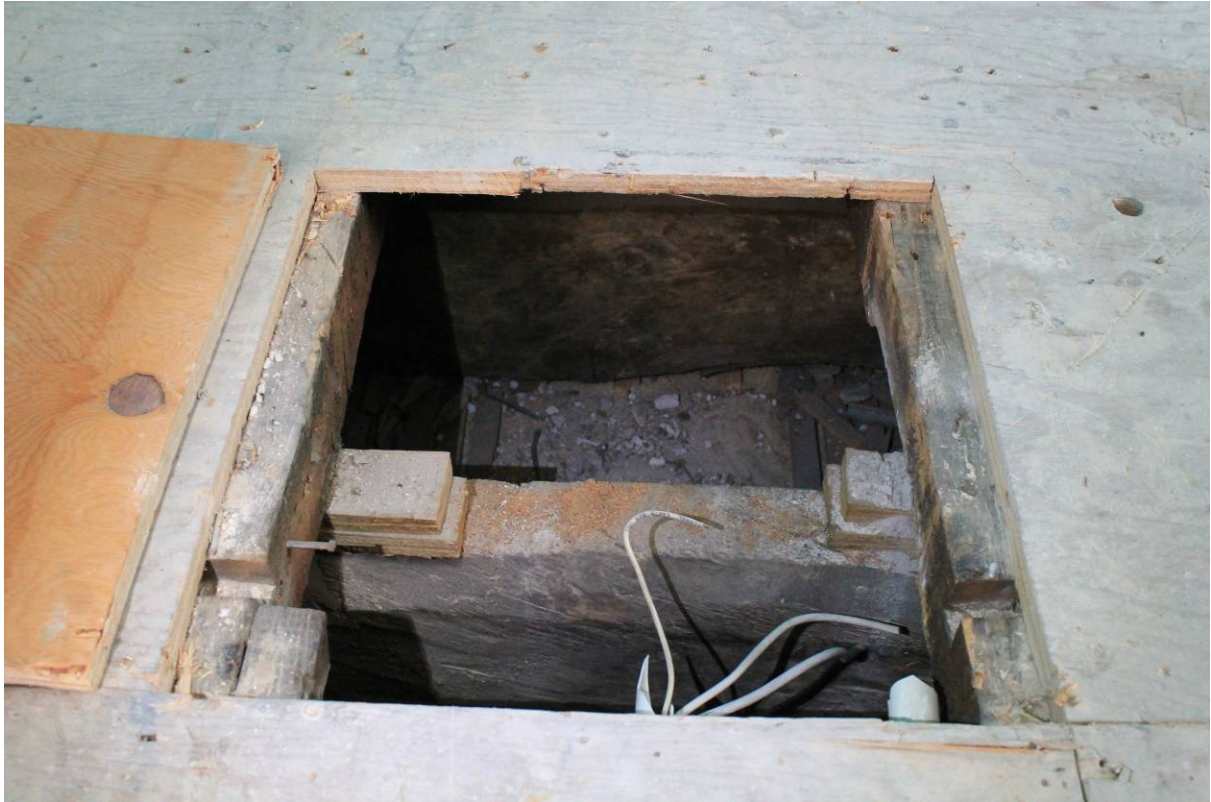
Plate 11 Floor joists seen in opening S8 (SF02), looking north

- 1.1.56 An opening (**S8**) cut through the plywood floor in SF02 revealed a similar floor structure (**Plate 11**) to that present in (**S7**) in SF03. Three east-west common joists were visible with one in plan. They were typically deep in section and comprised both oak and softwood. The oak joist was a slightly heavier scantling (11 x 3 inch) than the softwood joists. It was cleaved, not sawn, and was still slightly in the round at its 'corners'. The joists connected with a north-south bridging joist just visible some 82cm to the west, and close to the west side of the present wall between SF02 and SF07 (**Figure 9**).

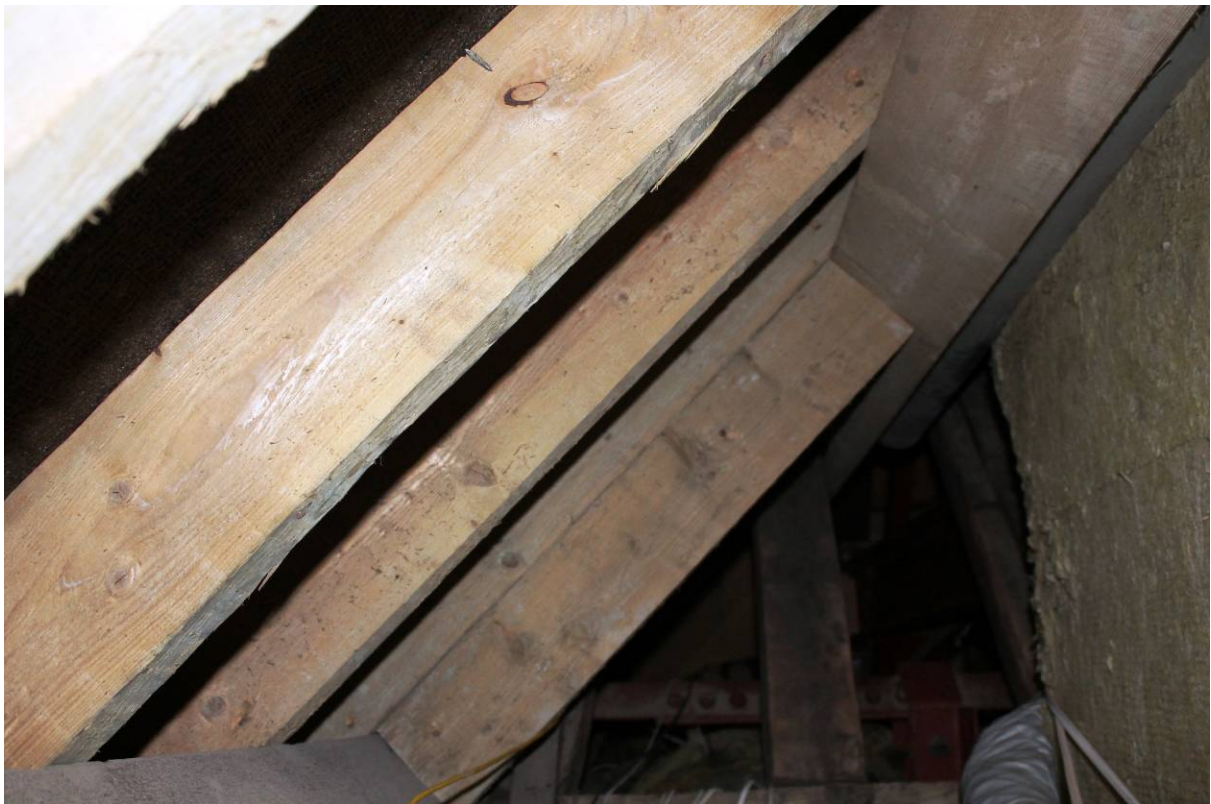
Plate 12 View east from (S11) showing modern roof over (SF08) towards the historic western roof

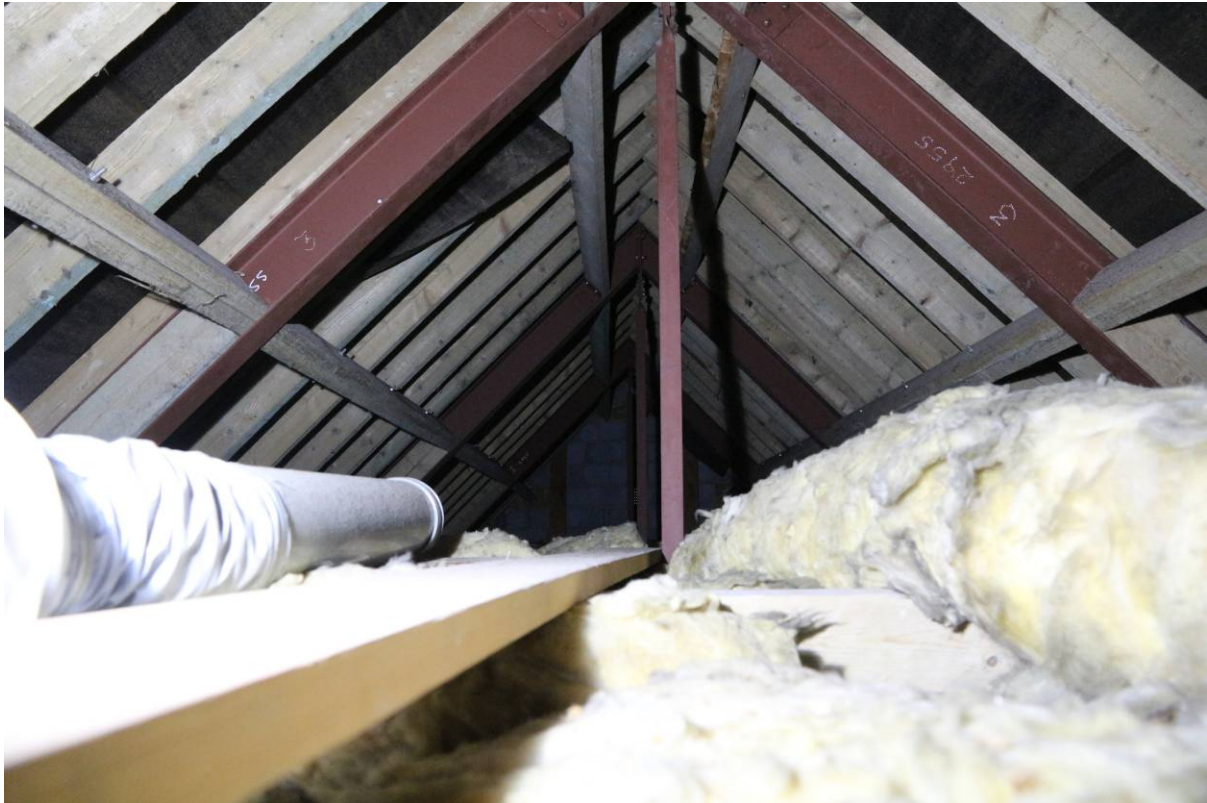
Plate 13 Roof over (SF11-SF13) looking west from (S12)

- 1.1.60 A hatch opening (**S12**; H05) over utility SF11 revealed that the roof over the perpendicular rear range (SF11-SF13) had been replaced using a modern steel and softwood roof (**Plate 13**). It had probably been replaced at the same time as the alterations to the main roof structure.

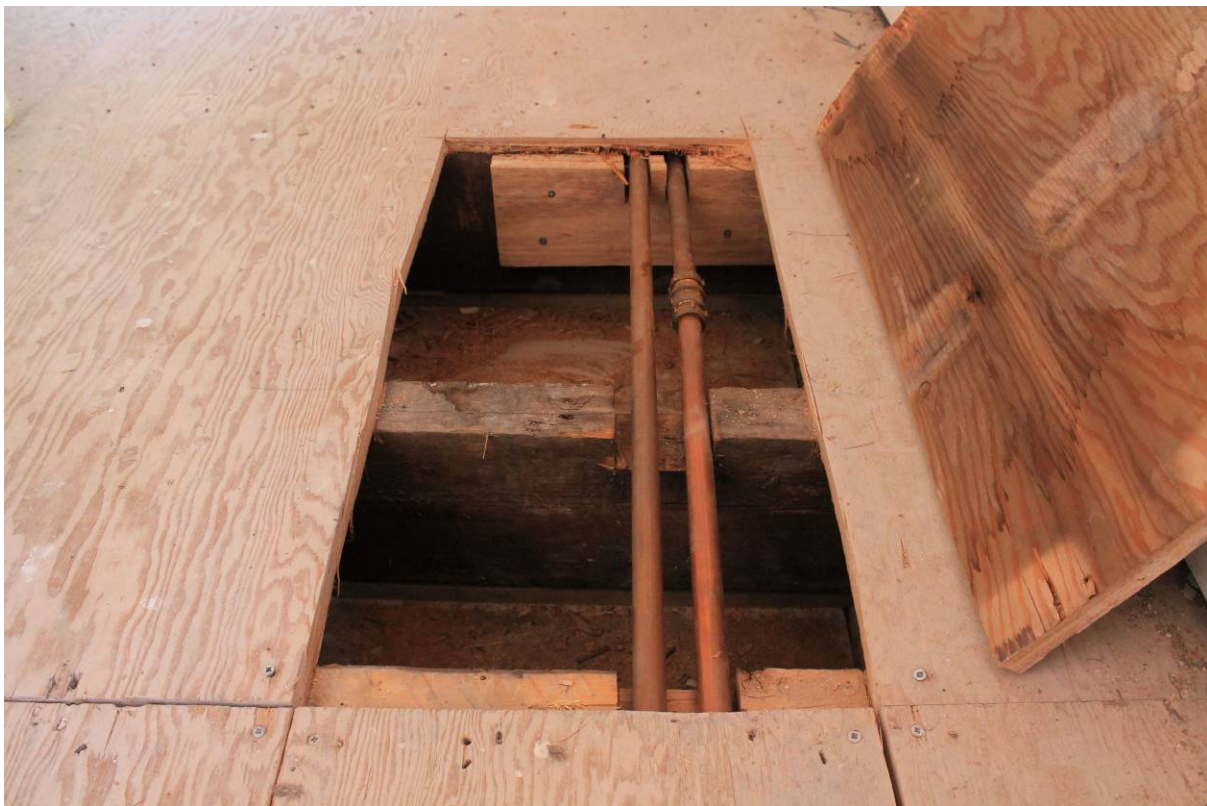
Plate 14 Floor joists in (SF13) within SF13

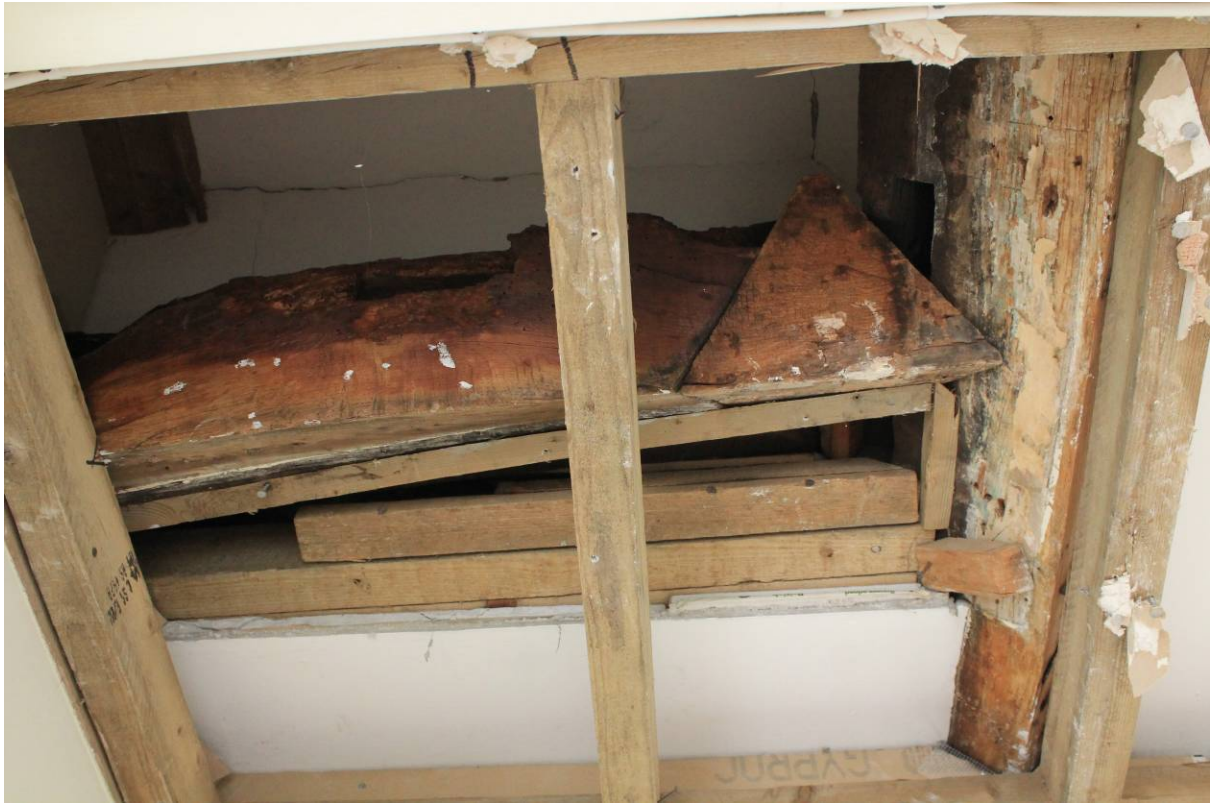
Plate 15 Collar, purlin and cut-off hip rafter over cupboard (S14) in SF07, looking south

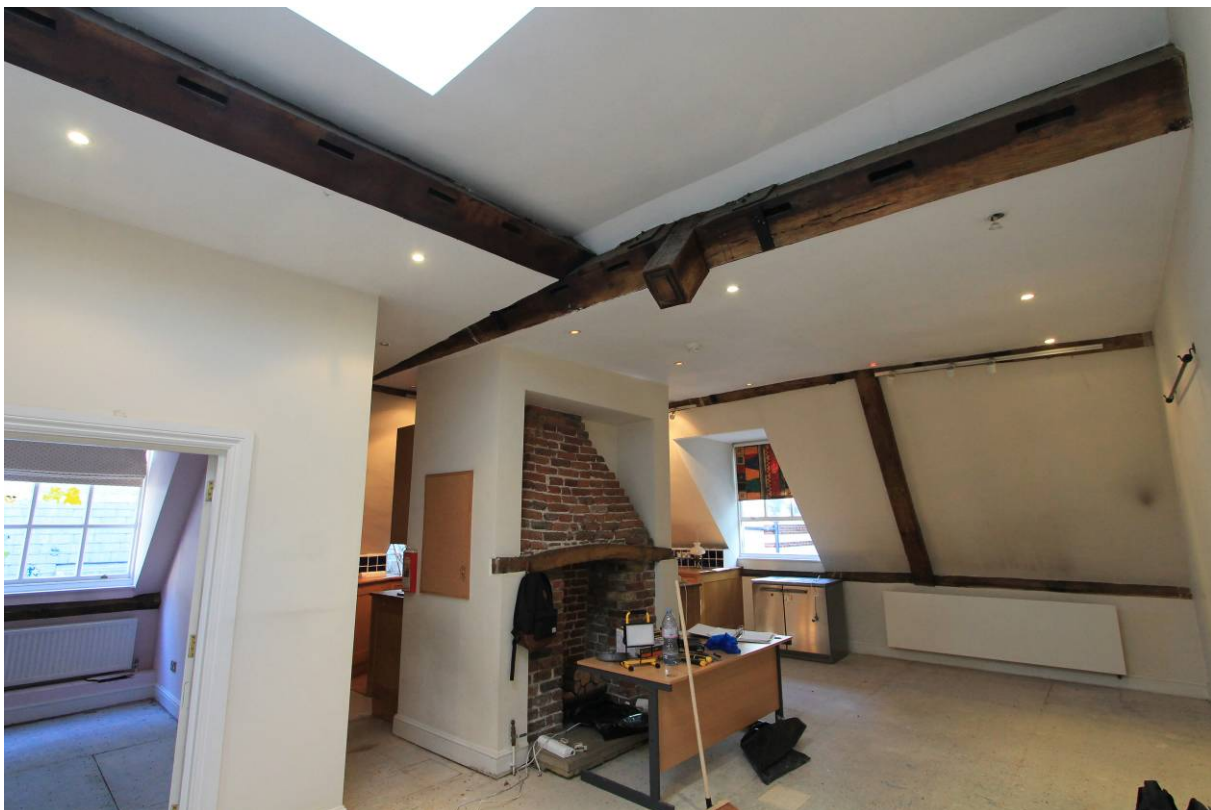
Plate 16 East roof with cut off principal rafters and butt purlins to former central roof well in SF03, looking north-east
