**ARCHAEOLOGICAL INVESTIGATIONS
AT THE PROPOSED SITE OF
STEPHENSON QUARTER PUBLIC
SQUARE, NEWCASTLE UPON TYNE**

**Areas 1 & 2
Foundation Trench
Trenches 1, 4, 5 & 6**

MARCH 2018

Pre-Construct Archaeology Limited Quality Control	
<i>Project Number</i>	K5065 & K5145
<i>Site Codes</i>	SSQ17, SQN17 & SFT17
<i>Report Number</i>	RN 11097

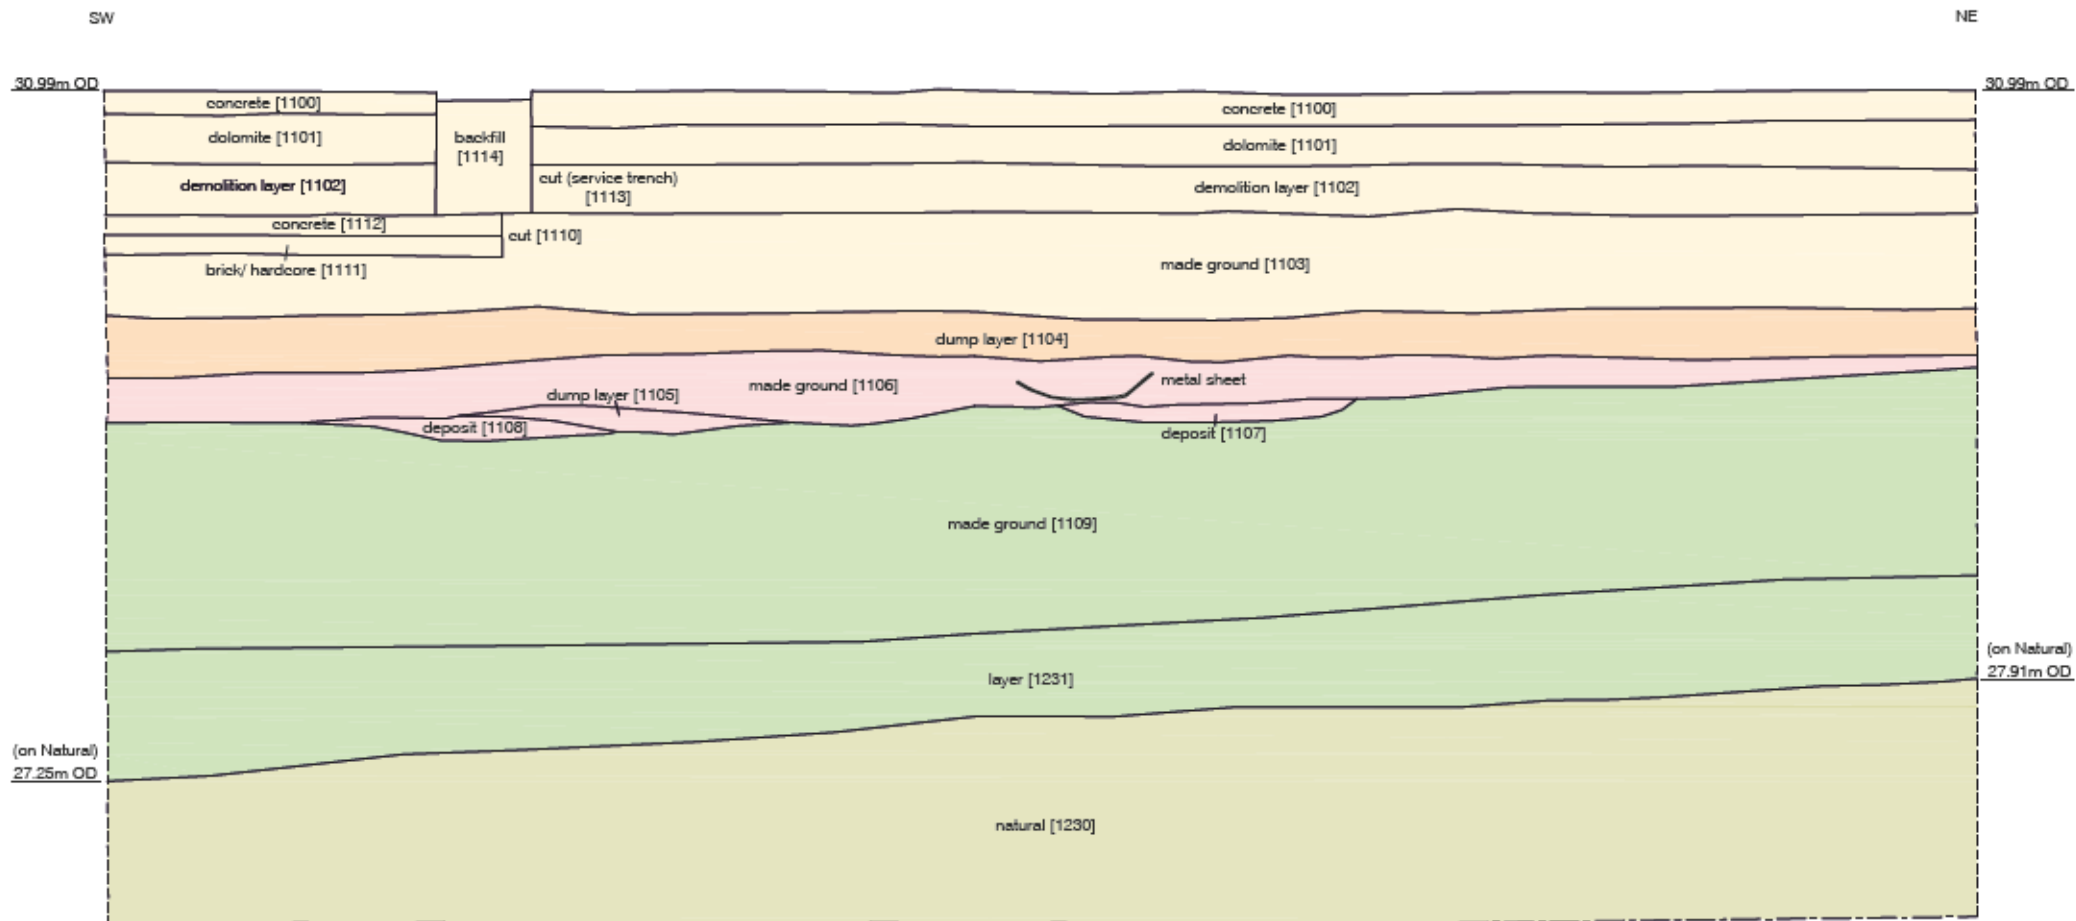
Figure 14
 Section of Foundation Trench
 1:40 at A4

Section 1
 South East Facing
 Foundation Trench

5.1.1 Phase 0 represents the geological material only exposed within the foundation trench and this comprised very firm mid greyish brown clay [1230] mottled white and yellow (Figure 19 – Section 1).

5.1.3 Natural clay was encountered at a depth of 3.08m below the existing surface at the north-east end of the foundation trench and 3.74m at the south-west end. Topographically the site is above the valley that sloped from north-east to south-west down to the Skinner Burn (c. 115m to the south-west). Area 2 was reduced to a depth of c. 1m below ground level so geological deposits were not observed during excavation.

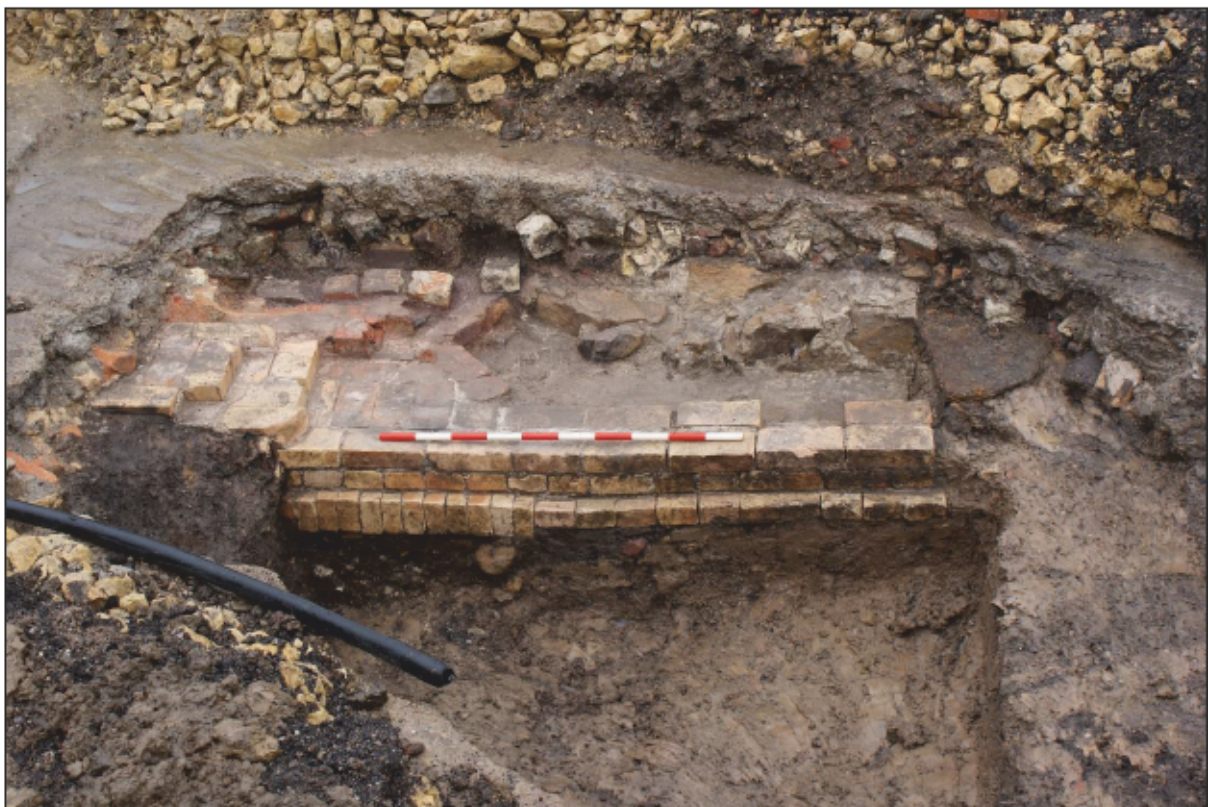
Plate 3: Floor [313]: view north-west, 1m scale

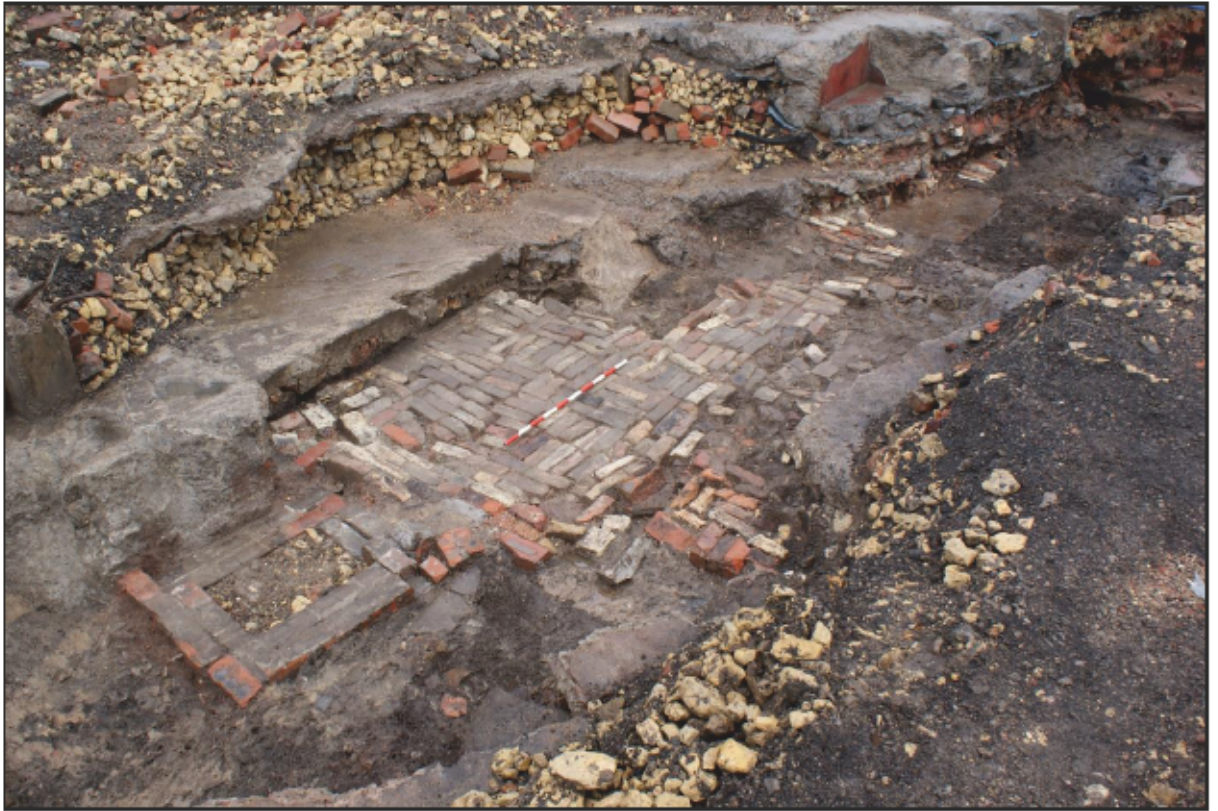
Plate 4: Trench 4, Wall [274], and column bases ([286] & [285] left to right in foreground).
Brick wall in background represent flue [269]: view north-west, 1m scale

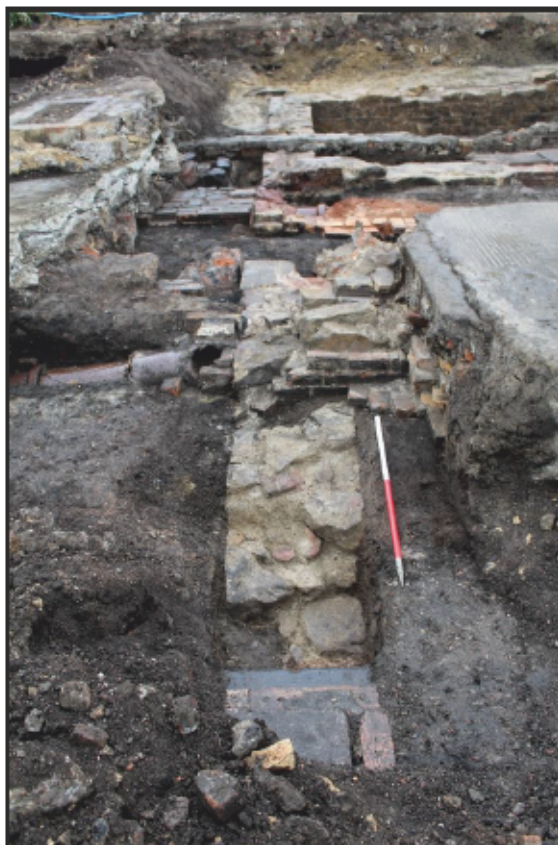
Plate 8: Inner wall [1191] showing surface [1139] in foreground: view north-west, 1m scale

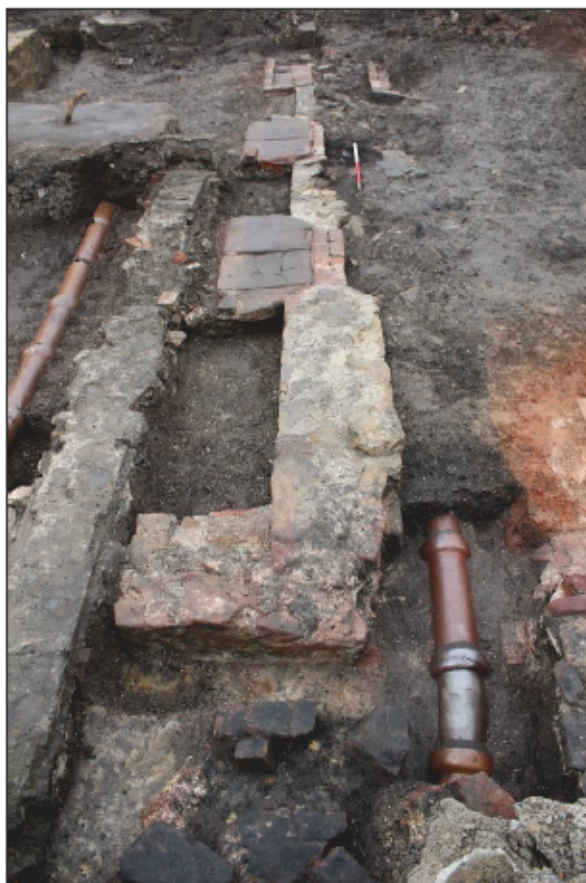
Plate 9: Inner wall [1152] after removal of wall [1143] & stoves [1214] & [1146]: view east, 1m scale

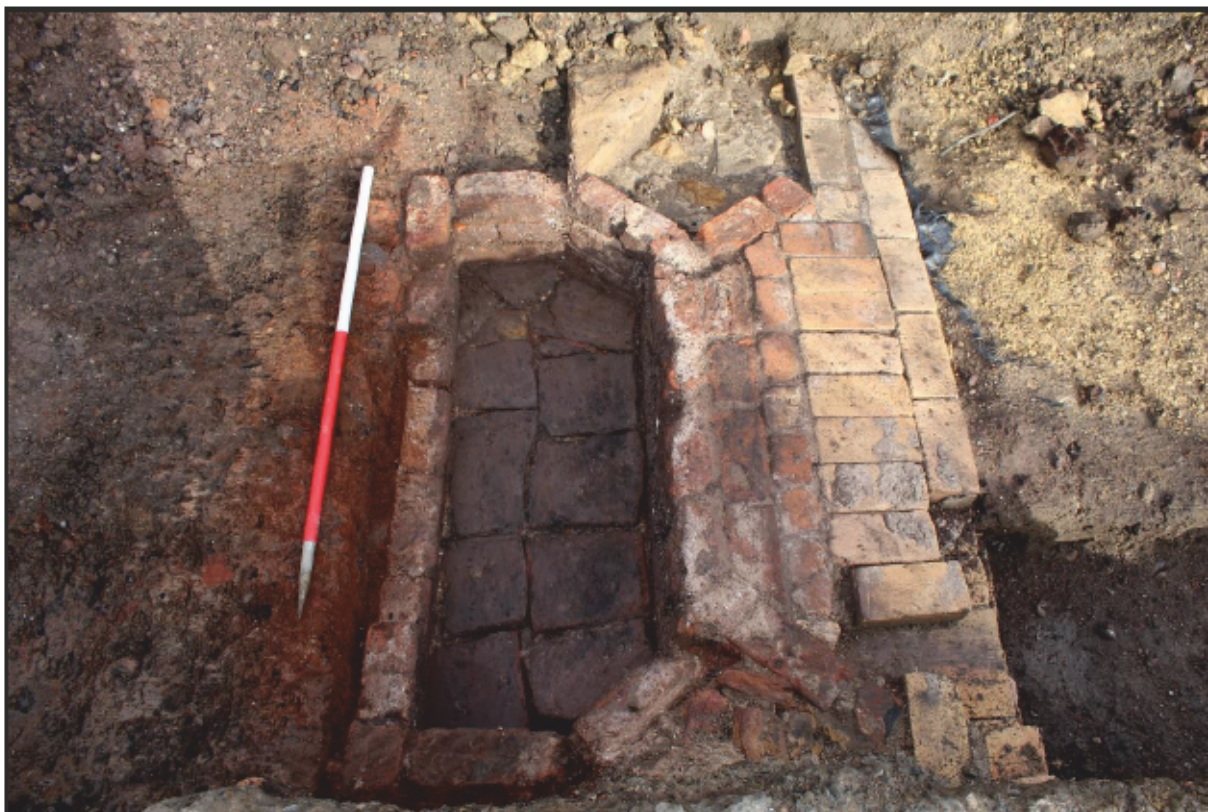
Plate 18: Stoves [1215]/[1216]/[1214] & [1144]/[1144]: view north-east, 1m scale

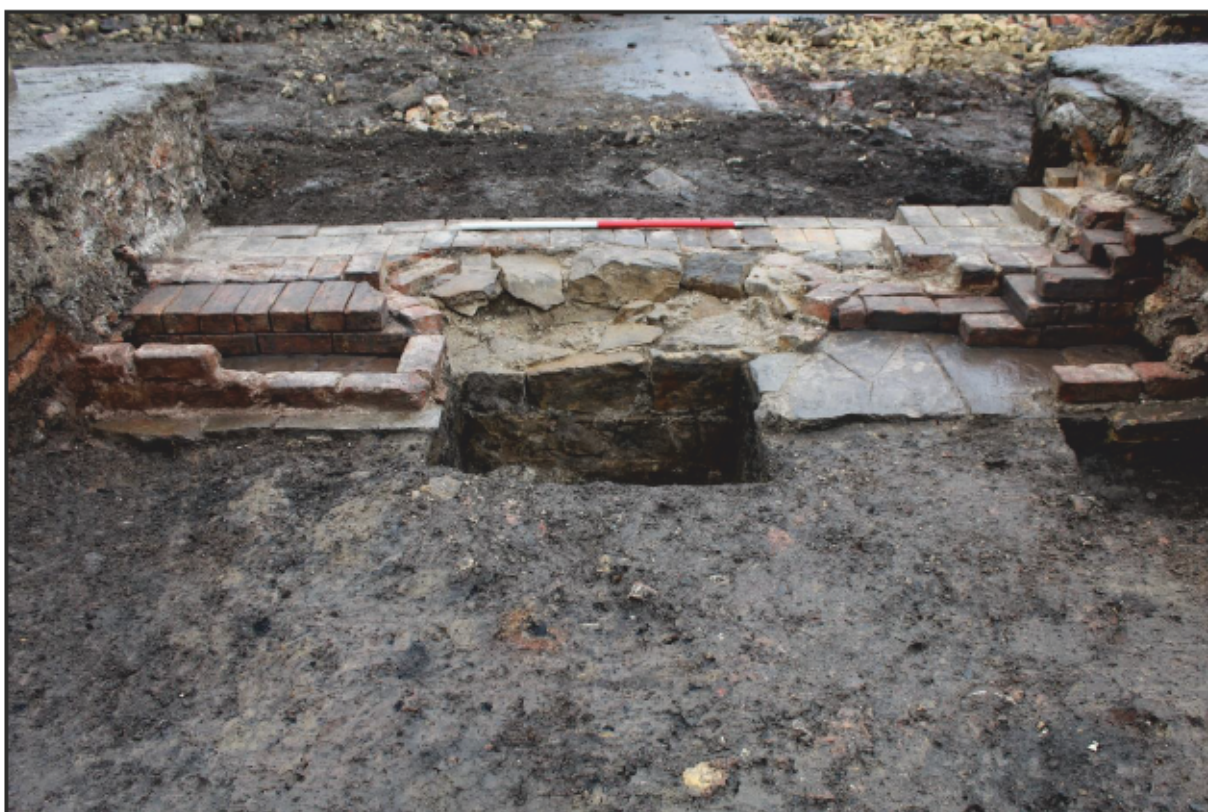
Plate 19: Backwall [1143] and stoves [1214] & [1144] with Furnace [1217] in the background:
view south, 1m scale

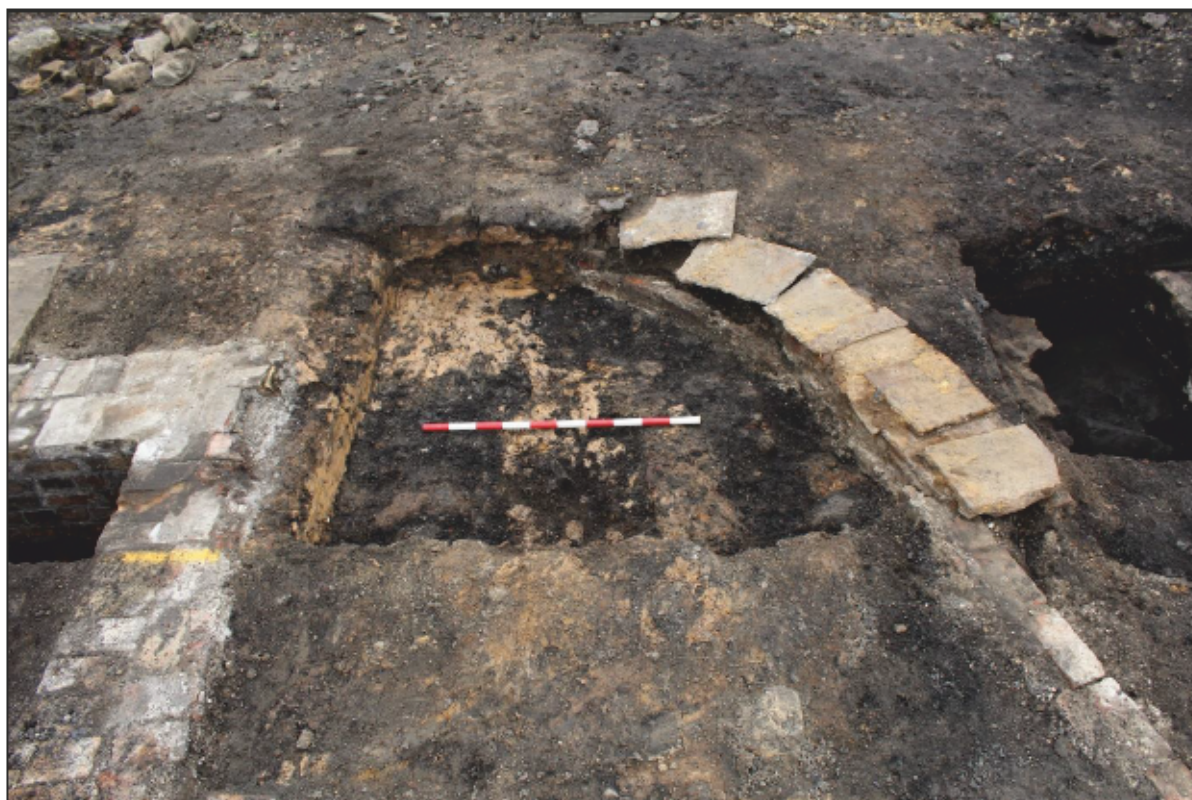
Plate 21: Flues across Area 1: view south, 2m scale
