**121 – 125 PECKHAM HIGH STREET,  
LONDON BOROUGH OF  
SOUTHWARK**

**AN ARCHAEOLOGICAL  
WATCHING BRIEF ON FOUR  
GEOTECHNICAL SITE  
INVESTIGATION TEST PITS**

**DECEMBER 2017**

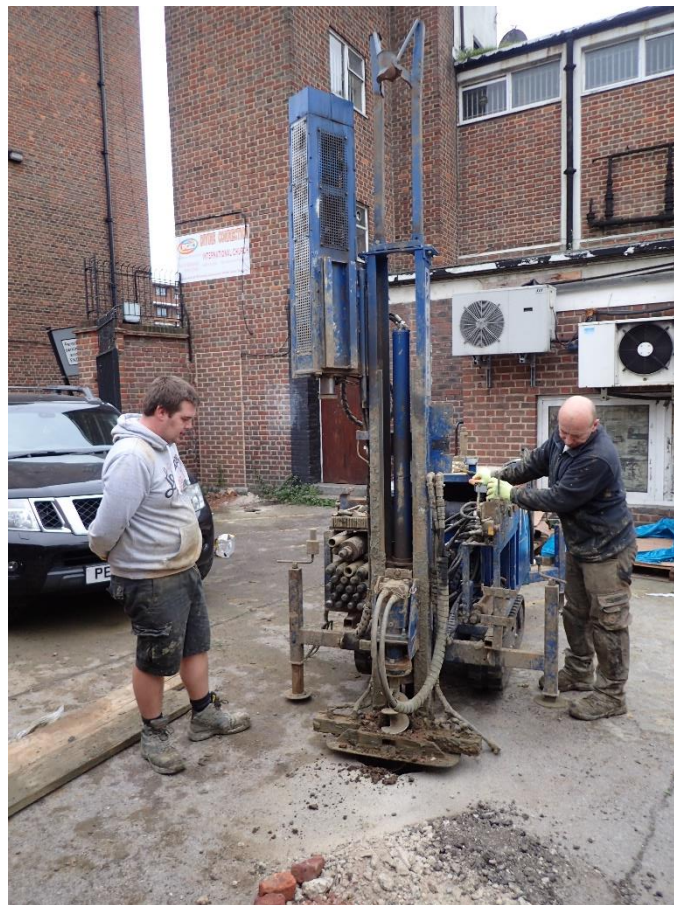
*Plate 1: Geotechnical works on the site.*

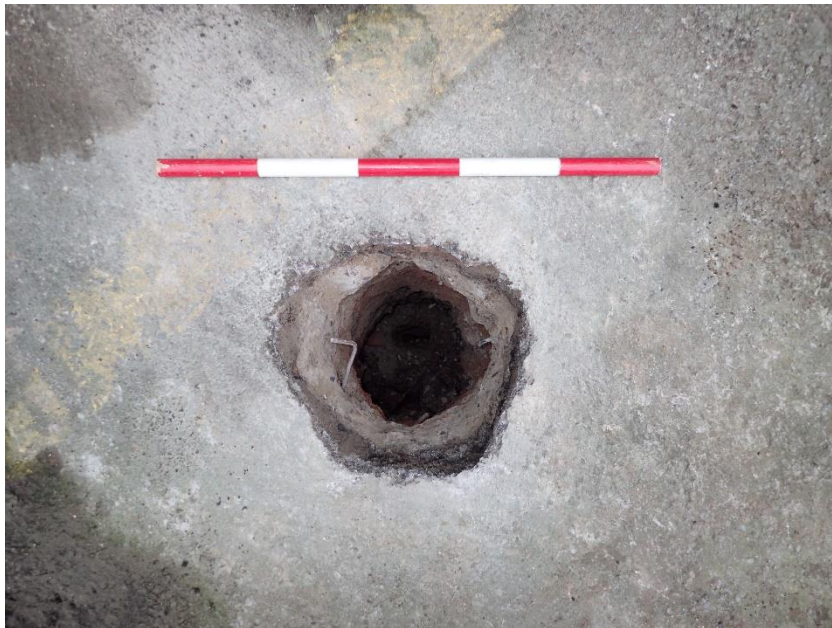
- 6.1.1 Pit 1 was located in the south-east corner of the study area 0.78m north of the present buildings outer wall and 1.9m west of the eastern perimeter wall. It was c.0.20m in diameter and excavated to a depth of 1.35m before refusal due to a second, lower layer of concrete.

- 6.1.2 The lowest layer encountered was a layer of made ground [3] consisting of a soft, dark brown silty clay with fragmentary CBM, modern concrete and degraded mortar inclusions. A tiny, abraded sherd of blue willow pattern ware was recovered from this layer. The layer was encountered at 5.40m OD (0.43m bgl) and was recorded as being 0.43m thick prior to the refusal due to the presence of concrete. Above this layer was a structure of red brick [2] at c.5.61m OD (0.22m bgl). The type of structure was unknown, but the bricks were dark red in colour and frogged suggesting a 20<sup>th</sup> century date. They had been laid on a thin layer of compacted gravel. All surfaces were capped/sealed by the current yard surface of concrete [1] 0.22-0.24m in thickness.

**Plate 2:** Test Pit 1.

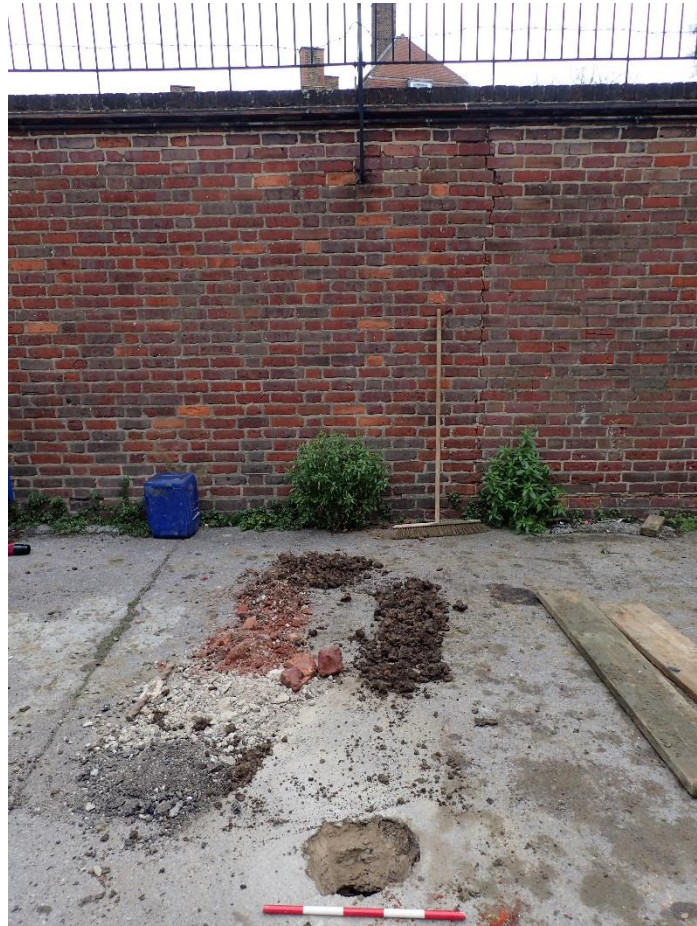
- 6.2.1 Pit 2 was located midway along the north wall delimiting the site, 7m east of the western perimeter. It was c.0.20m in diameter and excavated to a depth of 1.7m.
- 6.2.2 The revealed an identical sequence to TP 1 except that the depth of made ground [3] below the brick structure rubble [2] was 1.26m thick and had not been bottomed when boring ceased. Brick structure [2] beneath the concrete contained yellow London 'stock' brick as part of its fabric.

**Plate 3:** Location of Pit 2. Looking north.

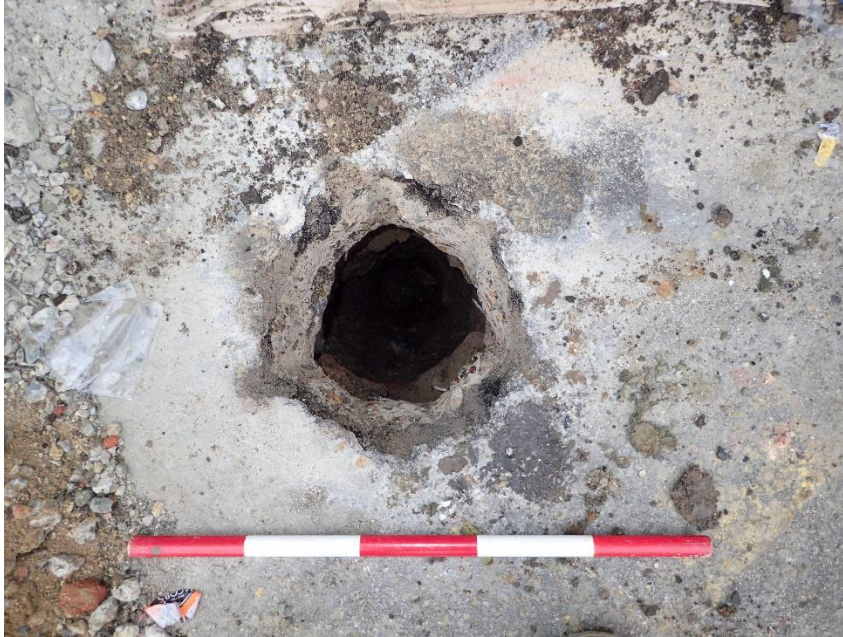
- 6.3.1 Pit 3 was located 0.50m north of the present building, about midway along the length of the site. It was c.0.20m in diameter and excavated to a depth of 2m.
- 6.3.2 The pit exhibited the same sequence to TP1 & TP2 as it was found that the concrete surface [1] lay on remains of a brick-built structure [2] as before. The brick layer was 0.26m thick. However, in this case a void was encountered directly below the bricks. The bore was lowered to a depth of 2m (bgl) without encountering any further deposits or structures. It may have been a cellar, a wall void or an opening between the brick structures - but this could not be verified from the surface.

**Plate 4: Test Pit 3.**

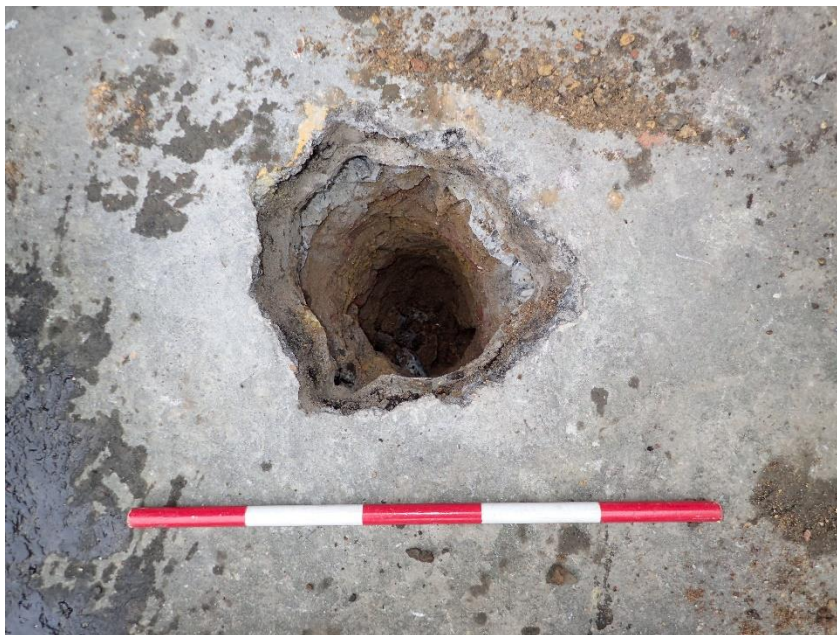
- 6.4.1 Pit 4 was located in the extreme south-west corner of the yard, 1.5m east of the current buildings to the west. It was c.0.20m in diameter and excavated to 1.7m in depth.
- 6.4.2 In the pit the concrete yard surface [1] was found to be resting on a much more substantial structure consisting of dark red bricks mixed with yellow London 'stock' bricks which was revealed to be 0.59m thick below the concrete surface [1]. However, once this was passed another void was present down to the total depth of the bore of 1.7m (bgl).

**Plate 5: Test Pit 4.**
