HISTORIC BUILDING RECORDING OF THE FORMER DOWNHILLS CENTRAL SCHOOL, KESTON ROAD, LONDON BOROUGH OF HARINGEY, N17 6PW

PCA REPORT NO: R13136

JANUARY 2018

Historic Building Recording

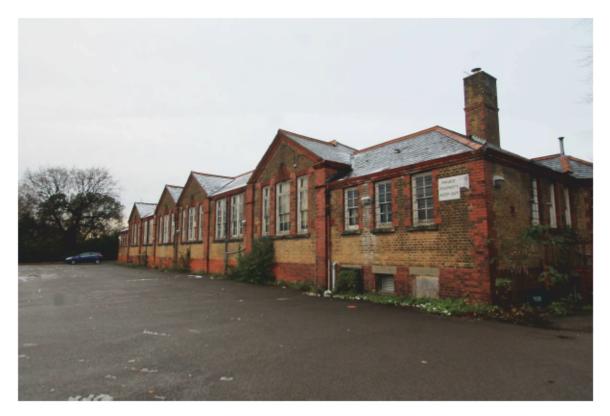
Plate 1 Southern Elevation, looking north-west

- The school is a largely balanced and symmetrical building (Historic Plate 1; Plate 1). 6.1.1 It is laid out in an H-shaped floor plan of single storey ranges, enclosing on four sides, a slightly taller full height central Assembly Hall (36) (Figures 4, 7 and 10). It also incorporates a small basement, built below the south-easternmost part of the eastern (Boys) wing (Figure 3). The longer, northern and southern ranges each terminate with an off-set canted room with a fully hipped roof (Figures 4, 7 and 10) and entrance. The eastern canted rooms originally accommodated the Boys Head and Assistant Head Teacher Rooms (Figure 3: Plates 6 and 8a). The corresponding canted rooms to the west side similarly accommodated the equivalent Head and Assistant Head Teacher for Girls (Figure 3; Plates 10 and 11). Six classrooms were aligned in-series along the north and south ranges as well as a further three to the east and west sides of the central Assembly Hall (36). The classrooms were lit by large window openings built into their external (outward facing) elevations (Historic Plate 1; Plates 1 to 4b, 6 to 8a, 9 to 11) and in some cases by borrowed light via lanterns built into a pair of corridors (16 and 37), which flanked the central Assembly Hall (36).

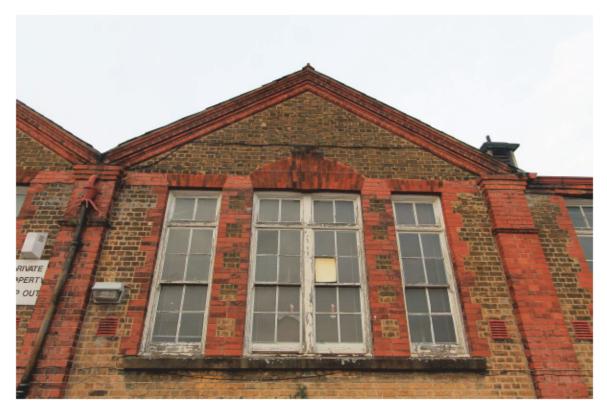
Plate 3 Detail of decorative brickwork, gaugework and fenestration

- 6.1.2 The elevations were constructed using polychromatic brickwork with contrasting red and yellow stock brickwork. The former was typically used to accentuate openings, angles (as quoining), pilasters and plinths, while the latter formed the main constituent of the external elevations. Oversailing, red brick mouldings are used along the eaves-line while fine, gauged brick voussoirs, with prominent keystones, embellish the taller windows openings to each gabled elevation, along both principal north and southern elevations (**Plate 3**). Simple half round terracotta mouldings are used to decorate the four main entrances into school building (**Plate 11**). Plain grid-like in-wall ventilators punctuate the elevations. The external brickwork is laid in English bond and incorporates queen closers to pilasters and to some openings and 'special' bricks to form the angles of the canted bays.

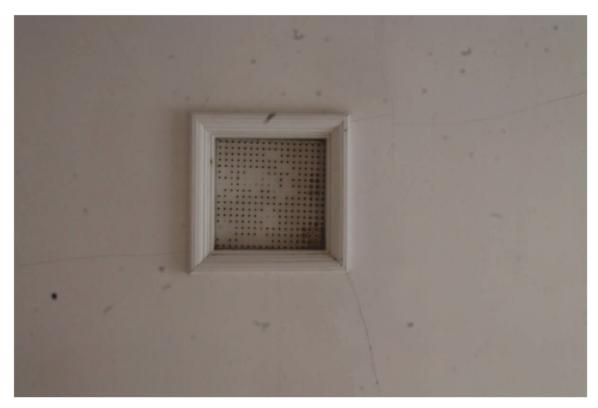
Plate 19 Ventilated ceiling hatch (10)

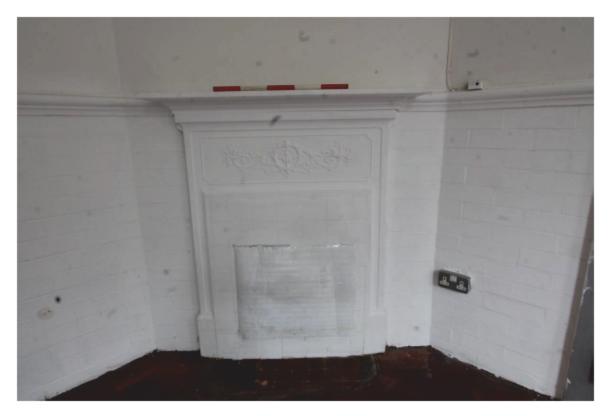
Plate 22 Cast-iron fire surround (13)

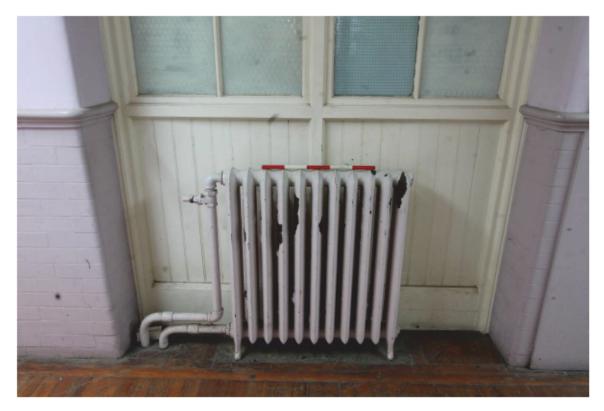
Plate 28 Typical floor mounted heater radiator (16)
