**HISTORIC BUILDING RECORDING
OF NO. 237 WALWORTH ROAD,
LONDON BOROUGH OF
SOUTHWARK,
SE17 1RL**

PCA REPORT NO: R13131

DECEMBER 2017

Historic Building Recording

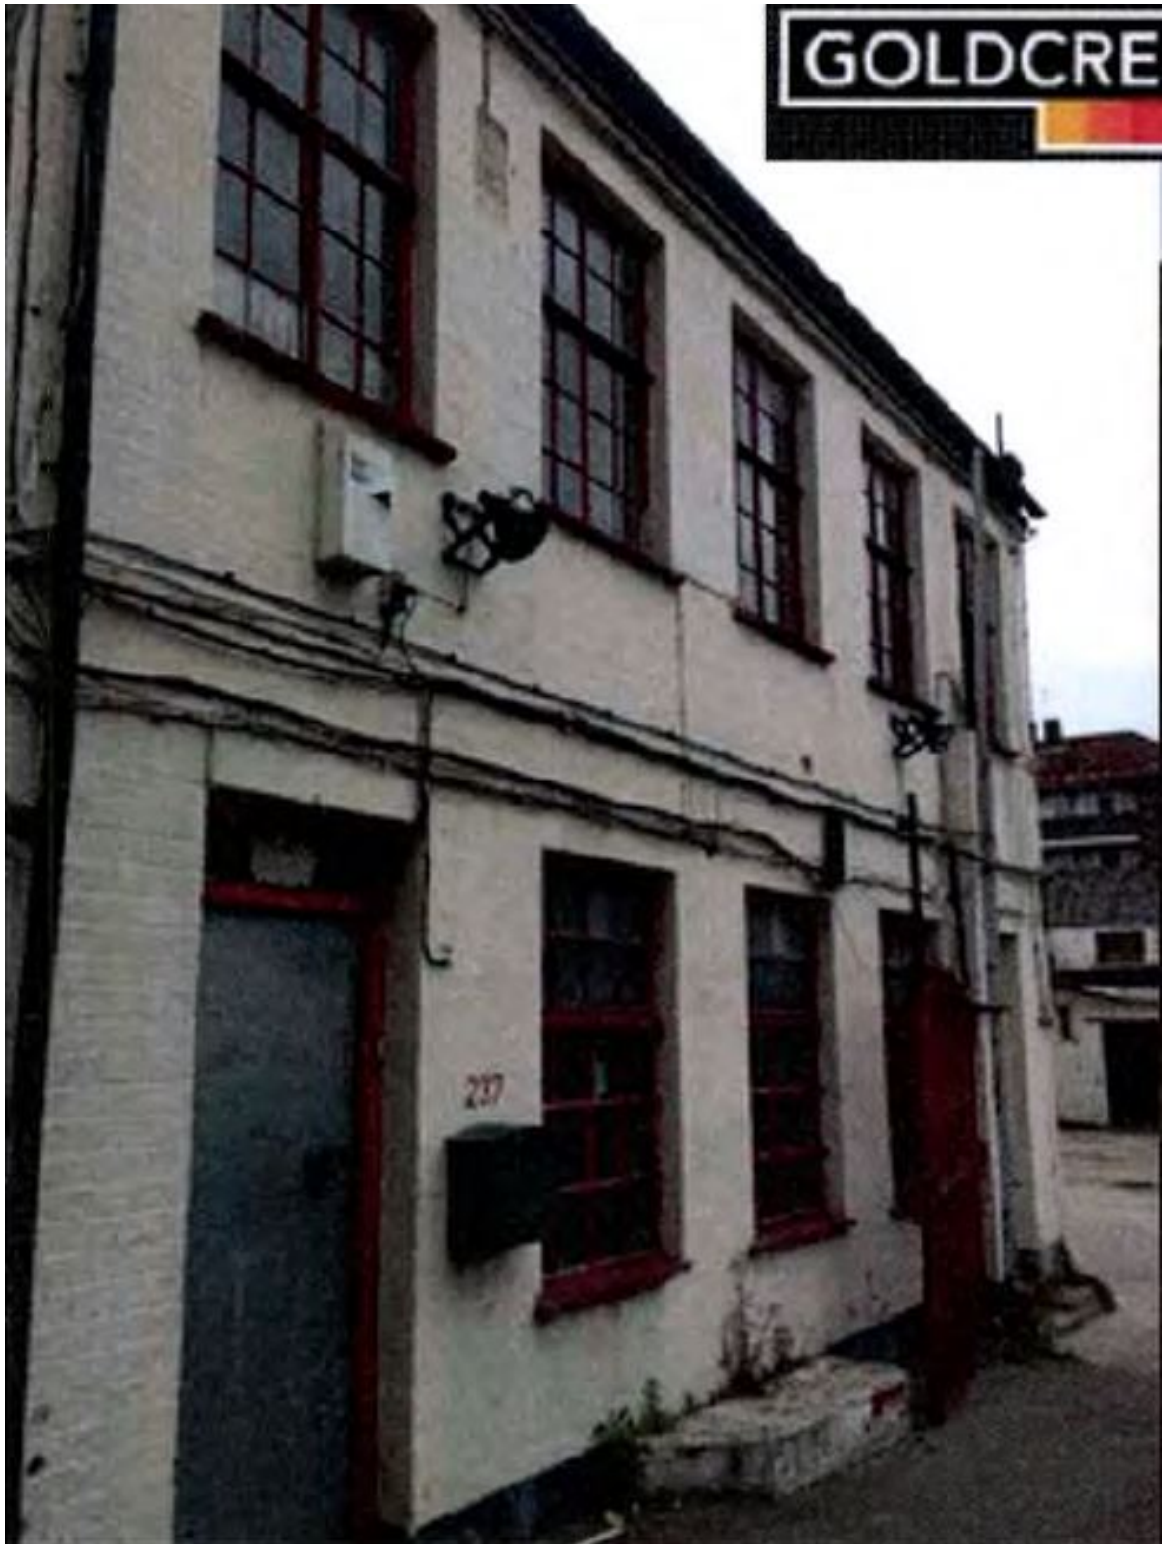
Historic Plate 7 Photograph of the front (south) elevation of Building 1 taken before 07 August 2013, looking north-east from the site entrance (Sloane Demolition, 2013)

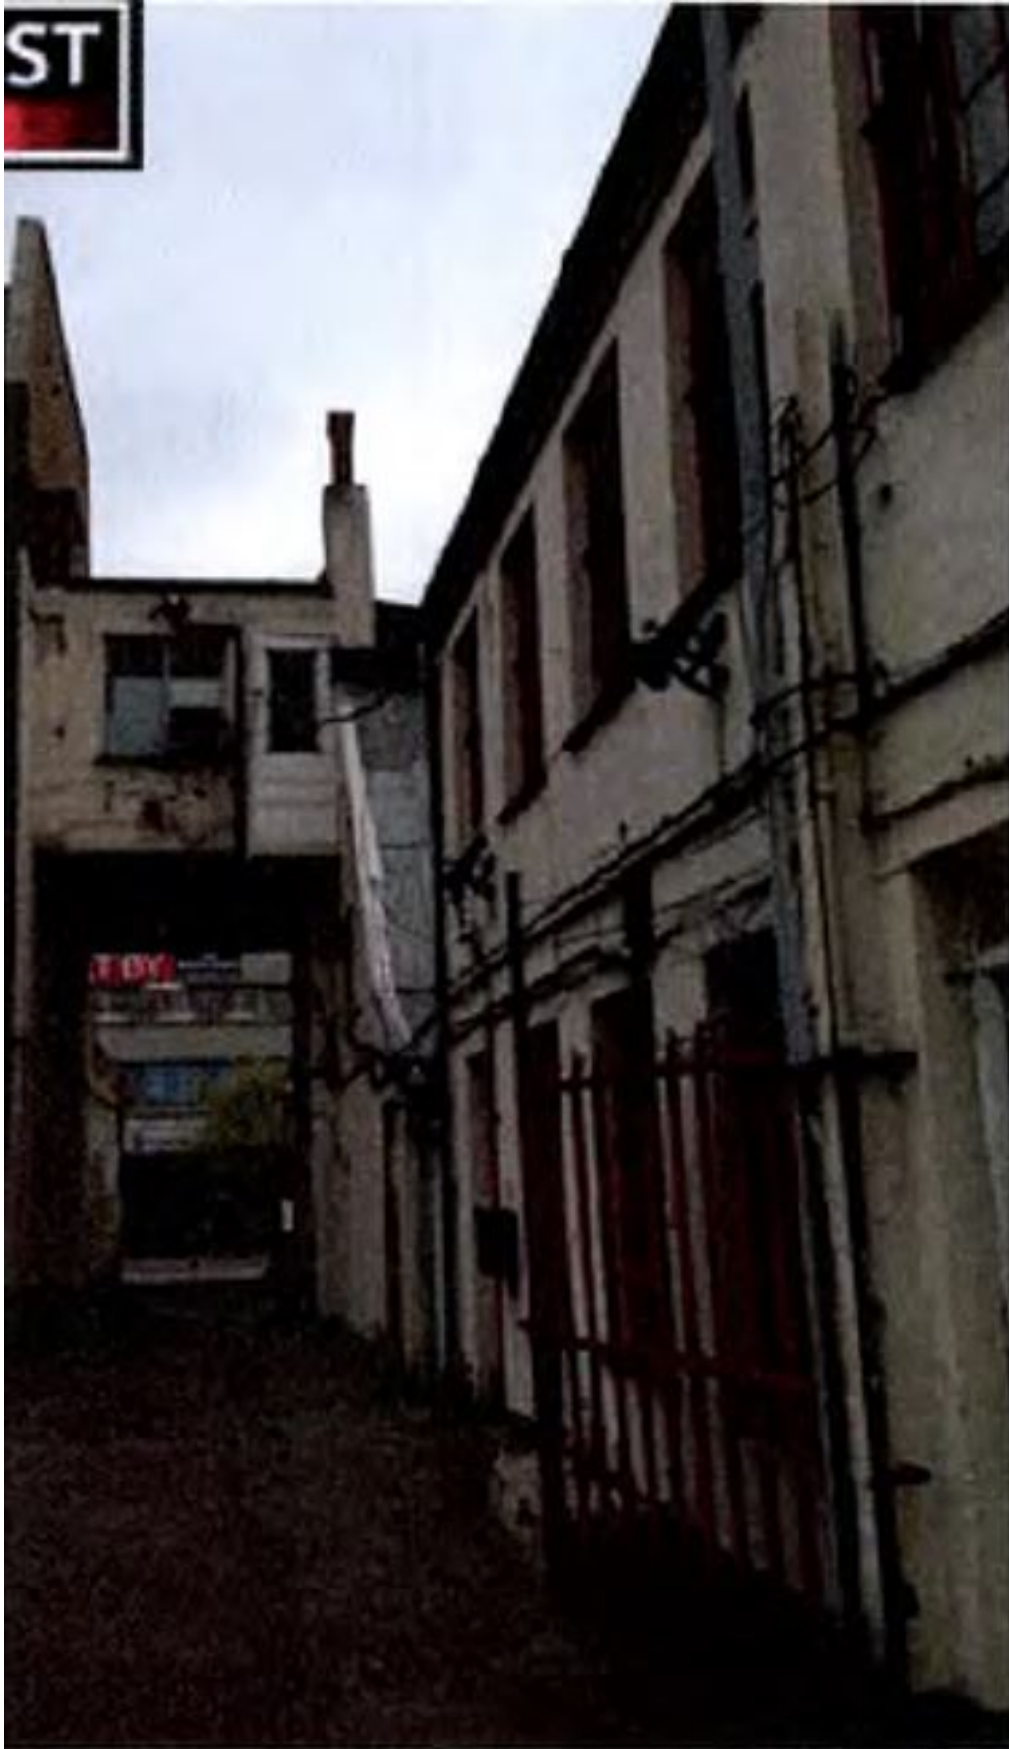
Historic Plate 8 Photograph of the front (south) elevation of Building 1 taken before 07 August 2013, looking west towards the site entrance (Sloane Demolition, 2013)

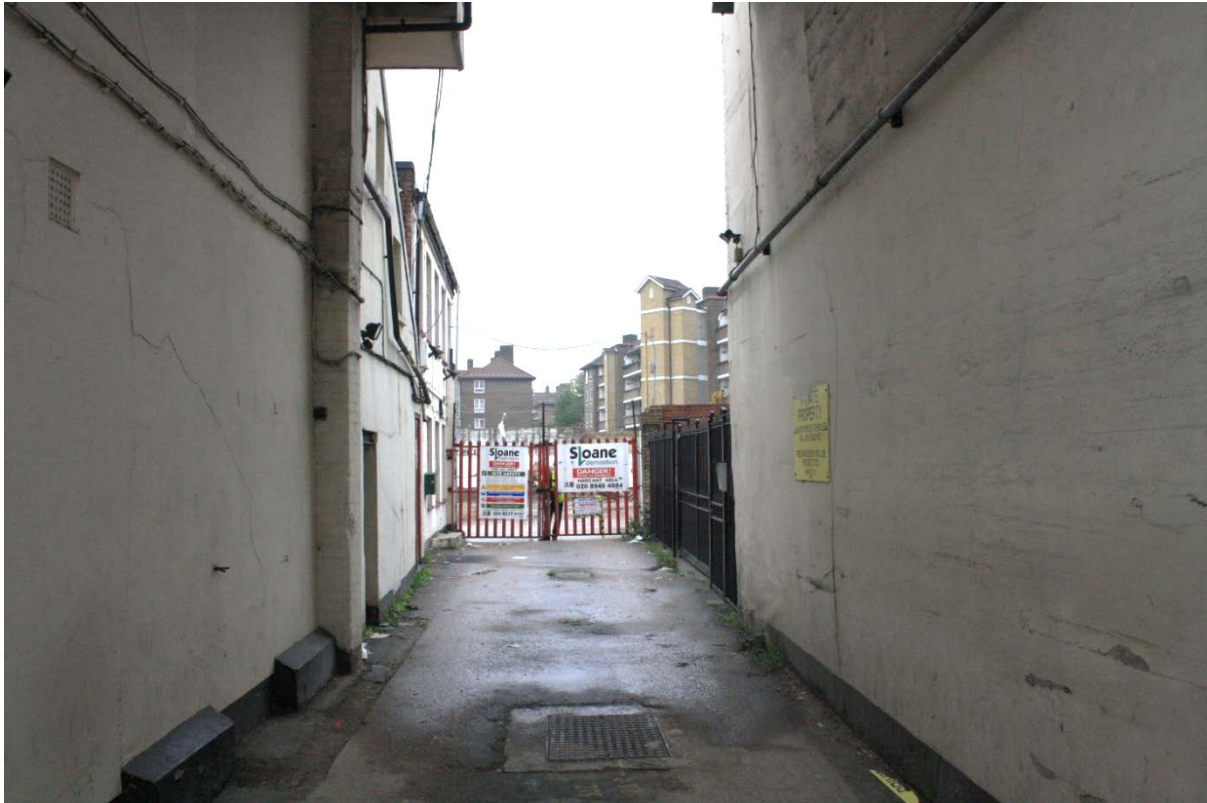
Plate 1 Photograph taken in March 2014 (CgMs part of RPS) of entrance to the site from Walworth Road, looking east (viewpoint on Figure 17)

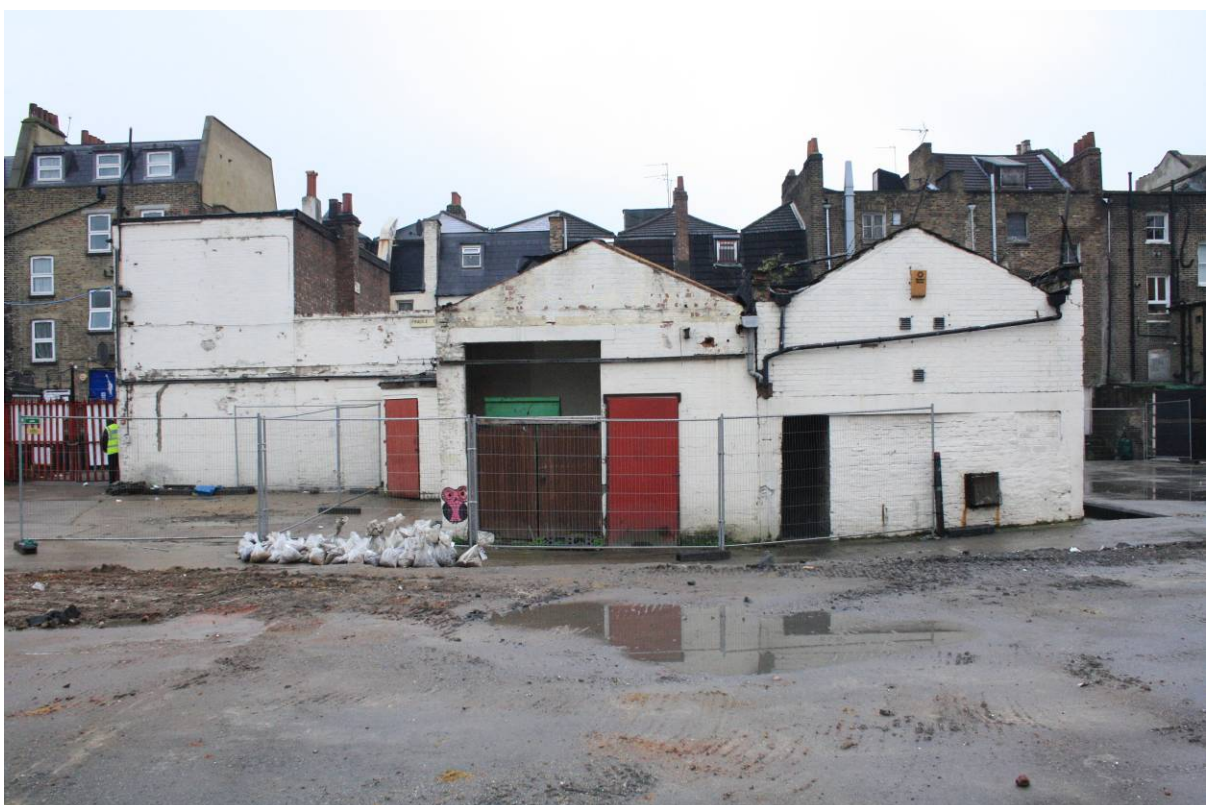
Plate 2 Photograph taken in March 2014 (CgMs part of RPS) of Buildings 1 to 4, looking west (viewpoint on Figure 17)

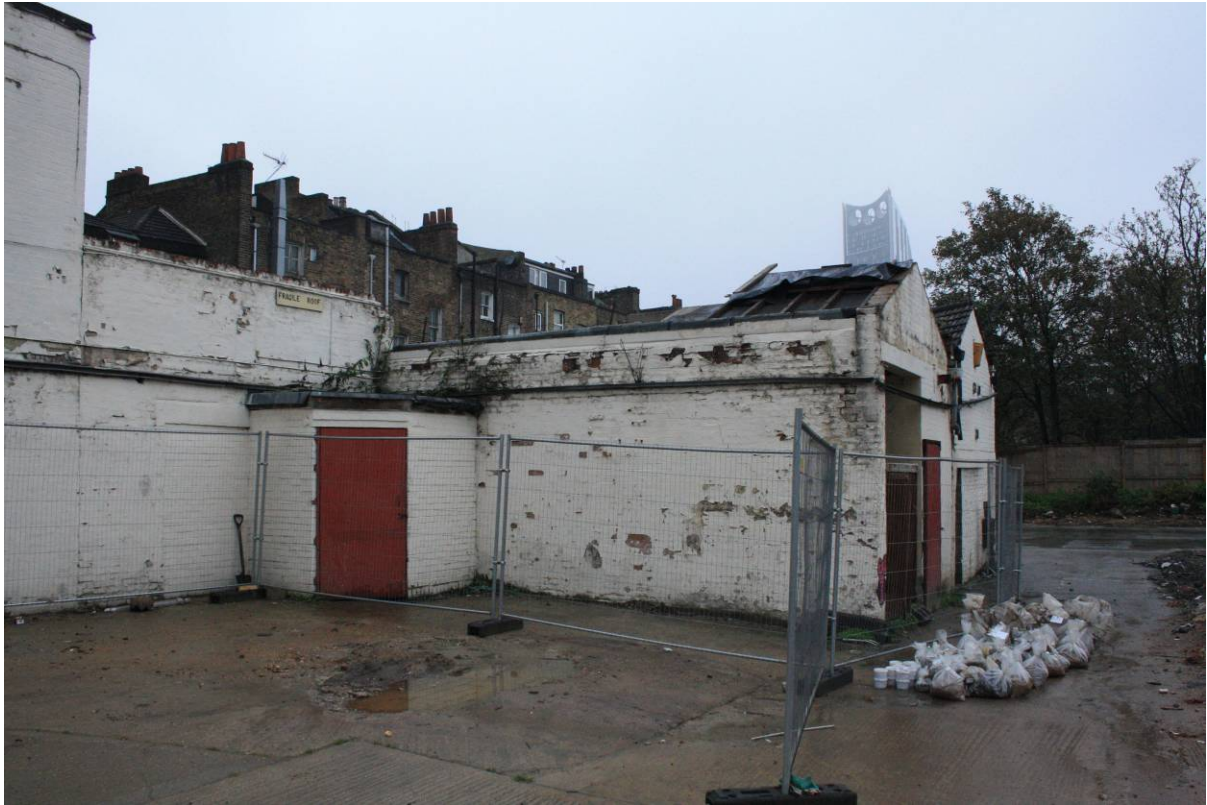
Plate 3 Photograph taken in March 2014 (CgMs part of RPS) of Buildings 1 to 4, looking west (viewpoint on Figure 17)

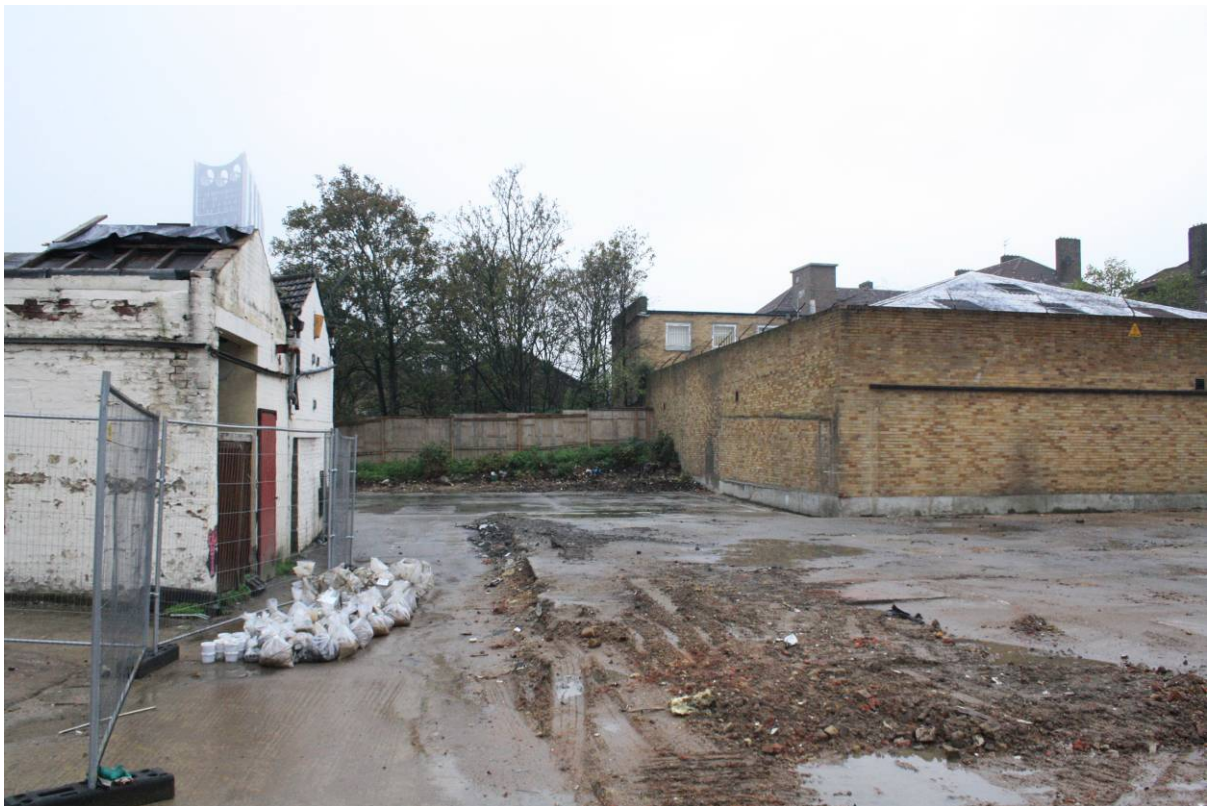
Plate 4 Photograph taken in March 2014 (CgMs part of RPS) of Buildings 3 and 4 (left) and boundary wall around York House, looking north (viewpoint on Figure 17)

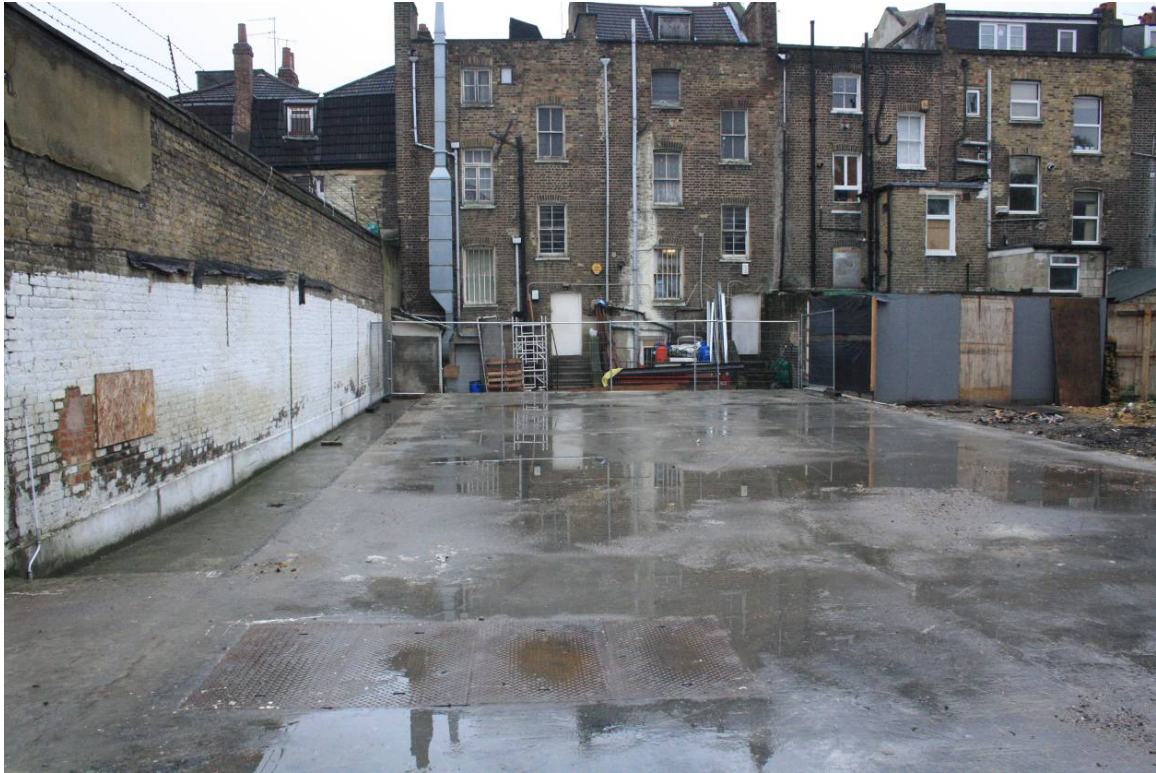
Plate 5 Photograph taken in March 2014 (CgMs part of RPS) showing north wall of Building 4 and concrete slab of Building 5 and rear (east) elevations of buildings along Walworth Road, looking west (viewpoint on Figure 17)

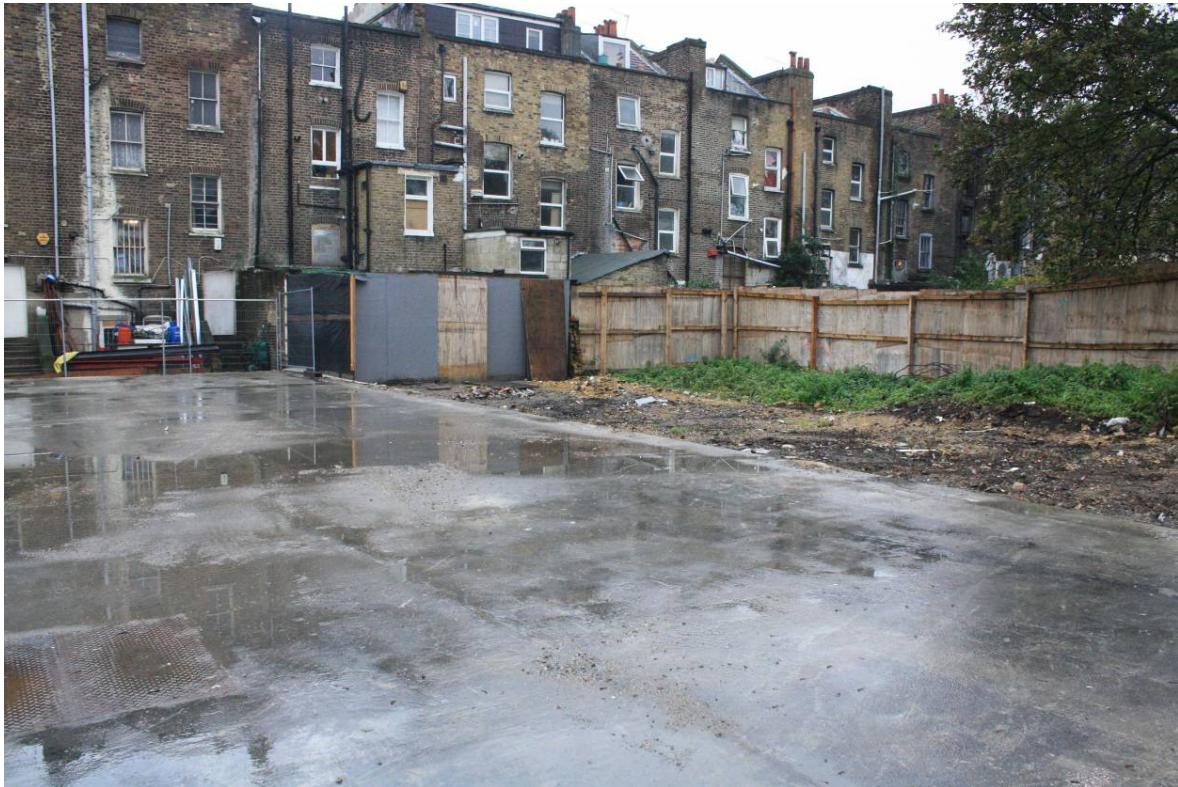
Plate 6 Photograph taken in March 2014 (CgMs part of RPS) showing concrete slab of Building 5 and rear (east) elevations of buildings along Walworth Road, looking north-west (viewpoint on Figure 17)

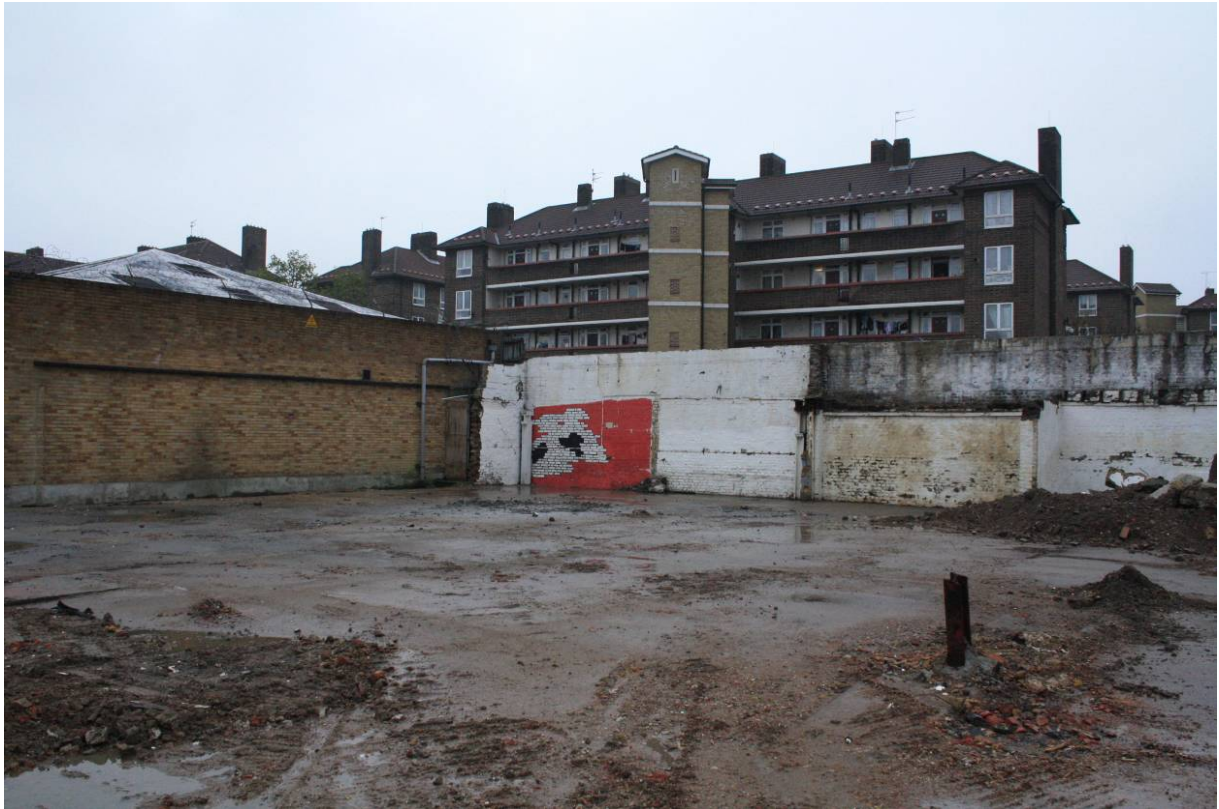
Plate 7 Photograph taken in March 2014 (CgMs part of RPS) of site boundary wall with York House (left) and Cowper House beyond (centre), looking north-east (viewpoint on Figure 17)

6.2.5 Building 6 lay in the angle formed by York House and the east boundary wall (**Figure 17; Plate 7**). The 19th and 20th century maps and aerial photographs suggest that it had a complex development. The building is labelled 'Iron Foundry' on the 1875 map. The foundry is listed in Kelly's Directories as being run by Venables and Broughan (1888), William Murrell & Co. (1893 to 1928) and Kelly and Cleaver (1936 to 1956). The building is shown as part of Blanchard, Martin and Simmonds Ltd Hearthstone

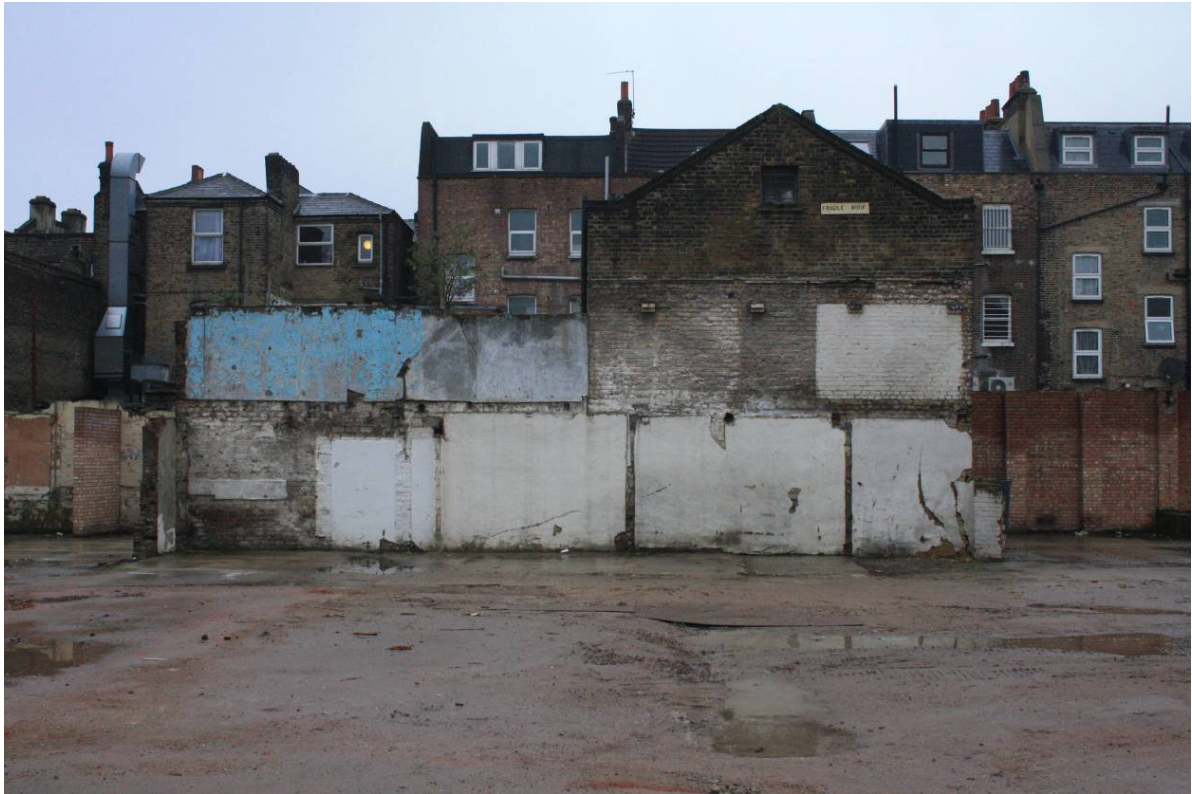
Plate 15 Photograph taken in March 2014 (CgMs part of RPS) of rear (east) elevations of buildings to the rear (east) of nos 243 and 245 Walworth Road, looking west (viewpoint on Figure 17)

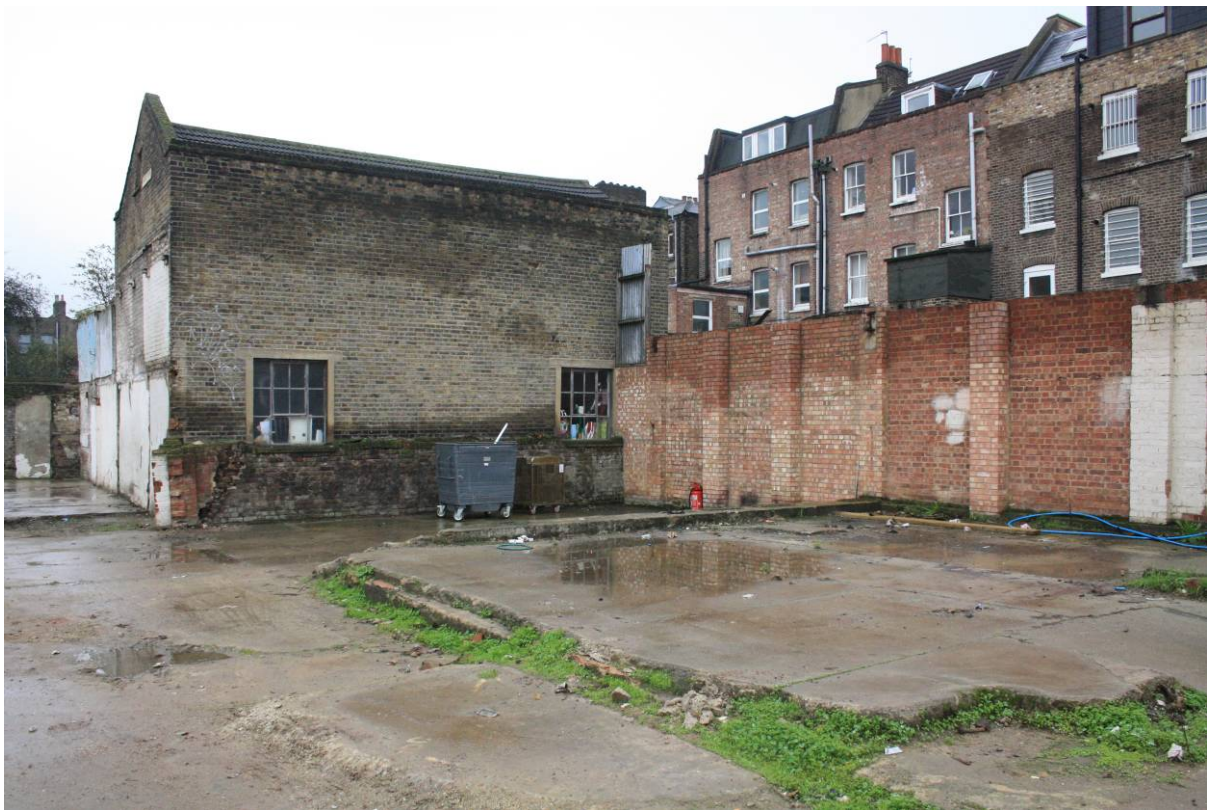
Plate 16 Photograph taken in March 2014 (CgMs part of RPS) of site boundary and north elevation of building to the rear (east) of no. 243 Walworth Road (left), looking south-west (viewpoint on Figure 17)

modern west site boundary brick wall to the south of the entrance to the site had also been rendered and painted light pink (compare **Plates 16** and **45**). The concrete slab that covered the site had been replaced with modern herring bone pavers (**Plates 45** and **46**). The new north and east buildings had been built (**Plates 47** to **49**). The party garden wall between nos 241 and 243 had been rendered and painted white on the site side (compare **Plates 17** and **50**).

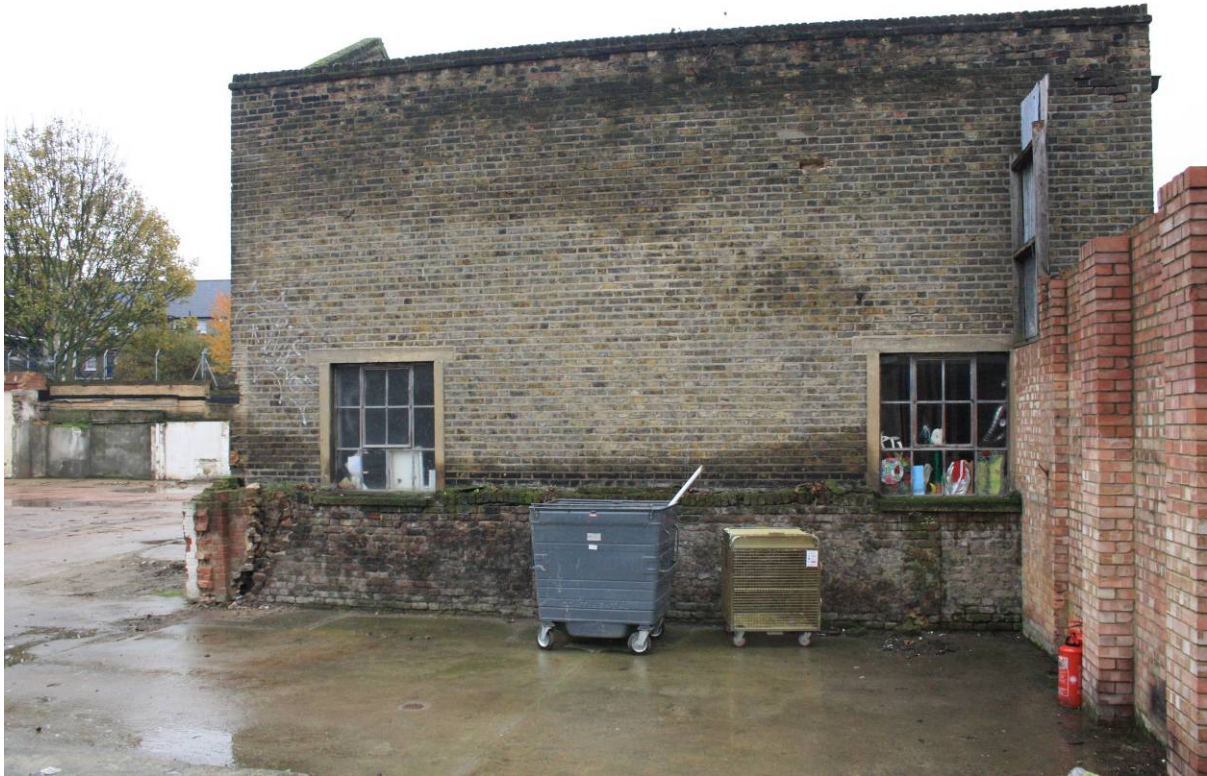
Plate 17 Photograph taken in March 2014 (CgMs part of RPS) of north elevation of building to the rear (east) of no. 243 Walworth Road, looking south (viewpoint on Figure 17)

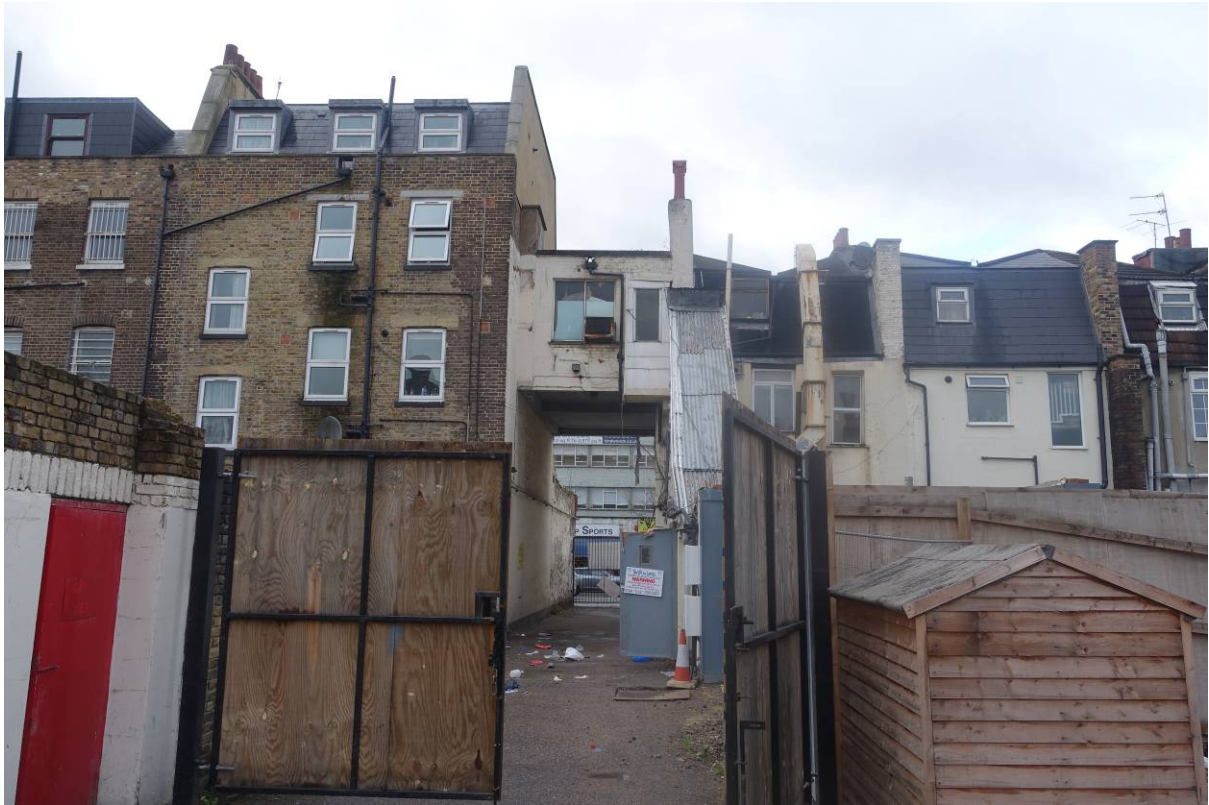
Plate 21 Photograph taken in early 2017 (CField Construction) showing site entrance and rear (east) elevations of buildings along Walworth Road, looking west (viewpoint on Figure 18)

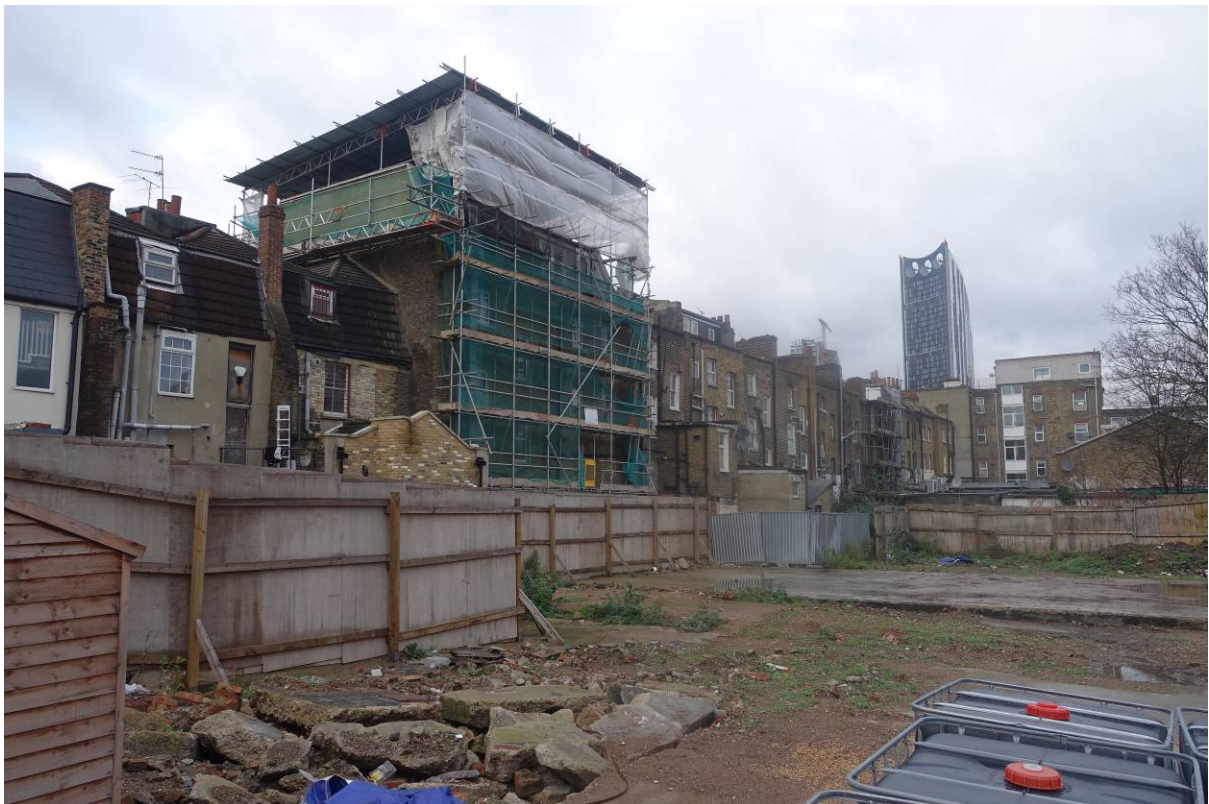
Plate 25 Photograph taken in early 2017 (CField Construction) showing rear (east) elevations of buildings along Walworth Road, looking north-west (viewpoint on Figure 18)

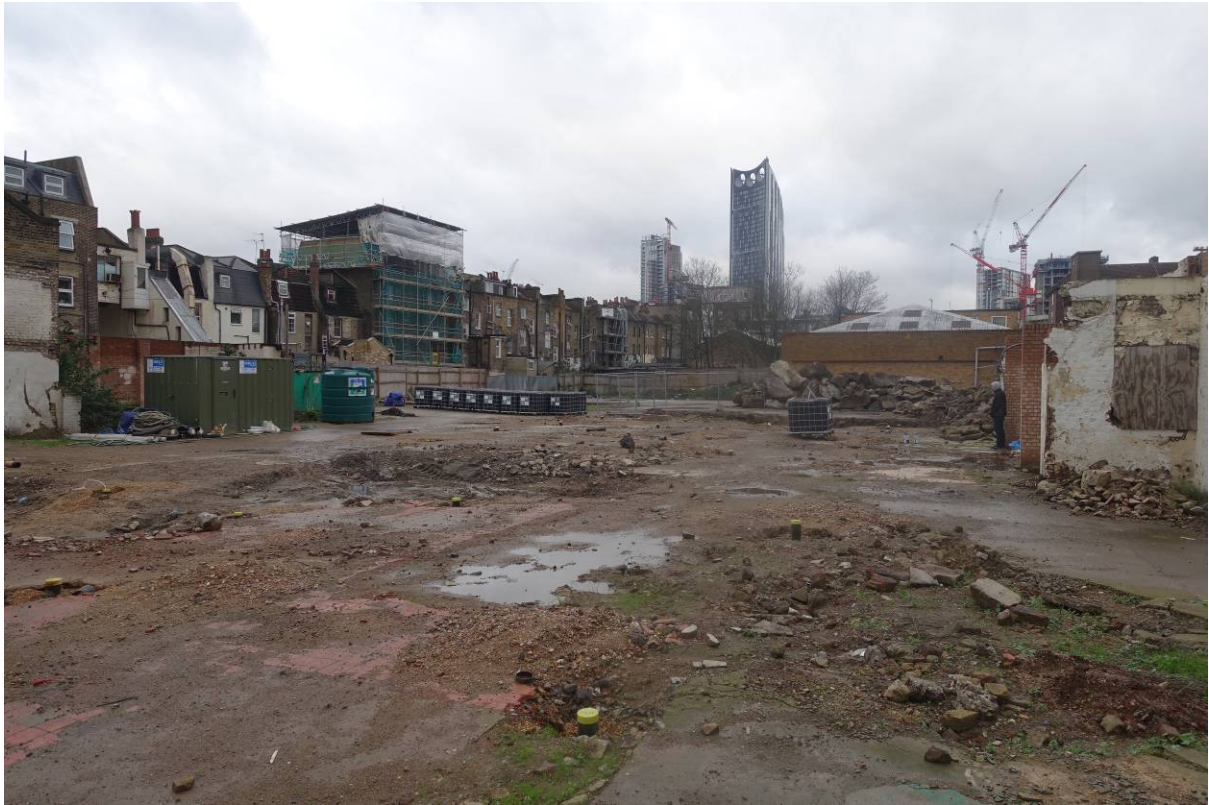
Plate 26 Photograph of site taken in early 2017 (CField Construction) showing rear (east) elevations of buildings along Walworth Road, looking north-west (viewpoint on Figure 18)

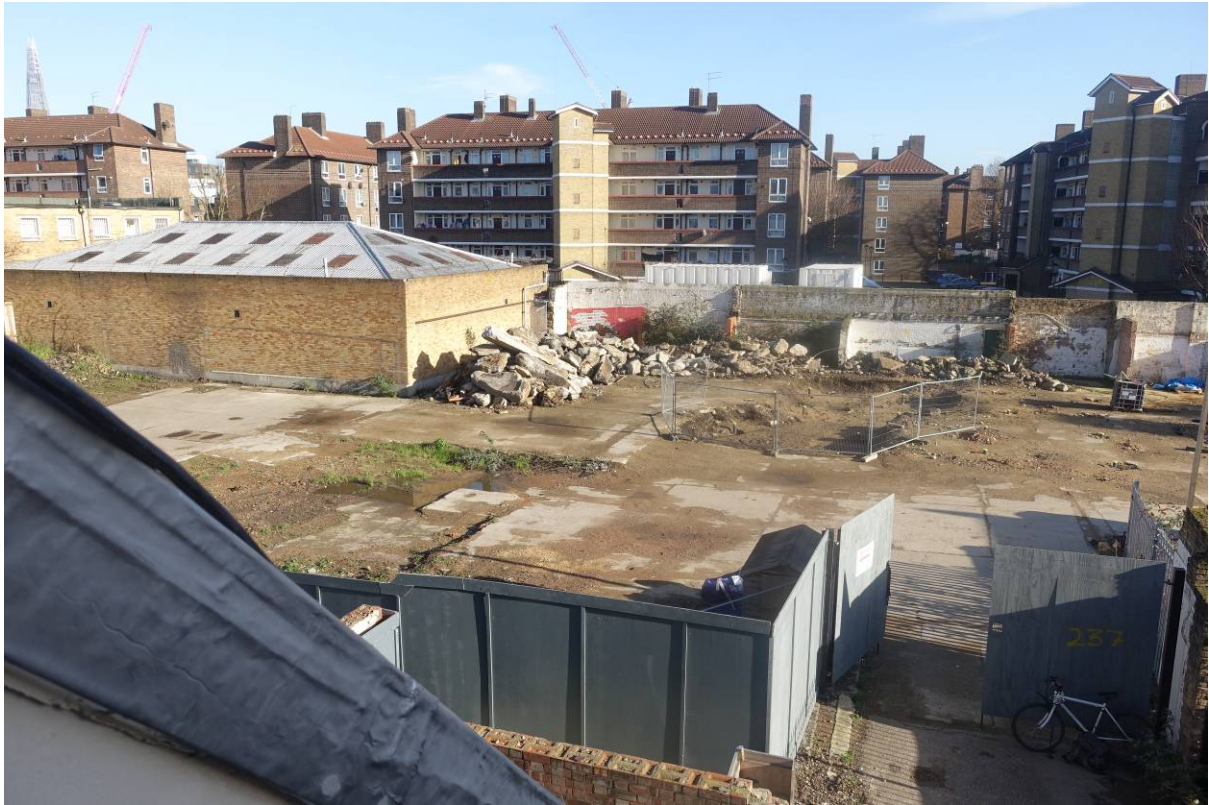
Plate 30 Photograph taken in early 2017 (CField Construction) showing York House (left) with Cowper House beyond, looking east (viewpoint on Figure 18)

- 6.3.2 The early 2017 photographs showed the same scars of the former Iron Foundry building as seen in the March 2014 photographs (**Plates 30 to 36**). Some of the photographs show more detail and clearly show that the walls were built of brick walls and show that the cut off timber floor joists still remained (**Plates 33 and 34**). The modern wall stubs between Buildings 6 and 7 clearly butt the eastern boundary wall (**Plates 38 and 39**). These photographs show that internal east and south walls of Building 7 were constructed of brick and painted white (**Plates 39 to 41**). The square red tiles that covered the floor of the hearthstone Works are clearly visible in **Plate 42**. The party garden wall on the south side of the entrance into the site had been replaced with modern railings (**Plate 43**).

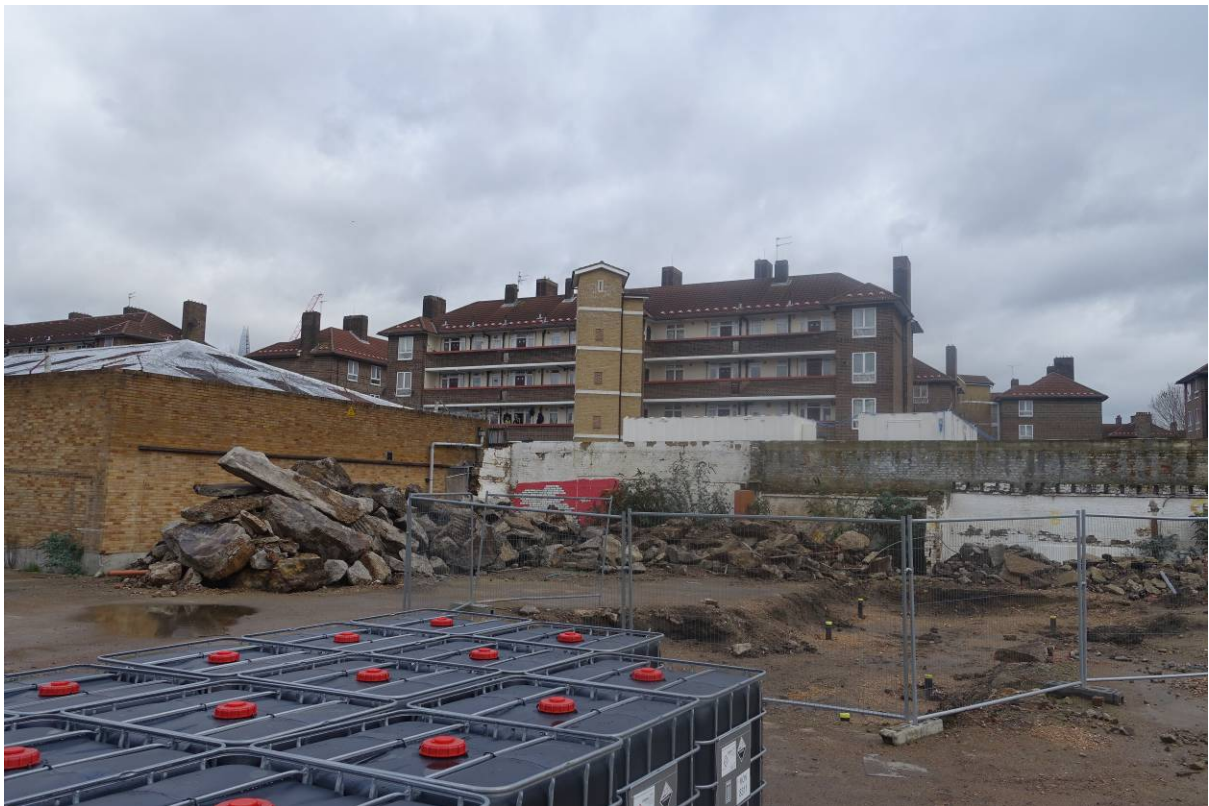
Plate 31 Photograph taken in early 2017 (CField Construction) showing York House (left) with Cowper House beyond, looking north-east (viewpoint on Figure 18)

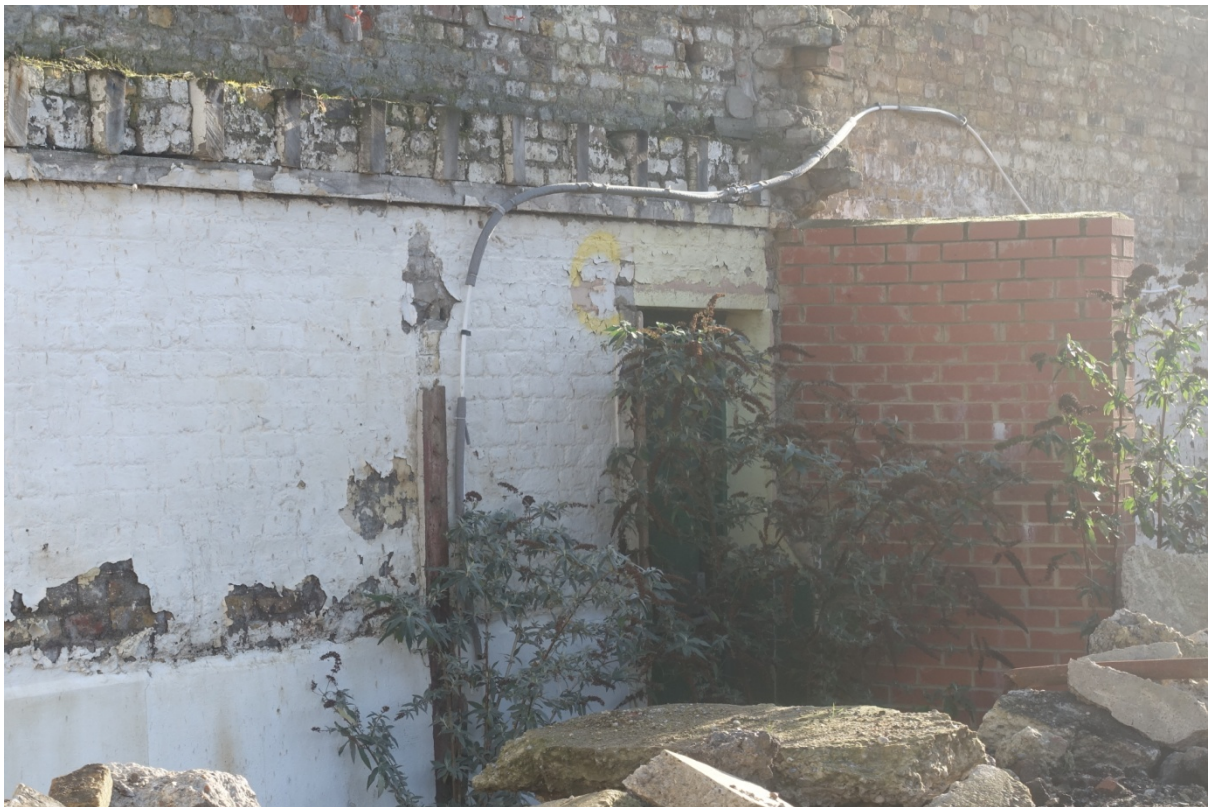
Plate 33 Photograph taken in early 2017 (CField Construction) of the boundary wall, looking south-east (viewpoint on Figure 18)

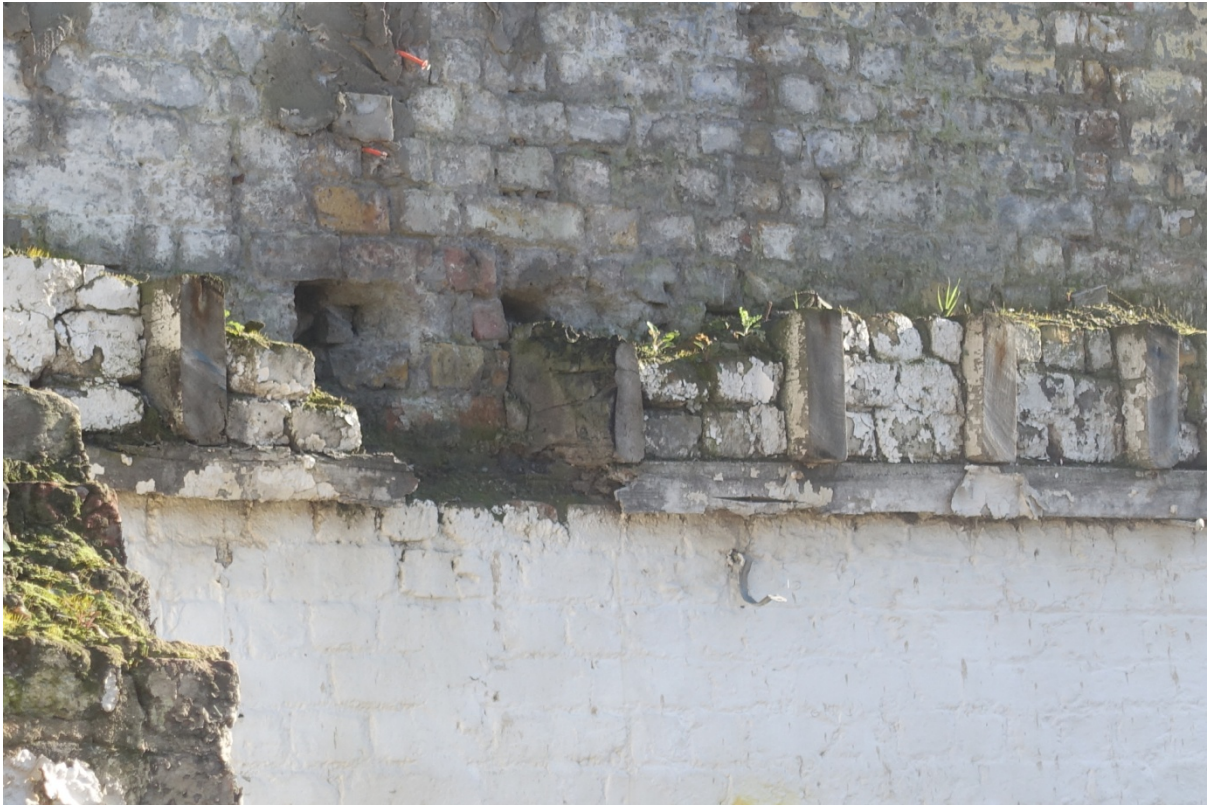
Plate 34 Photograph taken in early 2017 (CField Construction) of the boundary wall, looking east (viewpoint on Figure 18)

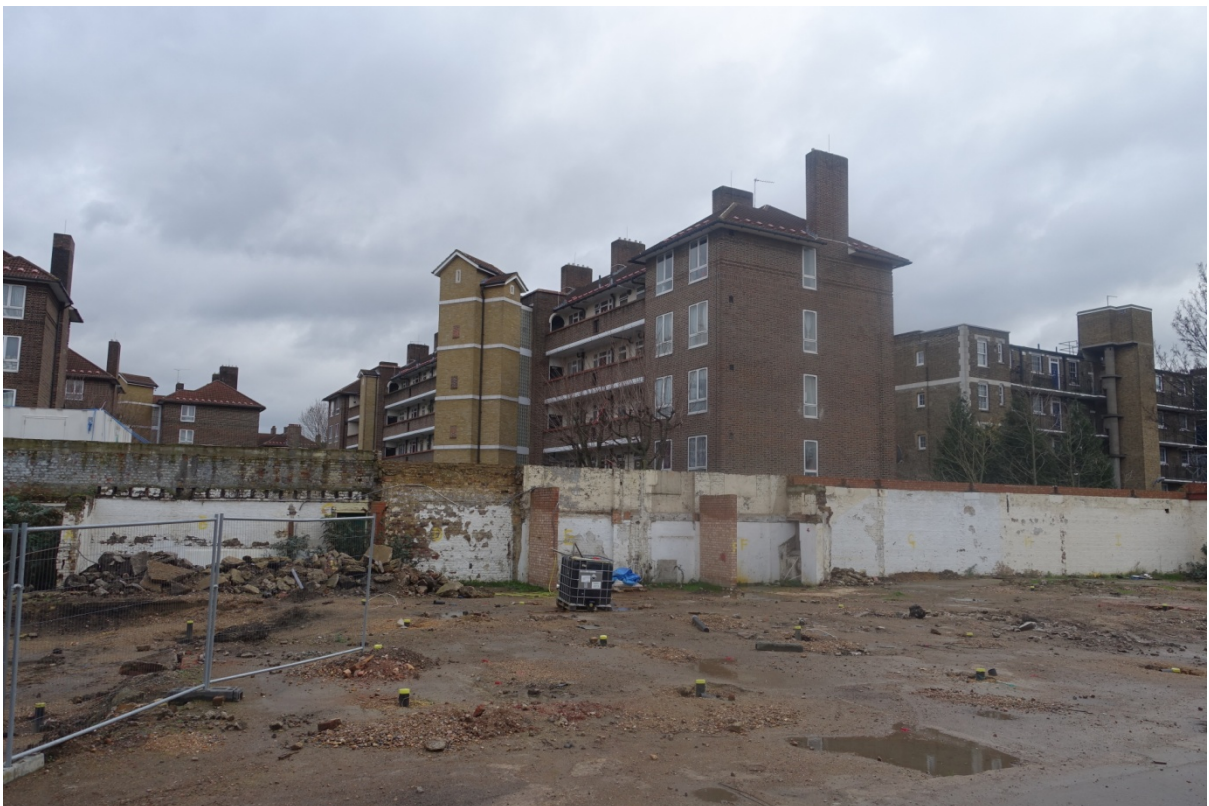
Plate 35 Photograph taken in early 2017 (CField Construction) of the boundary wall with Southey House beyond, looking east (viewpoint on Figure 18)
