**HISTORIC BUILDING RECORDING
OF NO. 237 WALWORTH ROAD,
LONDON BOROUGH OF
SOUTHWARK,
SE17 1RL**

PCA REPORT NO: R13131

DECEMBER 2017

Historic Building Recording

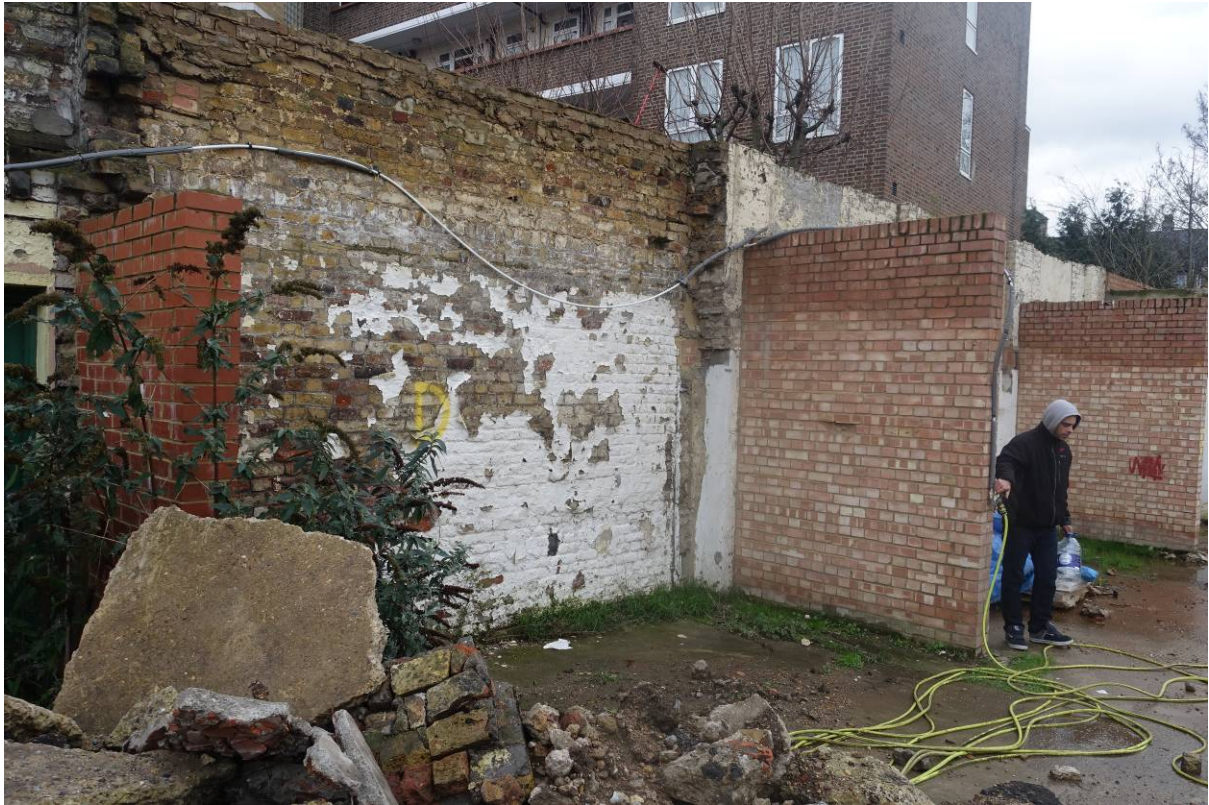
Plate 38 Photograph taken in early 2017 (CField Construction) of the boundary wall with Southey House beyond, looking south-east (viewpoint on Figure 18)

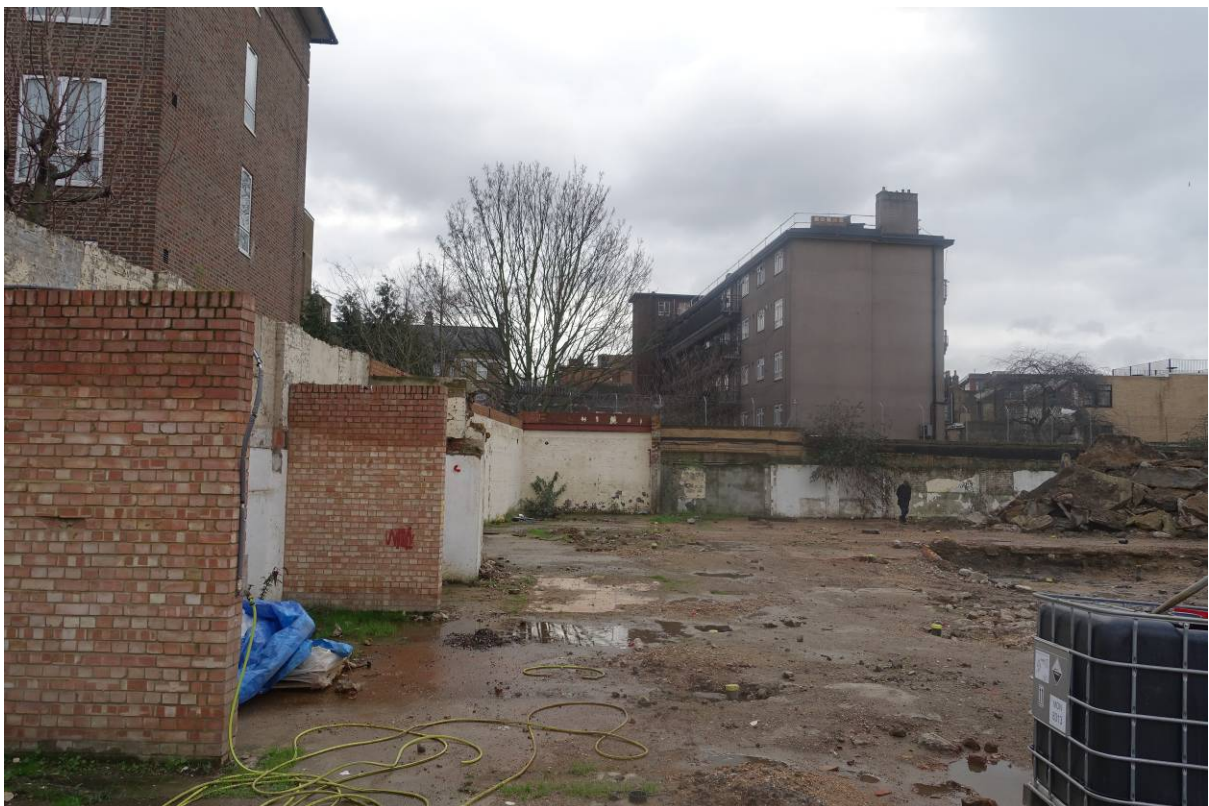
Plate 39 Photograph taken in early 2017 (CField Construction) of the boundary wall with Southey House (left) and Manchester House (centre) beyond, looking south (viewpoint on Figure 18)

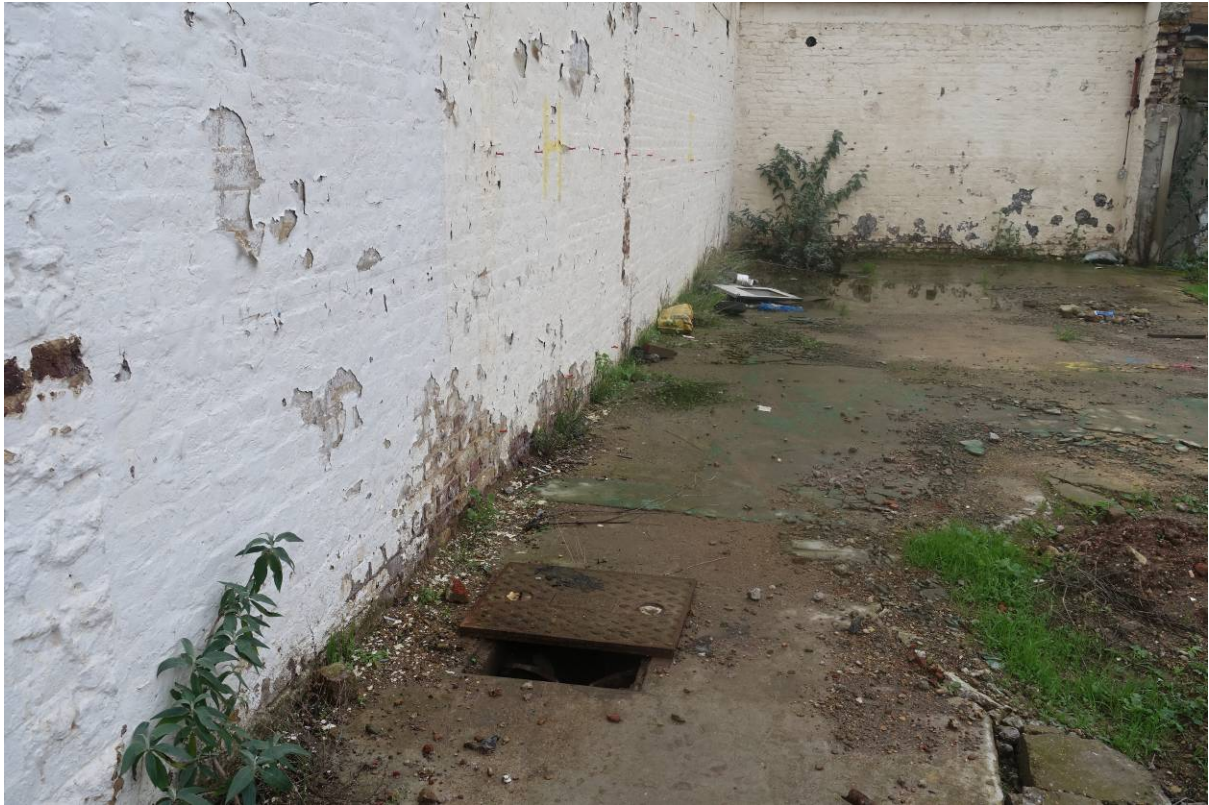
Plate 40 Photograph taken in early 2017 (CField Construction) of the boundary wall, looking south-east (viewpoint on Figure 18)

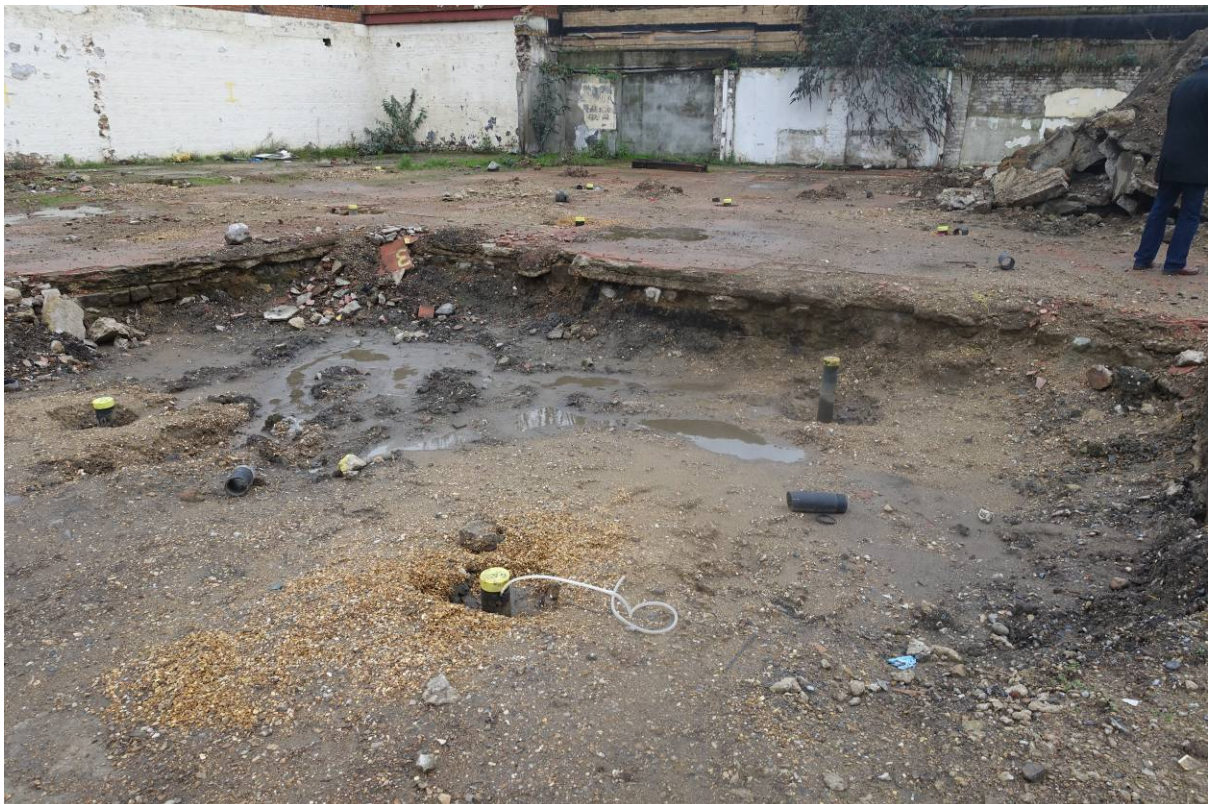
Plate 41 Photograph taken in early 2017 (CField Construction) of the boundary wall, looking south-east (viewpoint on Figure 18)

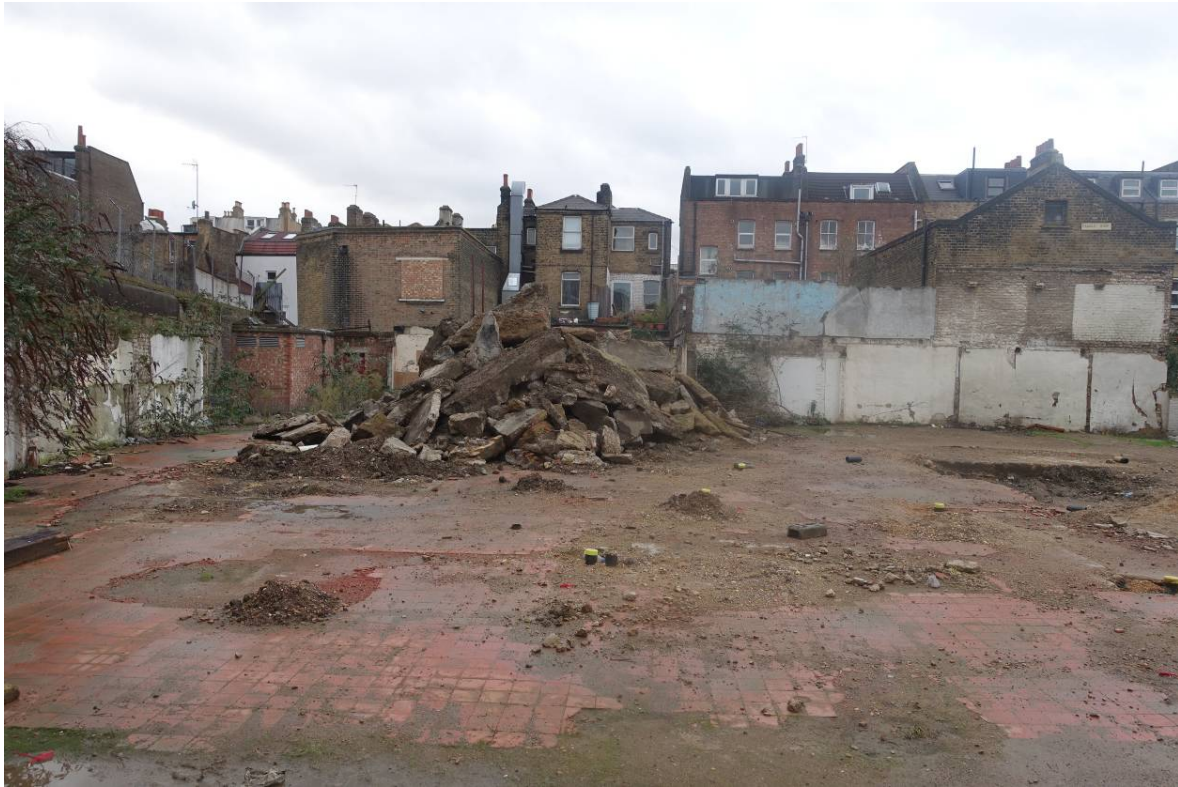
Plate 42 Photograph of the south end of the site taken in early 2017 (CField Construction) showing rear (east) elevations of buildings along Walworth Road, looking west (viewpoint on Figure 18)

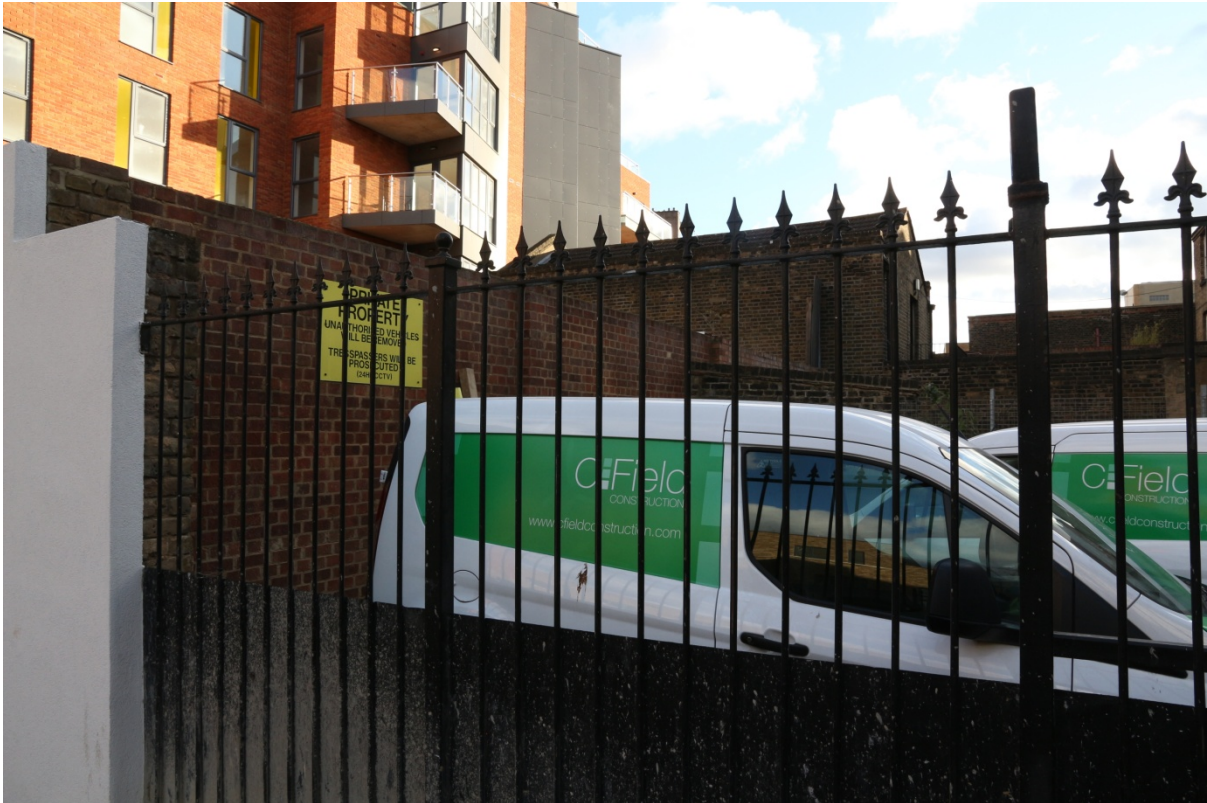
Plate 44 Photograph taken in December 2017 (PCA) from site entrance of the newly constructed east building (left), looking south (viewpoint on Figure 19)

- 6.4.1 By 08 December 2017, the remains of the yellow stock brick garden wall shown in **Plate 43** had been rendered and painted white on the site side (**Plate 44**). The

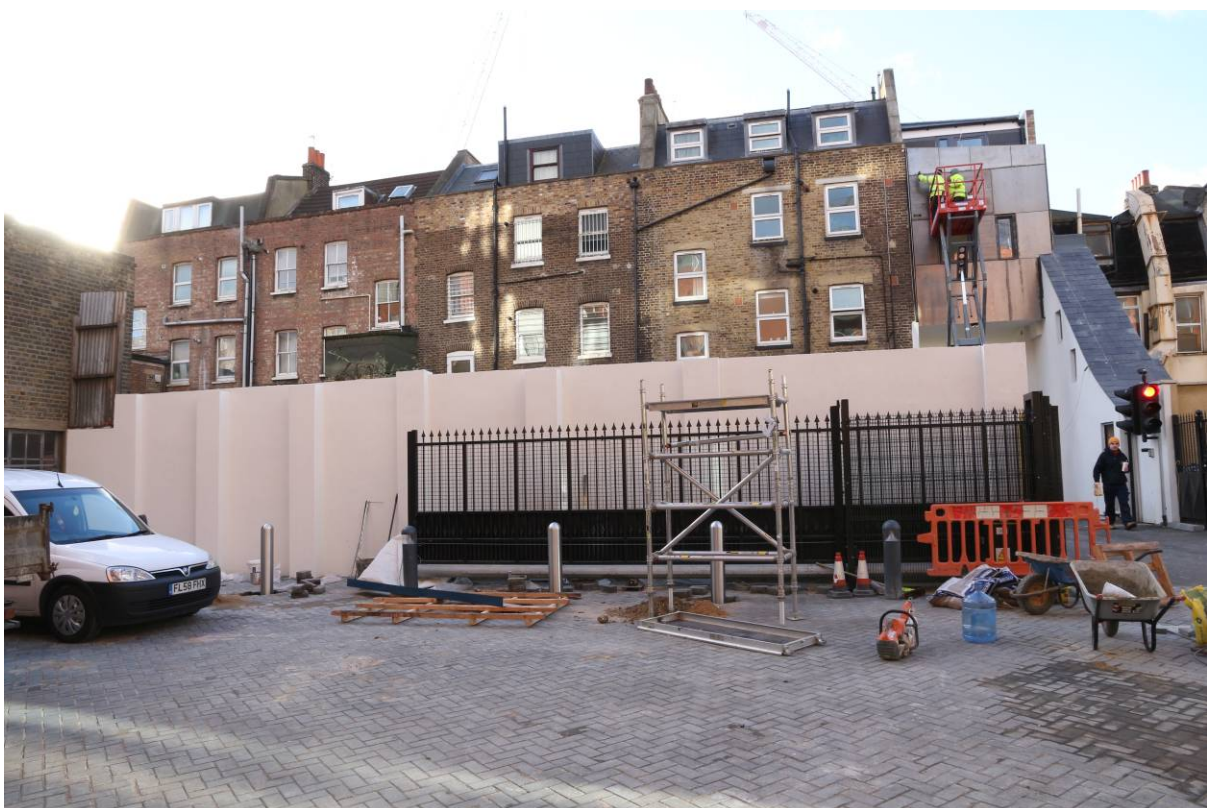
Plate 45 Photograph taken in December 2017 (PCA) of site entrance (right), boundary wall and rear (east) elevations of properties along Walworth Road, looking west (viewpoint on Figure 19)

modern west site boundary brick wall to the south of the entrance to the site had also been rendered and painted light pink (compare **Plates 16** and **45**). The concrete slab that covered the site had been replaced with modern herring bone pavers (**Plates 45** and **46**). The new north and east buildings had been built (**Plates 47** to **49**). The party garden wall between nos 241 and 243 had been rendered and painted white on the site side (compare **Plates 17** and **50**).

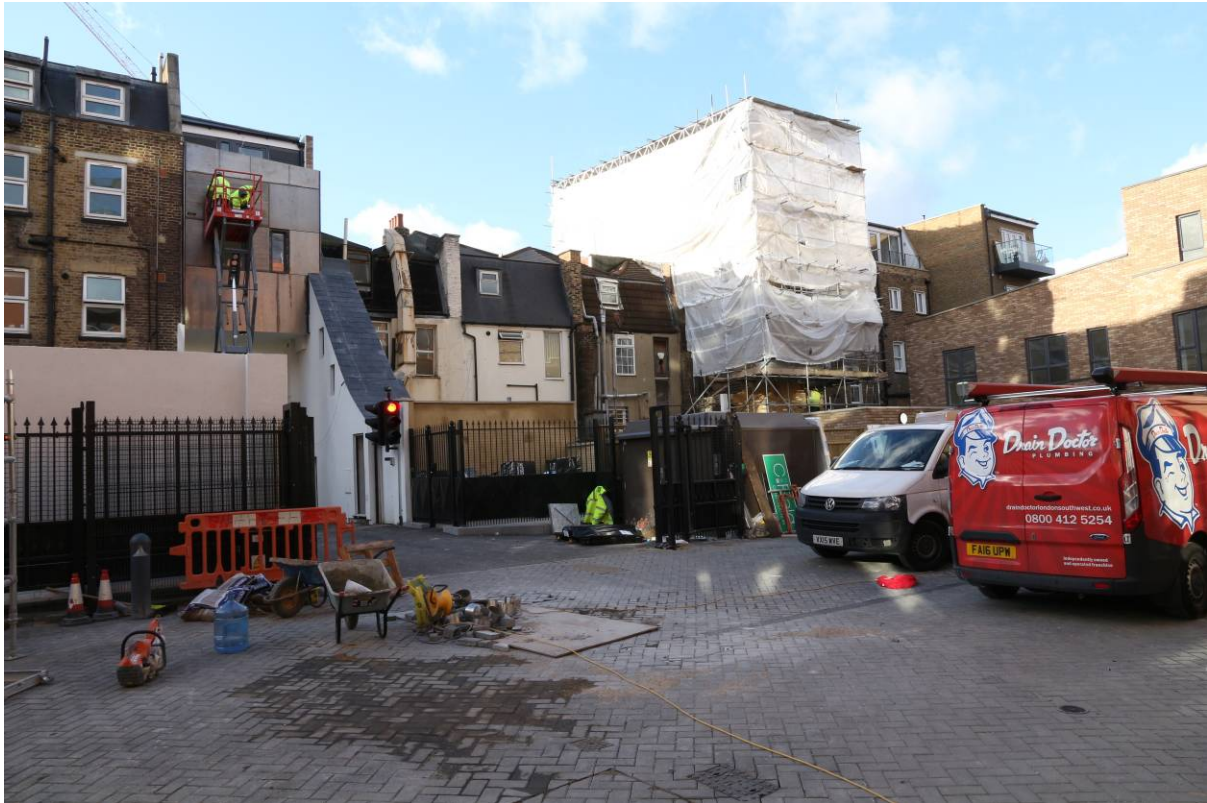
Plate 46 Photograph taken in December 2017 (PCA) of site entrance (left) and rear (east) elevations of properties along Walworth Road, looking north-west (viewpoint on Figure 19)

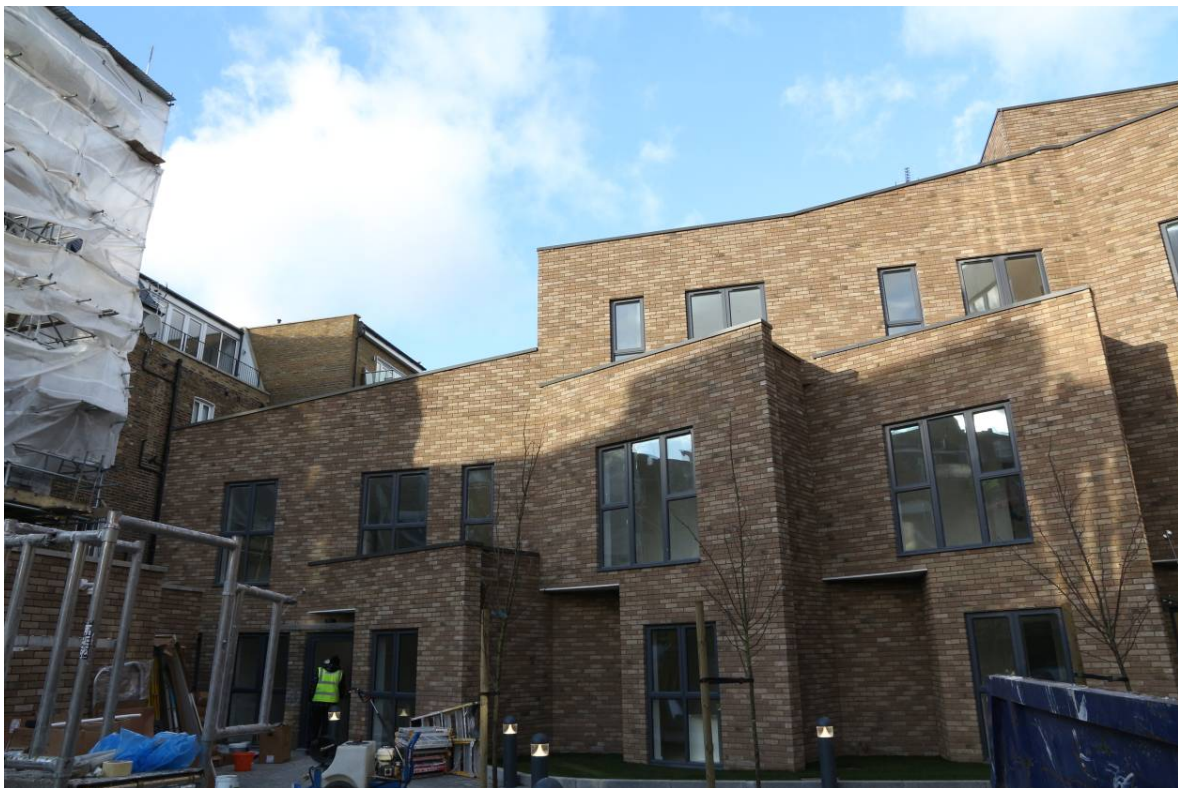
Plate 47 Photograph taken in December 2017 (PCA) of the newly constructed north building and the rear (east) elevations of buildings along Walworth Road (left), looking north-west (viewpoint on Figure 19)

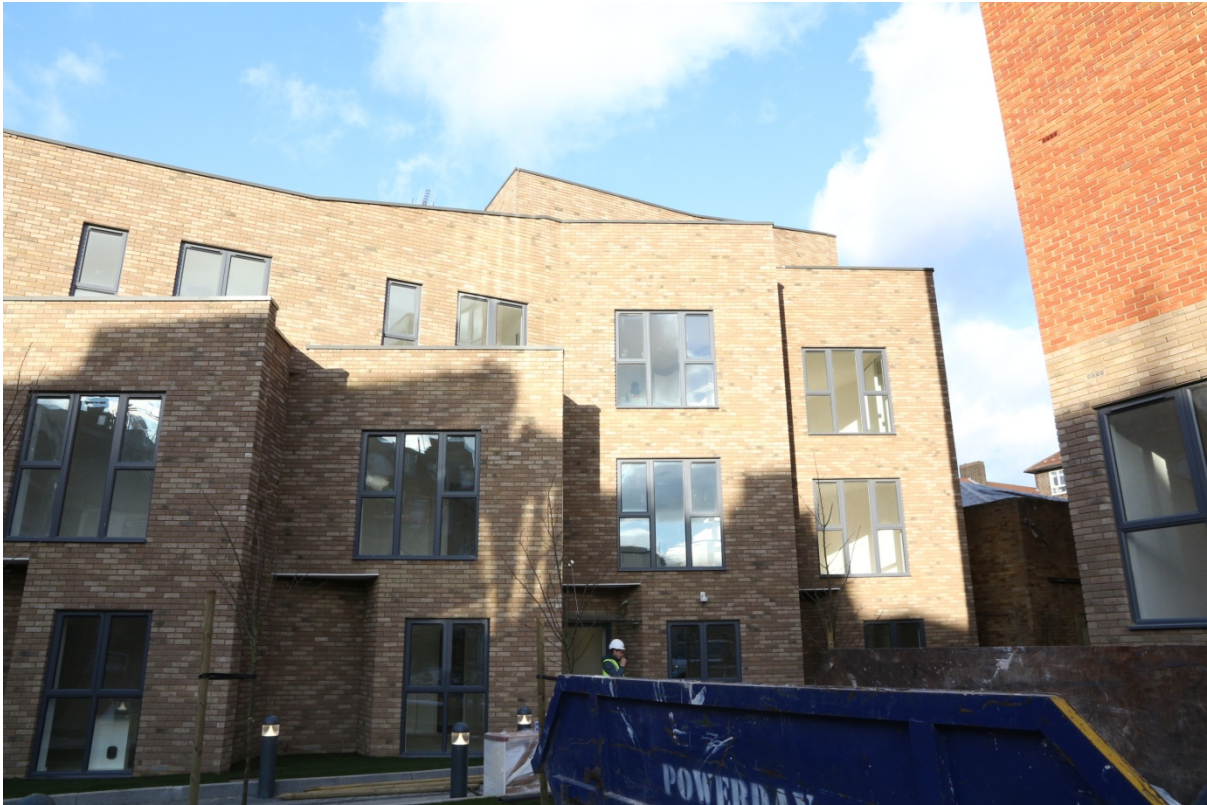
Plate 48 Photograph taken in December 2017 (PCA) of the newly constructed north and east buildings with the corner of York House in between, looking north-east (viewpoint on Figure 19)

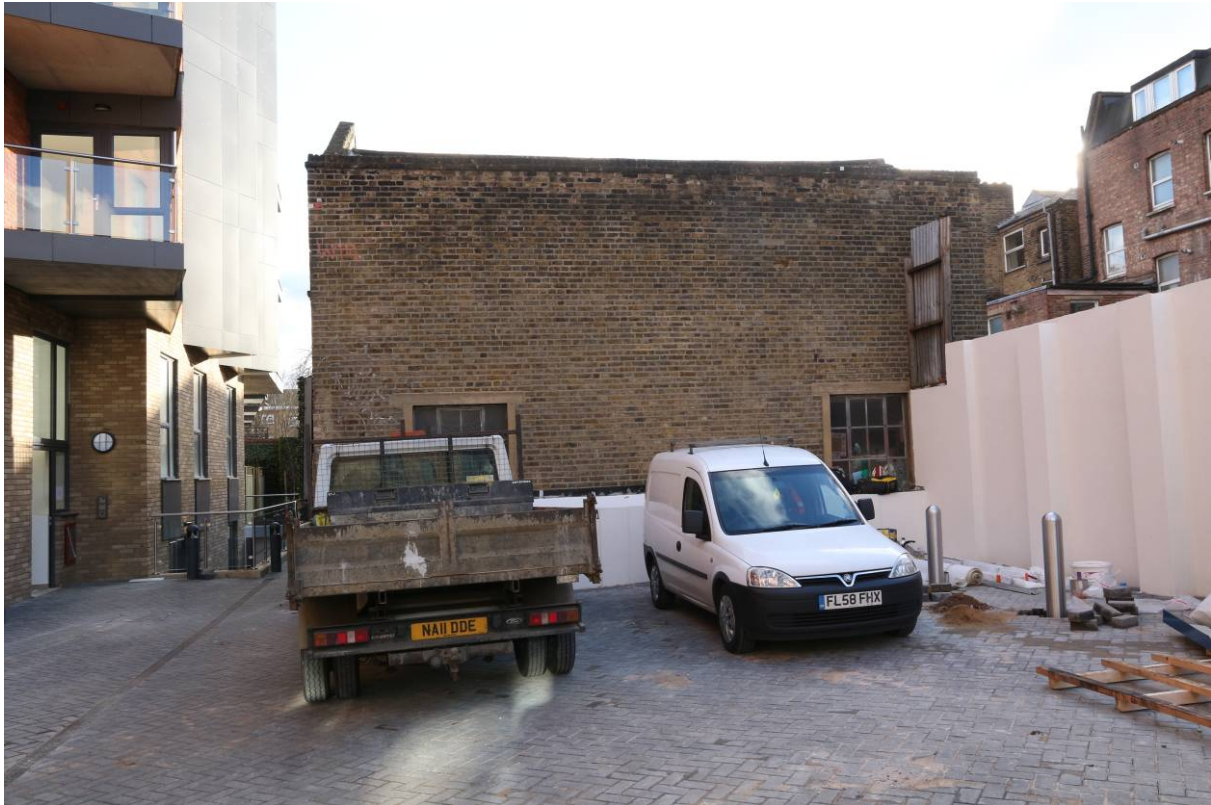
Plate 50 Photograph taken in December 2017 (PCA) of north elevation of building to the rear (east) of no. 243 Walworth Road, looking south (viewpoint on Figure 19)

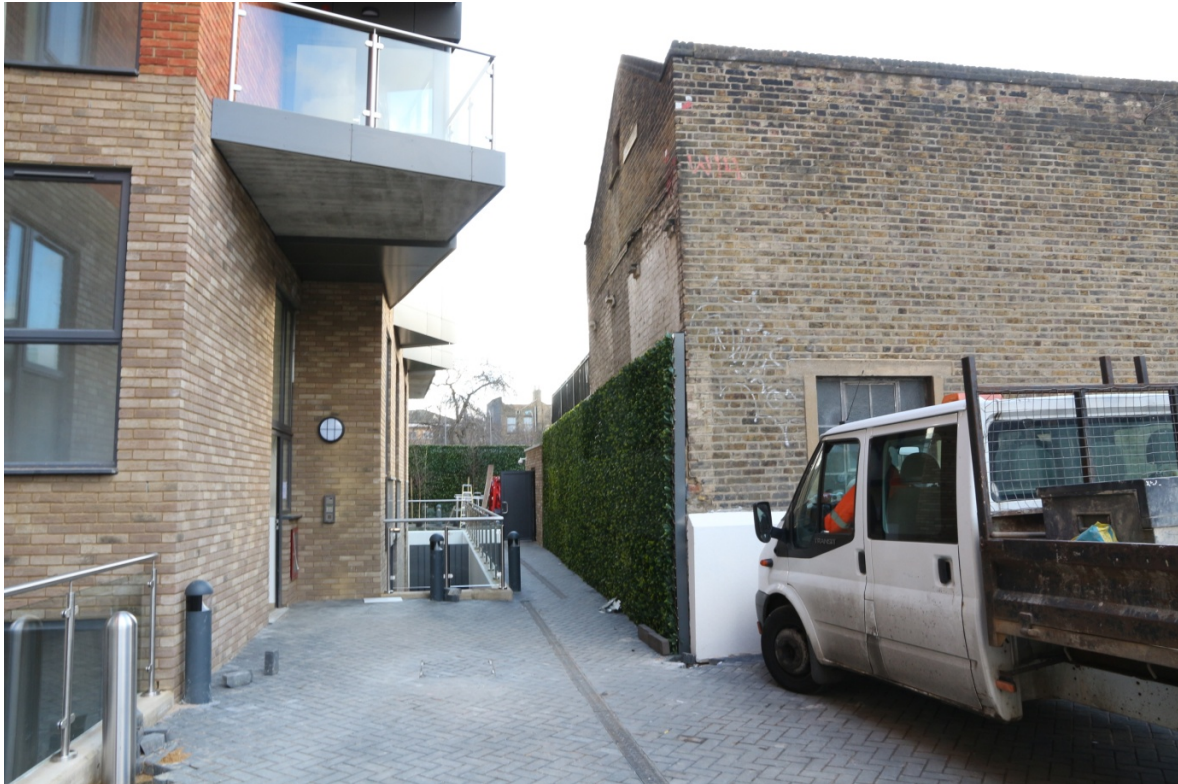
Plate 51 Photograph taken in December 2017 (PCA) of newly constructed building (left) and east and north elevations of building to the rear (east) of no. 243 Walworth Road (right), looking south (viewpoint on Figure 19)

- 6.4.2 The lower part of the east elevation of the building to the rear (east) of no. 243 Walworth Road had been clad with artificial hedging (**Plate 51** and **52**). The paint scars of former room divisions were still visible at first floor level. Four blocks of corbelled bricks at regular intervals at the top of the first floor level indicate the position of former roof trusses within a building that formed part of the Hearthstone Works. Changes had also taken place to the south of the building to the rear (east) of no. 243 Walworth Road (compare **Plates 14** and **15** with **53**). The west (south end), south and east boundary walls had been covered with artificial hedging (**Plates 54** to **60**).

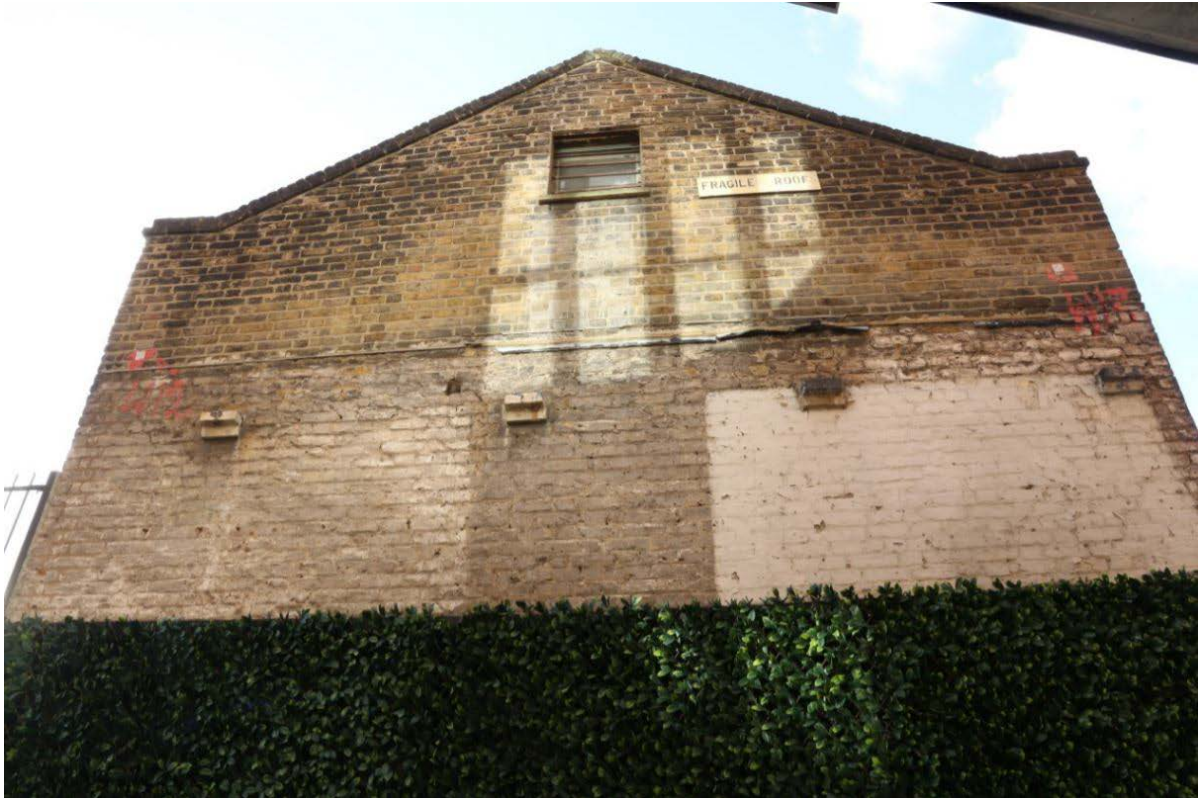
Plate 52 Photograph taken in December 2017 (PCA) of east elevation of building to the rear (east) of no. 243 Walworth Road, looking west (viewpoint on Figure 19)

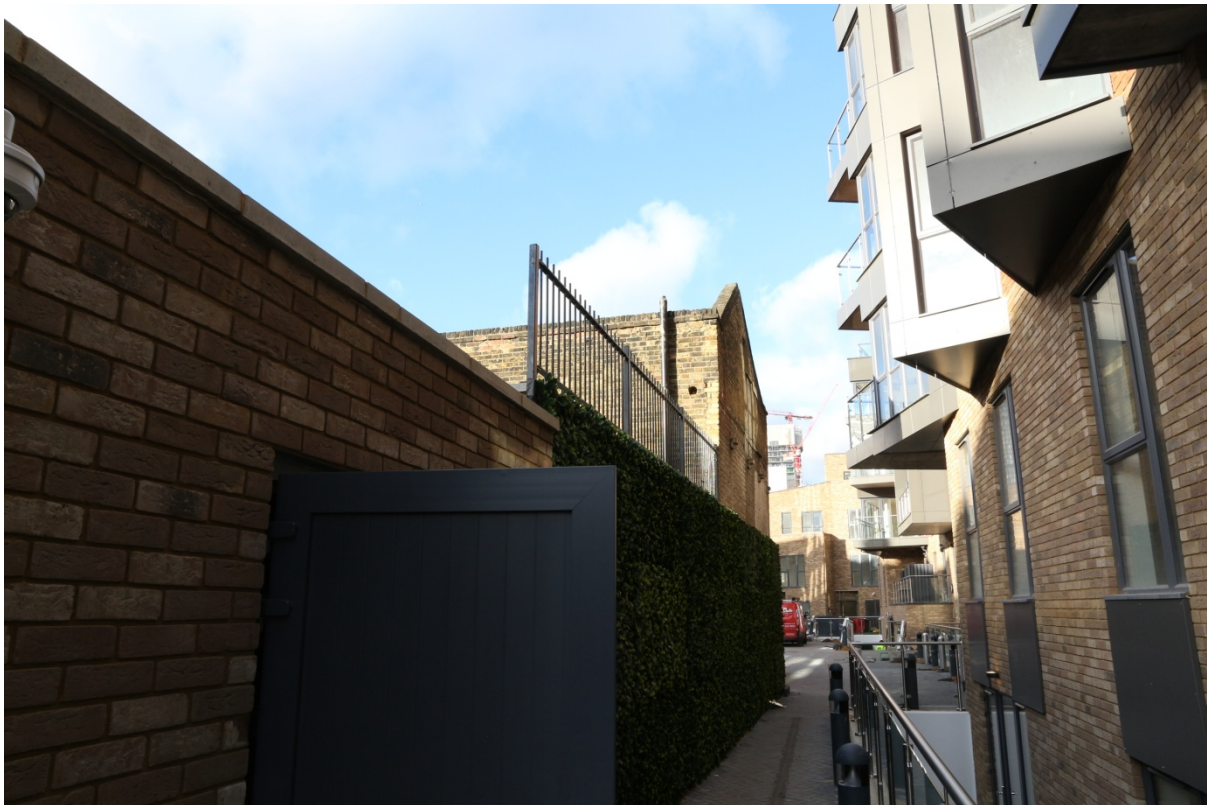
Plate 53 Photograph taken in December 2017 (PCA) of east elevation of building to the rear (east) of no. 243 Walworth Road (left) and newly constructed building (right), looking north (viewpoint on Figure 19)

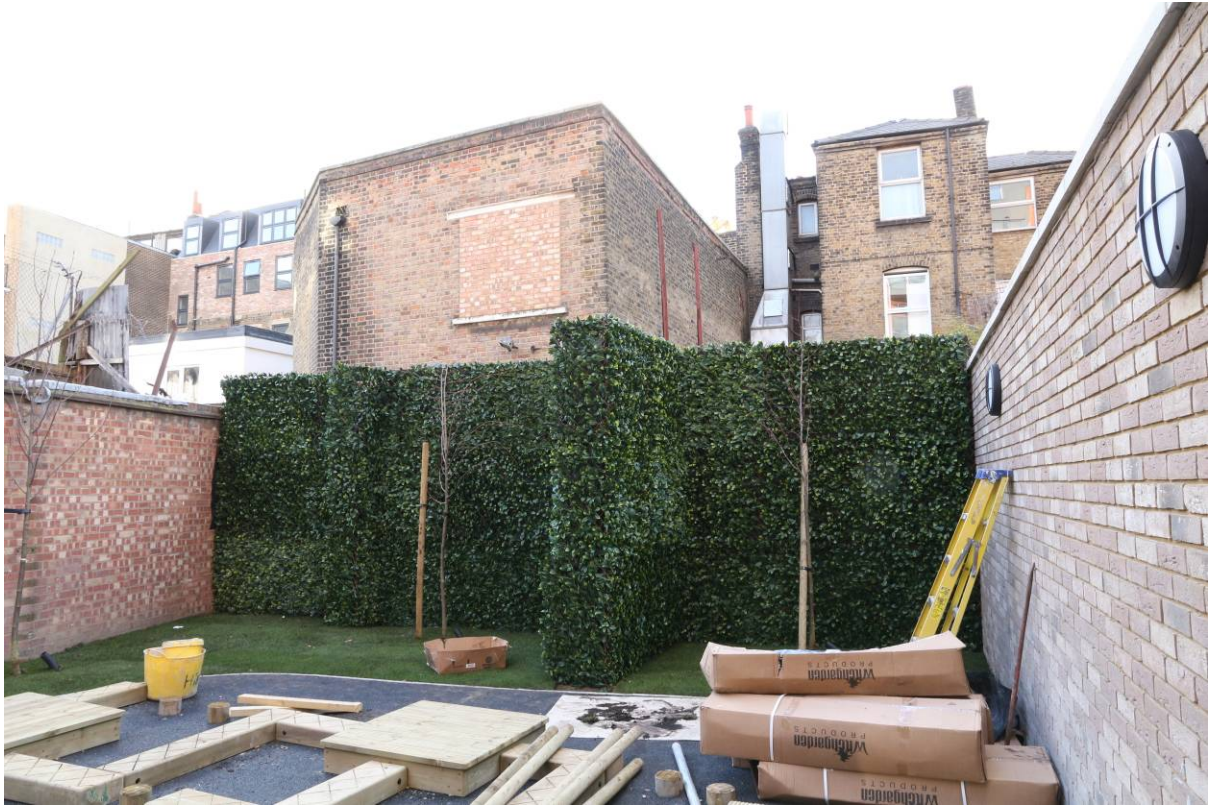
Plate 54 Photograph of the south end of the site taken in December 2017 (PCA) showing rear (east) elevations of buildings along Walworth Road, looking west (viewpoint on Figure 19)

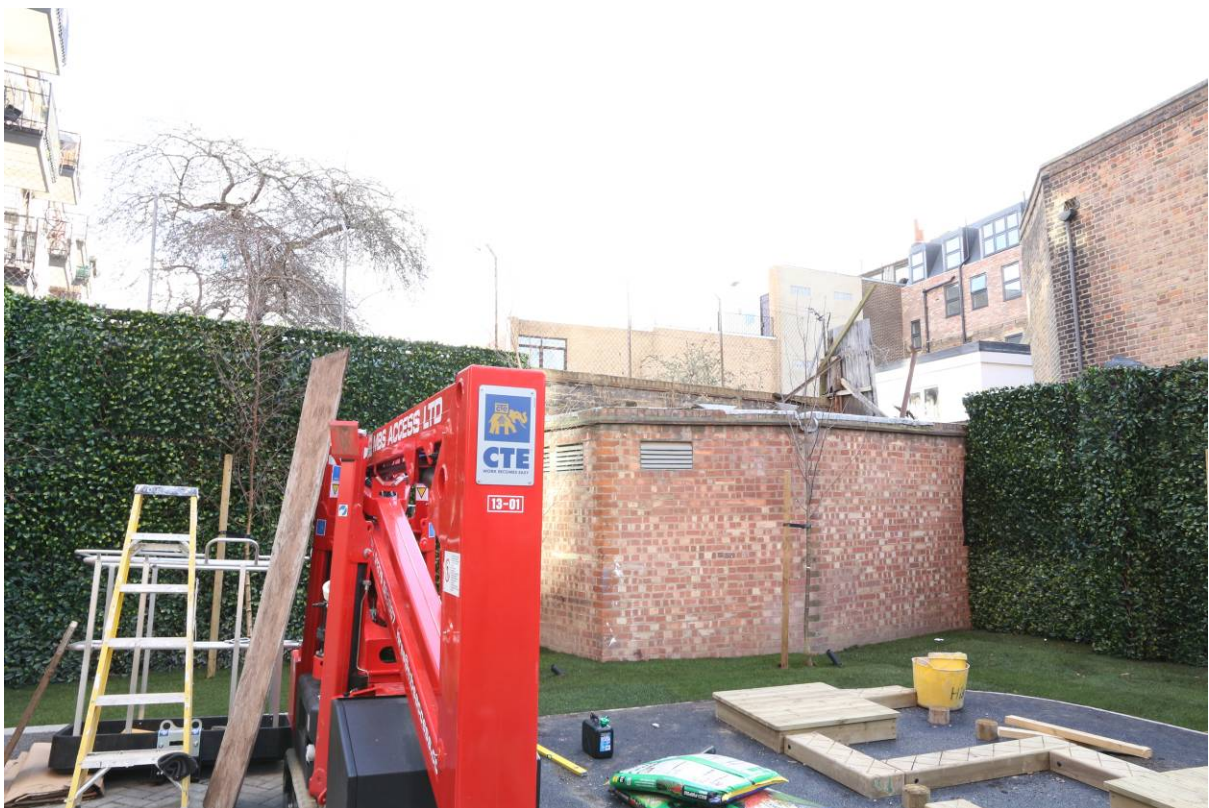
Plate 55 Photograph of the south-west corner of the site taken in December 2017 (PCA), looking south-west (viewpoint on Figure 19)

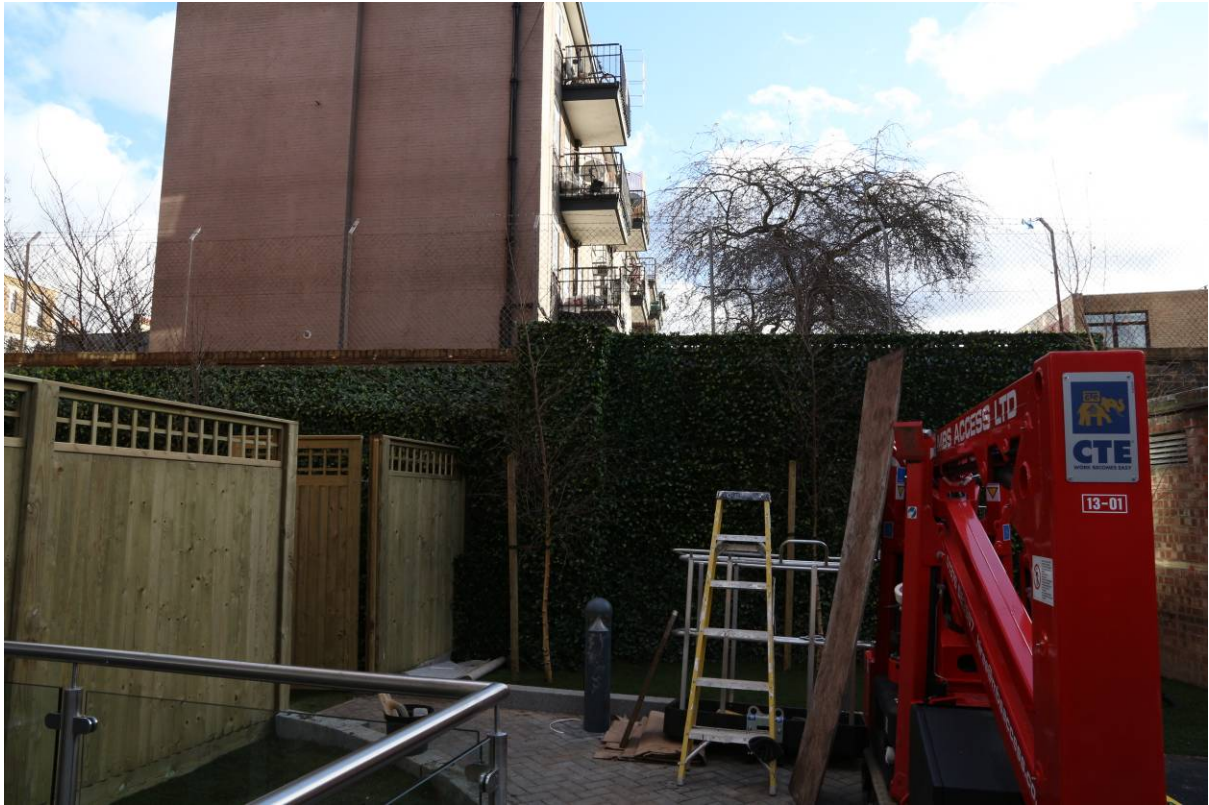
Plate 56 Photograph taken in December 2017 (PCA) of the boundary wall with Manchester House beyond, looking south (viewpoint on Figure 19)

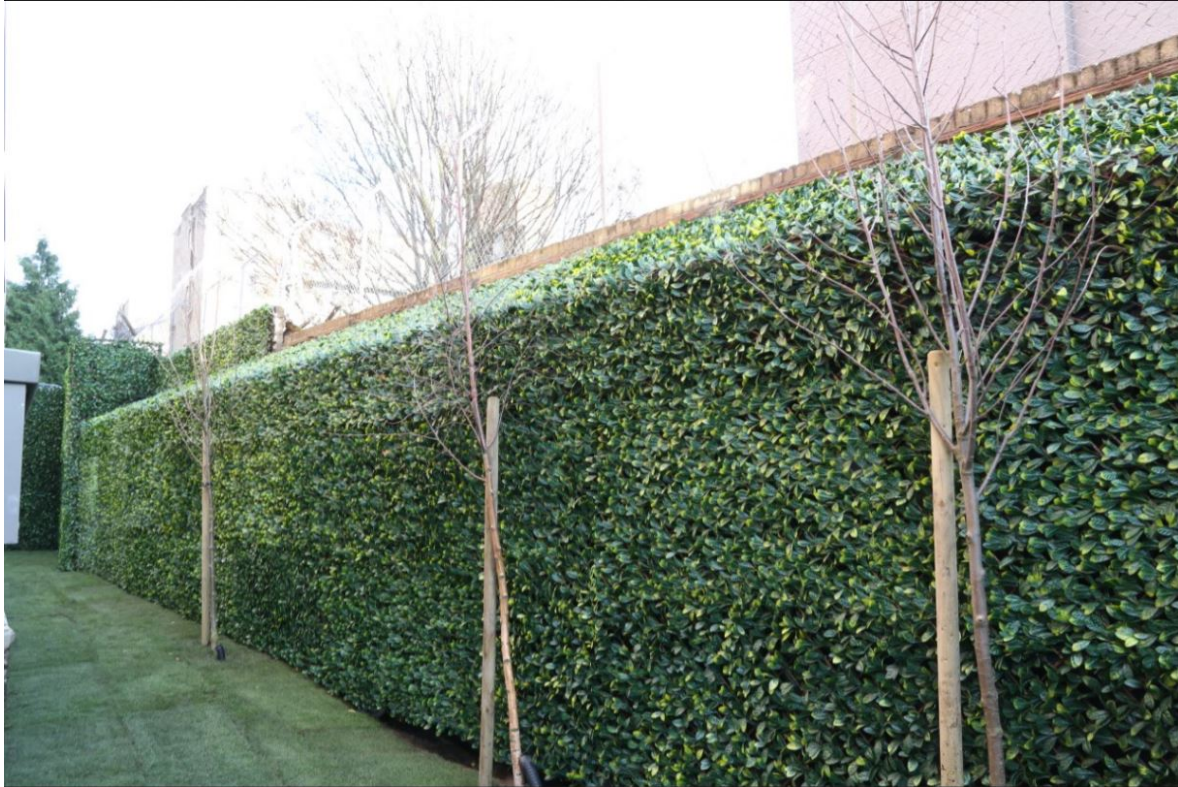
Plate 57 Photograph taken in December 2017 (PCA) of artificial hedging covering the south boundary wall, looking east (viewpoint on Figure 19)

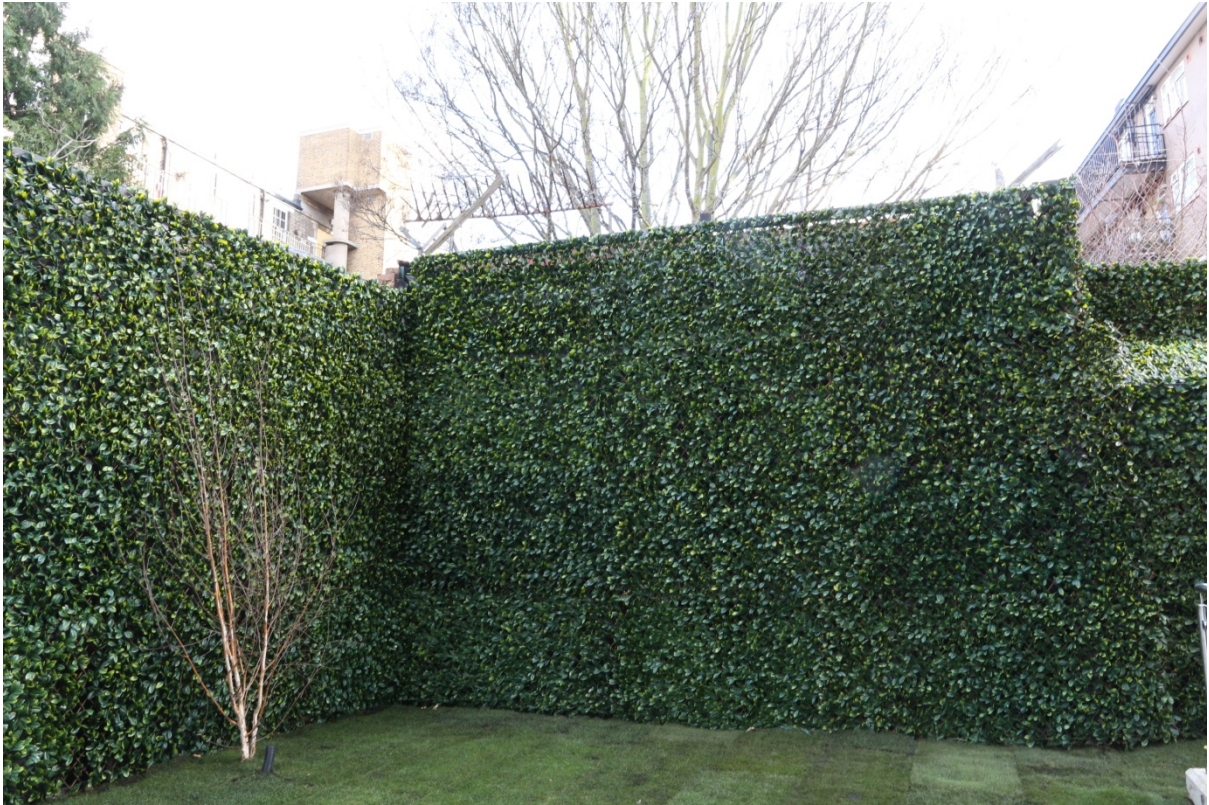
Plate 58 Photograph of the south-east corner of the site taken in December 2017 (PCA), looking south-east (viewpoint on Figure 19)

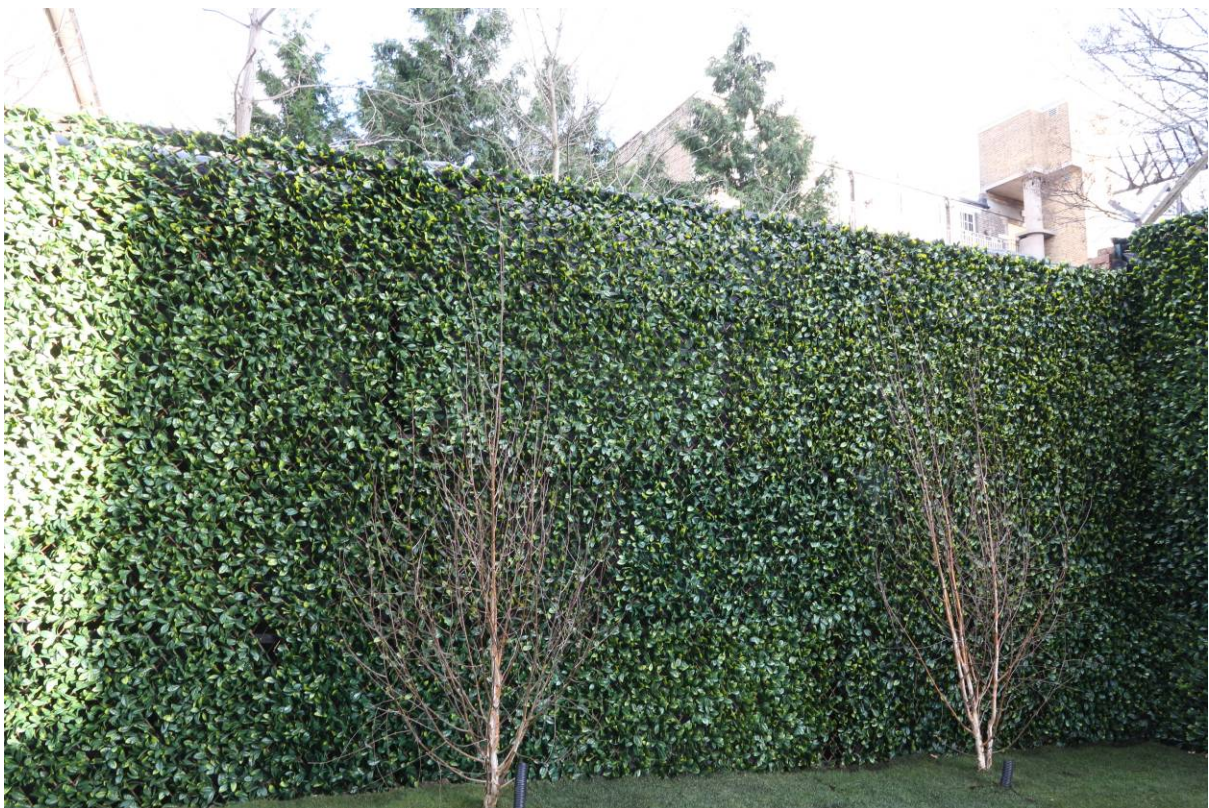
Plate 59 Photograph of the south-east corner (right) of the site taken in December 2017 (PCA), looking east (viewpoint on Figure 19)

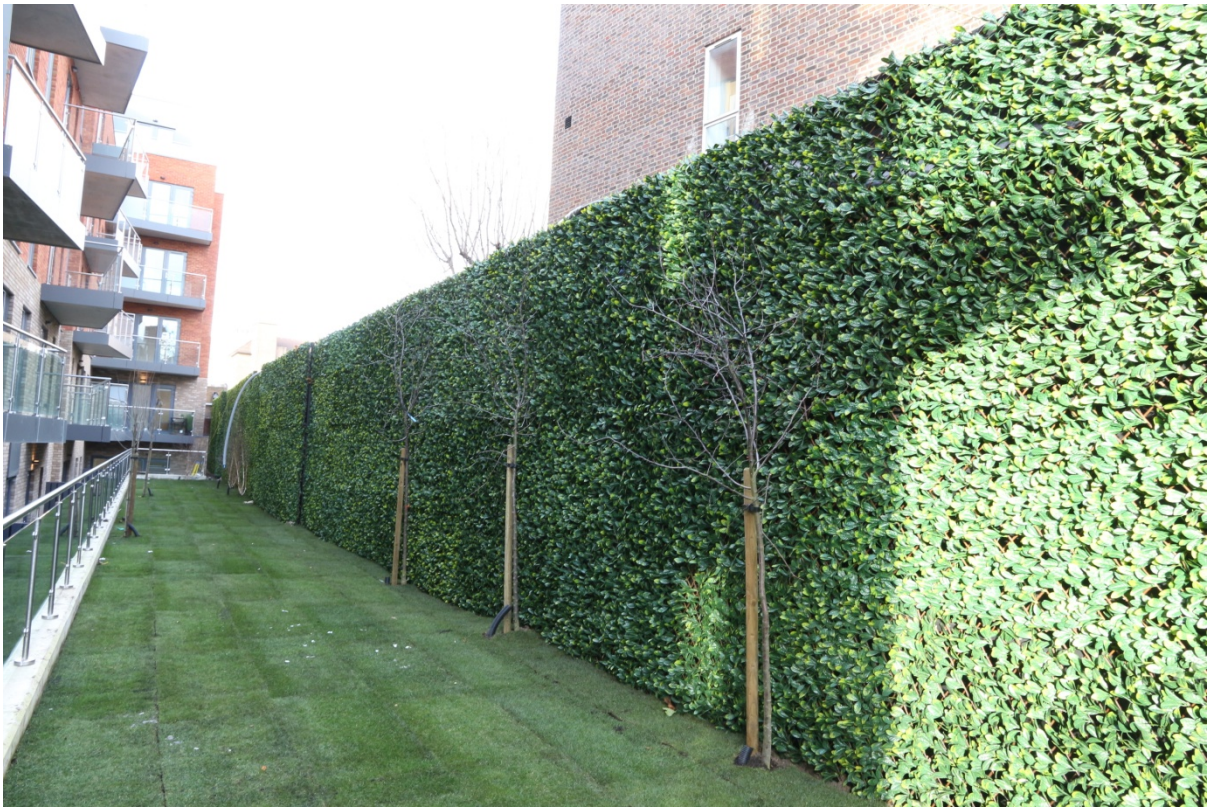
Plate 60 Photograph taken in December 2017 (PCA) of the boundary wall with the newly constructed building (left), and Southey House (right) beyond, looking north (viewpoint on Figure 18)
