**GIFFORD'S HALL
WICKHAMBROOK, SUFFOLK**

**ARCHAEOLOGICAL EVALUATION
AND WATCHING BRIEF**

**PARISH/SITE CODE: WKB 051
OASIS REF: preconst1-306521**

PCA REPORT NO: 13256

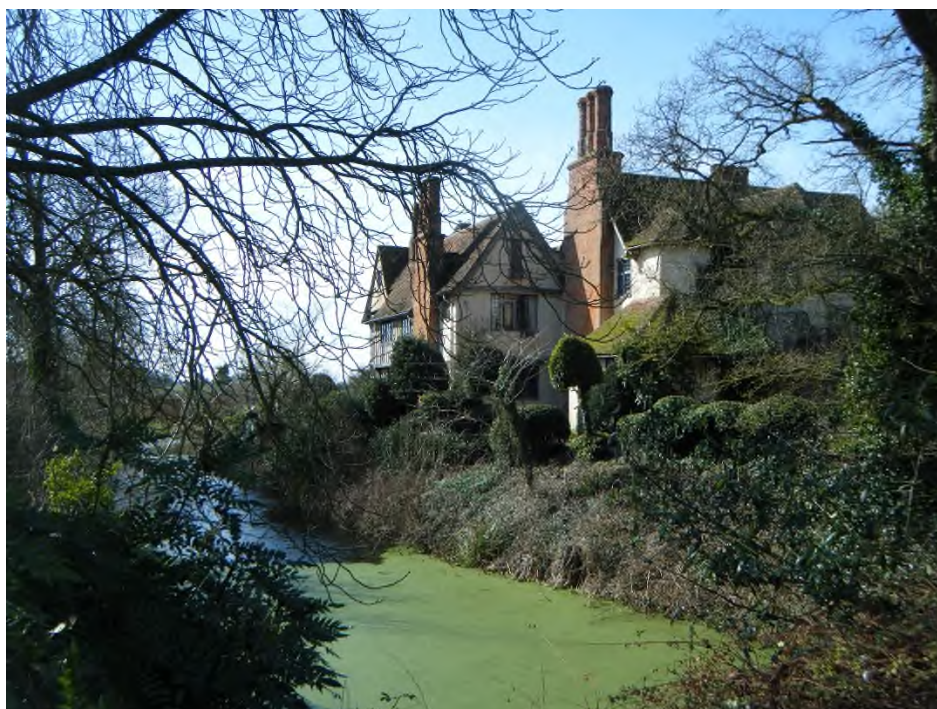
Plate 1: View of Gifford's Hall from the outer northwest corner of the moat (moat in foreground), looking southwest

of the original building (Plate 1). The north arm of the moat was infilled around this time. The interior has four fine 16th-century panelled rooms and one dating to the 17th/18th century. The bridge over the south arm of the moat dates to the 16th century.

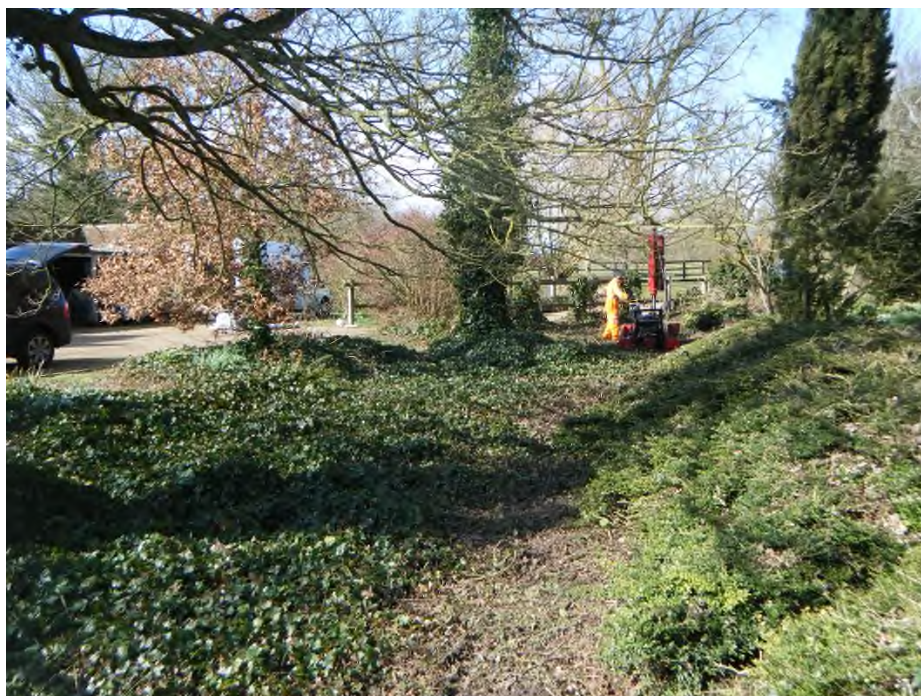
Plate 2: Window sampling rig in operation at the west end of the backfilled moat, looking west

- 5.1.2 The window sample boreholes (WSC–WSI) were positioned along the approximate centreline of the former moat (Plate 2), revealing a similar sequence of backfill deposits and a relatively consistent depth to the base of the moat of approximately 3.6m below ground level (bgl), at 93.5m aOD. It is likely that the shallower depths to the base of the moat recorded in some of the boreholes (e.g. WSH, WSI) is accounted for by the boreholes being 'off-centre' and penetrating the sides of the moat. With the exception of a thin layer of organic silty clay at the base of the moat in borehole WSD, there was no evidence for surviving *in situ* waterlogged deposits. It was clear that the moat had been thoroughly cleaned out, with soft sediment being removed prior to it being backfilled with dumps of boulder clay, soil and rubble in the early 1900s.

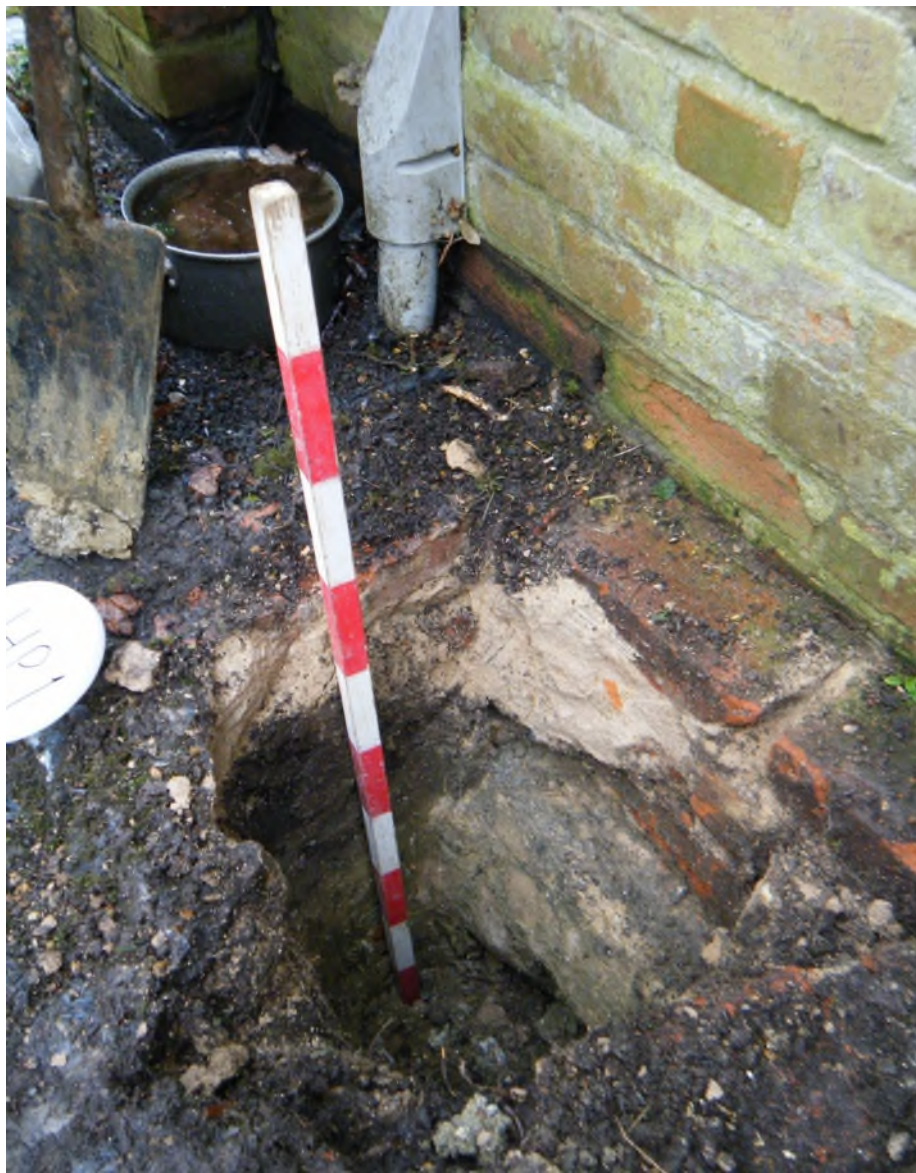
Plate 3: Geotechnical test pit HP1, looking northeast (scale 1m)

- 5.1.5 Test pit HP1 was dug against the foundation of the west wall of the granary building, in the northwest corner of the site (Plate 3). This was excavated to a depth of c. 1.2m bgl, exposing the geological substrate at a depth of c. 0.9m bgl (96.23m aOD). This was overlain by a layer, up to 0.7m thick, of soft, dark brown silty clay containing brick and tile fragments. This made-ground deposit was sealed by a 0.21m thick layer of concrete embedded with cobbles and bricks on the surface. The concrete foundations of the wall and its lower brick courses were exposed in the side of the excavation (base of concrete foundations at c. 0.6m bgl).

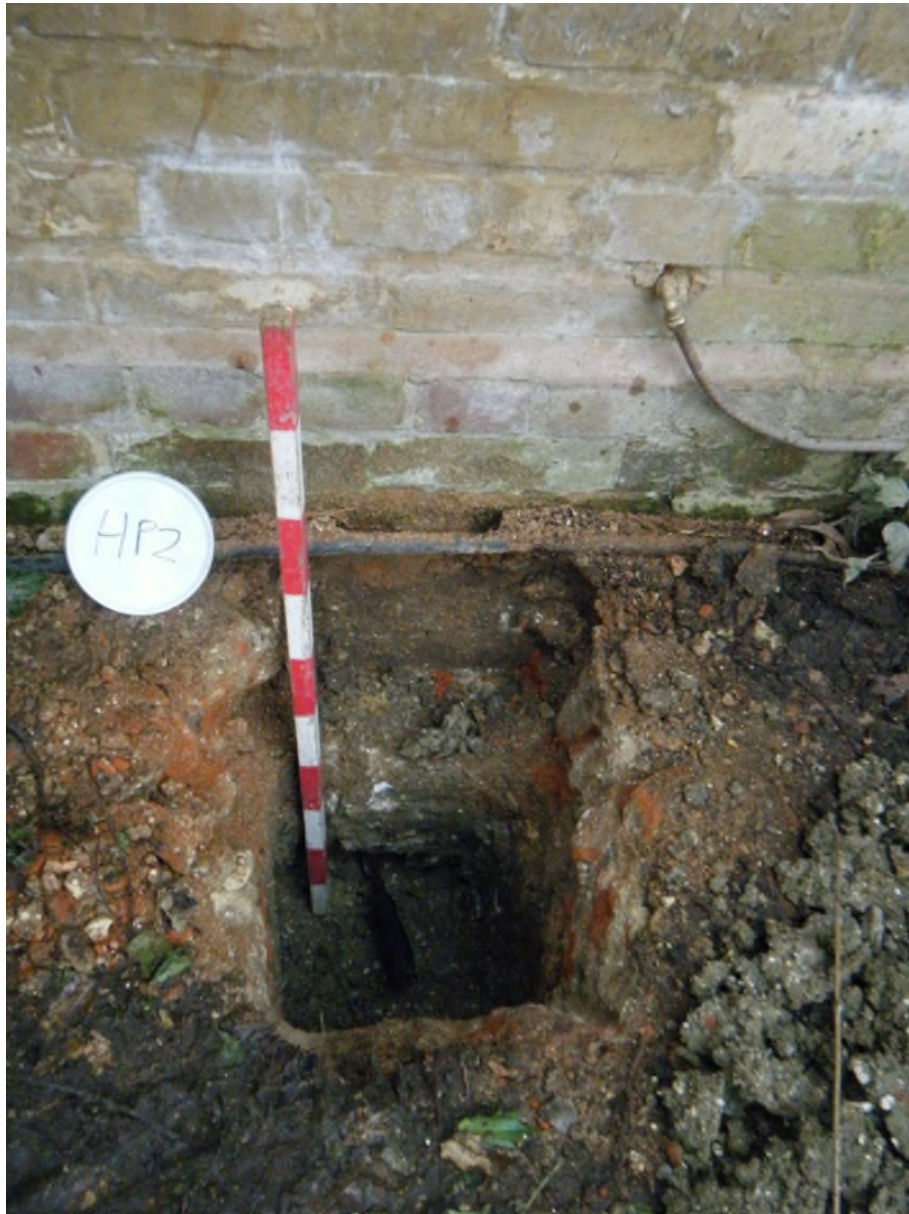
Plate 4: Geotechnical test pit HP2, looking south (scale 1m)

- 5.1.6 Test pit HP2 was dug against the foundation of the north wall of a small brick-built extension on the northeast corner of the house (Plate 4). This was excavated to a depth of c. 0.7m bgl, revealing a layer of made-ground, at least 0.5m thick, overlain by a 0.21m thick layer of concrete. The concrete foundations of the wall and its lower brick courses were exposed in the side of the excavation (base of concrete foundations at c. 0.6m bgl).

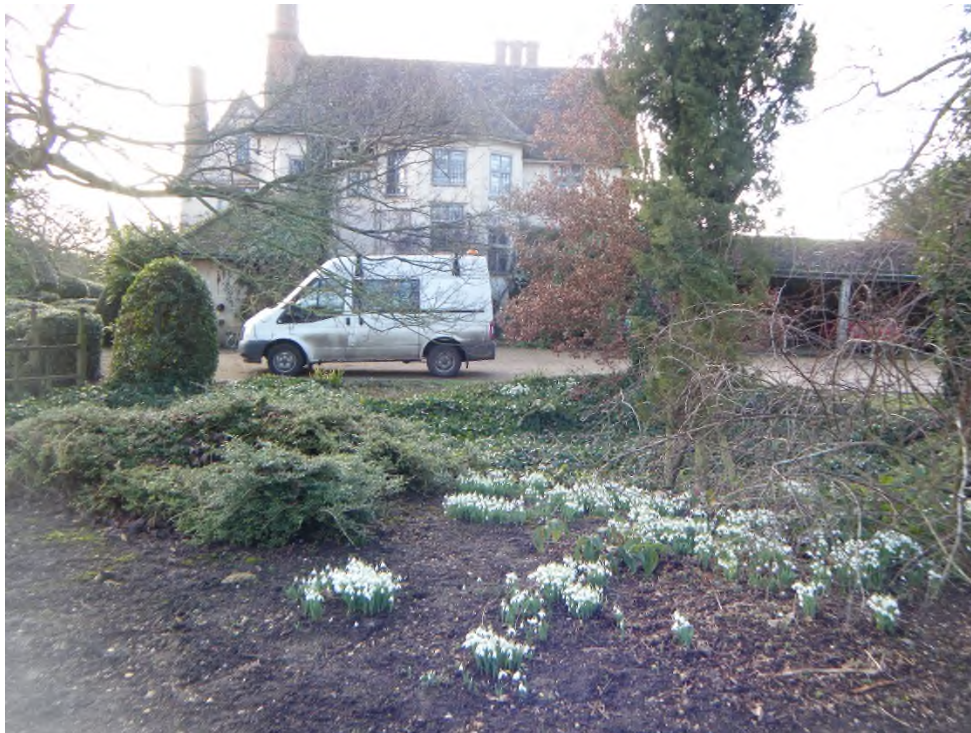
Plate 5: General view of the backfilled moat (north arm)
and car park, looking south

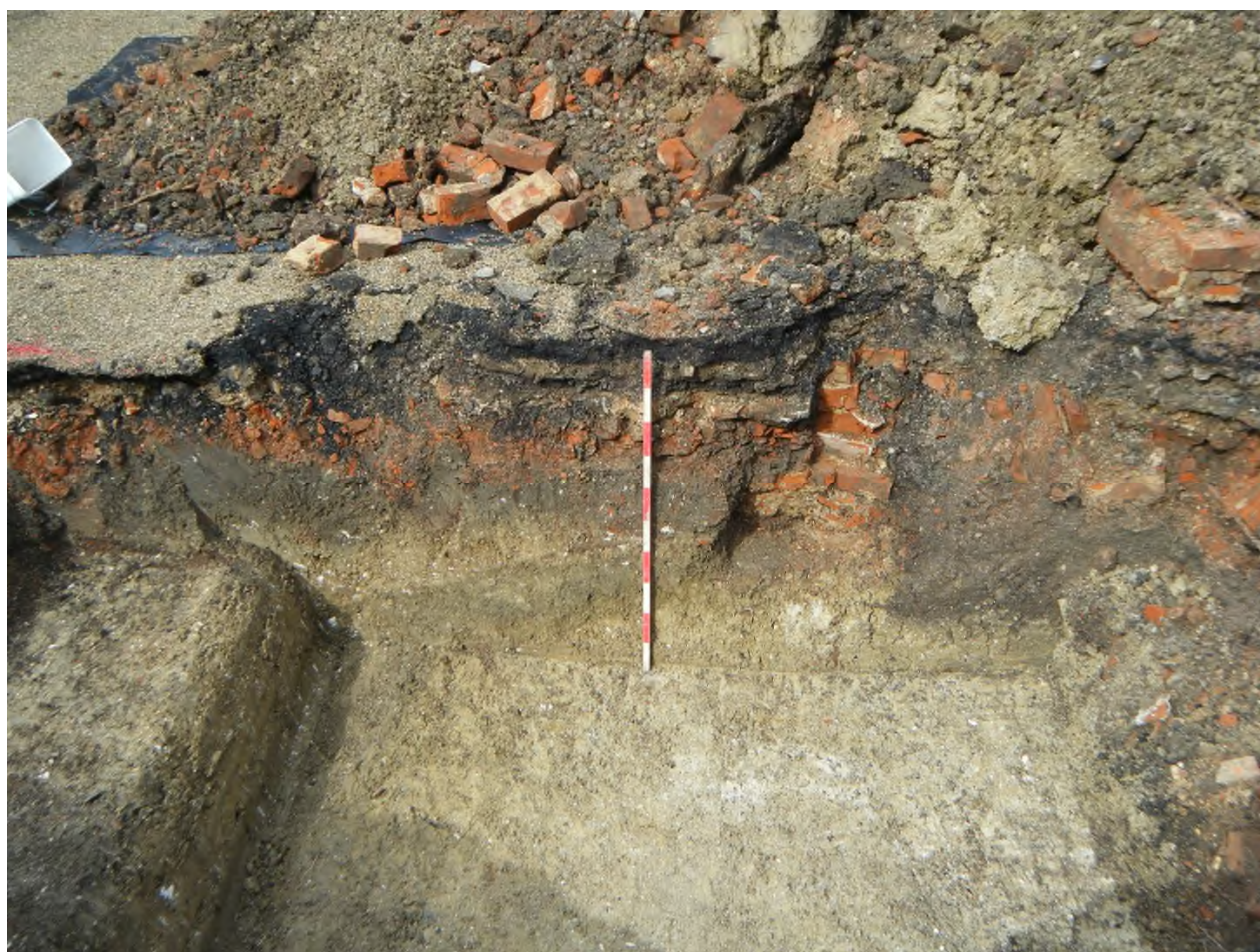
Plate 7: Trench 2, looking west (scale 1m)

- 5.3.1 Located within the footprint of the proposed new extension to the north elevation of the house, in the eastern part of the car park, Trench 2 measured 3.4m long by 1.6m wide and was aligned approximately north-northeast to south-southwest (Figs 2 and 4; Plate 6). In the northern half of the trench, the geological substrate (201) was encountered at a depth of 0.85m bgl (96.21m aOD; the nearby borehole BH1 recorded the surface of the boulder clay at 95.40m aOD). At the request of SCCAS, a machine-dug sondage was excavated into this layer to test that it was not redeposited. The hardness and compaction of the layer confirmed that it was *in situ*

boulder clay, with a thickness of at least 1.1m. The geological substrate was overlain by a layer of mid brown silty clay (202), up to 0.11m thick, probably the remnants of a former subsoil horizon.

5.3.3 Built directly over feature [203] was a brick building of probable early 20th-century date. The northeast corner of the building was exposed in the trench, with its surviving courses of mortar-bonded, machine-made frogged bricks [207] resting on a concrete foundation. The unstamped bricks had a shallow frog, a light brownish red sandy fabric and measured 9" x 4 ³/₈" x 2 ¹/₂". The area within the building had been infilled with charcoal-flecked soil (208) and brick rubble (209) and covered with a surface layer of concrete (210).

5.3.4 Abutting the north wall on the outside of the building was a layer of dark, loose soil (212) containing hearth waste, modern broken glass bottles and brick fragments, overlain by a layer of loose brick rubble (213). Extending over the entire trench was a layer of tarmac (211).

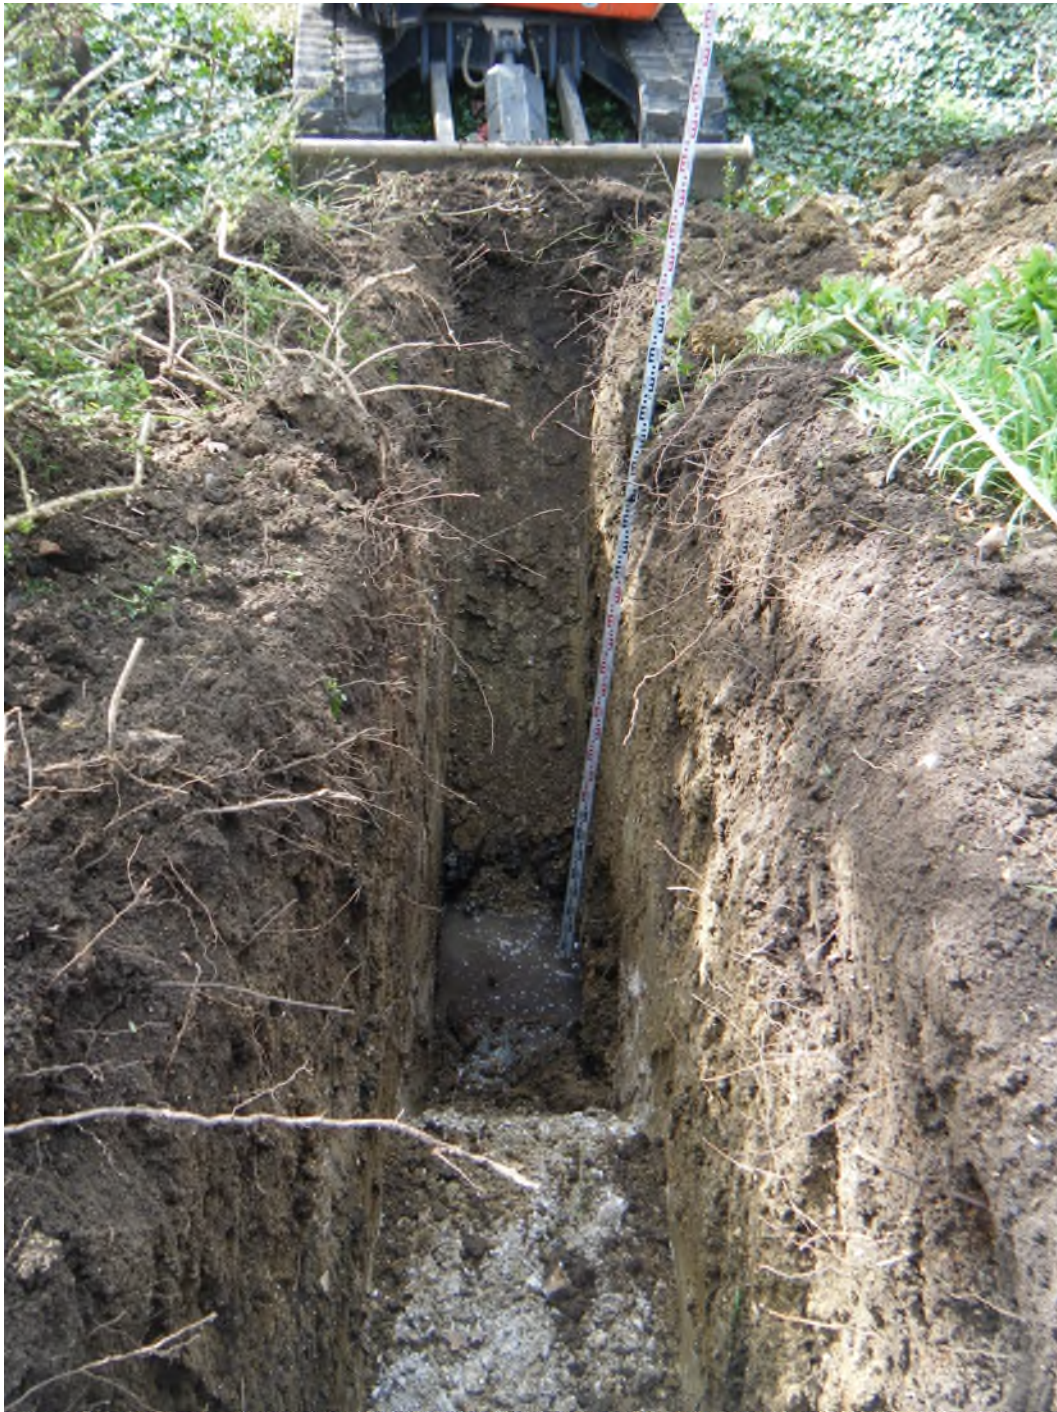
Plate 8: Trench 3 (through backfilled north arm of moat), looking south

- 5.4.5 Overlying (307) was a sequence of backfill deposits, (308) to (311), of redeposited silty clay and soil, with a combined thickness of c. 2.6m. The decaying branch of a tree protruded from (308) in section and early 20th-century glass bottles, mostly broken, were recovered from (309). It is possible that the moat was only partially backfilled at this time, as these deposits were sealed by a thin layer of topsoil (312), approximately 0.14m thick.

in Trench 2 and subsequent landscaping of the area of the car park. The basal fill of the cut was redeposited boulder clay (317), overlain by a layer of brick rubble and mortar (318), 0.12m thick, that dipped to the south. The upper deposit (319) consisted of mid brown silty clay and contained rusty sheet metal and other modern refuse.

- 8.8 The results of the excavation of the trial trench through the north arm of the moat (Trench 3) largely confirmed those of the borehole survey. The moat was shown to be approximately 3.6m deep and to have been cleaned out prior to it being backfilled with dumps of redeposited clay and soil. A thin layer of soft sediment was identified at the base of the moat; palaeoenvironmental assessment of this deposit indicated that it contained a statistically viable assemblage of weed seeds and snail shells characteristic of a damp/moist environment, along with large amounts of decayed plant matter. A thicker deposit of soft, possibly cassy soil that appeared to have been displaced by the backfilling and to have piled up against the inside (south) side of the moat, contained few ecofacts.

- 8.10 Not apparent in the results of the borehole survey was that the moat had undergone two phases of backfilling, along with a phase of groundworks that had largely truncated the south side of the moat. In the first stage the moat had been largely backfilled, leaving a depression of c. 1.2m from the top of the outside bank to the centre of the moat. Later in the 20th century and possibly associated with the demolition of a nearby brick building, the south side of the moat was dug away and the resultant pit backfilled with redeposited clay (the upper clay layer contained rusty sheet metal) and a dipping layer of brick rubble and mortar. Due to difficulties in positioning the machine on the uneven ground beneath the branches of the nearby trees, it was not possible to machine out the deposits in the very centre of the trench, so it was not possible to get an exact relationship between the backfill deposits and the cut of the pit.

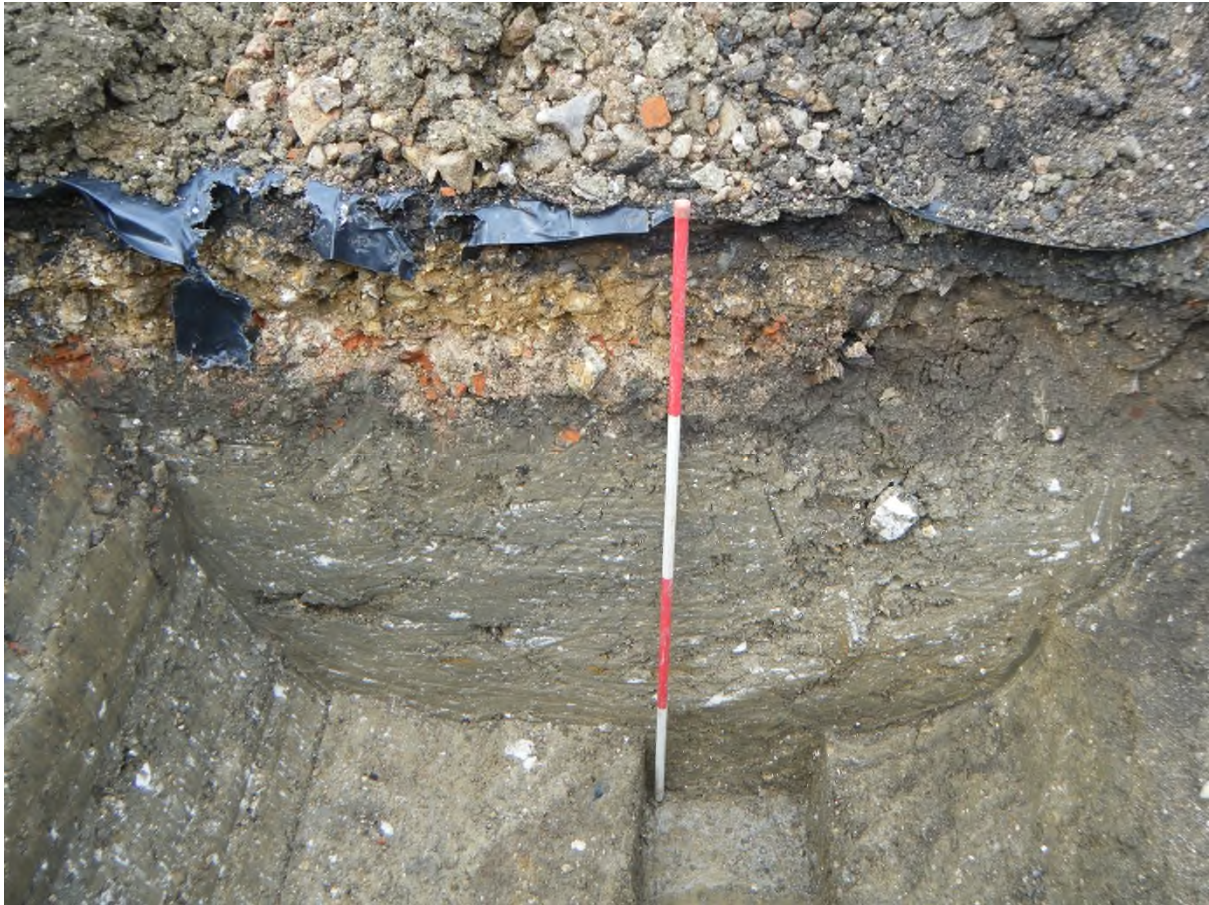
Plate 9: Trench 4, looking northwest (scale 2m)

- 5.5.5 Feature [405] was sealed by layers of modern made-ground, (409) to (411), that had
