**HISTORIC BUILDING RECORDING
OF THE OLD BAKERY,
TOP ROAD,
SLINDON,
ARUNDEL,
WEST SUSSEX,
BN18 0RP**

PCA REPORT NO: R13144

MARCH 2018

Historic Building Recording

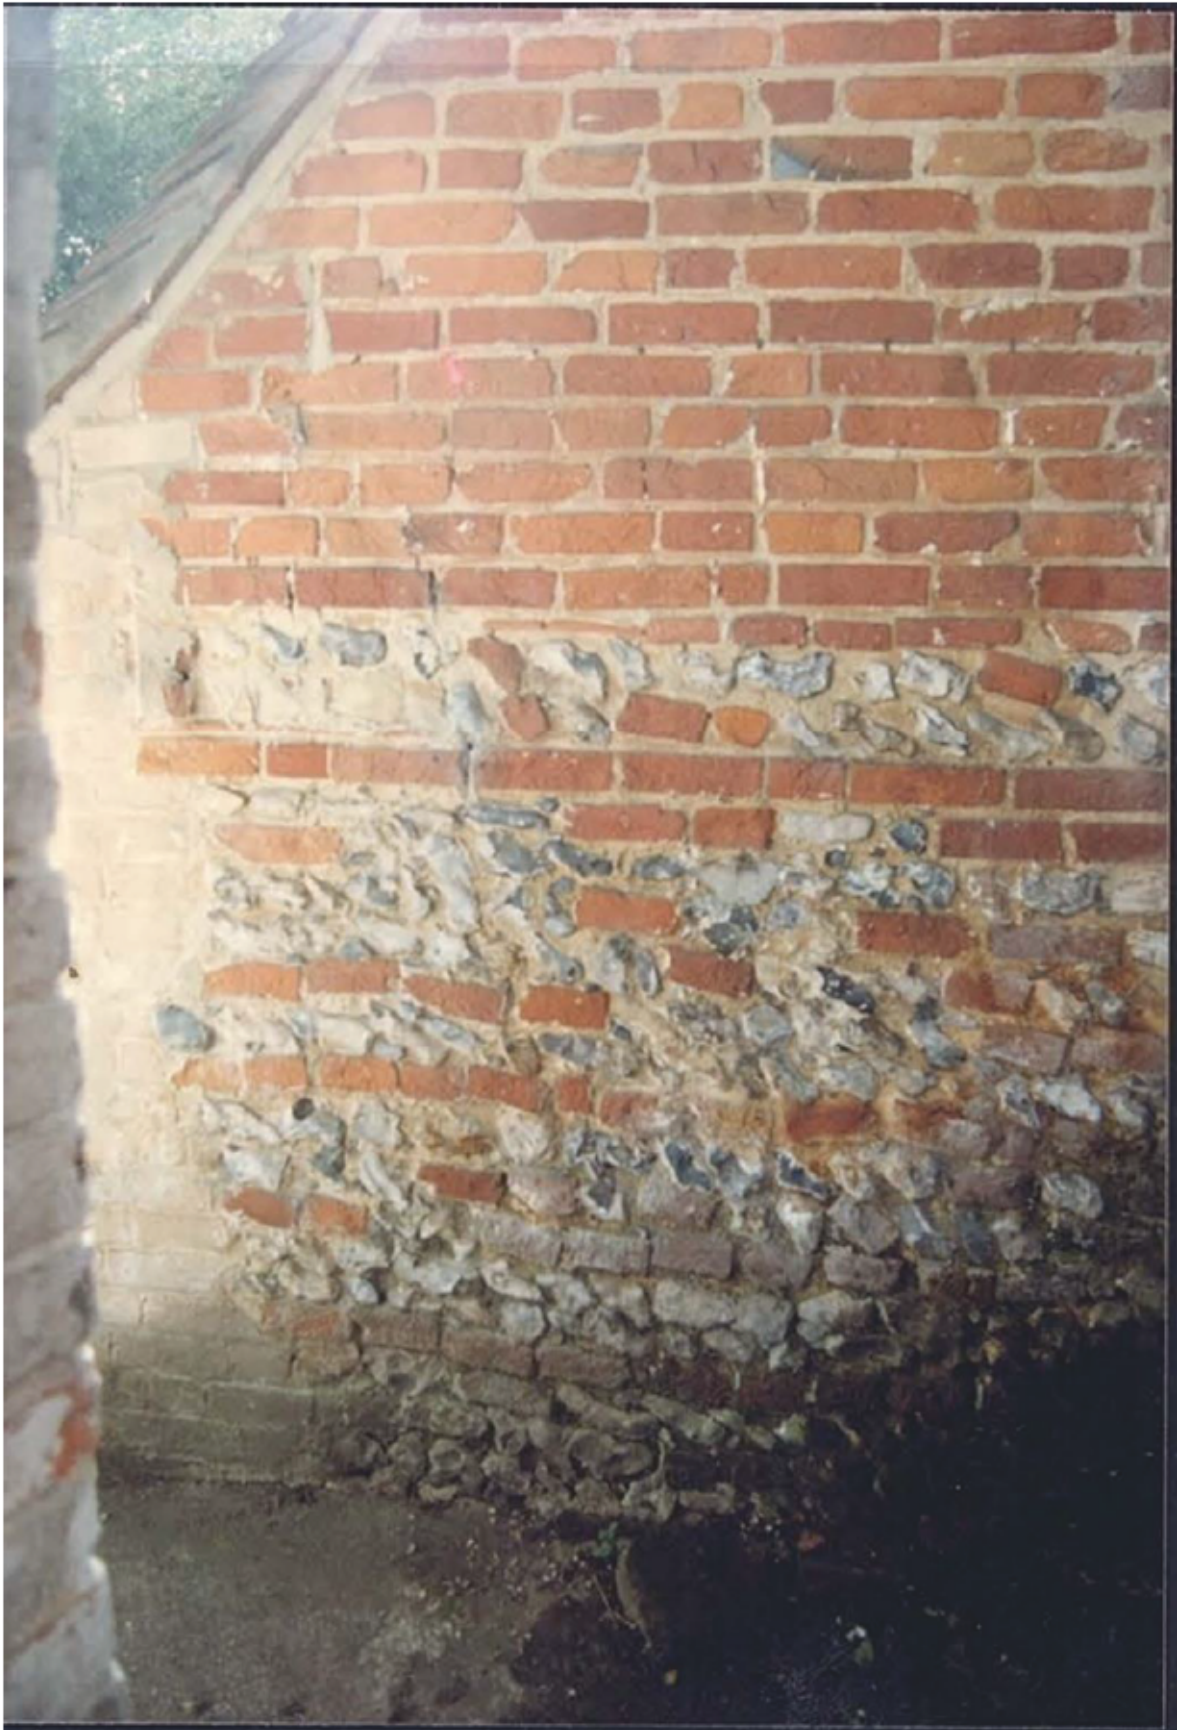
Historic Plate 4 Photograph taken by Sara Squires in September 1991 of the north gable elevation of the bakery building at the Old Bakery, looking south (© National Trust Wisley)

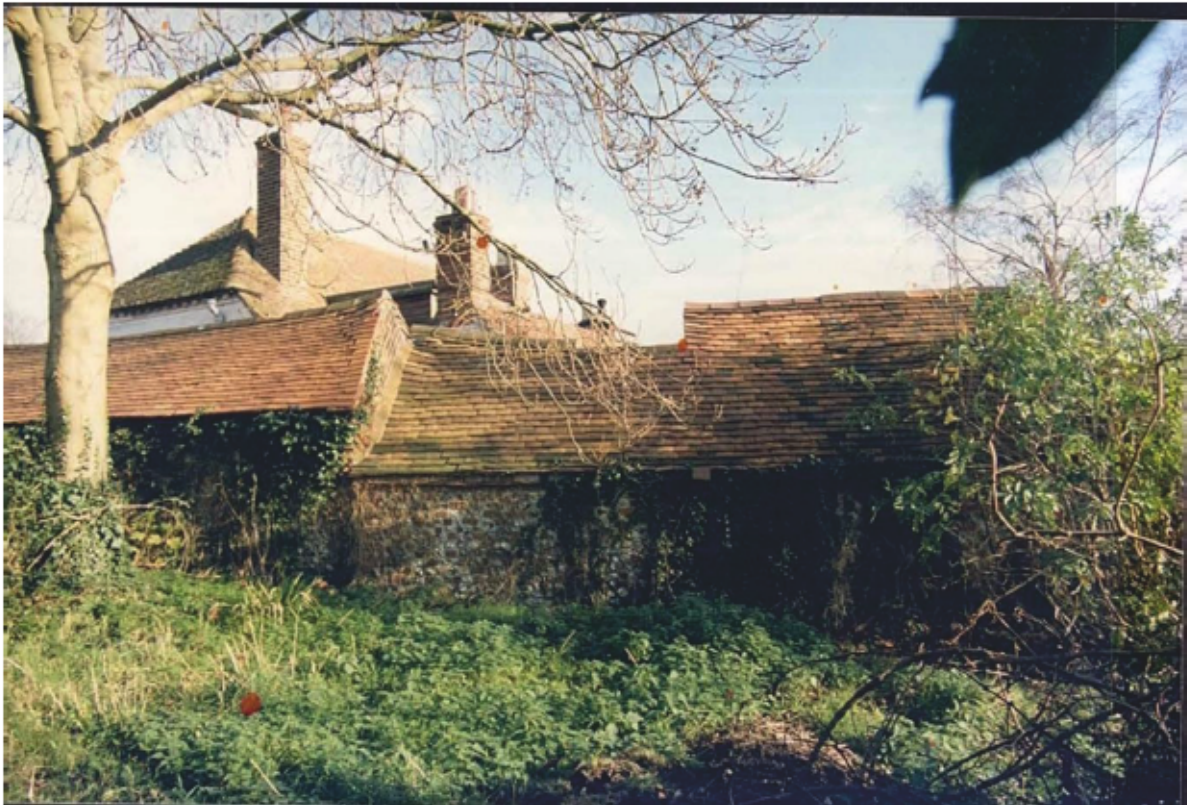
Historic Plate 5 Photograph taken by Sara Squires in September 1991 of the west elevations of the Bakehouse, WC and shelter building at the Old Bakery, looking east (© National Trust Wisley)

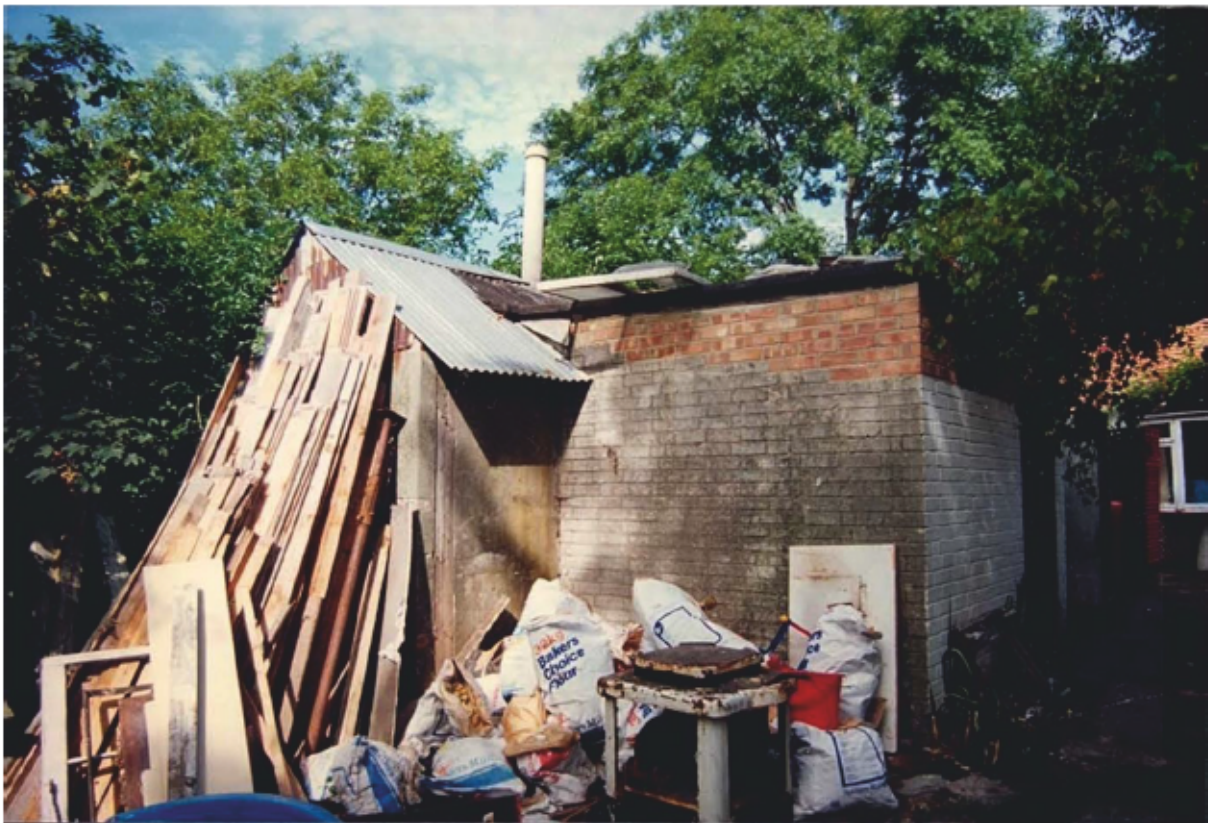
Historic Plate 6 Photograph taken by Sara Squires in September 1991 of the 1930s addition at the south end of the bakery, looking north (© National Trust Wisley)

'The original ovens at the Slindon Old Bakery were replaced in the 1930s (**Historic Plate 6**) by what was then modern technology in the form of a two deck hot air peel oven. Prior to that many of the small country bakeries were equipped with side flue ovens such as the one at Ore, Hastings (Martin, 1993).

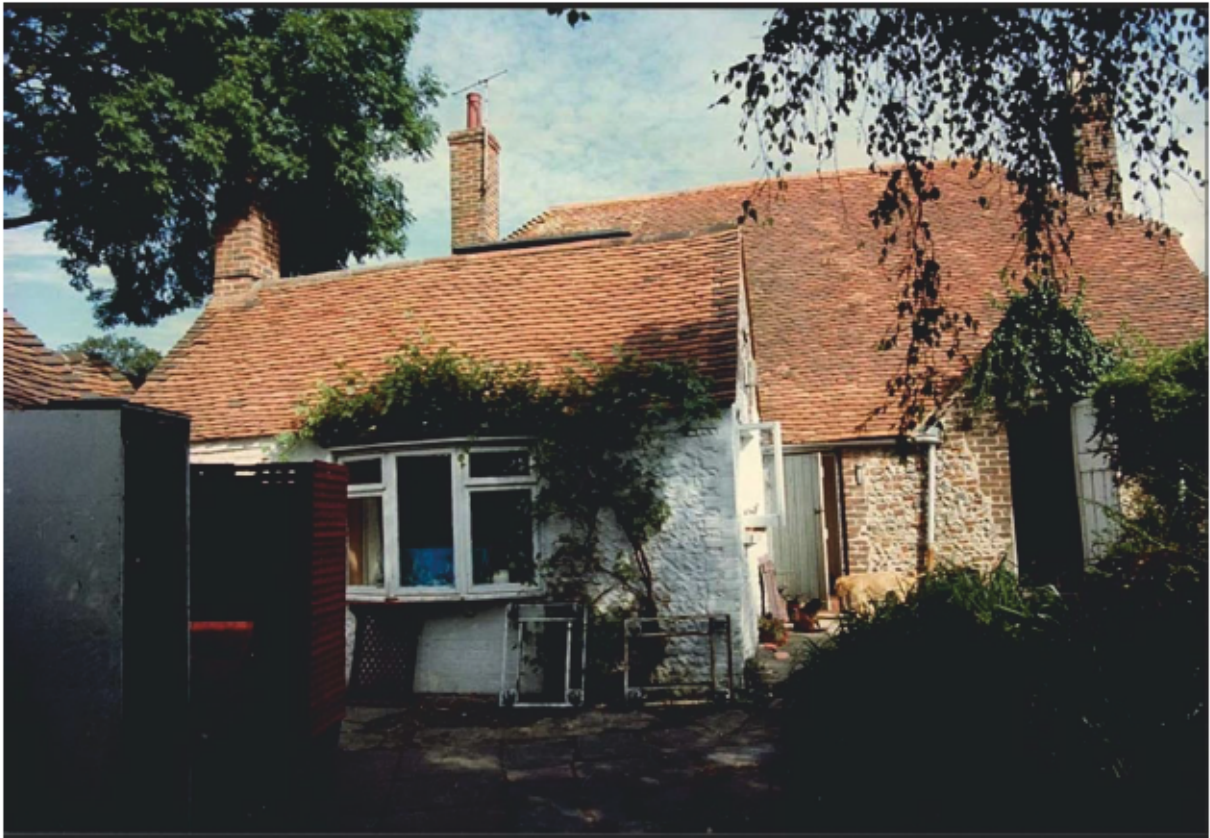
Historic Plate 9 Photograph taken by Sara Squires in September 1991 of the former bakehouse (now Kitchen) extension at the Old Bakery, looking north (© National Trust Wisley)

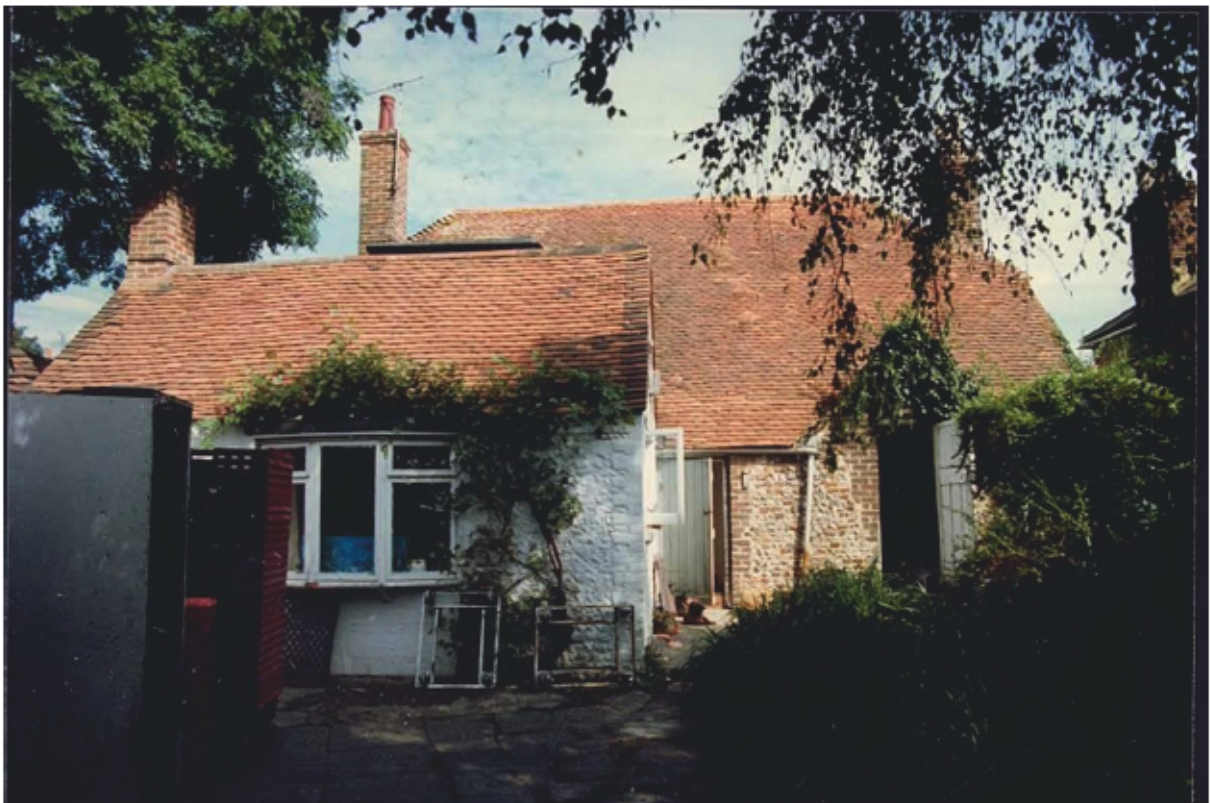
Historic Plate 10 Photograph taken by Sara Squires in September 1991 of the former bakehouse (now Kitchen) extension at the Old Bakery, looking north (© National Trust Wisley)

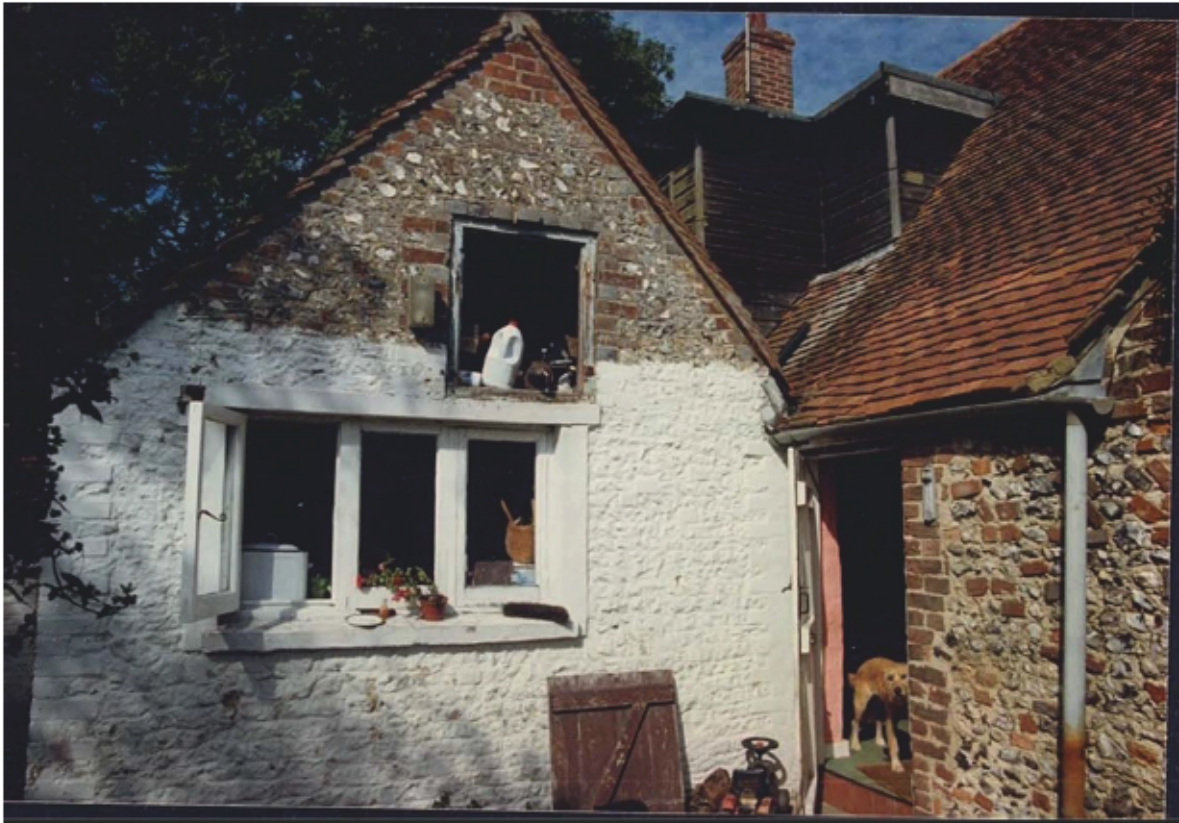
Historic Plate 11 Photograph taken by Sara Squires in September 1991 of the former bakehouse (now Kitchen) extension at the Old Bakery, looking east (© National Trust Wisley)

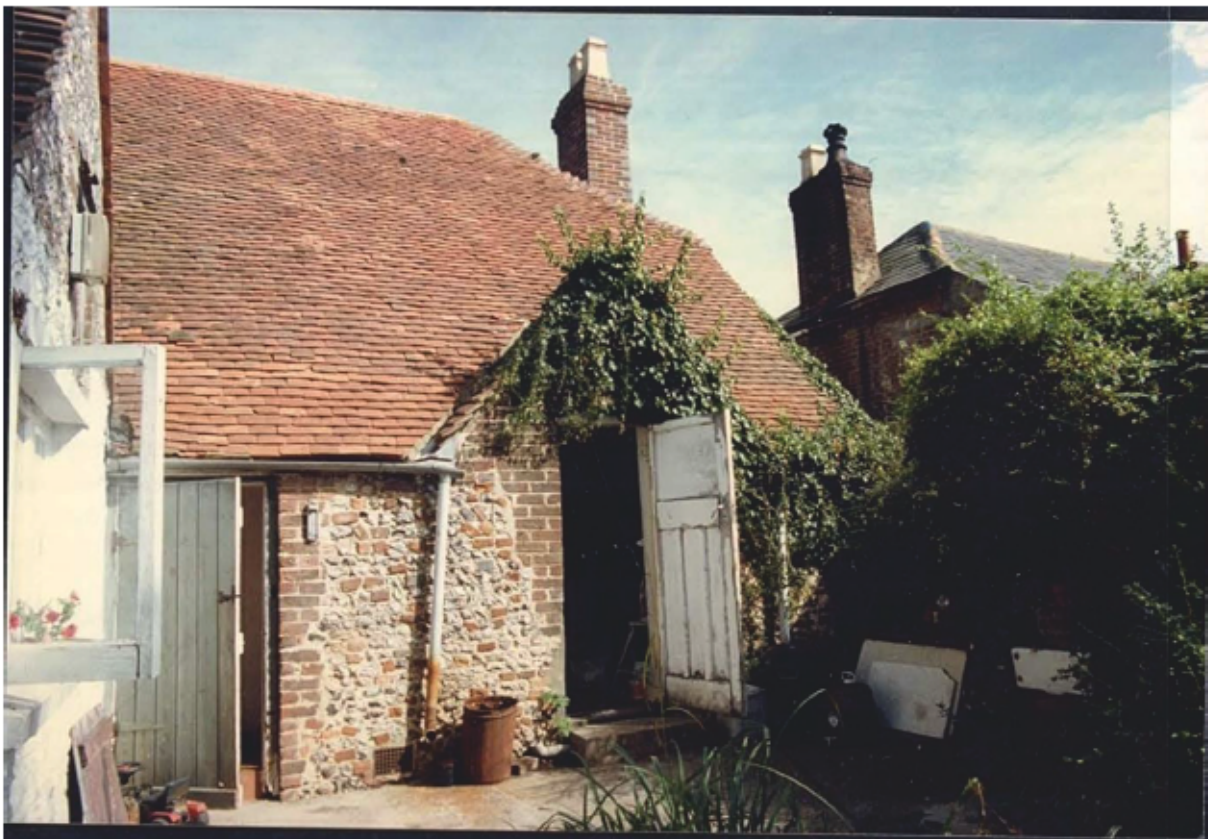
Historic Plate 12 Photograph taken by Sara Squires in September 1991 of the entrance to the storeroom in the south elevation of the Old Bakery, looking north (© National Trust Wisley)

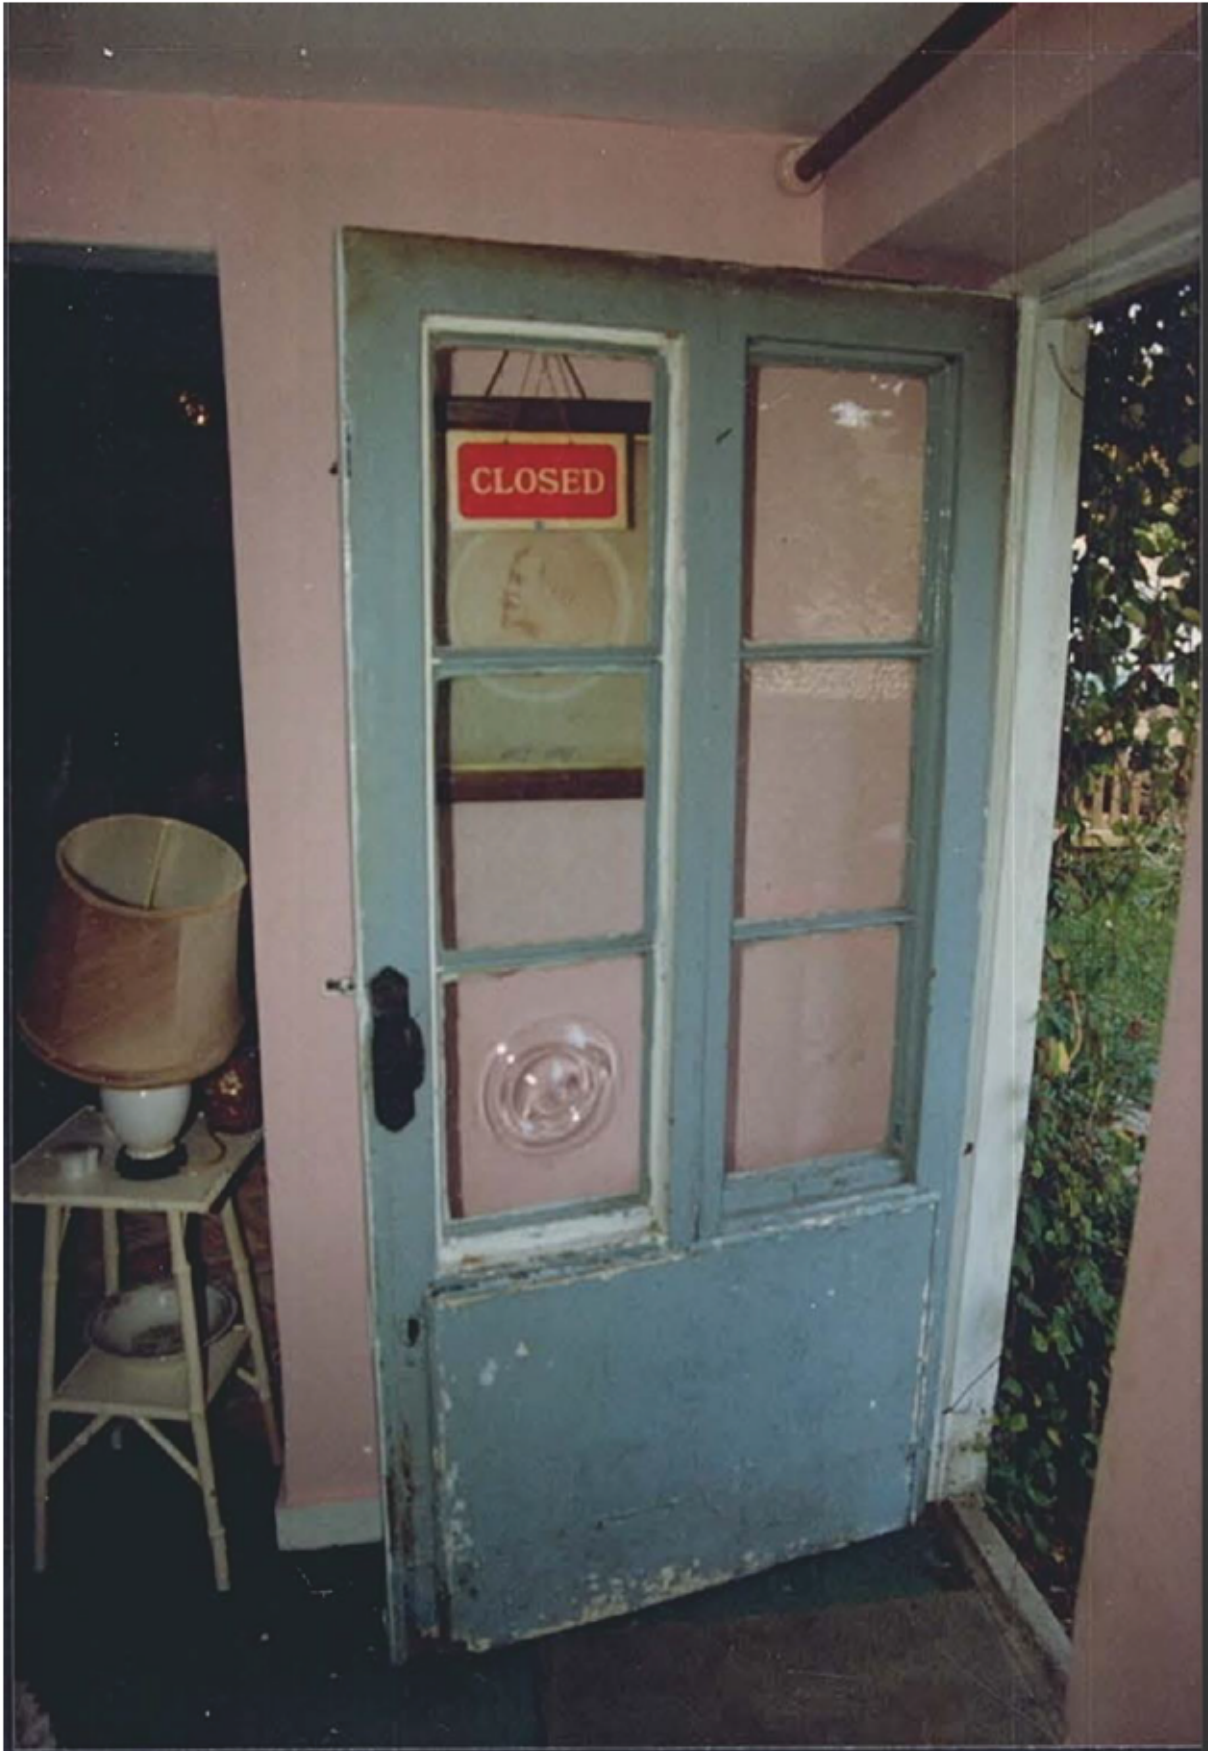
Historic Plate 14 Photograph taken by Sara Squires in September 1991 of the front door of the Old Bakery, looking west (© National Trust Wisley)

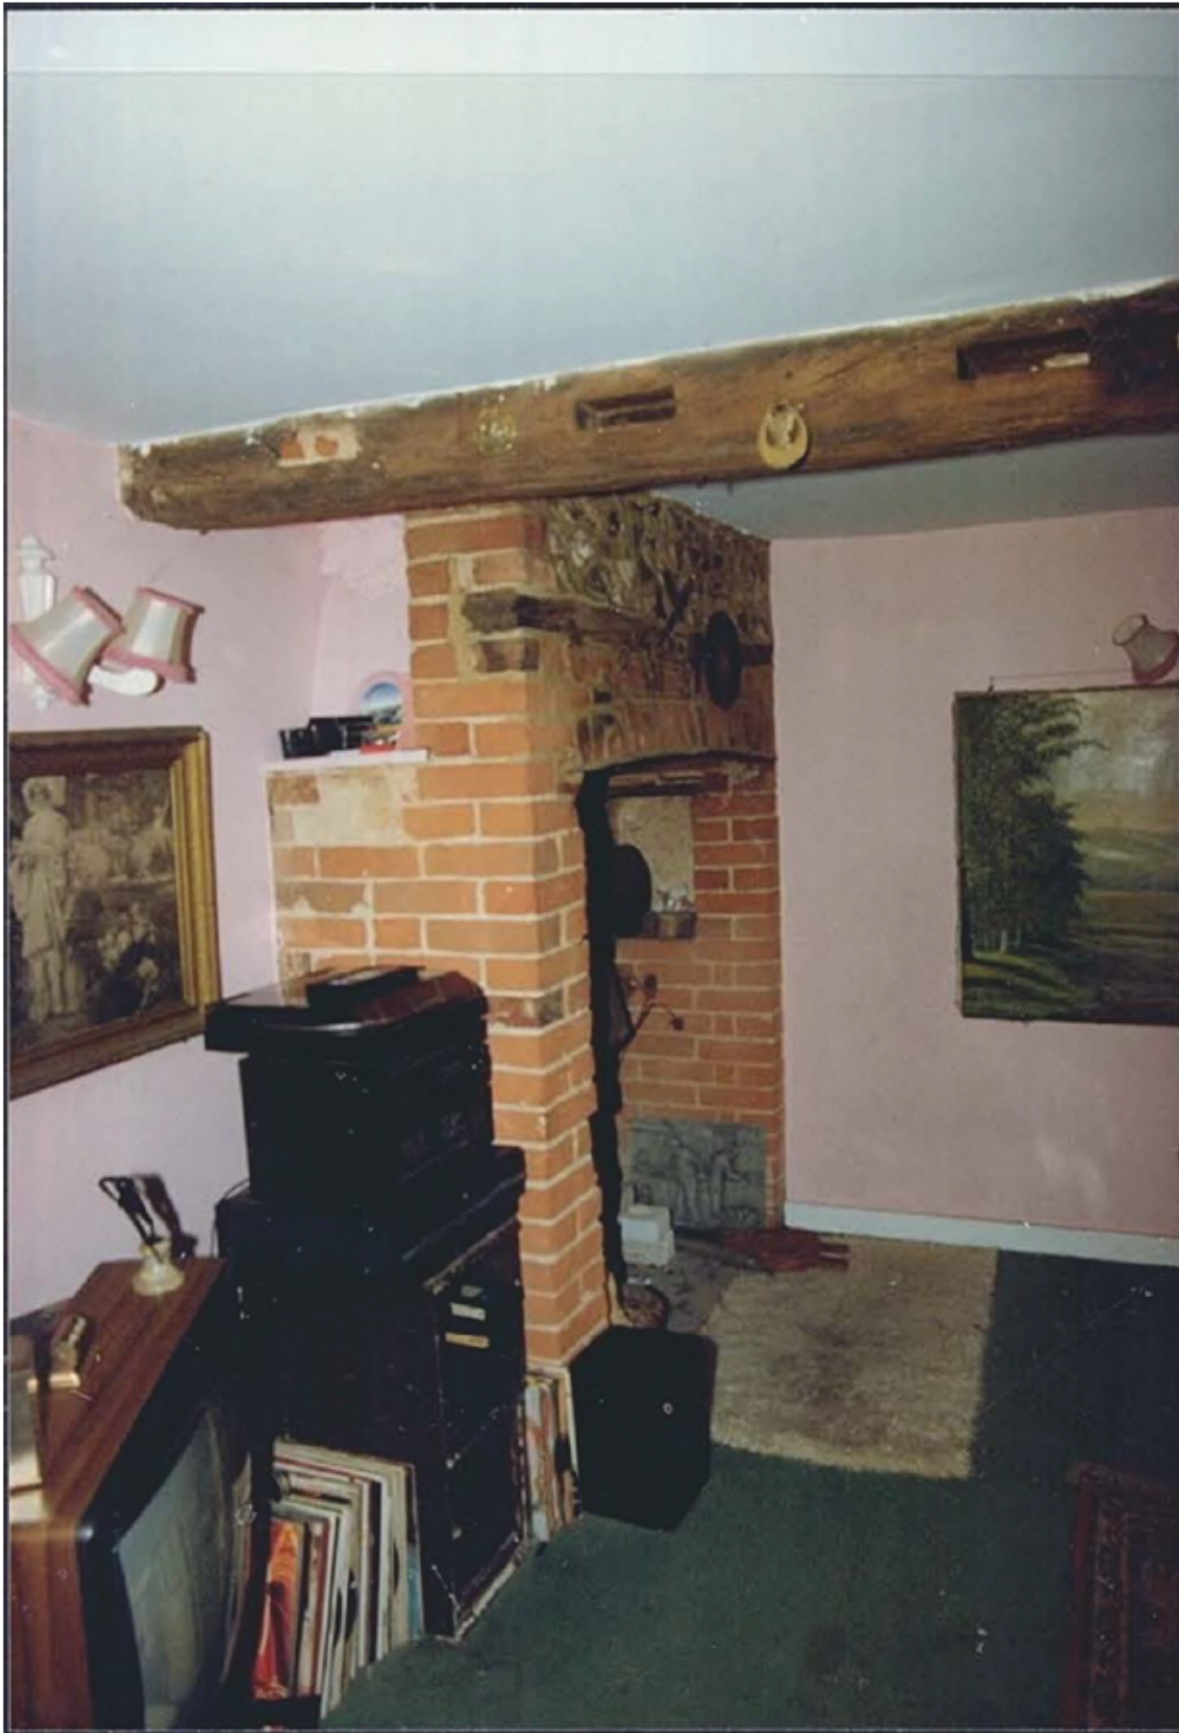
Historic Plate 15 Photograph taken by Sara Squires in September 1991 of the fireplace in the Sitting Room of the Old Bakery, looking west (© National Trust Wisley)

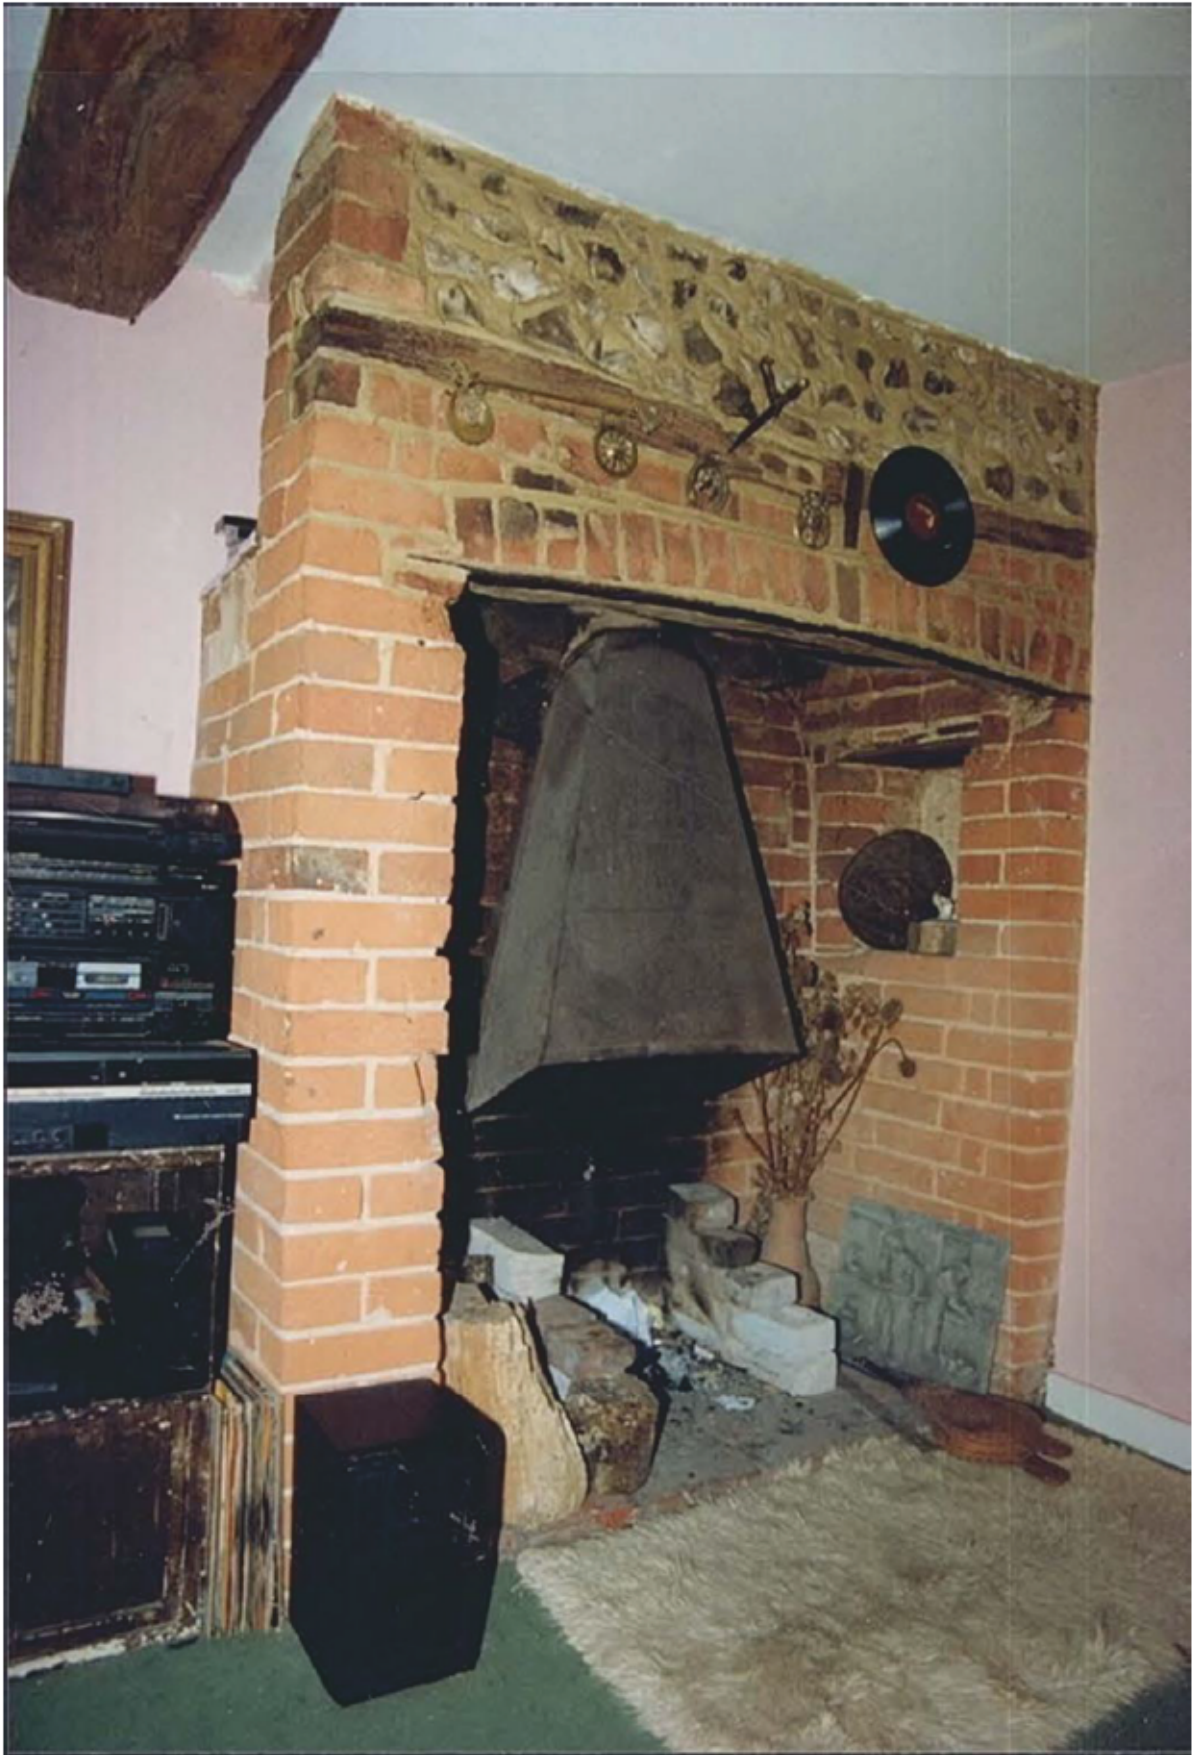
Historic Plate 16 Photograph taken by Sara Squires in September 1991 of the fireplace in the Sitting Room of Old Bakery, looking south-west (© National Trust Wisley)

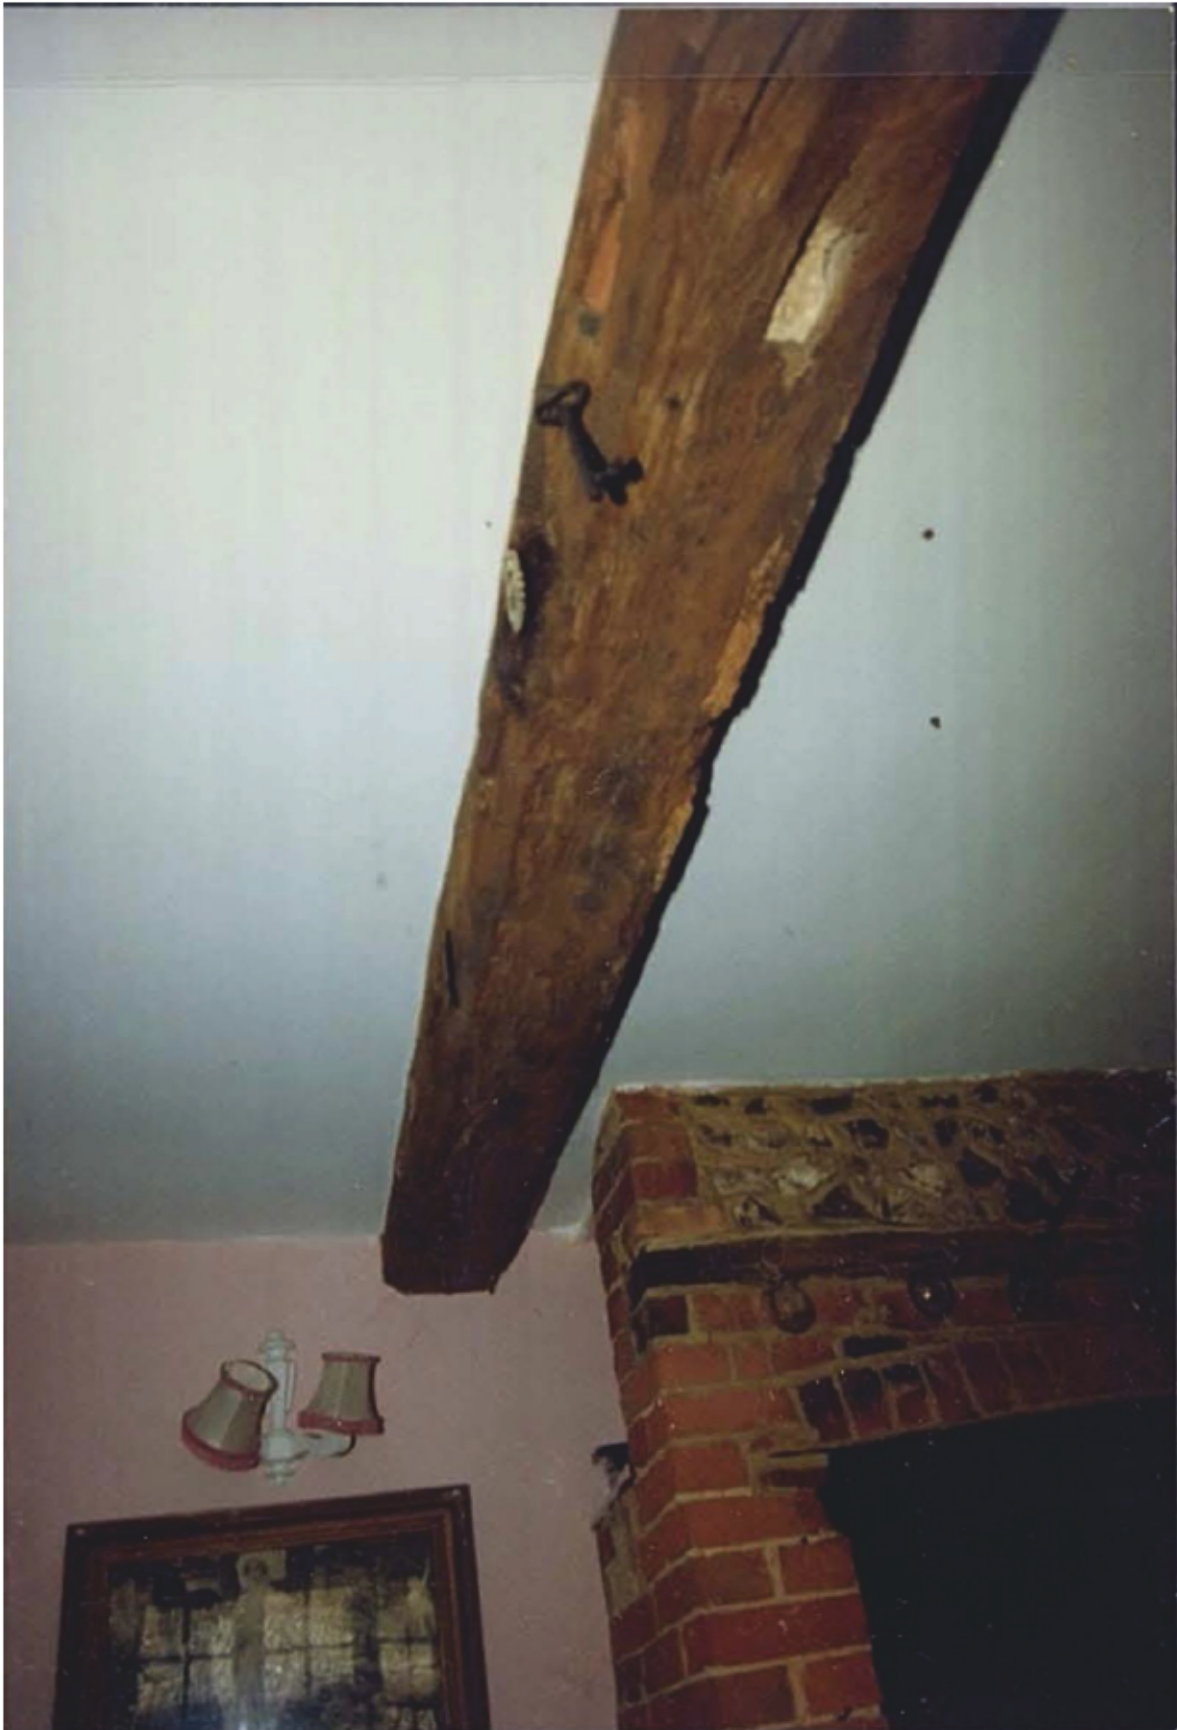
Historic Plate 17 Photograph taken by Sara Squires in September 1991 of the chamfered beam in the Sitting Room of Old Bakery, looking south (© National Trust Wisley)

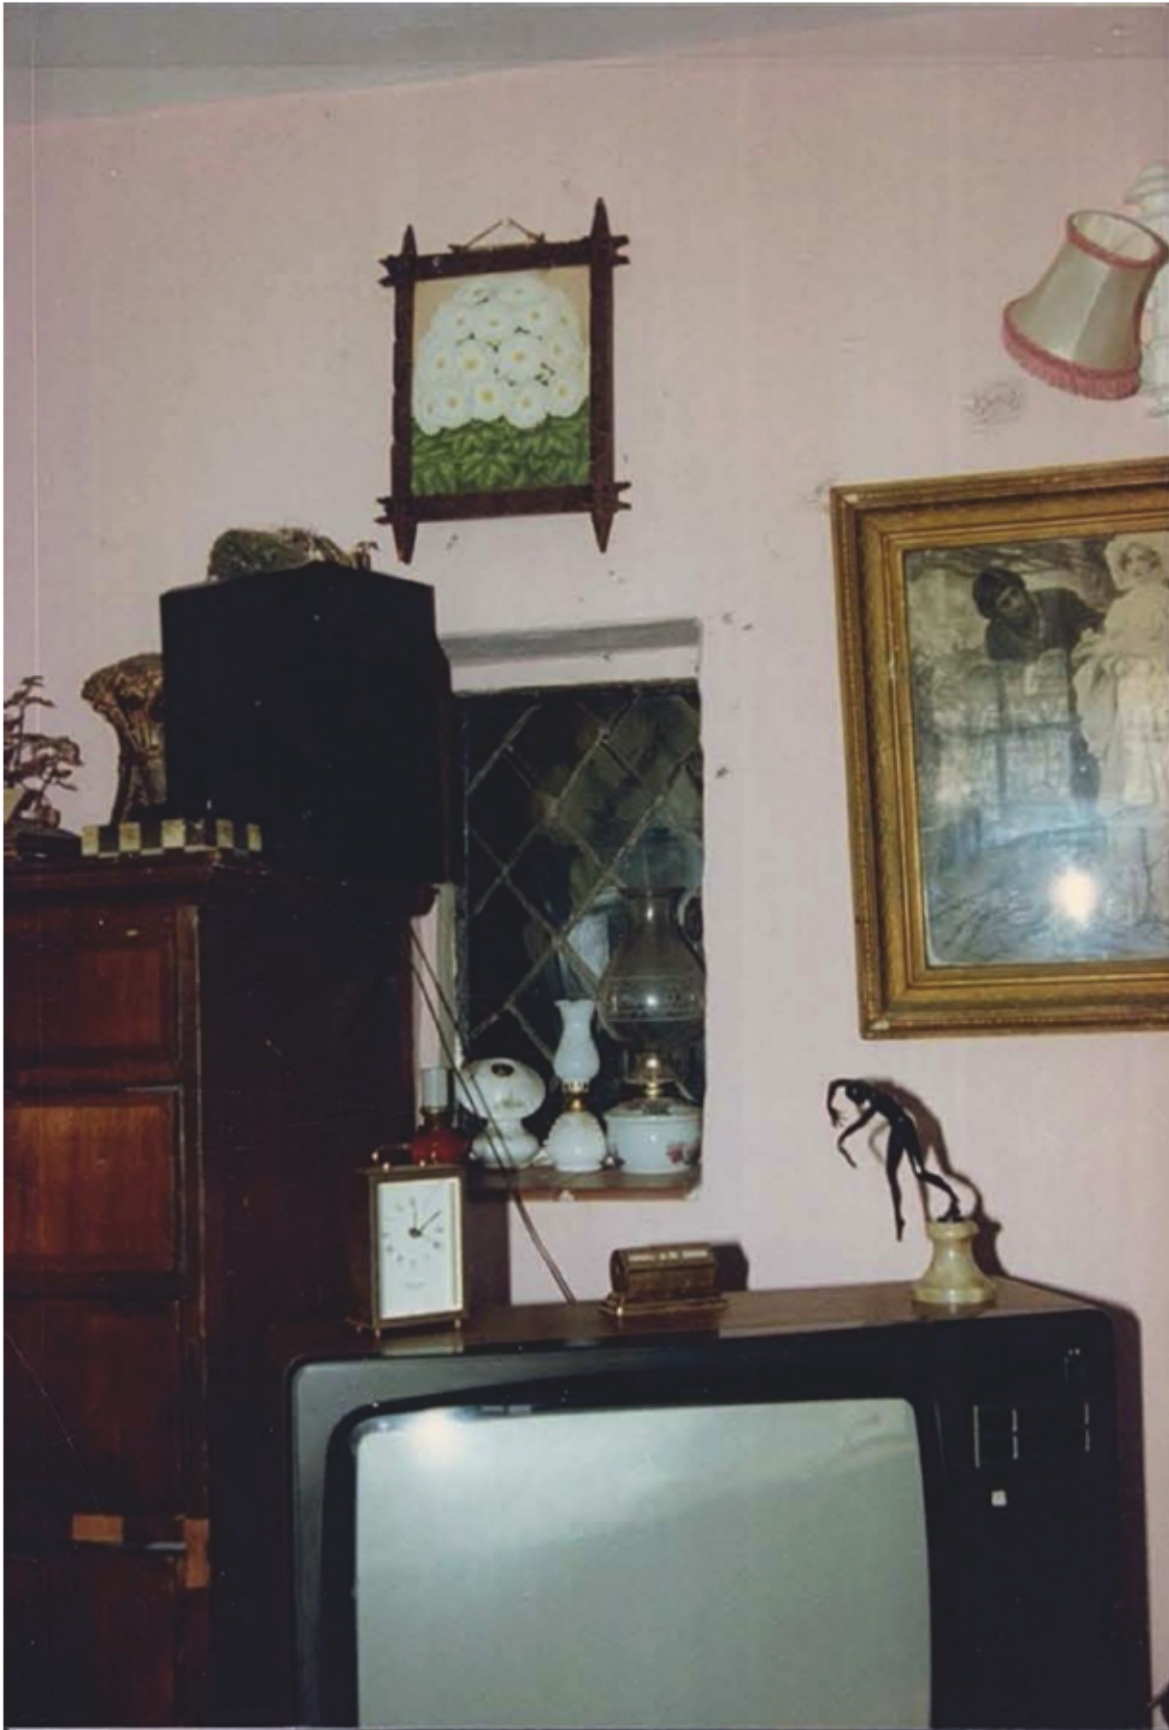
Historic Plate 18 Photograph taken by Sara Squires in September 1991 of the 17th century window in the Sitting Room of the Old Bakery, looking south (© National Trust Wisley)

- 6.3.3 To the east of the fireplace, an opening in the south wall houses a 17th century leaded window, which was being conserved at the time of the site visit (**Historic Plate 18; Plates 15, 17 to 19**). Sara Squires (1991) reports that it was 'found outside by the present tenants and proved to be a good fit'.

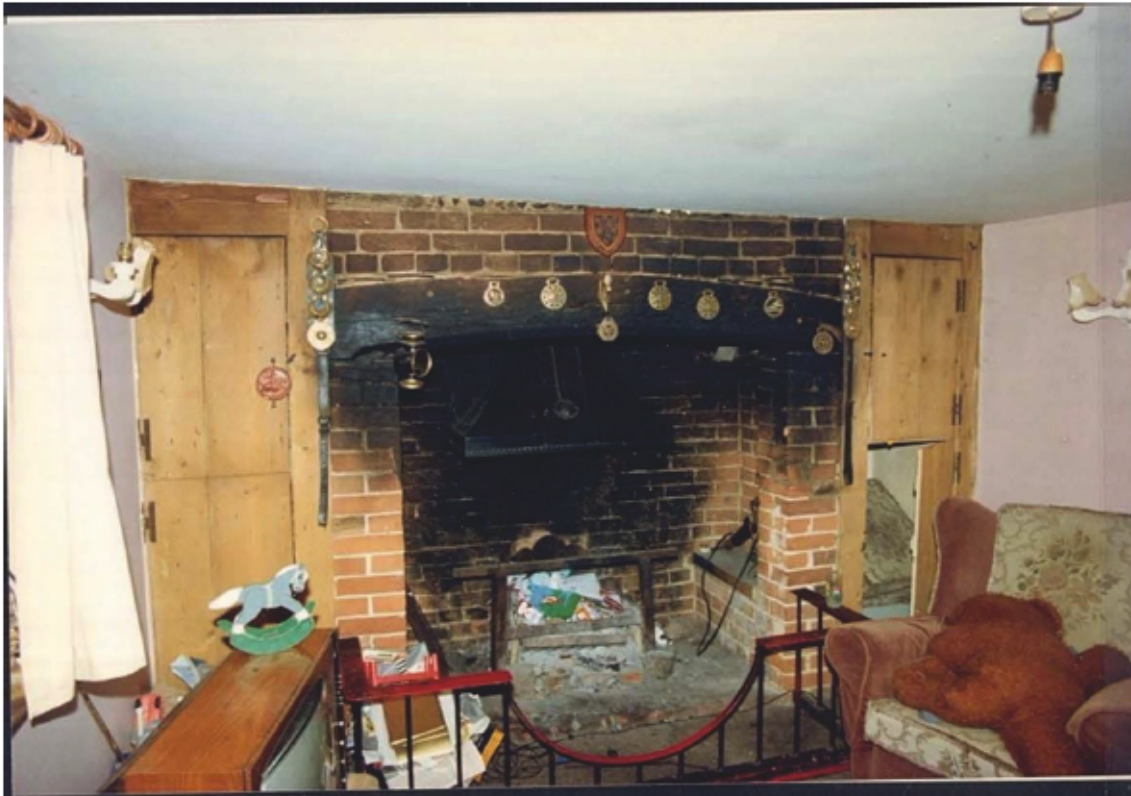
Historic Plate 19 Photograph taken by Sara Squires in September 1991 of the fireplace in the Dining Room of the Old Bakery, looking east (© National Trust Wisley)

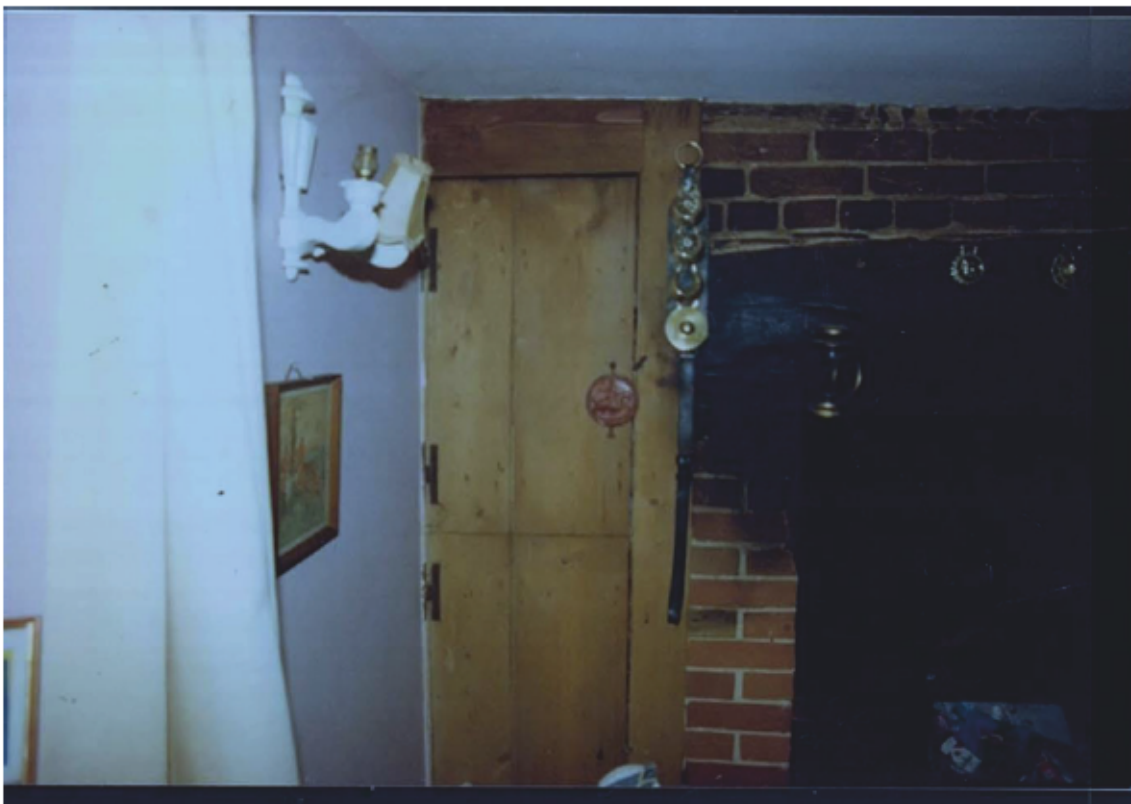
Historic Plate 20 Photograph taken by Sara Squires in September 1991 of the cupboard on the north side of the fireplace in the Dining Room of the Old Bakery, looking east (© National Trust Wisley)

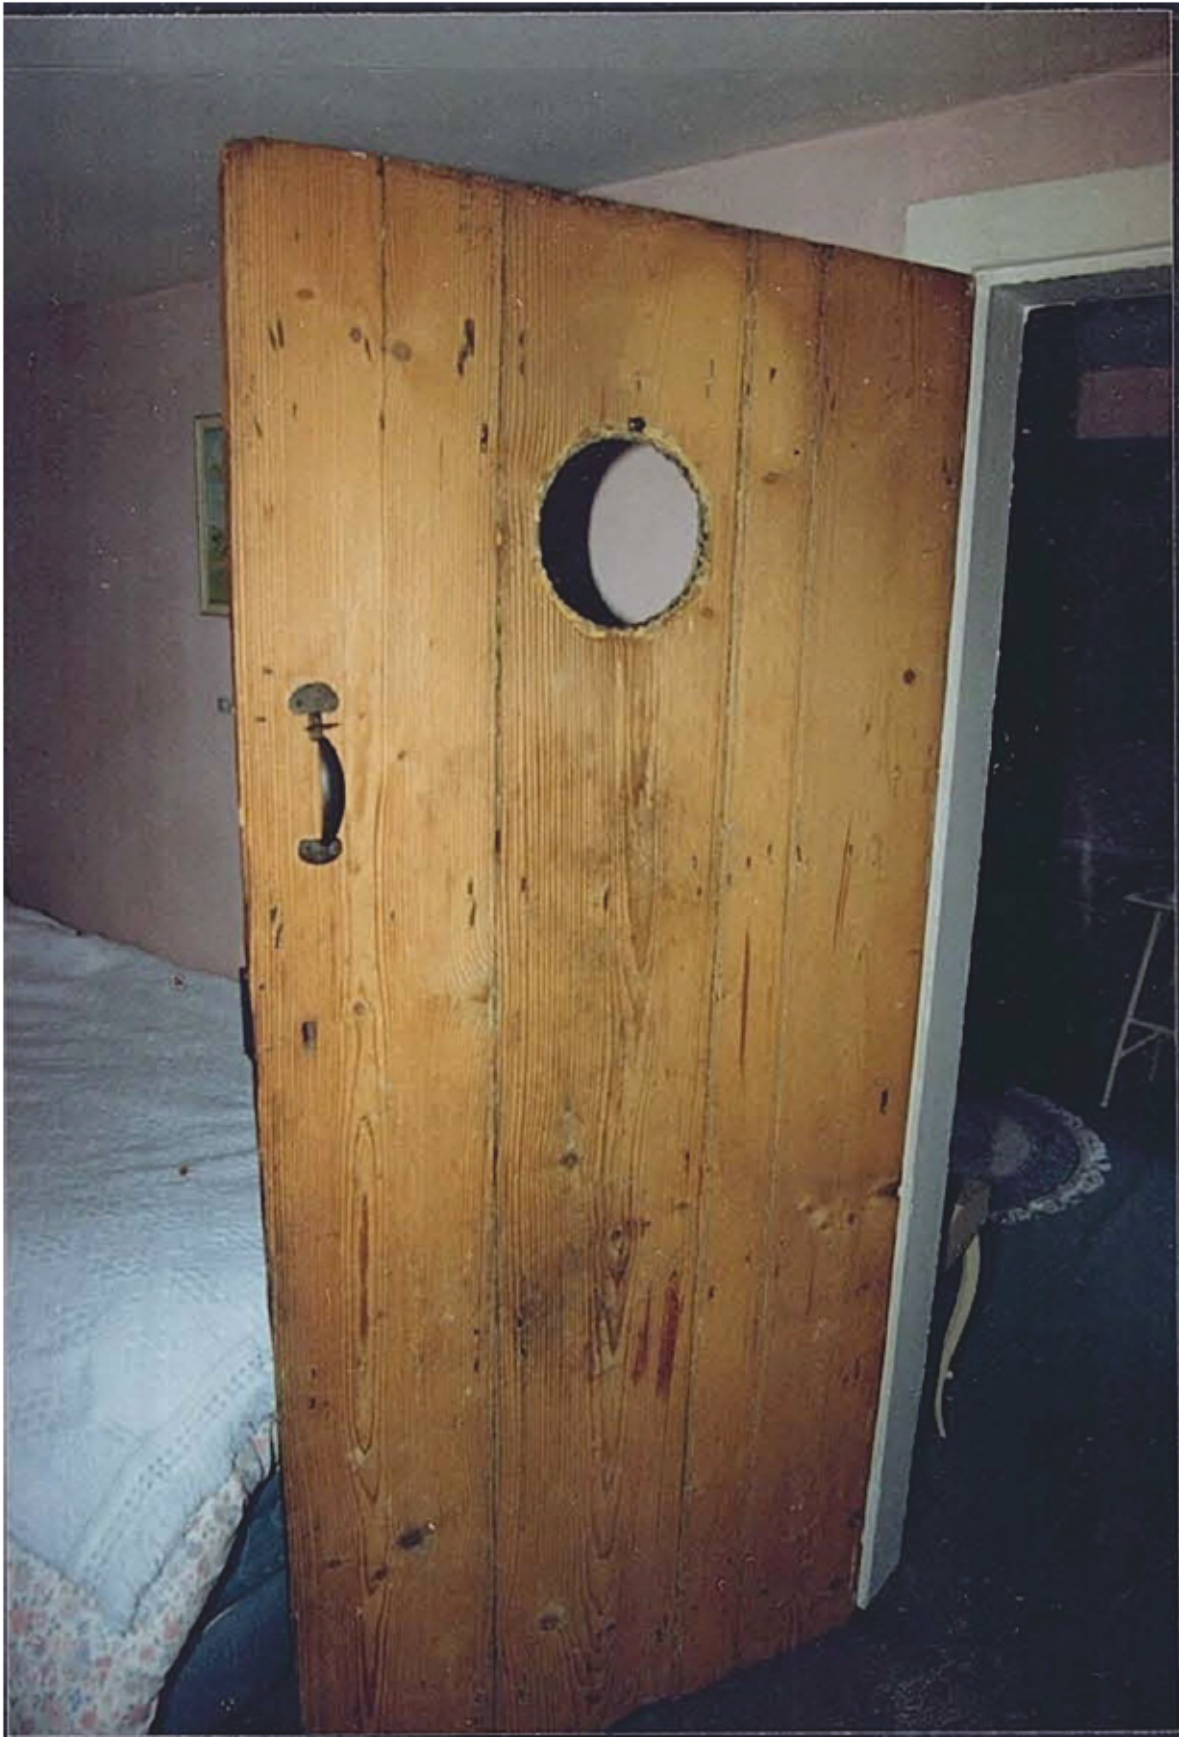
Historic Plate 22 Photograph taken by Sara Squires in September 1991 of the door from the Dining Room into the Sitting Room at the Old Bakery, looking south-west (© NT Wisley)
