**HISTORIC BUILDING RECORDING
OF THE OLD BAKERY,
TOP ROAD,
SLINDON,
ARUNDEL,
WEST SUSSEX,
BN18 0RP**

PCA REPORT NO: R13144

MARCH 2018

Historic Building Recording

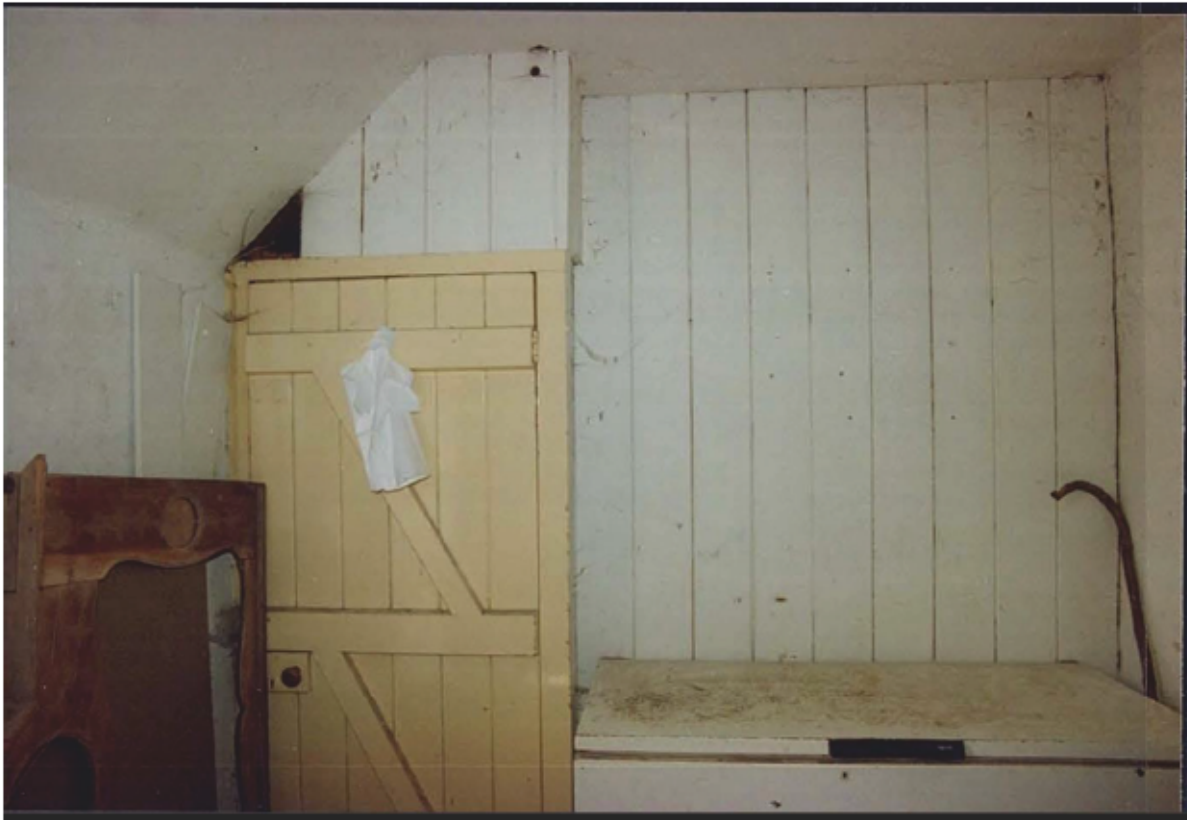
Historic Plate 24 Photograph taken by Sara Squires in September 1991 of west wall of the Study in the Old Bakery, looking west (© NT Wisley)

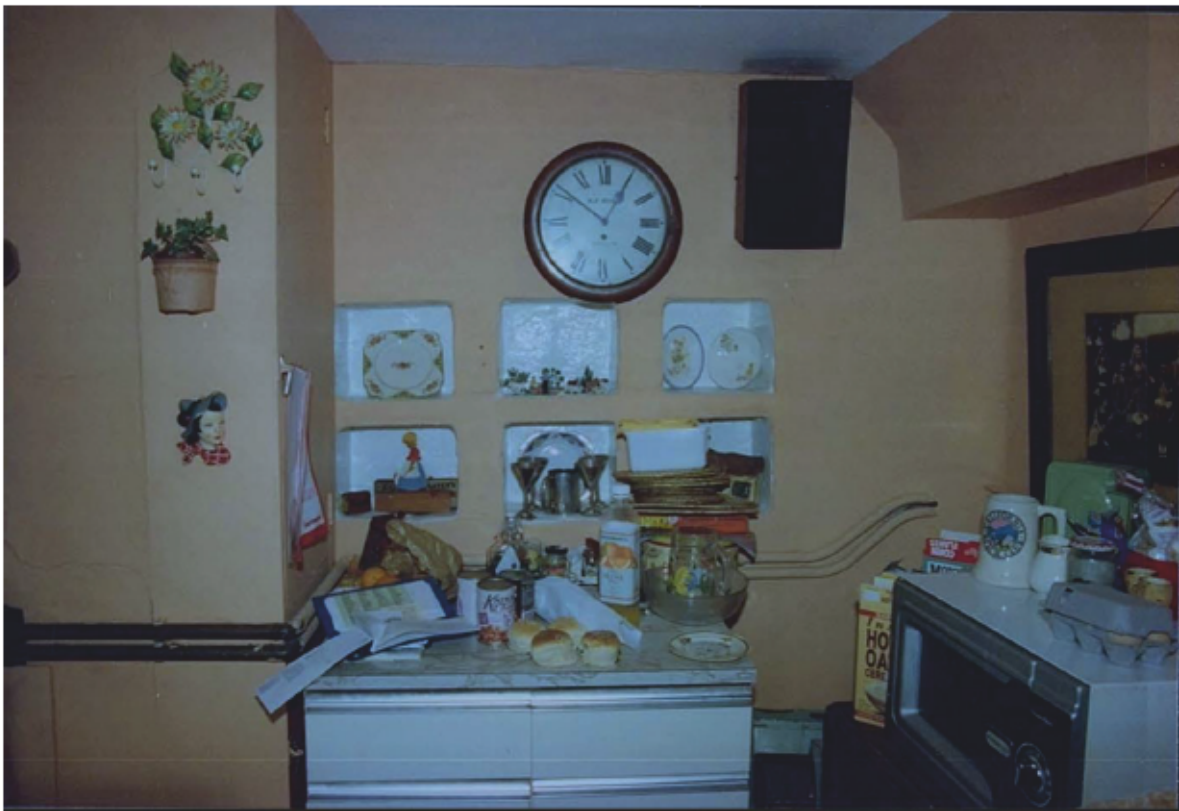
Historic Plate 25 Photograph taken by Sara Squires in September 1991 of the west wall of the Kitchen at the Old Bakery, looking west (© NT Wisley)

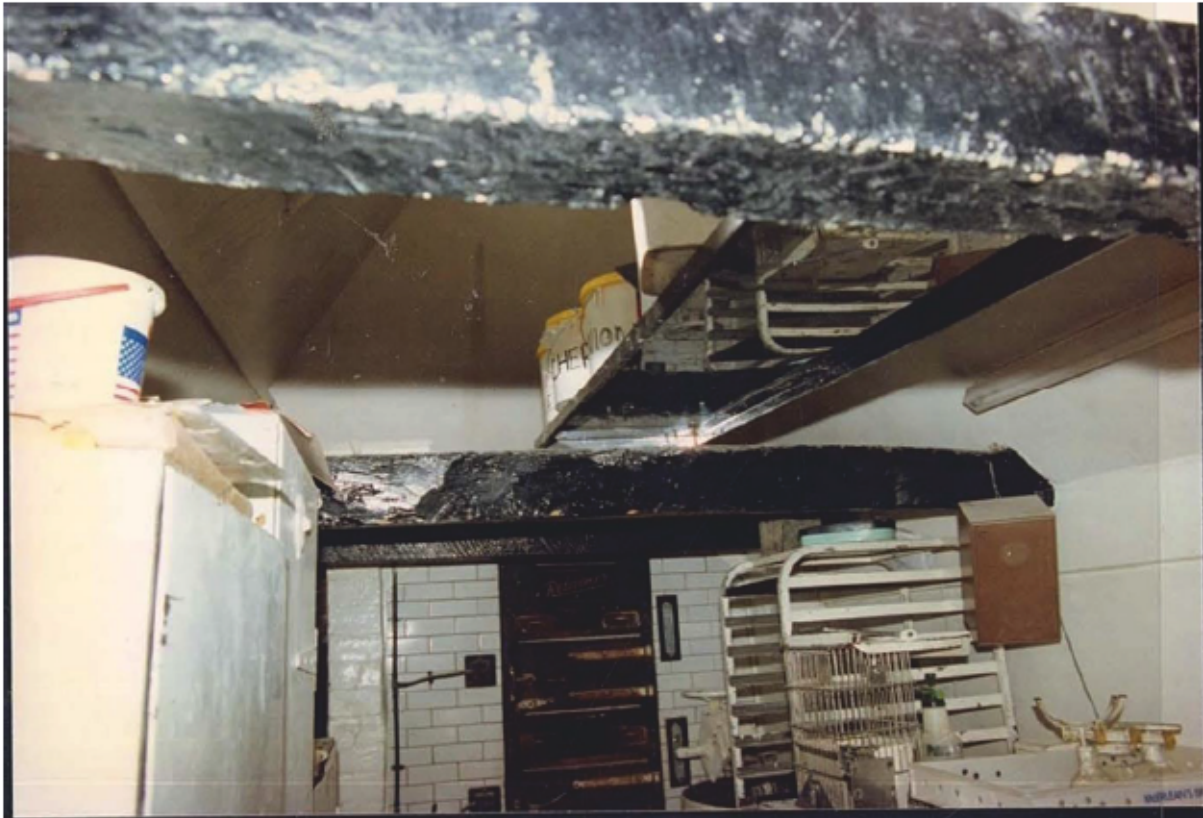
Historic Plate 26 Photograph taken by Sara Squires in September 1991 of the oven in the south elevation of the bakery building at the Old Bakery, looking south (© NT Wisley)

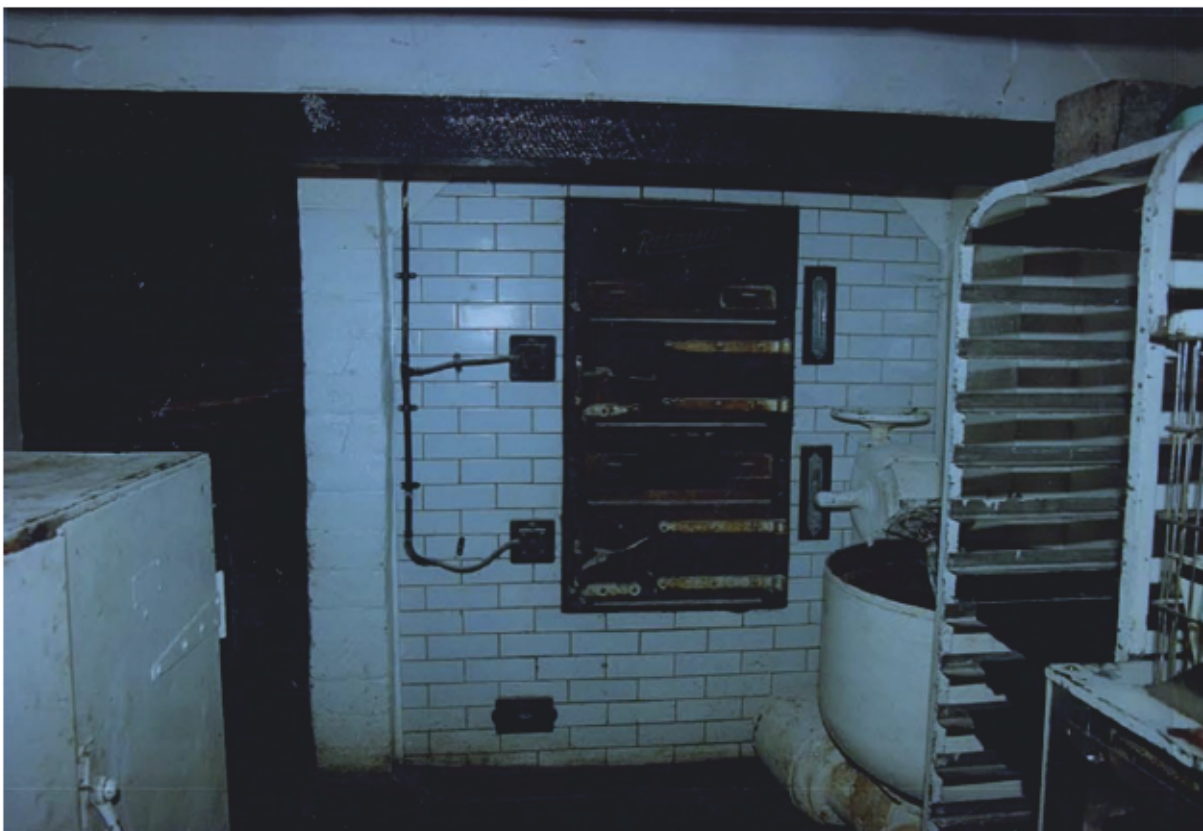
Historic Plate 27 Photograph taken by Sara Squires in September 1991 of the oven in the south elevation of the bakery building at the Old Bakery, looking south (© NT Wisley)

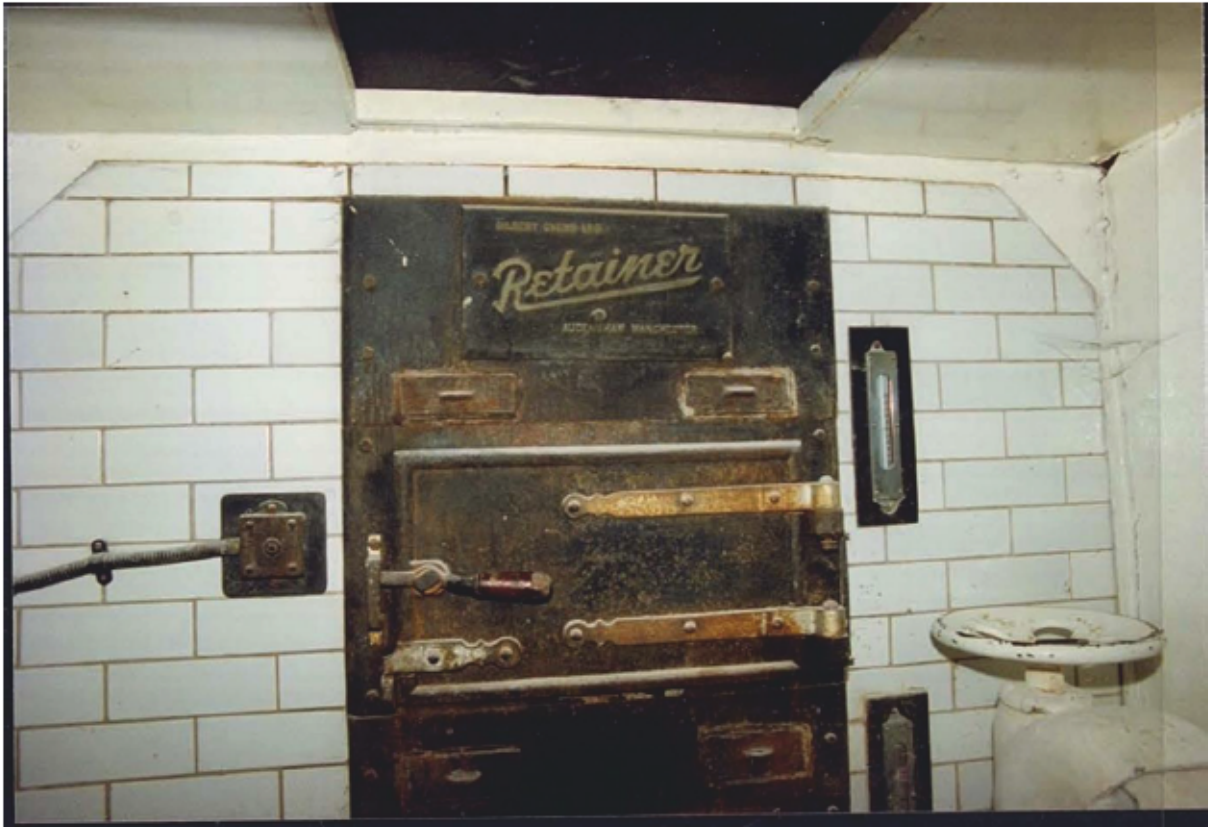
Historic Plate 28 Photograph taken by Sara Squires in September 1991 of the oven in the south elevation of the bakery building at the Old Bakery, looking south (© NT Wisley)

The oven is a "Retainer" Model manufactured by Gilbert Ovens Ltd of Audenshaw, Lancashire (**Historic Plate 28**) and it was used from the date of its installation in the 1930s until 1946 when it ceased production. The present (1993) owner Mr Andy Turner-Cross used it for several years from 1984 and was well satisfied with the bread produced, with wood as fuel but it suffered damage during the October 1987 storm since when it has been idle..."

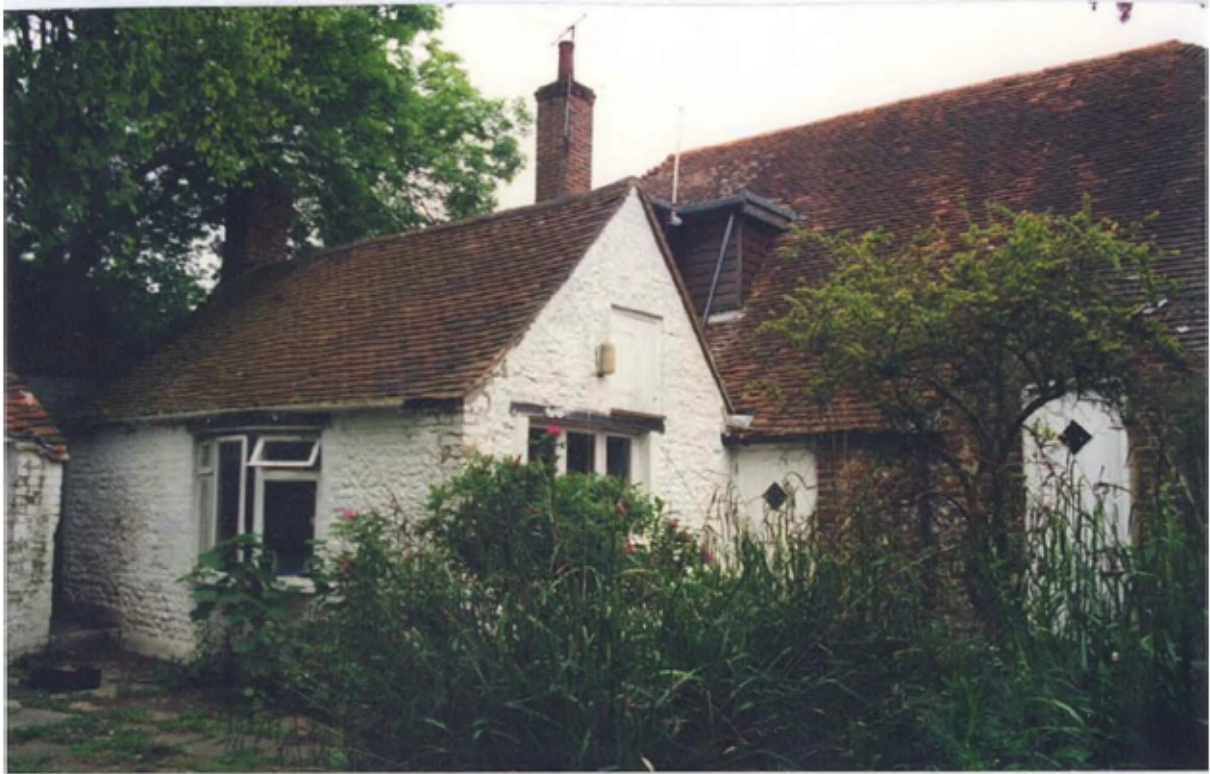
Historic Plate 36 Photograph taken in May 2000 of the former bakehouse (now Kitchen) extension at the Old Bakery, looking north-west (© NT Wisley)

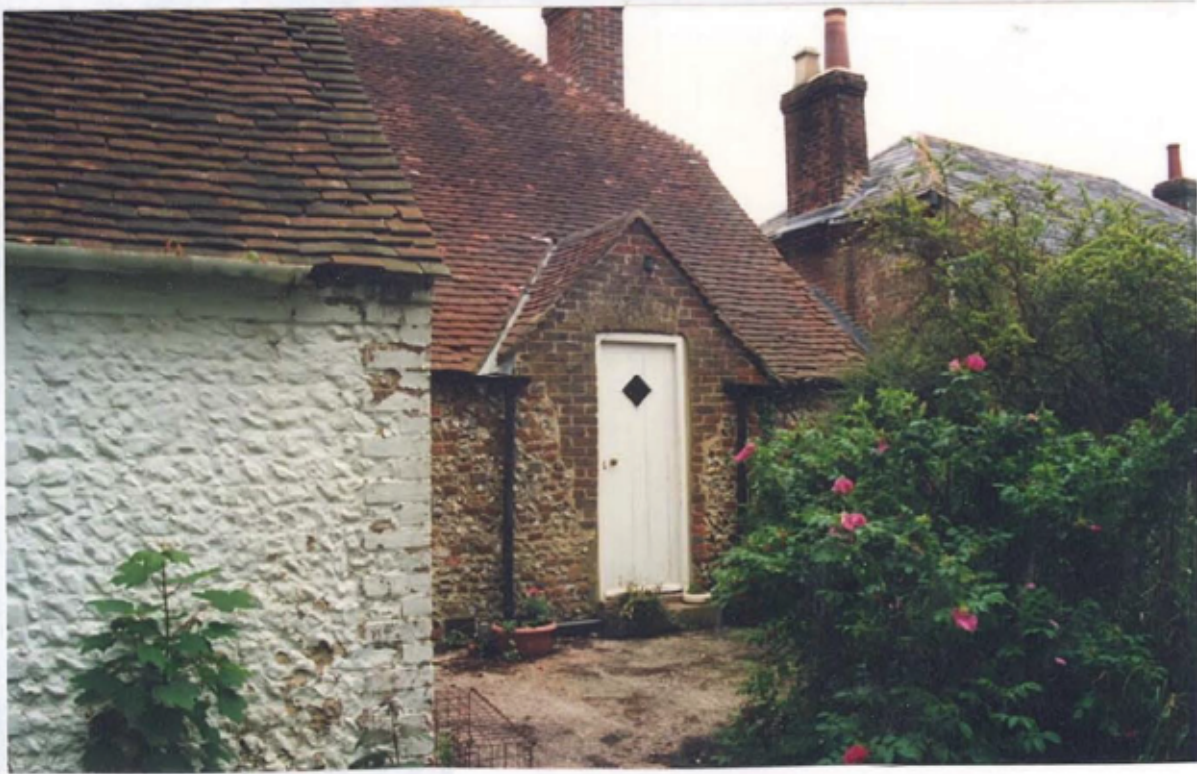
Historic Plate 37 Photograph taken in May 2000 of the former bakehouse (now Kitchen) extension at the Old Bakery, looking west (© NT Wisley)

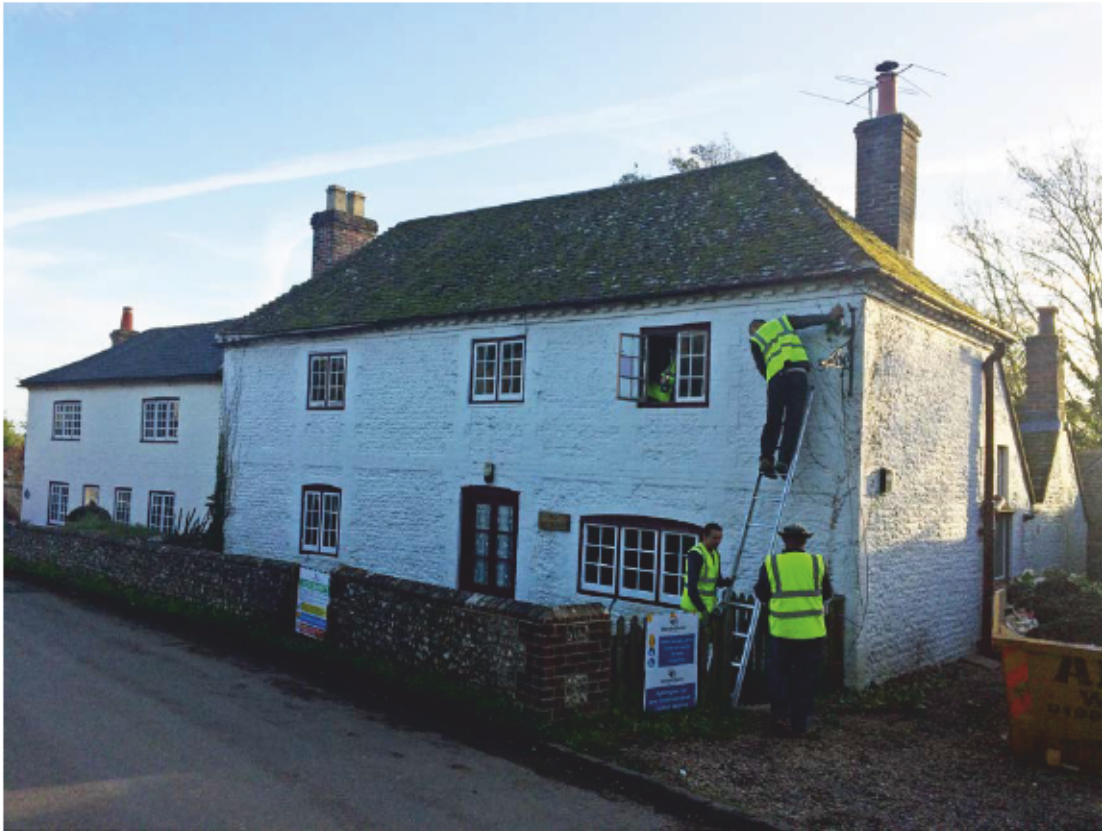
Historic Plate 38 Photograph taken in May 2000 of the Old Bakery, looking north-east (© NT Wisley)

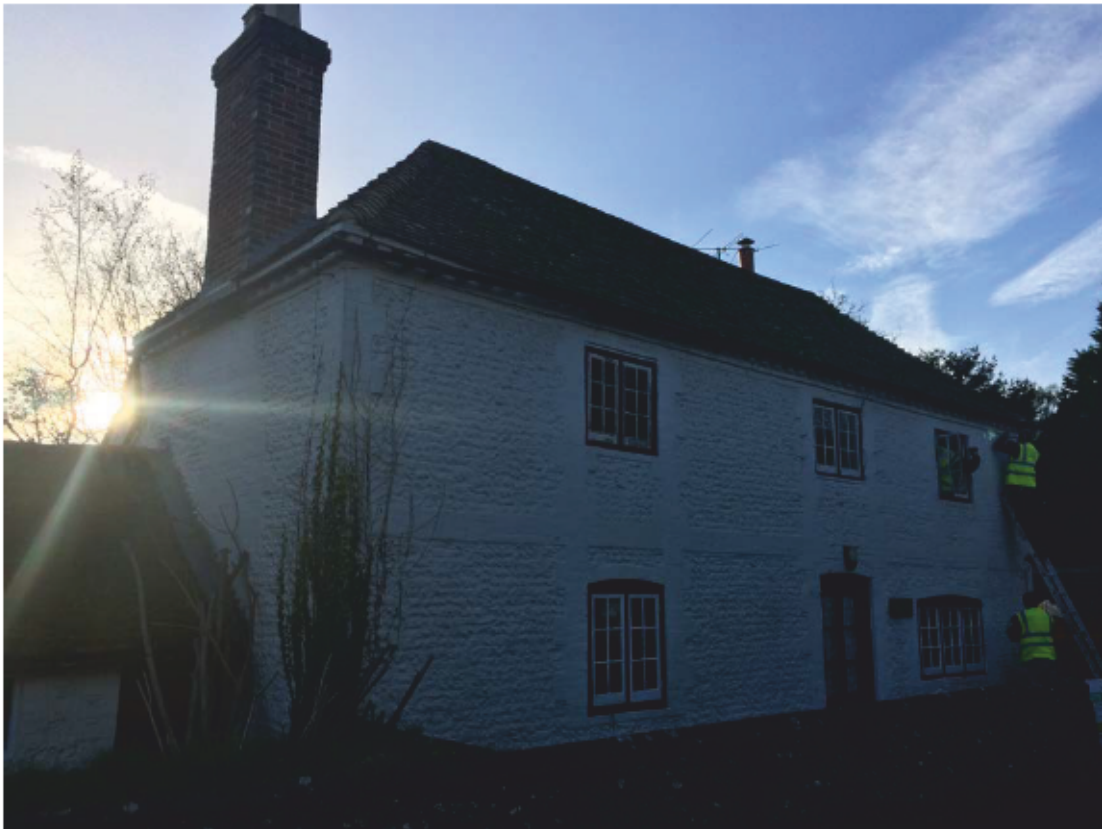
Plate 1: Front (north) and side (west) elevations of the Old Bakery, looking south-east (photograph provided by George Roberts)

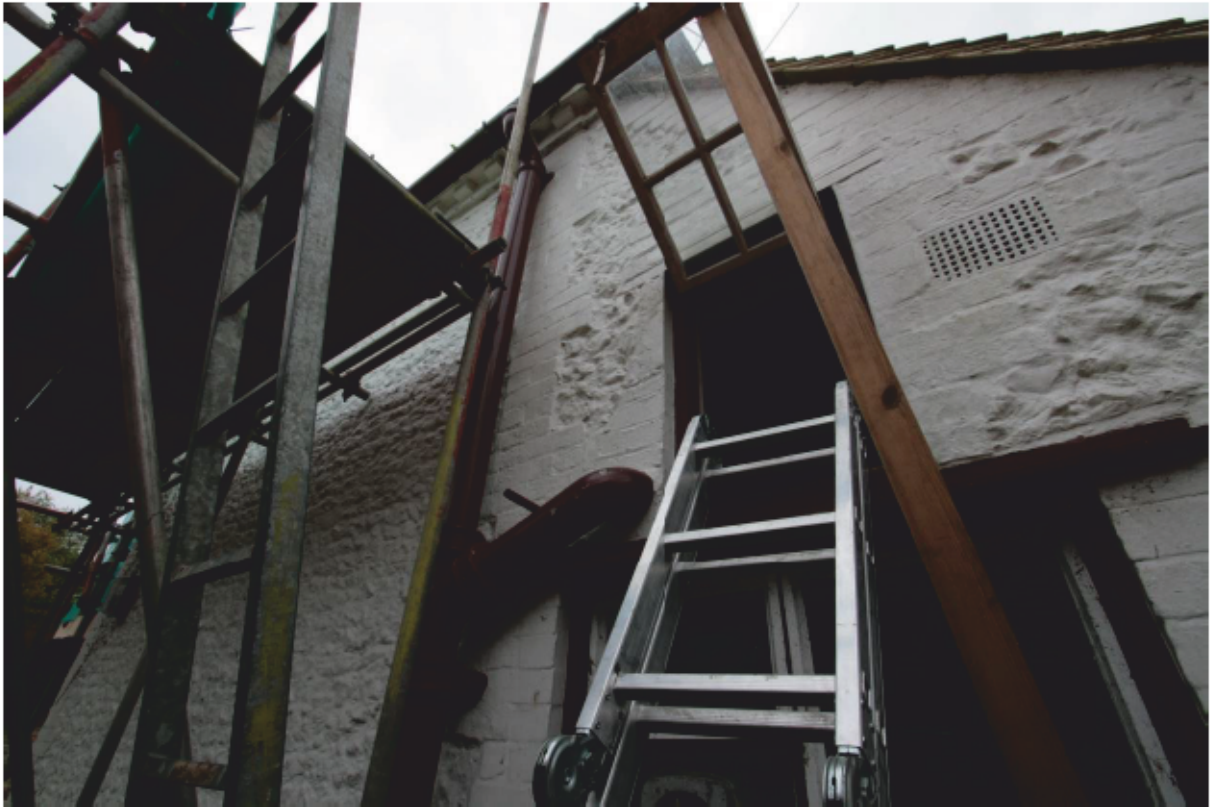
Plate 2: Front (north) and side (east) elevations of the Old Bakery, looking south-west (photograph provided by George Roberts)

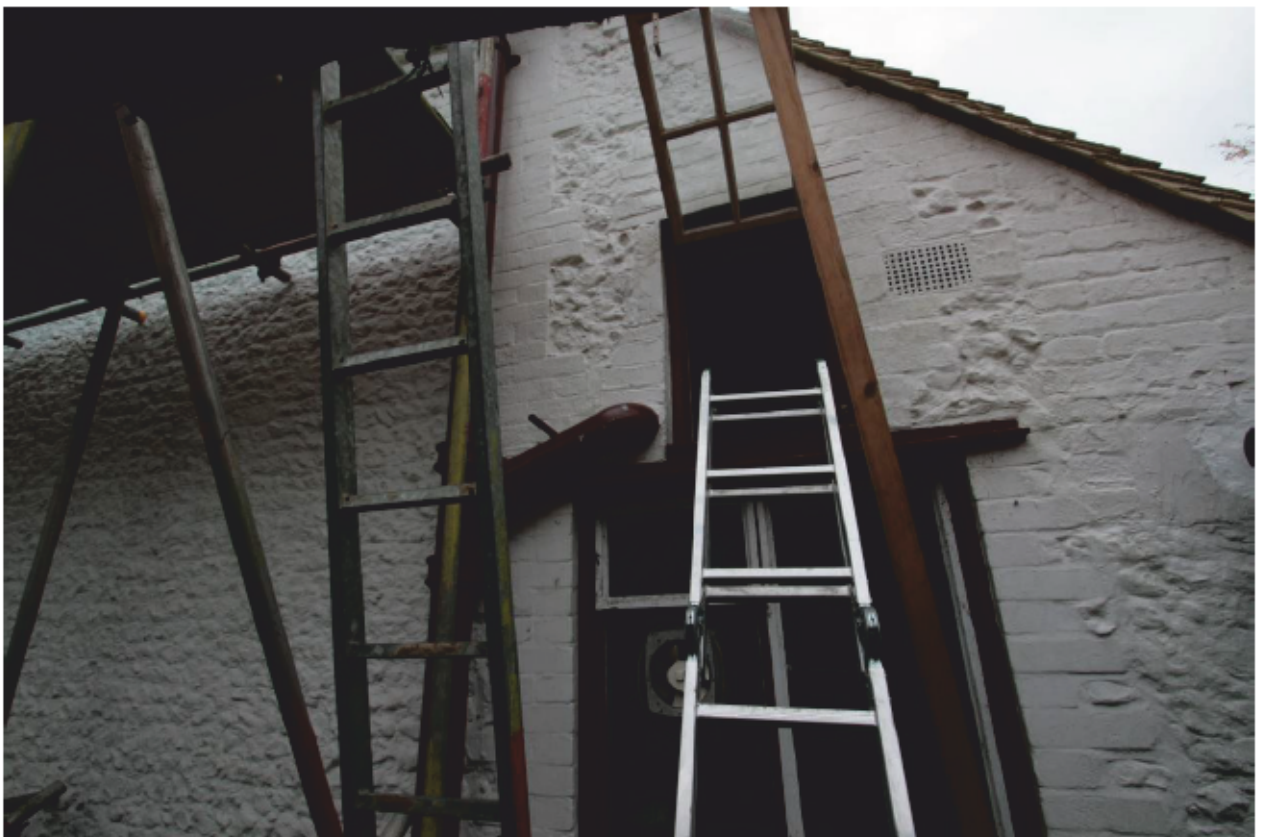
Plate 4: West elevation showing vertical brick strip in short and long work between the main house (left) and the rear pentice (right), looking east (D3 006)

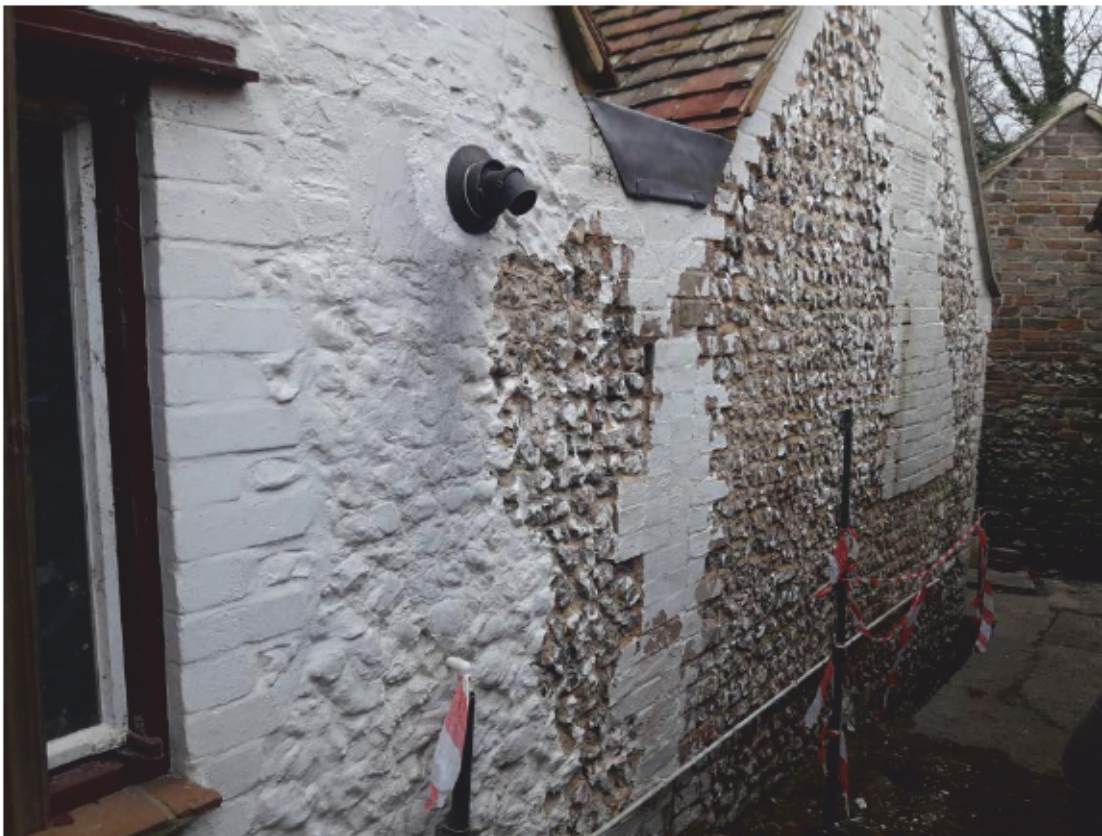
Plate 5: West elevation showing straight joint between Utility Room and Kitchen, looking east (D3 005)

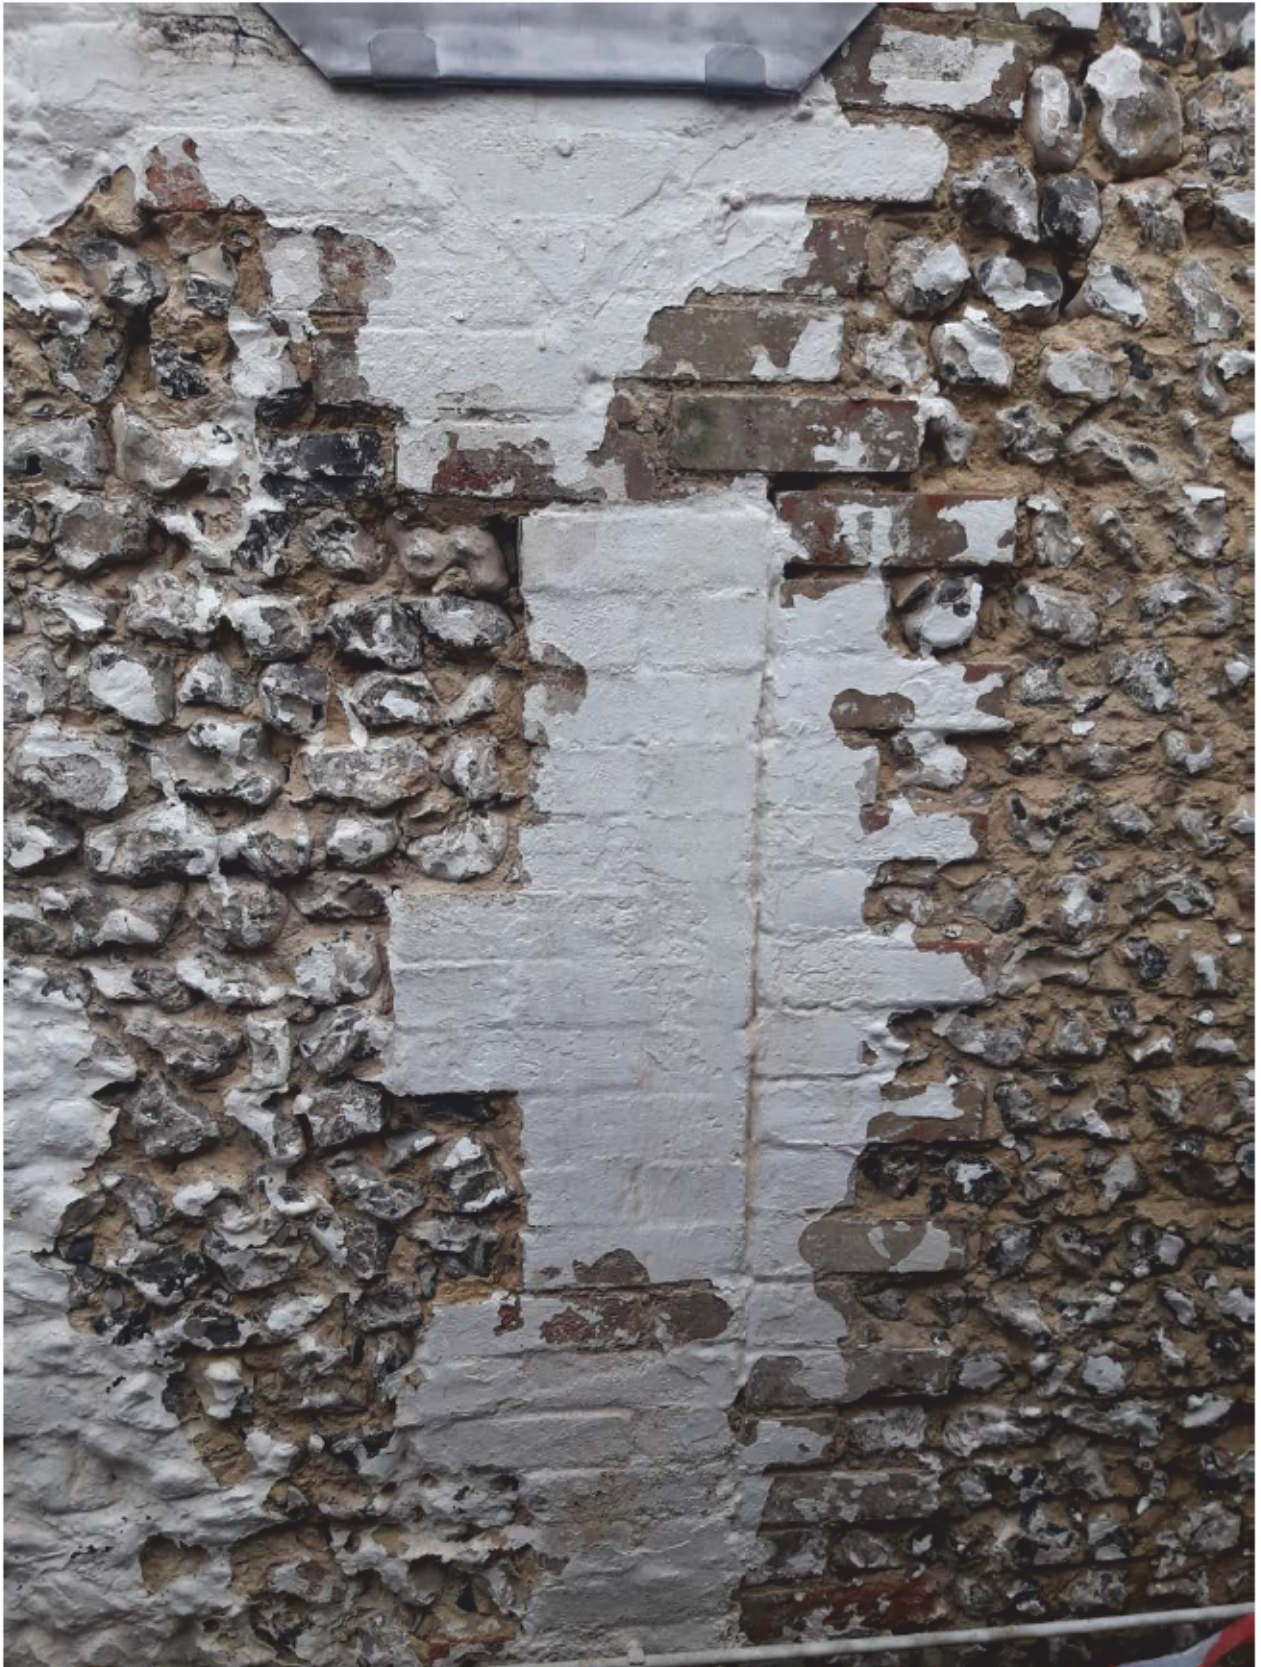
Plate 7: West elevation showing straight joint between Utility Room and Kitchen, looking east (photograph provided by George Roberts)

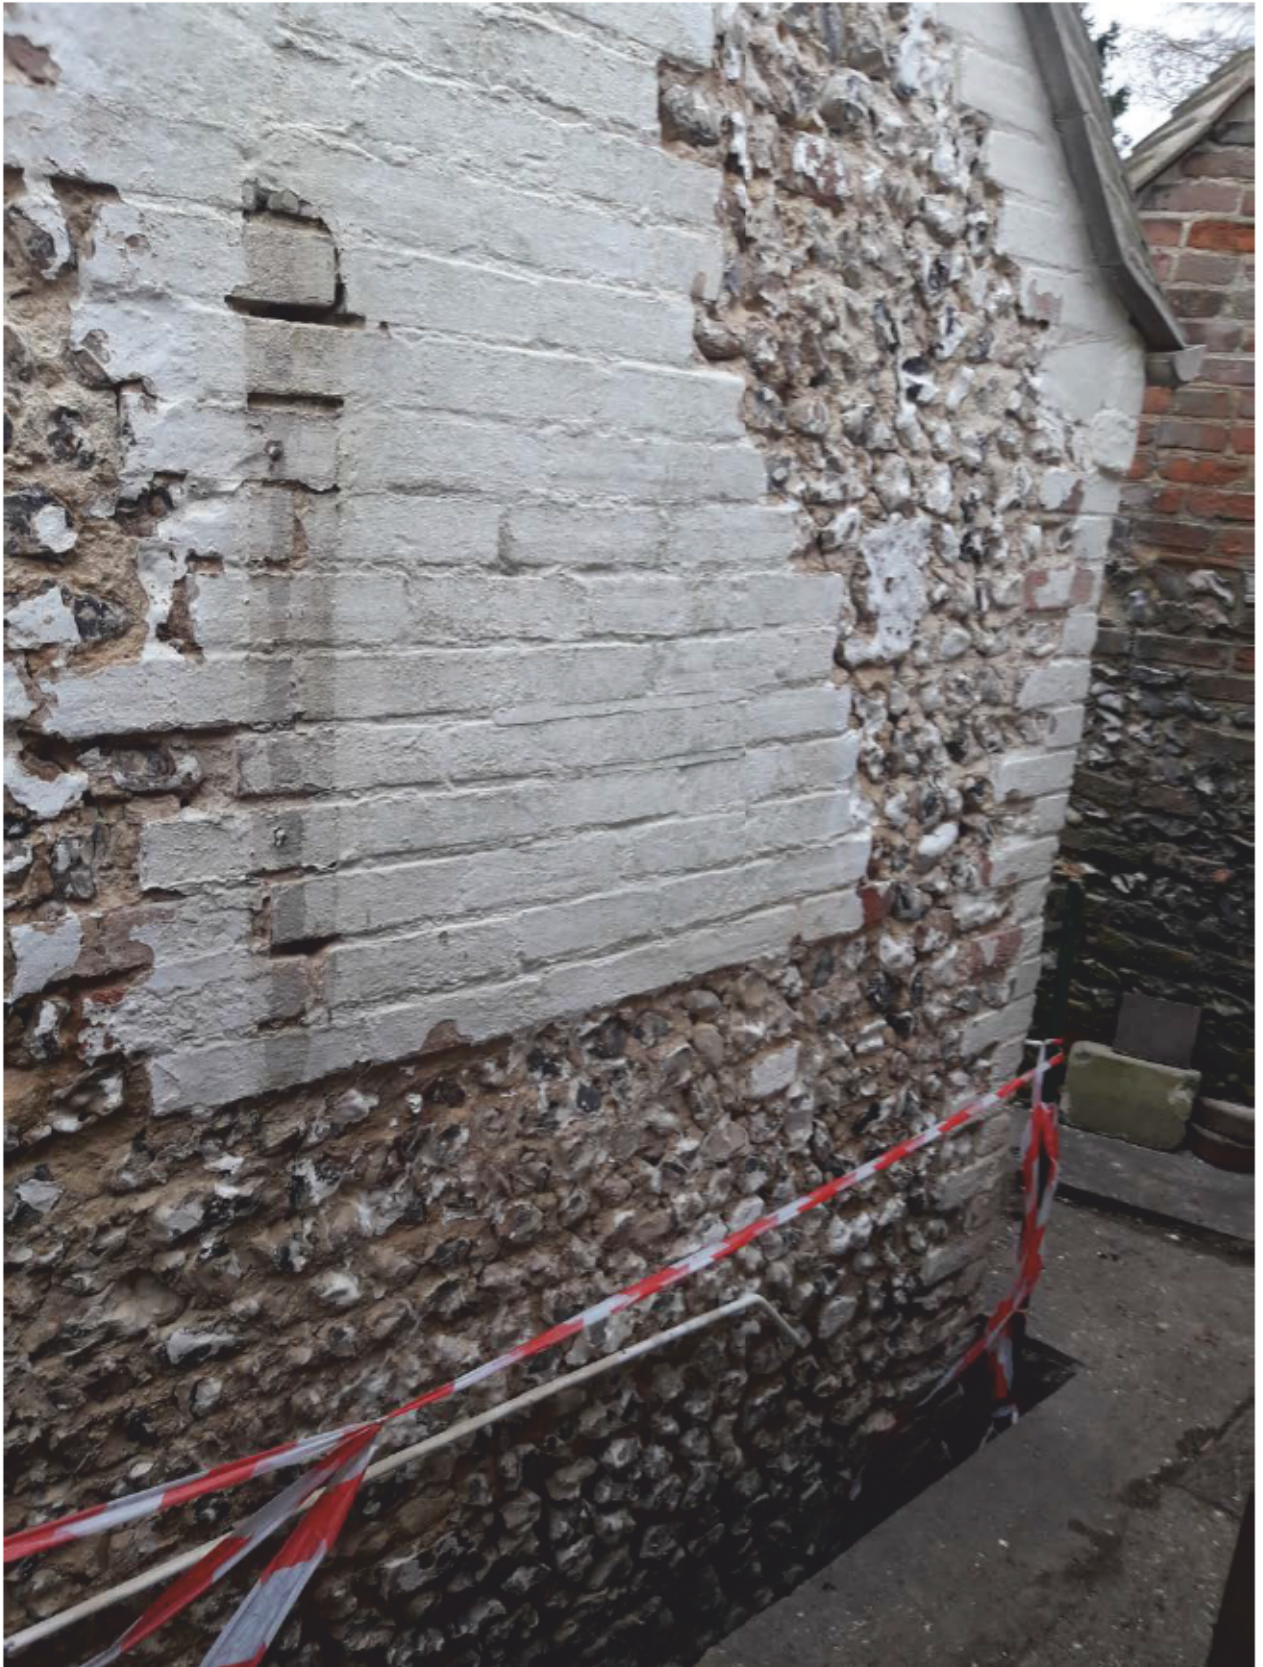
Plate 8: Side (west) elevations of the Old Bakery, looking north-east (photograph provided by George Roberts)

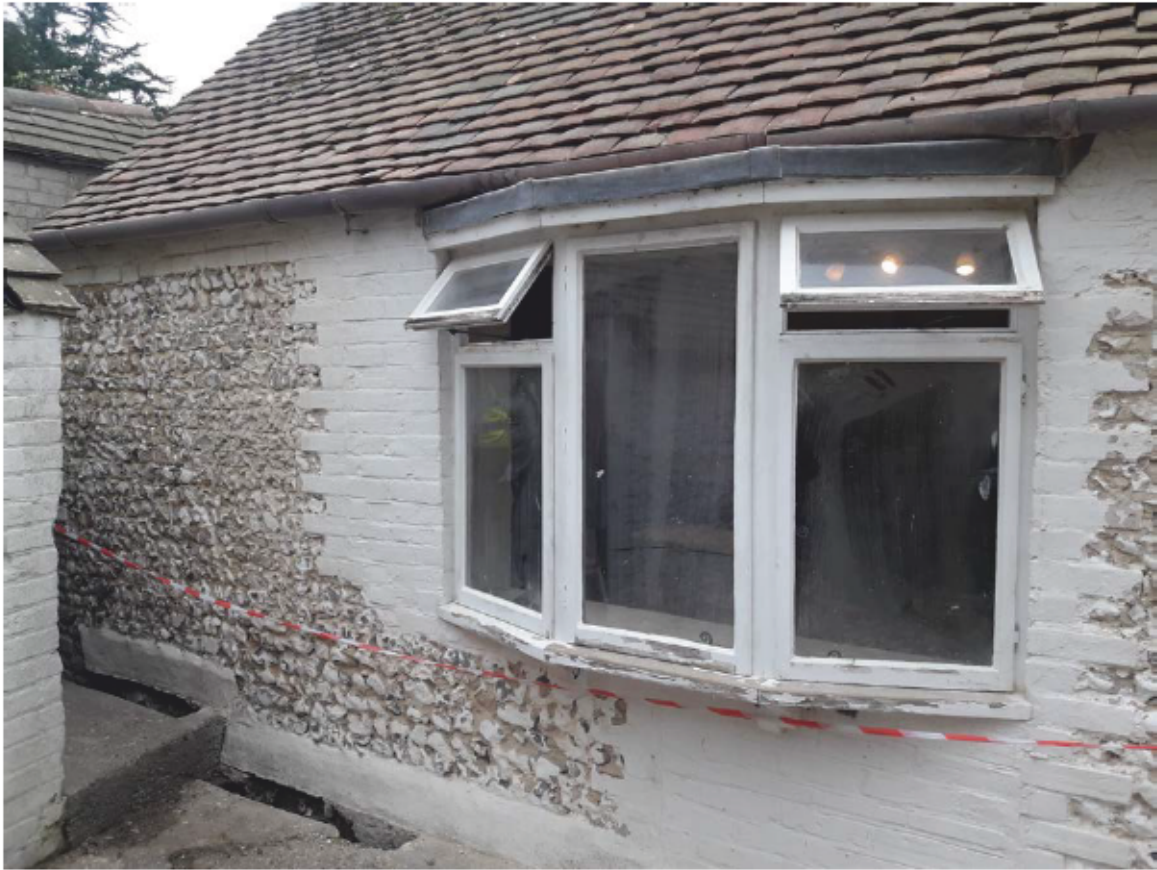
Plate 9: South end of the side (west) elevation of the Old Bakery, looking south-east (photograph provided by George Roberts)

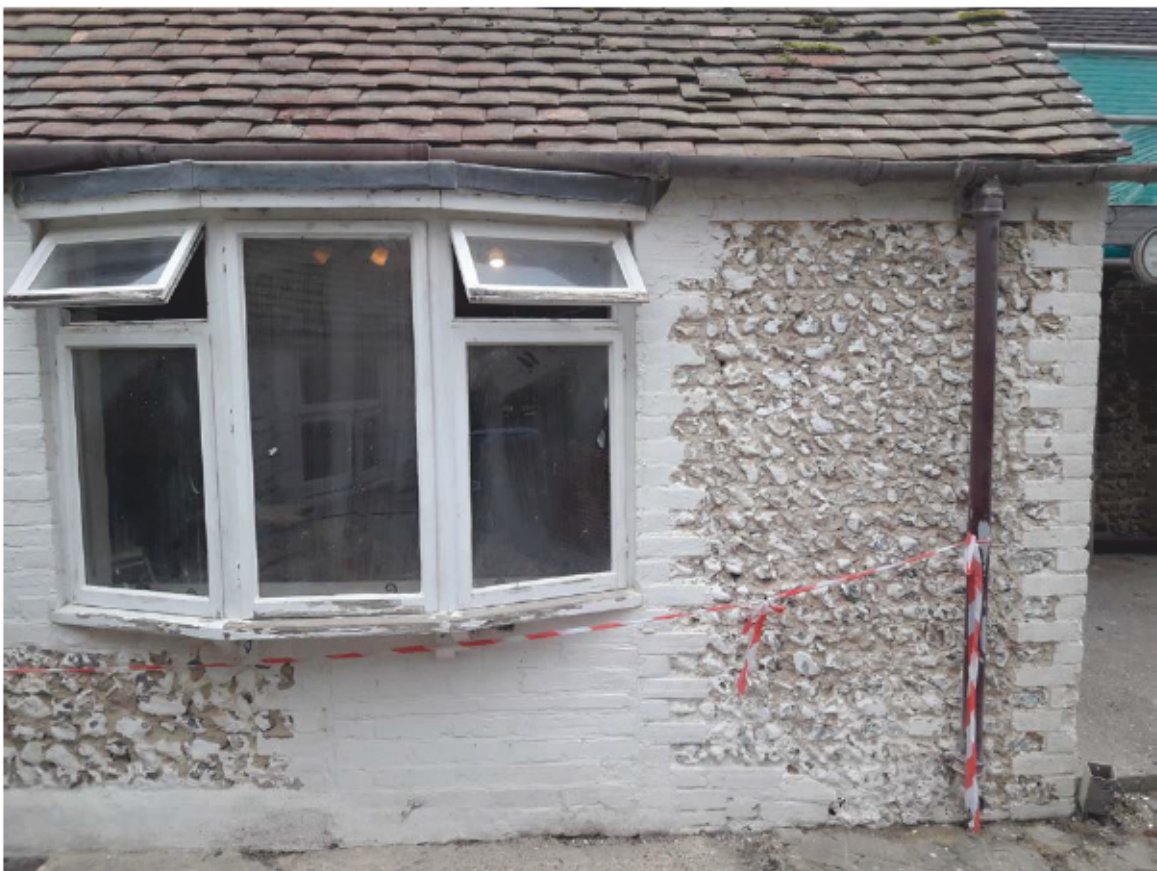
Plate 10: South elevation of the Kitchen, looking north (photograph provided by George Roberts)

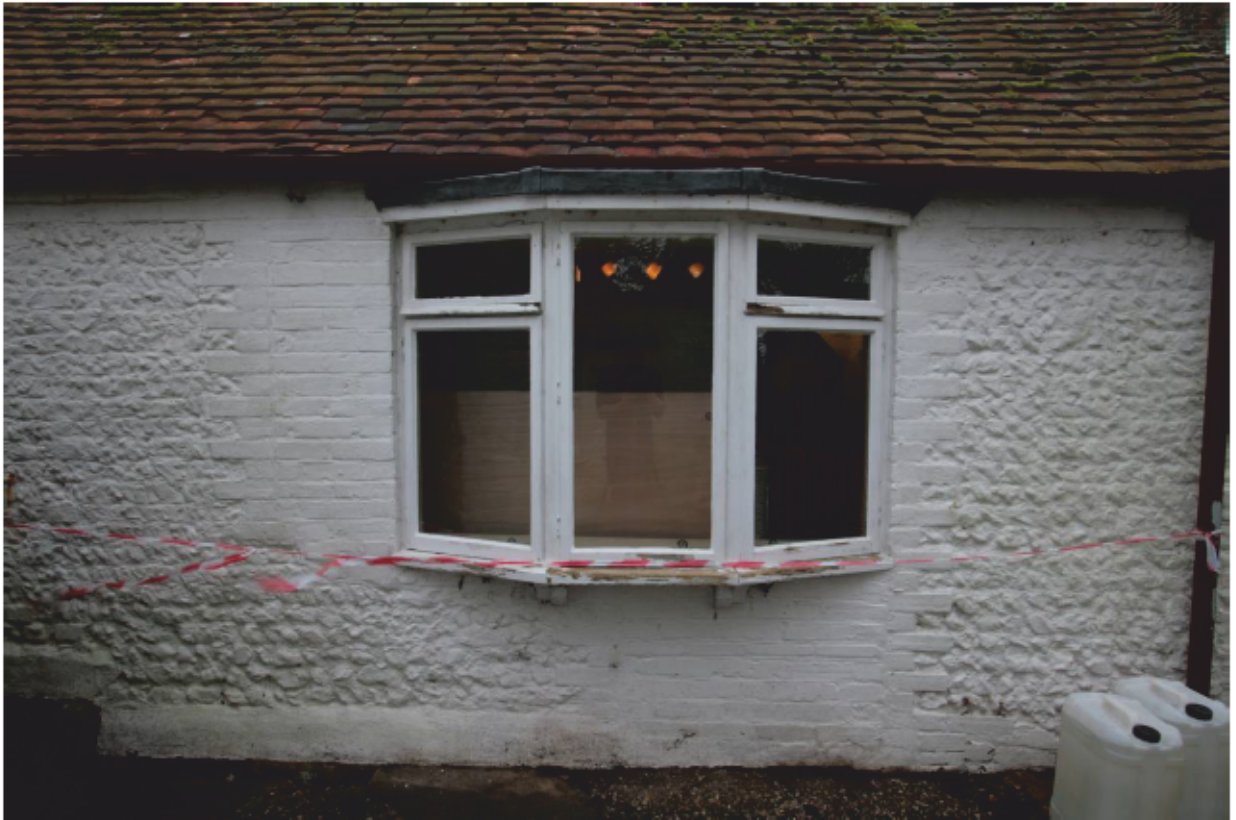
Plate 11: South elevation of the Kitchen, looking north (photograph provided by George Roberts)

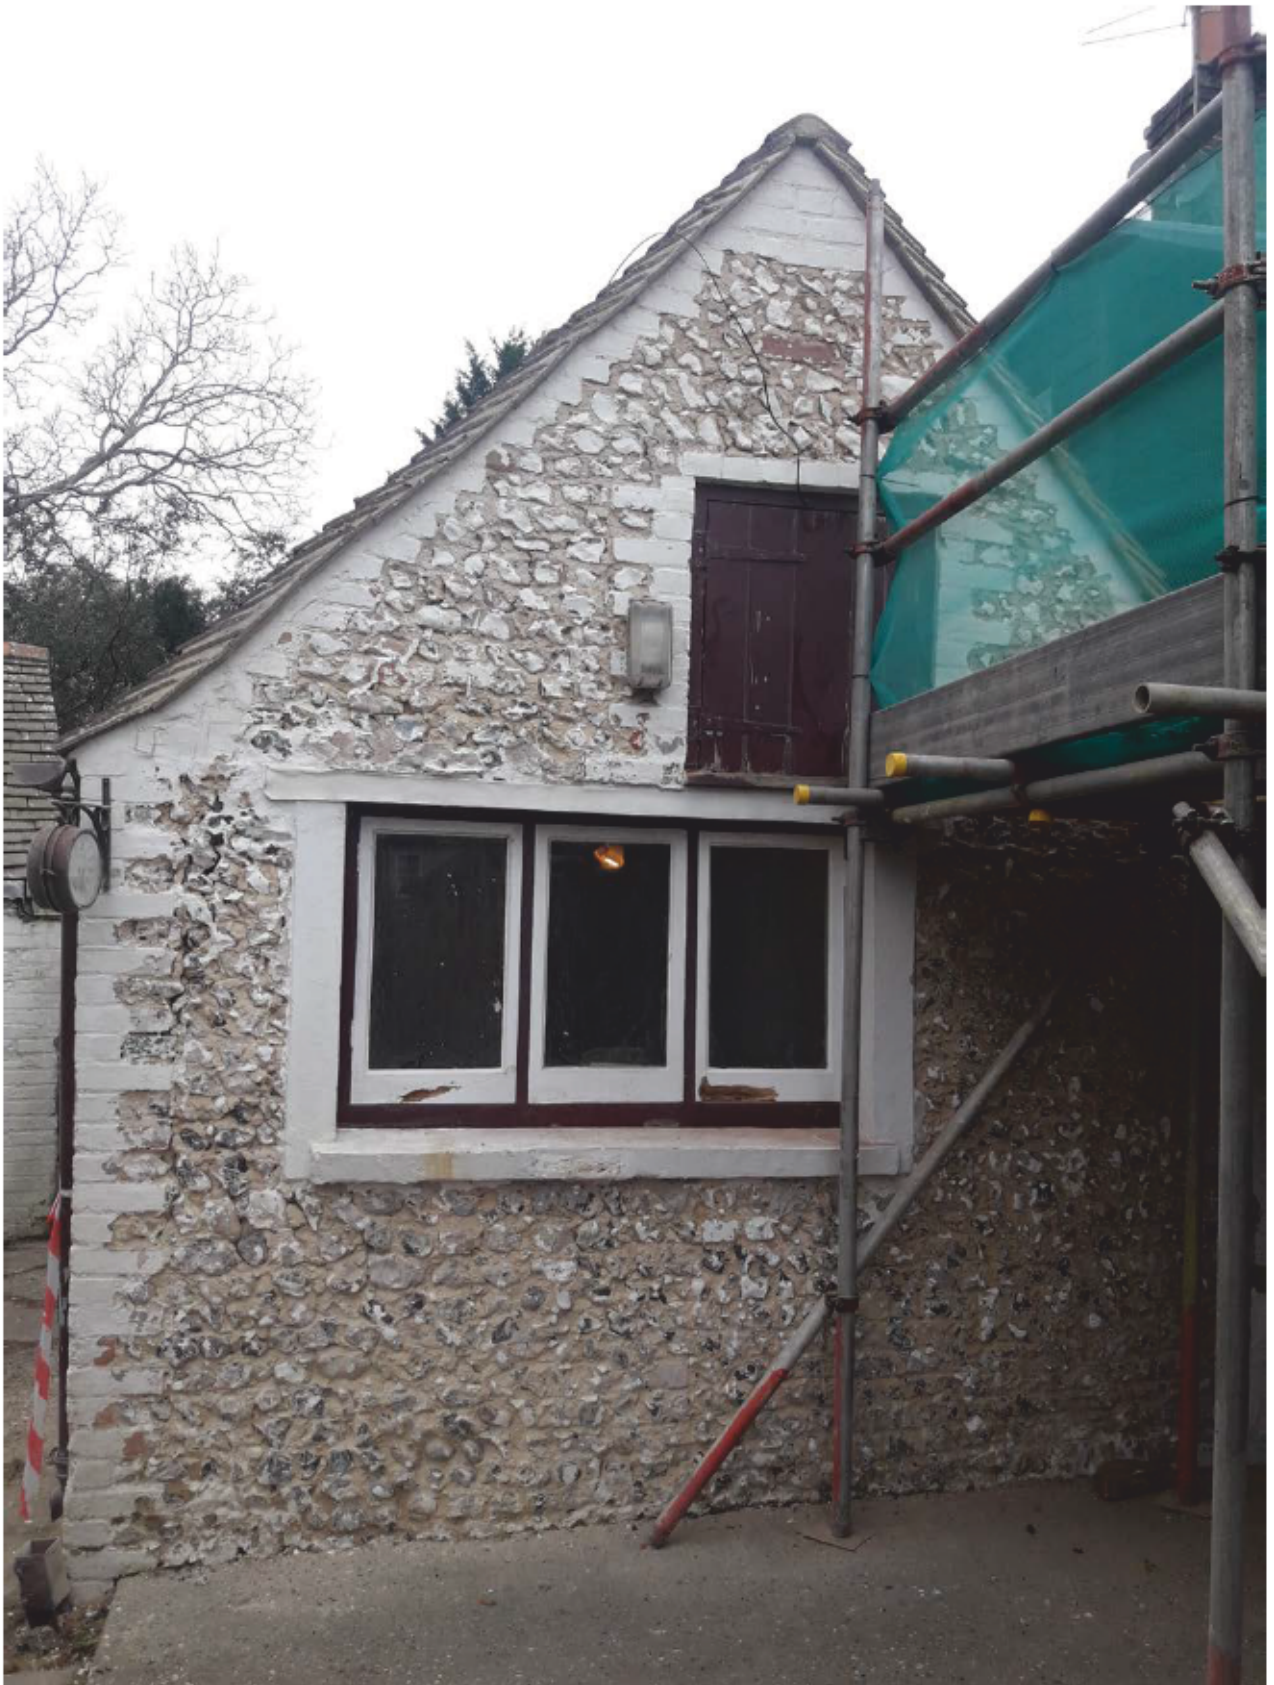
Plate 12: South elevation of the Kitchen, looking north (D3 004)
