**HISTORIC BUILDING RECORDING
OF THE OLD BAKERY,
TOP ROAD,
SLINDON,
ARUNDEL,
WEST SUSSEX,
BN18 0RP**

PCA REPORT NO: R13144

MARCH 2018

Historic Building Recording

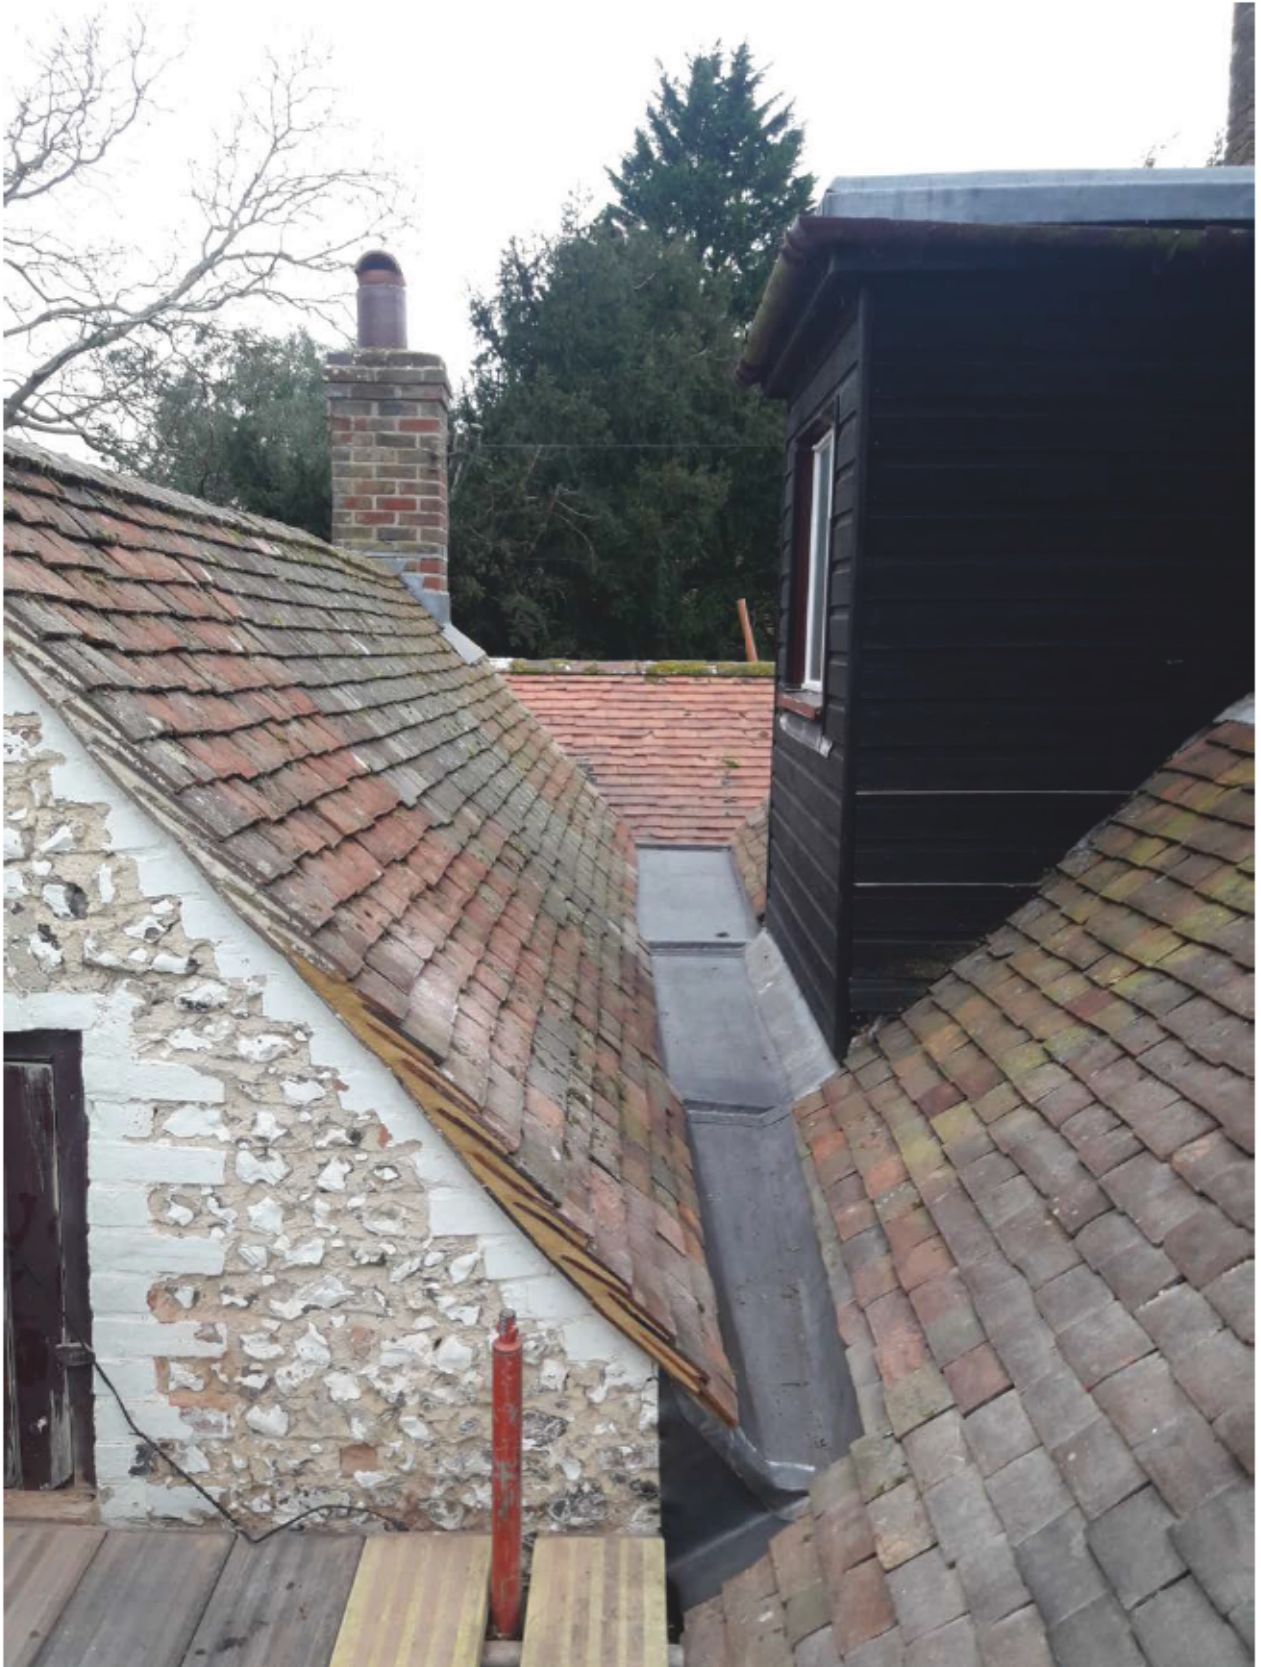
Plate 13: East elevation of the Kitchen at the Old Bakery, looking west (photograph provided by George Roberts)

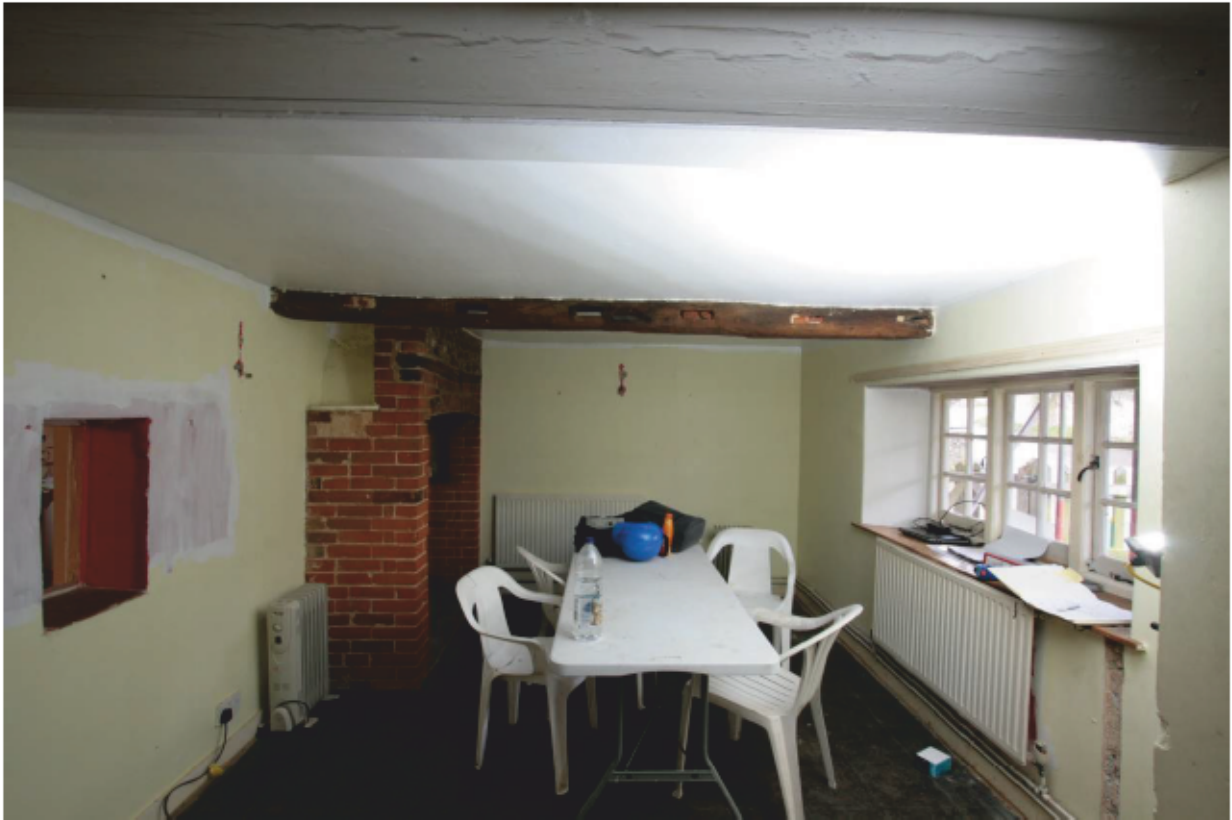
Plate 15: Fireplace and beam in the Sitting Room, looking west (D2 018)

- 6.3.3 To the east of the fireplace, an opening in the south wall houses a 17th century leaded window, which was being conserved at the time of the site visit (**Historic Plate 18; Plates 15, 17 to 19**). Sara Squires (1991) reports that it was 'found outside by the present tenants and proved to be a good fit'.

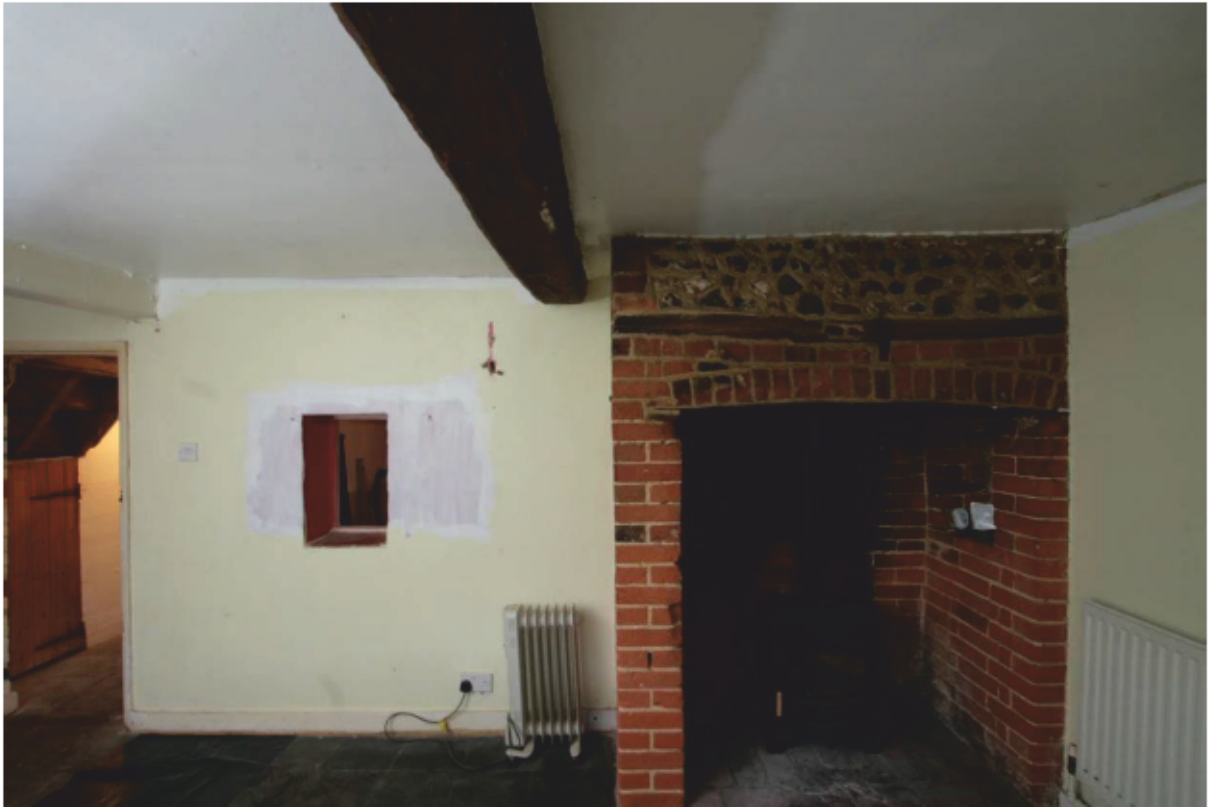
Plate 16: North wall of Sitting Room, looking north (D2 022)

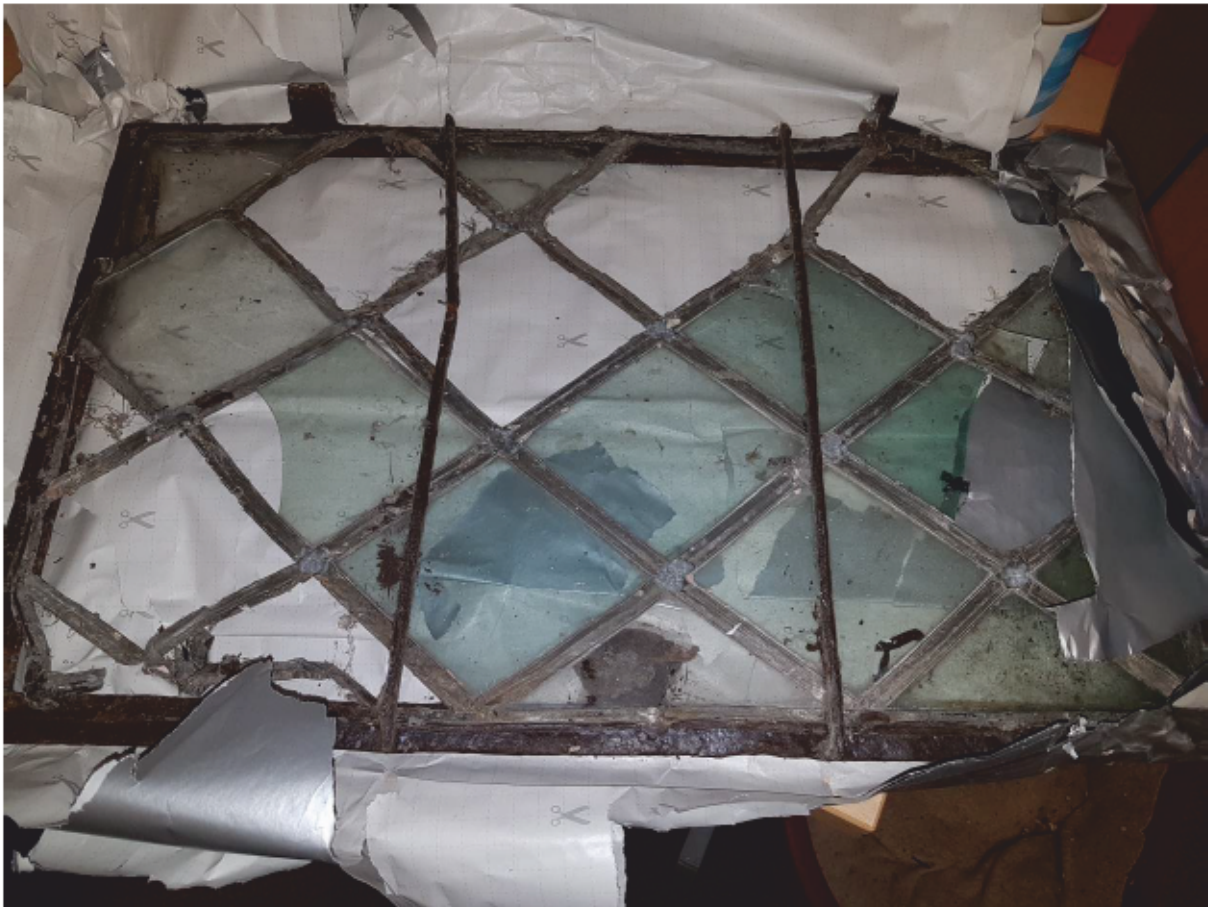
Plate 18: 17th century window after removal from south wall of Sitting Room for conservation (photograph provided by George Roberts)

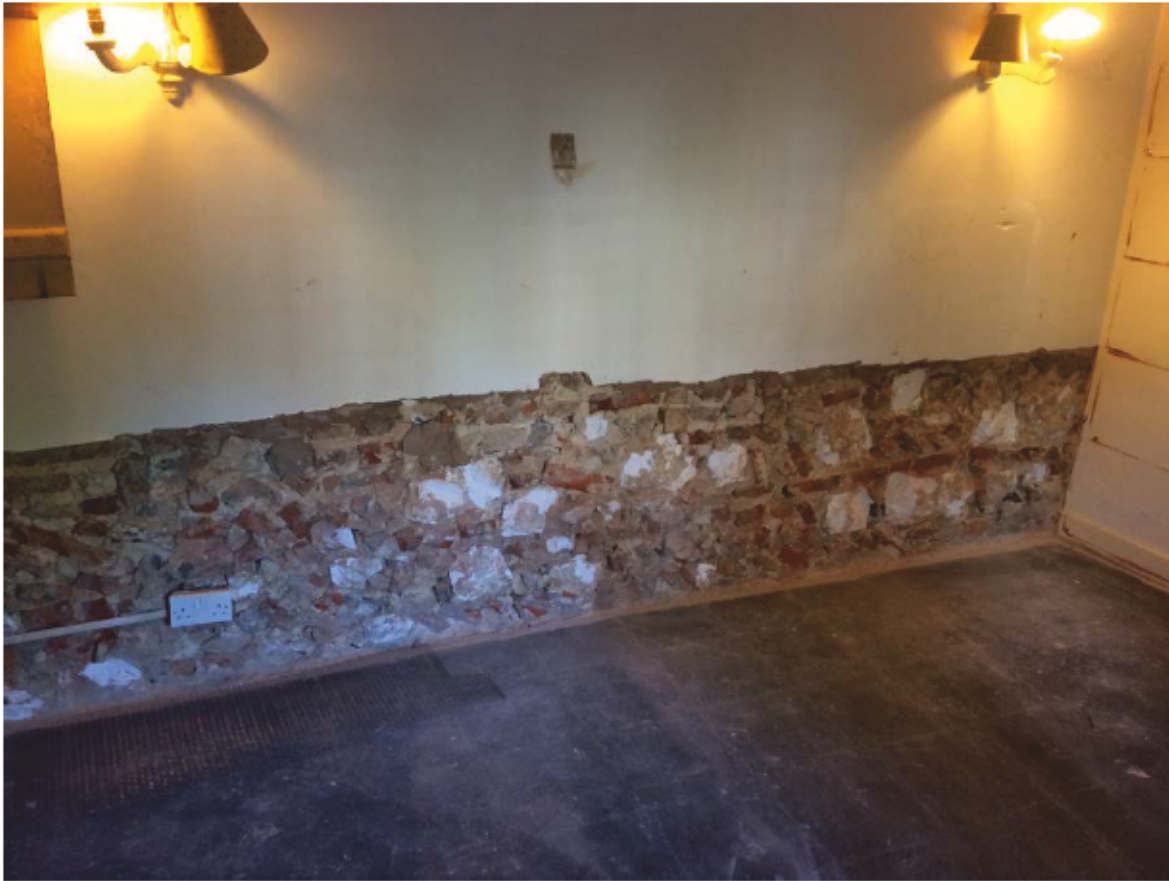
Plate 20: South wall of Dining Room, looking south (D2 027)

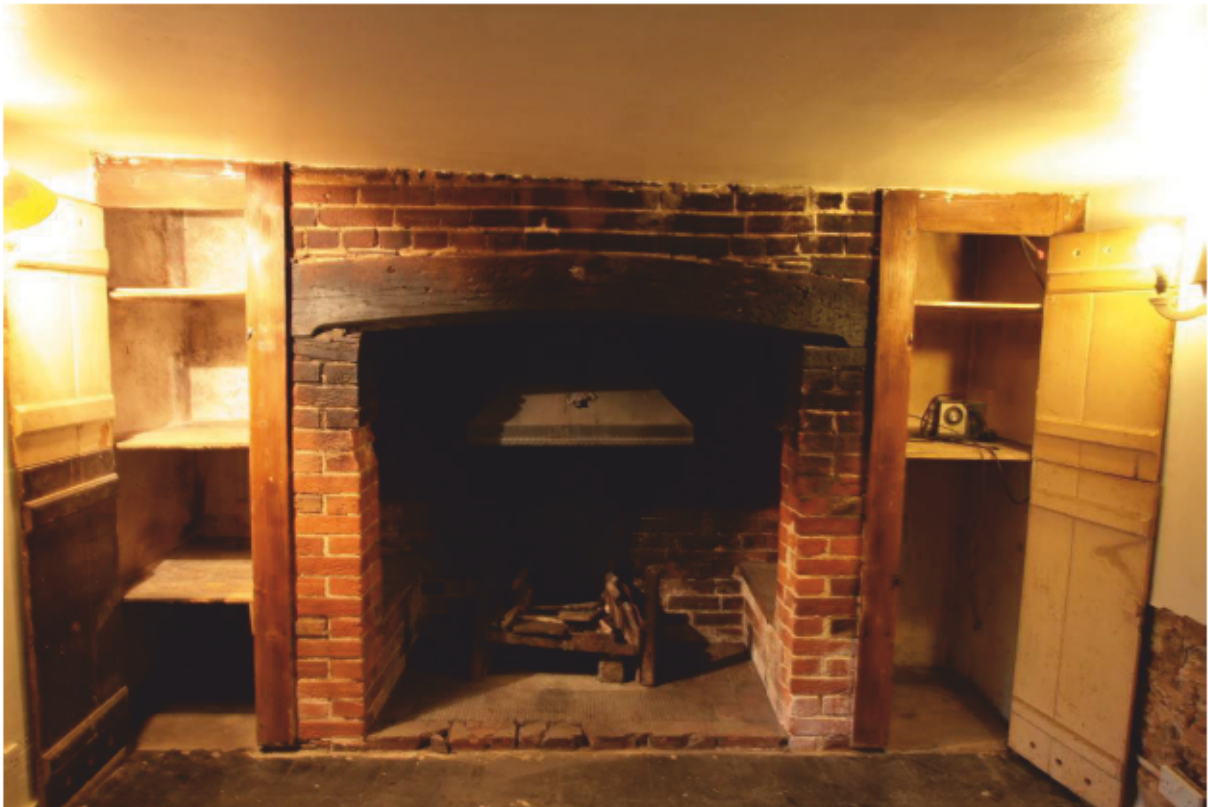
Plate 21: South wall of Dining Room, looking south (photograph provided by George Roberts)

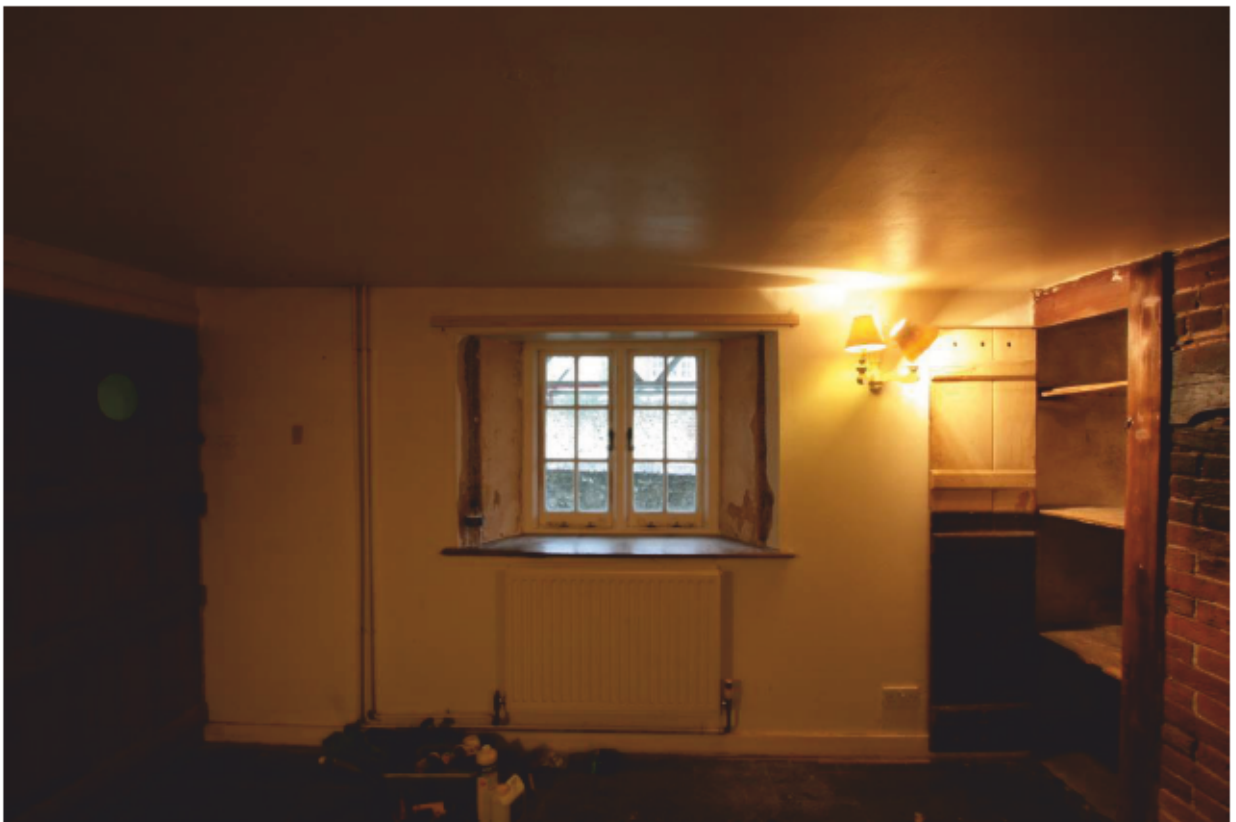
Plate 23: West wall of Dining Room, looking west (D2 031)

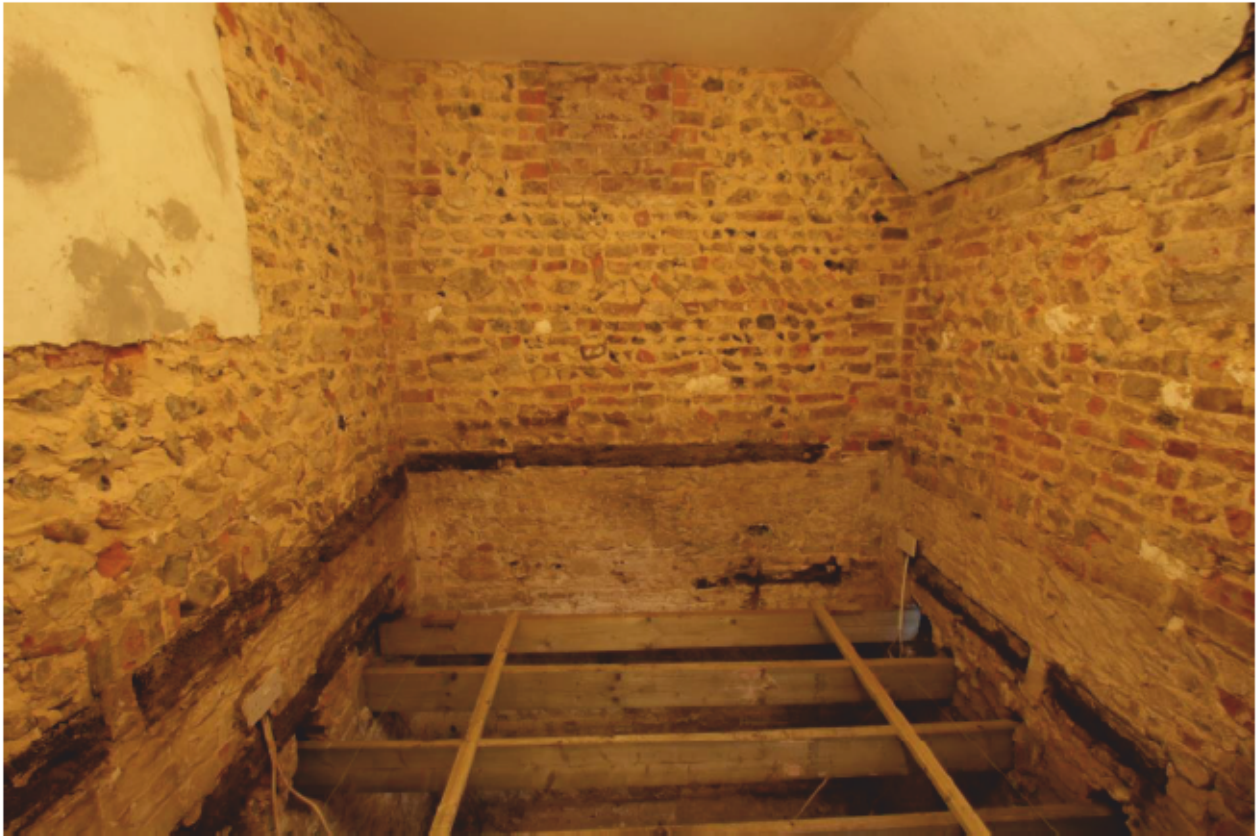
Plate 25: Blocked window in east wall of Study looking east (D1 011)

- 6.3.9 The Study lies in the eastern part of the rear (south) pentice (**Figure 10**). Blocked floor joist sockets immediately above timber sills in the north and south walls (one timber has been replaced with brick in the east side of the south wall) of the Study show that the floor level was originally 0.85m higher than the modern floor in this part of the building (**Plates 25 to 29**).

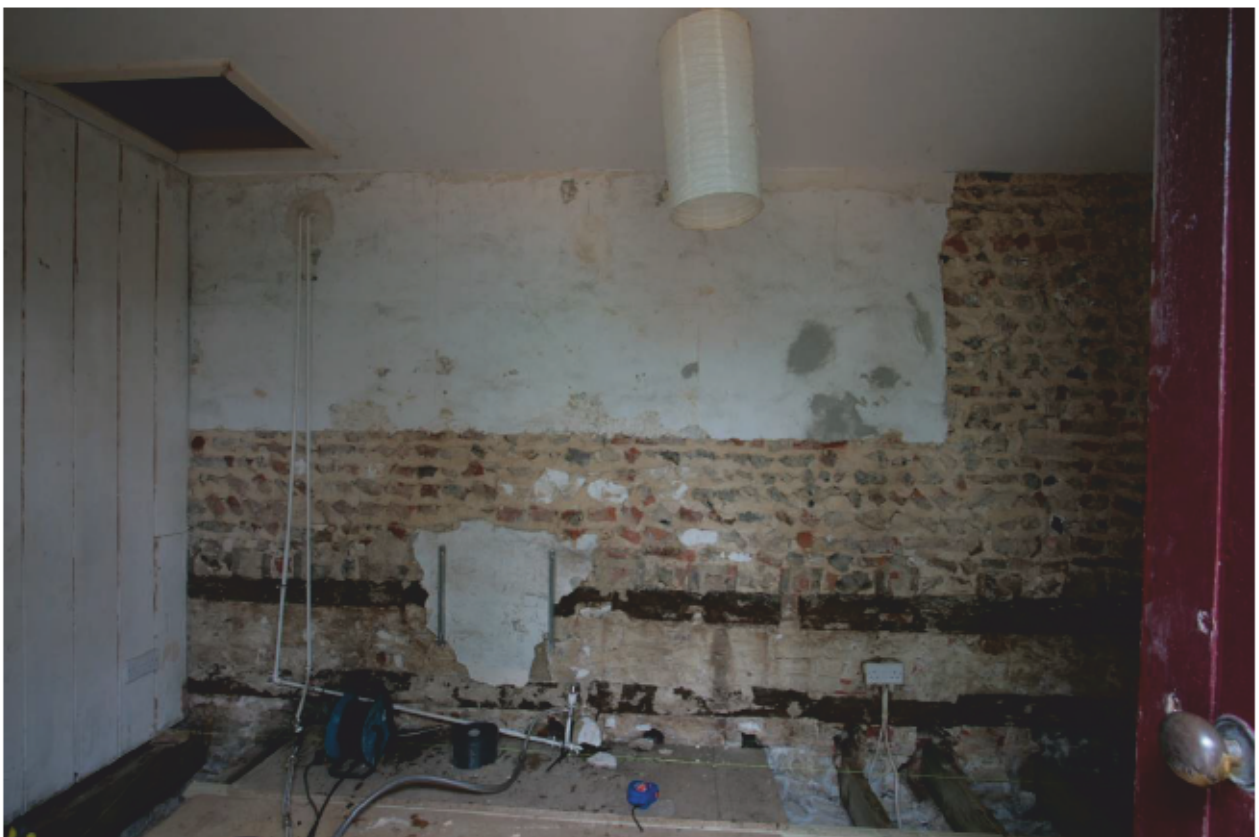
Plate 26: North wall of Study, looking north (D1 007)

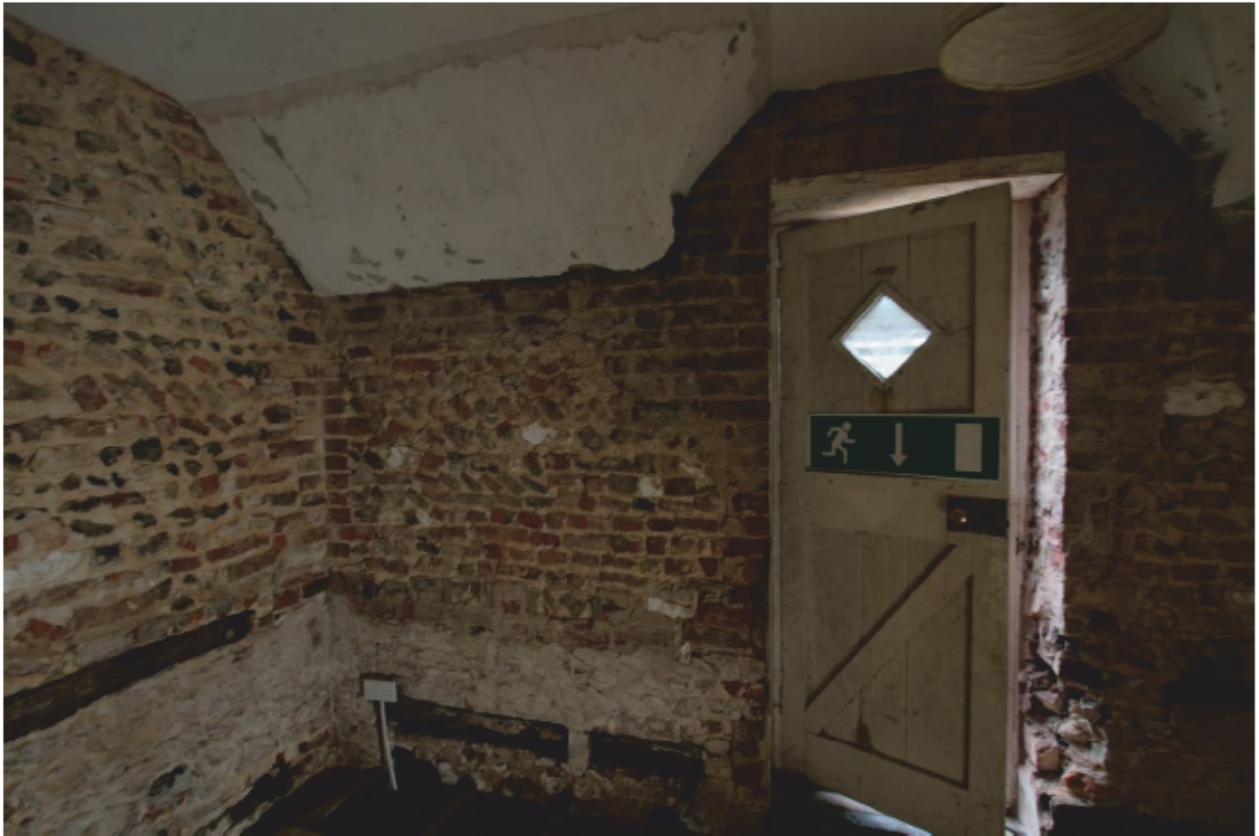
Plate 27: East (left) and south (right) walls of the Study, looking south (D1 004)

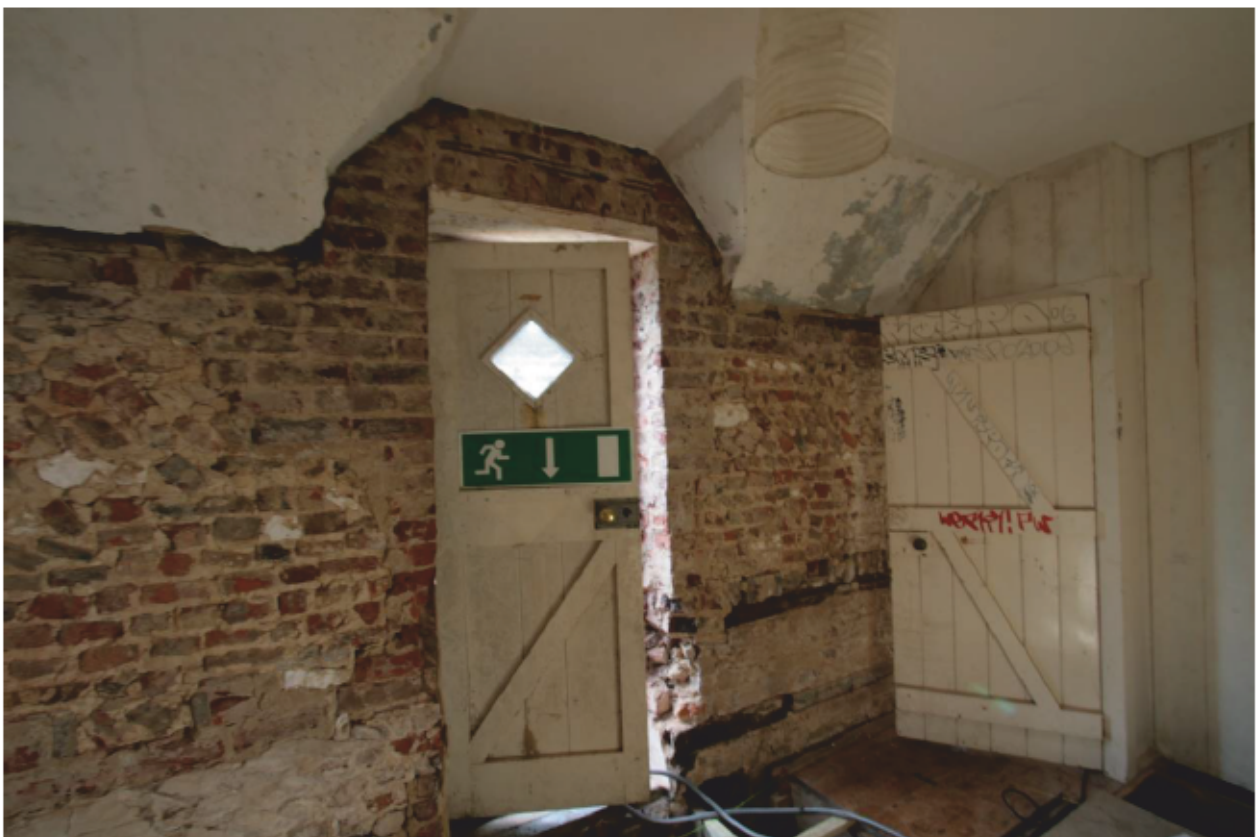
Plate 28: South (left) and west (right) walls of the Study, looking south-west (D1 005)

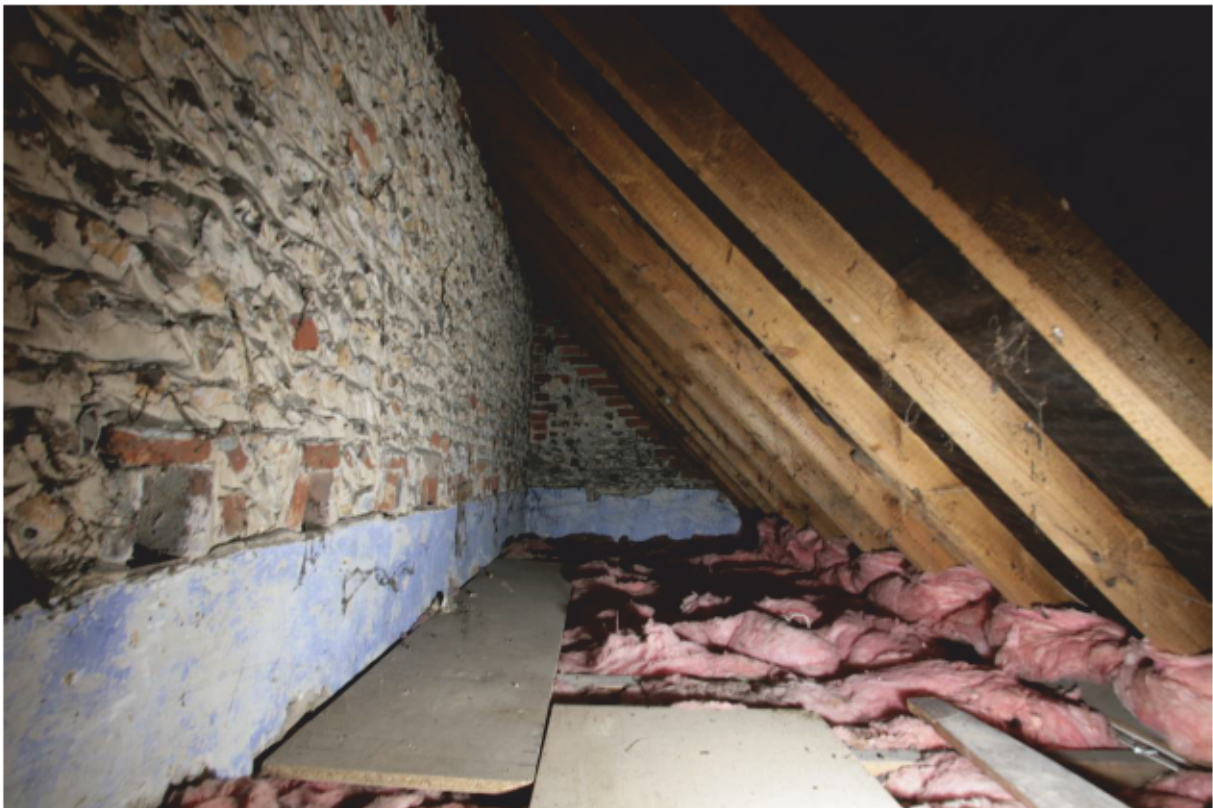
Plate 29: West wall of the Study, looking west (D1 003)

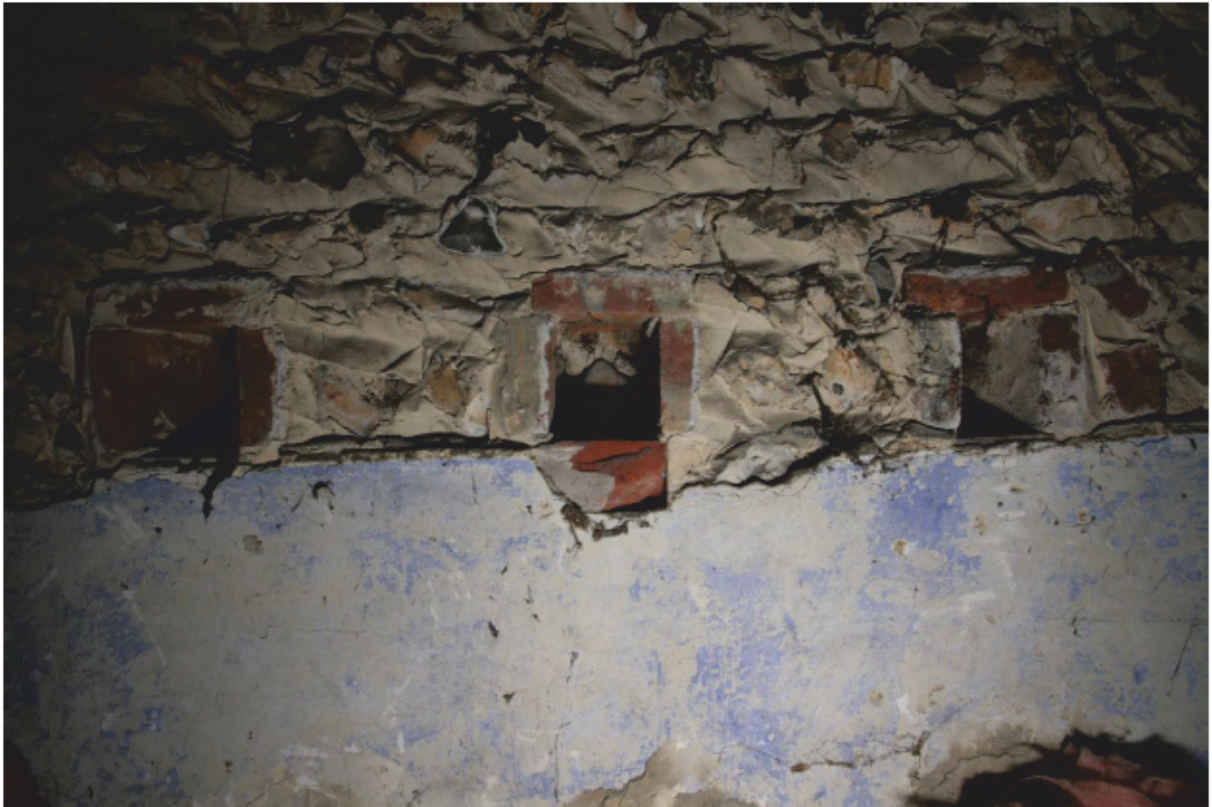
Plate 30: Roof space above Study, looking east (D1 019)

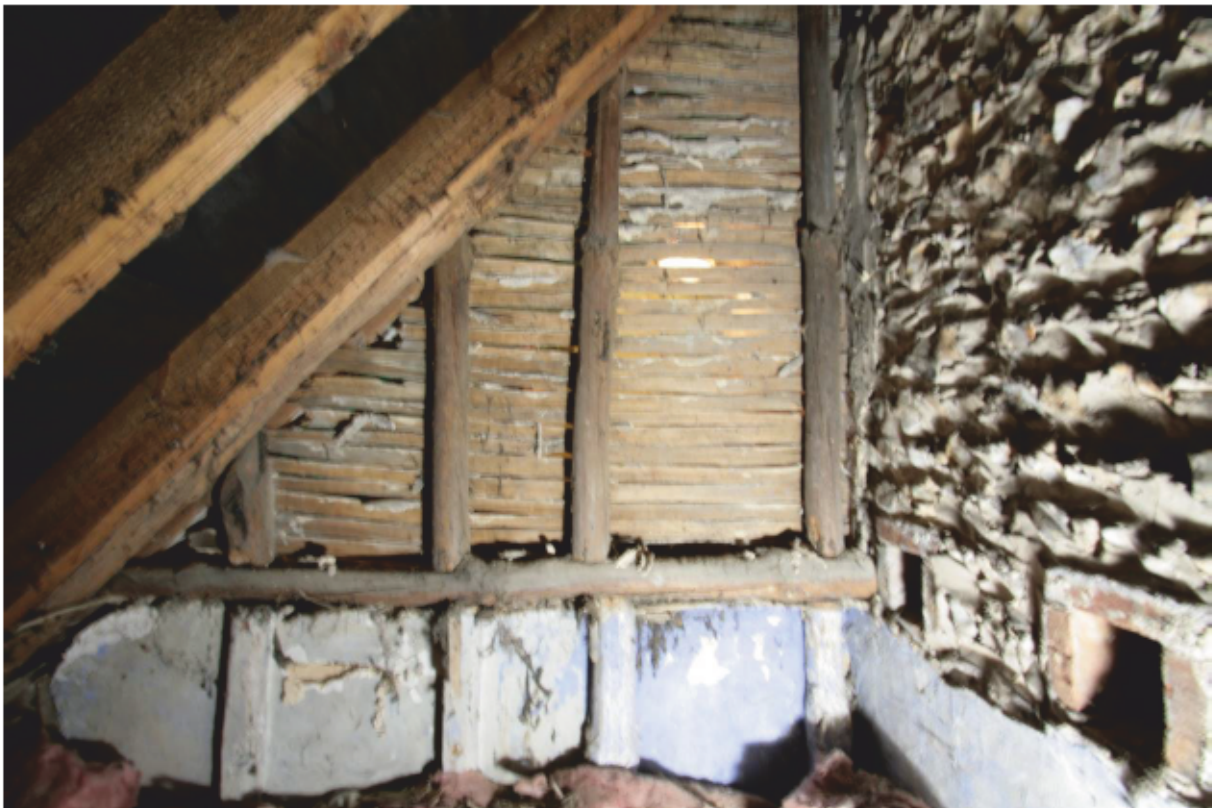
Plate 31: Joist sockets in north wall of roof space above Study, looking north (D1 018)

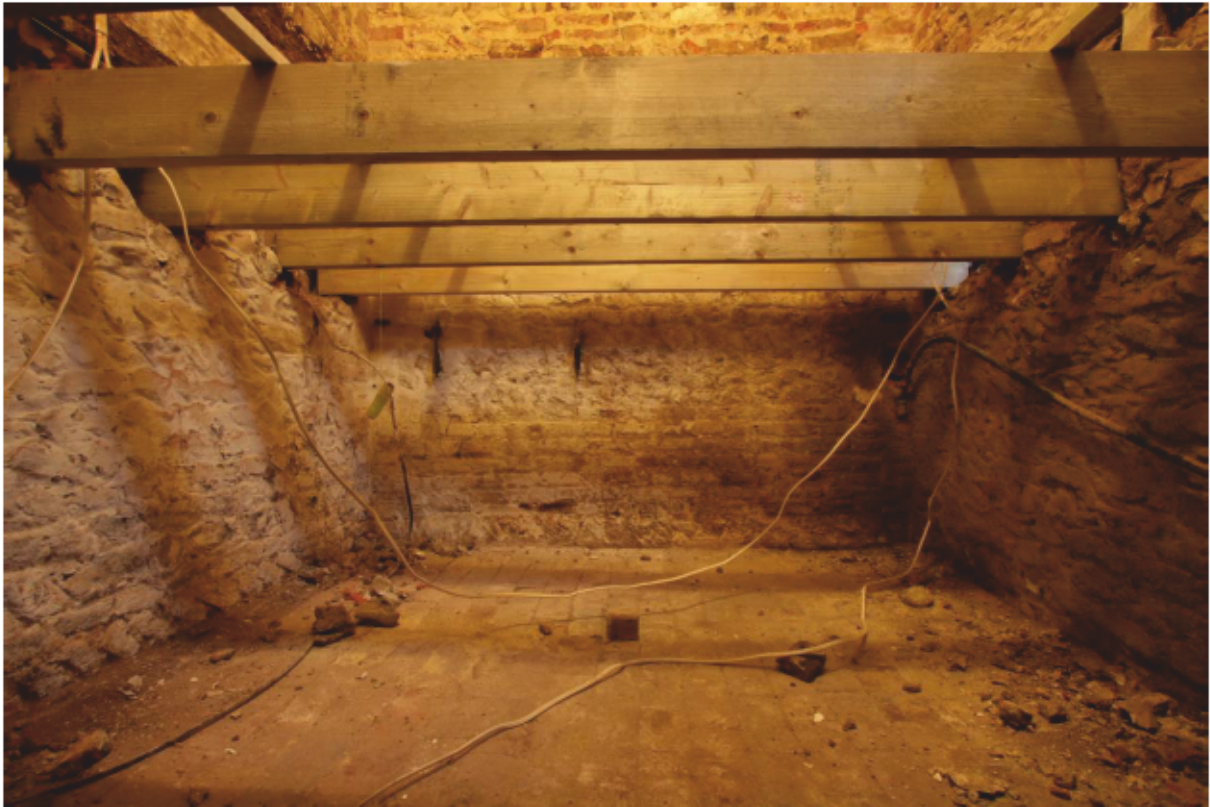
Plate 32: Roof space above Study, looking west (D1 020)

- 7.1.5 The cellar in the pentice has a brick floor. The floor level of the room above the cellar was some 0.85m higher than the current ground level. This room, now the Study, had a window in its east wall and a doorway in its west wall. Both have since been blocked. Plaster on the walls of the roof space above the Study showed that the ceiling was originally some 0.85m higher than the current ceiling. The roof over the pentice was constructed of common rafters-in-the-round (now mainly replaced). It was not clear if the staircase was original to the pentice or a later insertion. The room with the earlier higher floor now the Study may have originally been entered via steps perhaps with the rest of the pentice at a similar floor level to now. This

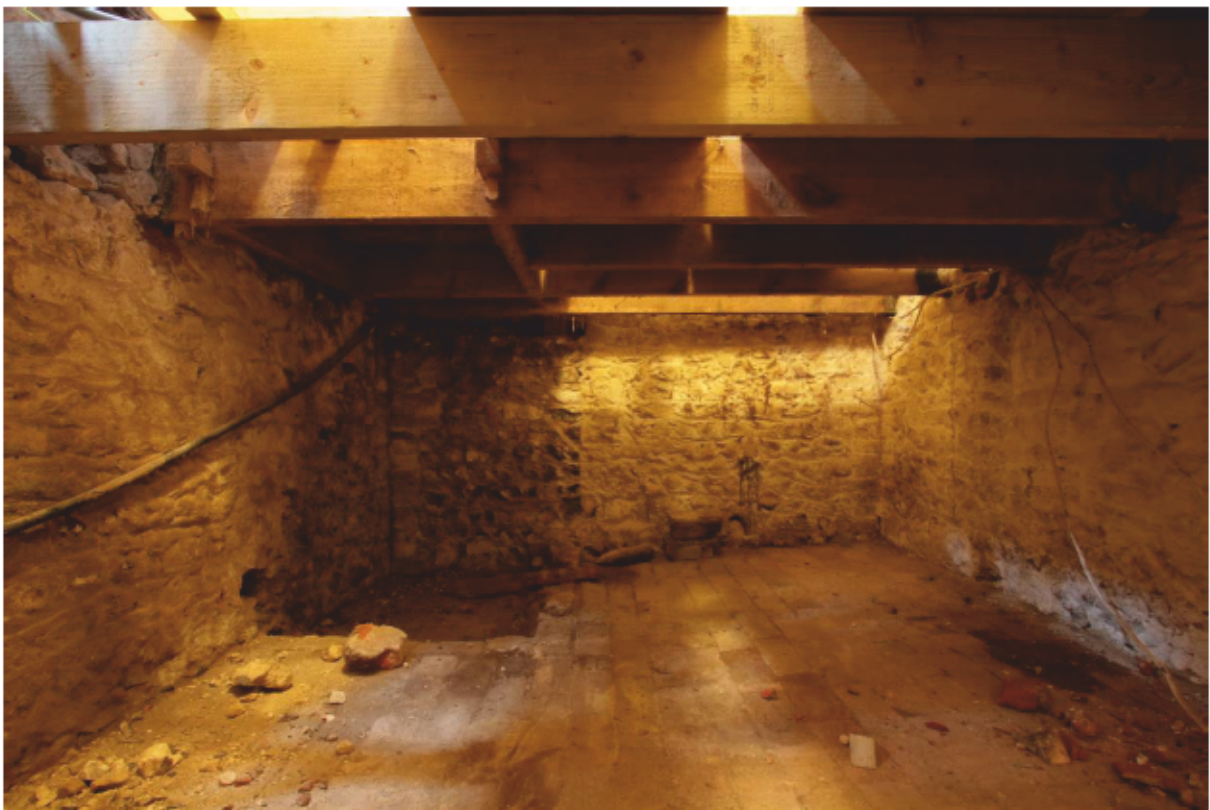
Plate 33: Cellar below Study, looking east (D1 012)

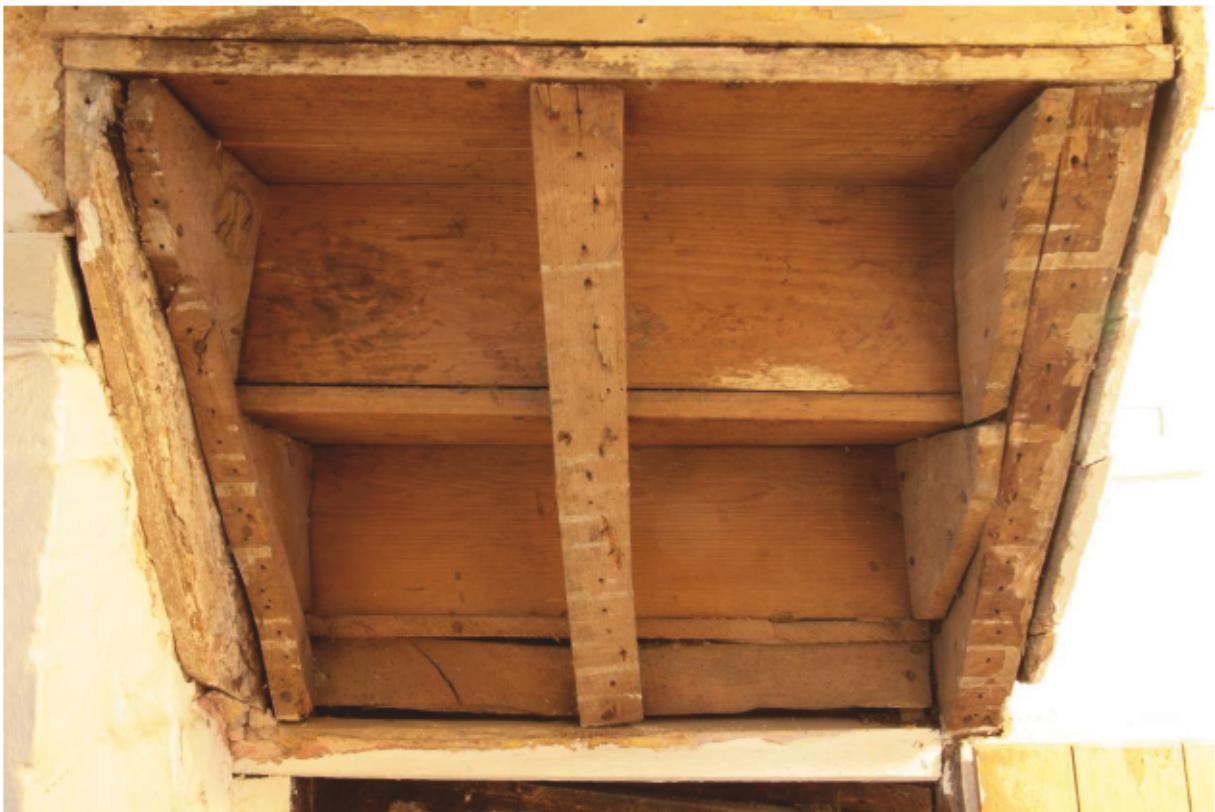
Plate 37a: Underside of staircase, looking east (D1 069)

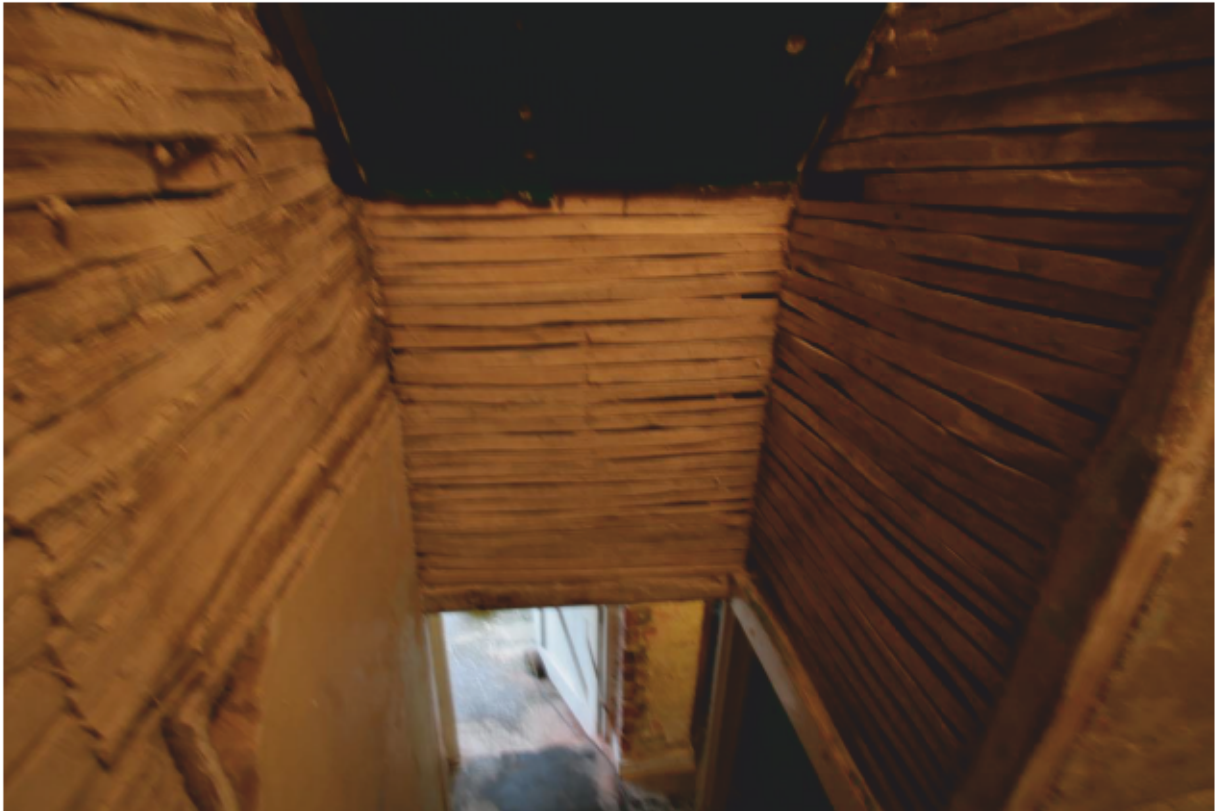
Plate 37b: Underside of staircase, looking east (D2 036)

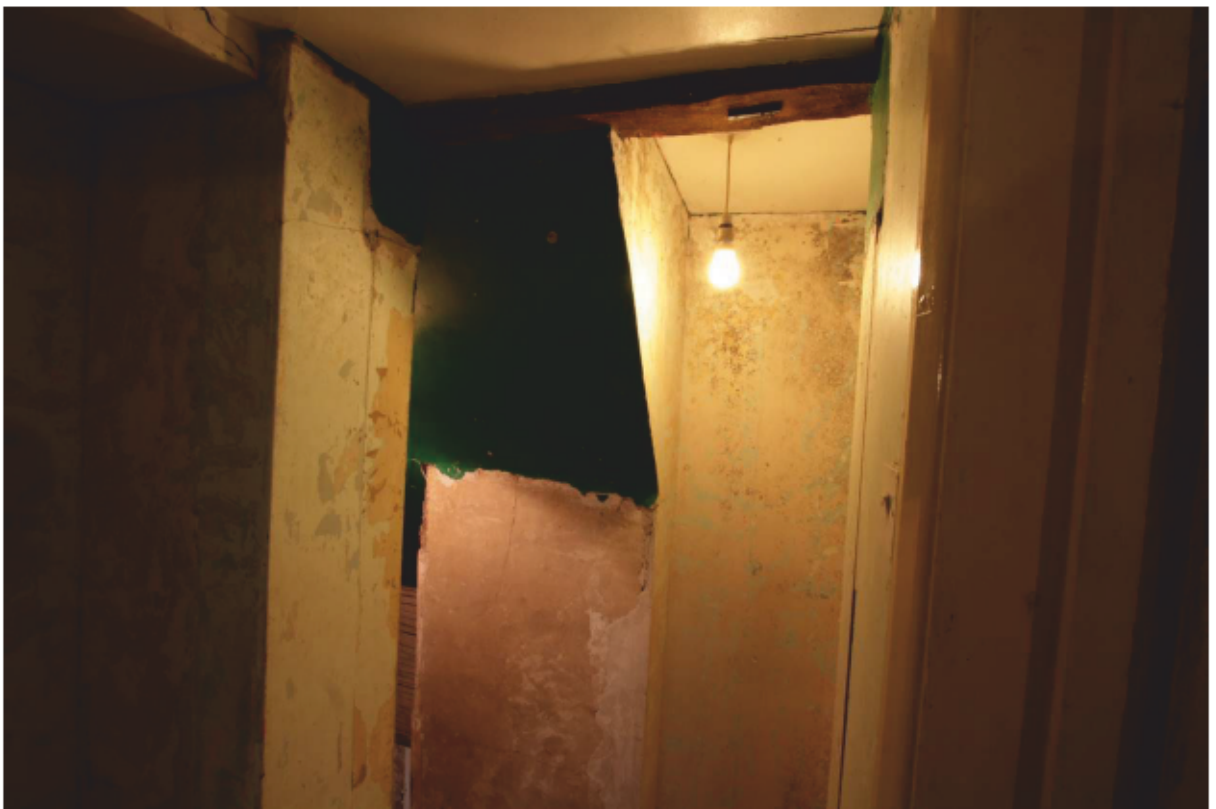
Plate 38: Stairwell, looking south (D1 027)

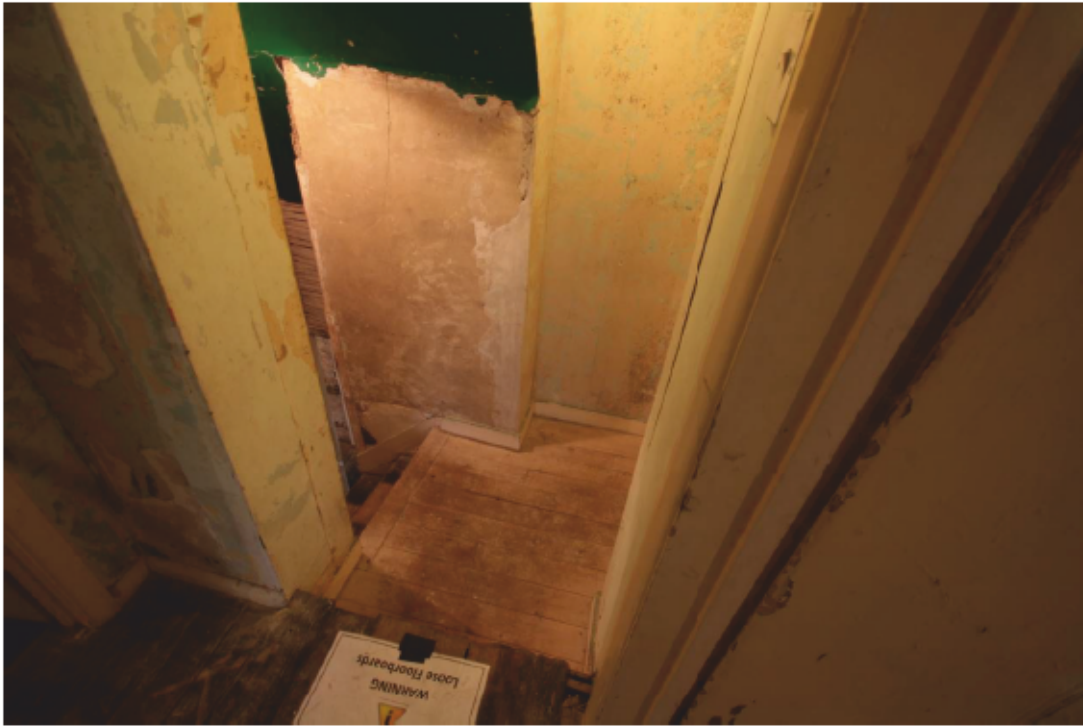
Plate 39: First floor Landing looking south (D2 016)

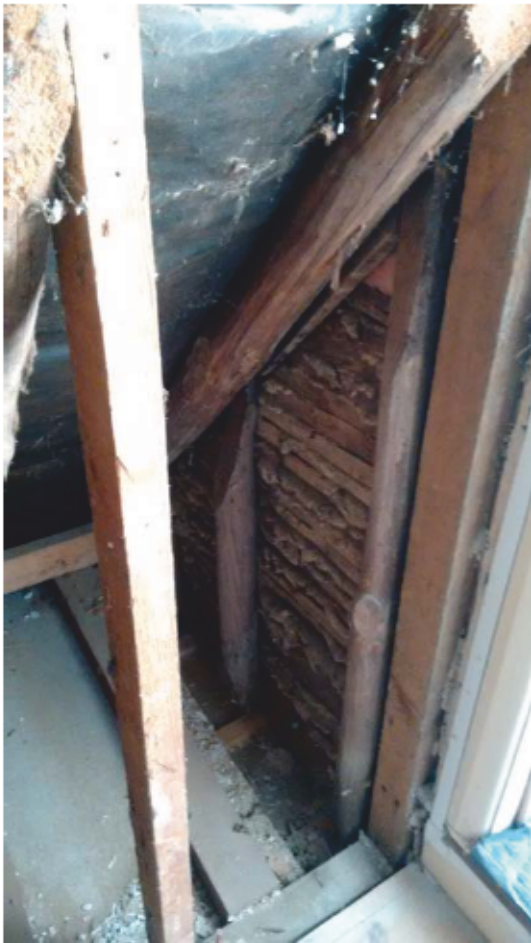
Plate 40: First floor Landing, looking south (D2 017)
