**HISTORIC BUILDING RECORDING
OF THE OLD BAKERY,
TOP ROAD,
SLINDON,
ARUNDEL,
WEST SUSSEX,
BN18 0RP**

PCA REPORT NO: R13144

MARCH 2018

Historic Building Recording

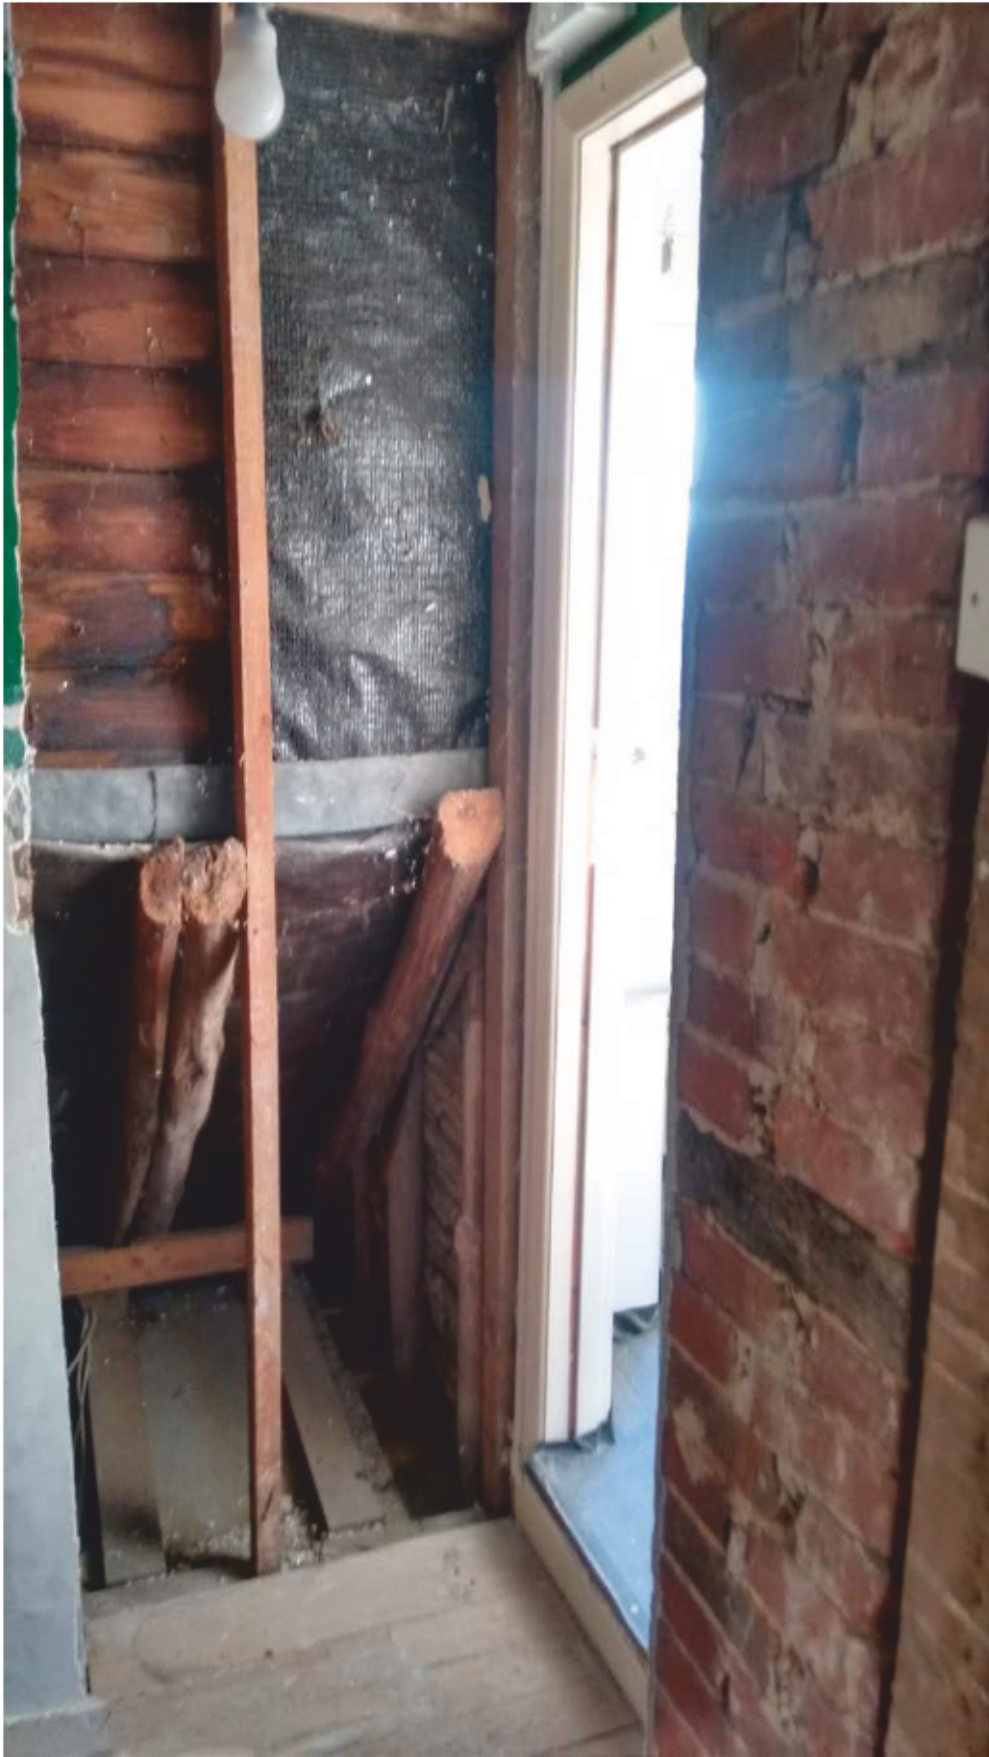
Plate 42: South and west walls of first floor Landing, looking south (photograph provided by George Roberts)

- 6.3.13 The roof of the rear (south) pentice originally had in-the-round rafters; a few of which remained above the Utility and at the top of the Staircase (**Plates 41, 42 and 44**). All the rafters above the Study had been replaced with modern, presumably late 20th century, softwood rafters (**Plates 30 and 32**).

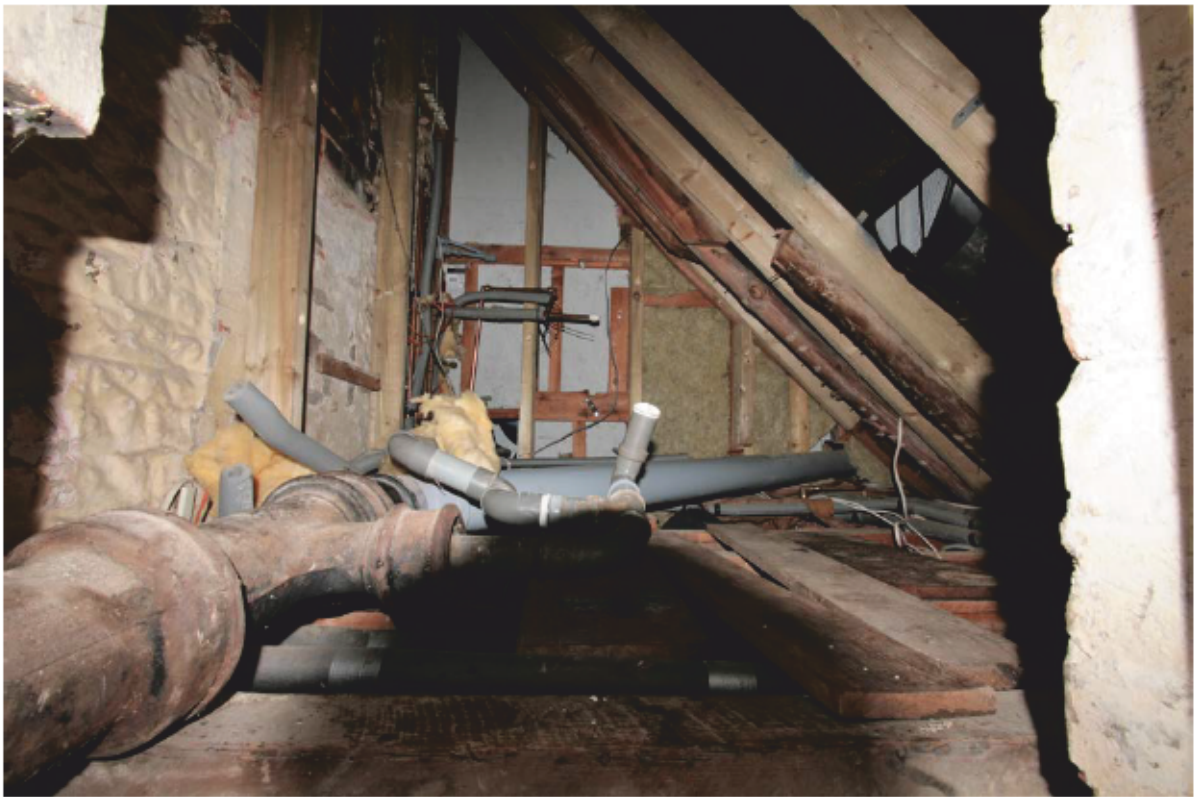
Plate 43: Utility Room, looking west (D2 032)

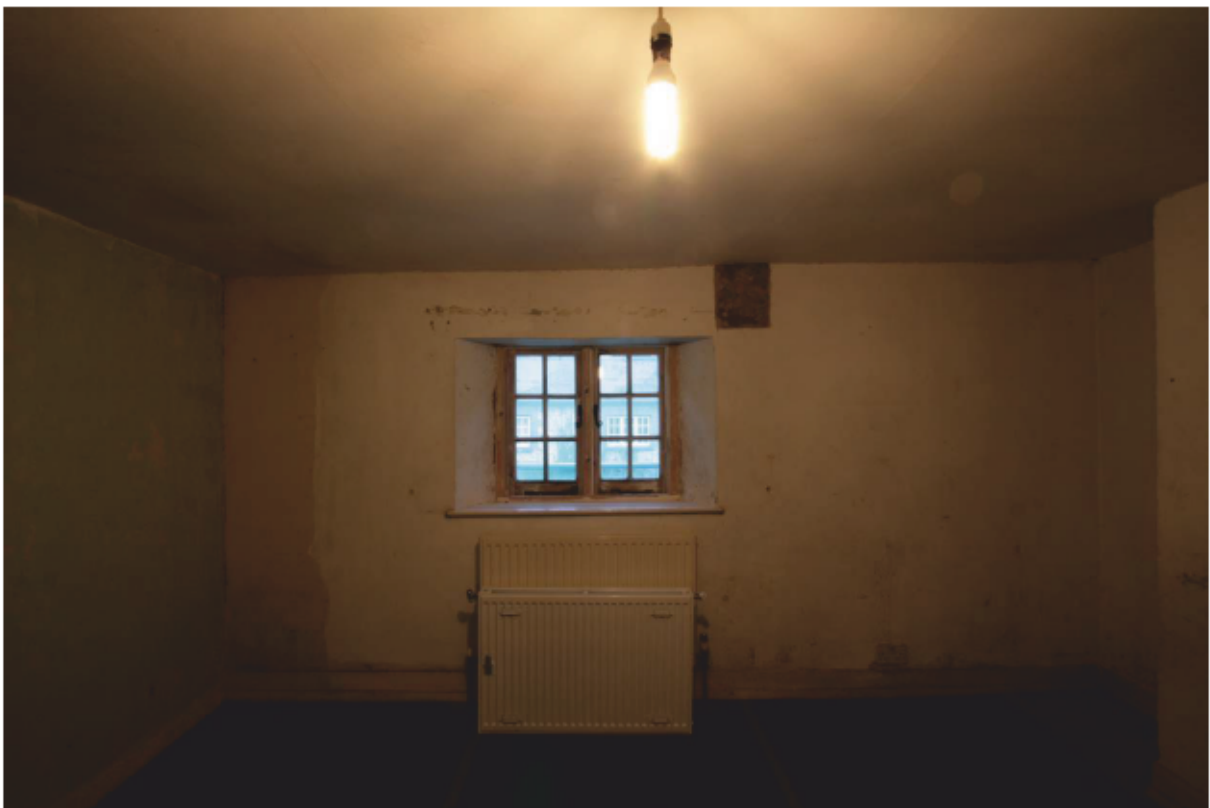
Plate 45: Bedroom 1, looking east (D1 028)

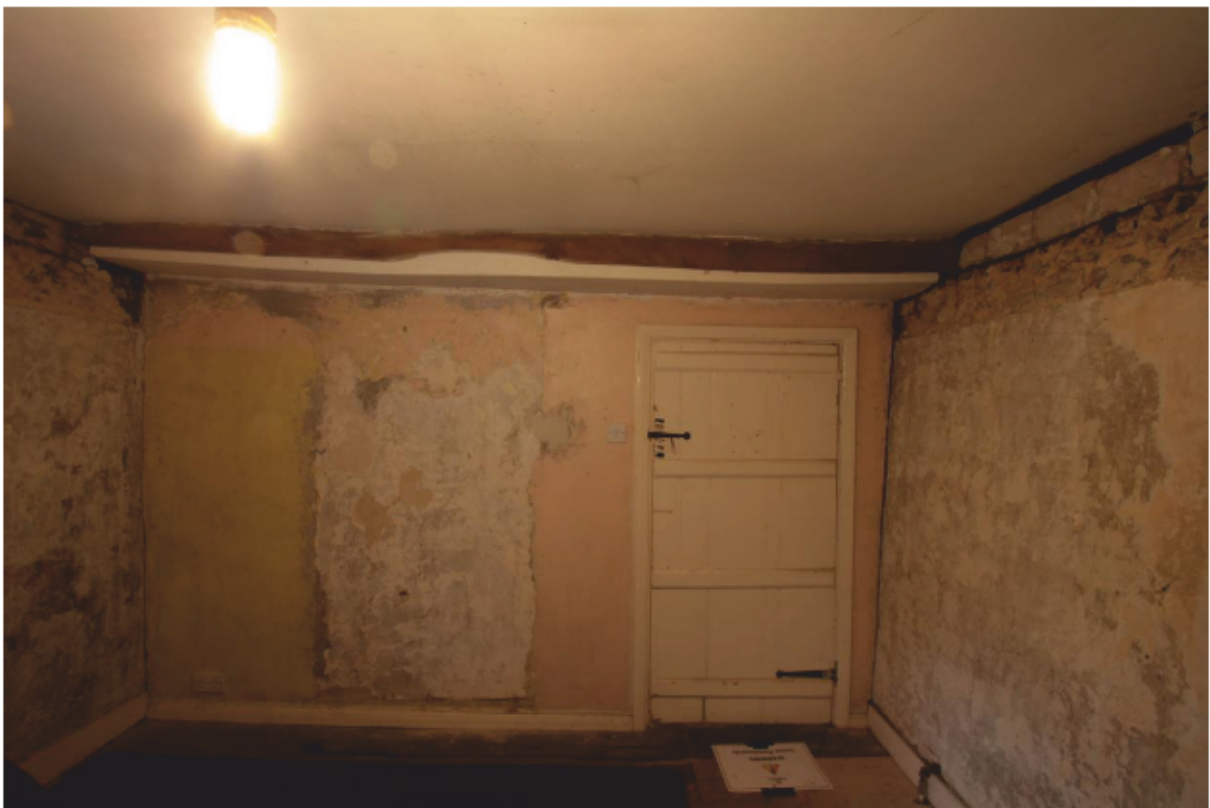
Plate 48: Bedroom 2, looking east (D2 011)

6.7.2 A north-south timber beam crosses the centre of the room from the east side of the chimneybreast (**Plates 49 and 51**). Another north-south timber beam crosses the east end of the room (**Plates 48 and 51**). Its soffit is covered with plaster marking the start of a lower ceiling to the east. These two timbers are visible in the attic above (**Plates 62 and 63**) as two

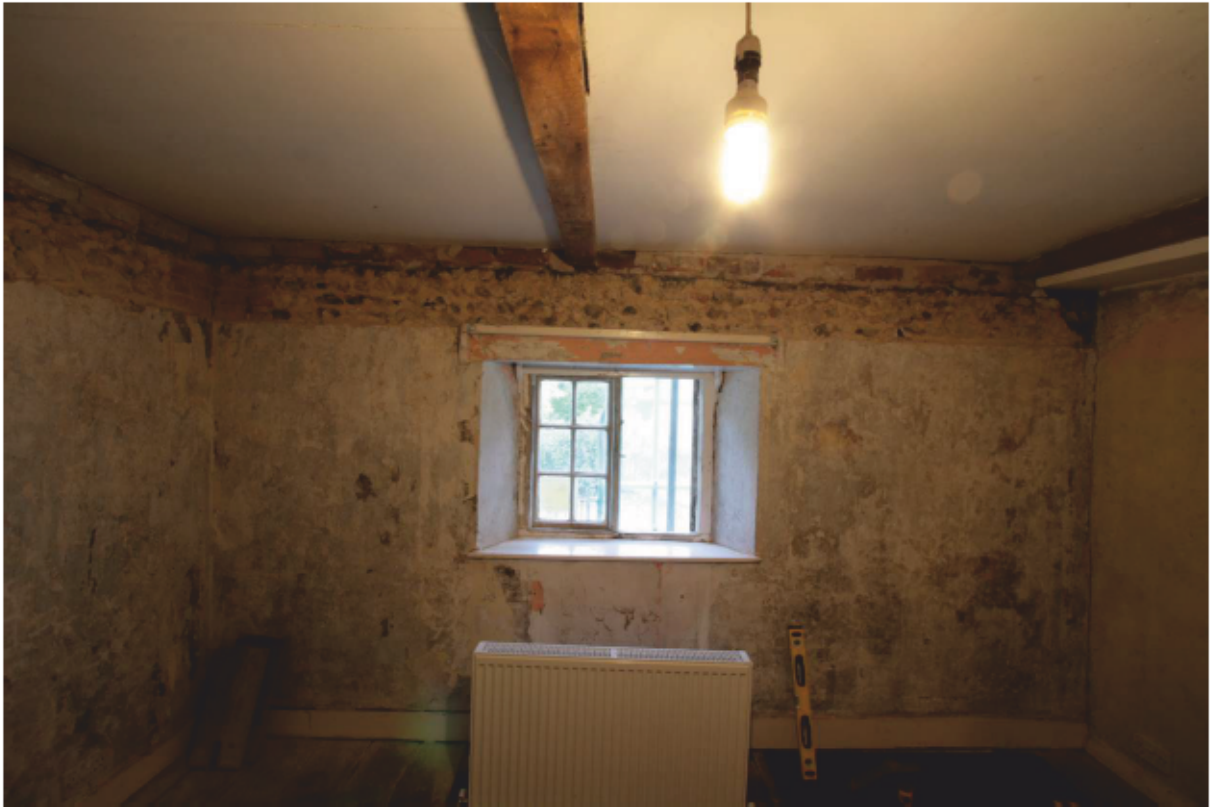
Plate 49: Bedroom 2, looking north (D2 012)

- 6.7.3 A single course of concrete blocks was visible at the time of the site visit at the top of the south and west walls of Bedroom 1 (**Plates 51 and 52**) with a course of modern bricks along the top of the north wall (**Plate 49**). These and the two north-south timber downstand beams show that the ceiling had been raised. It is clear in the roof space that the original lath and plaster ceiling had been replaced with plasterboard (**Plates 62 and 63**). This alteration may have taken place when the bathroom extension was added in 1968. North-south floorboards in Bedroom 2 measure 25cm in width.

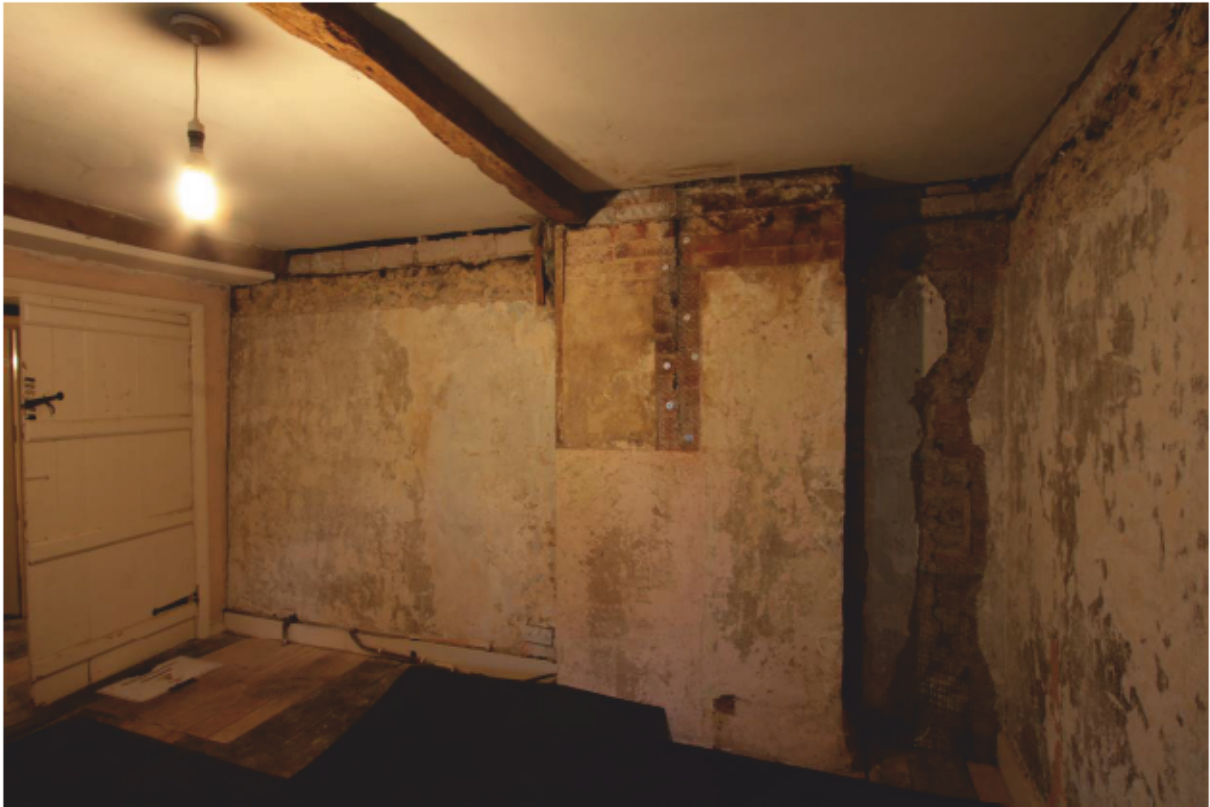
Plate 51: Bedroom 2, looking south (D2 007)

- 6.8.1 The west wall of Bedroom 3 is original whereas its east wall is later and may have replaced an earlier wall on a different line. At the time of the site visit, the studwork of the west wall of Bedroom 3 was covered with laths (**Plates 53 to 55**). The window opening in Bedroom 3 although original is not splayed like those in Bedrooms 1 and 2, presumably because of its proximity of the west wall (**Plate 55**). The east and south walls of Bedroom 3 appear to be constructed of plasterboard. North-south floorboards in Bedroom 3 measure 25cm in width. An area of modern floorboards lies in the north-west corner of Bedroom 3 (**Plate 57**). The ceiling of Bedroom 3 is lower to the east (**Plate 56**). The step in the ceiling height may mark a north-south timber beam that crosses the room at this point similar to those in Bedroom 2 (**Plate 51**).

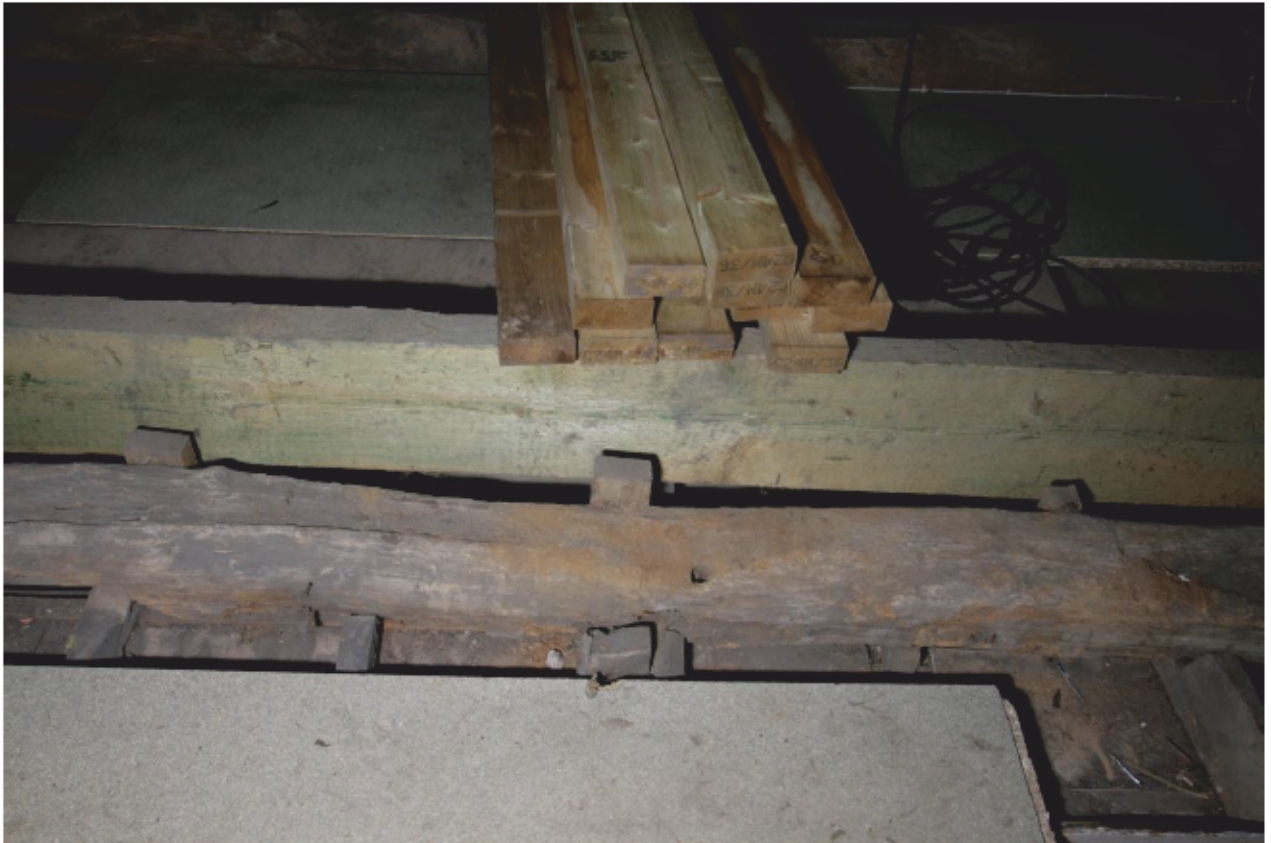
Plate 59: Tie beam in roof space over Bedroom 3 and Landing, looking east (D3 023)

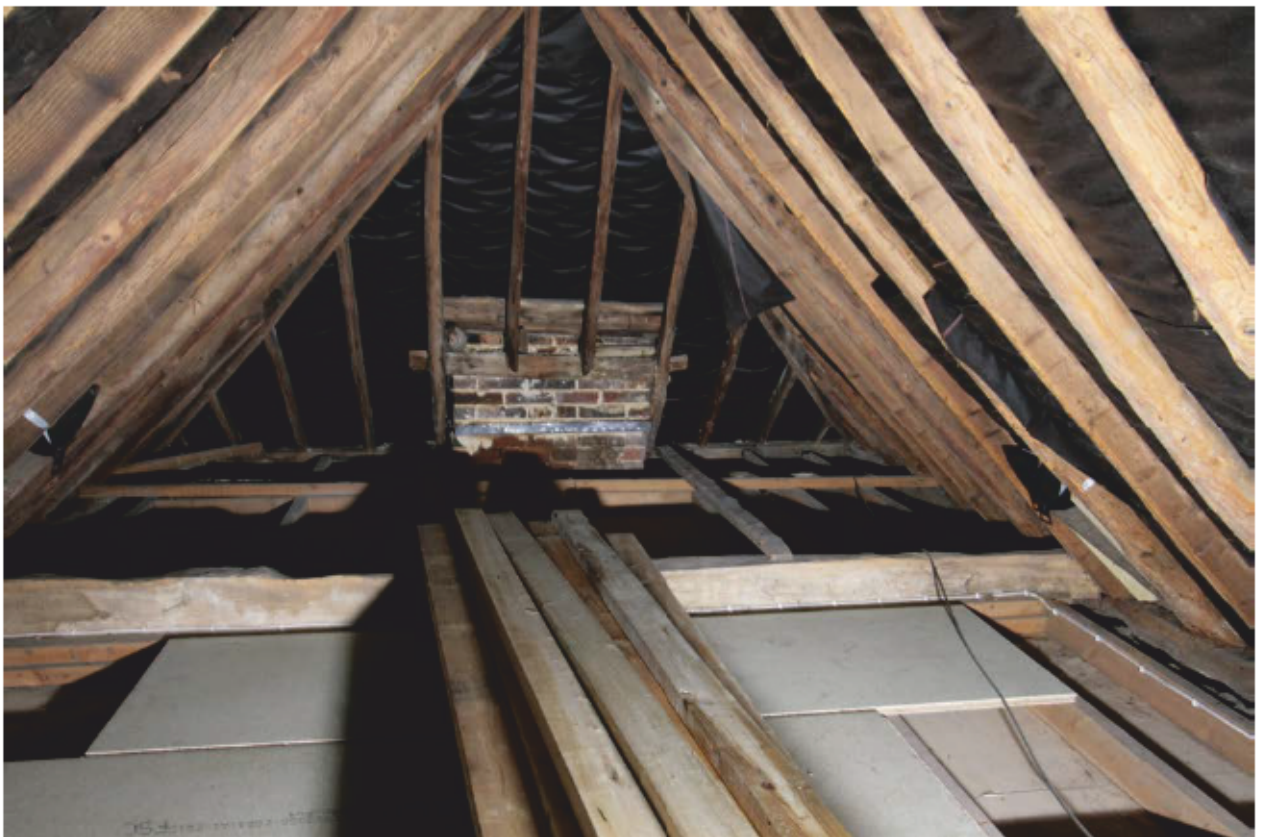
Plate 60: Roof space over Bedroom 1, looking east (D3 024)

of five large tie beams that span the roof space (**Plates 58 to 61**). These tie beams appear to have been reused from an earlier building.

- 6.9.2 The brick chimneystacks from the Sitting Room and Dining Room are visible in the attic (**Plates 60 and 62**).

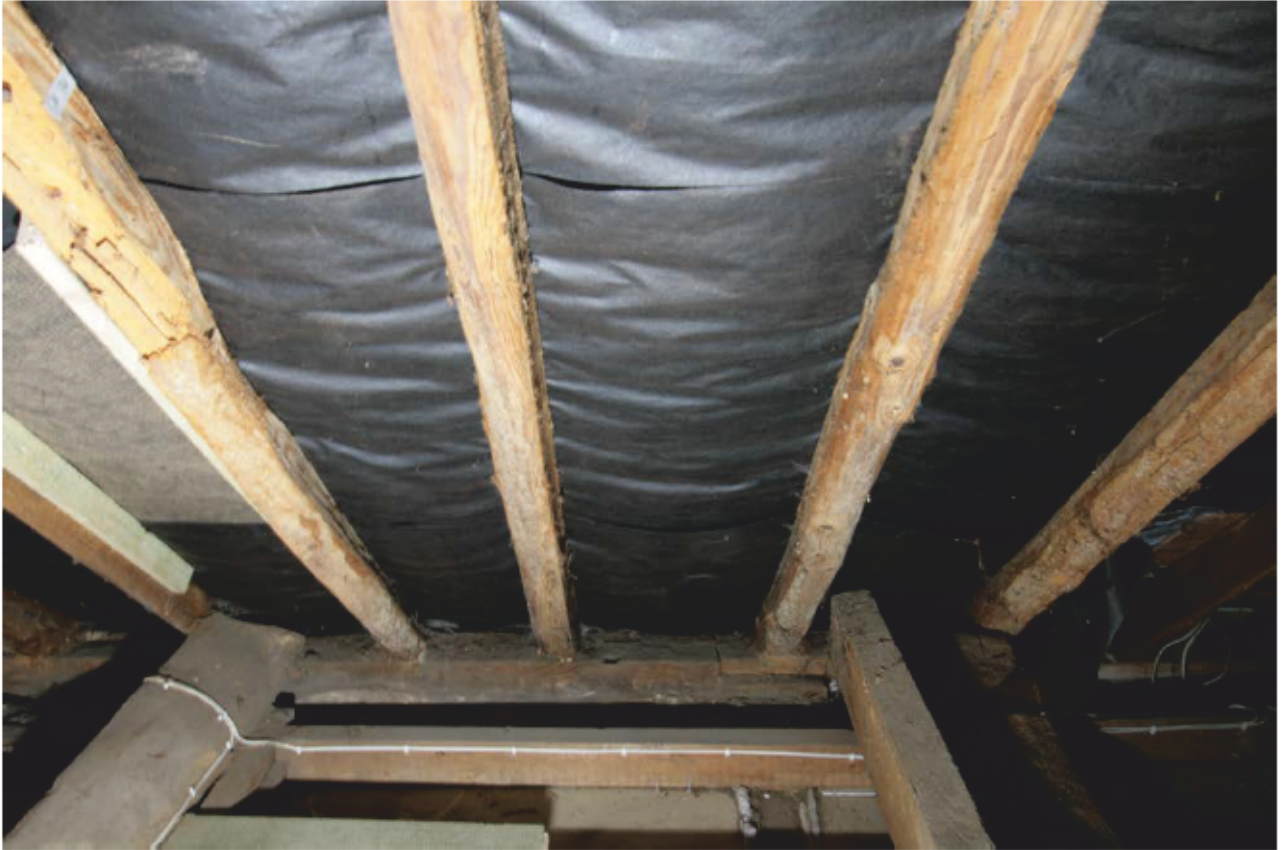
Plate 61: Common rafters in roof space over Bedroom 1, looking south (D3 025)

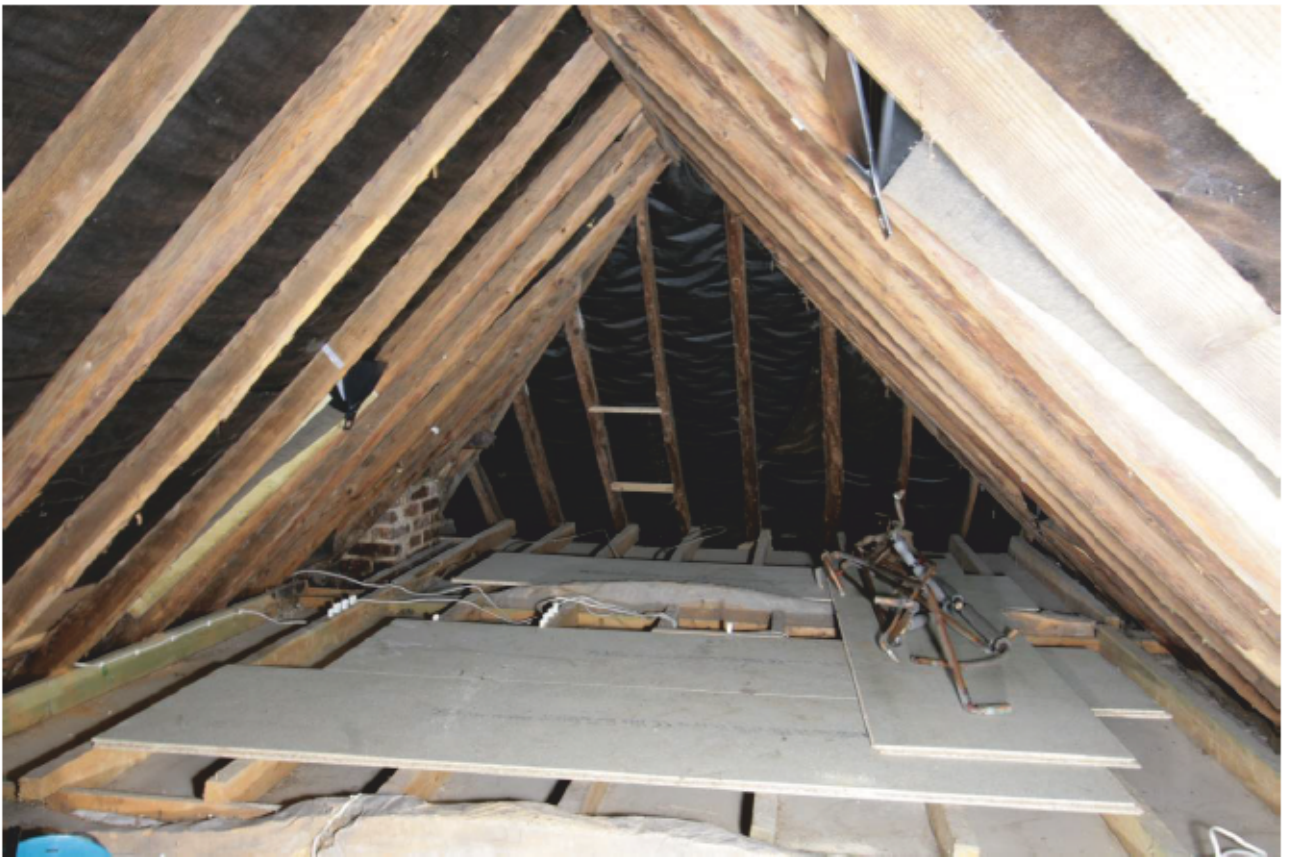
Plate 62: Roof space over Bedroom 2, looking west (D3 027)

- 6.9.1 Common softwood rafters sit on timber wall plates along the north and south walls (**Plates 61 and 63**) and pinch a thin ridge board (**Plates 58 and 64**). Five large north-south tie beams cross the roof space (**Figure 13; Plates 58, 59, 62 and 63**). These beams are roughly hewn. Empty mortices and treenail holes show that they have been reused from an earlier, perhaps 16th century, building. Like the common rafters, they sit on the timber wall plates (**Plates 61 and 63**). The tie beams do not support principal rafters and are placed between common rafters. Timber ceiling joists appeared to be coggled or nailed into the soffits of the tie beams (**Plate 59 and 63**). In some areas, lath and plaster still survives attached to the soffits of the ceiling joists (**Plate 63**). Over most of Bedroom 2, the original lower ceiling joists and lath and plaster ceilings have been removed and replaced with higher plasterboard ceilings attached to late 20th century east-west softwood ceiling joists (**Plates 62 and 63**).

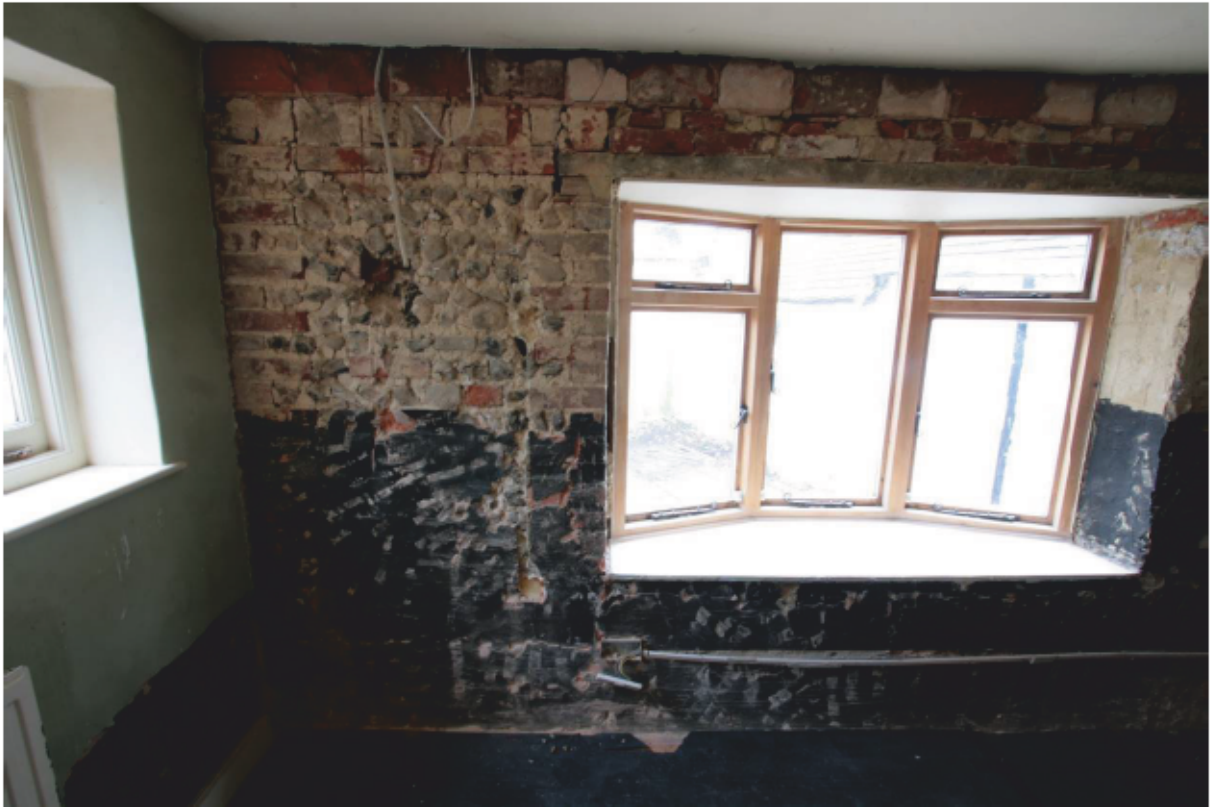
Plate 65: East side of south wall of Kitchen, looking south (D3 018)

- 6.10.1 At the time of the site visit, the internal plaster had been completely removed from the south and west walls (**Plates 65 to 69**) and partially removed from the north wall of the Kitchen (**Plates 69 and 70**). The east wall was still covered with plaster (**Plates 65 and 71**).

- 6.10.2 The south wall of the Kitchen was constructed of flint rubble with brick dressings and occasional courses of brickwork (**Plates 65** and **66**). The lower part of the wall had been covered with black bitumen to a height of 1m above floor level. The large bay window (measuring 1.7x1.1m) in the south wall had been inserted, possibly as part of the 1968 works, replacing a doorway at its east end (its brick blocking is visible externally; **Plates 10** to **12**) and a small window at its west end (its brick blocking also visible externally). Internally, the east brick jamb of the doorway was visible (**Plate 65**). The east end of the timber lintel of the doorway was just visible at the top of the brick jamb and below the timber lintel of the bay window. The west brick jamb of the blocked window opening was visible to the west of the inserted bay window (**Plate 66**). The west end of its timber lintel was visible at the top of the brick jamb. The former window opening has been infilled with cement.

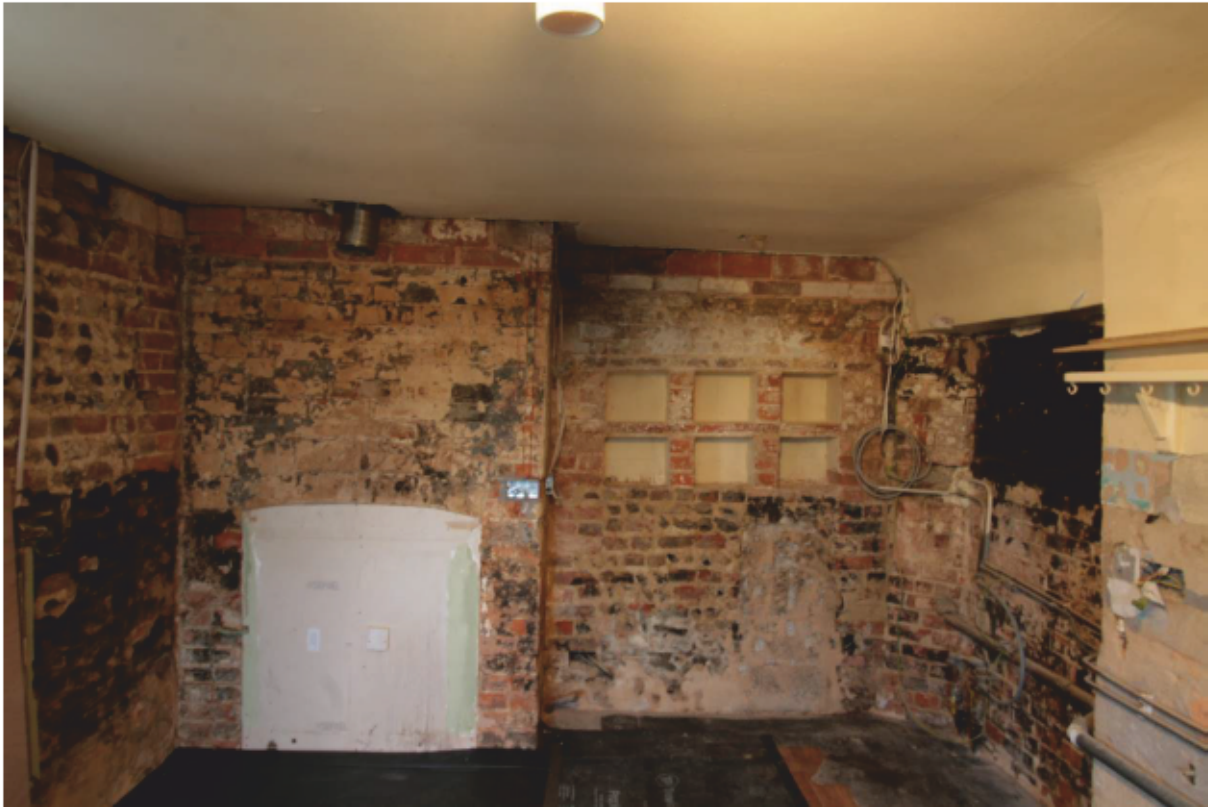
Plate 67: West wall of Kitchen, looking west (D3 011)

- 6.10.3 A brick chimneybreast at the south end of the west wall of the Kitchen contained a large fireplace (uncovered during the site visit) suitable for a range (**Figure 10**). The fireplace has a segmental arch formed of two courses of brick-on-edge (**Plates 67** and **68**). The north side of the west wall was constructed of coursed irregular brickwork with some flint rubble (**Plates 67** and **69**). Six square recesses in this side of the wall may have been a slightly later insertion into the wall because the bricks are a lighter red than those in the rest of the wall. The recesses may have provided convenient shelves for proving dough.

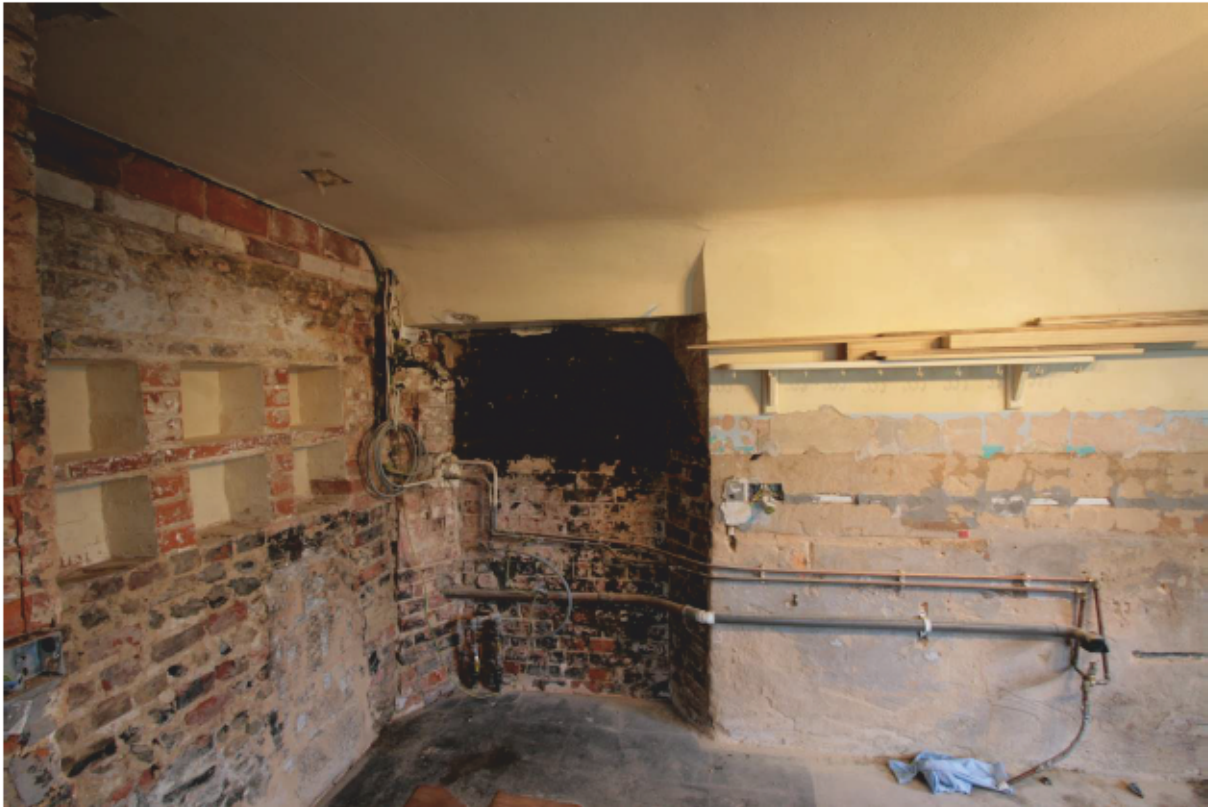
Plate 69: West side of north wall of Kitchen, looking north (D3 012)

- 6.10.5 At the time of the site visit, plaster had been removed from a large recess with canted sides at the west end of the north wall of the Kitchen (**Plate 69**). The bricks in the recess were soot blackened, especially higher up the wall, suggesting that it had been used as the rear of a fireplace/chimney breast. A straight vertical construction joint was visible between the west wall and the west canted side of the recess and it appeared that the fireplace was a later addition. The rear of the recess is visible in the south wall of the Utility, which juts out around it (**Plate 43**). The fireplace is some distance from the in-gable central chimney stack in the west elevation of the Kitchen and it may have had an iron side flue like the side flue bread oven built c.1872 at no. 325 Old London Road, Ore, Hastings (Martin, 1993). Martin (1994) comments that prior to the 1930s 'many small country bakeries were equipped with side flue ovens such as the one at Ore, Hastings'.
