**BUILT HERITAGE RECORDING AT
KING GEORGE V DOCK,
LONDON CITY AIRPORT,
LONDON BOROUGH OF NEWHAM,
E16 2PX**

PCA REPORT NO: R13162

**Built Heritage Recording at King George V Dock, London City Airport,
London Borough of Newham, E16 2PX**

Built Heritage Recording

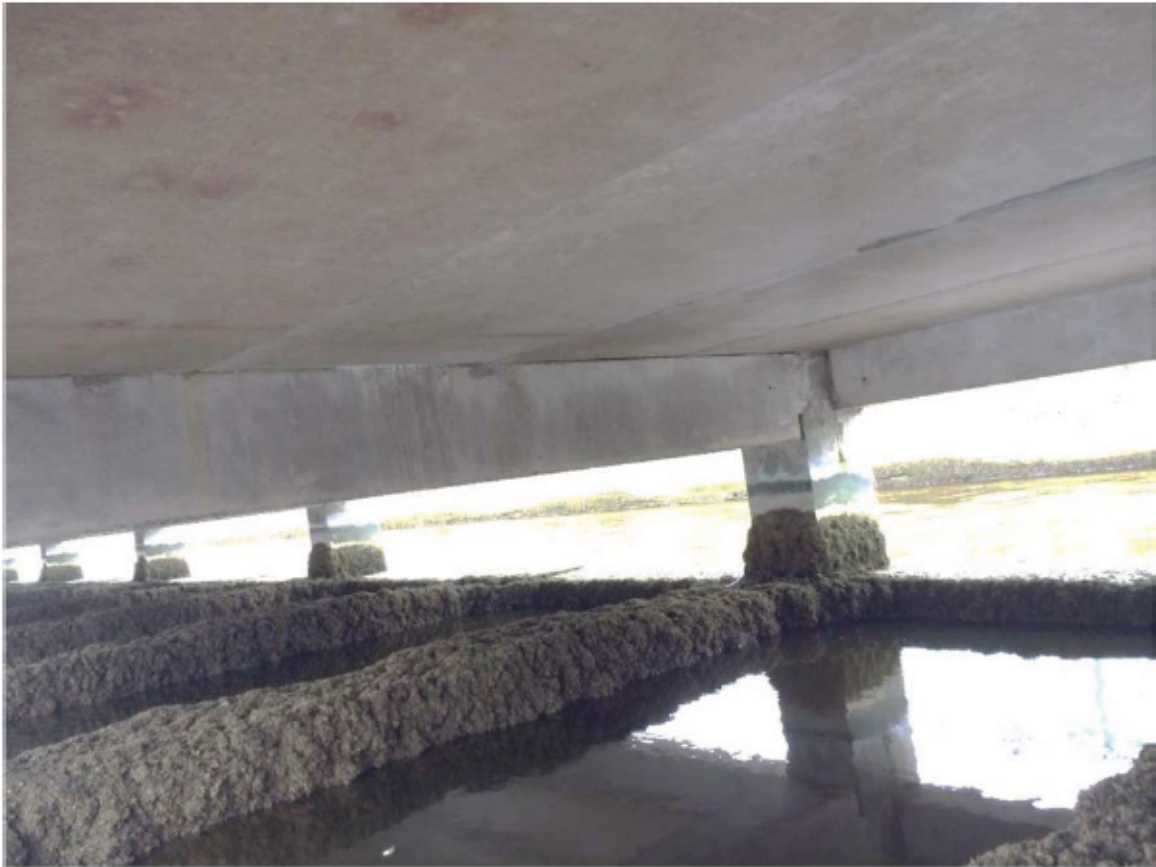
Historic Plate 26: Photograph taken in 2016 of the underside of Dolphin 7 by Constructex following the lowering of the water in King George V Dock, looking south-east

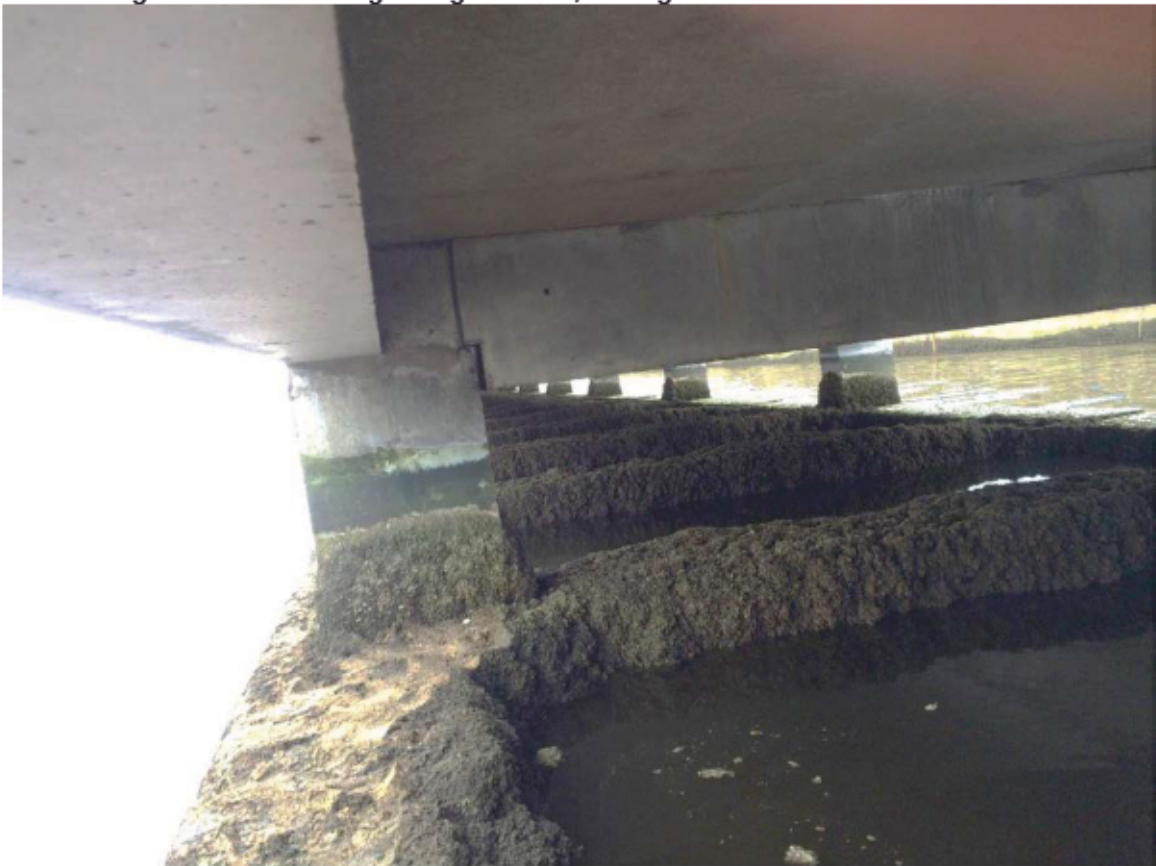
Historic Plate 27: Photograph taken in 2016 of the underside of Dolphin 7 by Constructex following the lowering of the water in King George V Dock, looking south-east

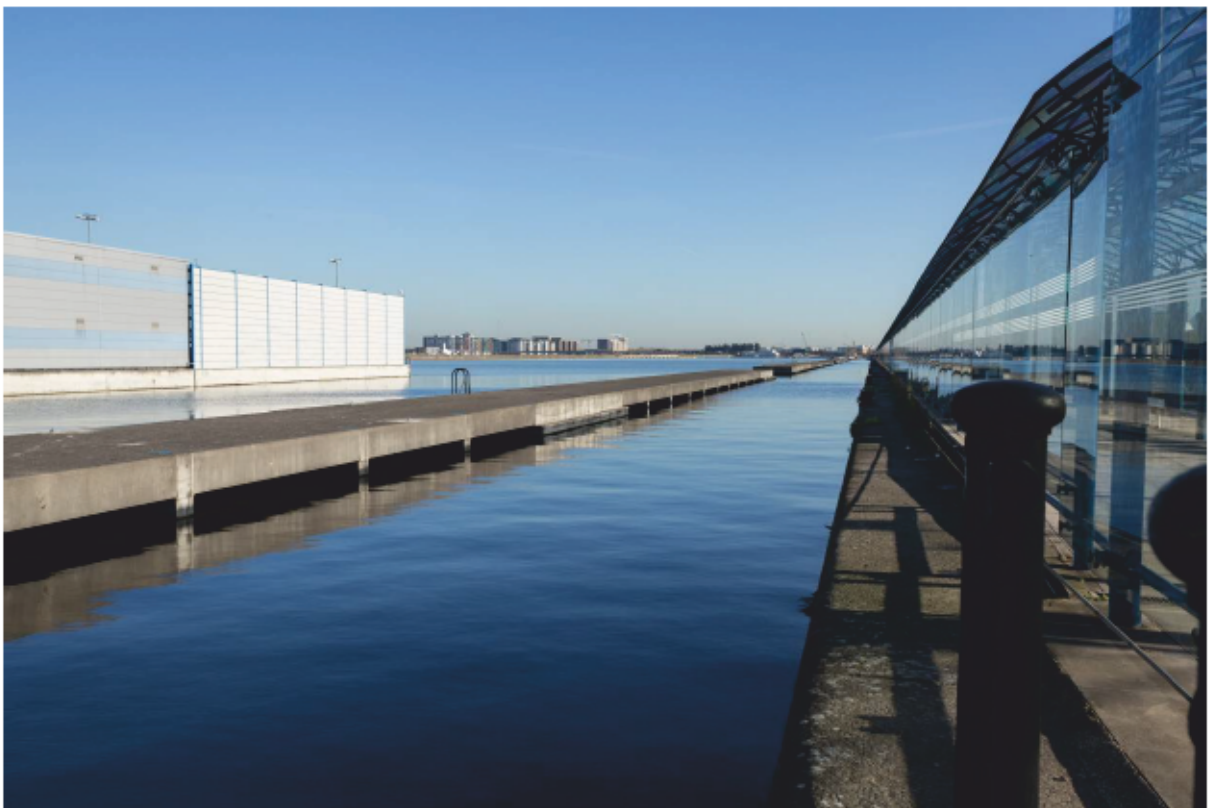
Plate 2: Dolphin 7 before removal of its cap, looking east (CIY17 D100 011)

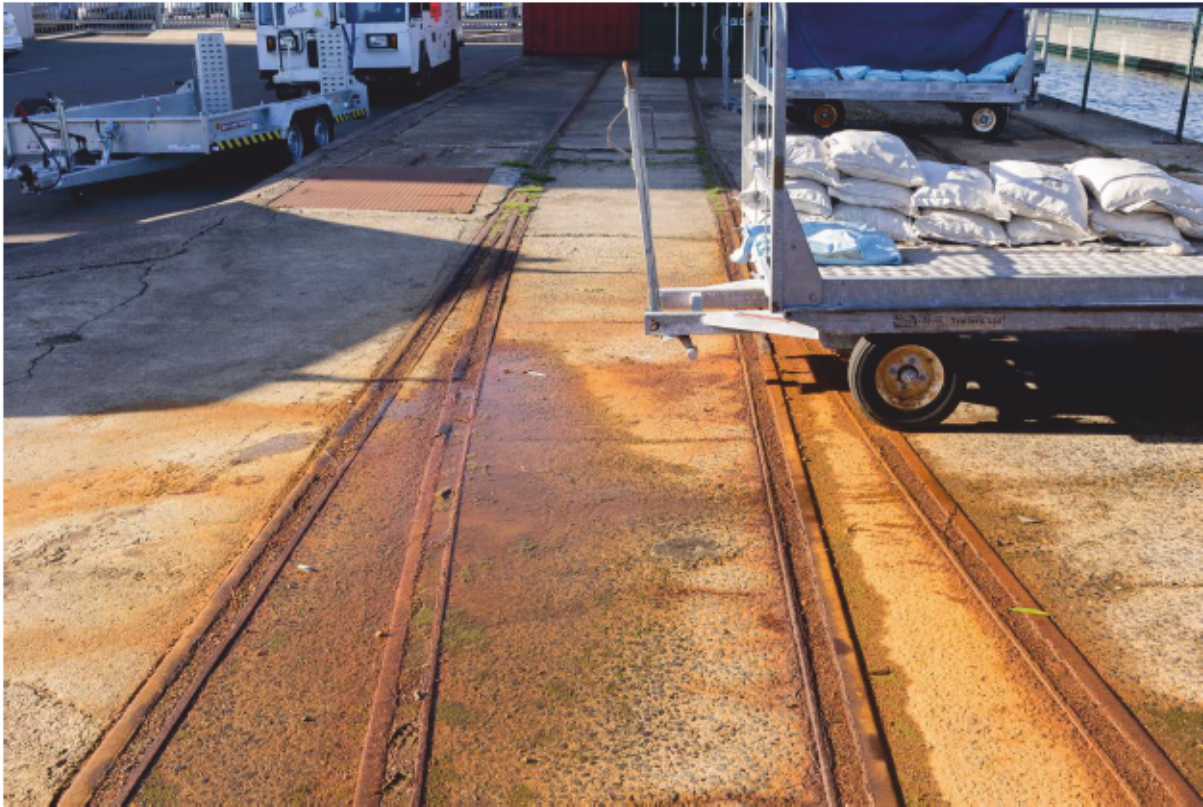
- 6.2.6 Two railway lines that lay along the South Quay to the north of the Transit Sheds were still visible in places (**Plates 13, 19 to 21**). They were better preserved at the east end of the quay (**Plates 13 and 19**) with rusted railway lines near KGV House (**Plate 21**). The 1958-60 map (**Figures 12 and 17**) shows that railway line crossovers were deliberately placed along the South Quay to the north of the gaps between the Transit Sheds. Crossovers survive to the north of the Transit Sheds in the spaces between Sheds nos 1, 2, 3, 4 and 5 (**Plates 19 and 20**).

Plate 21: Rusted railway lines outside KGV House on the north side of Transit Shed 5 with King George V Dock on the right, looking west (CIY17 D100 016)

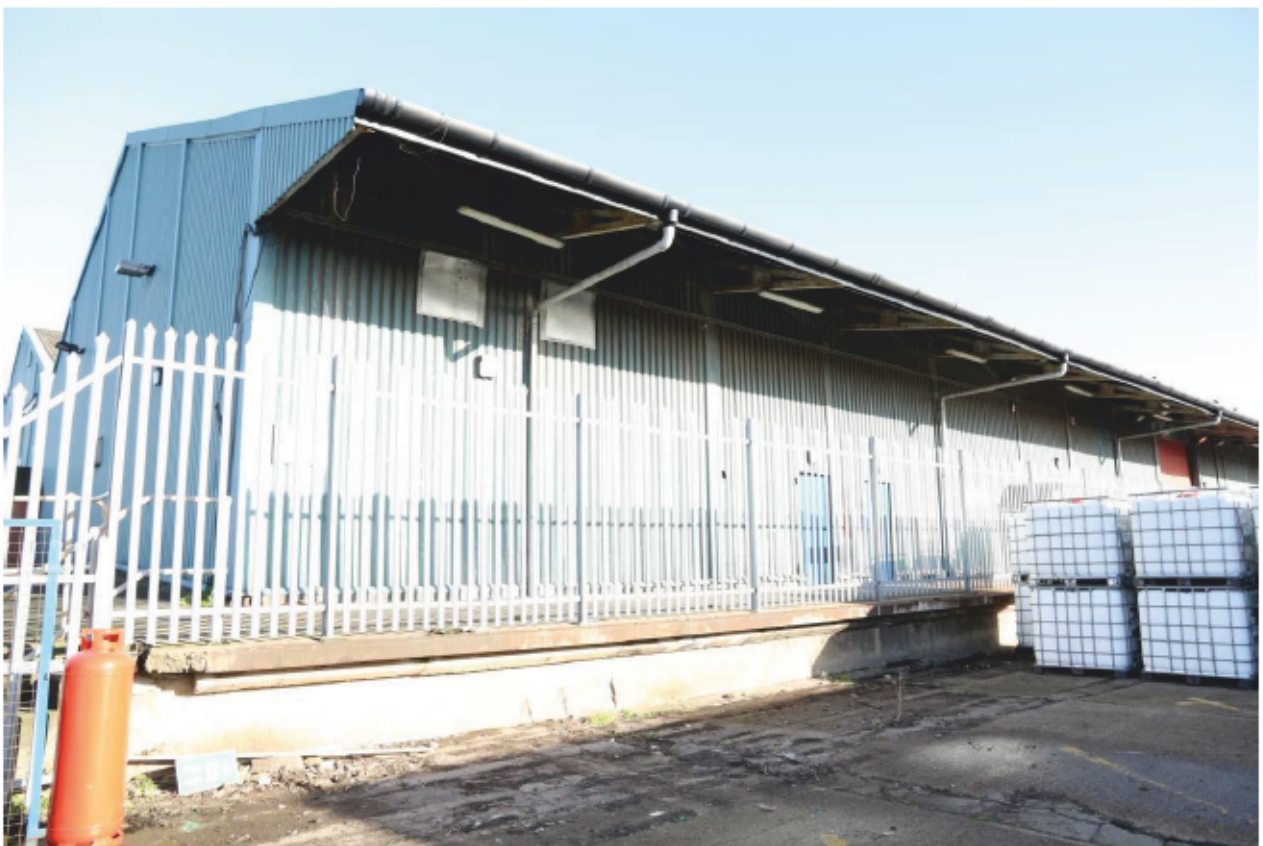
Plate 22: Original steel frame of Transit Shed 4 re-clad on the south side of King George V Dock, looking north-east (CIY17 D5 11)

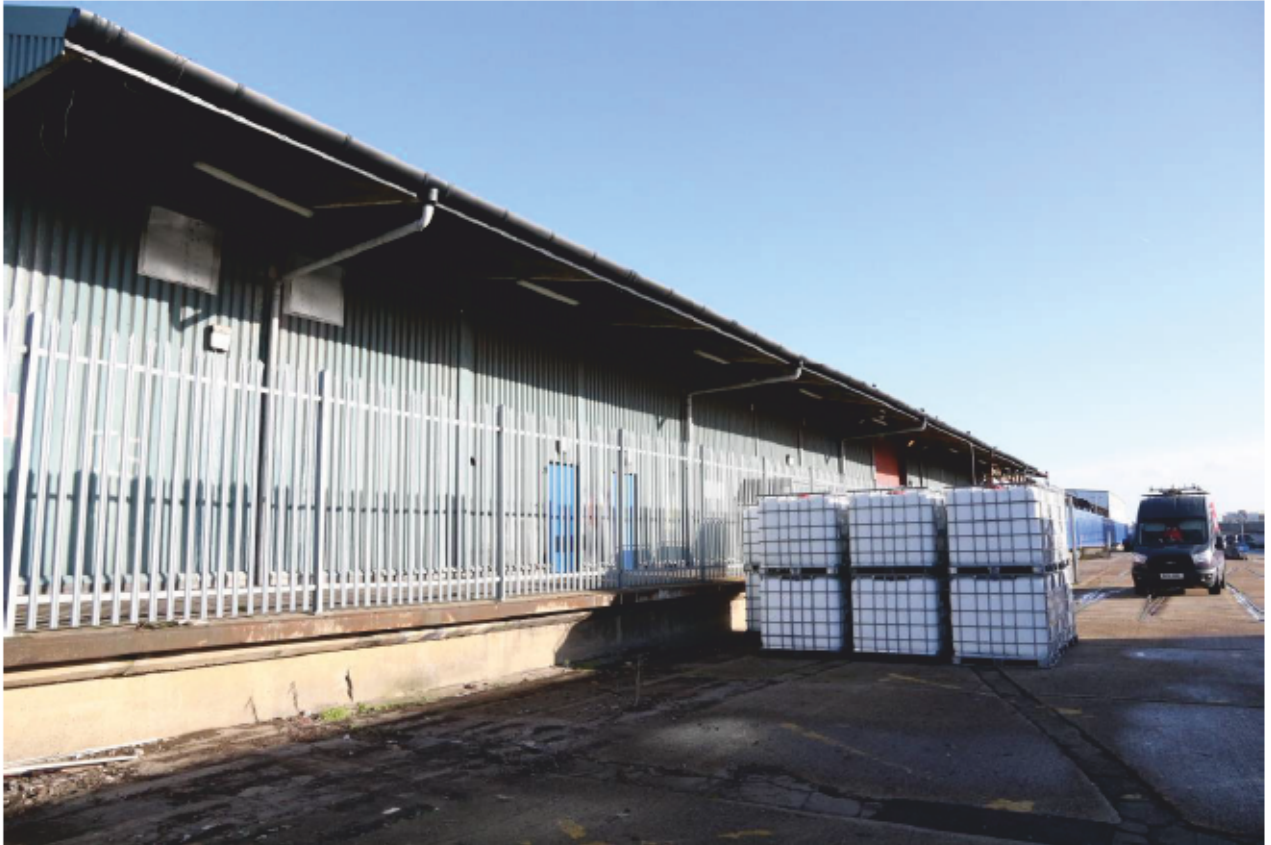
Plate 23: Original steel frame of Transit Shed 4 re-clad on the south side of King George V Dock, looking north-east (CIY17 D5 12)

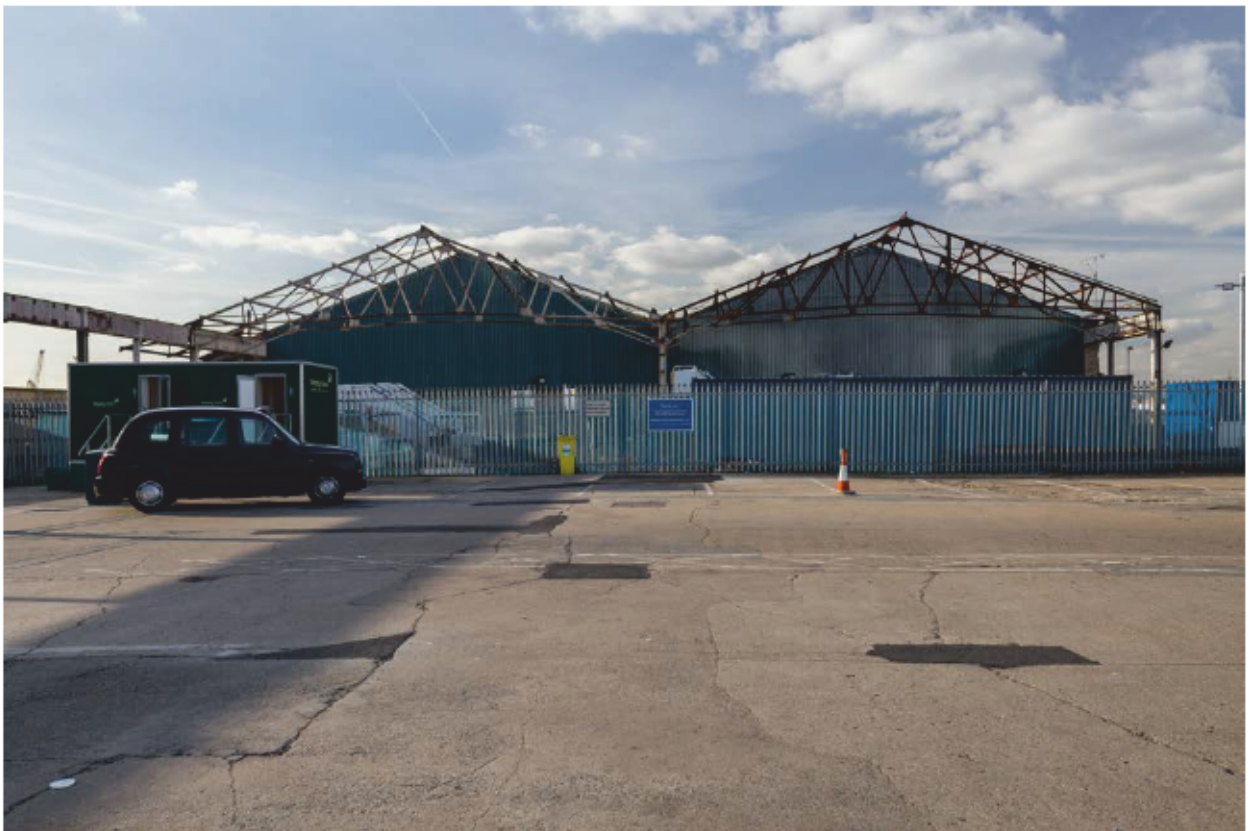
Plate 24: Steel angle roof trusses of Transit-Shed 4 on the south side of King George V Dock, looking west (CIY17 D100 026)

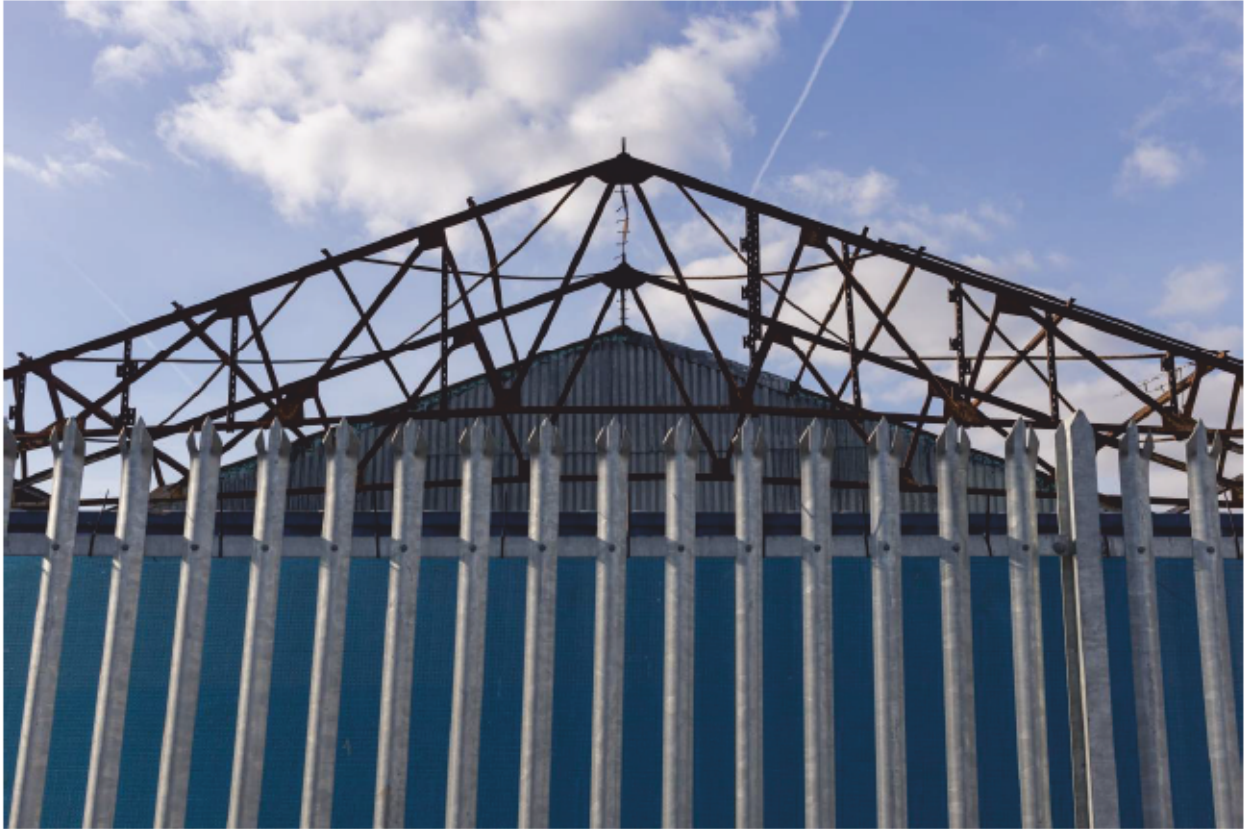
Plate 25: Steel angle roof trusses of Transit-Shed 4 on the south side of King George V Dock, looking west (CIY17 D100 027)

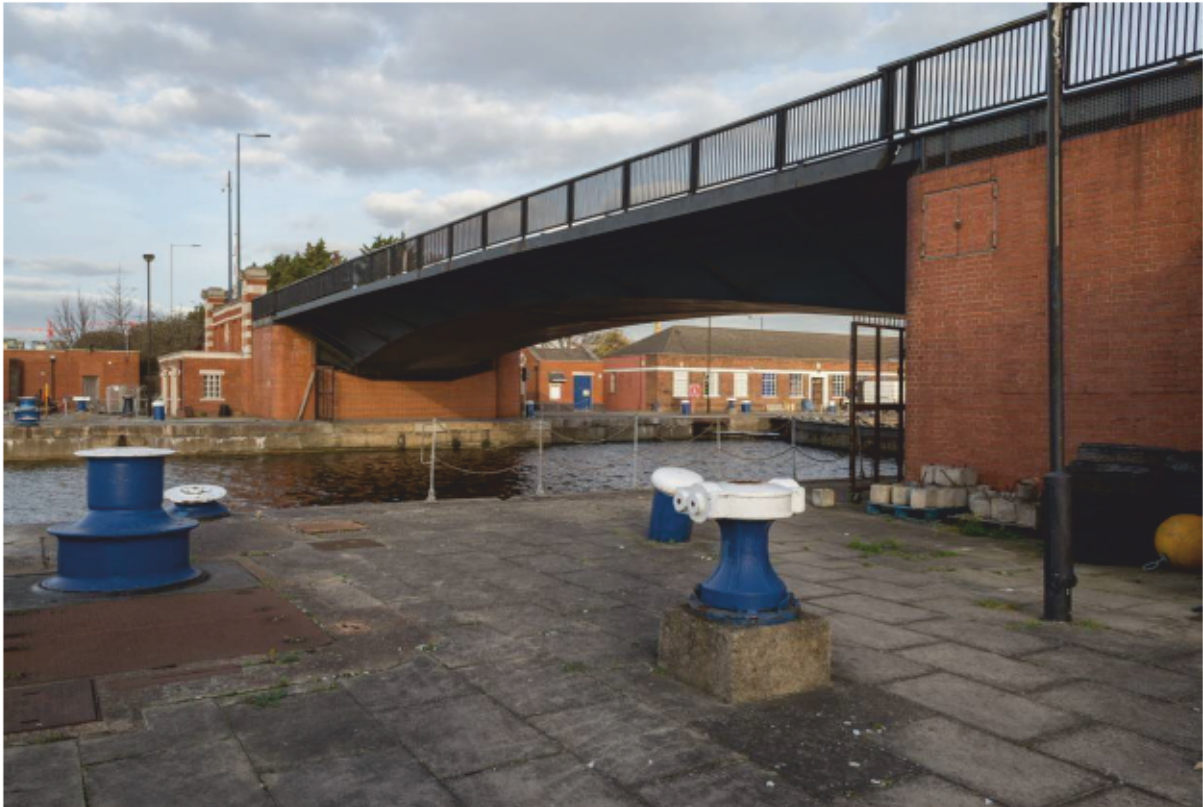
- 6.2.11 A Bascule Bridge at the mouth of the King George V Dock used to carry Woolwich Manor Way over King George V Lock (**Historic Plates 10 and 16**). It was replaced c.1990 with a steel bascule bridge (**Plate 39**). The bridge has classical red brick and stone abutments and was built c.1920 (**Plates 38 and 92**). King George V Lock lies to the east of the bridge (**Plate 40**).

Plate 39: Steel Bascule Bridge that replaced the former Bascule Bridge at the mouth of King George V Dock, looking north-east (CIY17 D100 042)

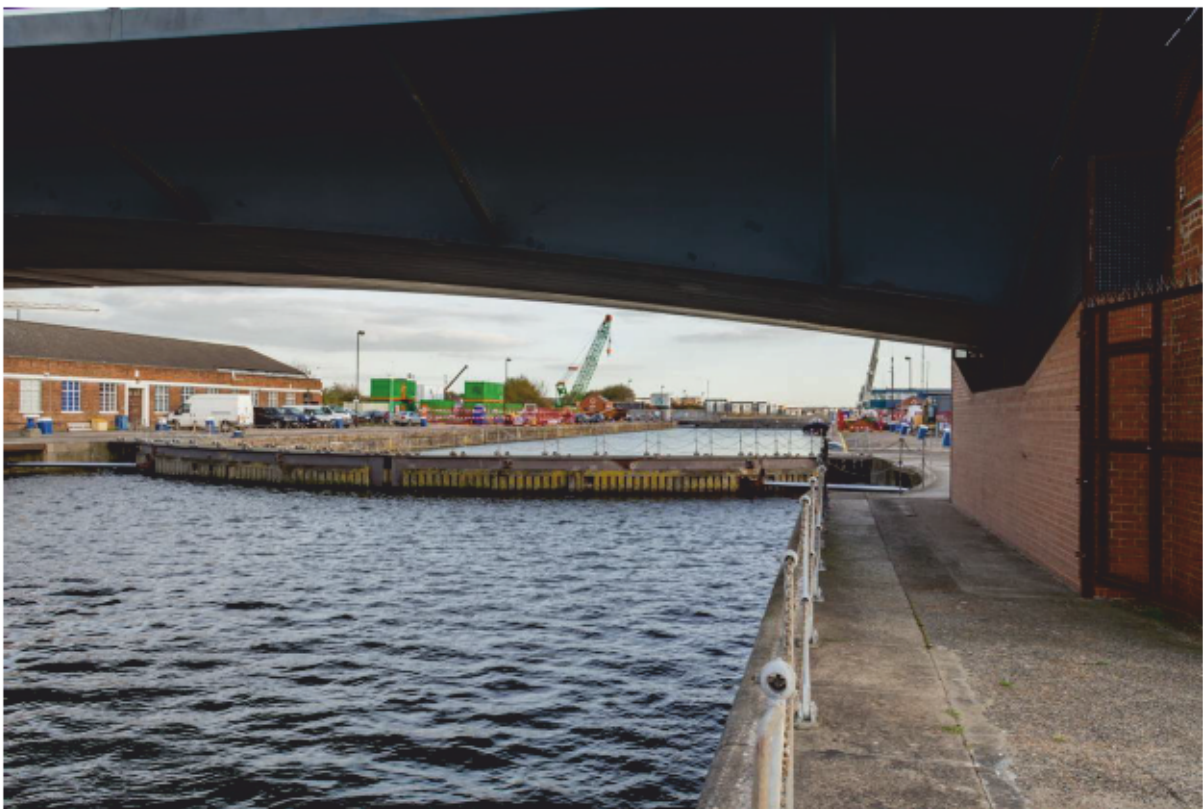
Plate 40: Lock gates of King George V Lock, looking east (CIY17 D100 043)

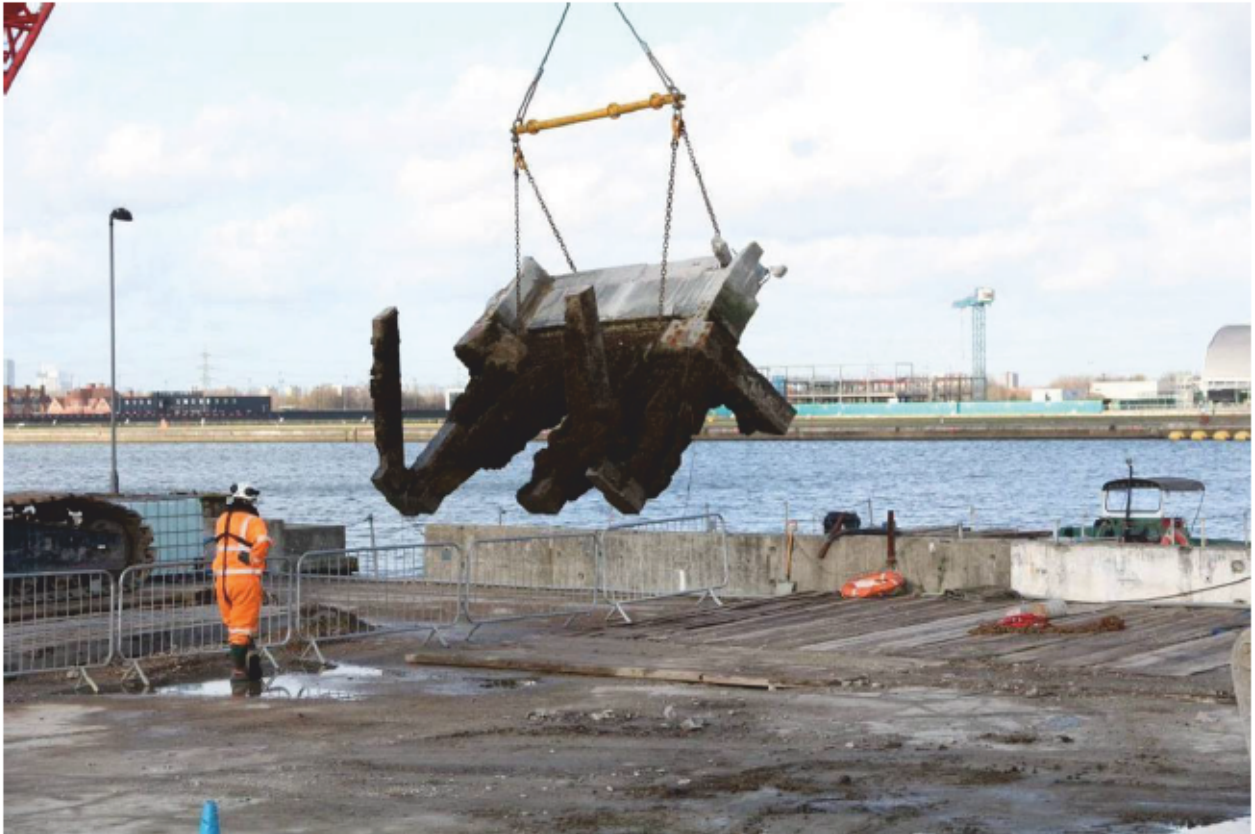
Plate 55: Large section of brace and mid-brace of Dolphin 7, looking north (CIY17 D5 59)

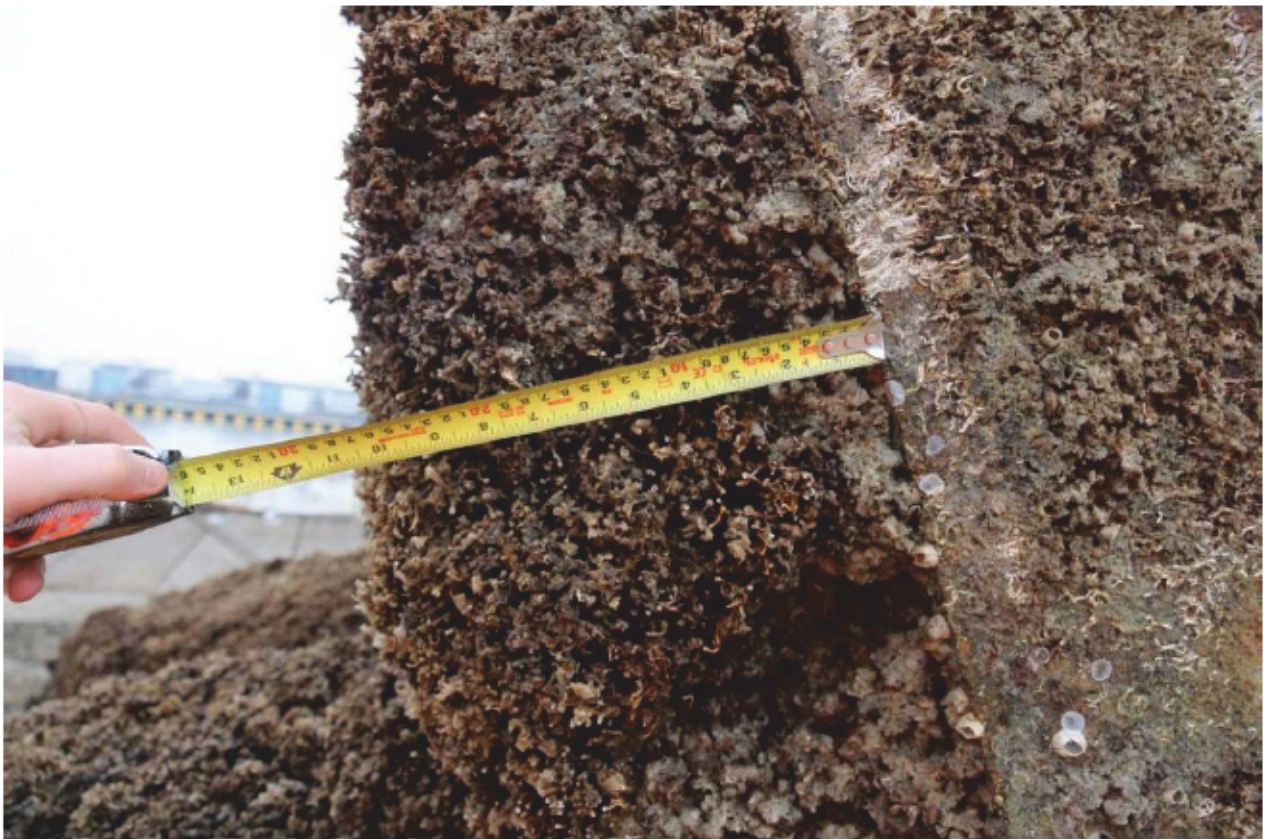
Plate 56: Aquatic growth on the below-water part of Dolphin 7, looking north (CIY17 D3 26)

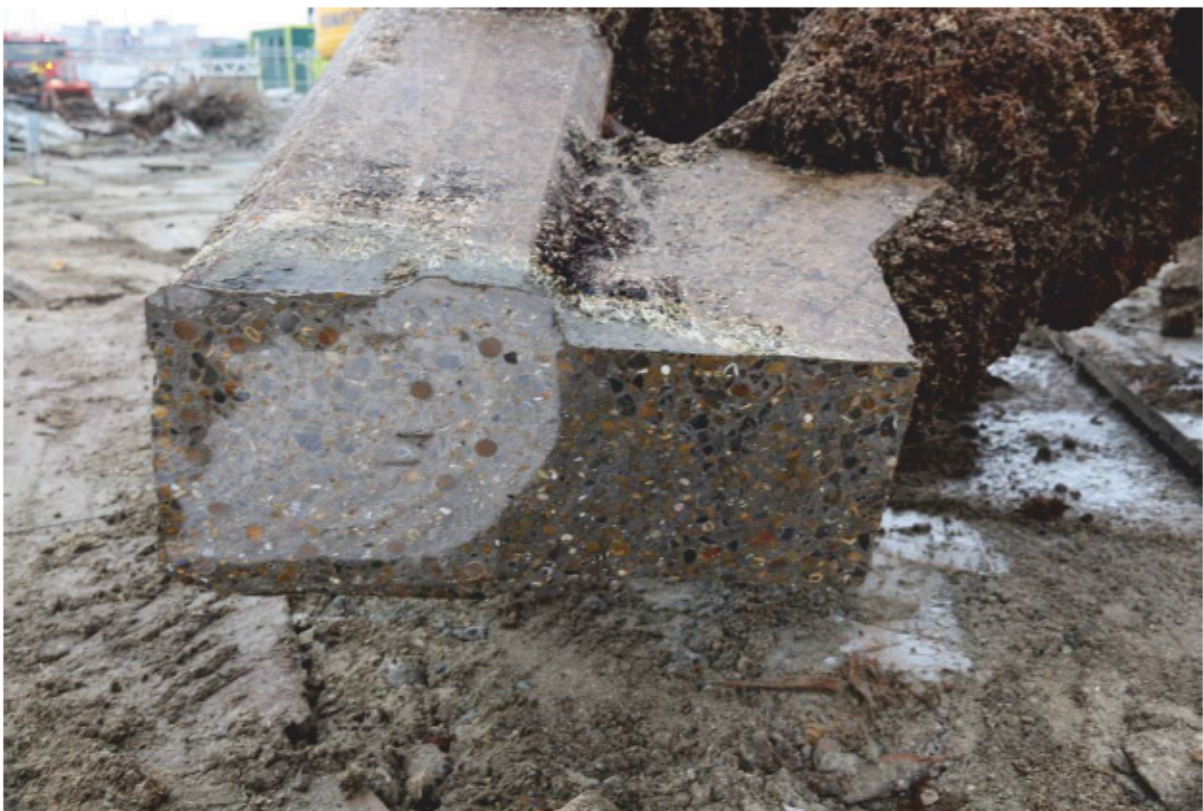
Plate 62: Cut section of Dolphin braced frame showing steel reinforcements, looking east (CIY17 D3 9)

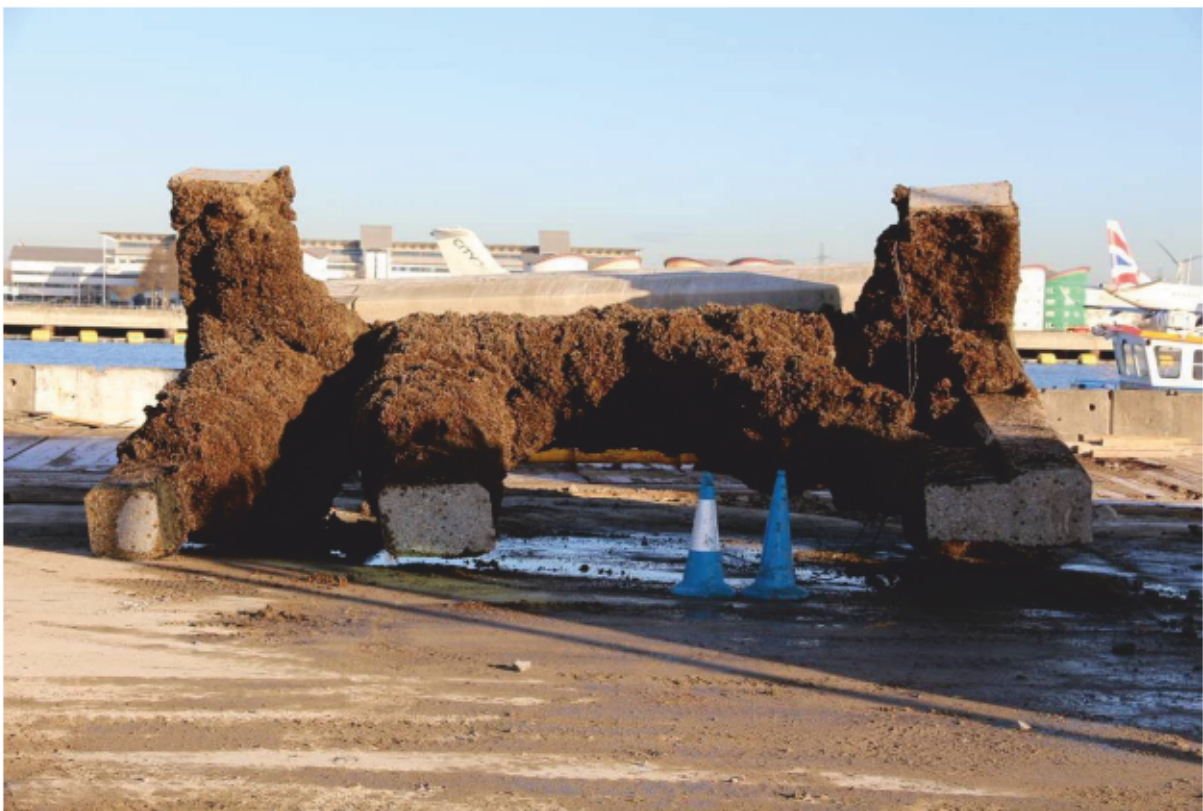
Plate 64: Below water part of Dolphin 7, looking north (CIY17 D4 29)

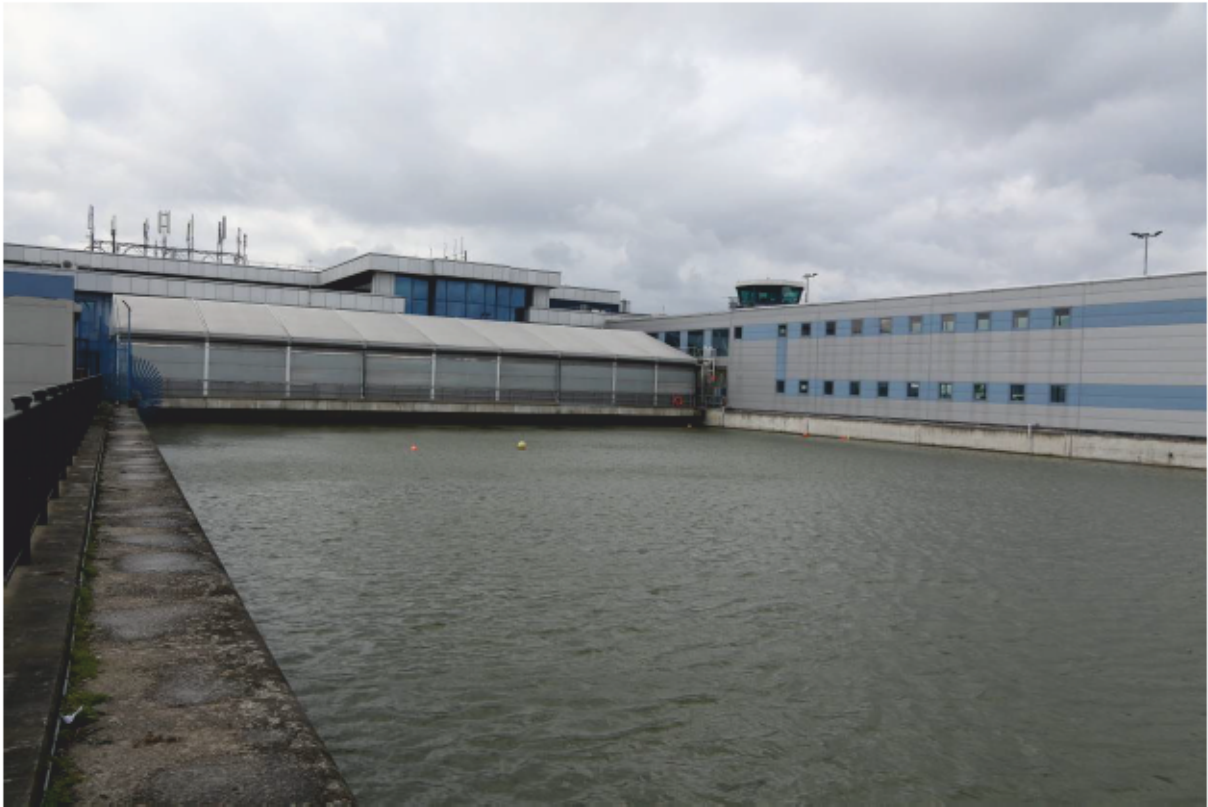
- 6.3.2 The 1980s concrete cap or deck of Dolphin 7 was removed from east to west by cutting it up into large slabs (some 5 to 6m in length and 2.7 to 3m in width) with a diamond wire saw. The slabs were then 'cradled' (held by two slings (looped chains) attached to a bar) and lifted by waterborne crane onto a floating compound/barge for transfer to the east end of the South Quay of the King George V Dock (**Plates 43 to 45**). The slabs were then lifted from the floating compound/barge by a crane on the dockside into the Topbond's Compound, where they were stacked, broken/crushed up and separated into steel rebars and concrete (**Plates 46 to 48**). The built heritage recording watching brief was carried out intermittently both from Topbond's boat and within Topbond's Compound (**Figure 19**).

Plate 67: West end of King George V Dock after removal of the upper part of Dolphin 7, looking north-west

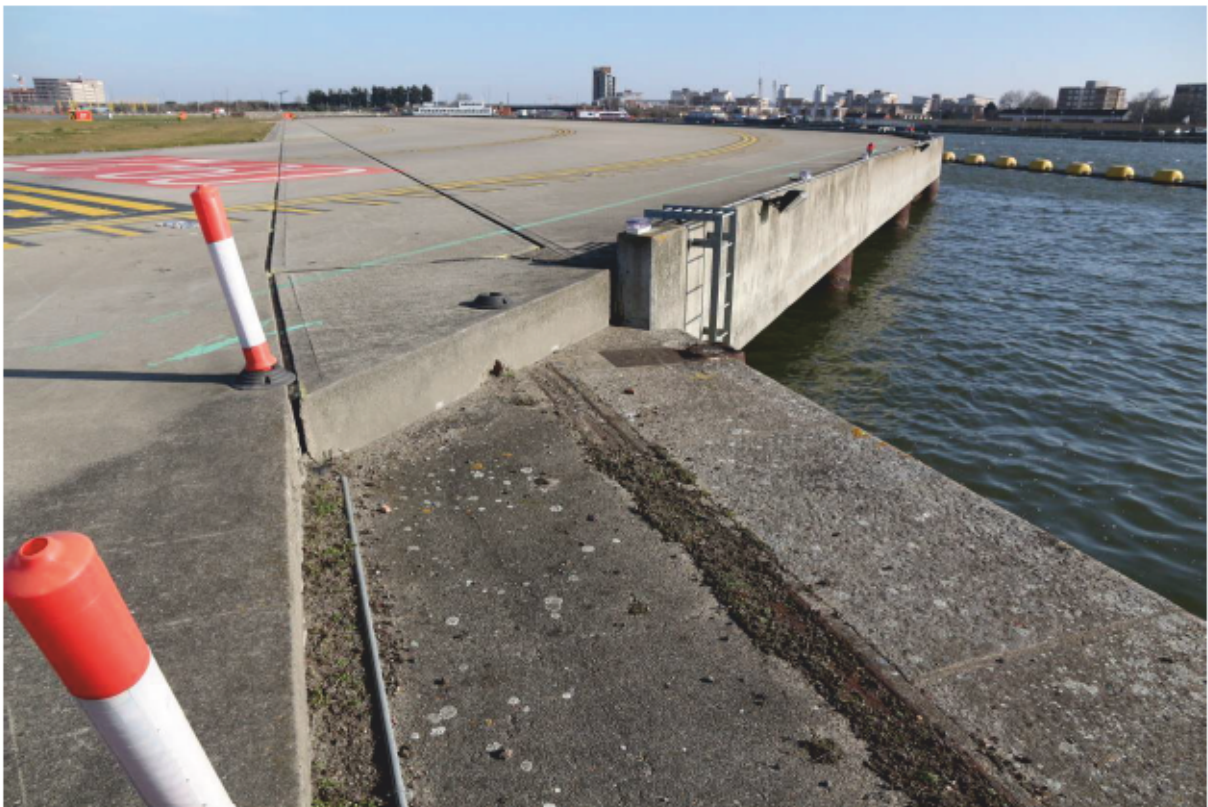
Plate 72: Railway tracks and coping stones continue under runway extension along north quayside of King George V Dock, looking east

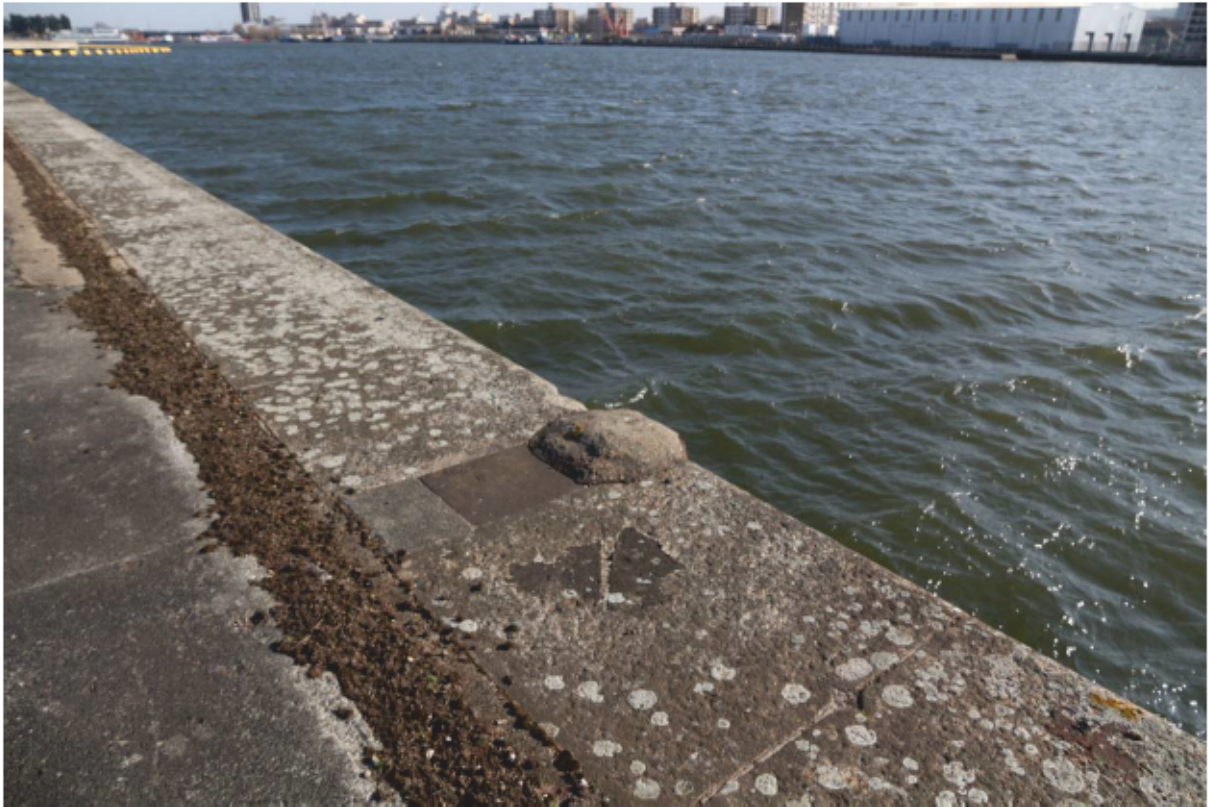
Plate 77: Remains of mooring post on the north quayside of King George V Dock, looking south-east
