**14 MOSS CLOSE, PINNER,
LONDON HA5 3AY**

**AN ARCHAEOLOGICAL WATCHING
BRIEF**

PCA REPORT NO: R13228

APRIL 2018

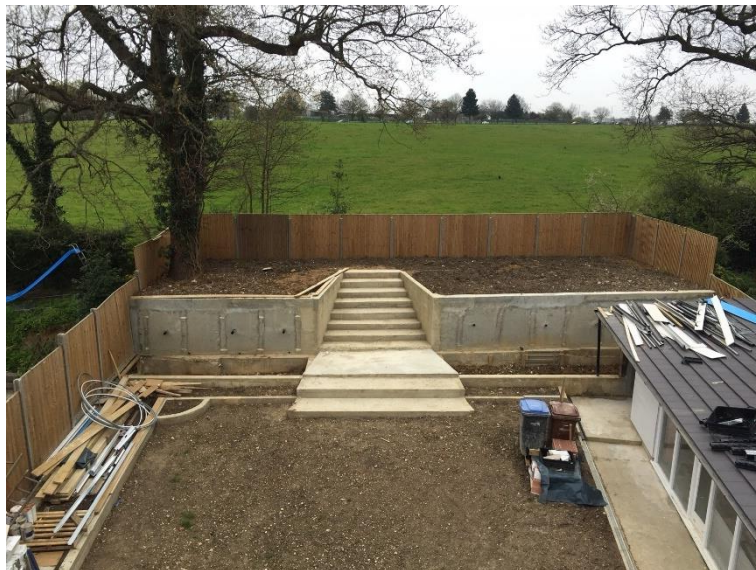
Plate 1: East facing view of recently constructed terrace, showing retaining wall and steps.

3.2.2 Mr Sisodia was not advised that his property included an element of the Scheduled Monument when he bought the property and then undertook the works to it. His alterations to the garden included: the construction of a detached summer house; the construction of a concrete retaining wall and steps to the rear of the River Pinn (on the side of the scheduled monument); the infilling of the land behind this retaining wall to create a level terrace atop the bank which provides views across the adjacent Pinner Deer Park; and the construction of a closed fence at the rear of the property (Plates 1 and 2).

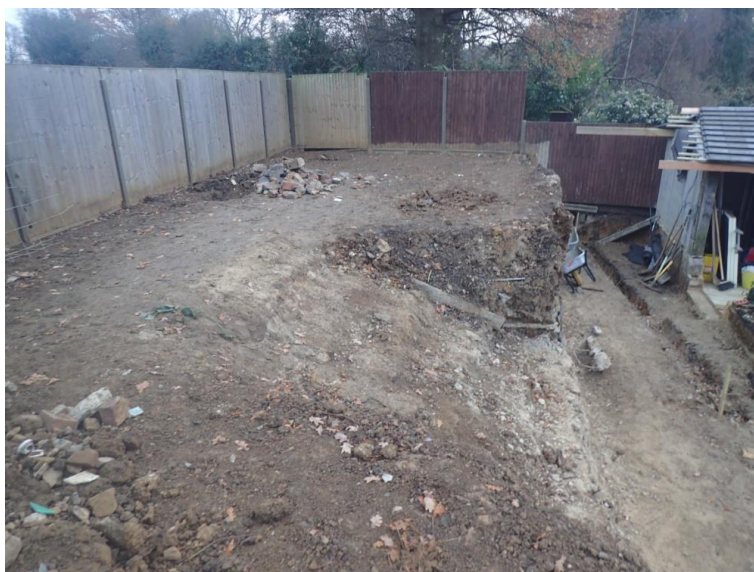
Plate 3: south-facing view after removal of retaining steps and excavation of slit trenches, prior to removal of modern ground.

- The excavation of 3 slit trenches aligned across the bank to establish the original surface of the monument and thereby guide the removal of modern made ground which had been deposited atop the bank behind the wall;
- The demolition and removal of the concrete retaining wall and steps;
- Then the removal of the modern made ground to expose the entirety of the earthwork.

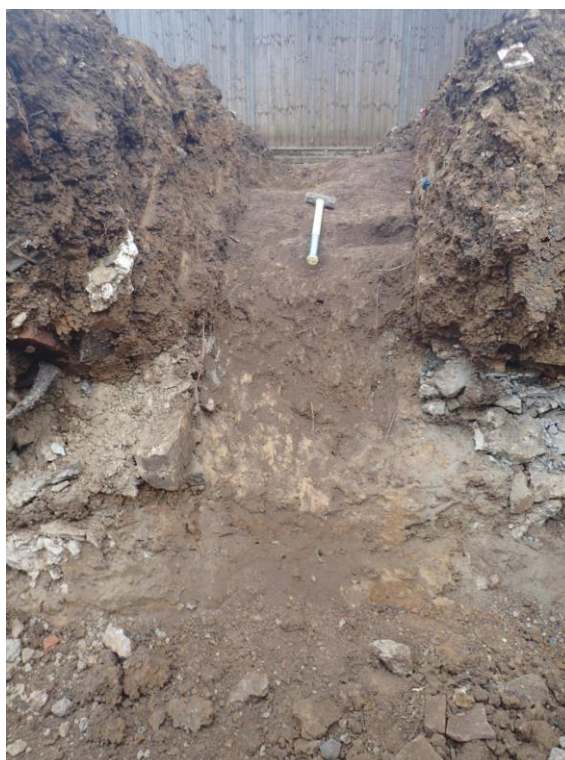
- 5.1.1 The earliest deposit recorded on the site was naturally deposited firm mid-light yellow-brown clay [1]. The clay had been heavily truncated by excavation in the medieval period to form the bank, however these excavation 'cuts' could no longer be discerned as sharp edges. The clay was recorded at levels between 54.34m OD and 53.40m OD; however the lower levels are entirely the product of human truncation and therefore are irrelevant.

Plate 4: Looking east at natural clay [1].

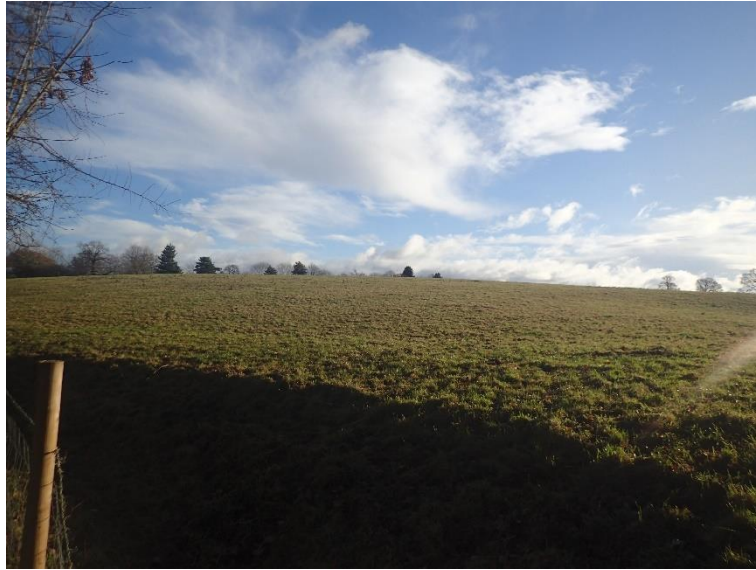
- 5.2.2 This excavation utilized the natural slope of the area (visibly falling from east on the monument to west, see Plate 5) to assist in the landscaping. A small inner ditch [2] excavated into the inner edge of the monument (corresponding to the small linear visible at the rear (east) of the site boundary) gives the impression of a raised earthwork at the perimeter bank. The bank then slopes down to the west [3], into the gardens of the site and the neighbouring properties, towards the River Pinn which flows N-S through the site.

Plate 5: View east across Deer Park from rear of site, showing natural topography (sloping down to

the site)

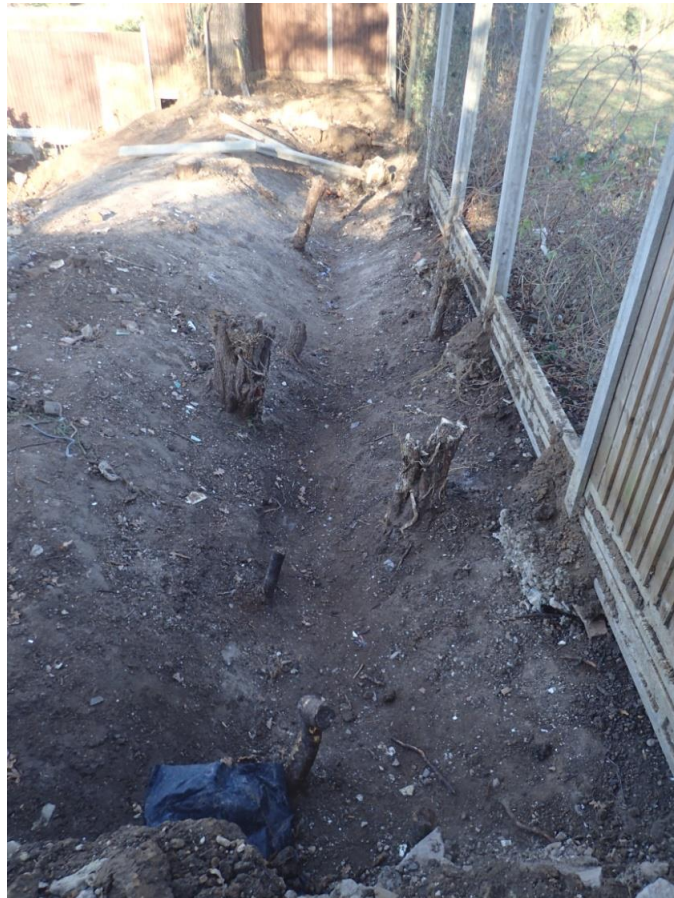
- 5.2.3 The bank was recorded during the watching brief at upper heights along its ridge between 54.34m OD and 54.13m OD. The inner ditch, no longer discernible as a cut feature but instead more of a gentle furrow (Plate 6), had basal levels between 53.70m OD and 53.58m OD. As the bank fell to the west to the River Pinn, the watching brief recorded levels between 53.84m OD and 53.40m OD.

Plate 6: Inner ditch [2] at rear of site, creating impression of raised bank to the west. The stumps are the result of modern (and older) vegetation, see Plate 7

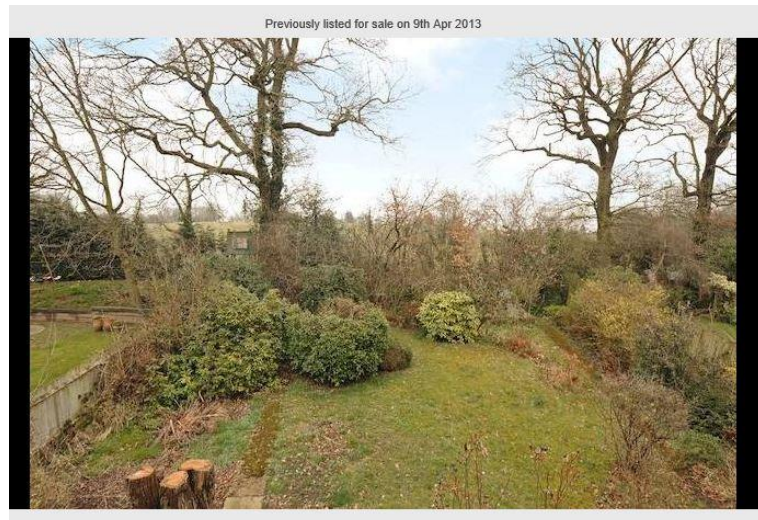
- 5.3.1 A thin layer of decomposing vegetation [4] was visible at the base of the inner ditch, the remnants of the vegetated and turfed surface to the bank as it was prior to the recent works (Plates 6 & 7).

Plate 7: View east of bank at rear of garden at point of client purchase.

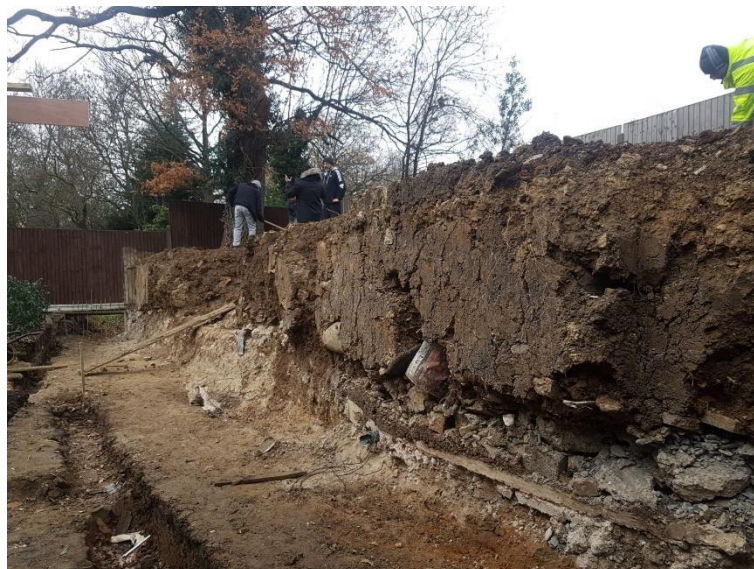
- 5.3.2 In the process of constructing a level terrace and steps leading to it, the recent works had caused truncation from construction cut [5] for the steps. This was a linear, open-sided cut which faced into the bank for a distance of approximately 7m N-S by a maximum of 1.71m E-W (Figures 3 & 4, Plates 8 & 9).

Plate 8: view north after removal of retaining wall, showing modern cut [5] into lower face of bank

[3]

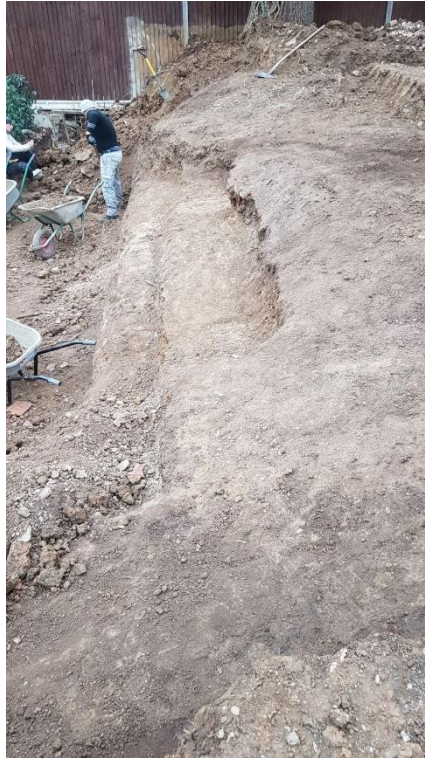
Plate 9: view north of bank, cleaned to show extent of modern truncation [5]

- 5.3.3 It was noted that only the lower portion of the bank facing the garden was damaged, the upper section remaining largely intact.
- 5.3.4 Sealing the clay bank was a substantial deposit of rubble and silty clay [6] dumped to create the recent terrace to a heights at around 54.50m OD.

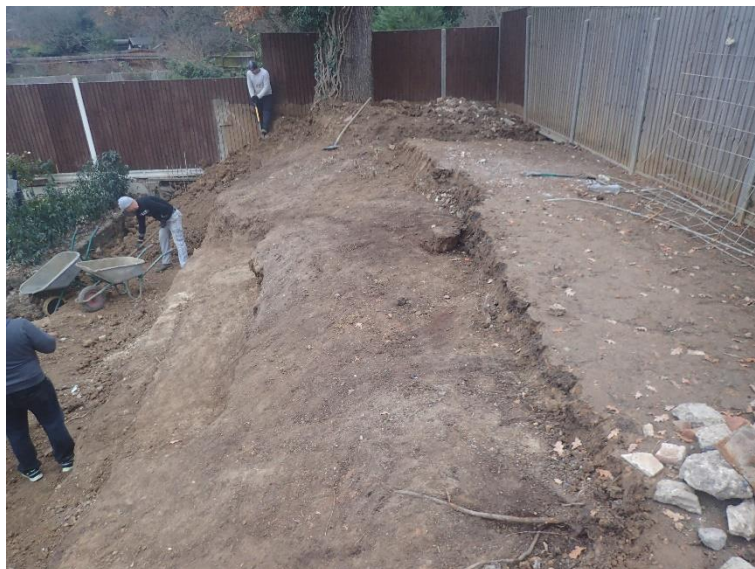
Plate 10: view north of bank during removal of modern dumped material [6]

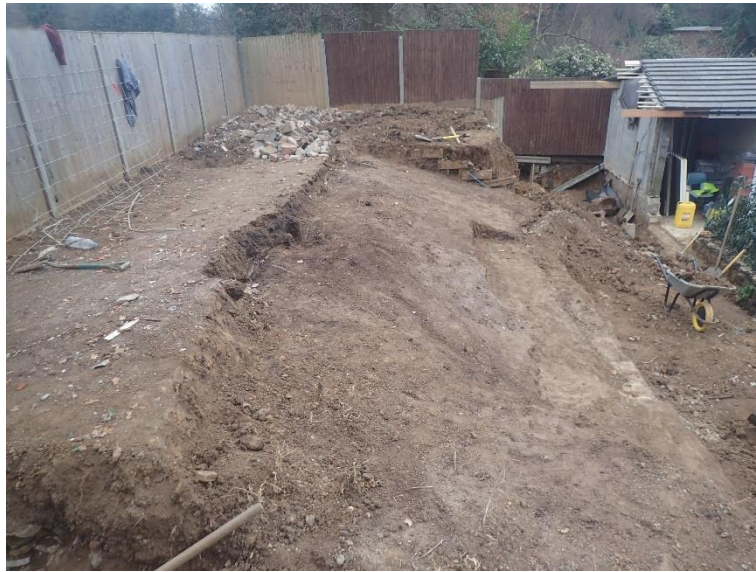
Plate 11: view south of bank during removal of modern dumped material [6]

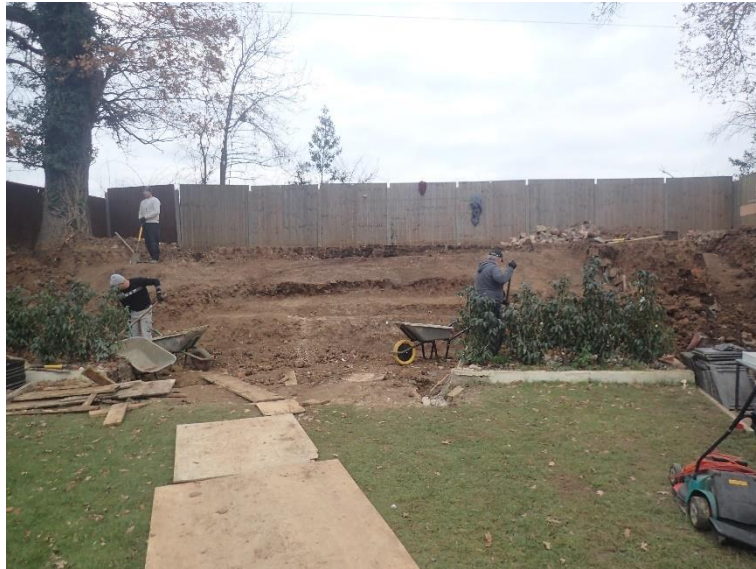
Plate 12: view east of bank during removal of modern dumped material [6]

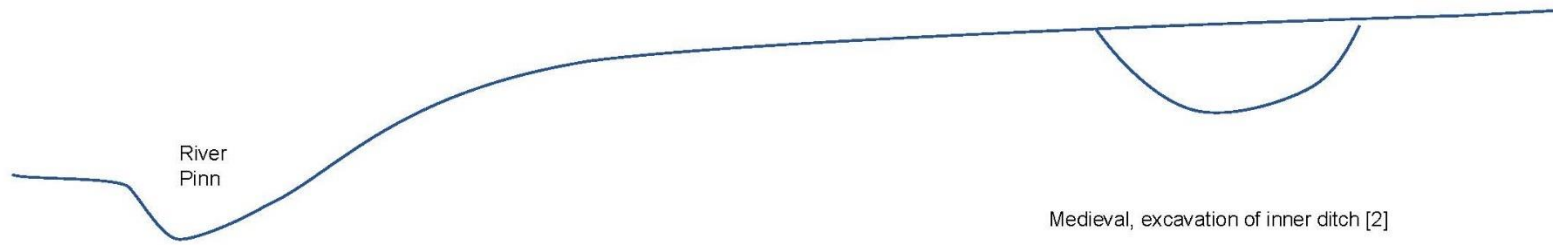
Schematic development of medieval earthwork, view north

- 6.2 The excavations have revealed the London Clay Formation which underlies the site, and the evidence suggests that the earth bank which forms the perimeter to the Old Pinner Deer Park scheduled monument was created by excavation into the naturally sloping topography of the area, rather than being the result of upstanding construction. On the inner face of the existing bank, a shallow ditch was found which is likely to be medieval in date (datable artifacts were notable in their absence from the site). The excavation of this ditch had the effect of raising the profile of the external bank. No evidence was found for any upcast material from the excavation of the ditch, and therefore it is possible that it was either removed from the area, ploughed away over later centuries or deposited to the east, beyond the site boundary. The bank incorporated an existing topographic feature (the River Pinn) to defined its western side.

- 6.3 A schematic interpretation of how the bank has been formed is suggested below.
- 6.4 With the exception of the modern construction cut for the steps and heavy tree rooting, the removal of the made ground revealed the monument in good state of preservation. A profile of the bank was recorded (Figures 3 & 4). The former surface of the bank prior to the modern work has been sealed below a membrane of geotextile material and then topsoil, and will eventually be turfed.
